ANNUAL REPORT FOR 2014

Georges Fork Site #26 Mitigation Site
Yancey County
TIP No. R-2519A
COE Action ID: SAW-2007-2197-357/300
DWR #: 2007-1134V.4

Prepared By:
Natural Environment Section & Roadside Environmental Unit
North Carolina Department of Transportation
December 2014

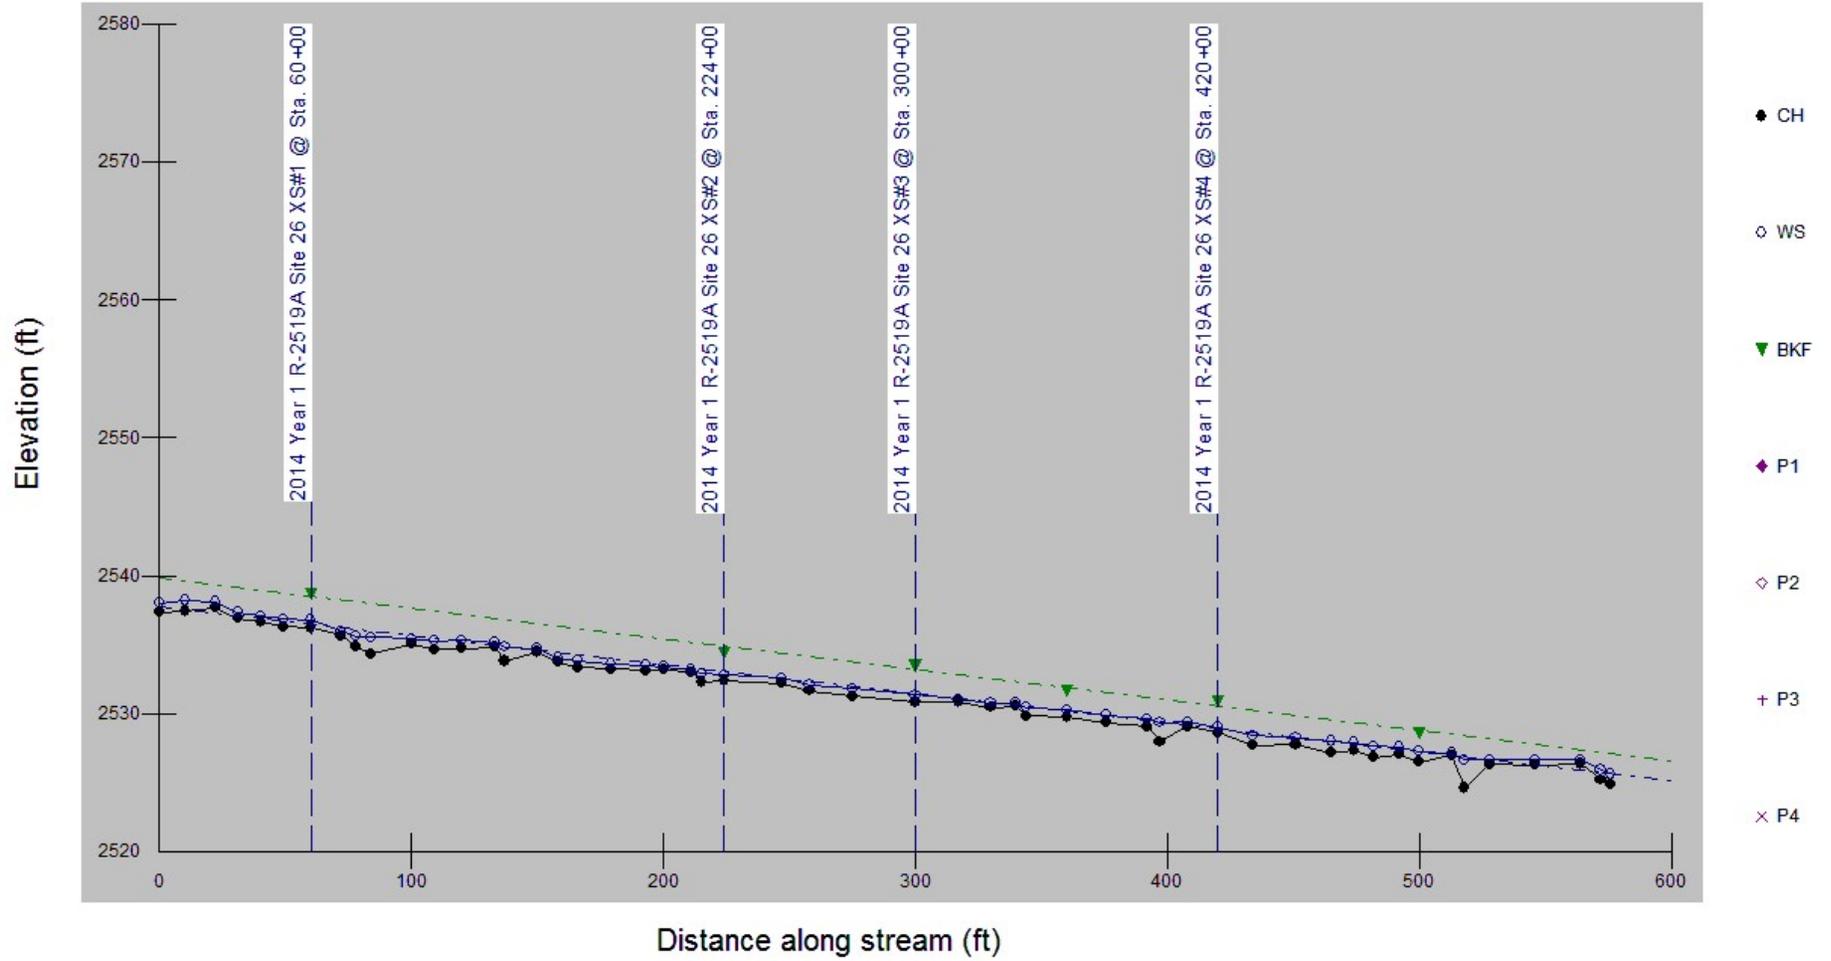
2014 Year 1 R-2519A Site 26 Profile

Based on comparisons of the As-Built to the monitoring data, all of the cross sections appear stable with little or no active bank erosion. Graphs of the cross sections are presented in Appendix A. Future survey data will vary depending on actual location of rod placement and alignment; however, this information should remain similar in appearance. The longitudinal profile showed that the channel was stable for the 2014 monitoring evaluation. Pebble counts were not required per the permit conditions and therefore were not completed. One bankfull event was documented visually by a noted wrack line at Site #26 during the 2014 monitoring year.
