ANNUAL REPORT FOR 2014

**Plum Branch Site #33 Mitigation Site
Yancey County
TIP No. R-2519A
COE Action ID: SAW-2007-2197-357/300
DWR #: 2007-1134V.4**

Prepared By:
Natural Environment Section & Roadside Environmental Unit
North Carolina Department of Transportation
December 2014

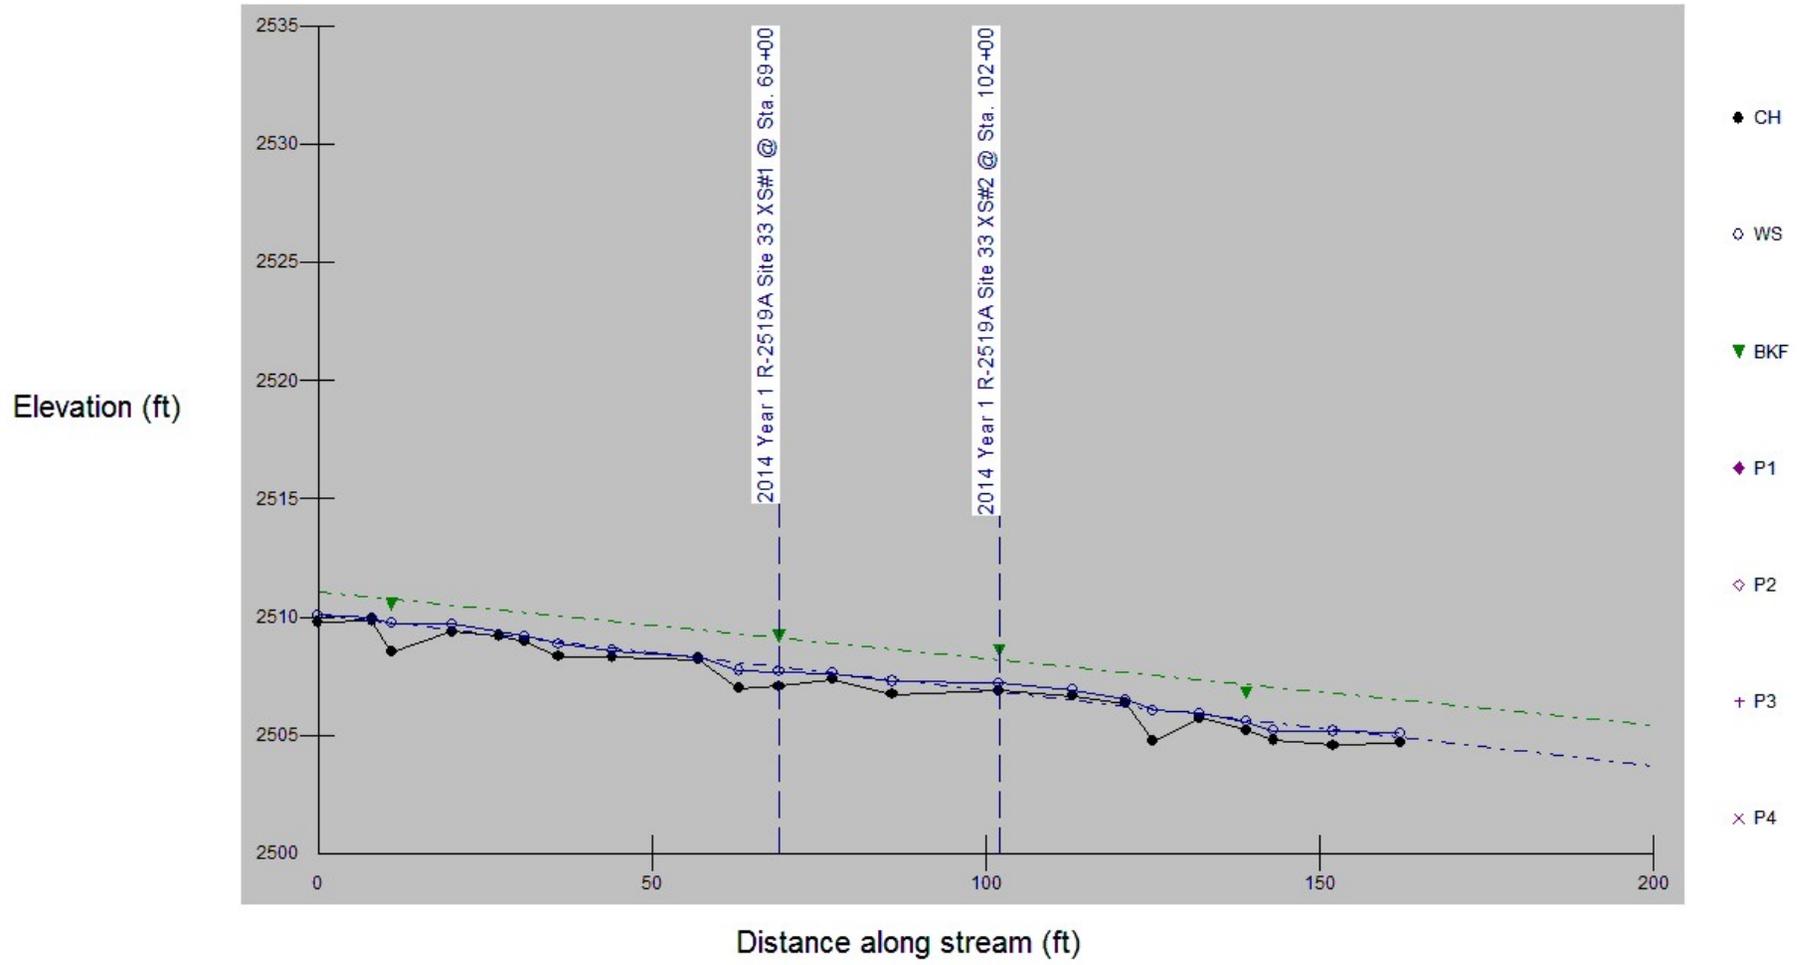
2014 Year 1 R-2519A Site 33 Profile

Based on comparisons of the As-Built to the monitoring data, all of the cross sections appear stable with little or no active bank erosion. Graphs of the cross sections are presented in Appendix A. Future survey data will vary depending on actual location of rod placement and alignment; however, this information should remain similar in appearance. The longitudinal profile showed that the channel was stable for the 2014 monitoring evaluation. Pebble counts were not required per the permit conditions and therefore were not completed. One bankfull event was documented visually by a noted wrack line at Site #33 during the 2014 monitoring year.
