# ANNUAL REPORT FOR 2015

**Plum Branch Tributary Site #32 Mitigation Site  
Yancey County  
TIP No. R-2519A  
COE Action ID: SAW-2007-2197-357/300  
DWR #: 2007-1134V.4**

Prepared By:  
Natural Environment Section & Roadside Environmental Unit  
North Carolina Department of Transportation  
December 2015

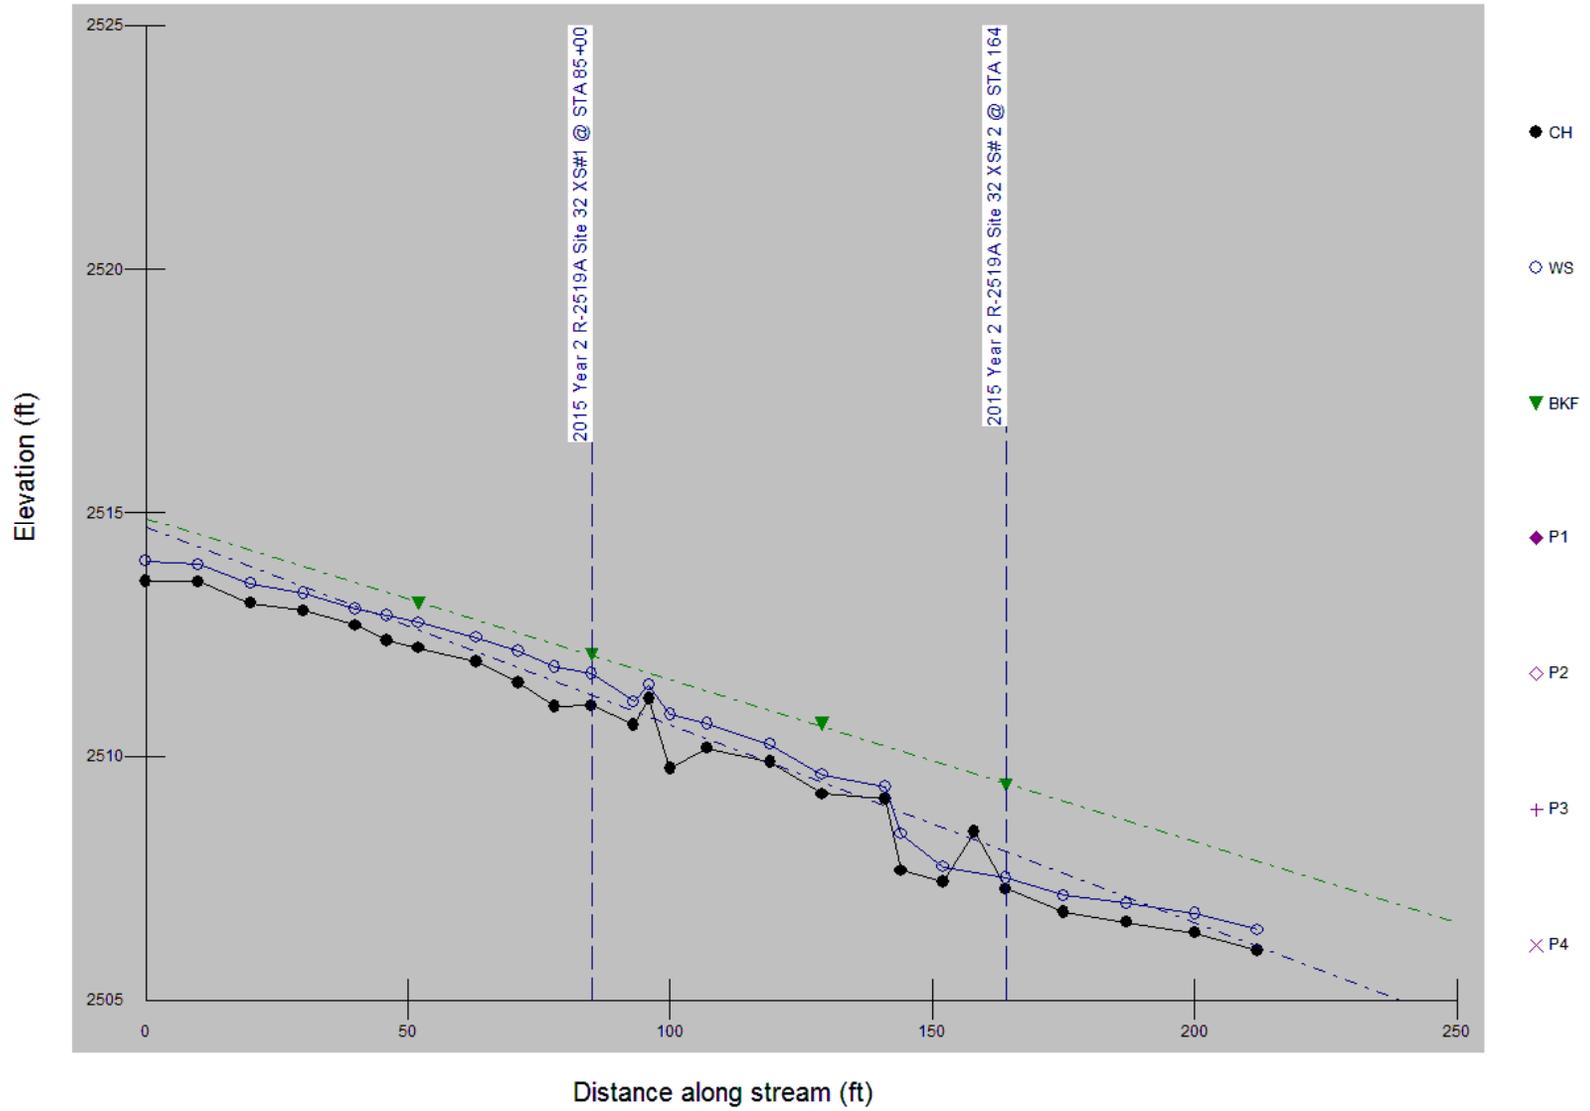
2015 Year 2 R-2519A Site 32 Profile

Based on comparisons of the As-Built to the monitoring data, all of the cross sections appear stable with little or no active bank erosion. Some sediment deposition was noted within the upstream portion of the site as seen in Cross Section #1. Graphs of the cross sections are presented in Appendix A. Future survey data will vary depending on actual location of rod placement and alignment; however, this information should remain similar in appearance. The longitudinal profile showed that the channel bed had formed a headcut at longitudinal profile Sta. 140+00. The right bank at longitudinal profile Sta. 179+00 is scouring causing an undercut bank. NCDOT plans to repair the stream. Pebble counts were not required per the permit conditions and therefore were not completed. One bankfull event was documented visually by a noted wrack line at Site #32 during the 2014 monitoring year but none were visually noted in 2015.
