ANNUAL REPORT FOR 2014

**Unnamed Tributary to Smith Mill Run
Wayne County
TIP No. R-2554BA – Permitted Site 4
COE Action ID: SAW-200-00252
DWQ #: 20080570**

Prepared By:
Roadside Environmental Unit & Natural Environment Section
North Carolina Department of Transportation
August 2014

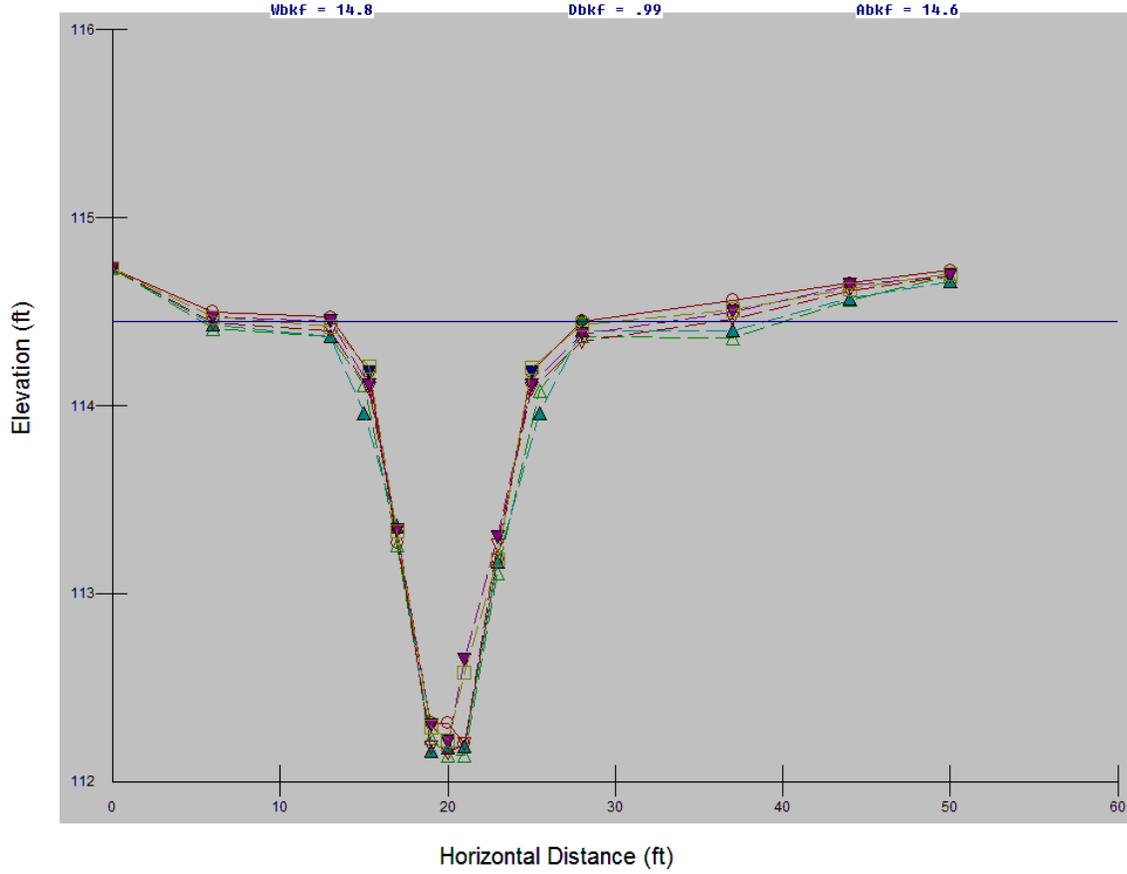
R-2554BA Site 4 XS-2 @ Sta. 251+00

Based on comparisons of the as-built to the monitoring data, all six cross sections appear stable with little or no active bank erosion. Graphs of the cross sections are presented in Appendix A. Future survey data will vary depending on actual location of rod placement and alignment; however this information should remain similar in appearance.

Cross-Section #2 (Pool) Abbreviated Morphological Summary*					
	2010	2011	2012	2013	2014
Bankfull Cross Sectional Area (ft ²)	15.81	13.74	13.12	13.76	14.64
Maximum Bankfull Depth (ft)	2.24	2.19	2.17	2.21	2.25
Bankfull Mean Depth (ft)	0.85	0.94	0.9	0.84	0.99
Bankfull Width (ft)	18.5	14.55	14.53	16.4	14.84

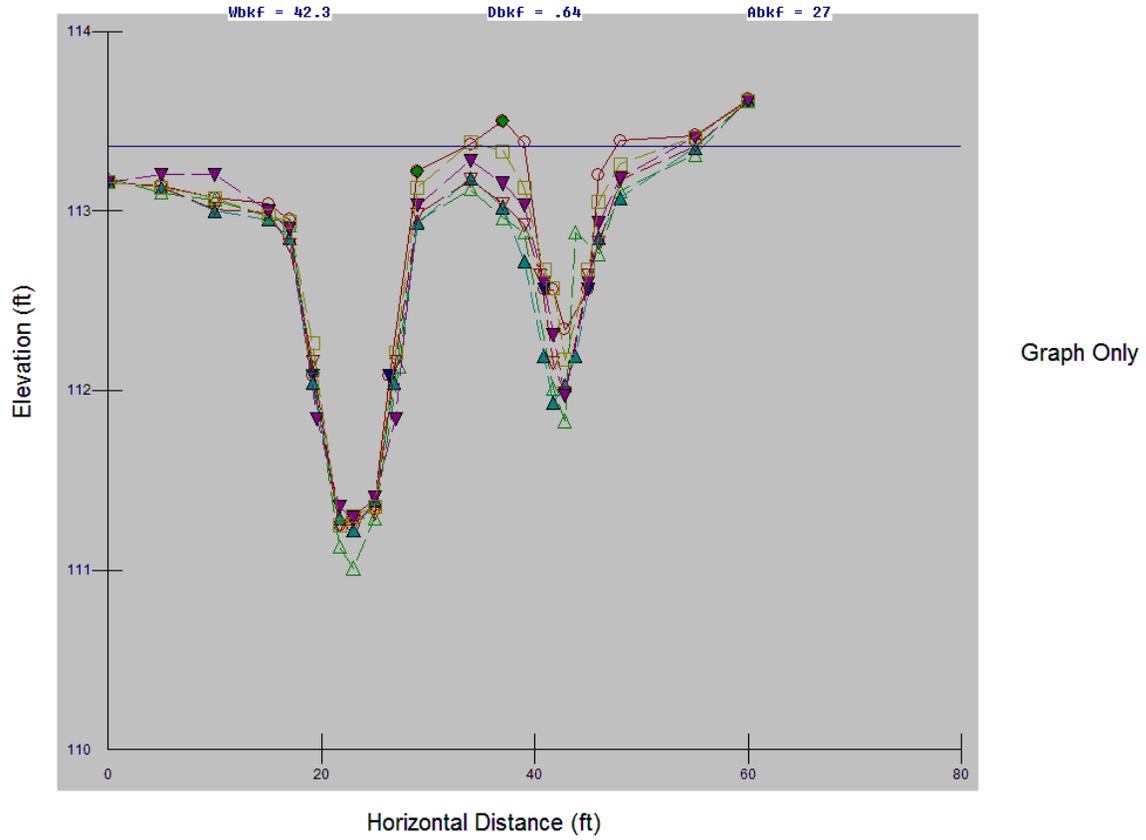
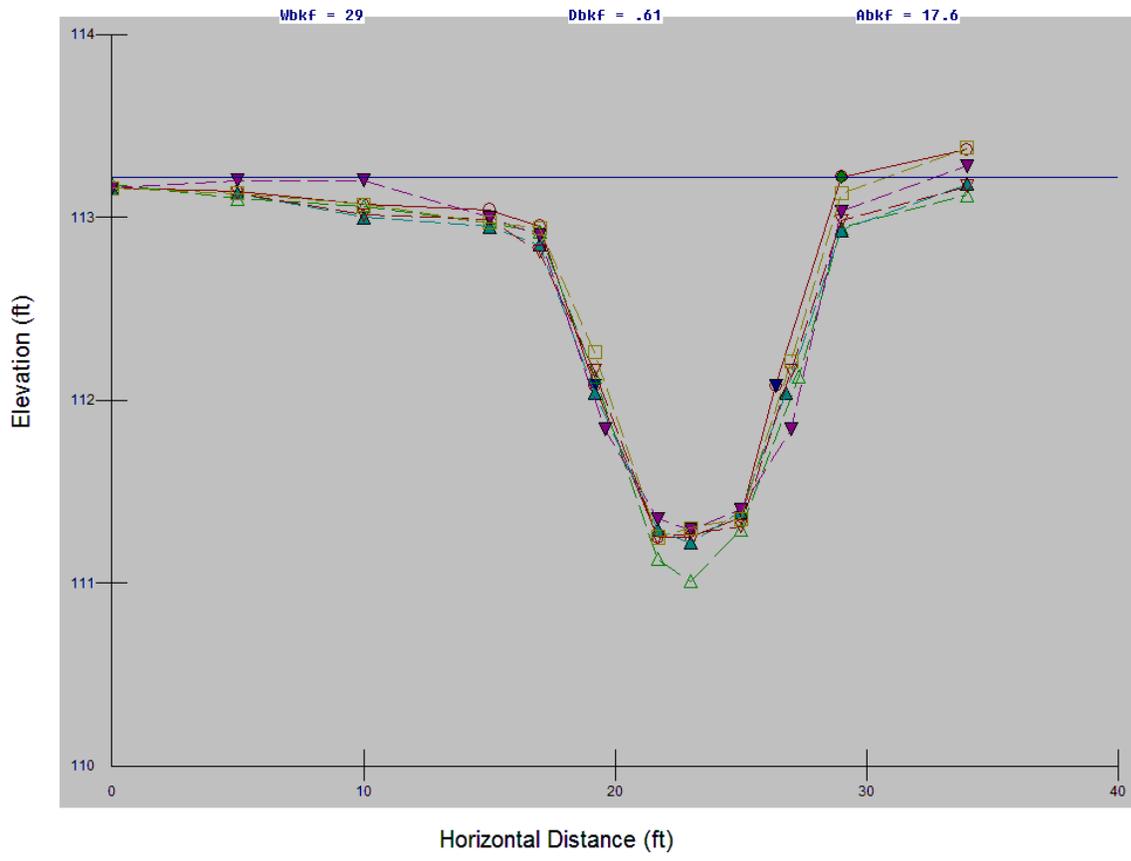
R-2554BA Site 4 Pool XS-4 @Sta. 426+50 on Main Channel

Cross-Section #4 (Main Pool) Abbreviated Morphological Summary*					
	2010	2011	2012	2013	2014
Bankfull Cross Sectional Area (ft ²)	12.89	13.36	14.5	15.14	15.41
Maximum Bankfull Depth (ft)	1.71	1.73	1.74	1.88	1.97
Bankfull Mean Depth (ft)	0.95	0.96	0.98	0.8	1.28
Bankfull Width (ft)	13.6	13.89	14.75	19	12

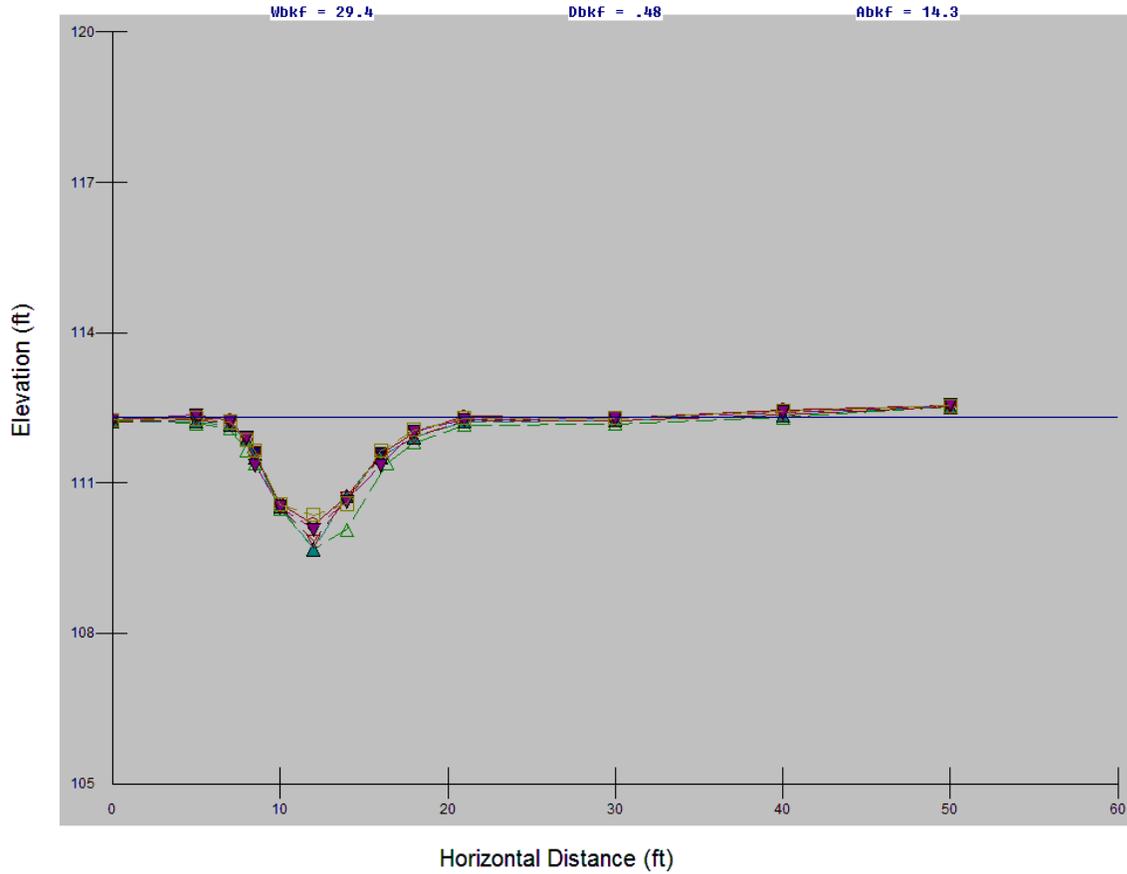
R-2554BA Site 4 XS-5 @ Sta 593+50

Cross-Section #5 (Pool) Abbreviated Morphological Summary*					
	2010	2011	2012	2013	2014
Bankfull Cross Sectional Area (ft ²)	14.34	14.6	14.27	13.37	13.99
Maximum Bankfull Depth (ft)	2.55	2.43	2.19	1.94	2.15
Bankfull Mean Depth (ft)	0.9	0.91	0.99	0.84	0.88
Bankfull Width (ft)	16	16	14.36	16	15.91

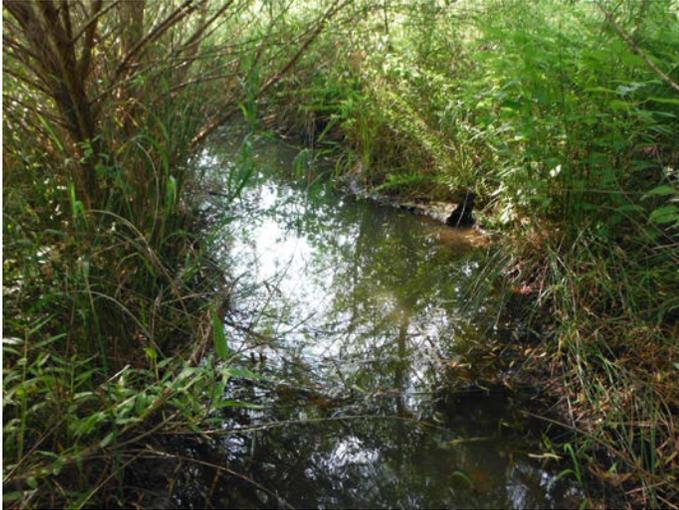
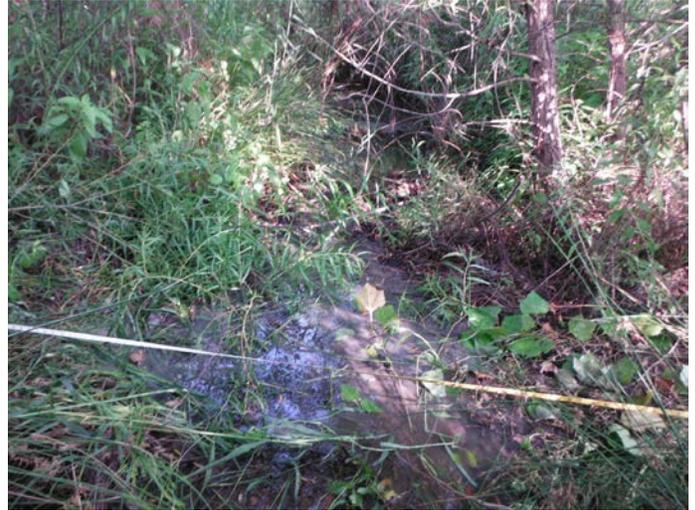
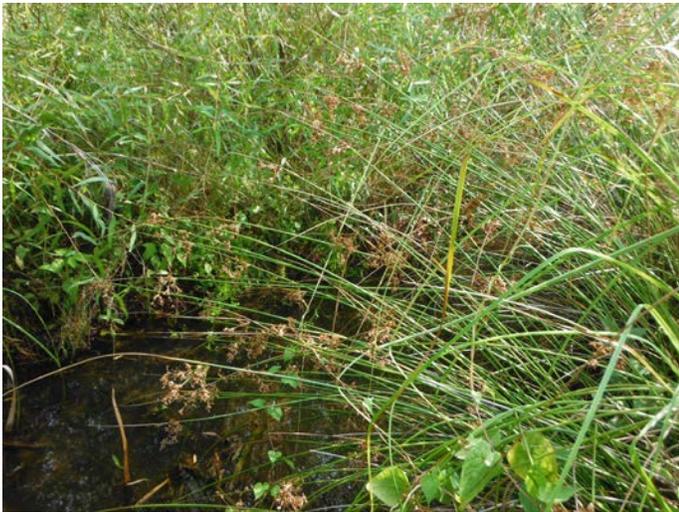
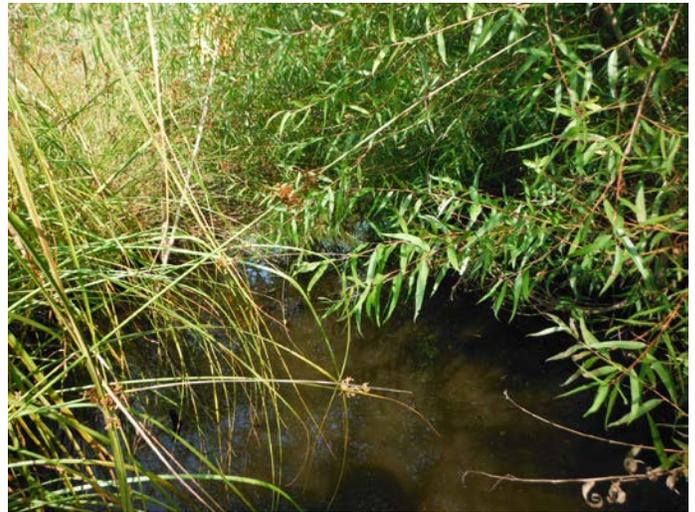
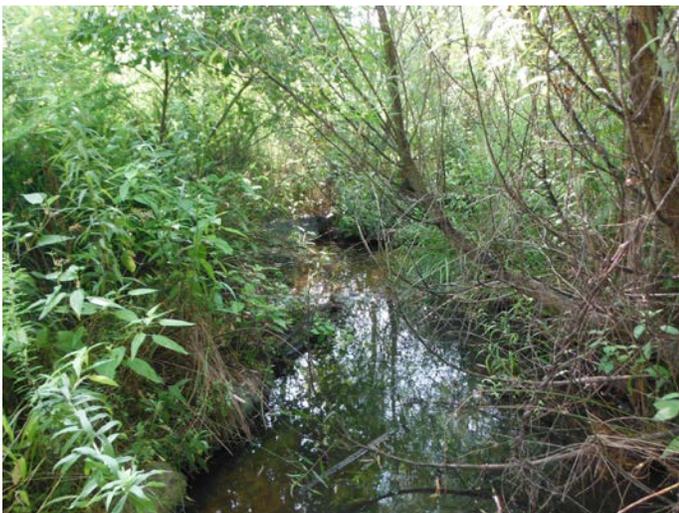
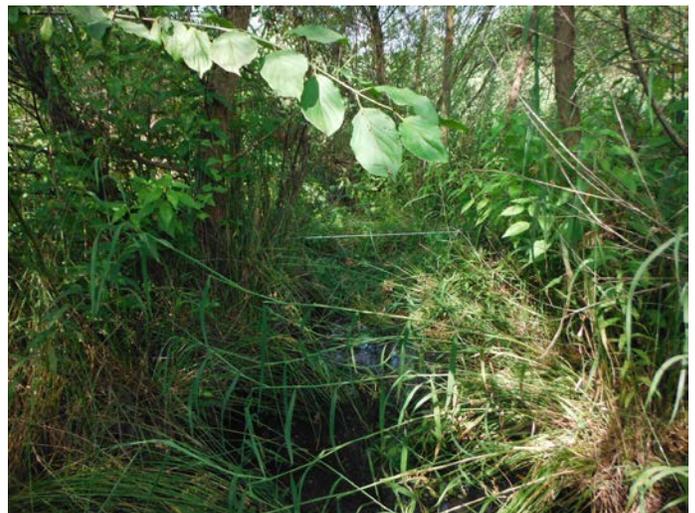
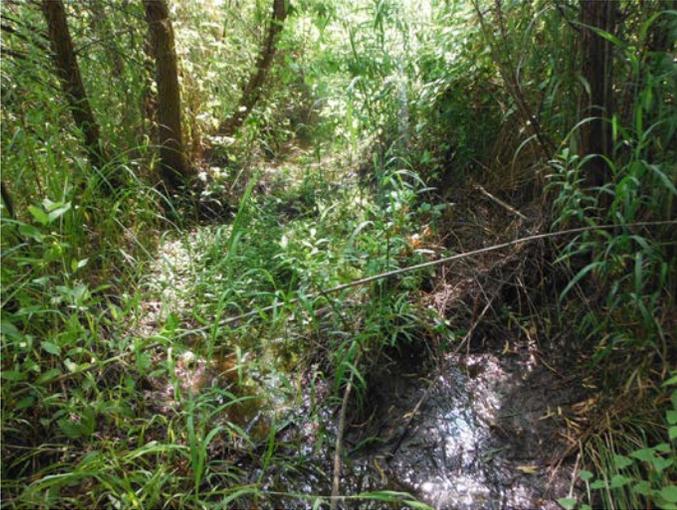
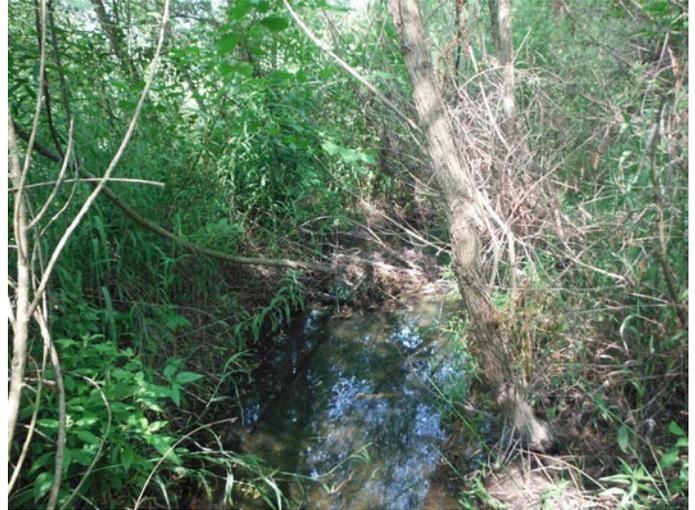
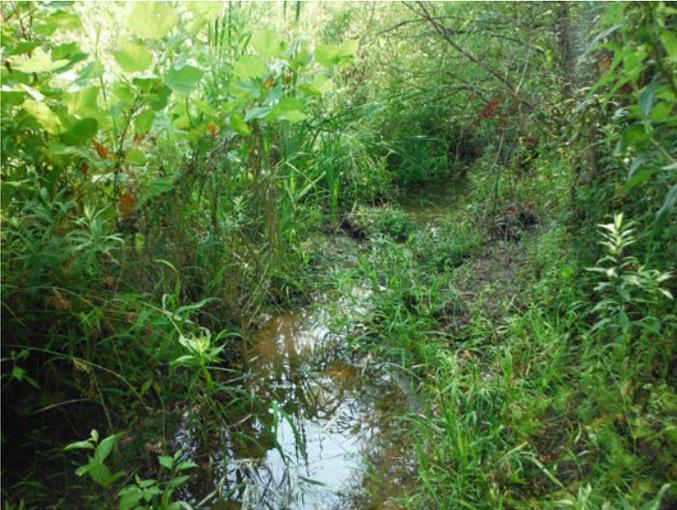
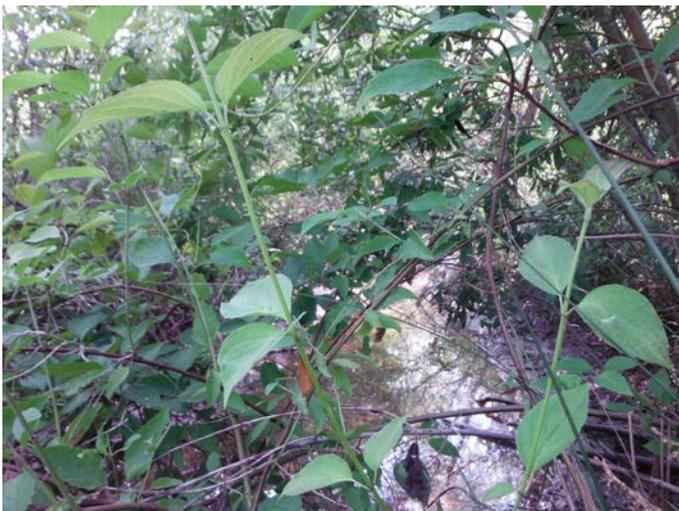
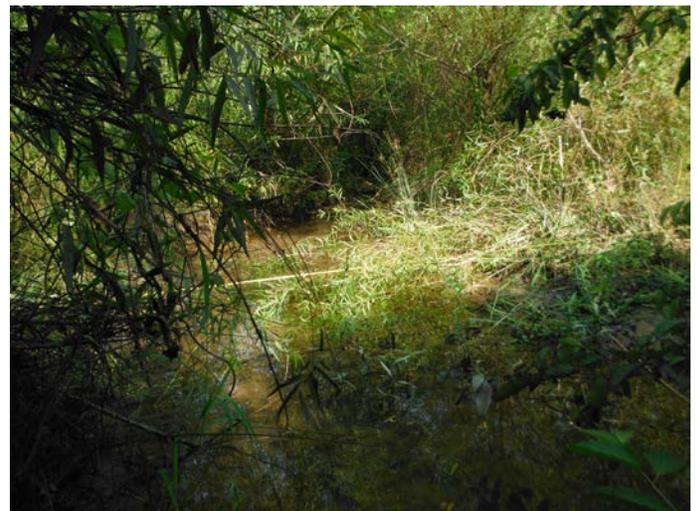
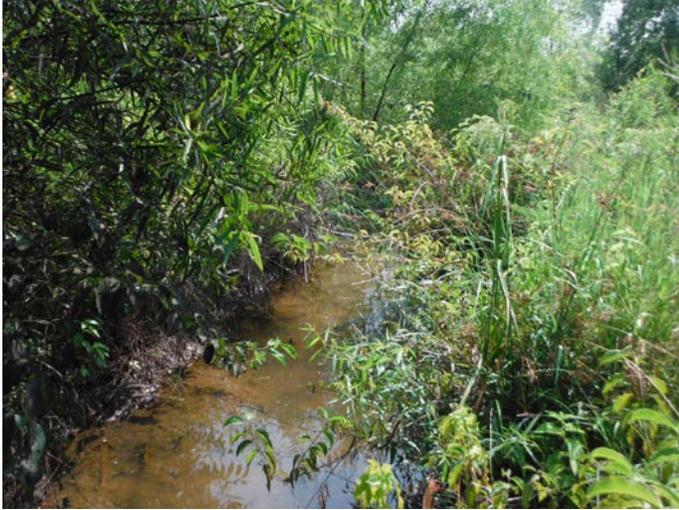
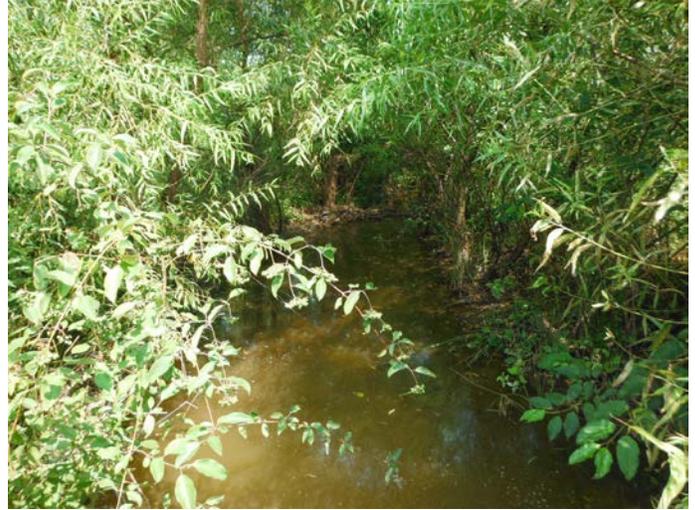
A visual inspection of the channel and photos taken from photo points 1 through 6 showed that the channel bed is stable throughout the stream relocation at this time. Two small beaver dams were noted up and downstream of Cross Section #6. USDA will be contacted to remove the beavers and dams.
