ANNUAL REPORT FOR 2014

UT to Muddy Creek Mitigation Site

Randolph County

TIP No. R-2606WM

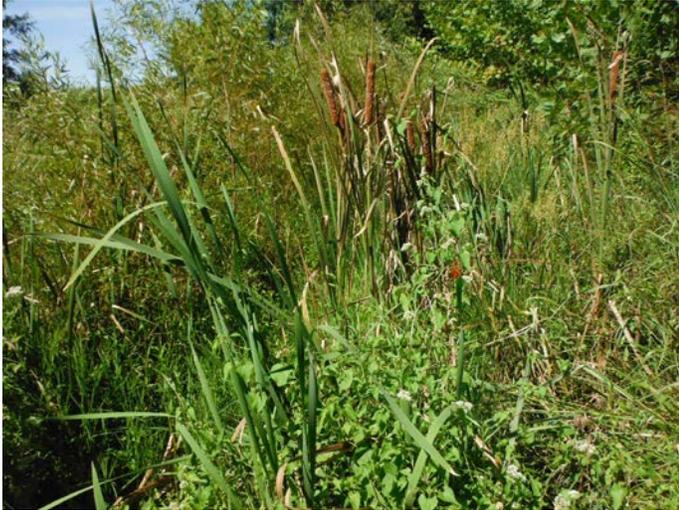
Photo Point #1 (Upstream)

A visual inspection of the channel and photos taken from photo points 1 through 7 showed that the channel bed is stable throughout the stream relocation at this time. Bankfull events have been visually noted by wrack lines on 9/13/12 and 8/26/14.
