Monitoring Data Record

Project Title: U-2524AB (Site 3) COE Action ID: 200321137

Stream Name: UT #3 Reddicks Creek DWQ Number: 030909

City, County and other Location Information: Greensboro Western Loop, Guilford Co.
Sta. 34+00 to Sta. 37+10 -L-

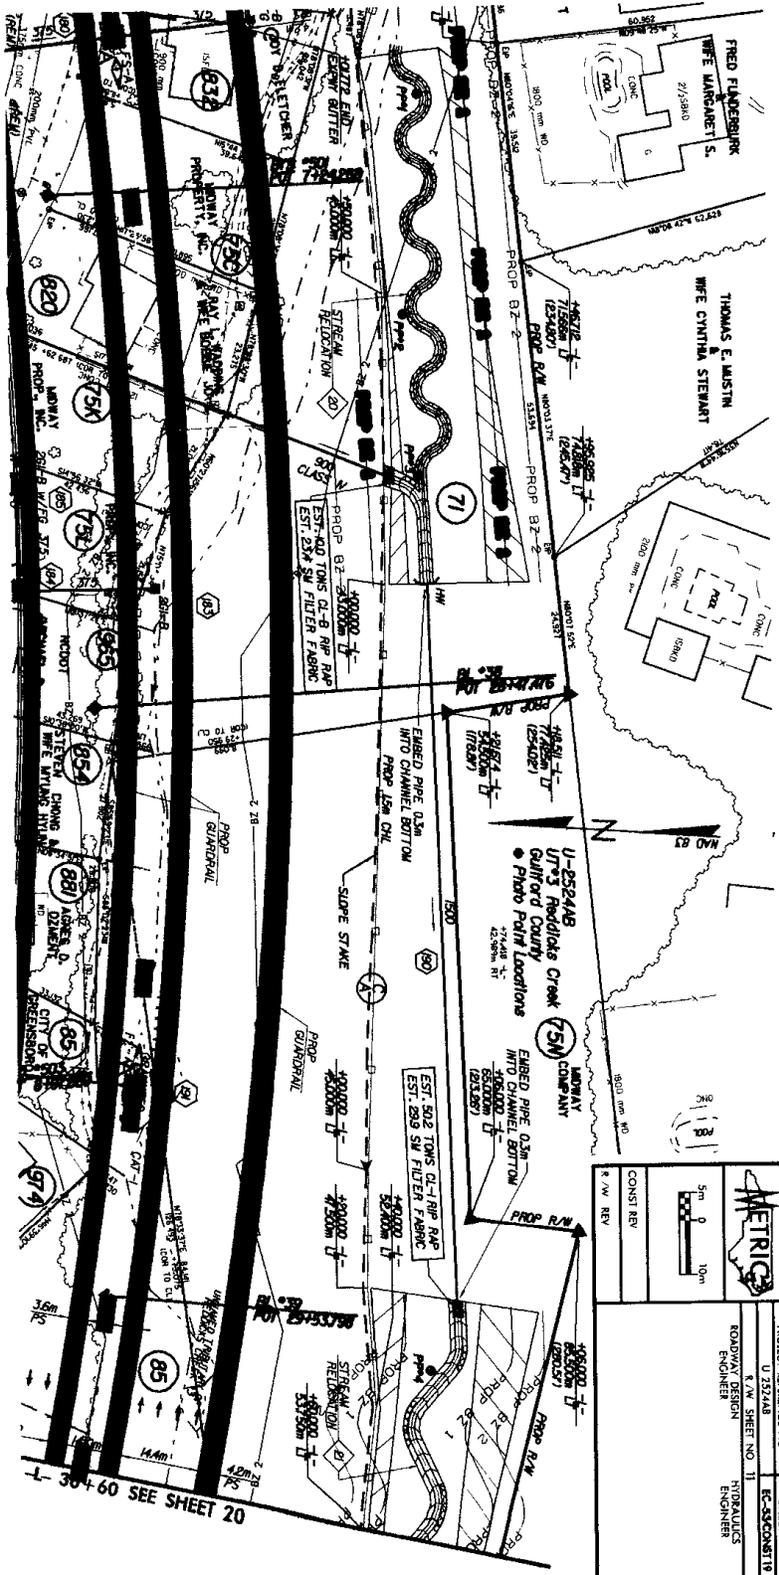
Photo Point #6 (Downstream)

The UT #3 Reddicks Creek stream relocation is stable for the Year 5 Summer evaluation, except for, some minor bank scouring noted on the left bank at Photo Point #6 (upstream) which had little or no change since the last evaluation. A site visit was conducted on August 2, 2011 with the regulatory agencies and NCDOT personnel present. NCDOT proposes to discontinue monitoring at this stream relocation.
