# **FINAL PHASE II CLOSEOUT REPORT**

## **Croatan Wetland Mitigation Bank Craven County, North Carolina**

**The Ecosystem Enhancement Program  
EEP Project No. 103**

January 2008

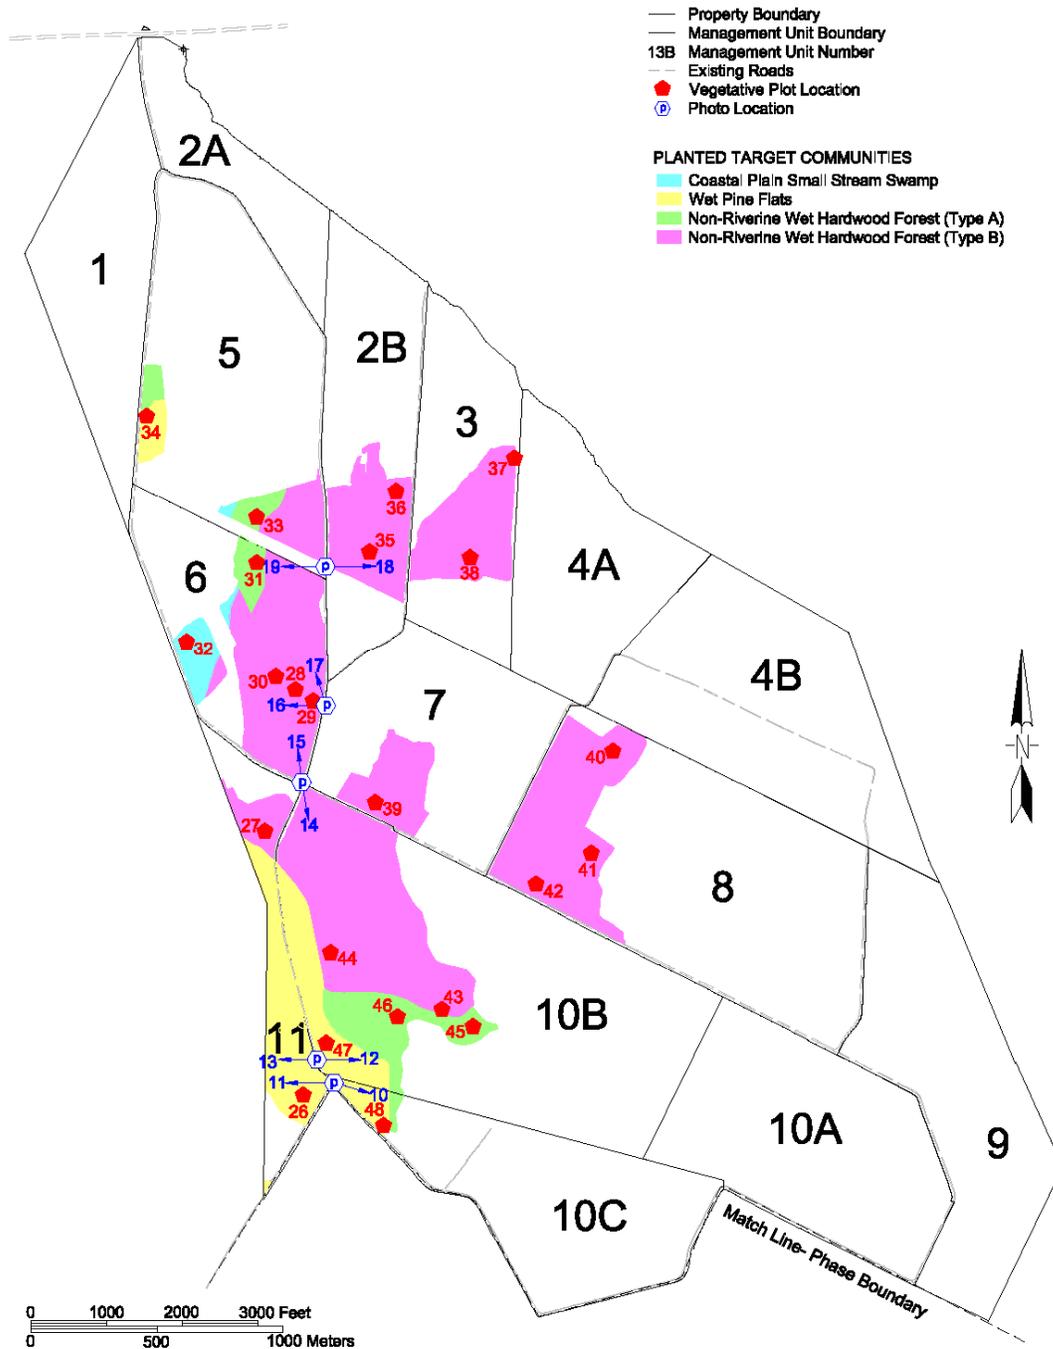
Figure 4. Target Communities, Vegetative Plot, and Photostation Locations, Phase II

The Non-Riverine Wet Hardwood Forest (Type A) Target Community does not meet the average success criteria for Year 5 with an average density of 248 trees/acre; specifically, plots 33 and 45 are not meeting success criteria. Commonly observed species in the Non-Riverine Wet Hardwood Forest (Type A) Target Community, in addition to the planted species, include giant plume grass (*Saccharum giganteum*), red maple, pine-barren goldenrod, slender goldentop, southern waxy sedge (*Carex glaucescens*), swamp bay, and Virginia chain fern (*Woodwardia virginica*). Additional investigation may be needed to determine why this Target Community is not meeting minimum success criterion and if further action is needed.

The Non-Riverine Wet Hardwood Forest (Type B) Target Community does not meet the average success criteria for Year 5 with an average density of 243 trees/acre; specifically, plots 35, 37, 39, 41, 42, 43, and 44 are not meeting success criteria. Commonly observed species in the Non-Riverine Wet Hardwood Forest (Type B) Target Community, in addition to the planted species, included giant plume grass, Maryland meadow-beauty, red maple, and cottongrass bulrush (*Scirpus cyperinus*). The Non-

Riverine Wet Hardwood Forest (Type B) Target Community, with 14 plots, is the largest Target Community in Phase II. Further investigation may be needed to determine why the seven plots failed to meet the Year 5 success criterion.
