2013 Geo<sup>3</sup>T<sup>2</sup> Conference

# Crosshole Sonic Logging: A 10 Year Perspective

**Kyle Murrell, PE**

**S&ME, Inc.**

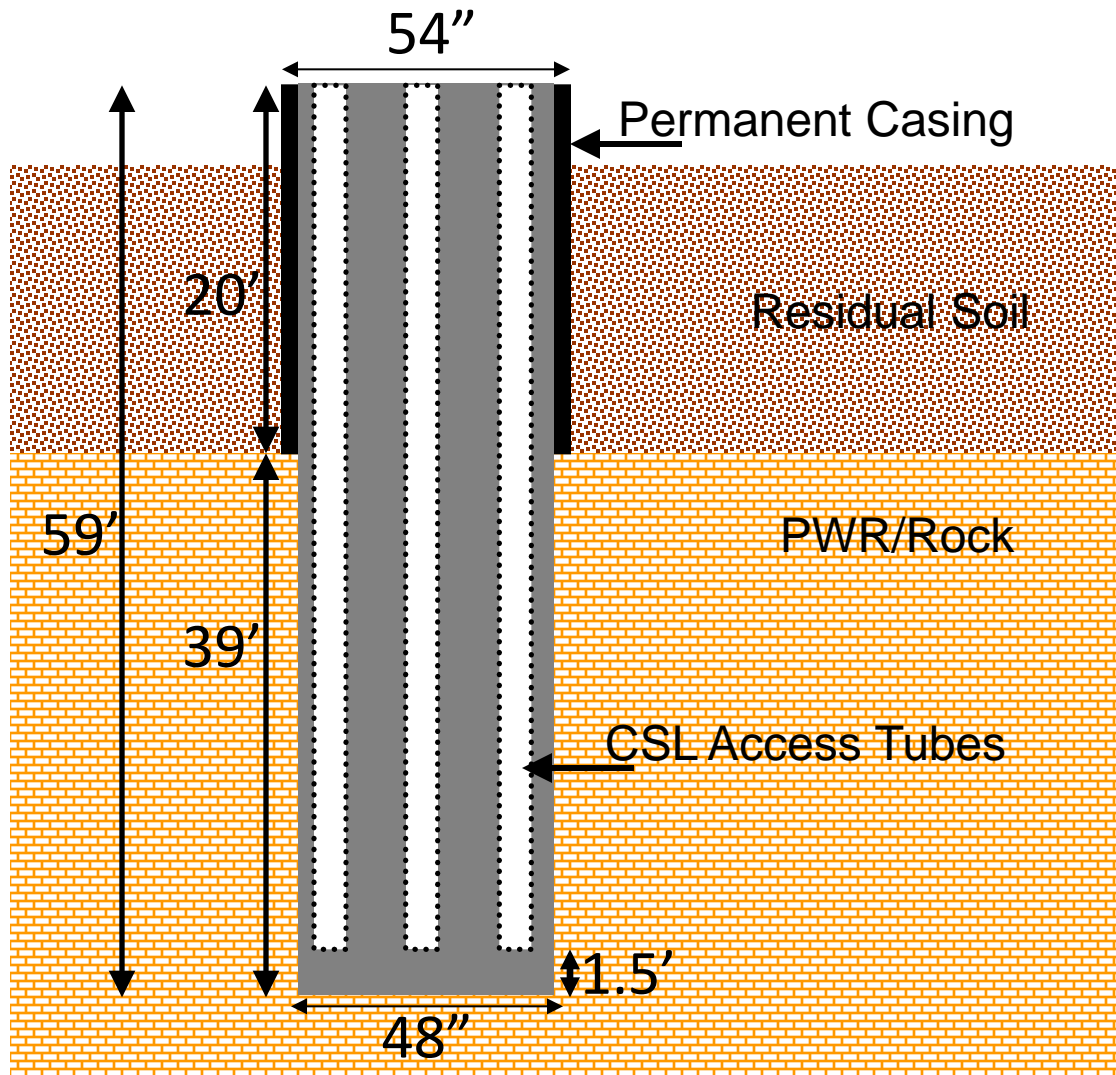
# Example – Hellers Creek (2005)

- Dry Construction
- Concrete Placed by Tremie
- CSL Performed 9 Days After Concrete Placement
- First of Four Shafts

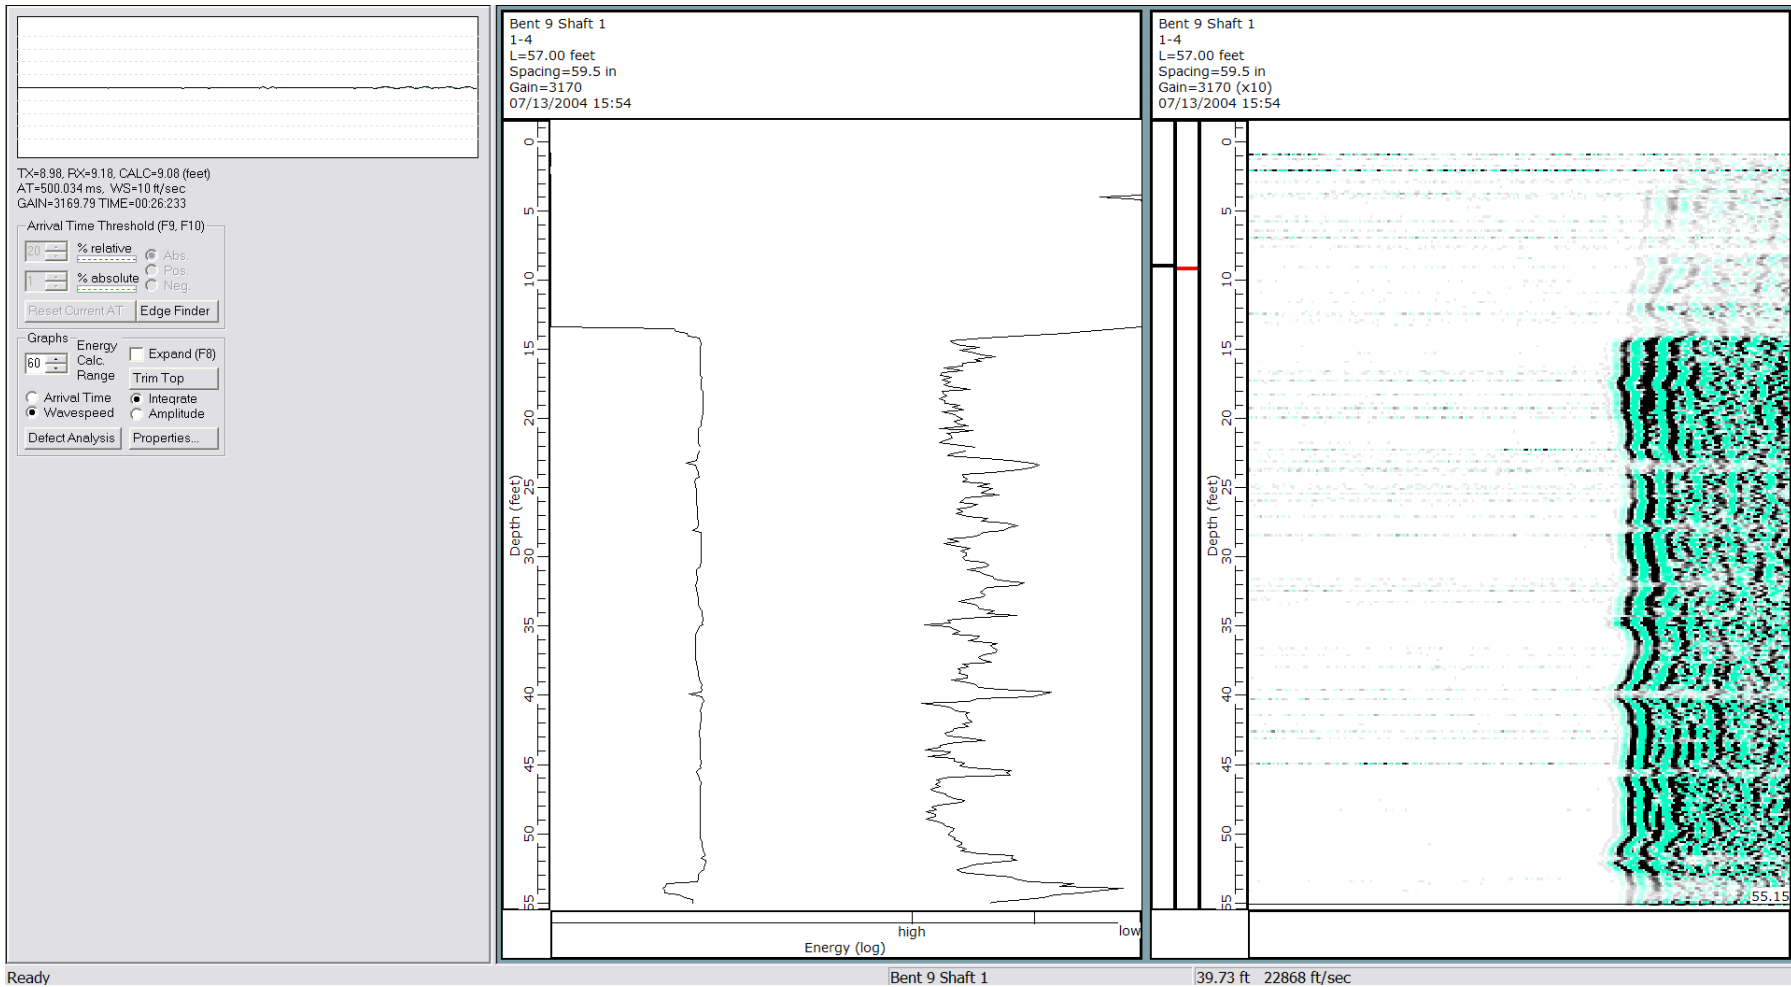
# Edge Finder

- Top Anomalies
  - 6-ft Diam Shaft in River
  - Mudline is 12 to 18 ft below top of shaft
  - Casing is 30 ft below top of shaft
  - Anomalies in the top of every shaft

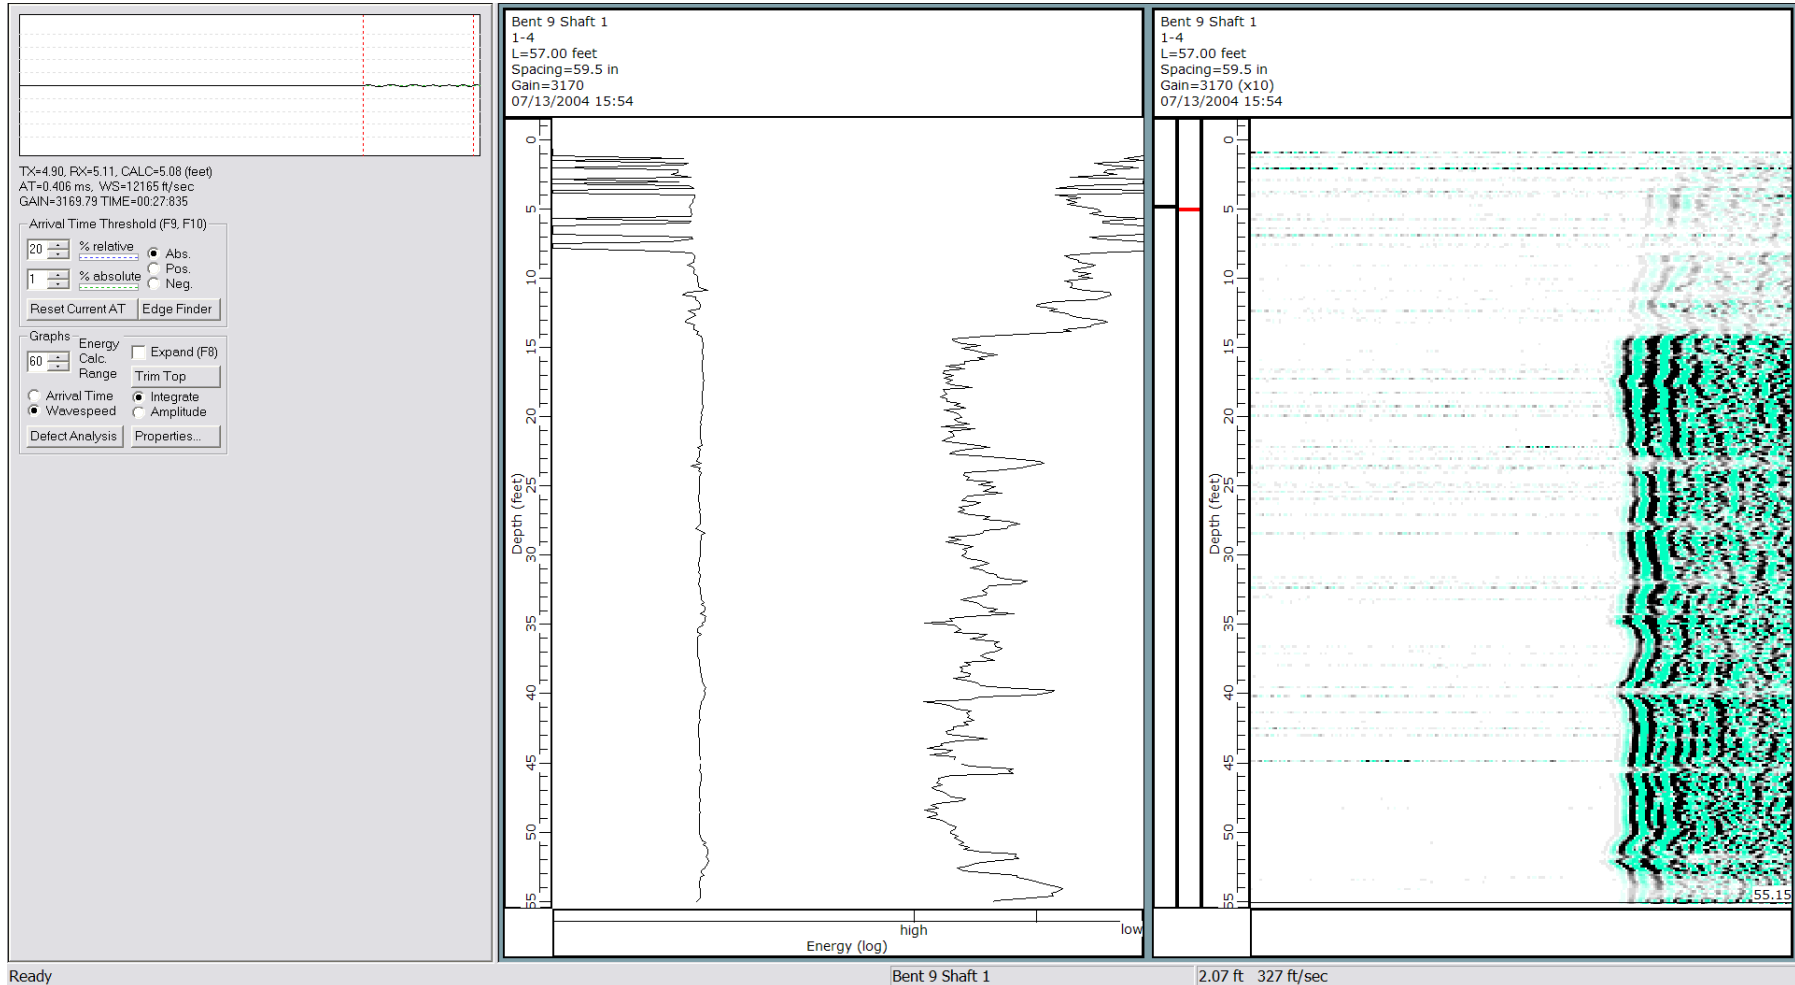
# Aggressive Manual Picks

- De-bonding (SCDOT access tubes are steel)
- Flowing water created large thermal gradients leading to micro-cracking during curing
- Bleed water causing flow paths through concrete
  - Supported by coring

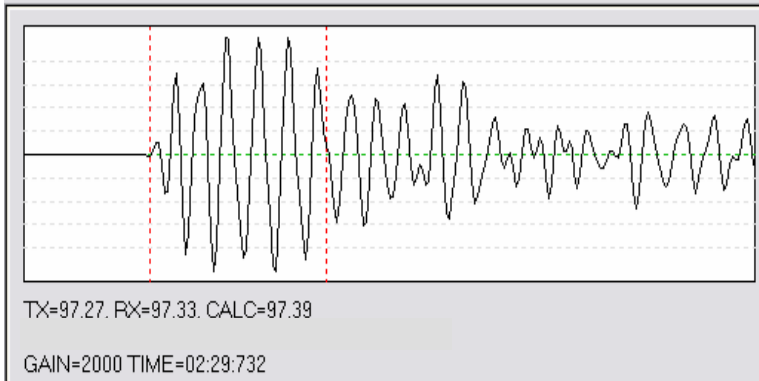
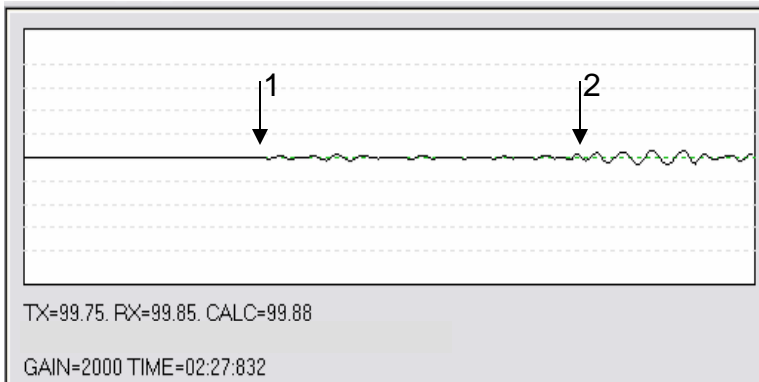
# Consequences of Bleed Water Features

Wavespeed at 97.39 ft = 13,351 fps

Possible interpretations at 99.55  
and 99.88 ft:

1) Wavespeed of 8,564 (36%  
reduction)

2) Wavespeed of 4,647 (65%  
reduction)
