Highway Geophysical Applications From the Rocky Mountains to the Volcano National Park Jacob Sheehan

Collier Geophysics

NPS Emergency Response Problem Statement: pavement distress and holes/voids along Chain of Craters Road

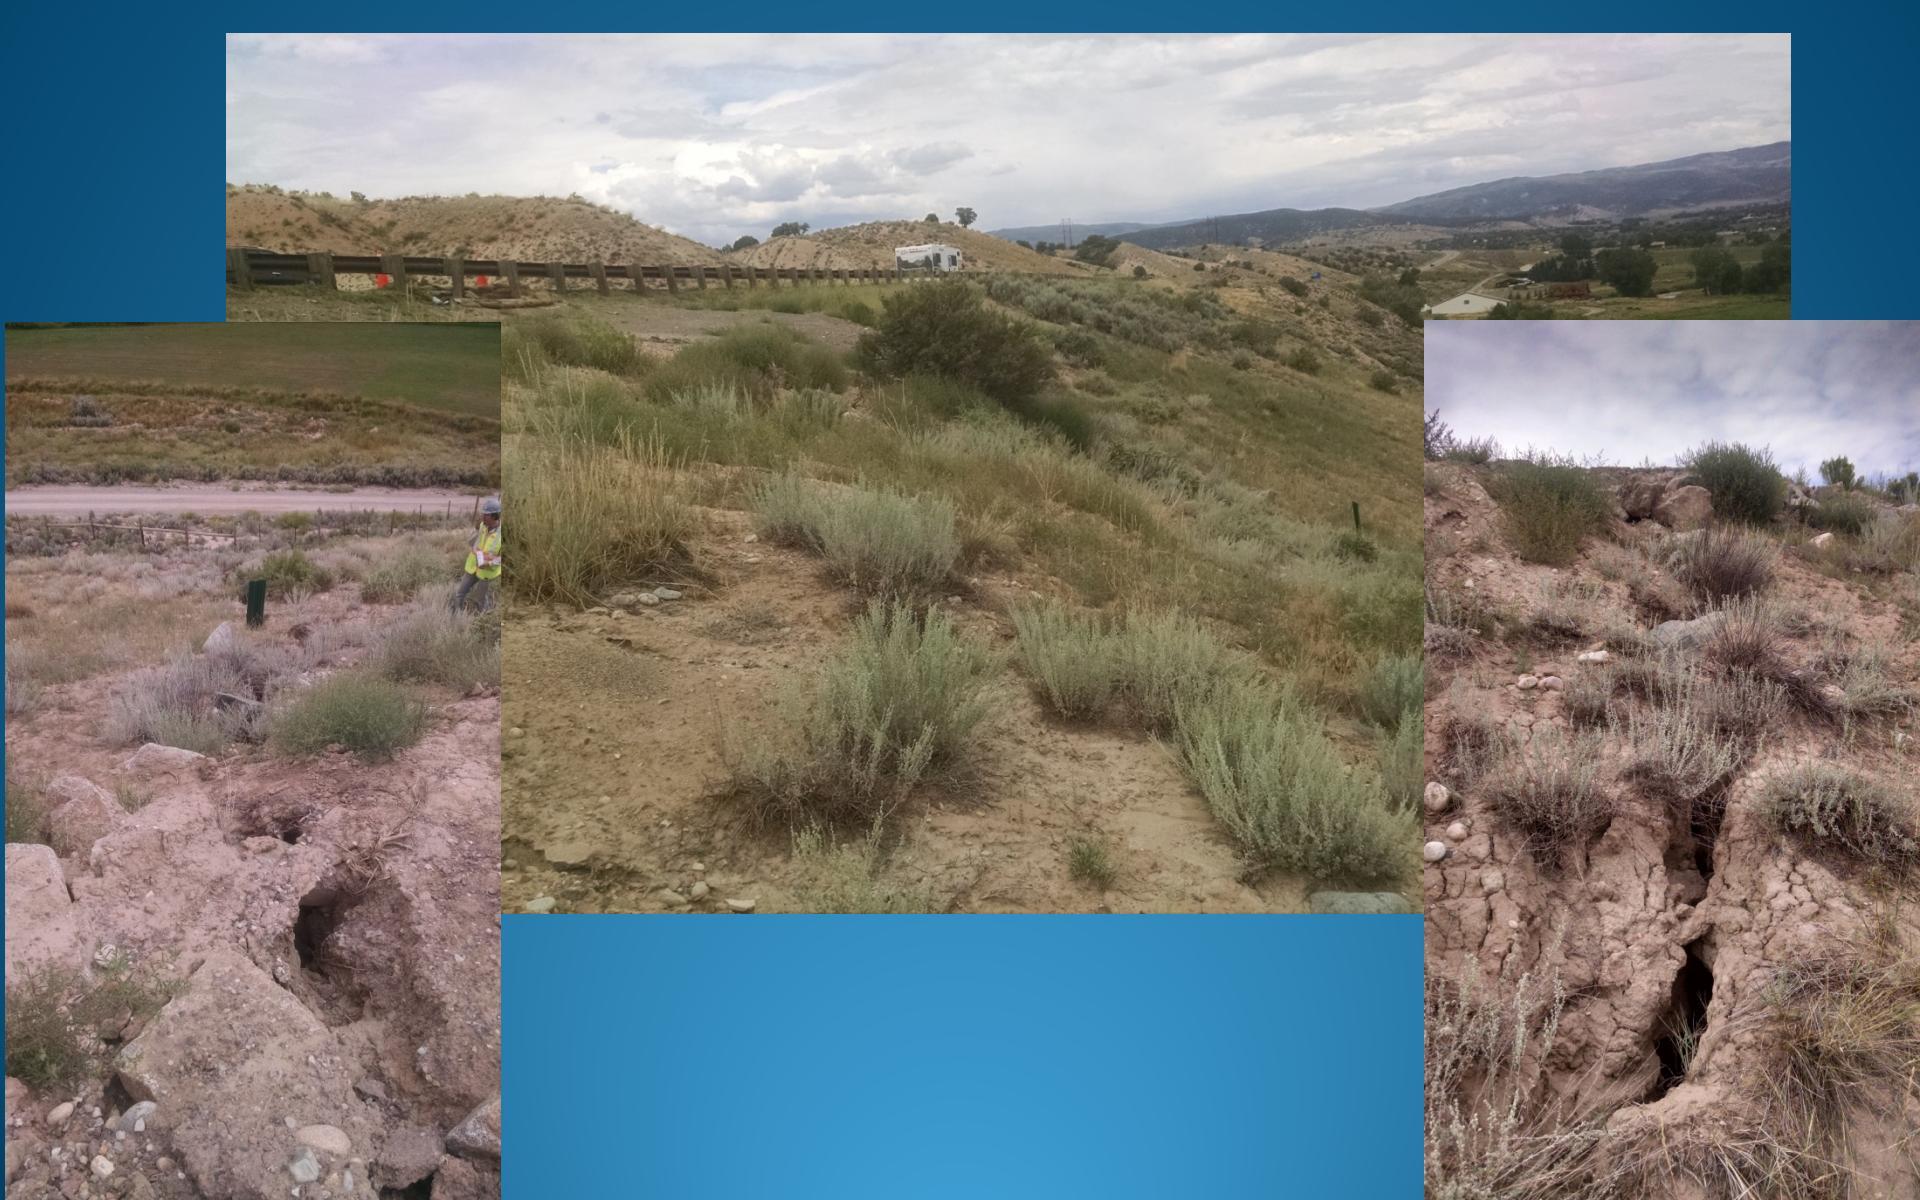
Site Conditions

We were asked by Colorado DOT to perform a geophysical survey located along I70 west of Eagle and east of Gypsum to investigate the cause of a subsidence or erosional feature

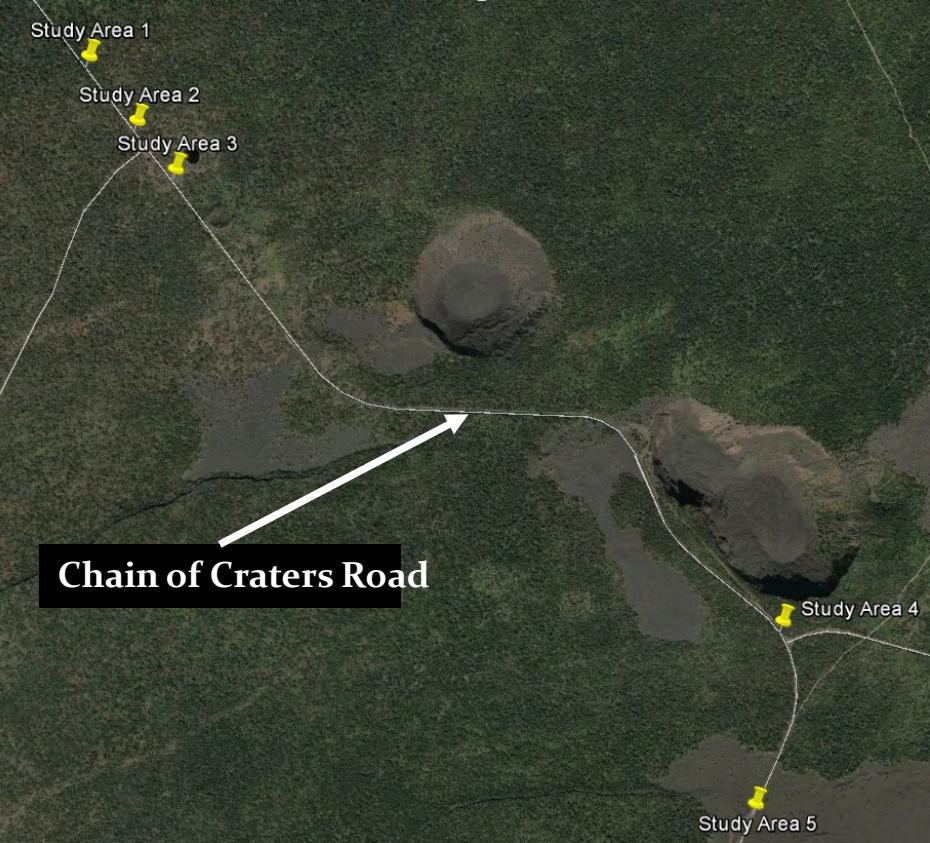
Five Study Areas

July 27th CFL performed site assessment and based on field observations identified 5 areas displaying pavement distress each needed to be studied by **non-destructive methods** (with minimal impact to traffic!).

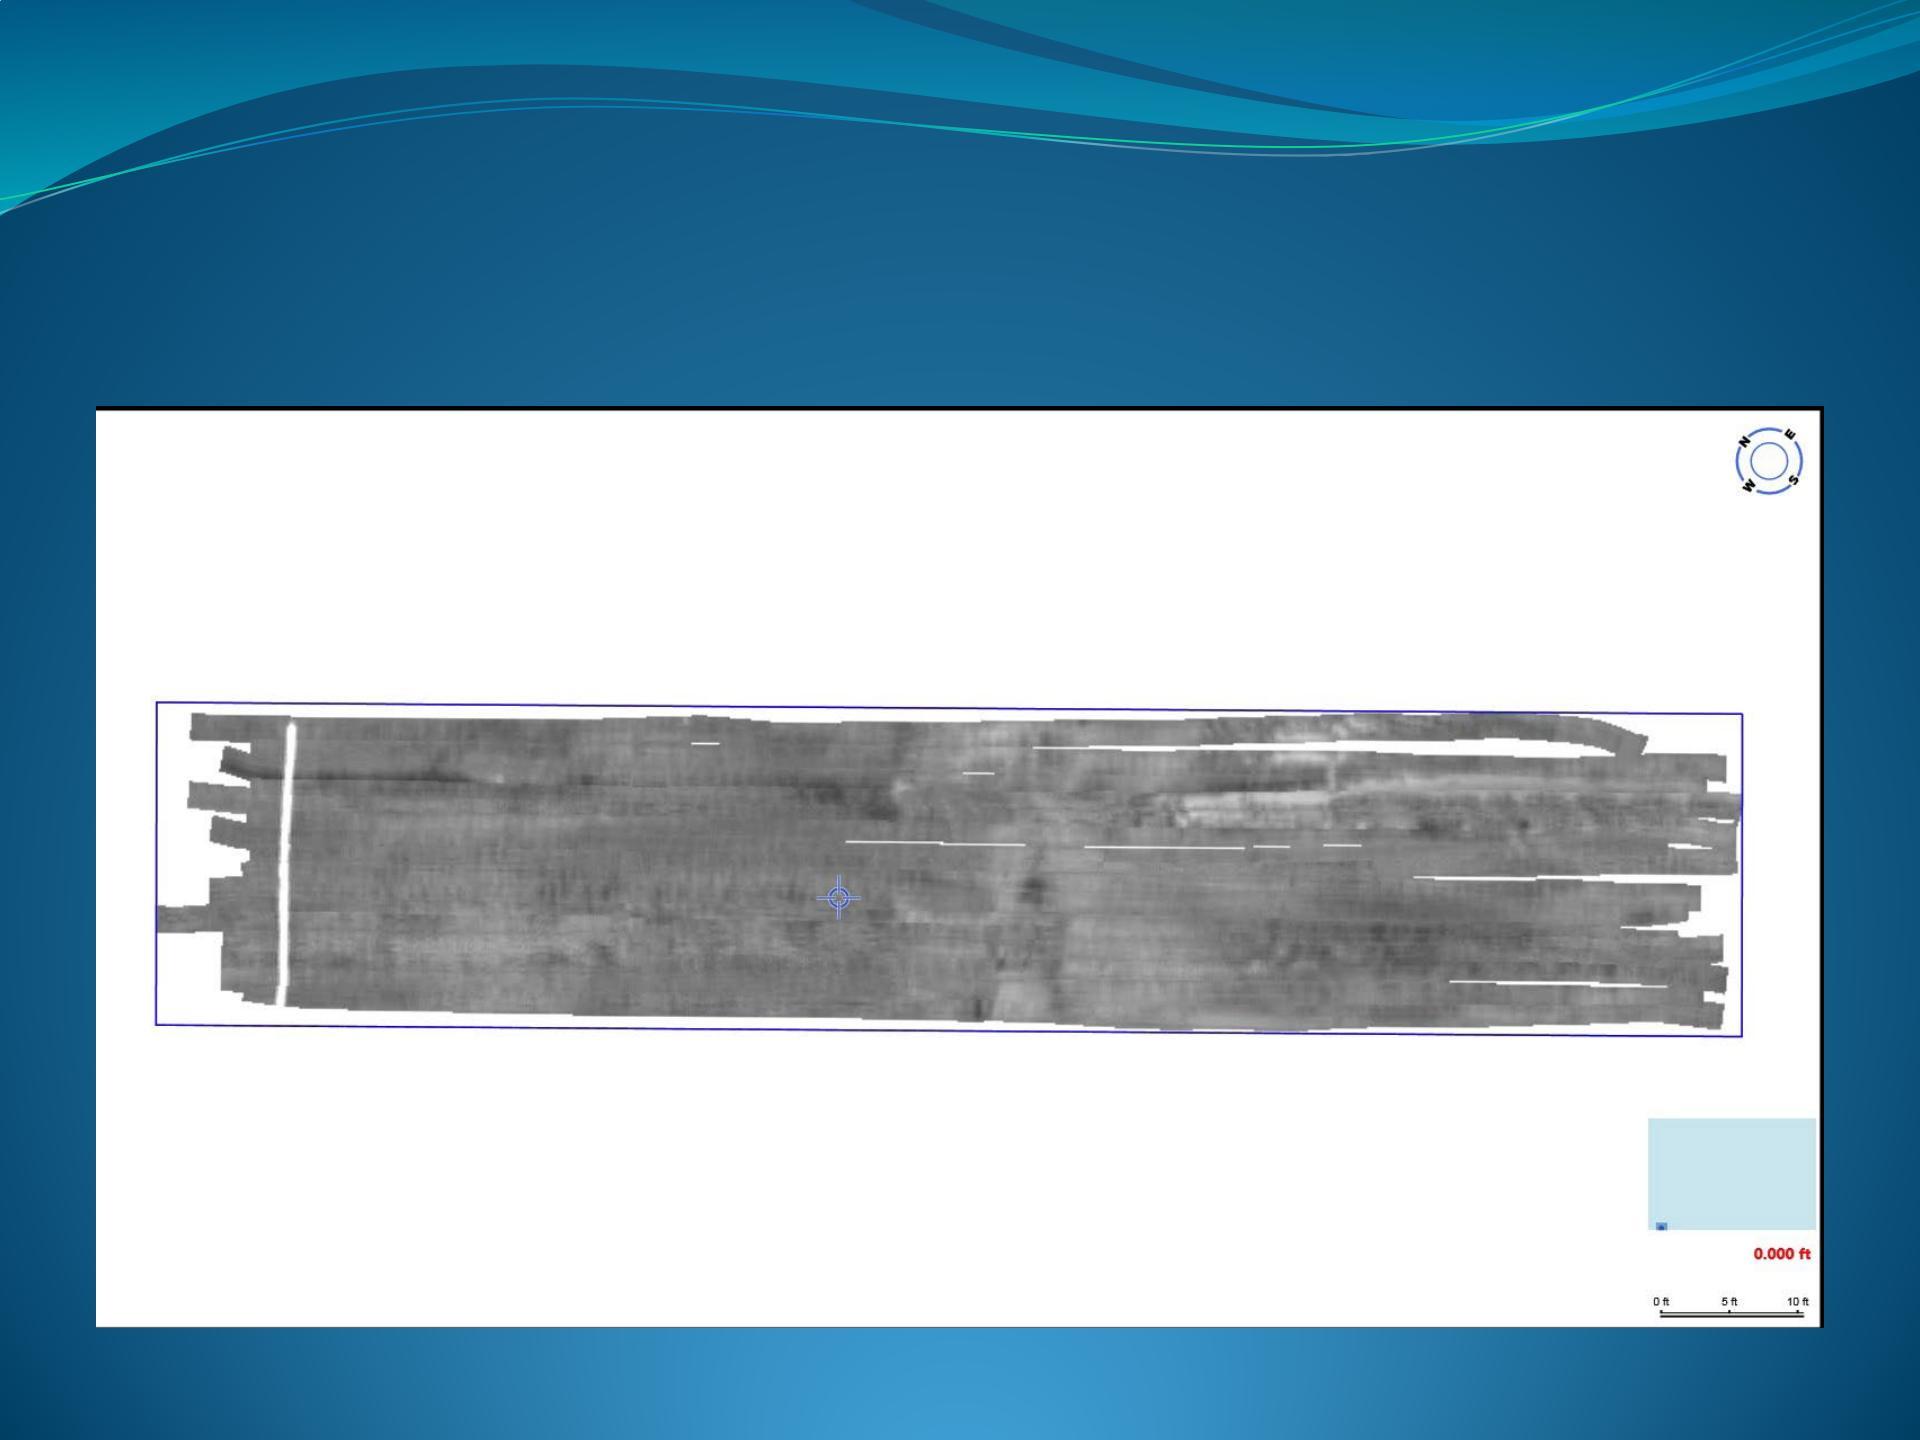
3D GPR - Video Result (Study Area 2) This .wmv file is a final

- *Anomaly*: Something that deviates from what is standard, normal, or expected.
- Several anomalies were detected different number, size and character at each site.
- CFL categorized the anomalies into three severity classes based on the quality and reliability of the geophysical data, the risk of near-future distress, and public safety.
 - <u>Class 1 (High Severity)</u>: Immediate remediation is a high priority.
 - <u>Class 2 (Medium Severity)</u>: Immediate remediation is beneficial. Site should be visually monitored regularly.
 - Class 3 (Low Severity): Immediate remediation unnecessary. Occasional visual monitoring should be performed.
