Emergency Sinkhole Mitigation & Void Investigation of Abandoned Railroad Tunnel along US HWY 24 Tennessee Pass, CO – Case Study

Kanaan Hanna, Steve Hodges, John Nolte, ZAPATA
Joseph Elsen, Rex Goodrich, Matthew Figgs, David Thomas, CDOT
Tom Szynakiewicz, Hayward Baker
Mark Vessely, Shannon and Wilson

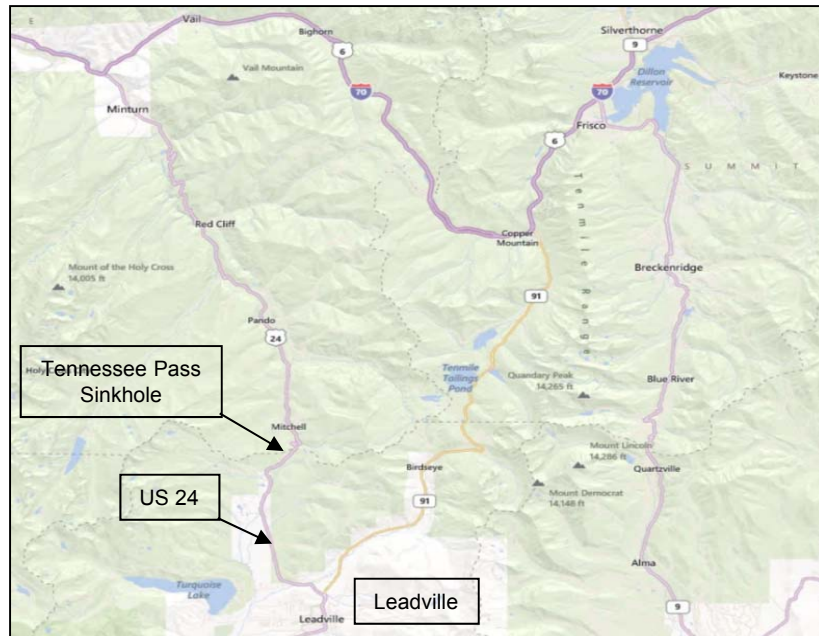
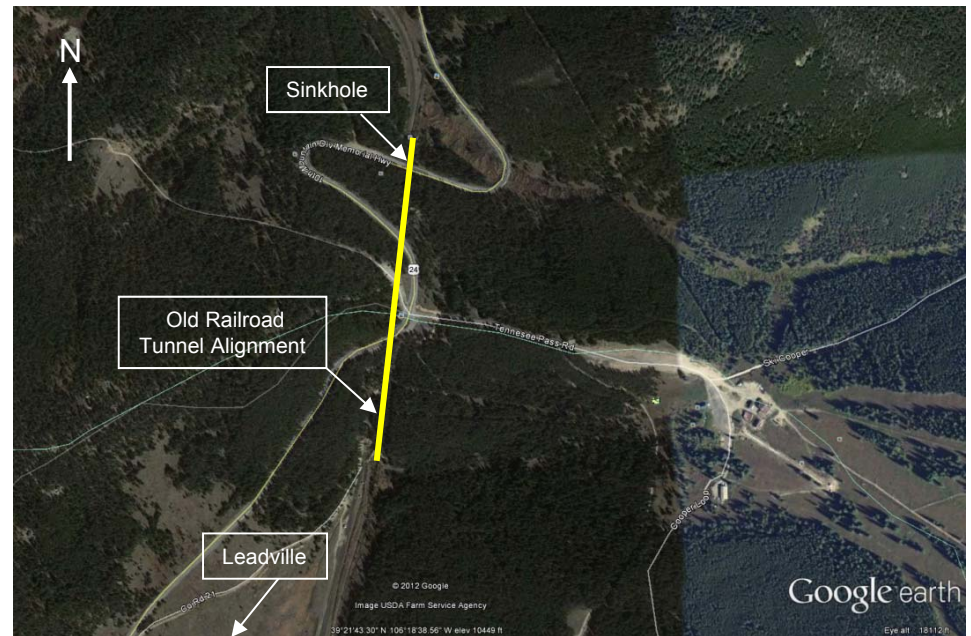
Project Site Location – Critical Issues

- Safely opening the road as quick as possible.
- Prime tourist season in mountains, accommodating bike rides / races.
- Permanent mitigation of collapse and settlement hazard within CDOT easement.
- Excessive grout loss.
- Avoid damage to the existing tunnel.
- Project delivery ~ Less < 25 days to complete, bonus to re-open at least one lane earlier than 20 days from start date.

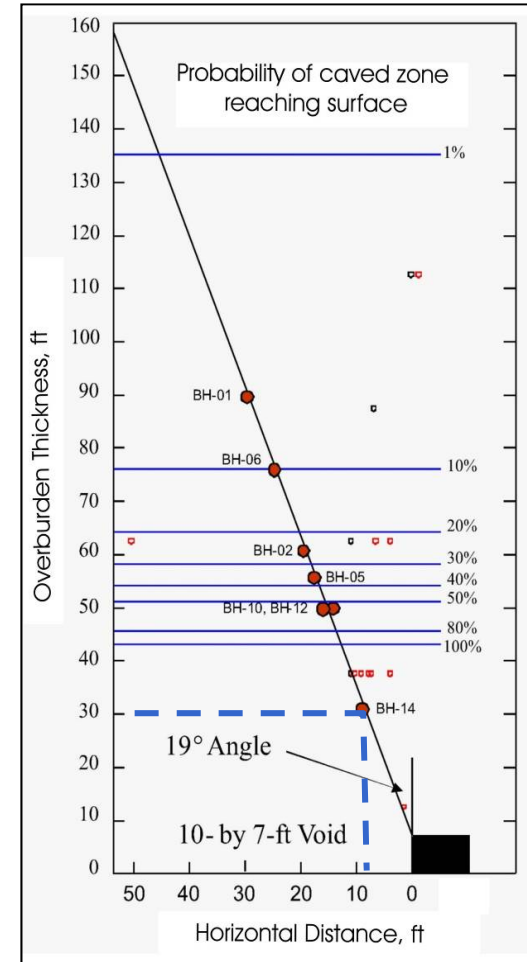
Qdpb:

- The area is highly faulted.
- Sheet-like drift from two glaciations.
- Glacial deposits at the site were found to range from 24 to > 50' in depth overlaying weathered gneiss.
- Clayey sand/boulder/gravel with thickness $\geq 175'$ at the sinkhole.
