NC DEPARTMENT OF TRANSPORTATION  
 DIVISION OF HIGHWAYS  
 STRUCTURE MANAGEMENT UNIT

# Structure Safety Report

## Routine Element Inspection

COUNTY: GASTON STRUCTURE NUMBER: 350126 FREQUENCY: 24 MONTHS

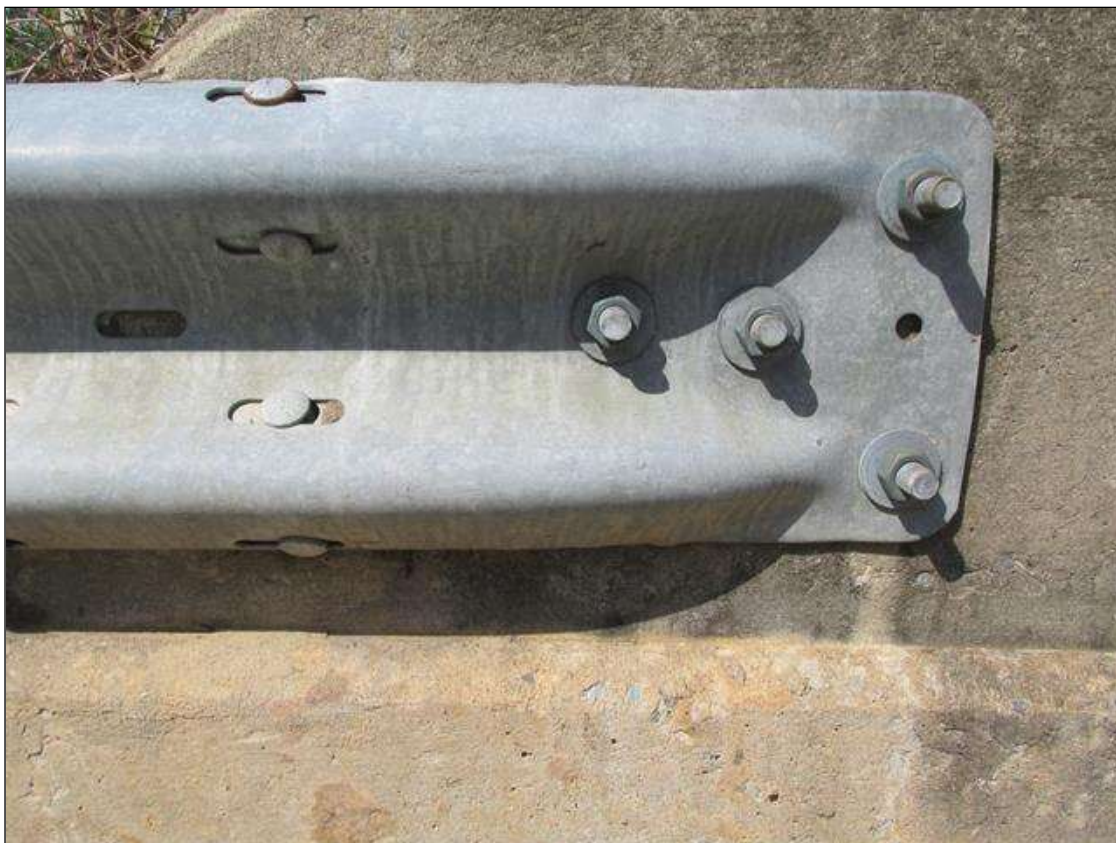
TYP GR CONNECTION

2 Feet of Connection: Missing bolts, rivets, or fasteners; broken welds; or pack rust with distortion but does not warrant a structural review. GUARDRAIL CONNECTION TO CONCRETE BRIDGE RAIL.
