NC DEPARTMENT OF TRANSPORTATION
DIVISION OF HIGHWAYS
STRUCTURE MANAGEMENT UNIT

Structure Safety Report

Routine Element Inspection - Contract

FEATURE INTERSECTED: ALLIGATOR RIVER

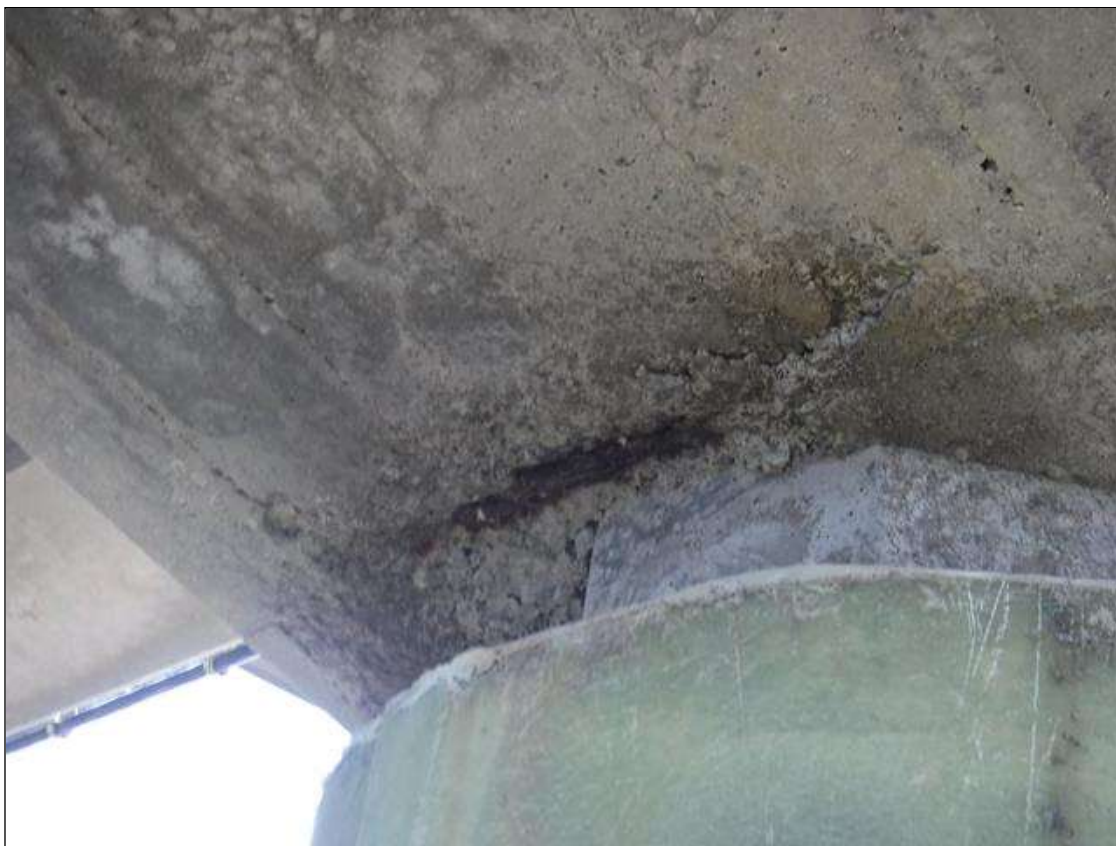
Bent 22 Cap 1: (PAR) 12" X 24" X 6" SPALL, WITH EXPOSED PRIMARY REINFORCING, BOTTOM FACE, BETWEEN BEAMS 3 AND 4. REBAR HAS 10% SECTION LOSS

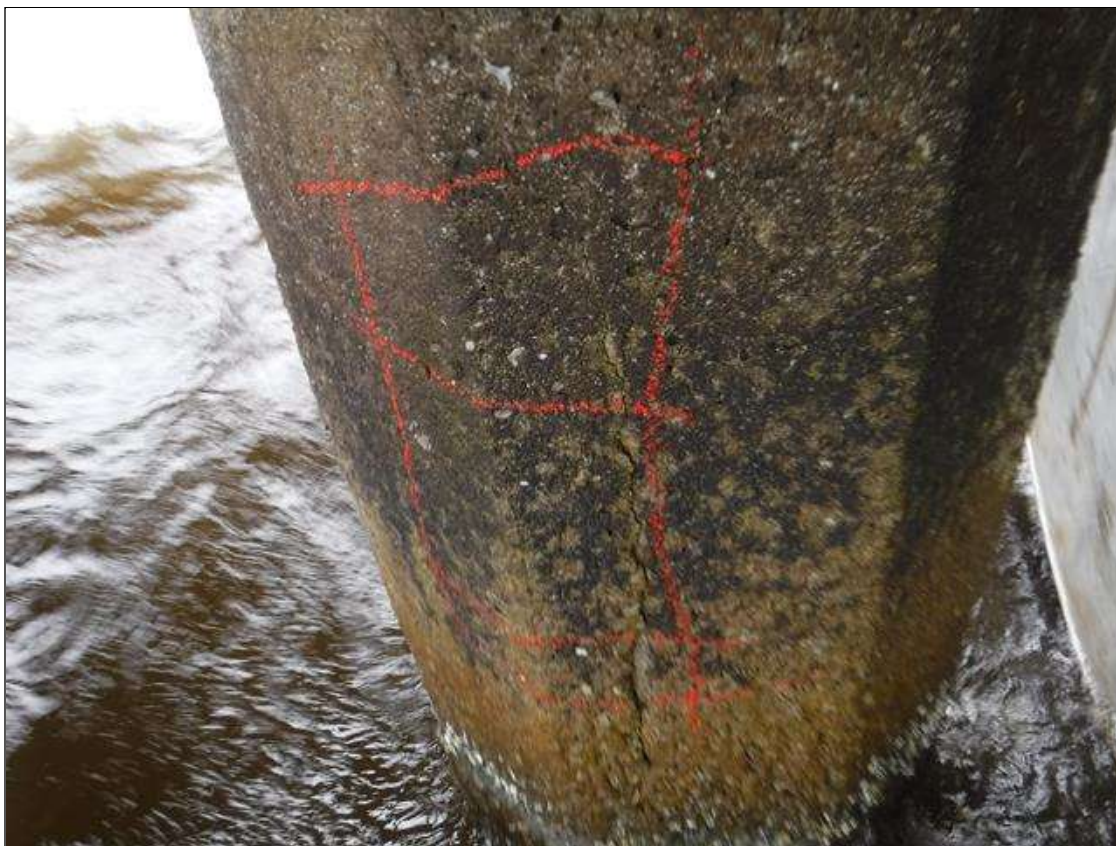
Bent 192 Pile 4: (PAR) HAIRLINE TO 1/8" CRACKS, 8' BELOW CAP, DOWN 4', MULTIPLE FACES. SCALING TO 1" DEEP WITH LOOSE AGGREGATE FROM WATERLINE TO MUDLINE.

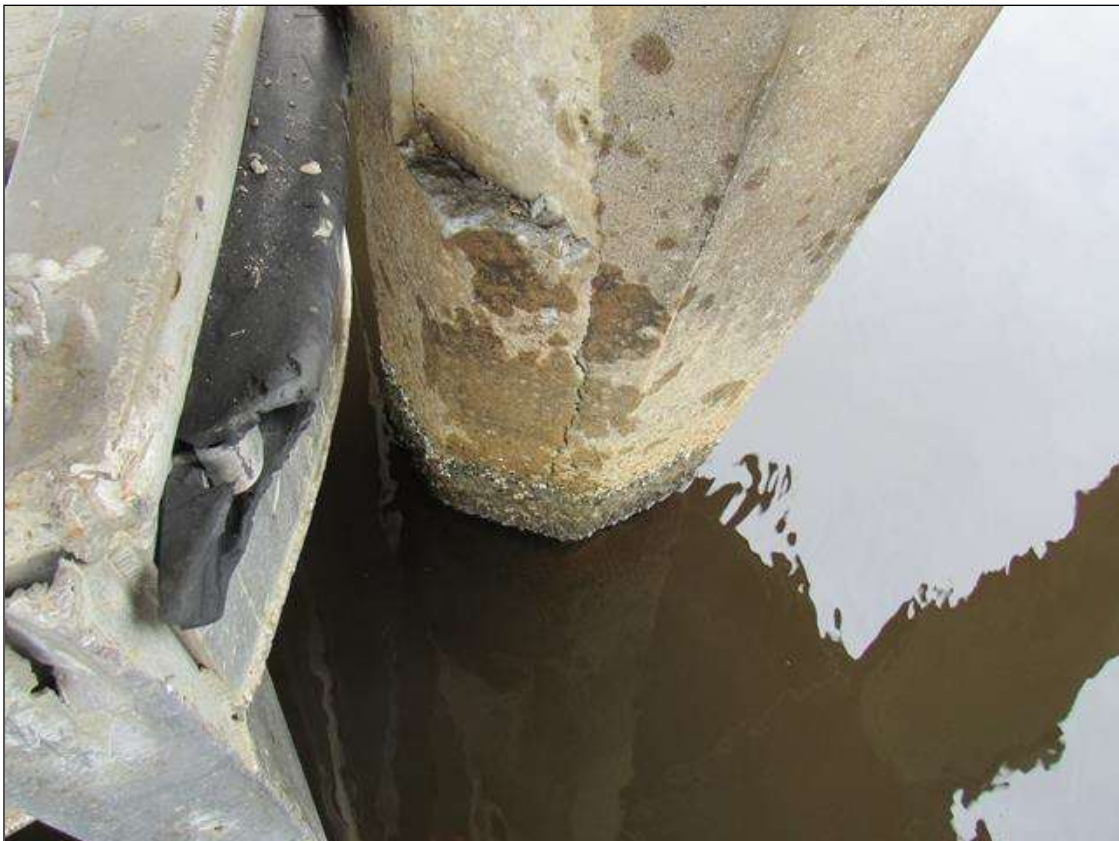
Bent 32 Saved Pile 3: 3" DIAMETER X 1/4" DEEP SPALL ON EAST FACE LOCATED 3' FROM BOTTOM OF CAP

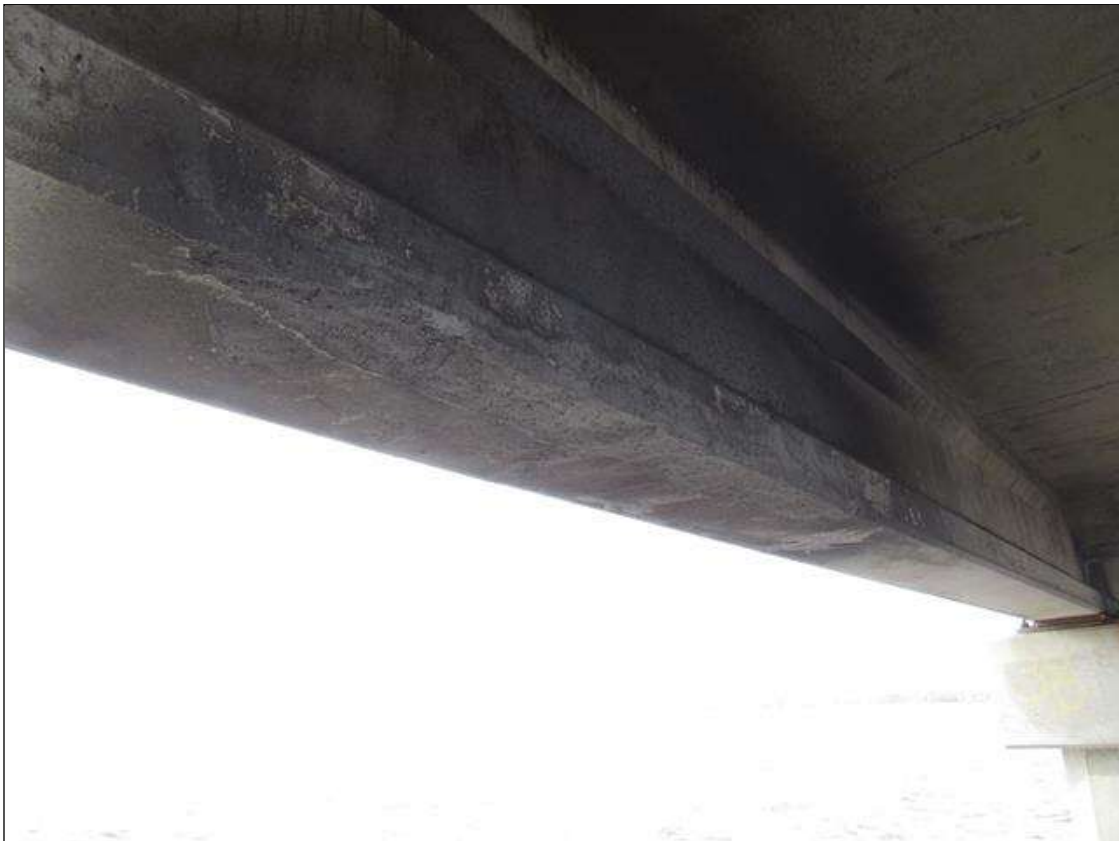
Span 38 Beam 4: 2.5' X UP TO 8" PATCHED AREA, BOTTOM FACE, EXTENDING 10" ONTO NORTH FACE, AT BENT 37.
