NC DEPARTMENT OF TRANSPORTATION  
DIVISION OF HIGHWAYS  
STRUCTURE MANAGEMENT UNIT

## Structure Safety Report

### Routine Element Inspection - Contract

STRUCTURE NUMBER: 260016 SAP STRUCTURE NO: 0270016 FHWA STRUCTURE NO: 000000000530016  
DIVISION: 1 COUNTY: CURRITUCK INSPECTION DATE: 09/21/2022 FREQUENCY: 24 MONTHS  
FACILITY CARRIED: US158E MILE POST: \_\_\_\_\_  
LOCATION: .01 MI.E.JCT.SR1187  
FEATURE INTERSECTED: CURRITUCK SOUND  
LATITUDE: 36° 5' 11.69" LONGITUDE: 75° 46' 0.21"  
SUPERSTRUCTURE: RC FLOOR ON PPC GIRDERS & CORED SLAB  
SUBSTRUCTURE: EBTS:RC CAP/PPC PILES;IBTS:RCP&B & RC CAPS/PPC PILES  
SPANS: 248 SPANS. SEE SPAN PROFILE SHEET FOR SPAN DETAILS  
☐ FRACTURE CRITICAL ☐ TEMPORARY SHORING ☐ SCOUR CRITICAL ☐ SCOUR PLAN OF ACTION  
GRADES: (Inspector/NBI Coding) DECK 6 / 6 SUPERSTRUCTURE 5 / 5 SUBSTRUCTURE 6 / 6 CULVERT N / N  
POSTED SV: Not Posted POSTED TTST: Not Posted  
OTHER SIGNS PRESENT: None

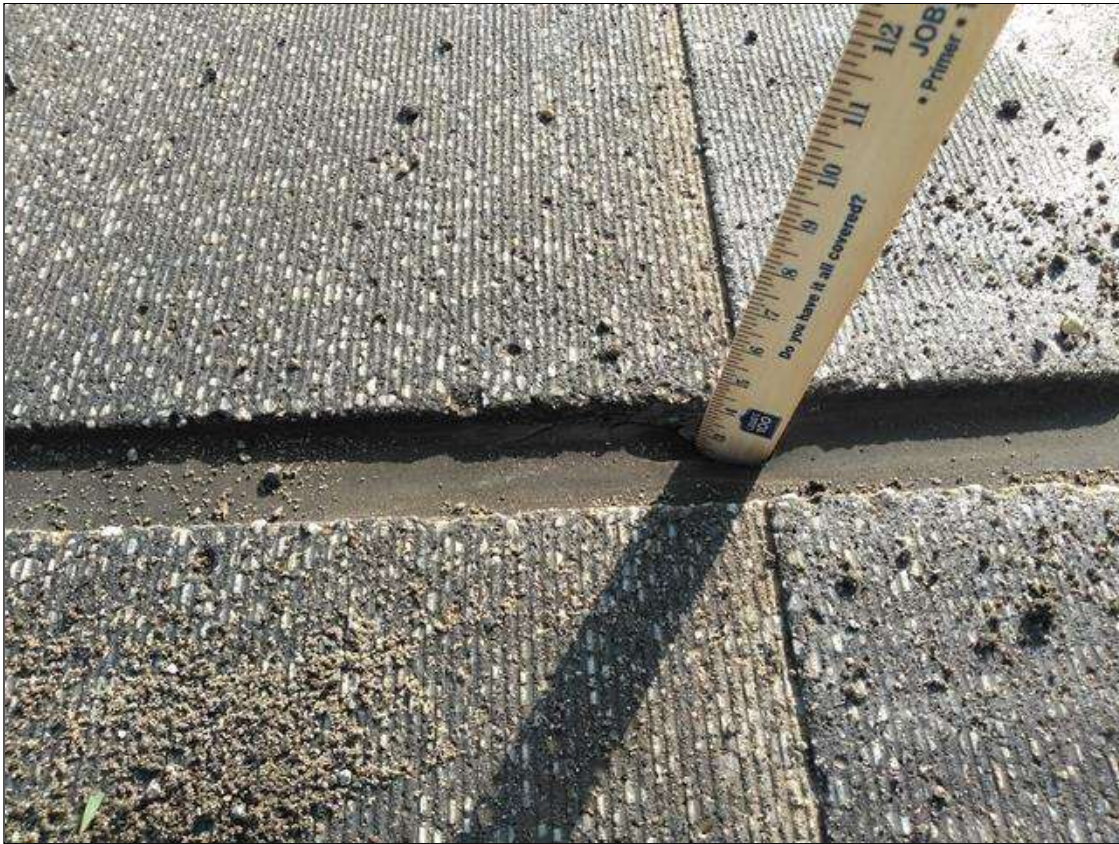
Span 1 Expansion Joint End Bent 1: AT END BENT 1 JOINT RIGHT EDGE OF TRAVEL, TEAR 6 INCH LONG X FULL DEPTH

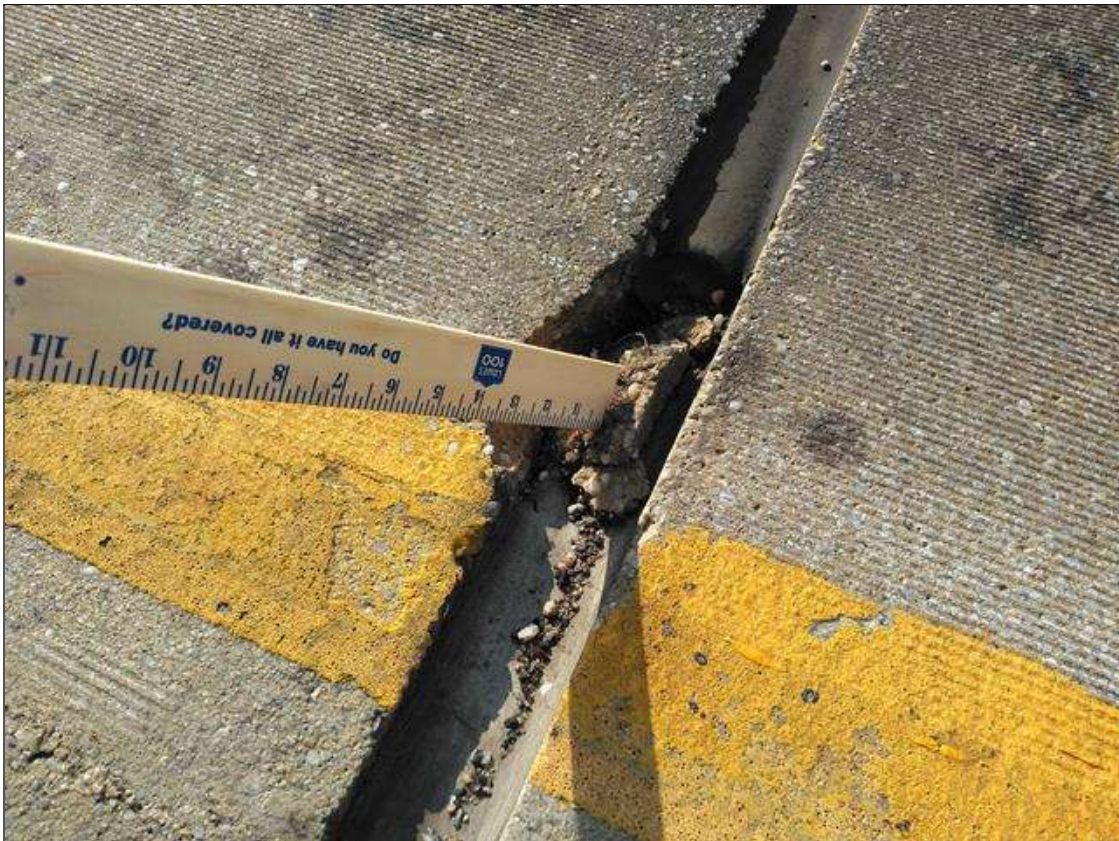
Span 1 Expansion Joint End Bent 1: AT END BENT 1 JOINT, LEFT EDGE OF TRAVEL, EDGE SPALL 6 INCH LONG X 1 INCH WIDE. NO SEAL OF JOINT MATERIAL.

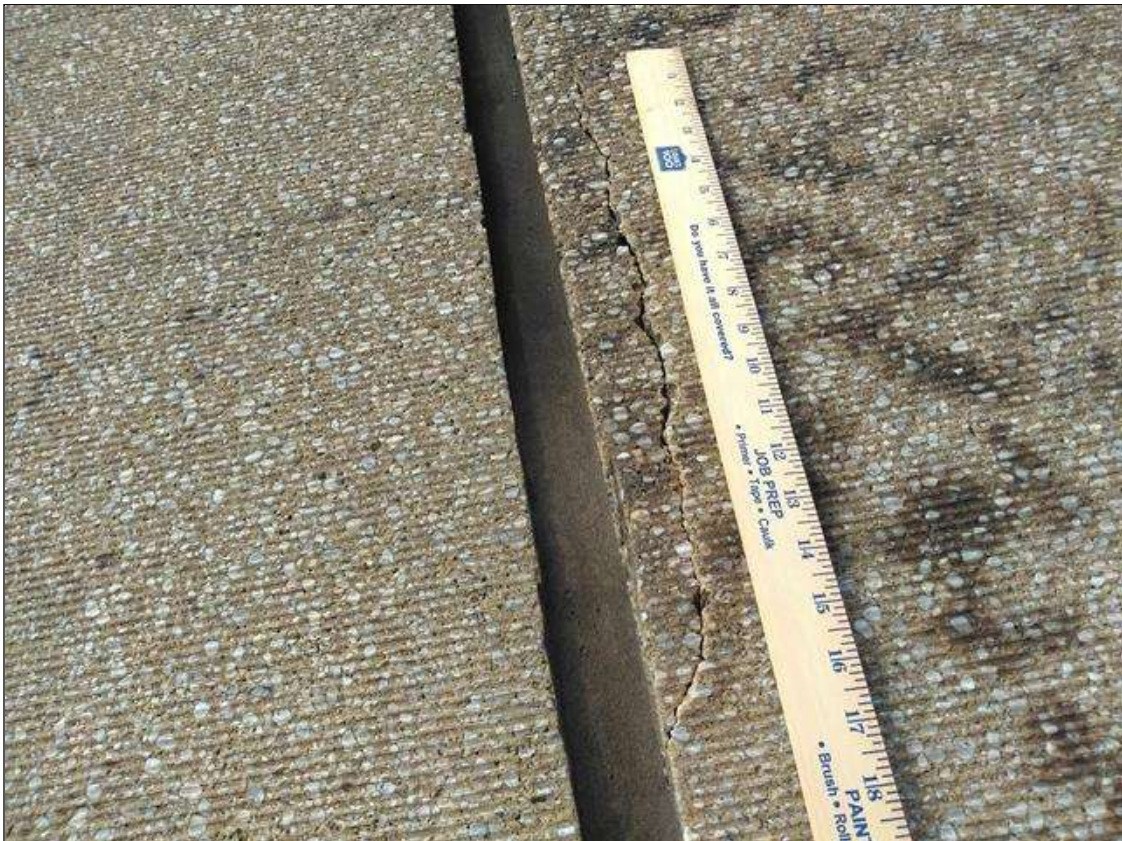
Span 16 Expansion Joint Bent 15: LEFT LANE, DELAMINATION 16 INCH WIDE X 2 INCH LONG

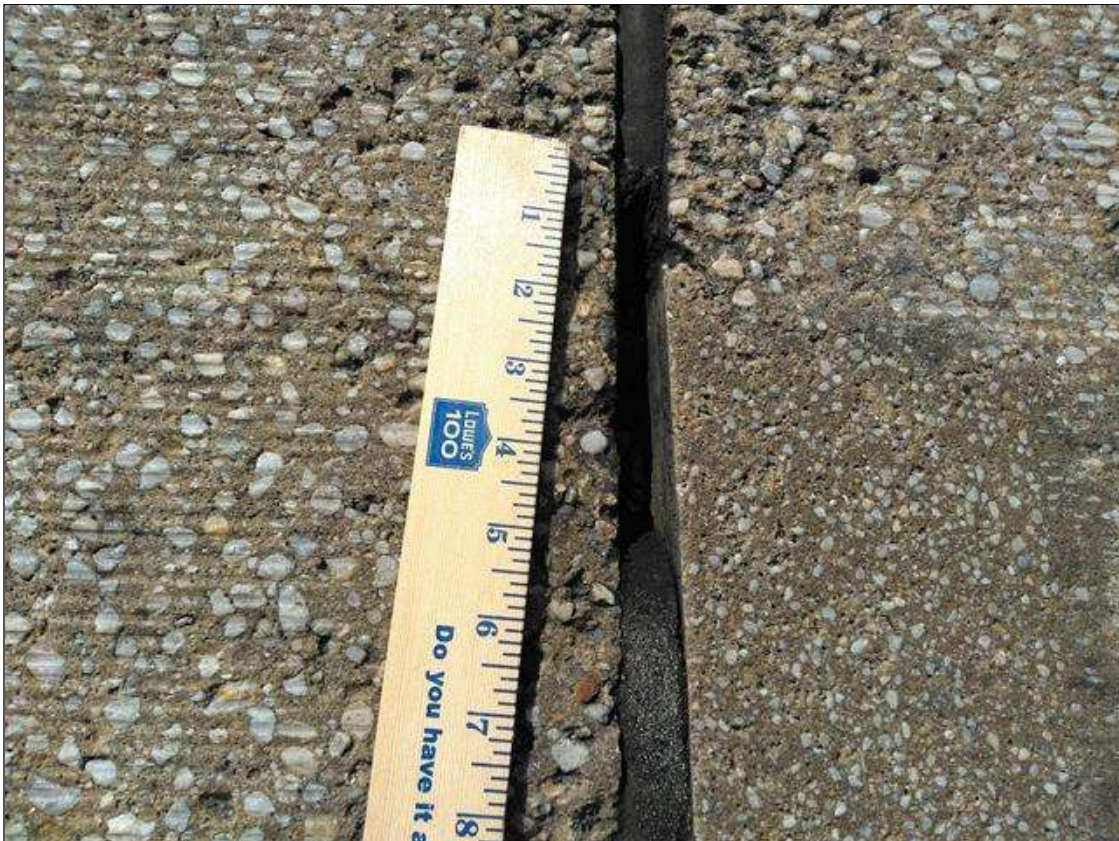
Span 23 Expansion Joint Bent 22: BENT 22 JOINT, MISSING JOINT MATERIAL LEFT LANE 5 INCH LONG PARTIAL DEPTH

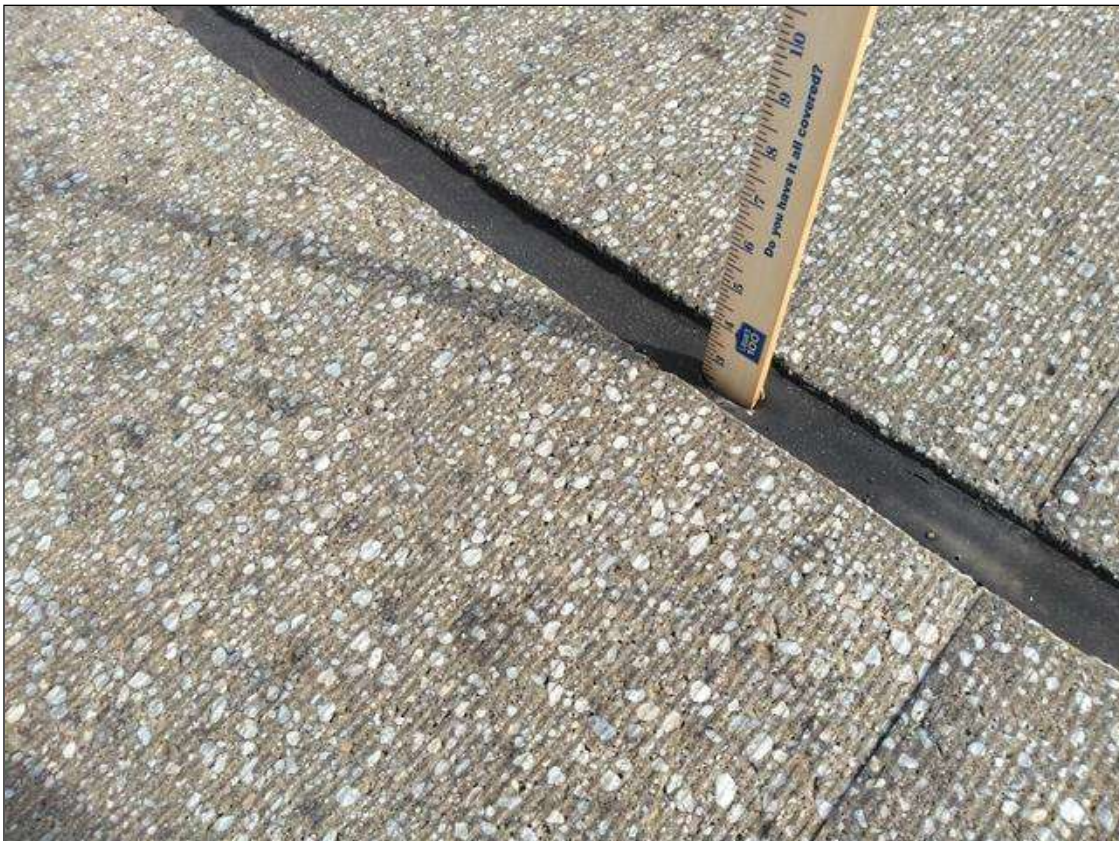
Span 26 Expansion Joint Bent 25: AT BENT 25, SEAL CRACKING UP TO 6 INCH TOTAL ACROSS 3 LOCATIONS IN RIGHT LANE

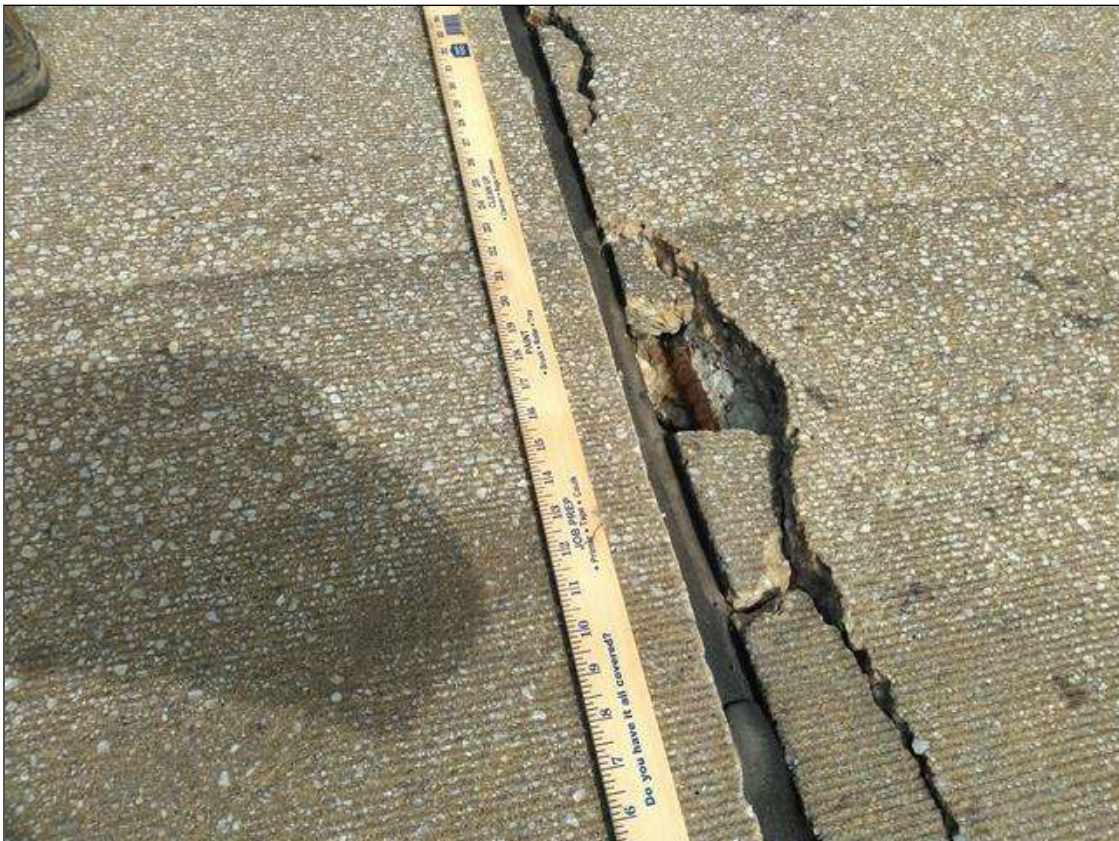
<b>3310</b>	<b>Expansion Joint Bent 30</b>	Standard Joint	
Priority Level	Defect Type	Quantity	Defect Description
<b>2</b>	Adjacent Deck or	4	Span 31 Expansion Joint Bent 30: (PAR) AT BENT 30, RIGHT LANE SPALL 4 FEET WIDE X 6 INCH LONG X 5 INCHES DEEP WITH EXPOSED REBAR

Span 31 Expansion Joint Bent 30: (PAR) AT BENT 30, RIGHT LANE SPALL 4 FEET WIDE X 6 INCH LONG X 5 INCHES DEEP WITH EXPOSED REBAR

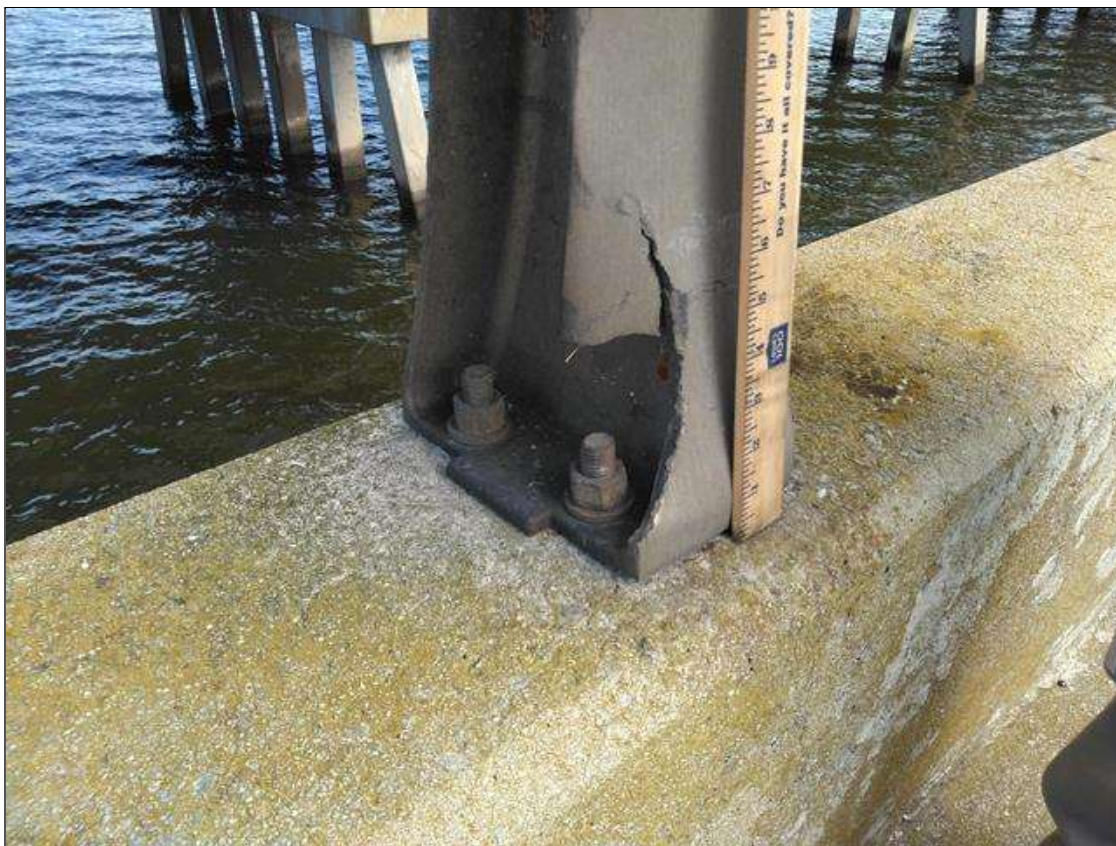
<b>3318</b>	<b>Left Bridge Rail</b>	Concrete and Metal Railing	
Priority Level	Defect Type	Quantity	Defect Description
<b>2</b>	Damage	1	Span 34 Left Bridge Rail: (PAR) RAIL POST 6, IMPACT DAMAGE

Span 34 Left Bridge Rail: (PAR) RAIL POST 6, IMPACT DAMAGE

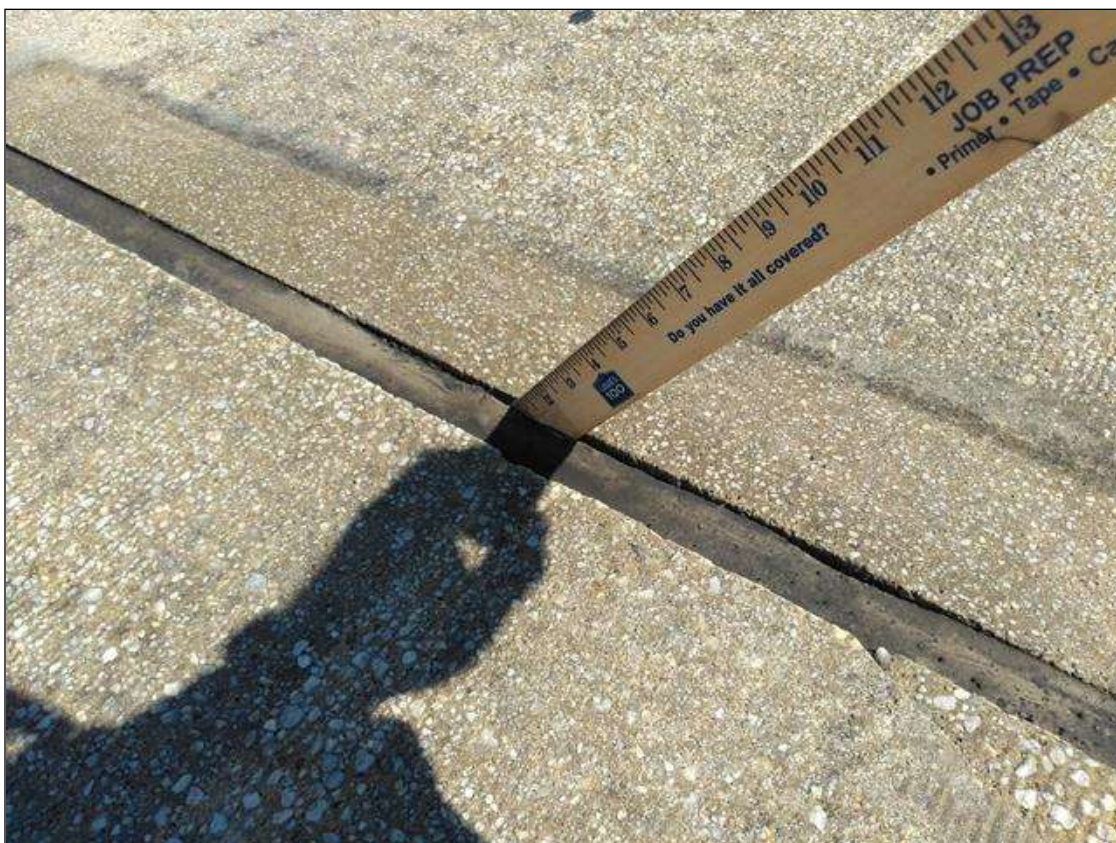
Span 37 Expansion Joint Bent 36: AT BENT 36, LEFT LANE PARTIAL DEPTH ADHESION LOSS 2 FEET LONG

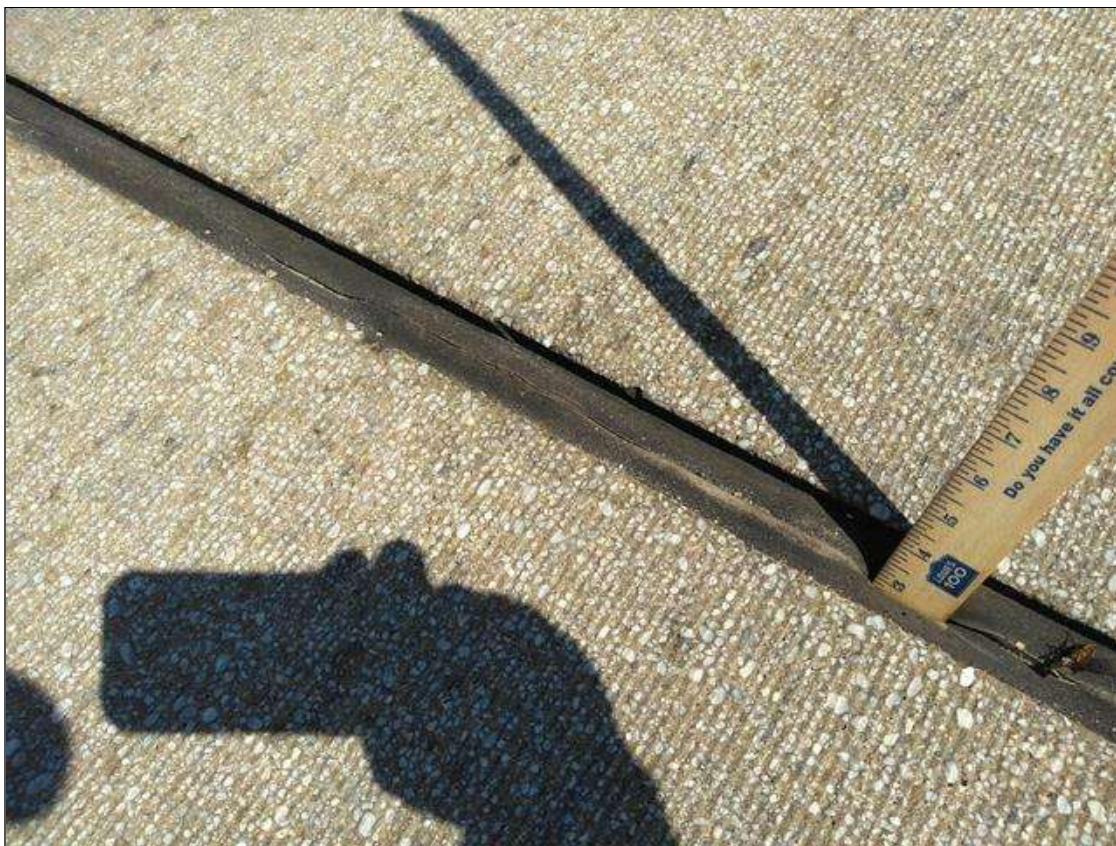
Span 38 Expansion Joint Bent 37: AT BENT 37, FULL DEPTH FULL WIDTH CRACK

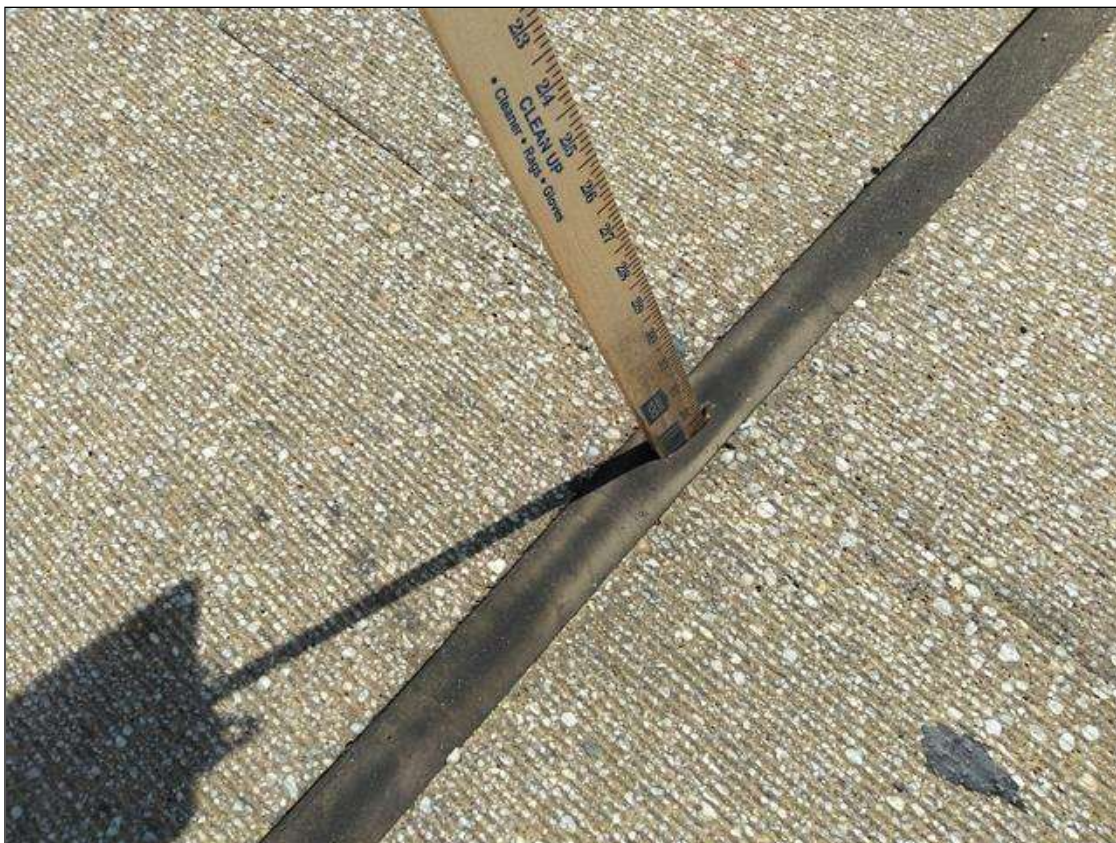
Span 41 Expansion Joint Bent 40: AT BENT 40, RIGHT LANE FULL DEPTH CRACK 2 INCHES WIDE

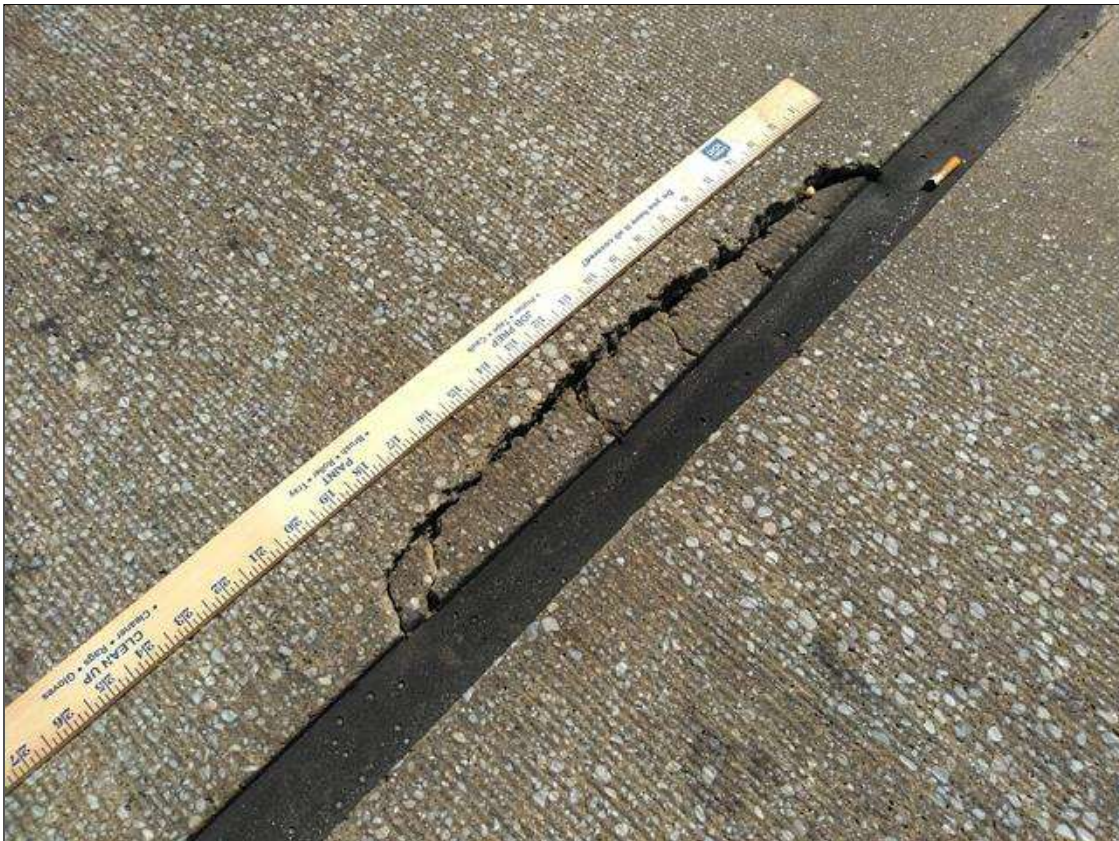
Span 53 Expansion Joint Bent 52: (PAR) AT BENT 52, RIGHT LANE 20 INCH LONG X 2 INCH WIDE SPALL AND DELAMINATION

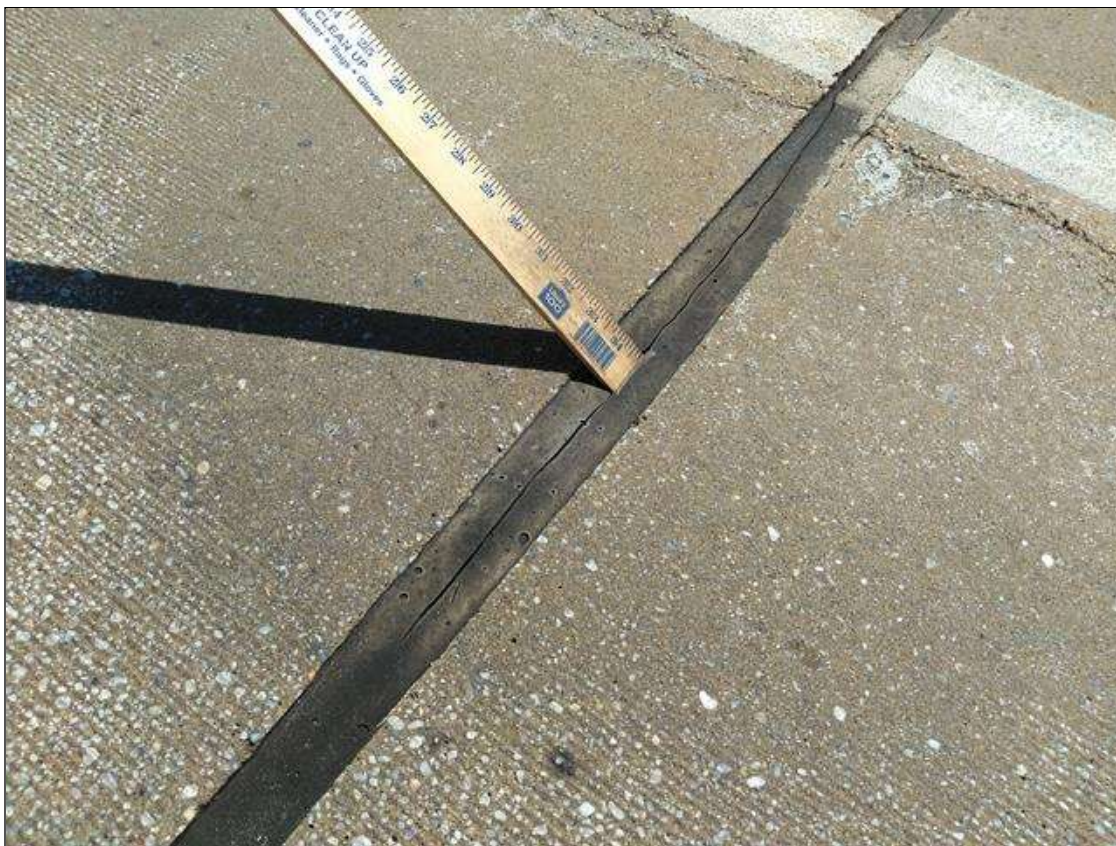
Span 56 Expansion Joint Bent 55: AT BENT 55, INTERMITTENT FULL DEPTH CRACKS THROUGHOUT

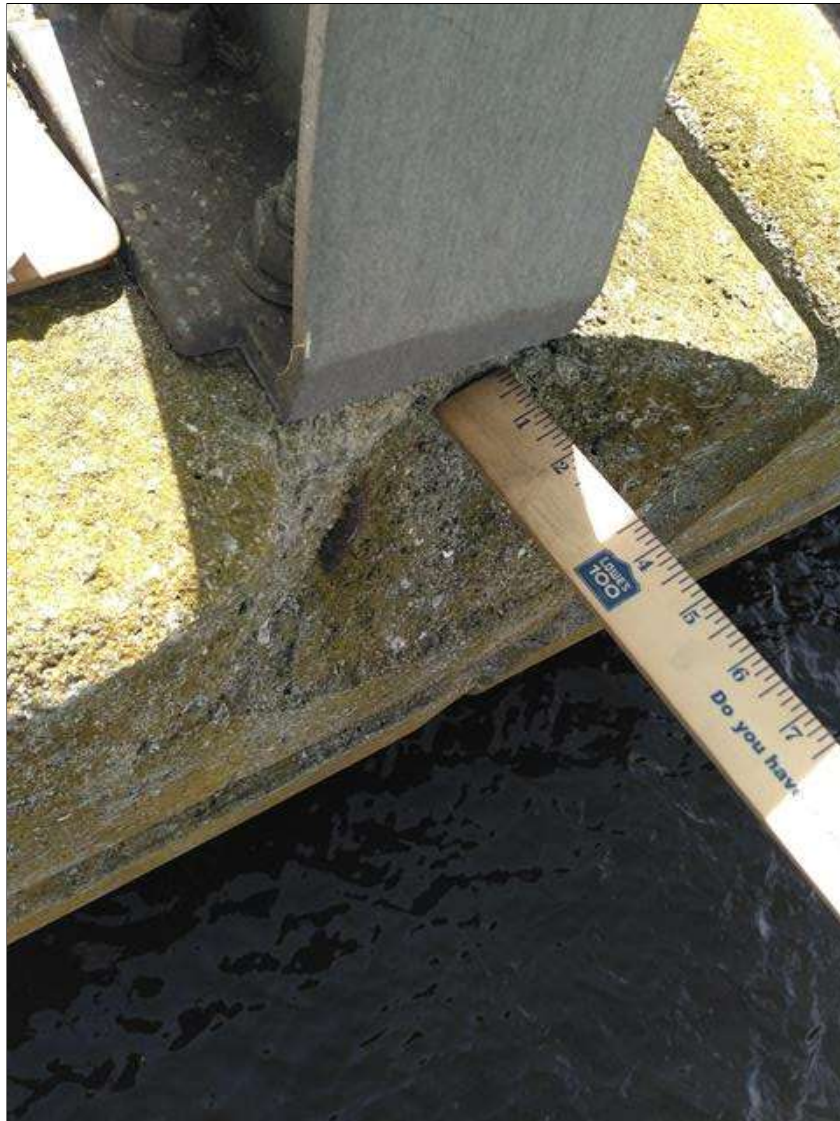
Span 57 Left Bridge Rail: BACK OF RAIL AT POST 1, 12 INCH LONG X 9 INCH HIGH X 2.5 INCH DEEP SPALL WITH EXPOSED REBAR WITH CORROSION

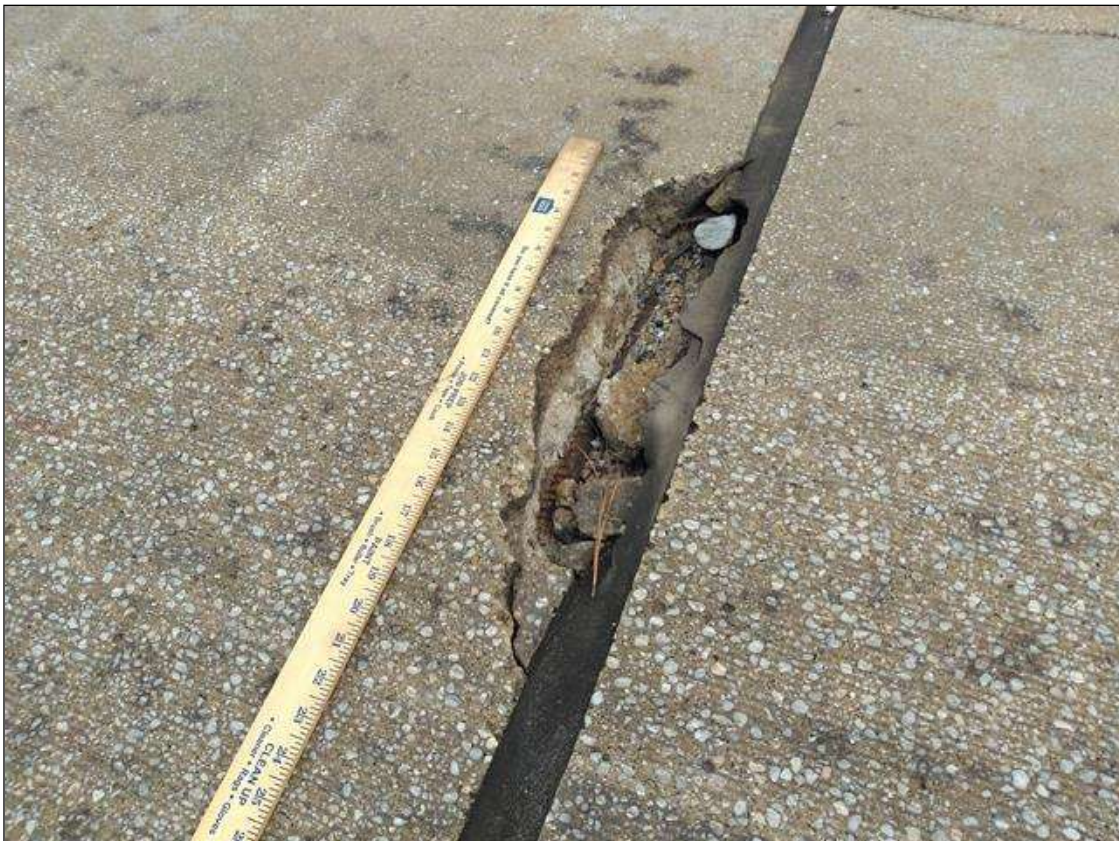
Span 77 Expansion Joint Bent 76: (PAR) AT BENT 76, RIGHT LANE SPALL WITH EXPOSED REINFORCEMENT WITH CORROSION. 2 FEET WIDE X 4 INCHES LONG X 3 INCHES DEEP.

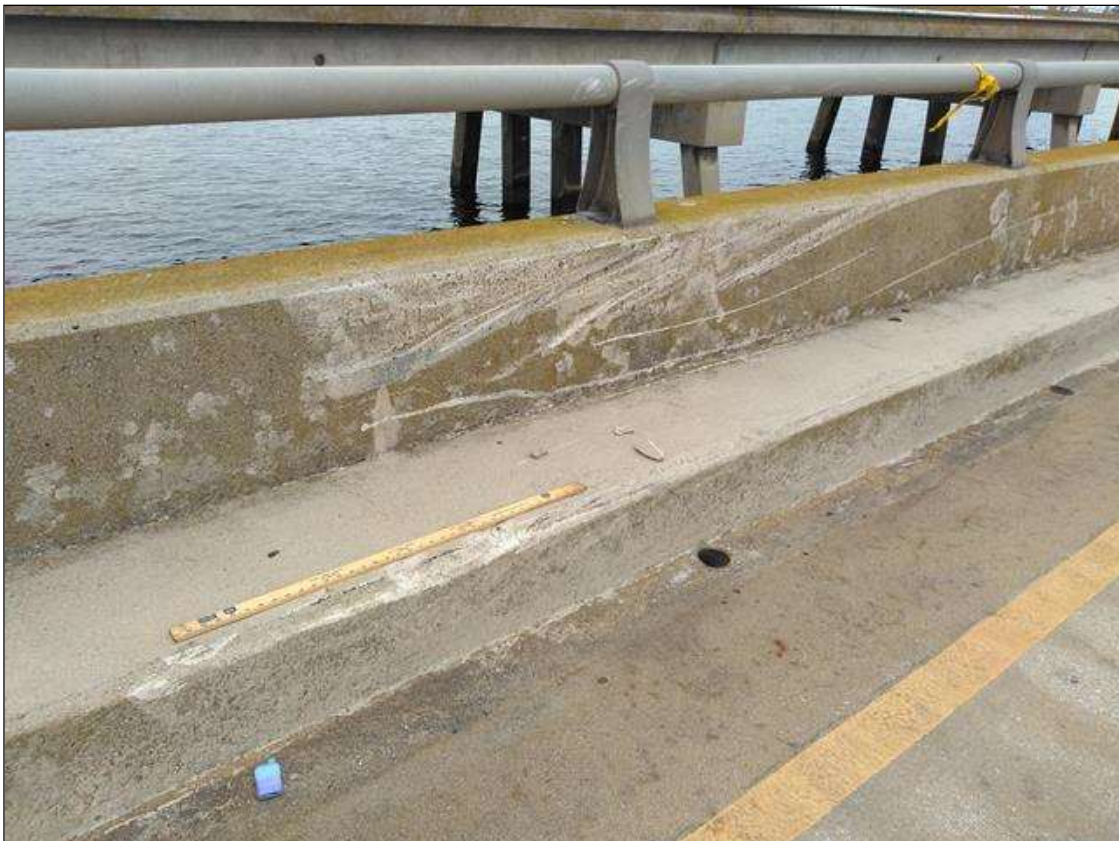
Span 83 Left Bridge Rail: BETWEEN POSTS 2 AND 4, IMPACT SCRAPES ON RAIL AND SPALLS ON CURB UP TO 3 FEET LONG X 3 INCHES HIGH X 1 INCH DEEP

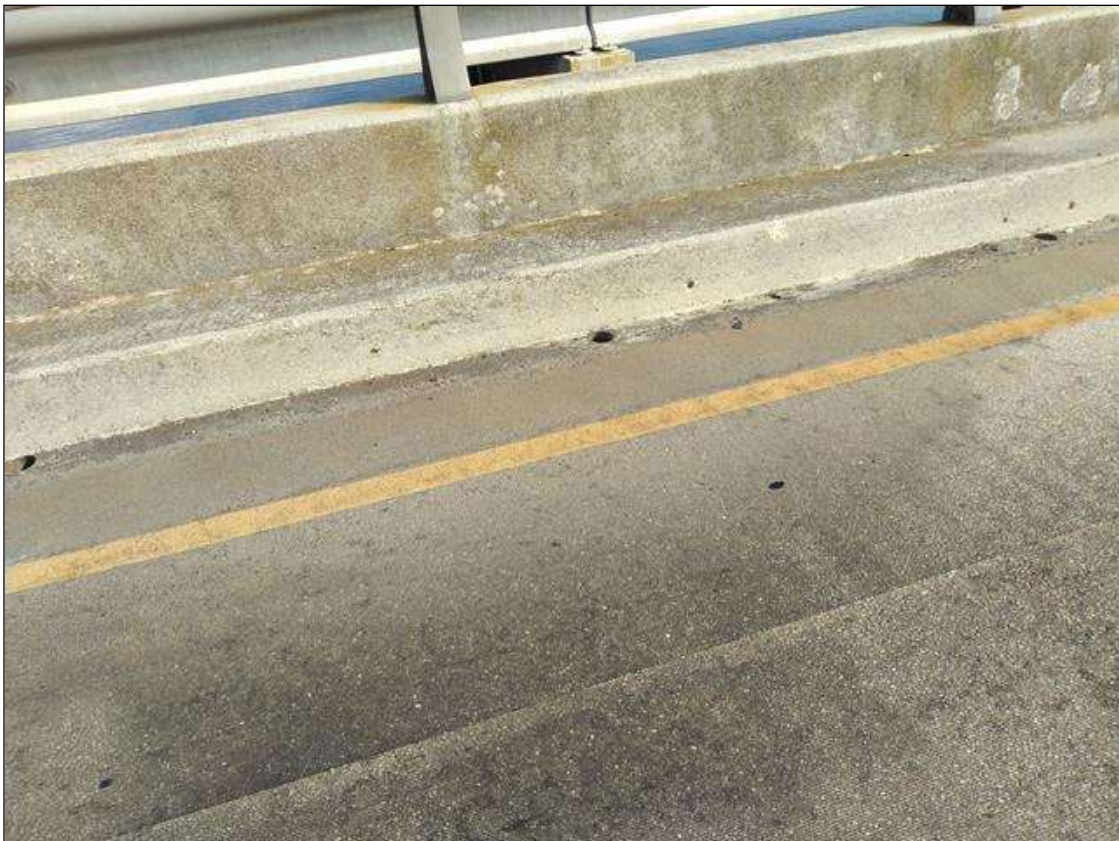
Span 2 Deck: DECK SURFACE 12 FEET FROM BENT 2 NEAR LEFT CURB, PATCHED AREA (12INCHES X 16 INCHES) (DEFECT NOT FOUND 9/12/22)

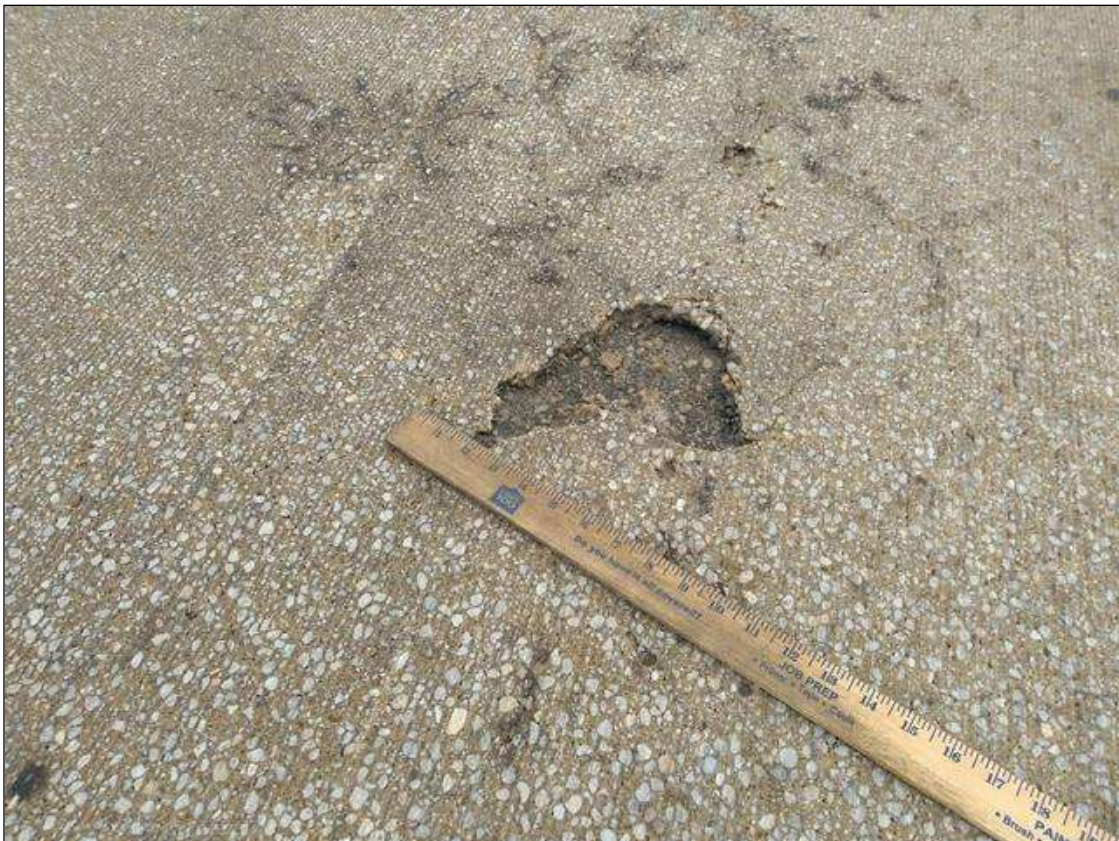
Span 86 Deck: RIGHT LANE AT 16 FEET FROM BENT 86, SPALLS (8 INCHES X 6 INCHES X 1/2 INCHES) AND 3 INCH X 1 INCH X 0.50 INCH DEEP

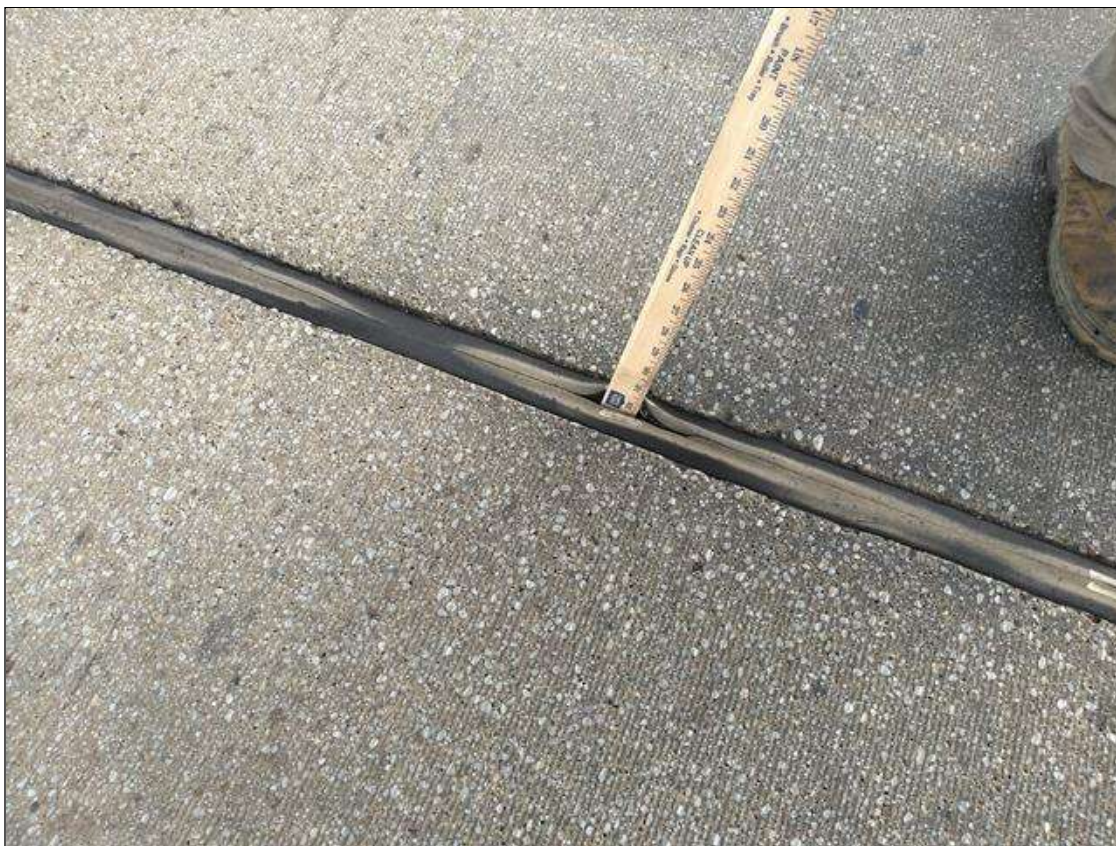
Span 3 Expansion Joint Bent 2: LEFT HALF SEAL DAMAGE

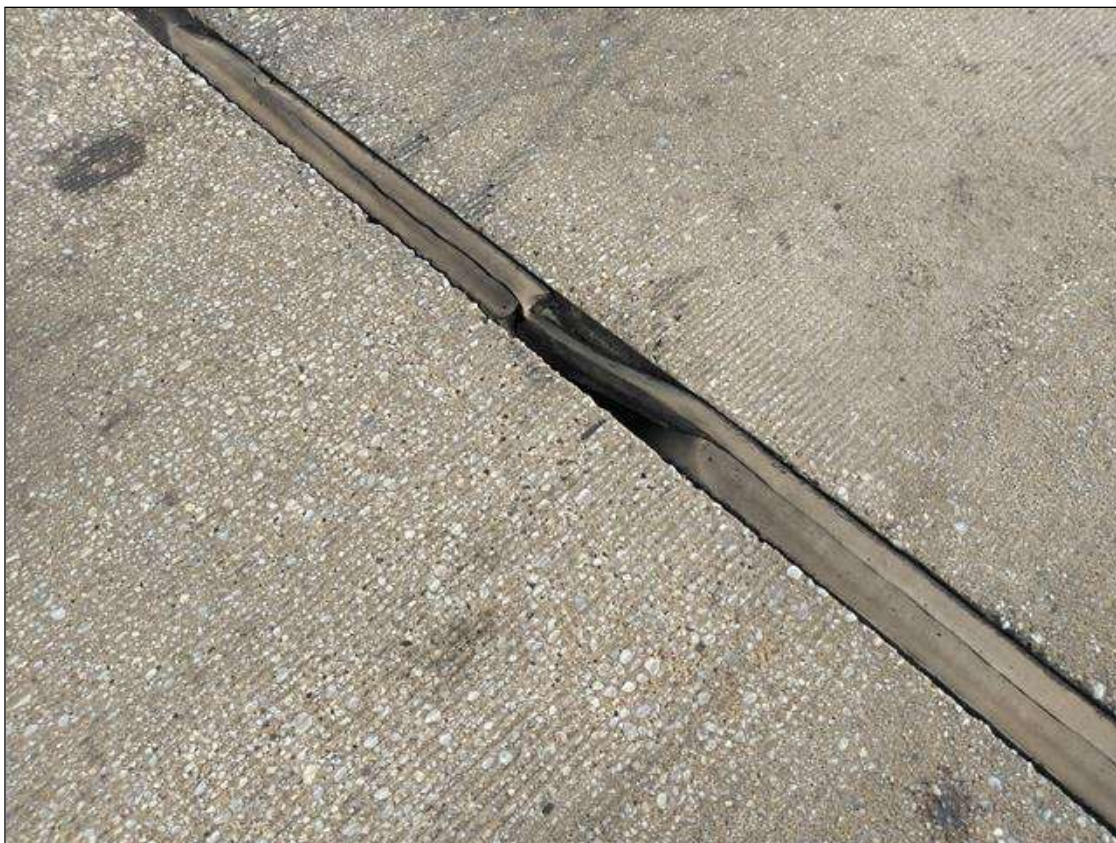
Span 3 Expansion Joint Bent 2: RIGHT HALF, SEAL DAMAGE

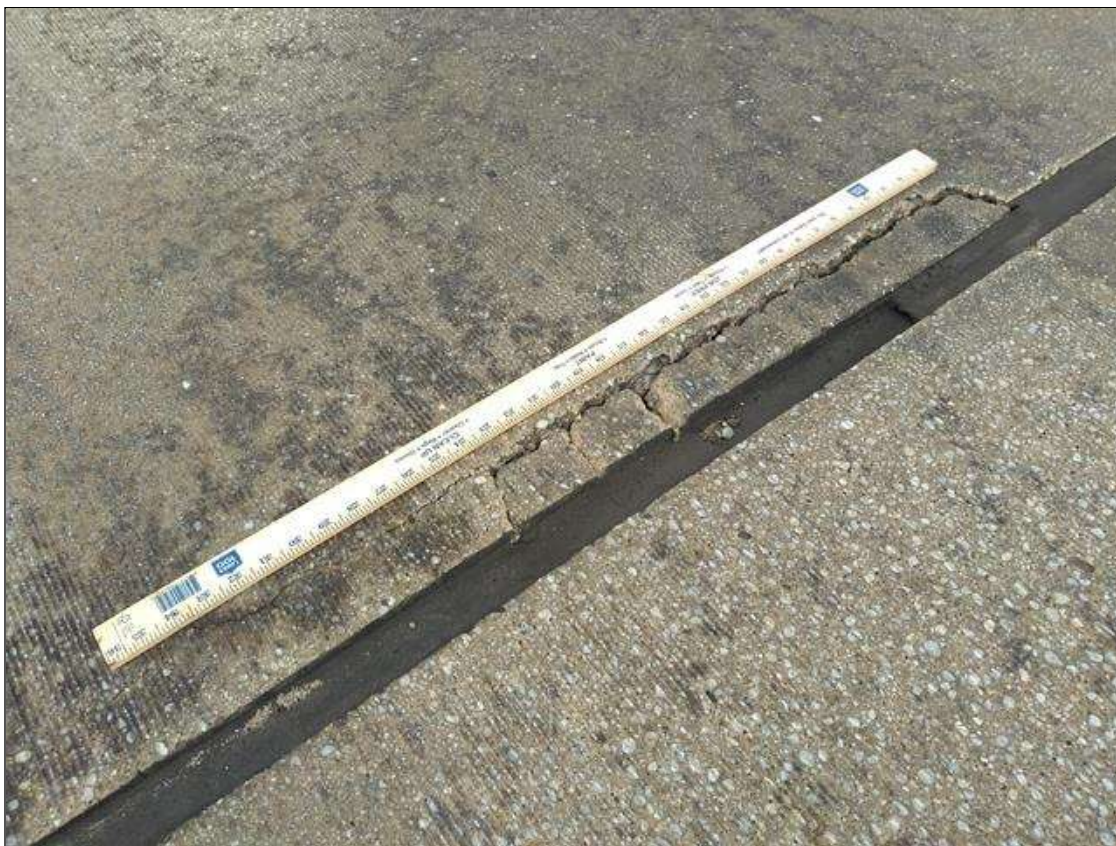
Priority Level	Defect Type	Quantity	Defect Description
2	Adjacent Deck or	4	Span 9 Expansion Joint Bent 8: (PAR) AT BENT 8, RIGHT LANE SPALL 4 FOOT WIDE X 2.5 INCH LONG

Span 9 Expansion Joint Bent 8: (PAR) AT BENT 8, RIGHT LANE SPALL 4 FOOT WIDE X 2.5 INCH LONG

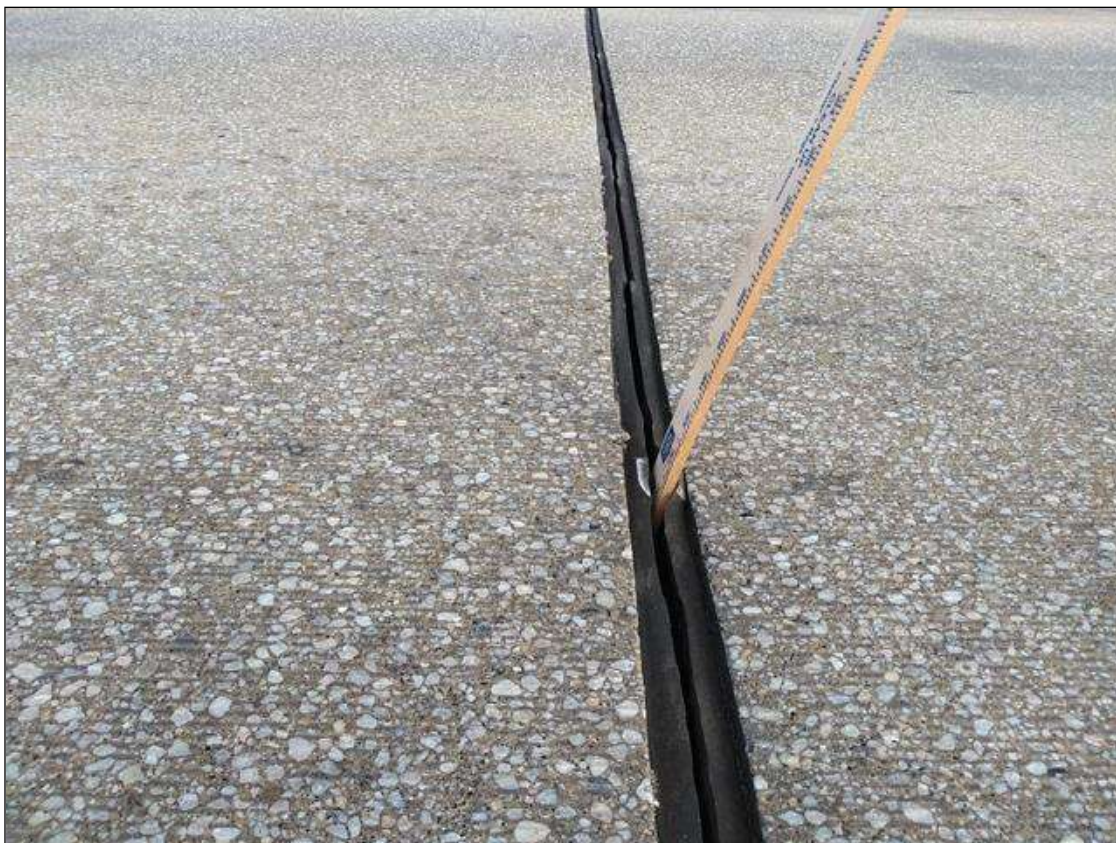
Span 13 Expansion Joint Bent 12: BOTH LANES SCATTERED THROUGHOUT, SEAL DAMAGE FULL DEPTH

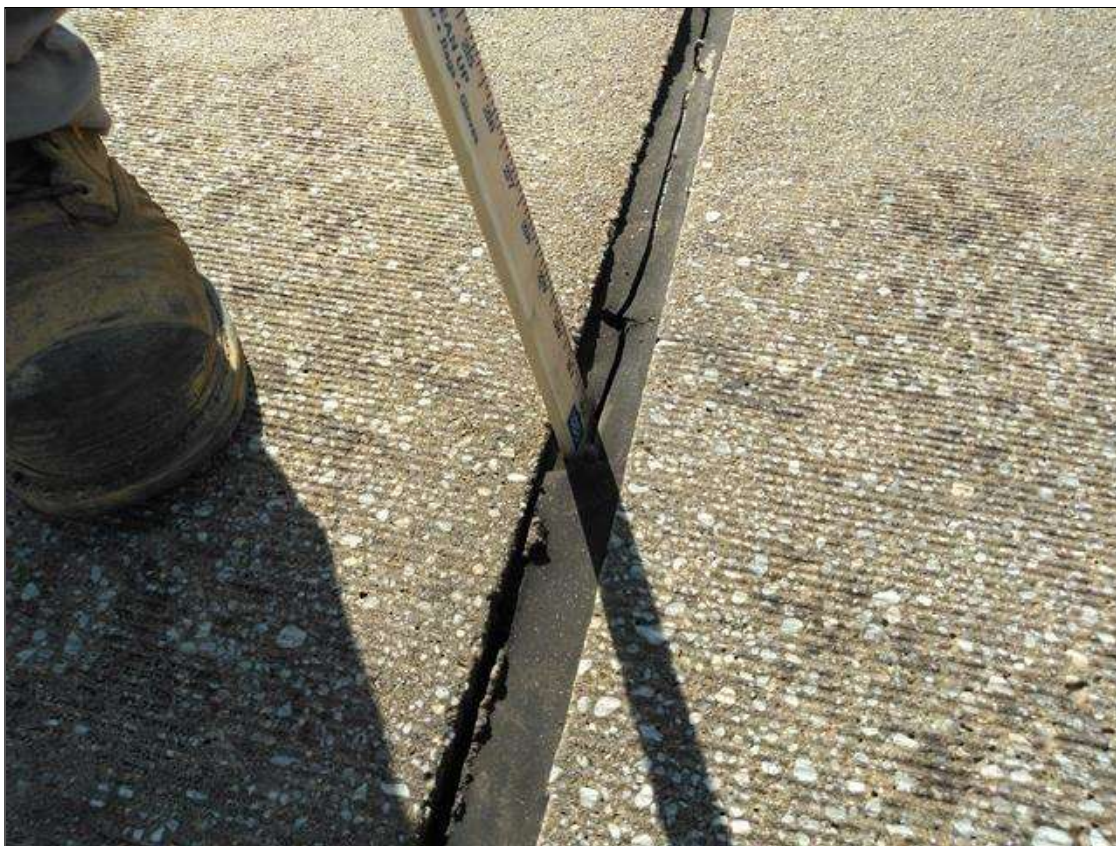
Span 24 Expansion Joint Bent 23: INTERMITTENT THROUGHOUT, SEAL DAMAGE

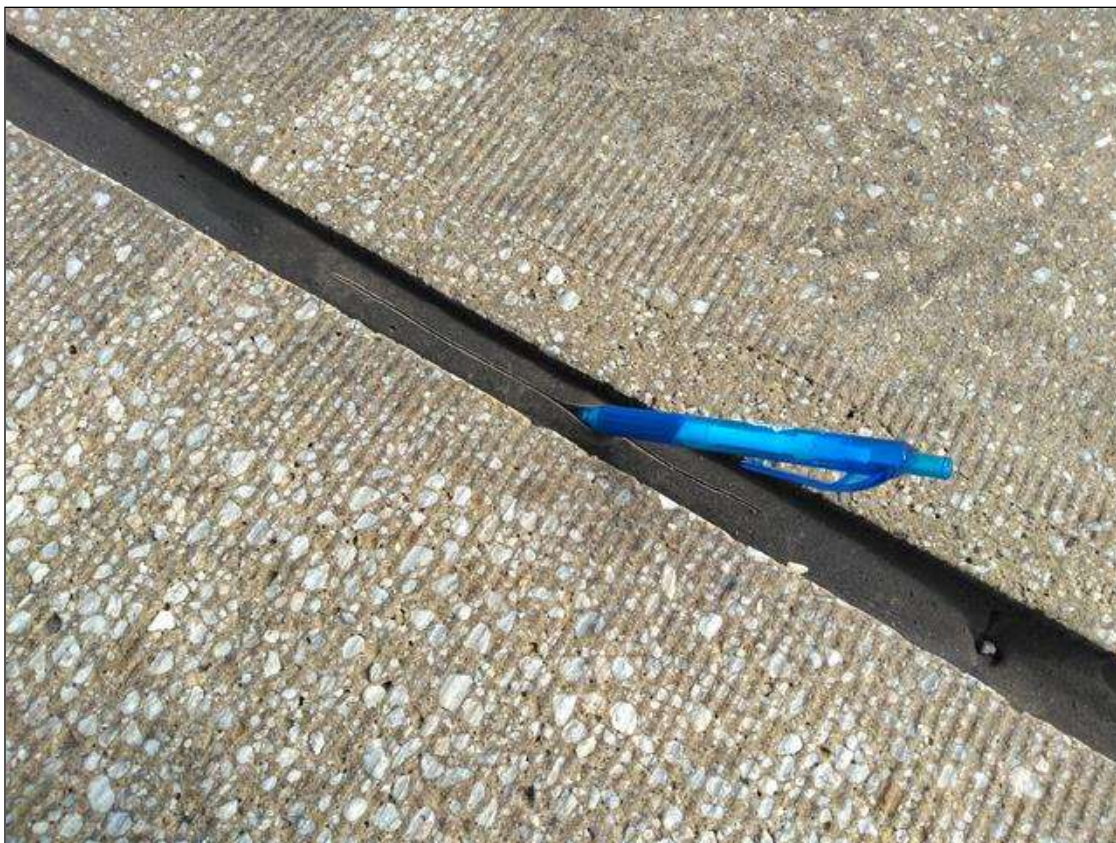
Span 28 Expansion Joint Bent 27: LEFT LANE, PARTIAL DEPTH SEAL DAMAGE (14 FEET)
