NC DEPARTMENT OF TRANSPORTATION  
DIVISION OF HIGHWAYS  
STRUCTURE MANAGEMENT UNIT

## Structure Safety Report

### Routine Element Inspection - Contract

STRUCTURE NUMBER: 260016 SAP STRUCTURE NO: 0270016 FHWA STRUCTURE NO: 000000000530016  
DIVISION: 1 COUNTY: CURRITUCK INSPECTION DATE: 09/21/2022 FREQUENCY: 24 MONTHS  
FACILITY CARRIED: US158E MILE POST: \_\_\_\_\_  
LOCATION: .01 MI.E.JCT.SR1187  
FEATURE INTERSECTED: CURRITUCK SOUND  
LATITUDE: 36° 5' 11.69" LONGITUDE: 75° 46' 0.21"  
SUPERSTRUCTURE: RC FLOOR ON PPC GIRDERS & CORED SLAB  
SUBSTRUCTURE: EBTS:RC CAP/PPC PILES;IBTS:RCP&B & RC CAPS/PPC PILES  
SPANS: 248 SPANS. SEE SPAN PROFILE SHEET FOR SPAN DETAILS  
☐ FRACTURE CRITICAL ☐ TEMPORARY SHORING ☐ SCOUR CRITICAL ☐ SCOUR PLAN OF ACTION  
GRADES: (Inspector/NBI Coding) DECK 6 / 6 SUPERSTRUCTURE 5 / 5 SUBSTRUCTURE 6 / 6 CULVERT N / N  
POSTED SV: Not Posted POSTED TTST: Not Posted  
OTHER SIGNS PRESENT: None

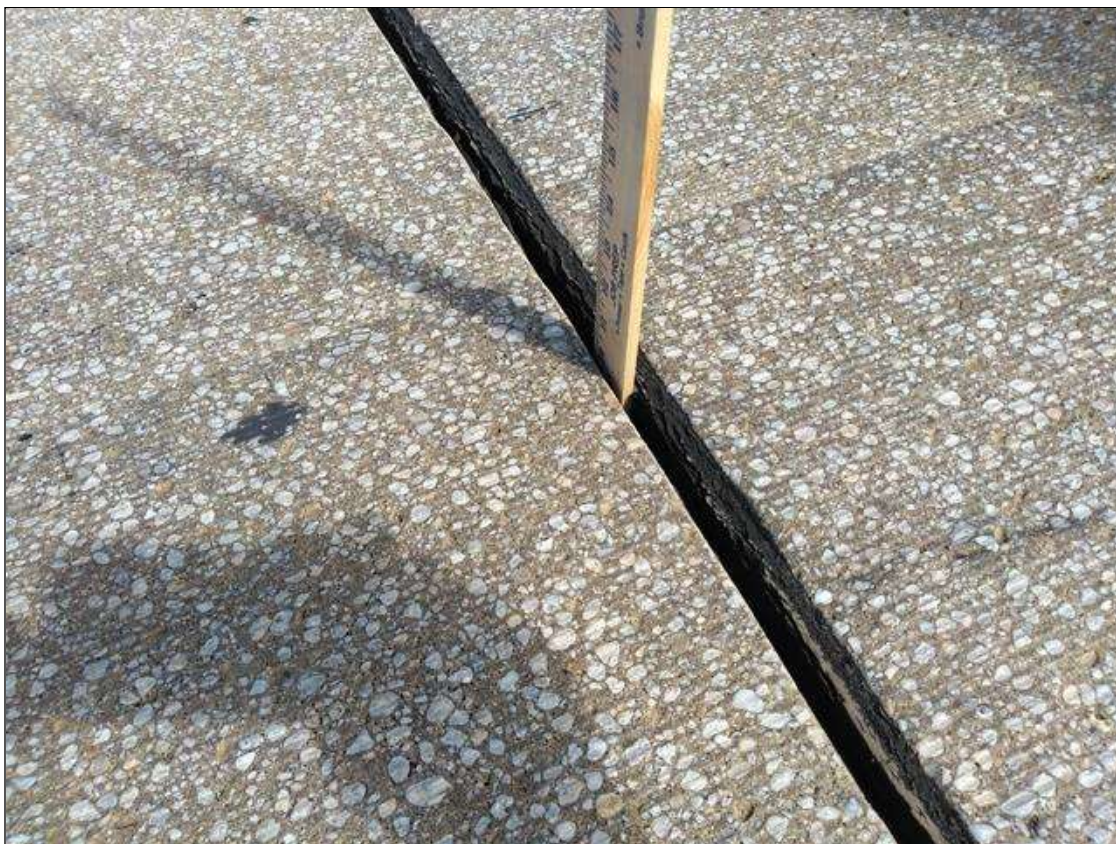
Span 36 Expansion Joint Bent 35: BOTH LANES AND SHOULDERS, SEAL DAMAGE (FULL DEPTH X FULL LENGTH)

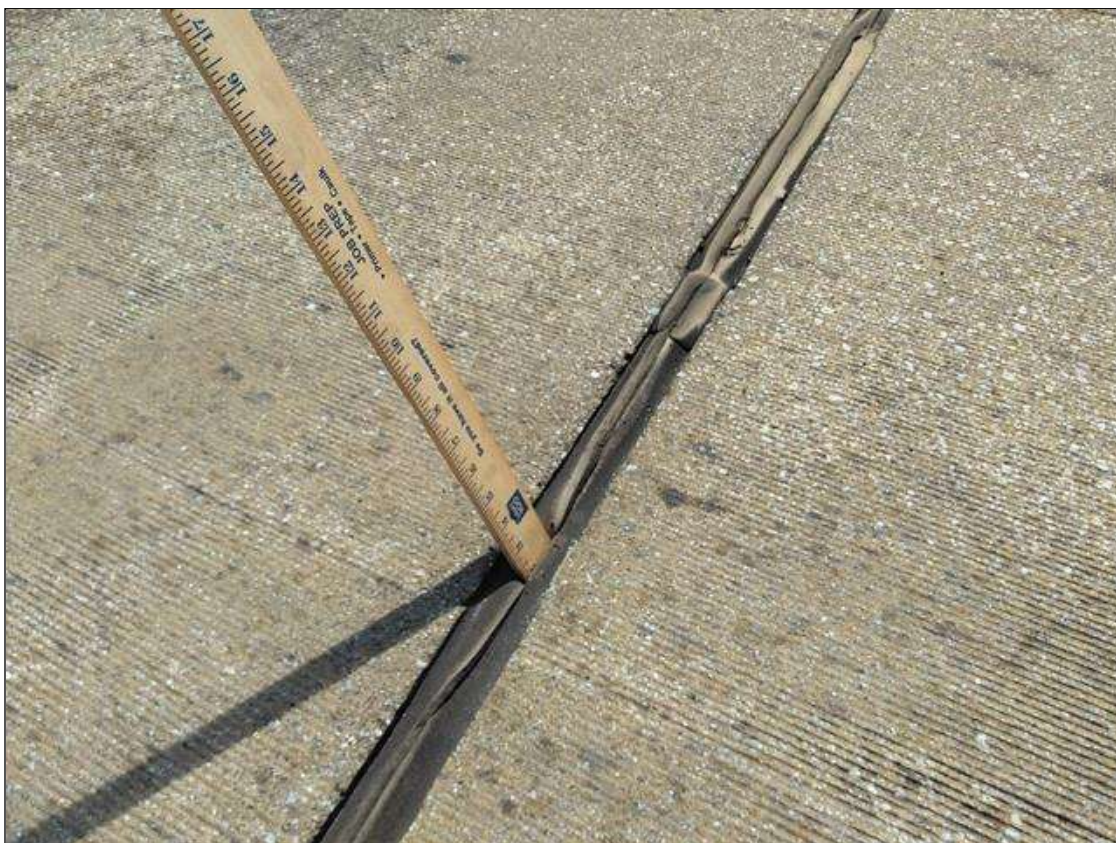
Span 43 Expansion Joint Bent 42: BOTH LANES AND SHOULDERS, SEAL DAMAGE (FULL DEPTH X FULL WIDTH)

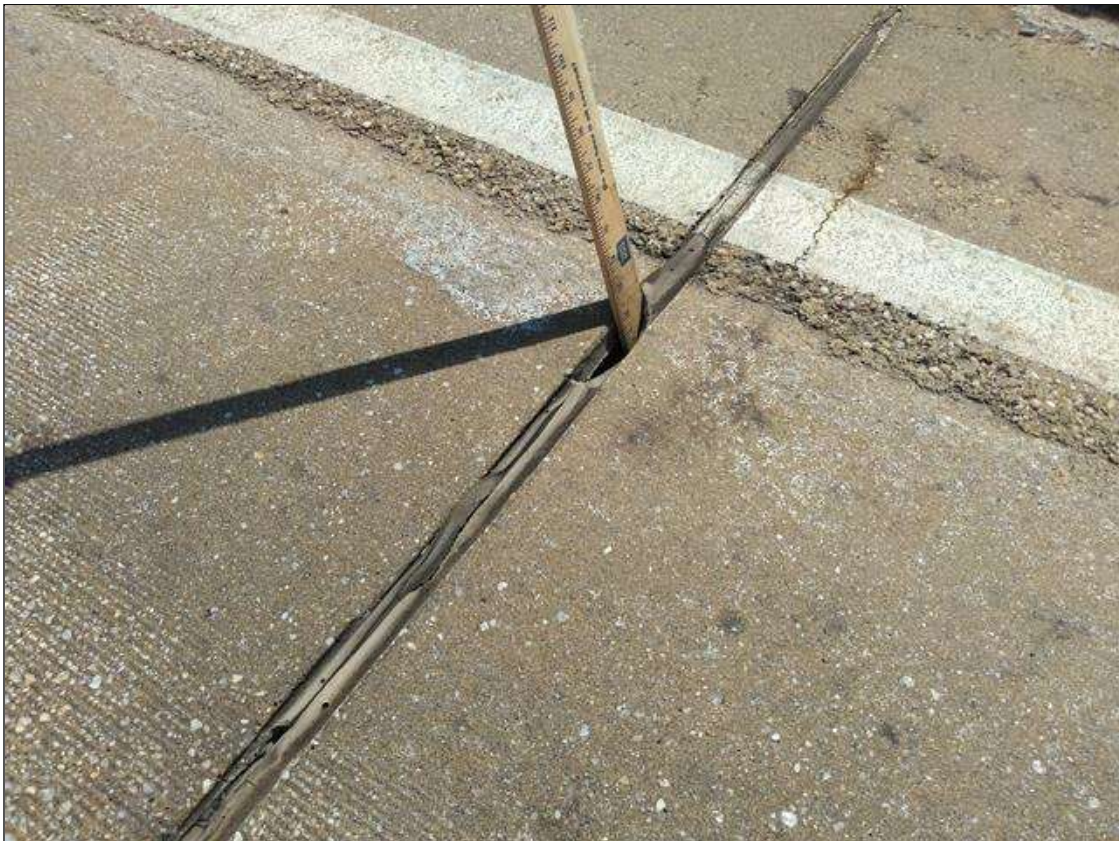
Span 50 Expansion Joint Bent 49: BOTH SHOULDERS, SEAL DAMAGE (2) 4 INCH LONG PIECES MISSING IN RIGHT SHOULDER

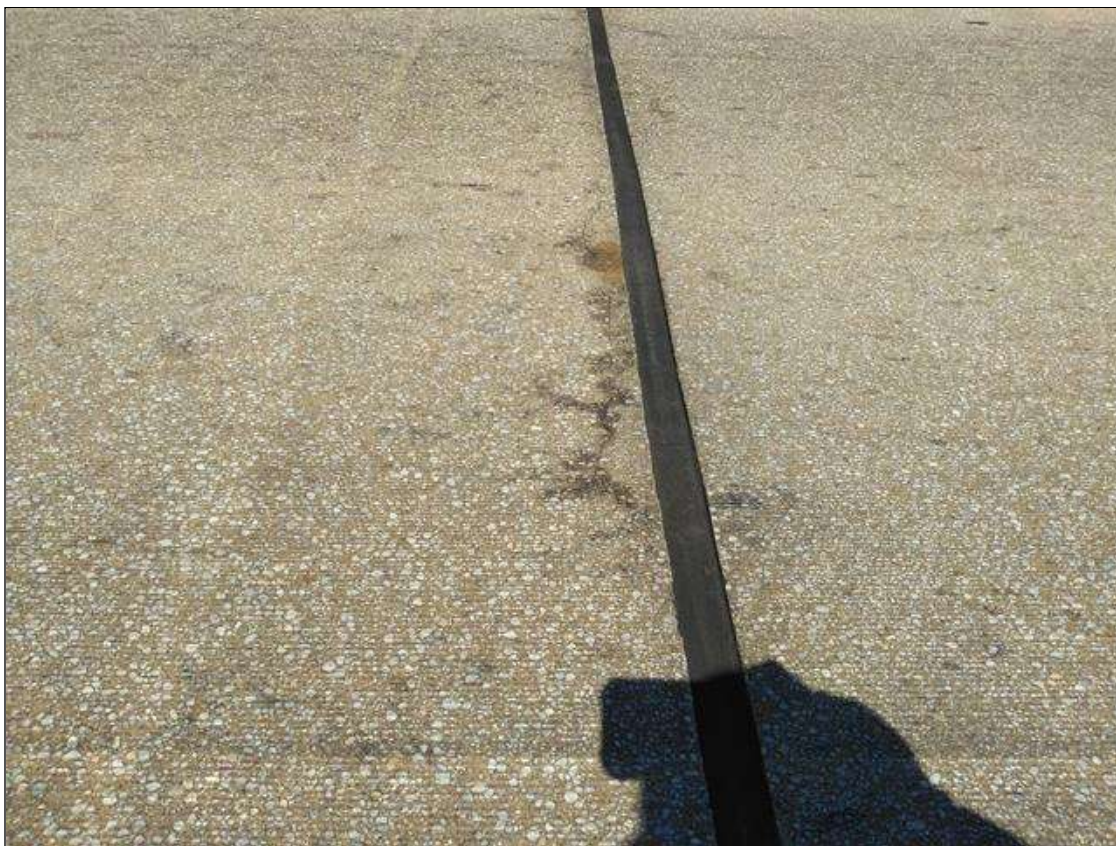
Span 55 Expansion Joint Bent 54: MIDDLE OF LANE, DELAMINATION (3FEET X 3 INCHES)

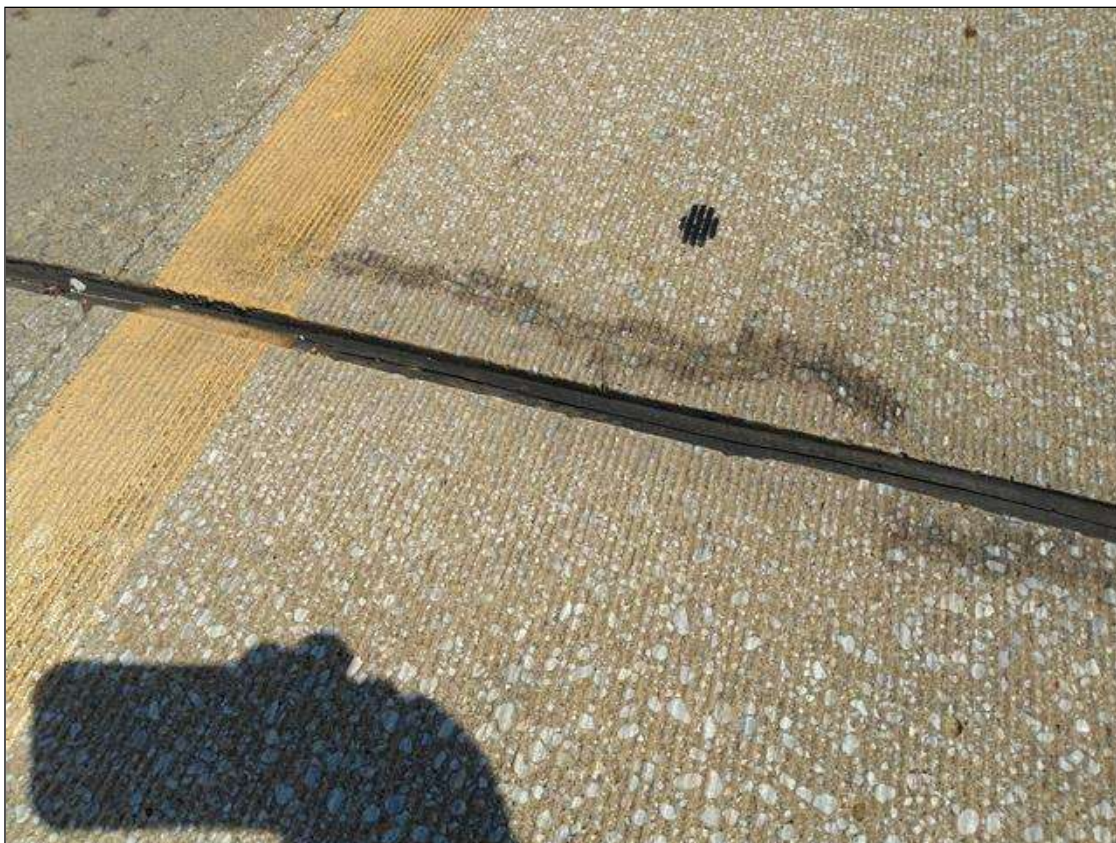
Span 56 Expansion Joint Bent 55: LEFT LANE NEAR CURB, DELAMINATION (2FEET X 3 INCHES)

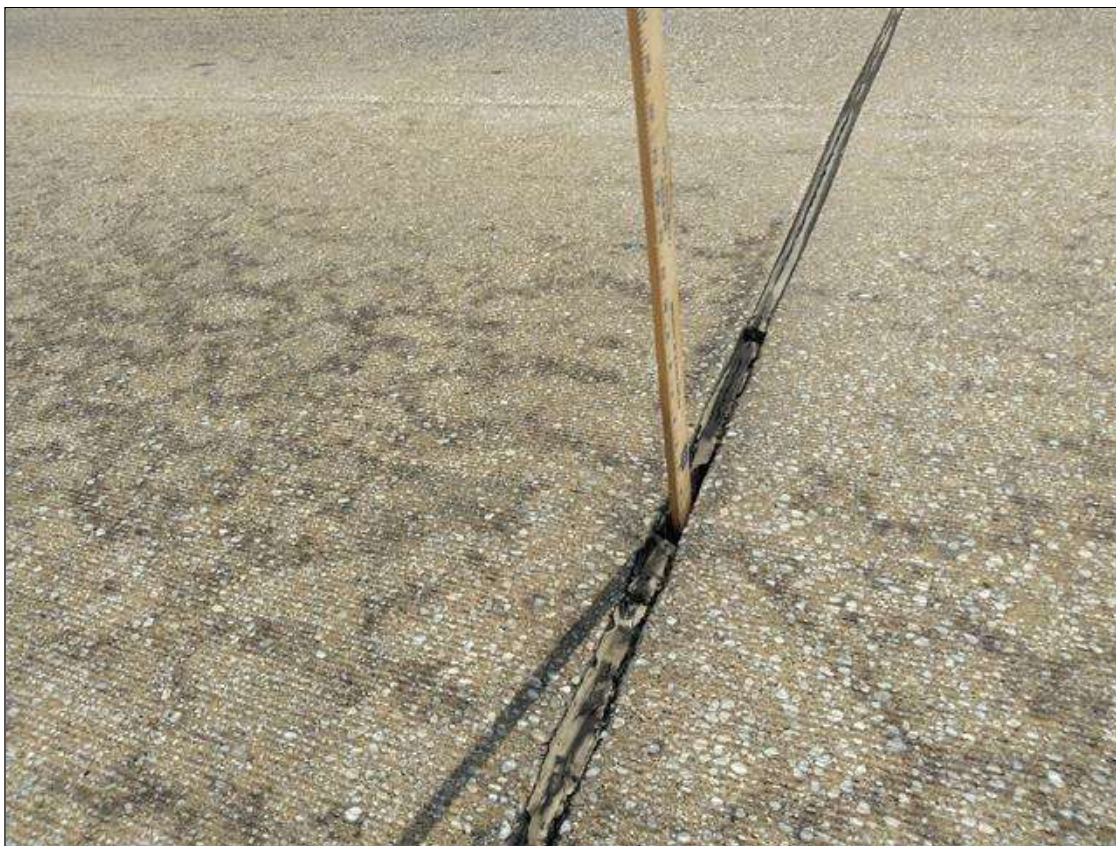
Span 58 Expansion Joint Bent 57: SCATTERED THROUGHOUT BOTH LANES, SEAL DAMAGE AND TORN (18 FEET)

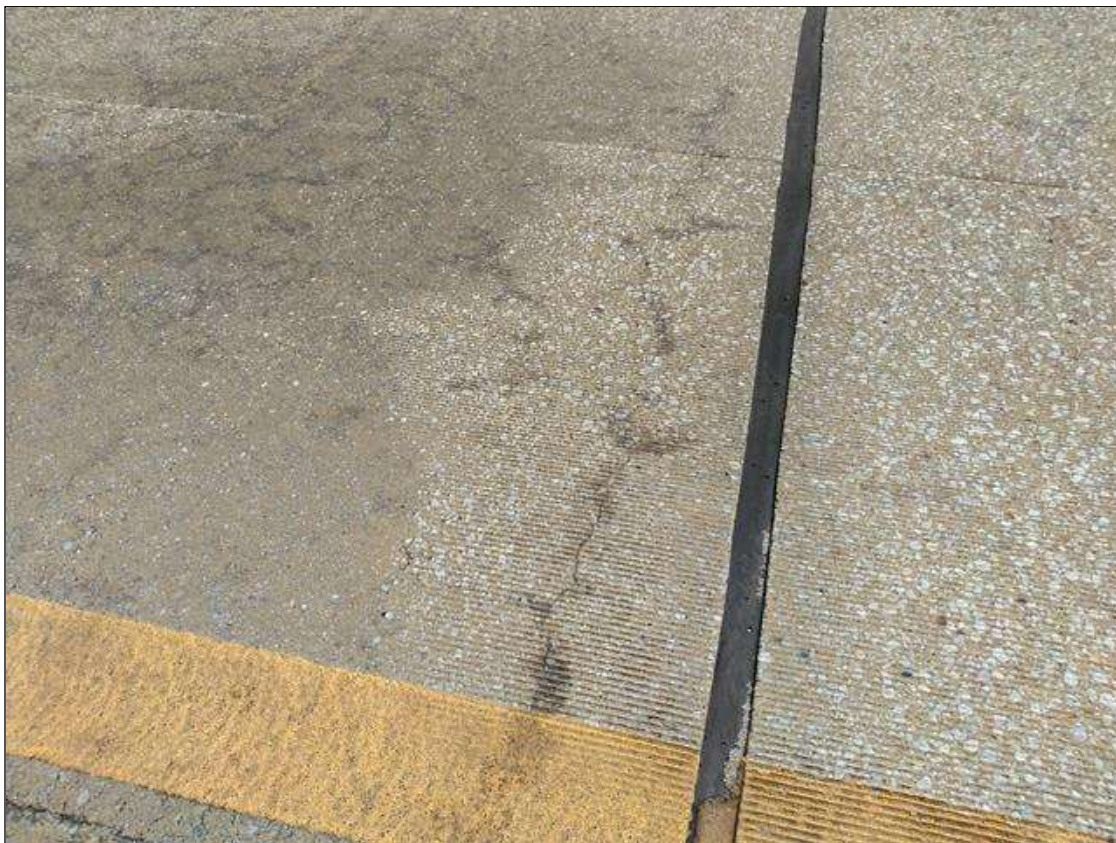
Span 62 Expansion Joint Bent 61: LEFT LANE NEAR CURB, DELAMINATION (4FEET X 6 INCHES)

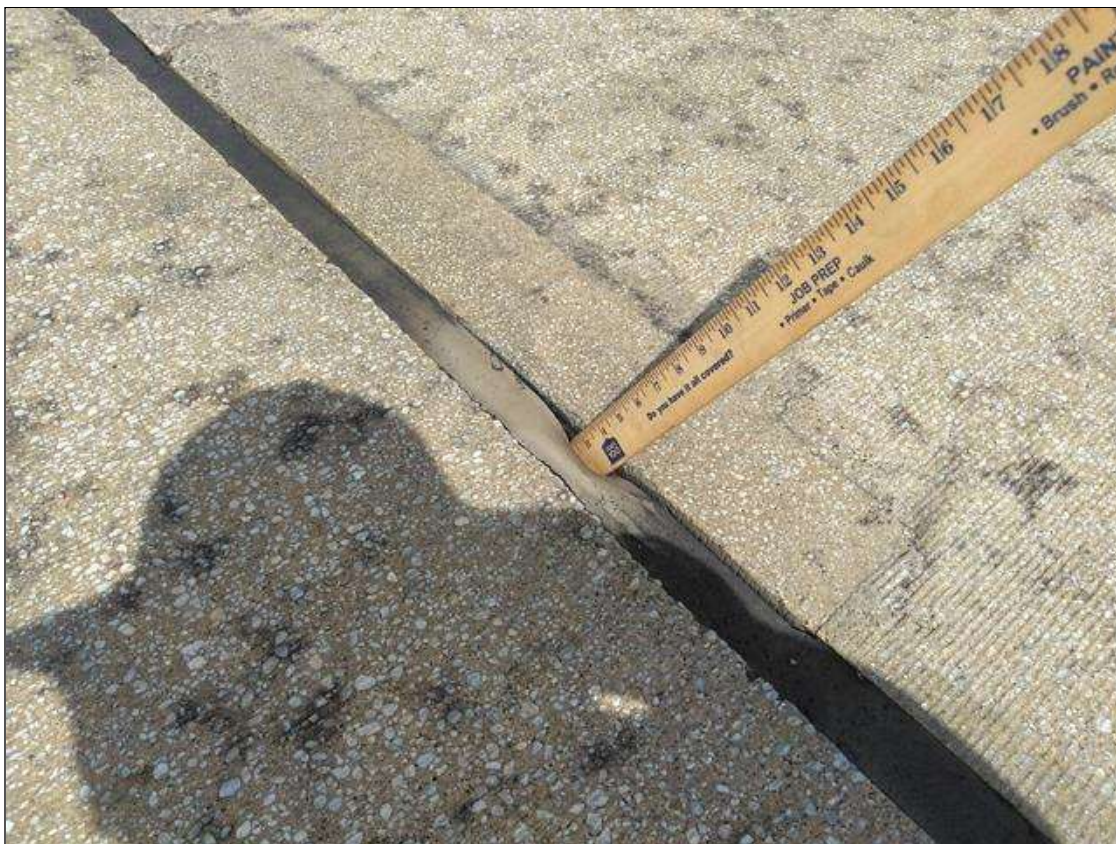
Span 63 Expansion Joint Bent 62: LEFT LANE, (2) PATCHED AREAS (UP TO 6FEET 4INCHES). NO ADHESION AT PATCHES

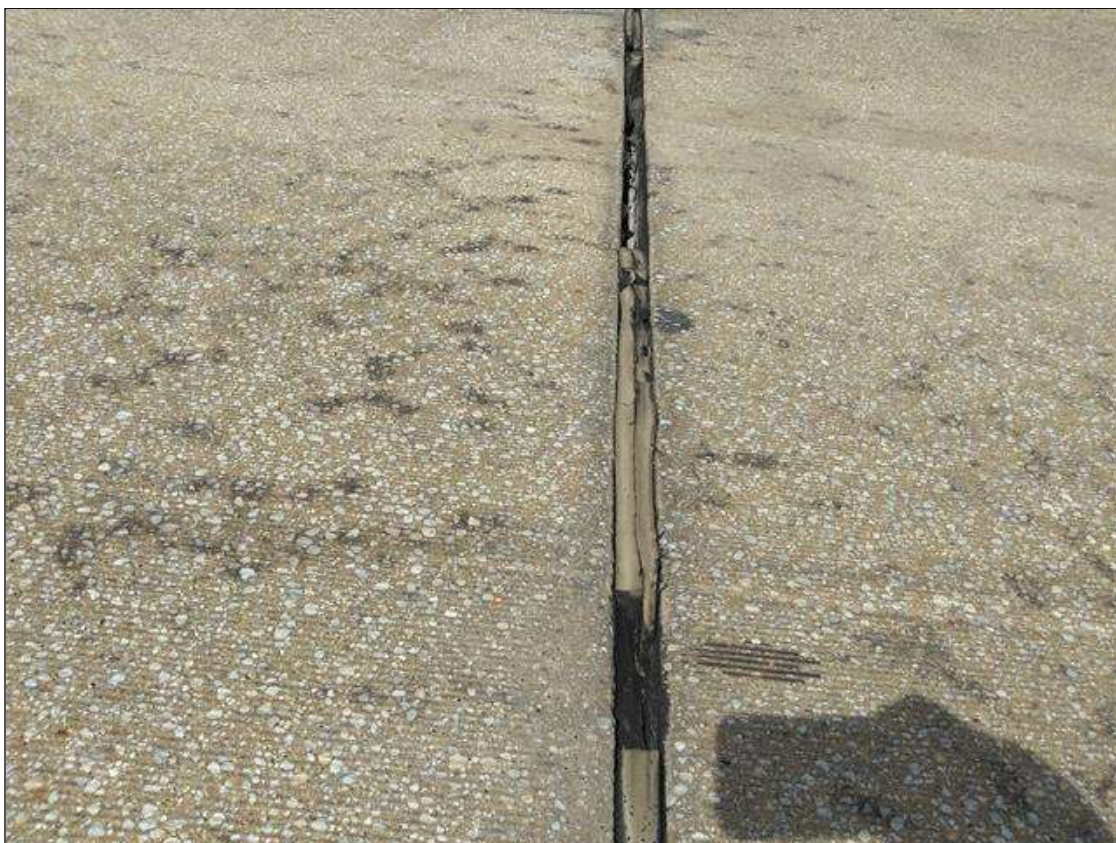
Span 67 Expansion Joint Bent 66: BOTH LANES AND SHOULDERS, SEAL DAMAGE ( UP TO FULL LENGTH)

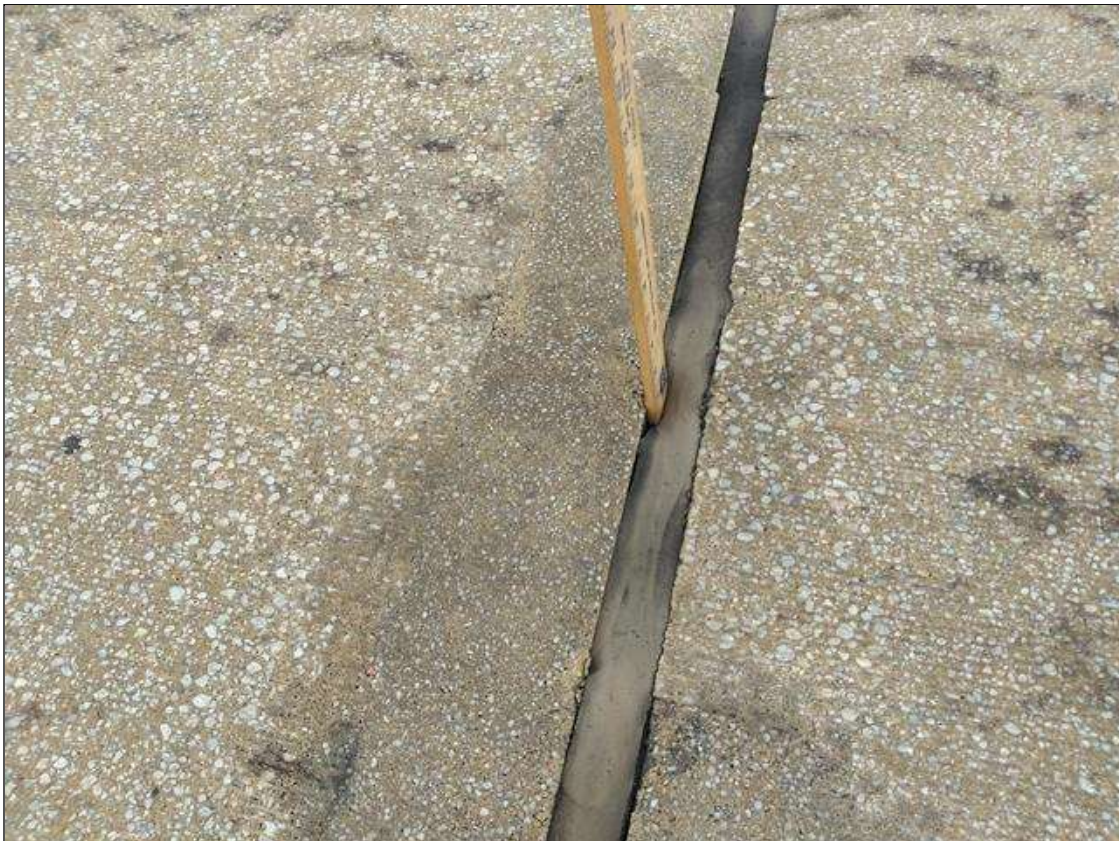
Span 72 Expansion Joint Bent 71: LEFT LANE NEAR CENTERLINE OF ROADWAY, (2) PATCHED AREAS (UP TO 1FEET X 5 INCHES). NO ADHESION AT PATCHES

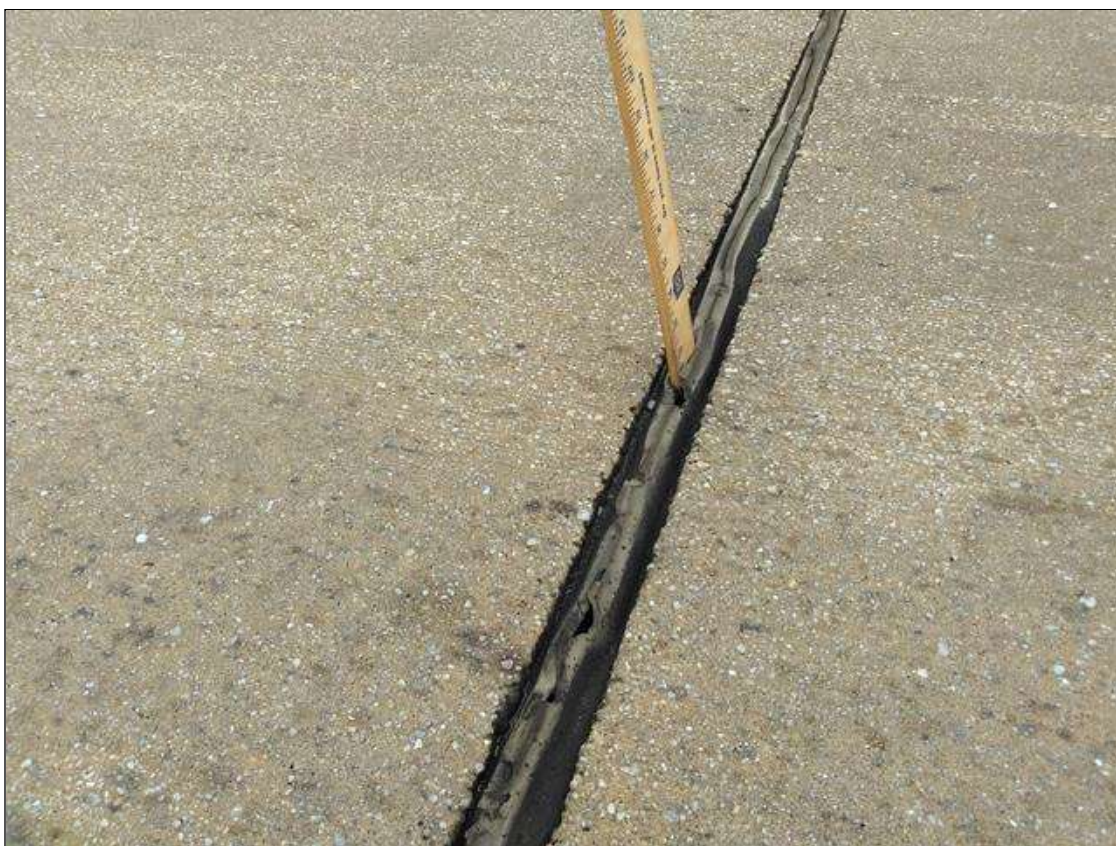
Span 83 Expansion Joint Bent 82: SCATTERED THROUGHOUT BOTH LANES, SEAL DAMAGE AND TORN (FULL WIDTH)

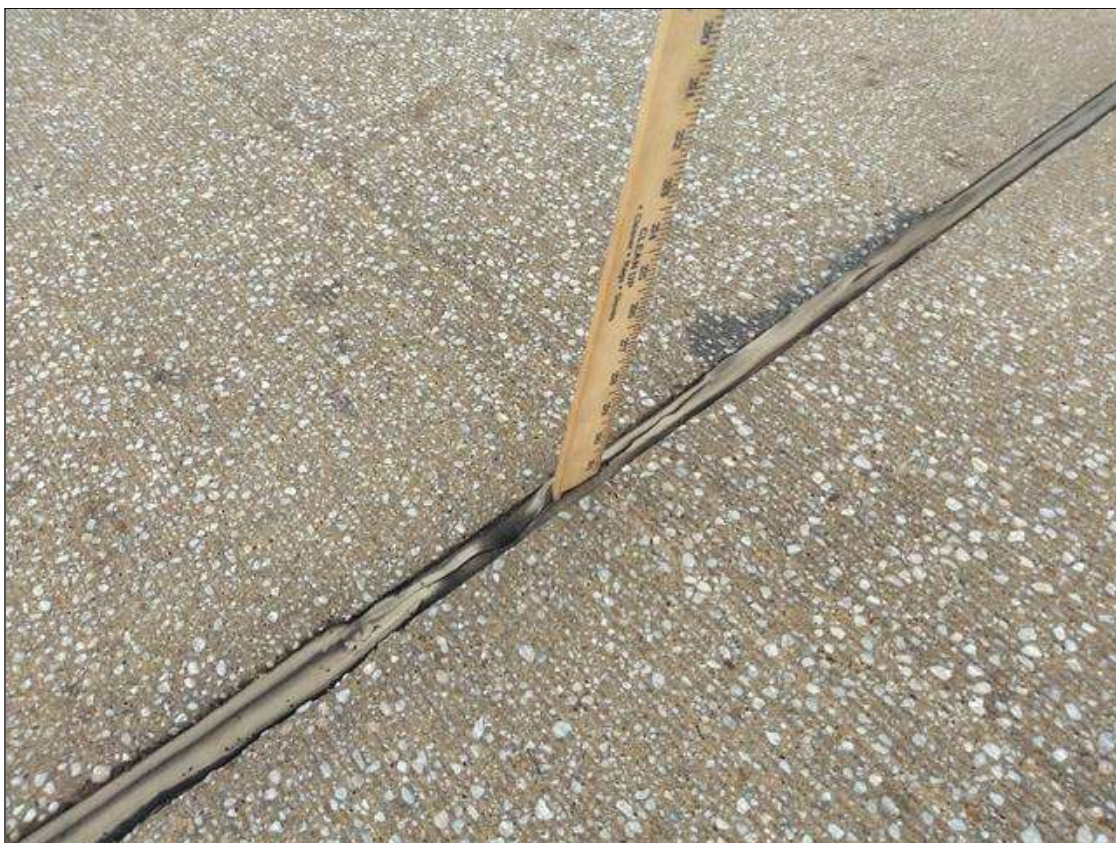
Span 89 Expansion Joint Bent 88: SCATTERED THROUGHOUT BOTH LANES, SEAL DAMAGED AND TORN (25 FEET)

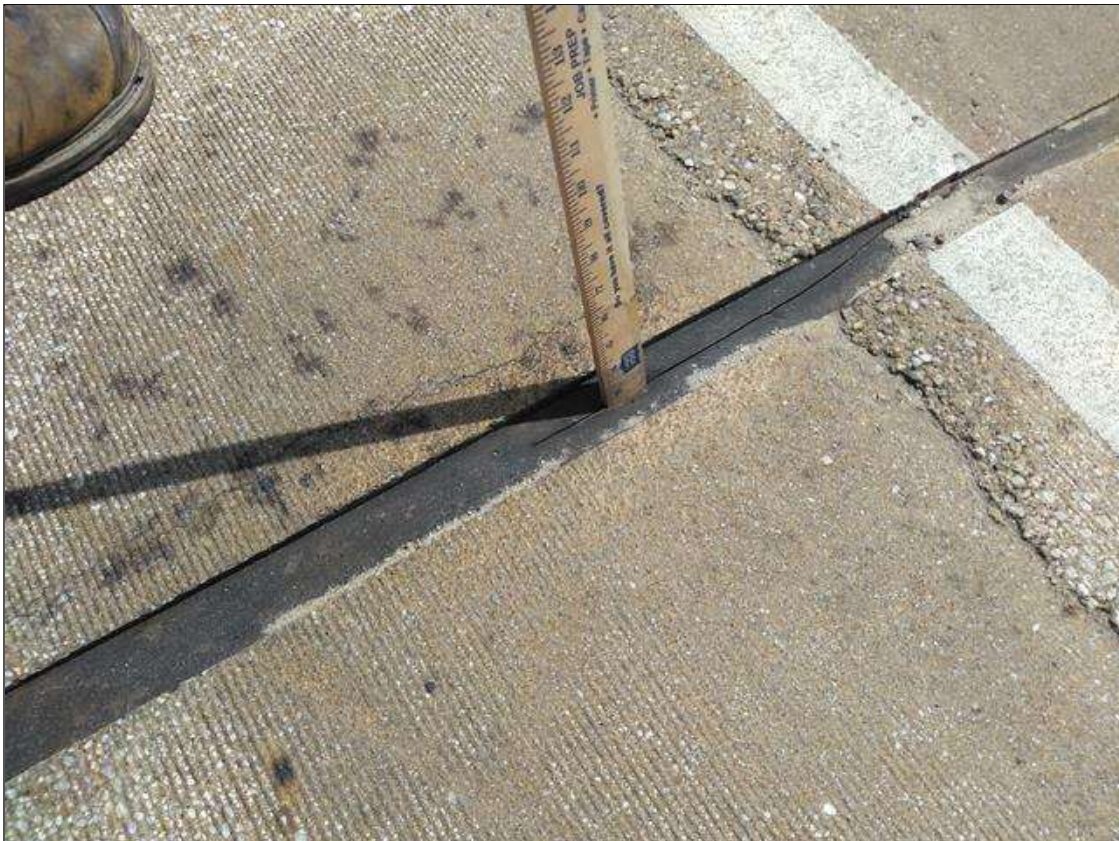
Span 47 Expansion Joint Bent 46: AT BENT 46, EACH SHOULDER 12 INCH LONG TEAR FULL DEPTH AND 24 INCH LONG TEAR FULL DEPTH AT CENTERLINE

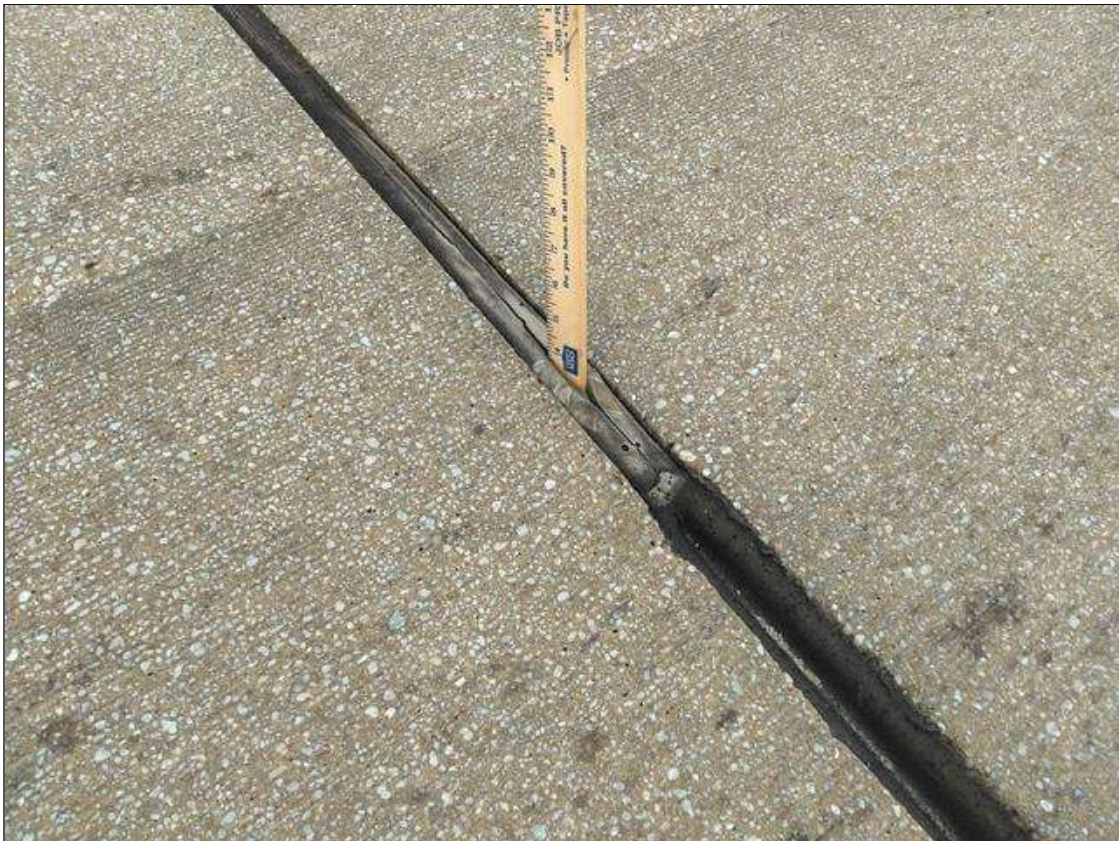
Span 95 Expansion Joint Bent 94: INTERMITTENT SPLITTING AND TEARING FULL DEPTCH IN LEFT SHOULDER TO CENTERLINE AND JOINT SUNKEN 1 INCH IN RIGHT LANE AND SHOULDER

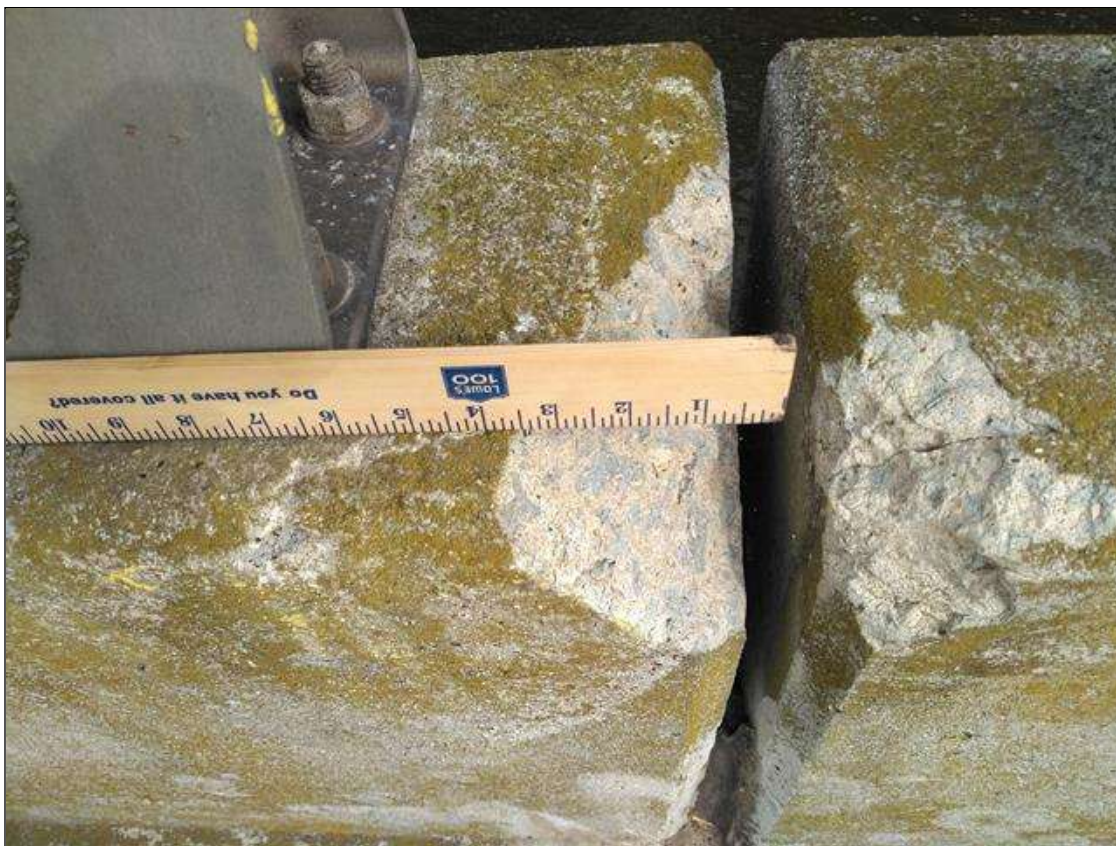
Span 5 Left Bridge Rail: AT BENT 5, SPALL (4INCHES X 10INCHES X 1INCH)

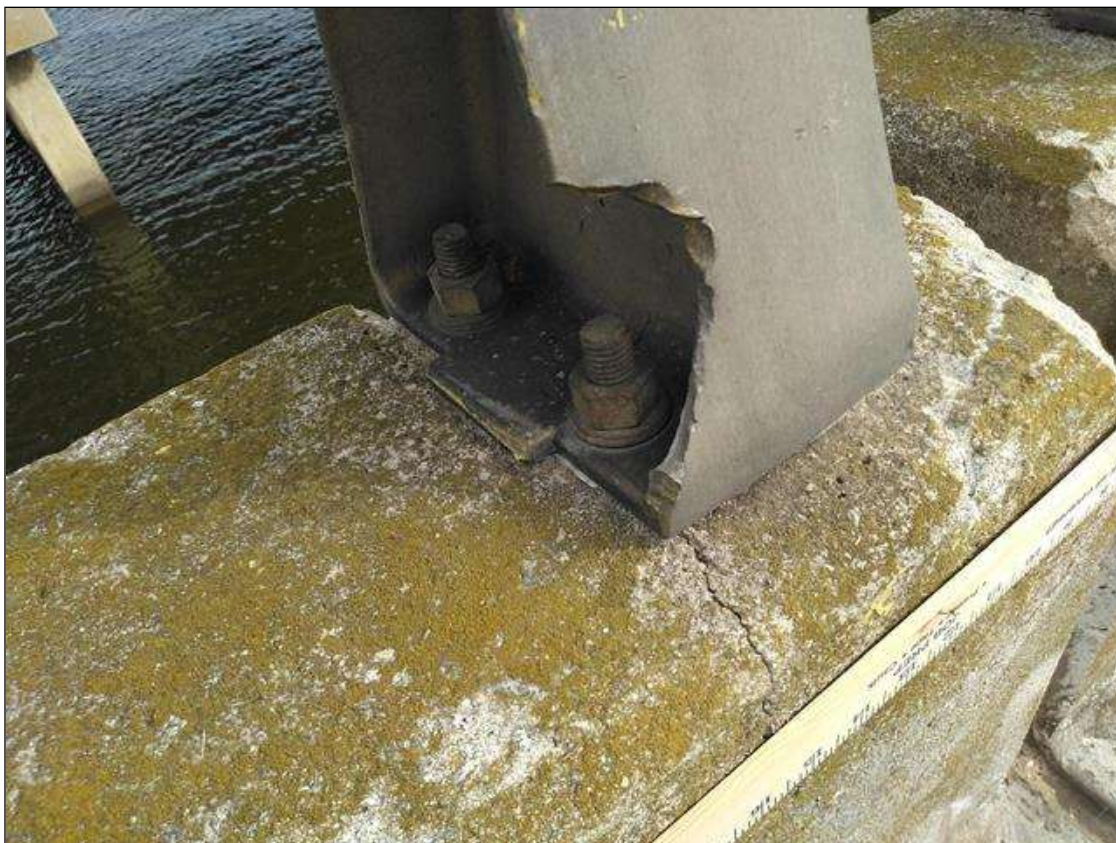
Span 5 Left Bridge Rail: RAIL POST 2, IMPACT DAMAGE (3 FEET)

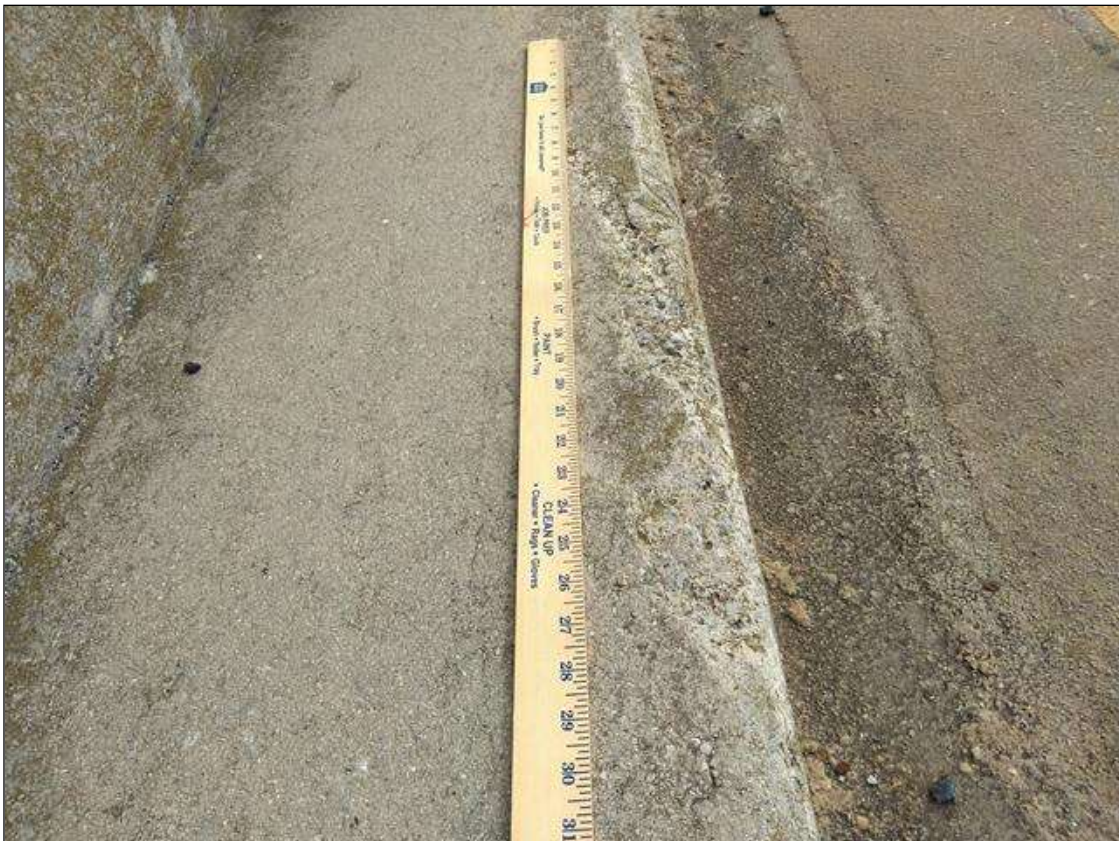
Span 6 Left Bridge Rail: AT BENT 5, SPALL (6INCHES X 6INCHES X 1/2 INCHES)

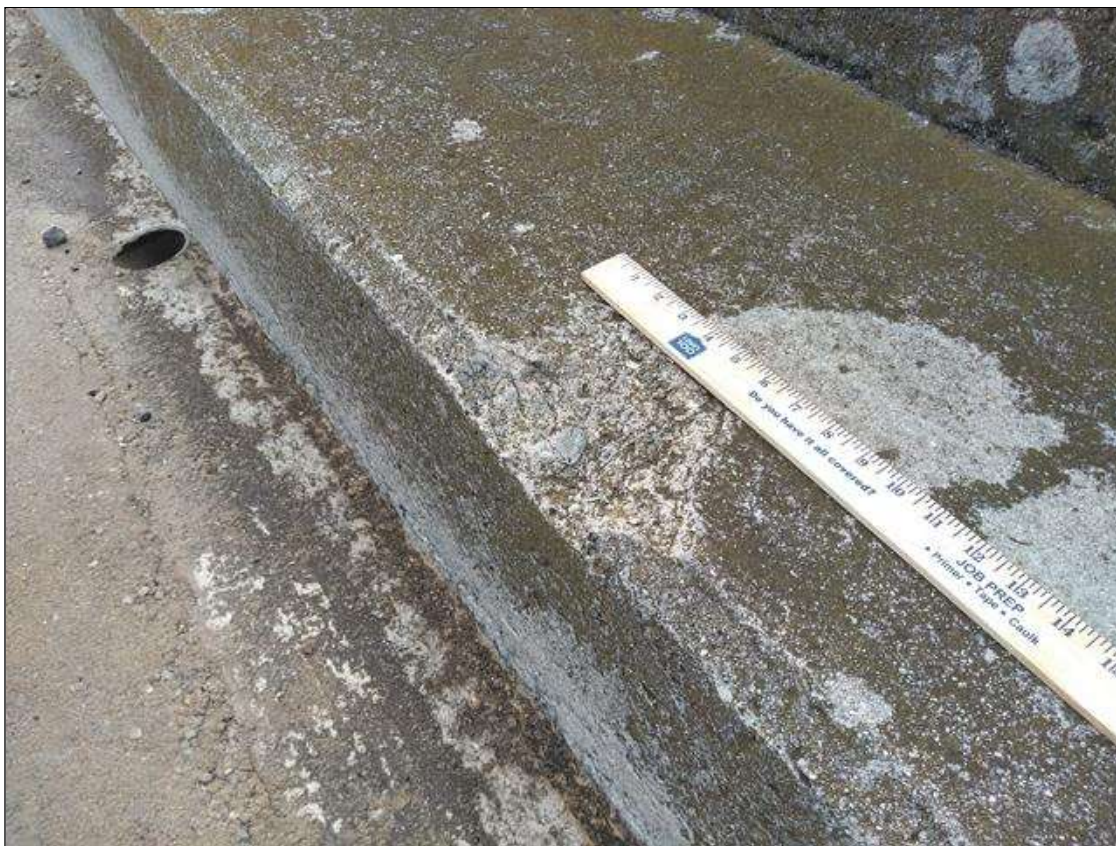
Span 13 Left Bridge Rail: TOP CORNER OF CURB AT BENT 12, SPALL (3FEET X 1INCHES X 1 INCHES)

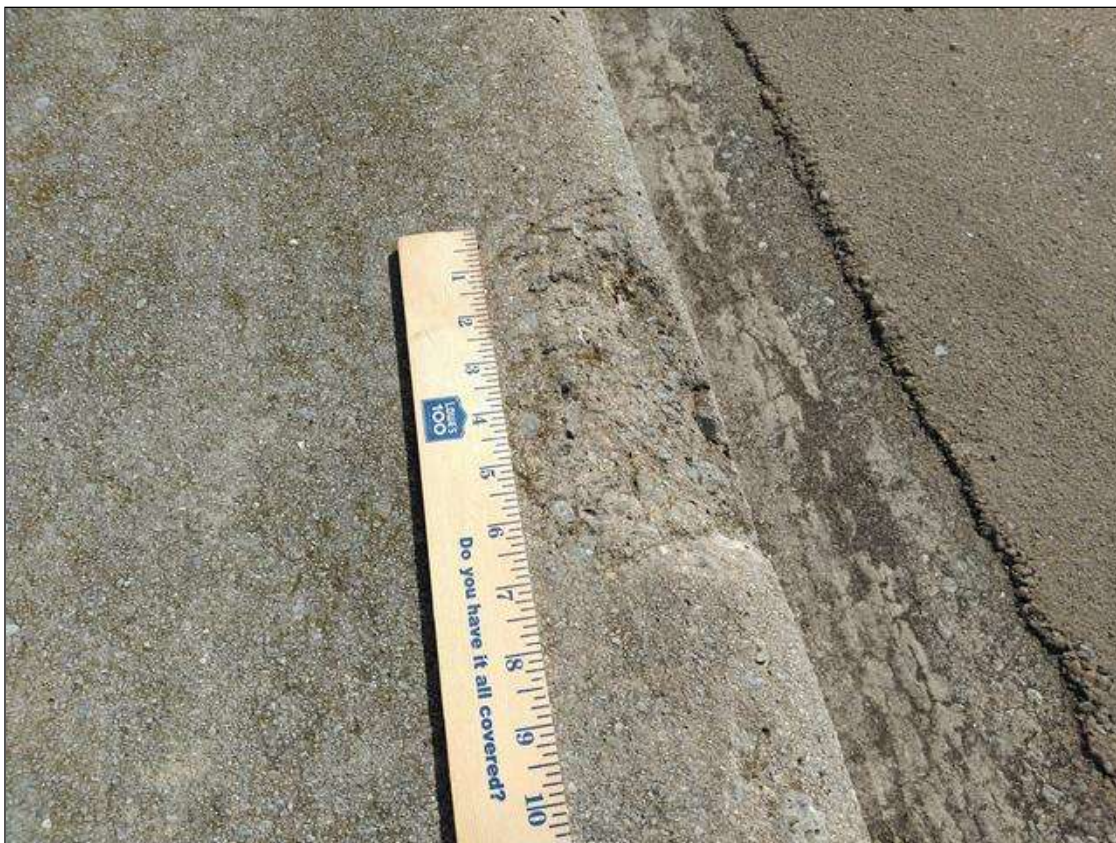
Span 15 Right Bridge Rail: CURB BETWEEN RAILPOSTS 3 AND 4, SPALL (8INCHES X 4INCHES X 2 INCHES)

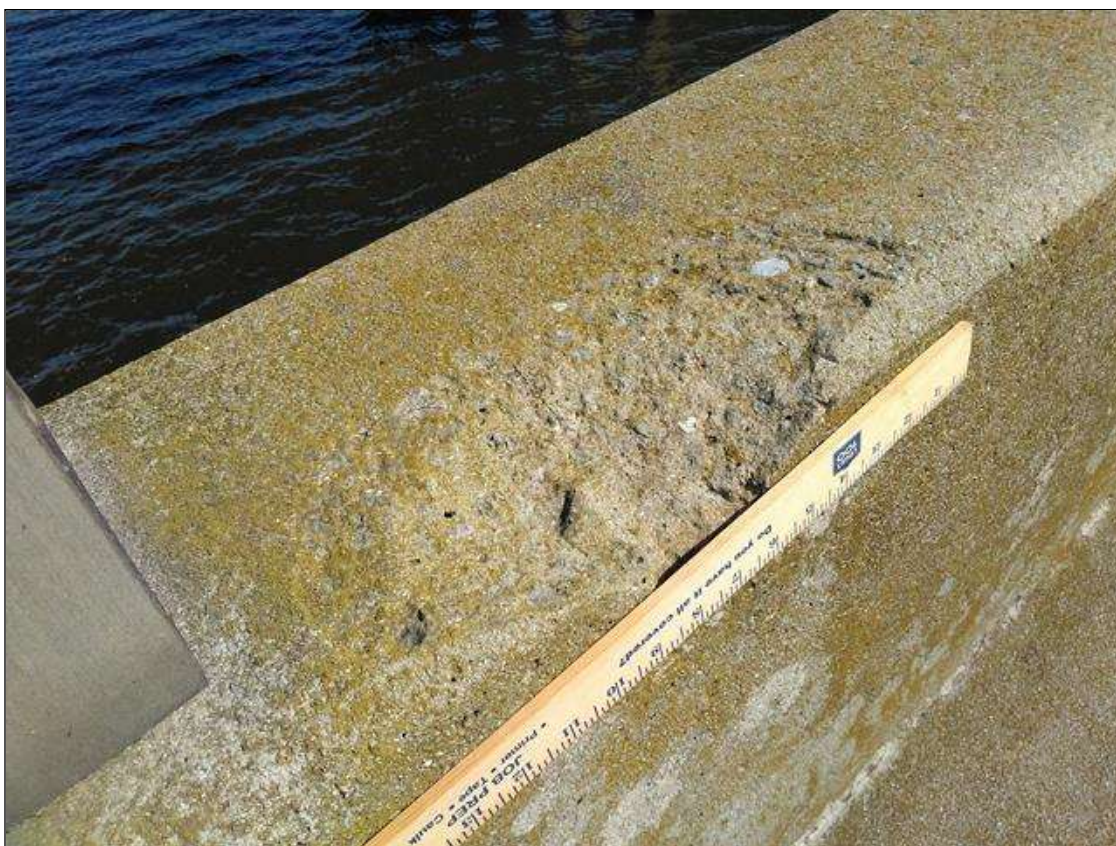
Span 21 Left Bridge Rail: CURB AT RAILPOST 3, SPALL (8INCHES X 4INCHES X 1 INCHES)

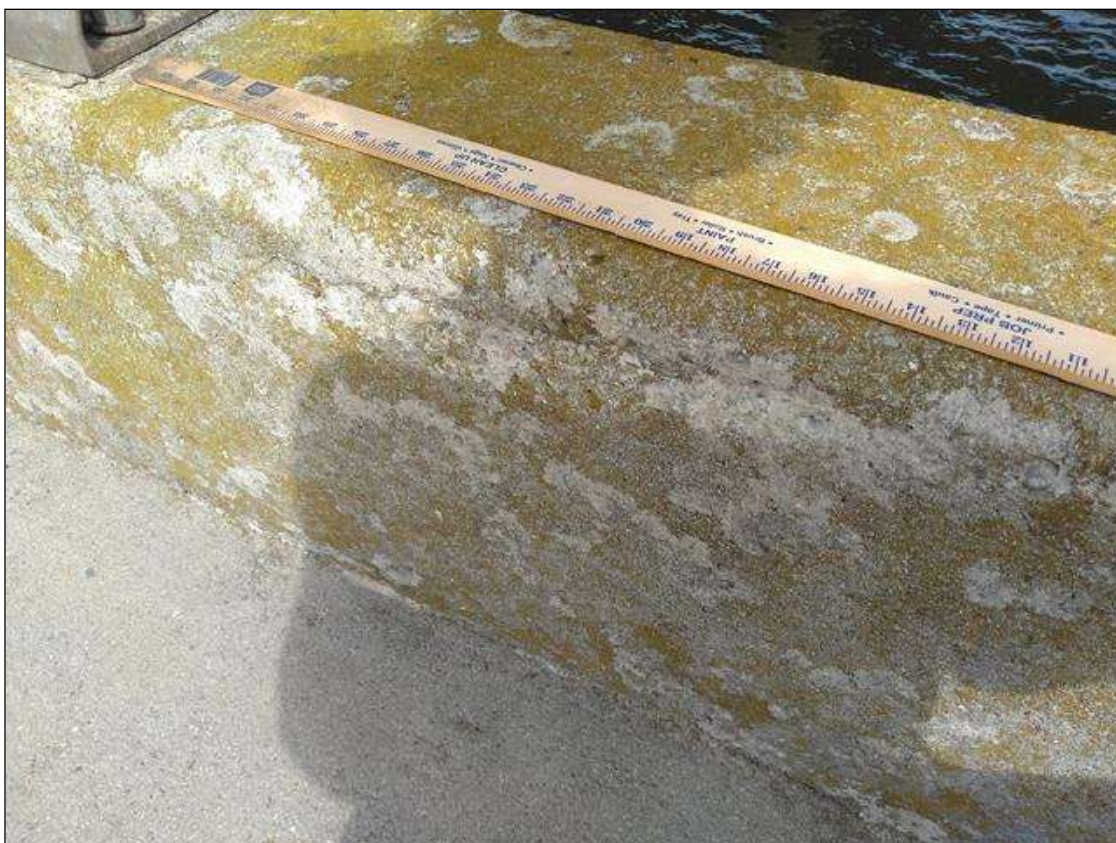
Span 21 Left Bridge Rail: RAIL AT RAILPOST 4, SPALL (12INCHES X 6INCHES X 1 INCHES)

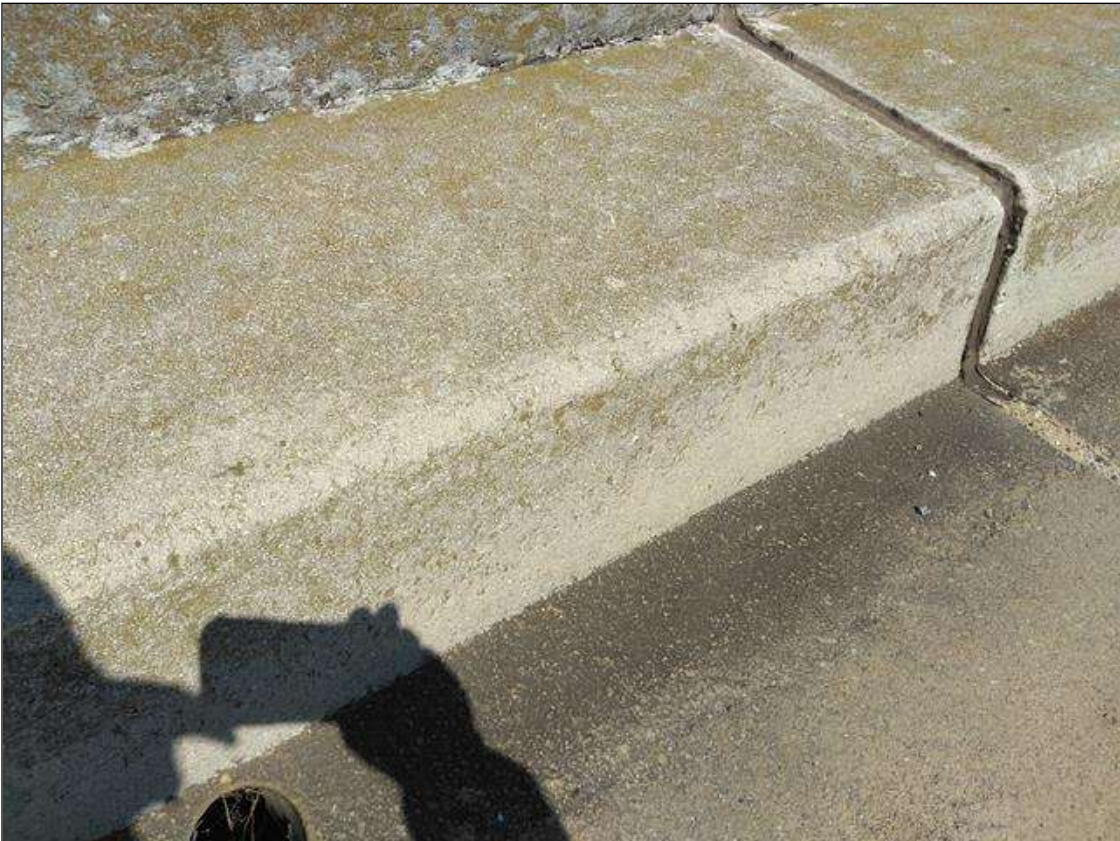
Span 50 Left Bridge Rail: RAIL AT RAILPOST 2, IMPACT SPALLS (4) UP TO 2 FEET LONG X 0.50 INCH DEEP

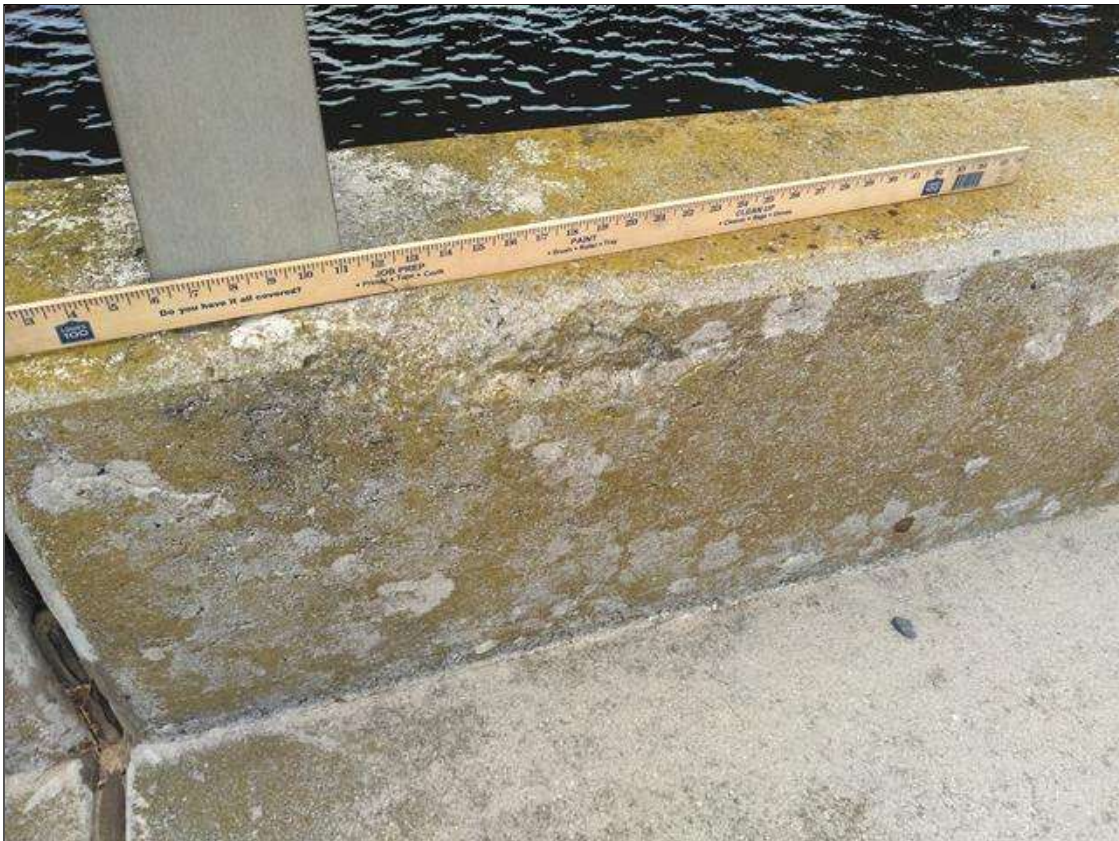
Span 65 Left Bridge Rail: CURB AT 6FEET FROM BENT 64, SPALL (4INCHES X 6INCHES X 1/2 INCHES) WITH EXPOSED RUSTED REBAR (DEFECT NOT FOUND 9/12/22)
