NC DEPARTMENT OF TRANSPORTATION  
DIVISION OF HIGHWAYS  
STRUCTURE MANAGEMENT UNIT

## Structure Safety Report

### Routine Element Inspection - Contract

STRUCTURE NUMBER: 260016 SAP STRUCTURE NO: 0270016 FHWA STRUCTURE NO: 000000000530016  
DIVISION: 1 COUNTY: CURRITUCK INSPECTION DATE: 09/21/2022 FREQUENCY: 24 MONTHS  
FACILITY CARRIED: US158E MILE POST: \_\_\_\_\_  
LOCATION: .01 MI.E.JCT.SR1187  
FEATURE INTERSECTED: CURRITUCK SOUND  
LATITUDE: 36° 5' 11.69" LONGITUDE: 75° 46' 0.21"  
SUPERSTRUCTURE: RC FLOOR ON PPC GIRDERS & CORED SLAB  
SUBSTRUCTURE: EBTS:RC CAP/PPC PILES;IBTS:RCP&B & RC CAPS/PPC PILES  
SPANS: 248 SPANS. SEE SPAN PROFILE SHEET FOR SPAN DETAILS  
☐ FRACTURE CRITICAL ☐ TEMPORARY SHORING ☐ SCOUR CRITICAL ☐ SCOUR PLAN OF ACTION  
GRADES: (Inspector/NBI Coding) DECK 6 / 6 SUPERSTRUCTURE 5 / 5 SUBSTRUCTURE 6 / 6 CULVERT N / N  
POSTED SV: Not Posted POSTED TTST: Not Posted  
OTHER SIGNS PRESENT: None

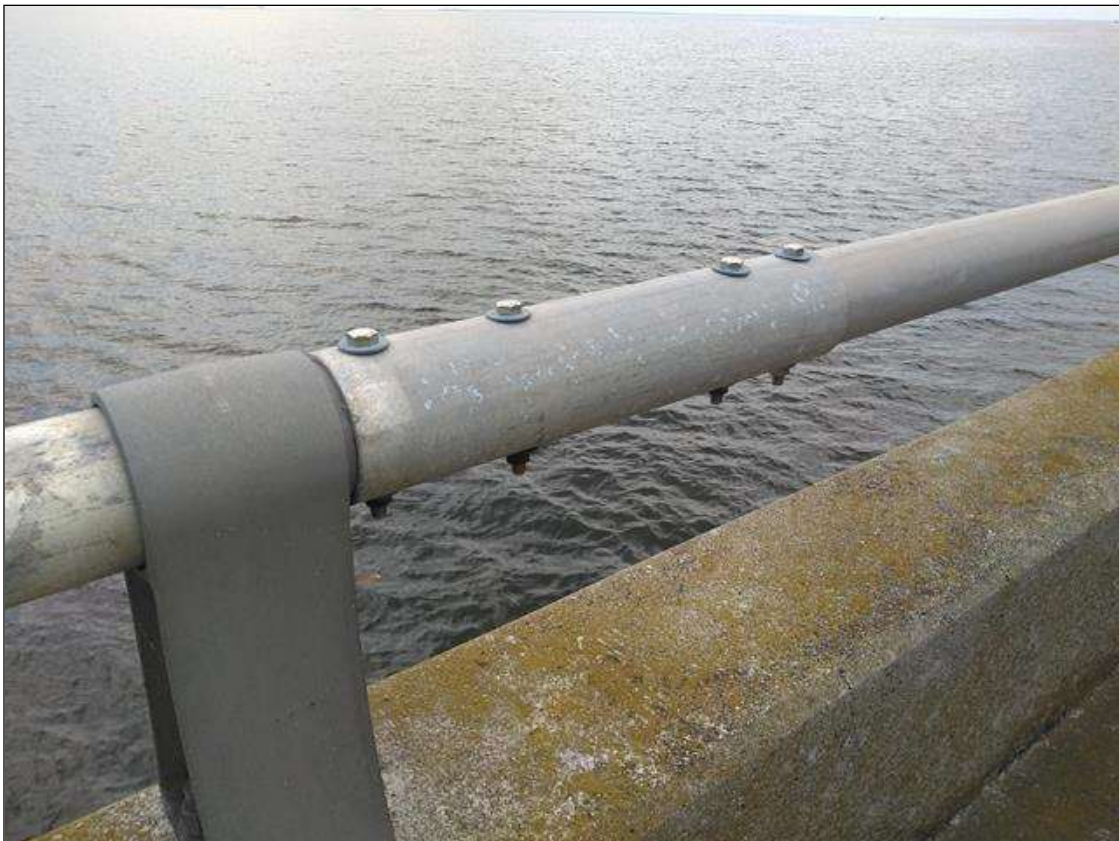
Span 82 Left Bridge Rail: RAILPOST 8, IMPACT SPALL (4FEET X 6INCHES X 1/2 INCHES)

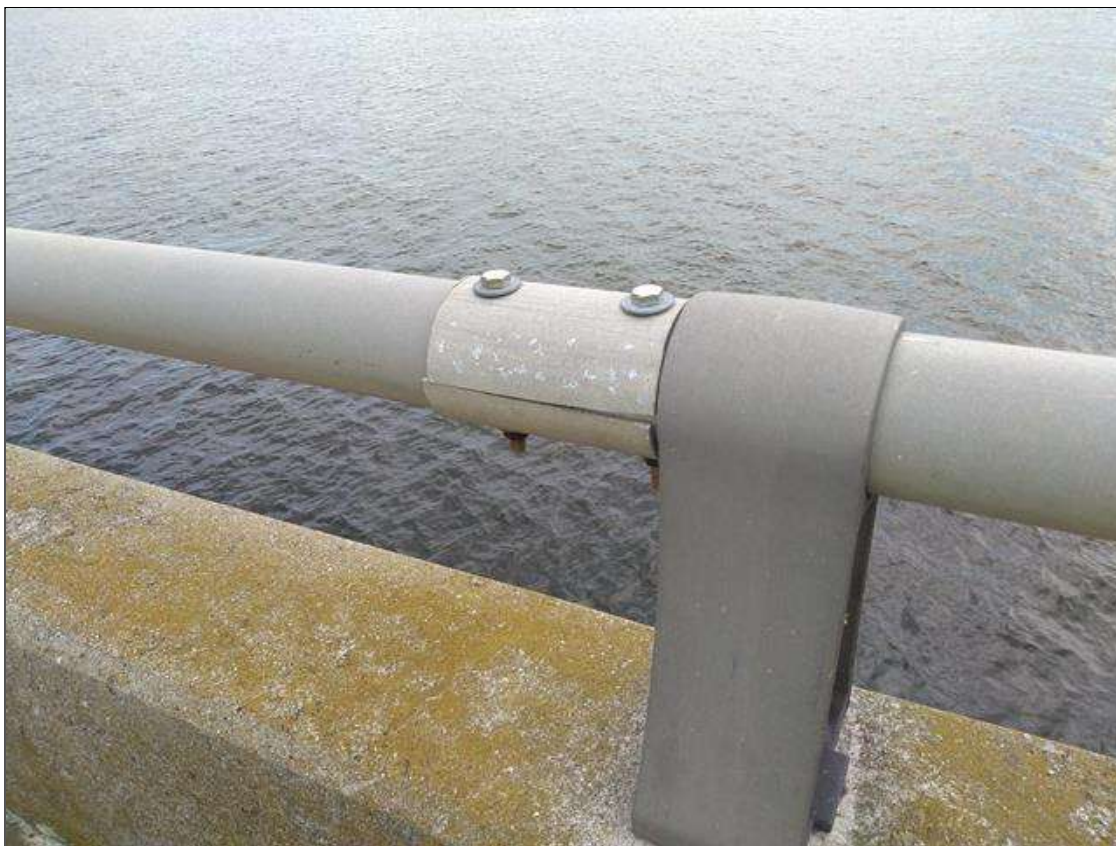
Span 70 Right Bridge Rail: METAL RAIL AT RAILPOSTS 6 AND 7, REPAIRED

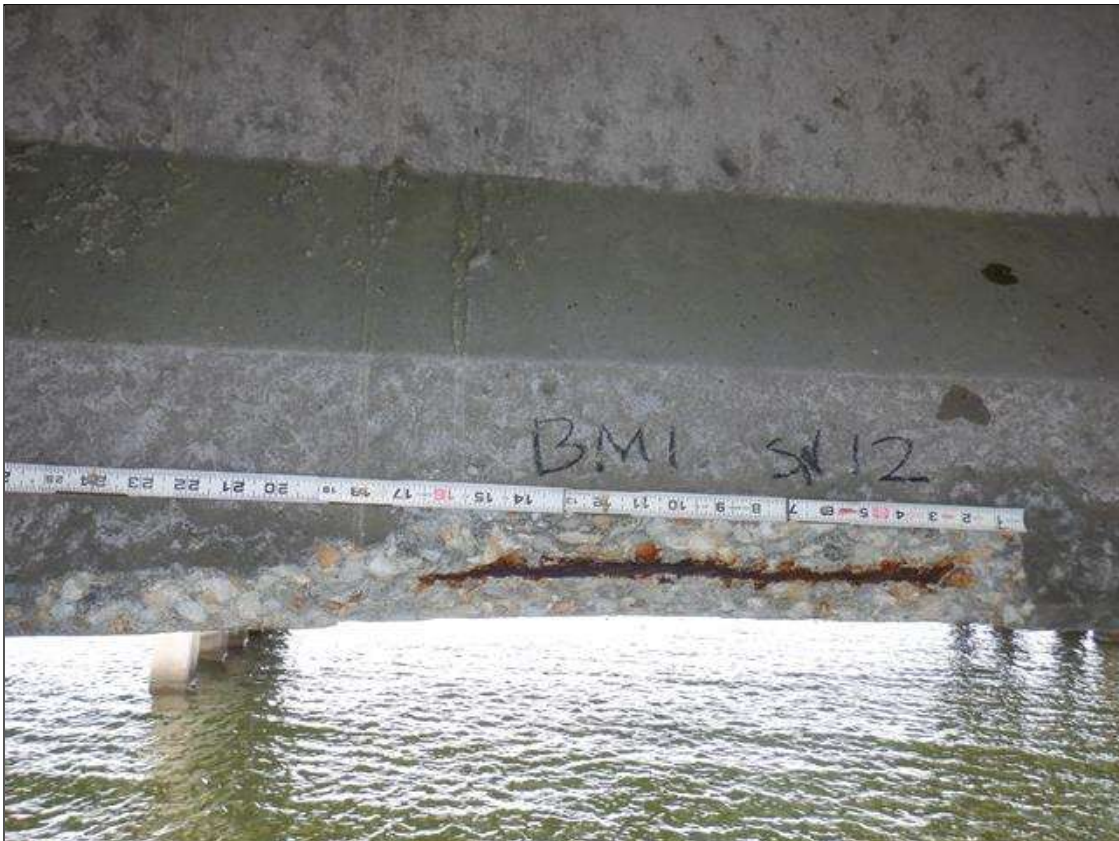
Span 11 Beam 4: (PAR) NORTH FACE BOTTOM FLANGE, AT BENT 10, SPALL (12 INCHES X 7 INCHES X 2 INCHES) WITH (2) EXPOSED RUSTED STRANDS, SECTION LOSS (30 PERCENT) ON BOTTOM STRAND

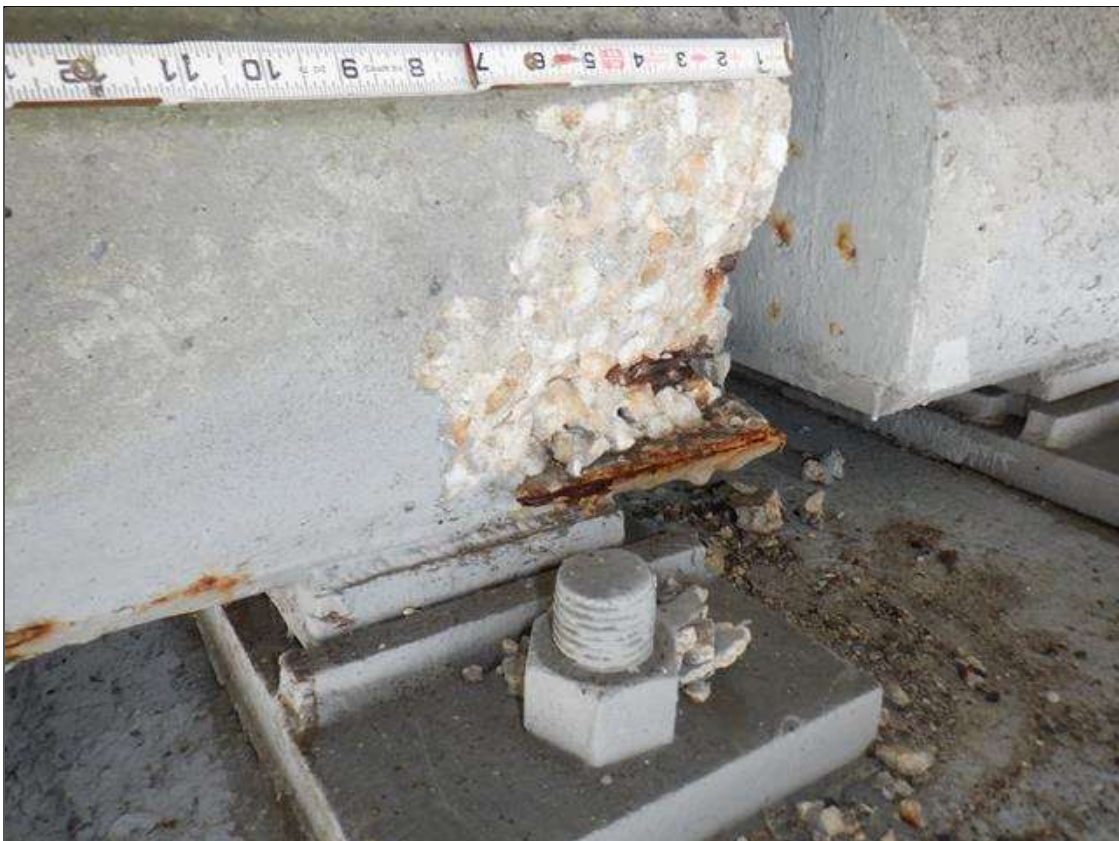
Span 13 Beam 2: (PAR) BOTTOM FLANGE NORTH FACE, AT BENT 13, SPALL (34 INCHES X 8 INCHES X 2 INCHES DEEP) WITH EXPOSED RUSTED STRANDS (20 PERCENT SECTION LOSS)

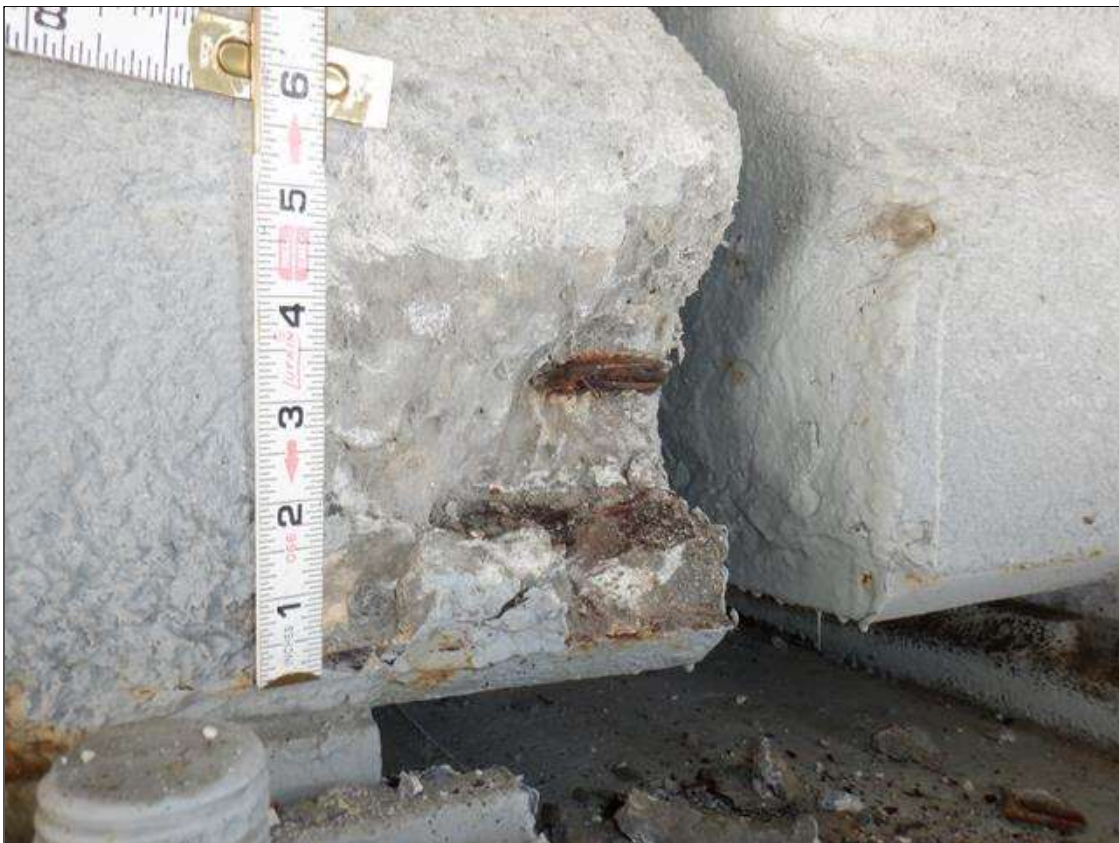
Span 16 Beam 3: (PAR) BOTTOM FLANGE SOUTH FACE, AT BENT 15, SPALL ( 4 FEET X UP TO 12 INCHES X 2 INCHES DEEP) WITH MULTIPLE EXPOSED RUSTED STRANDS (20 PERCENT SECTION LOSS)

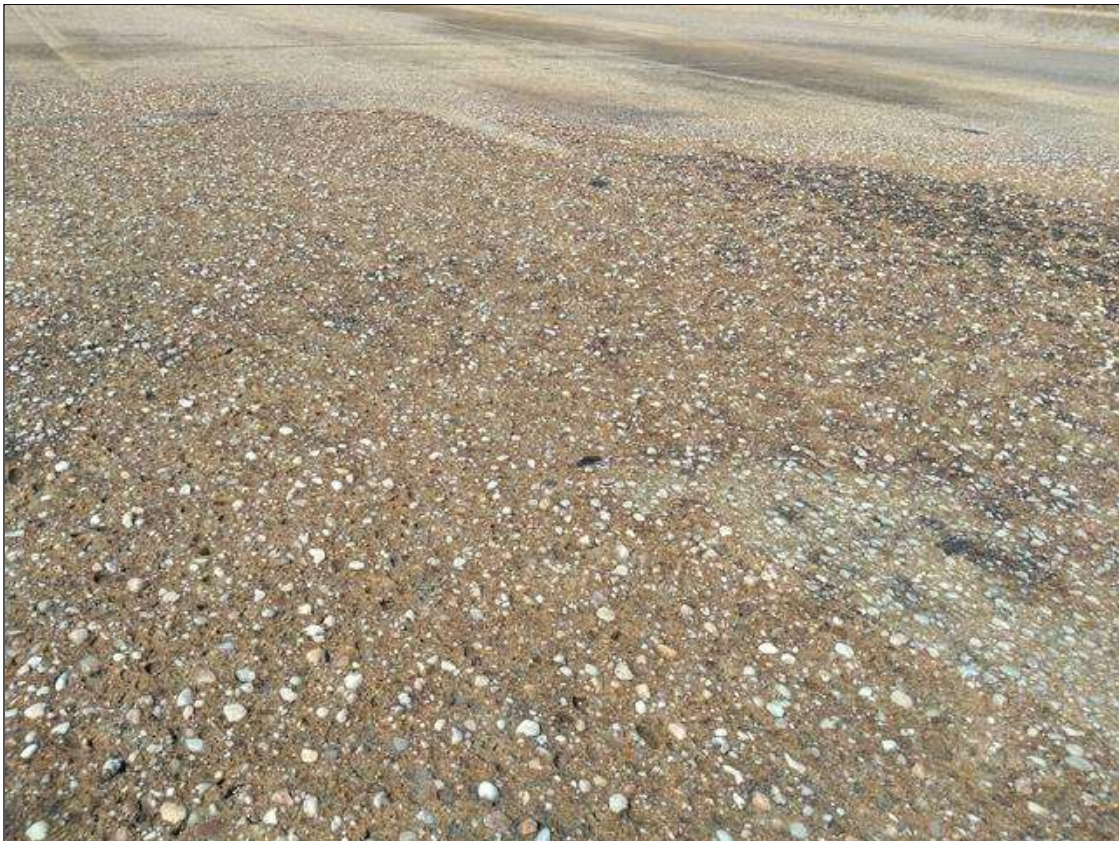
Span 139 Deck: WITHIN 8 FEET OF BENT 139 IN RIGHT SHOULDER (2) 2 FOOT X 0.06 INCH TRANSVERSE CRACKS

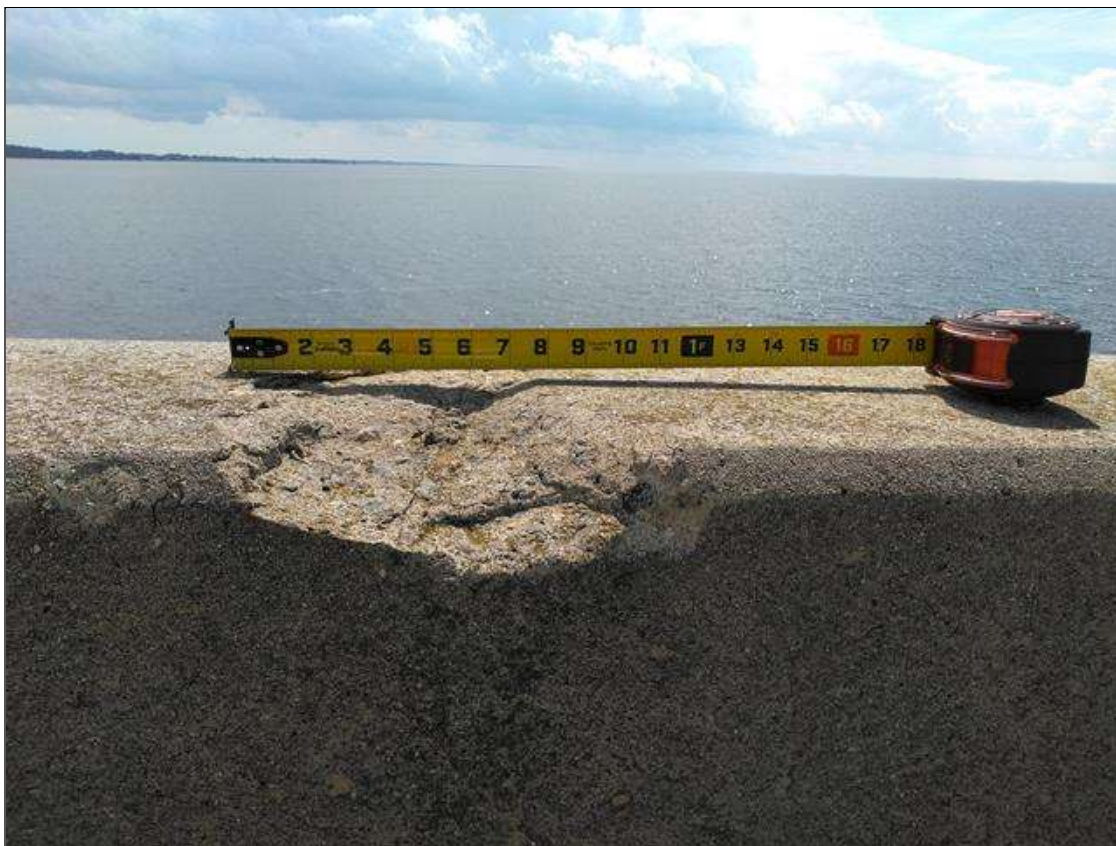
Span 148 Right Bridge Rail: FIRST 14 FEET OF RAIL APPEARS REPAIRED FROM IMPACT

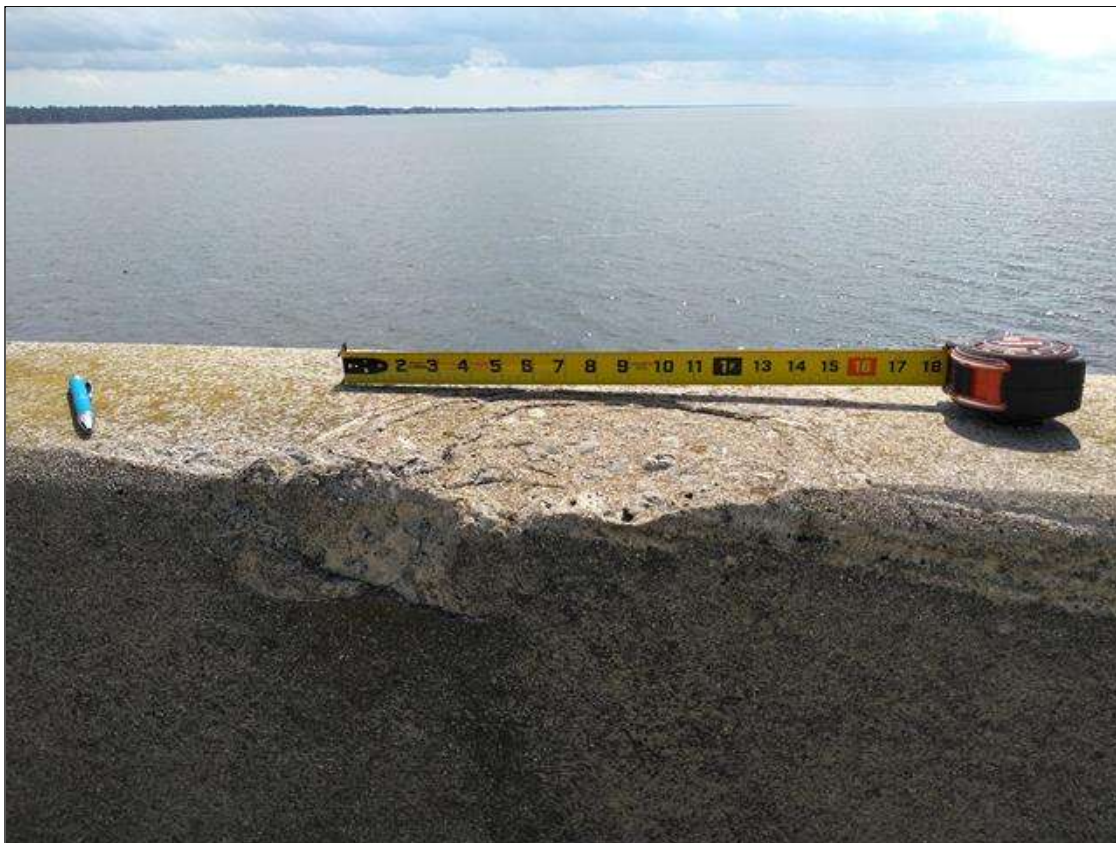
Span 173 Right Bridge Rail: TOP OF RAIL BETWEEN RAILPOSTS 2 AND 3, SPALL (16INCHES X 6INCHES X UP TO 1 INCHES). BETWEEN POSTS 3 AND 4, SPALL (9 INCH DIAMETER X 1.25 INCH DEEP)

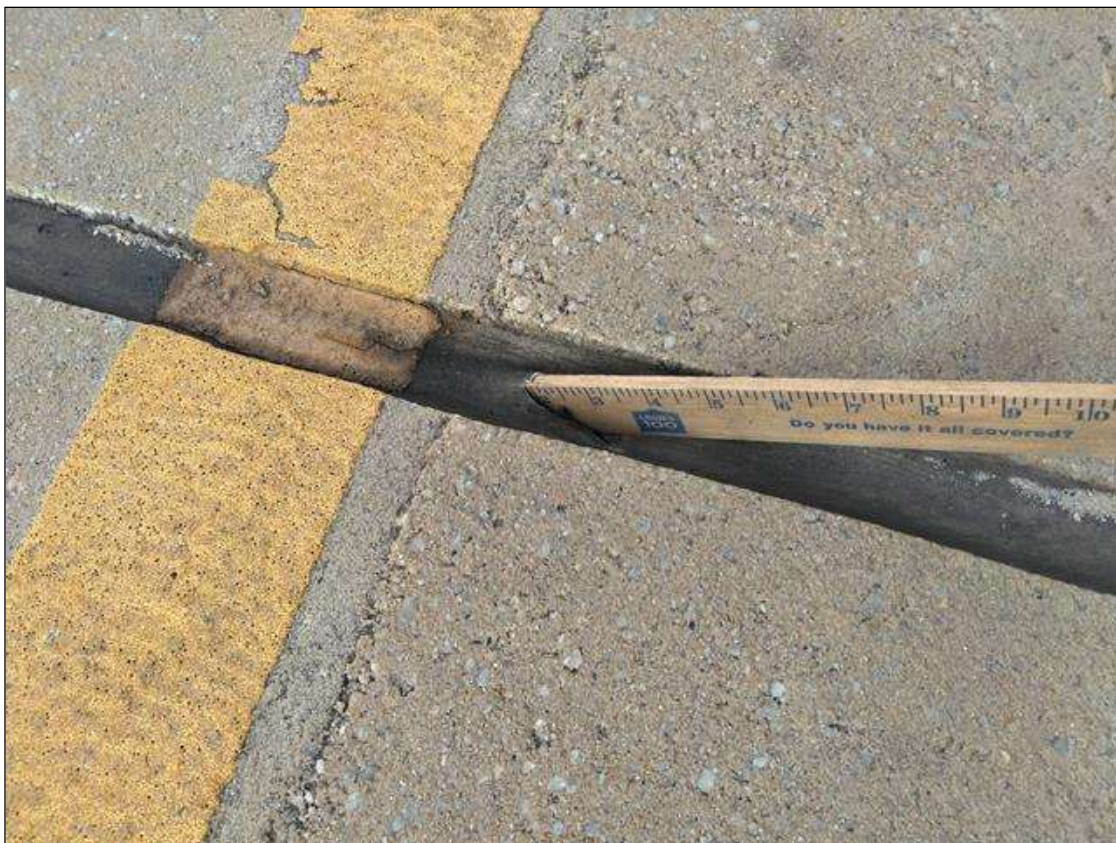
Span 107 Expansion Joint Bent 106: AT BENT 106, PARTIAL DEPTH TEAR INTERMITTENT THROUGH

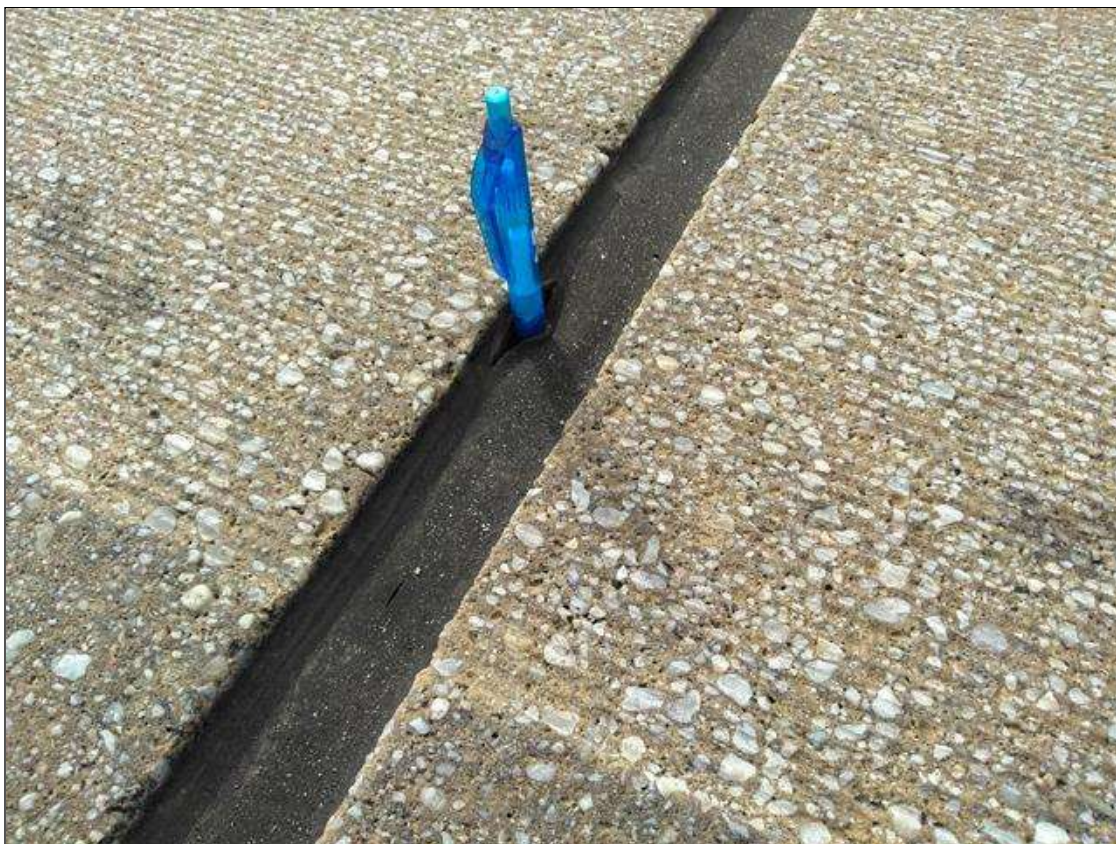
Span 112 Expansion Joint Bent 111: AT BENT 111, AT LEFT SHOULDER, 2 INCH FULL DEPTH TEAR

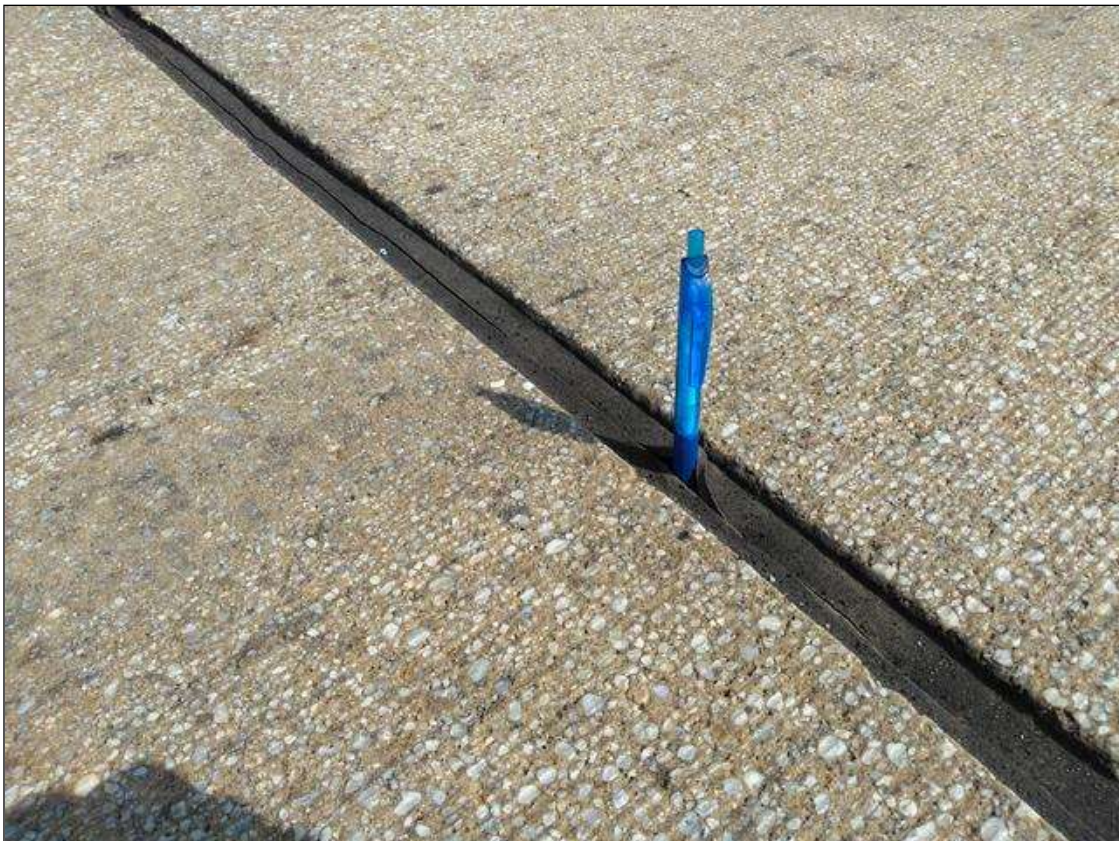
Span 125 Expansion Joint Bent 124: BENT 124, CRACK AT CENTERLINE 8 INCH LONG FULL DEPTH

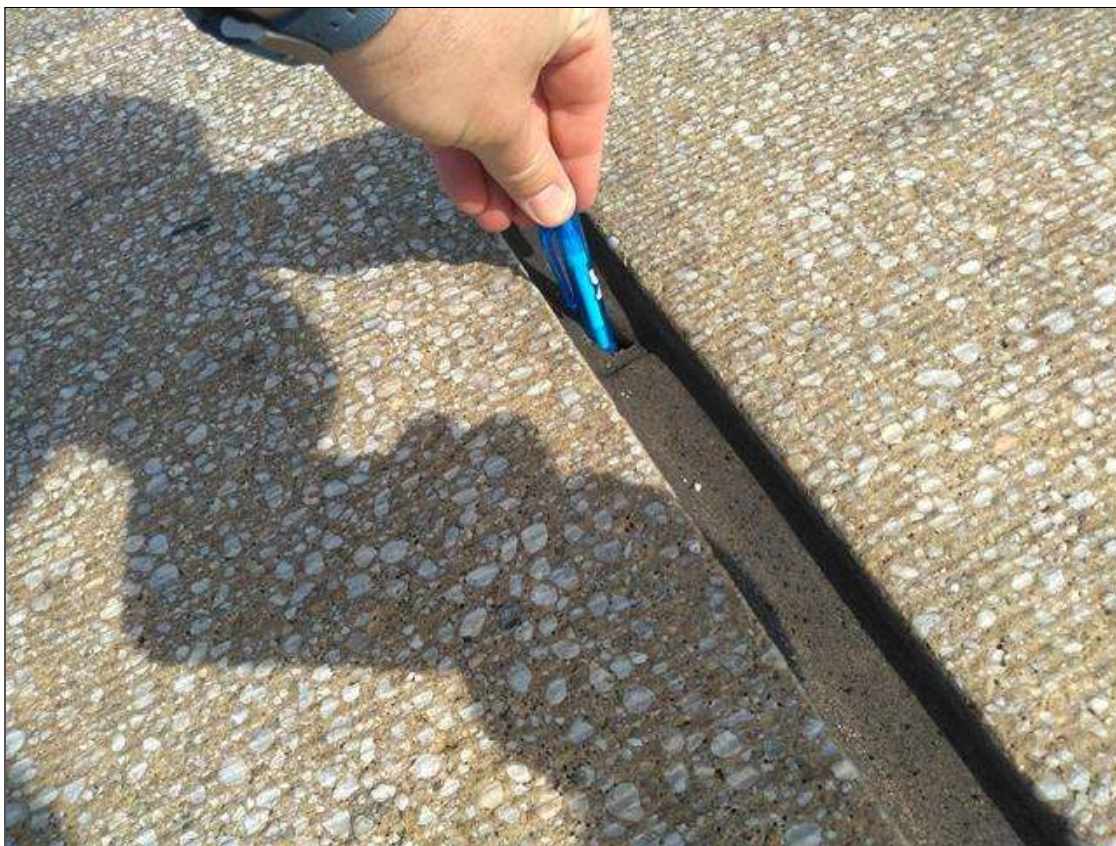
Span 129 Expansion Joint Bent 128: AT BENT 128, FULL DEPTH AND WIDTH CRACK

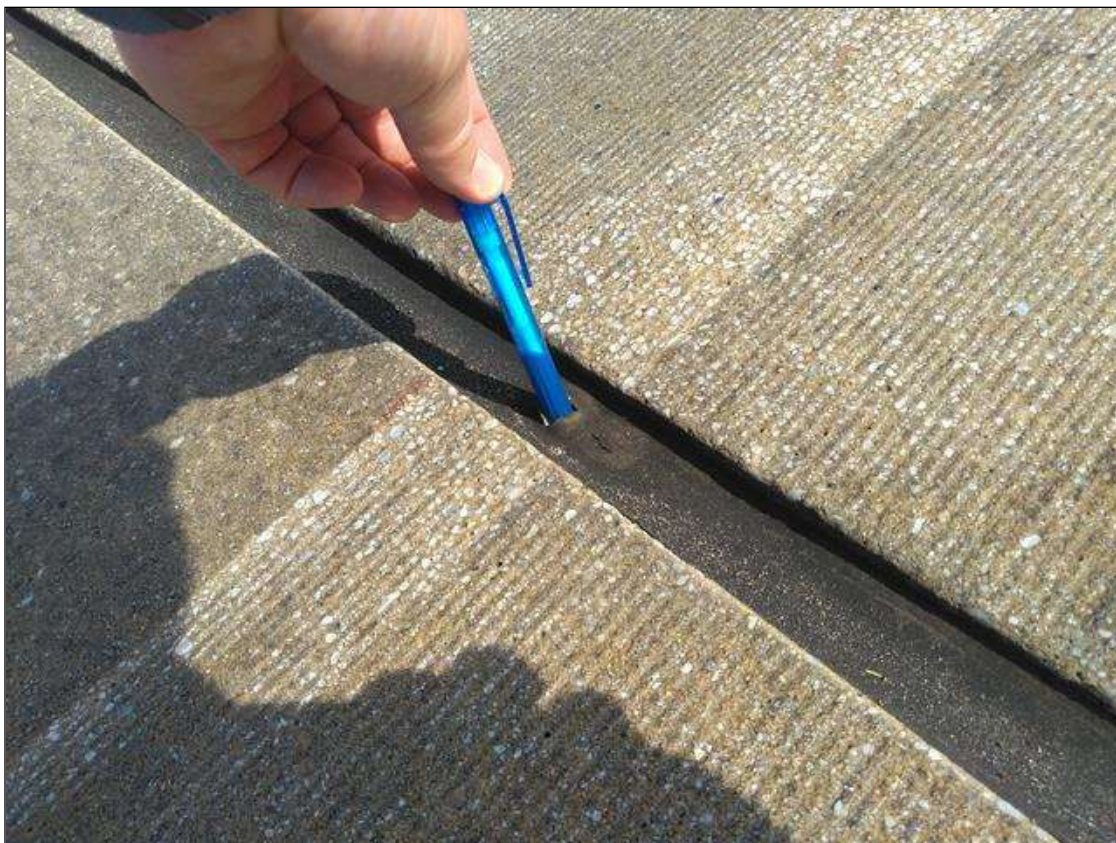
Span 132 Expansion Joint Bent 131: AT BENT 131, 2 INCH WIDE X FULL DEPTH CRACK IN RIGHT LANE

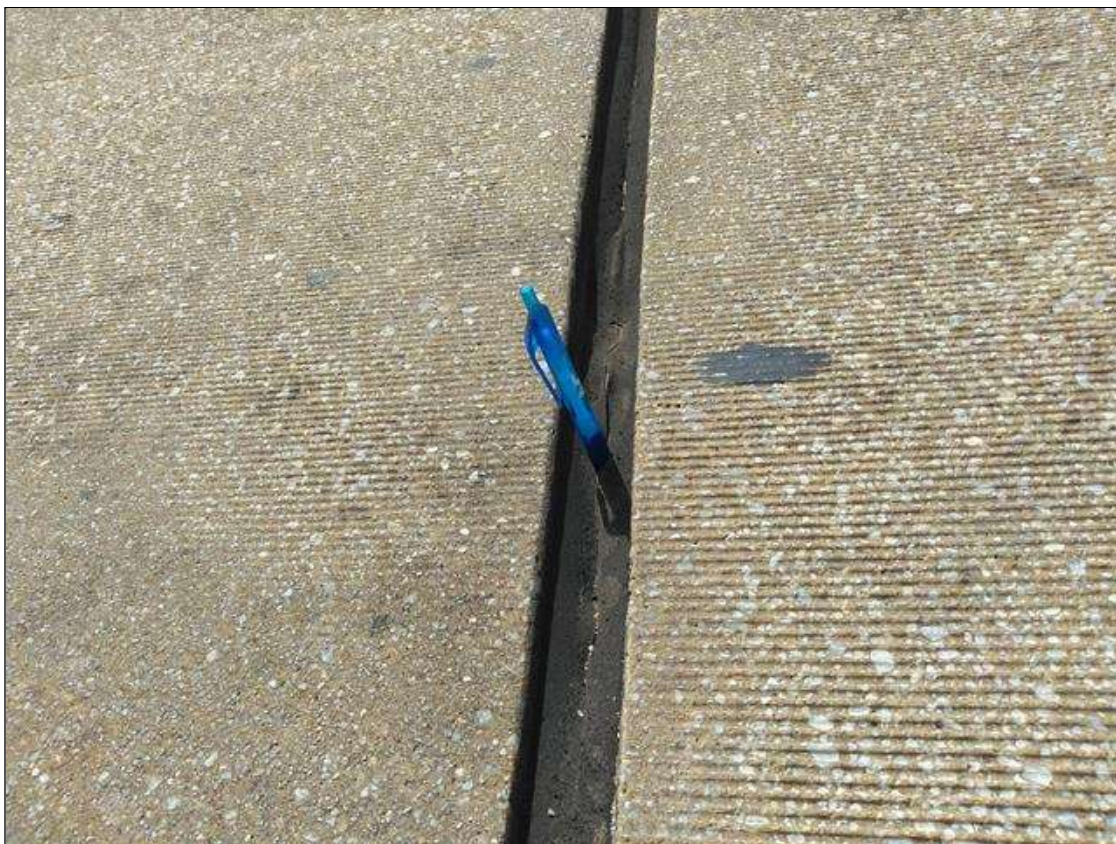
Span 134 Expansion Joint Bent 133: AT BENT 133, 2 INCH WIDE X FULL DEPTH CRACK IN RIGHT LANE

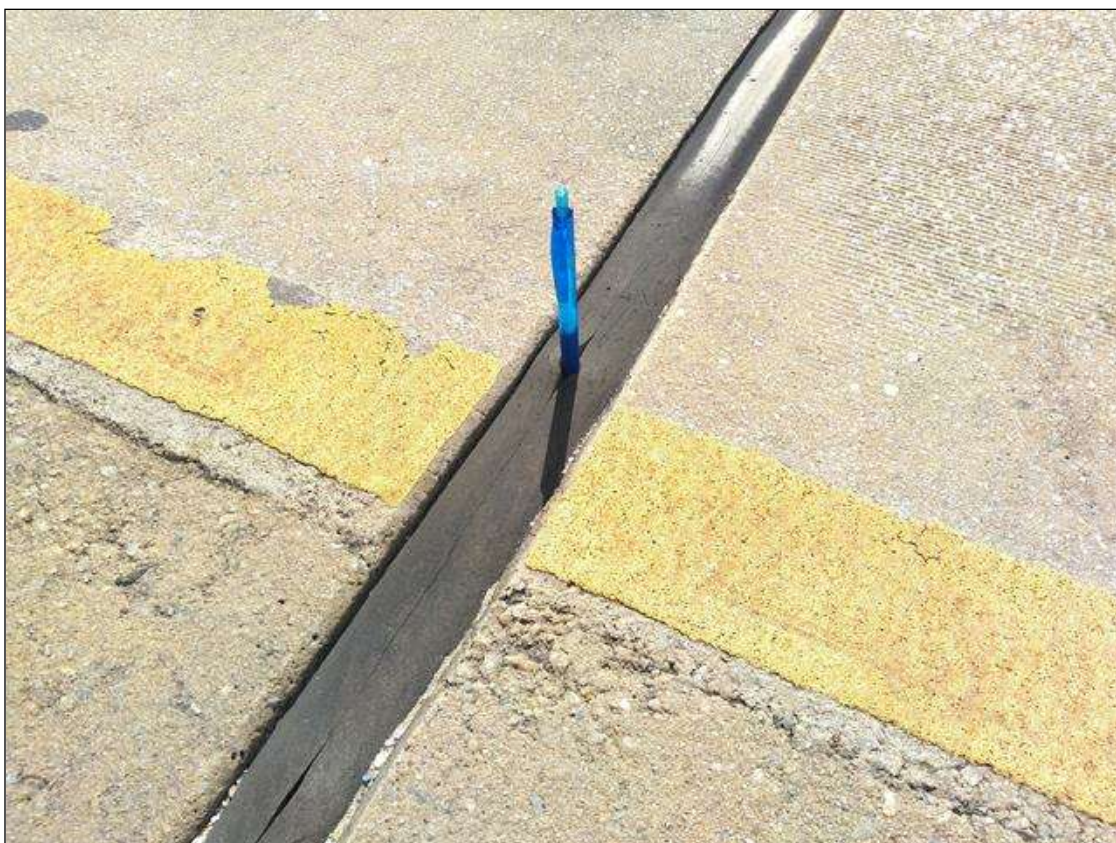
Span 136 Expansion Joint Bent 135: AT BENT 135, PARTIAL DEPTH CRACK IN LEFT LANE 1 FOOT LONG

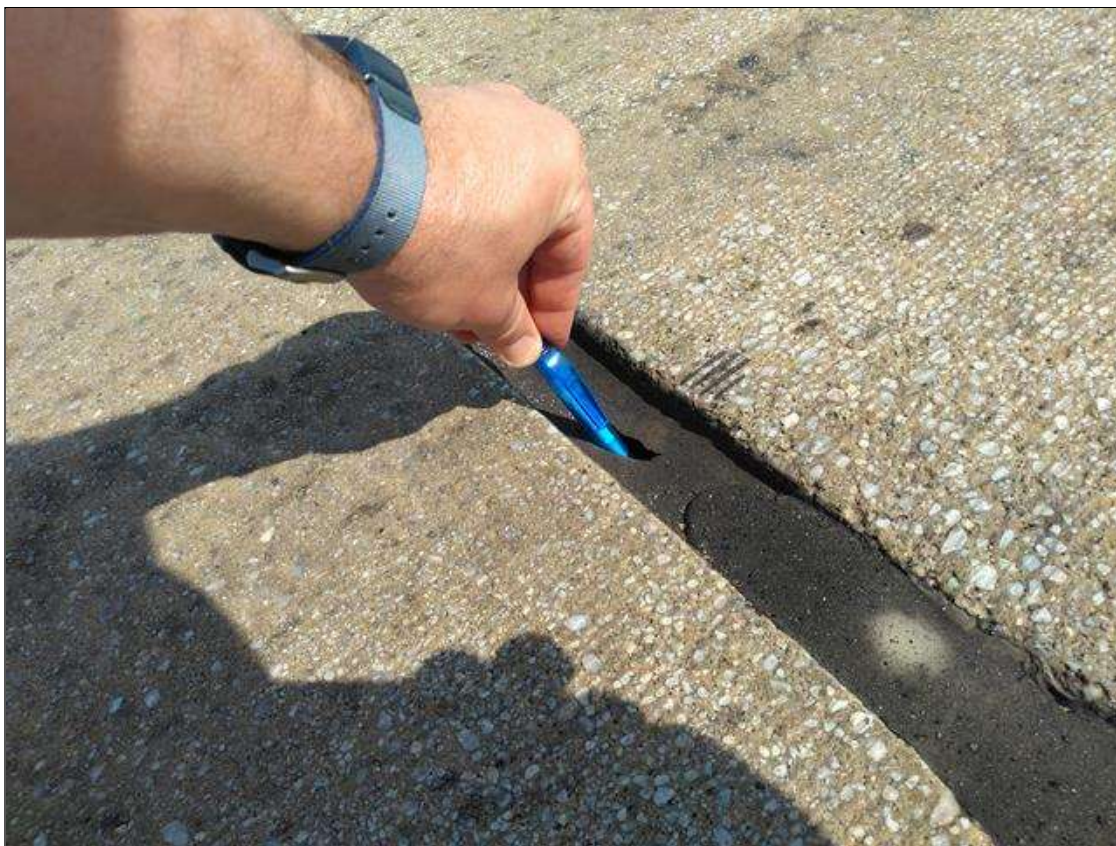
Span 140 Expansion Joint Bent 139: AT BENT 139, LEFT LANE 6 FOOT LONG PARTIAL DEPTH CRACK

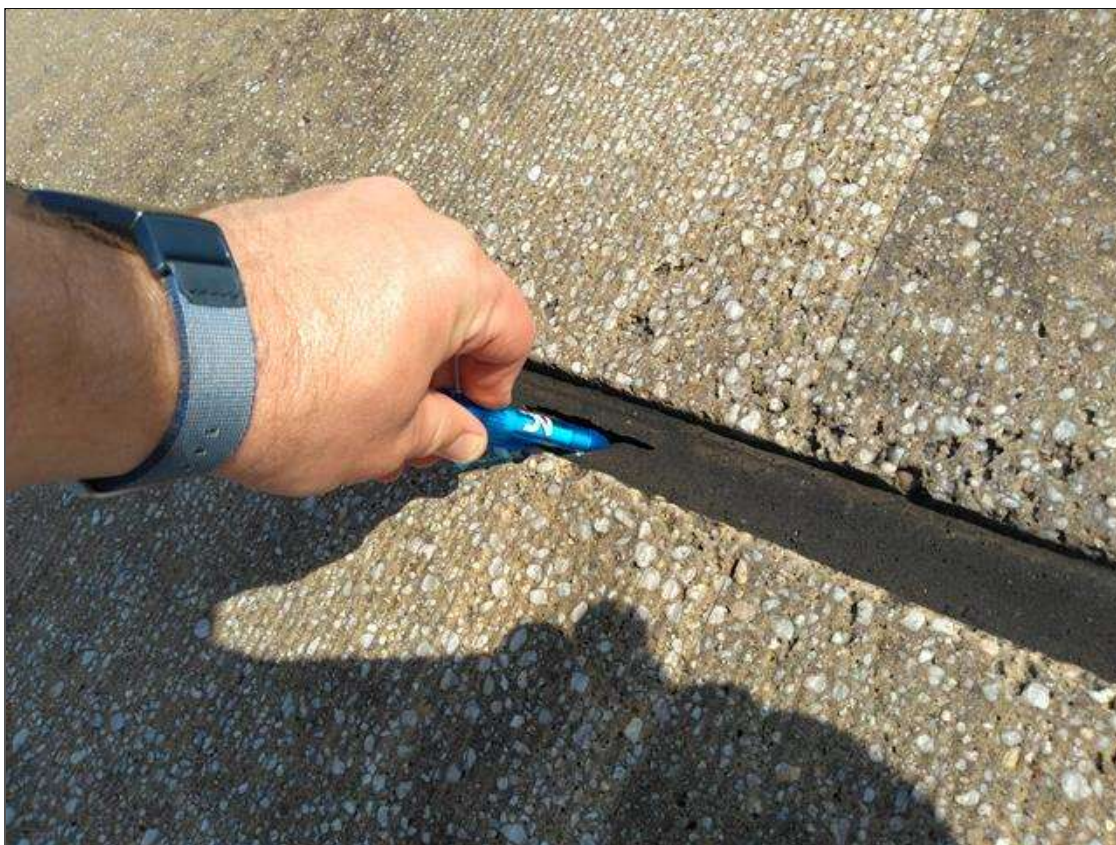
Span 141 Expansion Joint Bent 140: AT BENT 140, RIGHT LANE INTERMITTENT FULL DEPTH CRACKS UP TO 2 INCH LONG

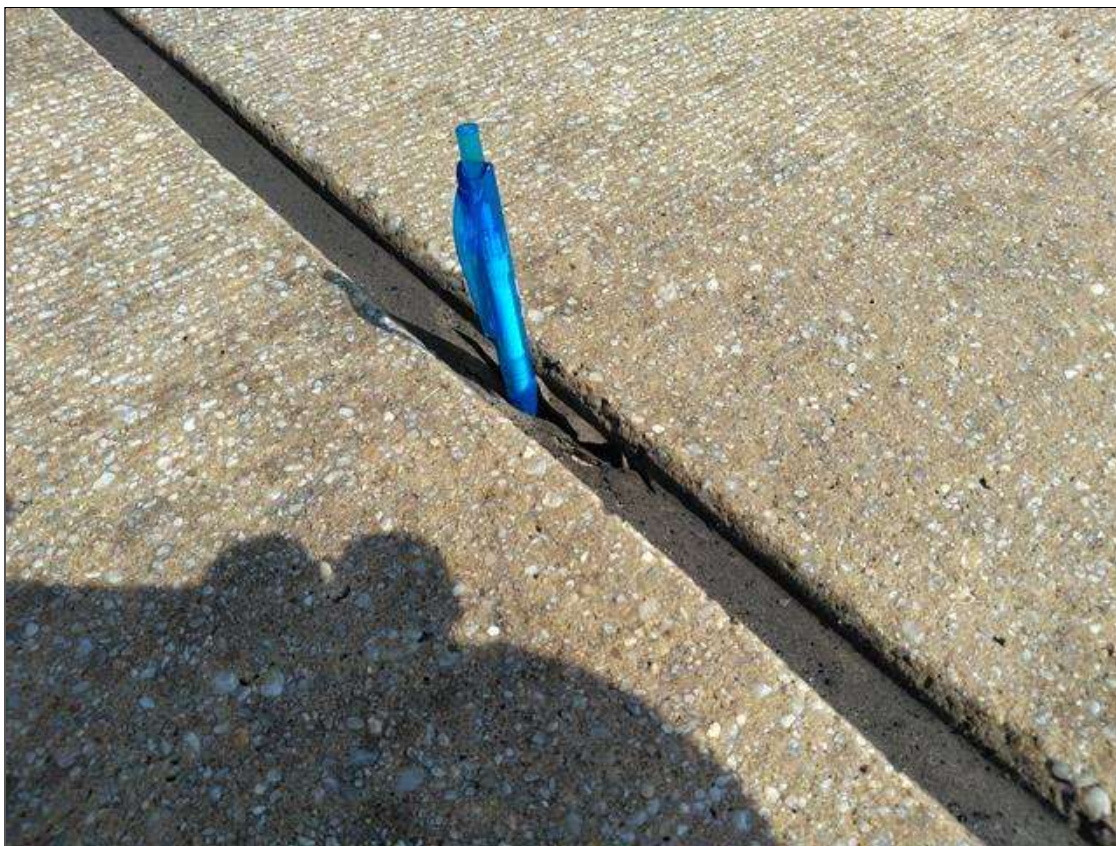
Span 144 Expansion Joint Bent 143: AT BENT 143, LEFT LANE, 2 INCH LONG X FULL DEPTH CRACK

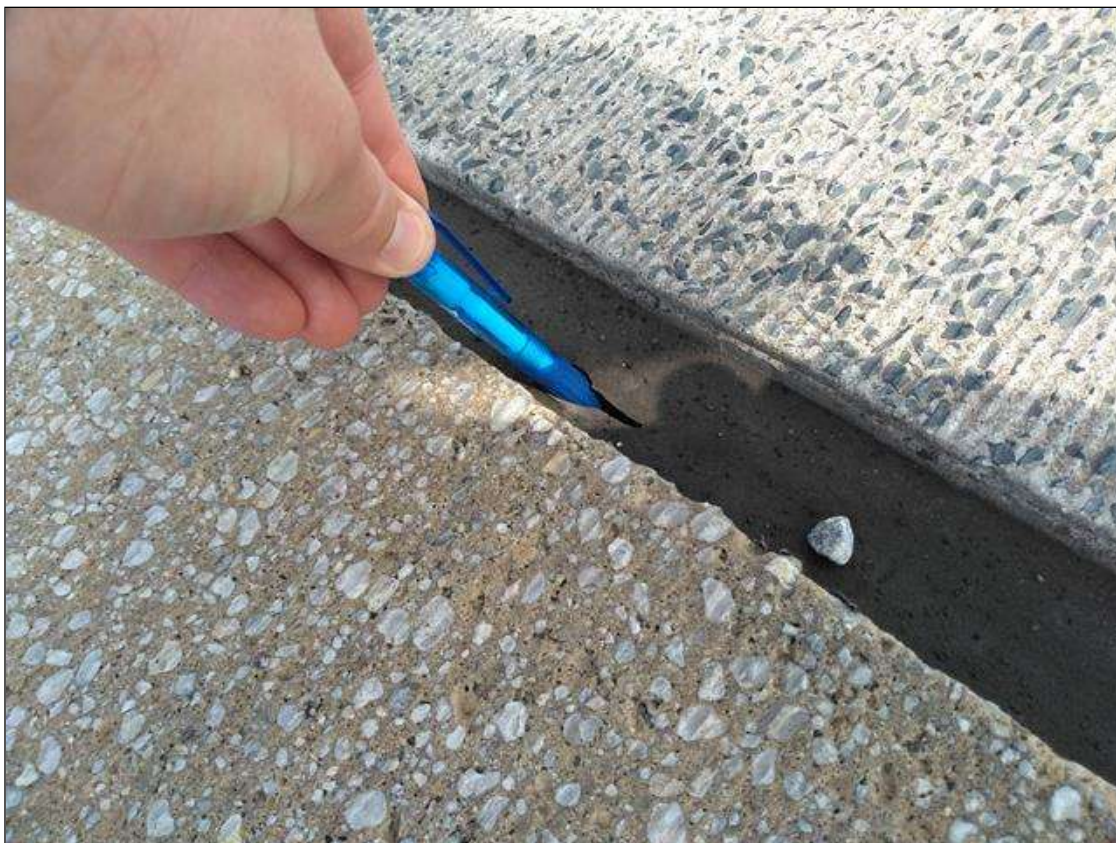
Span 147 Expansion Joint Bent 146: AT BENT 146, LEFT LANE, 4 INCH LONG PARTIAL DEPTH TEAR

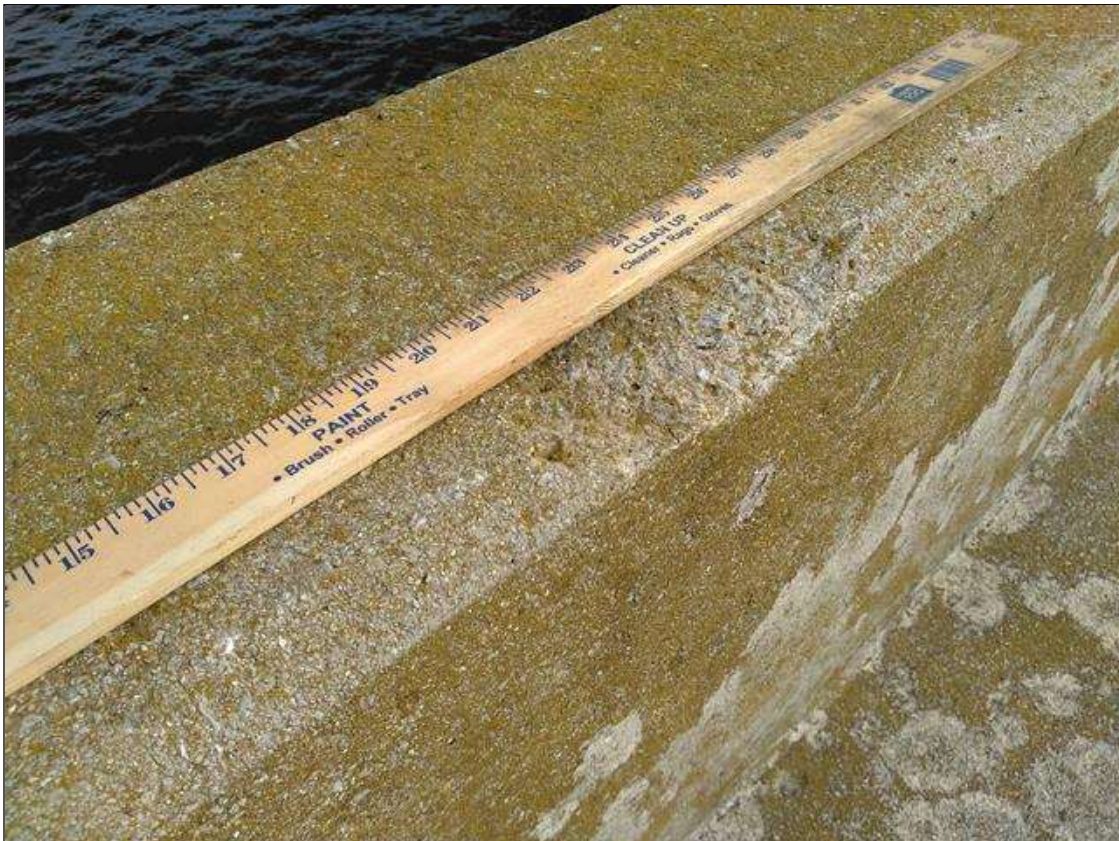
Span 116 Left Bridge Rail: TOP OF RAIL BETWEEN POSTS 8 AND 9, SPALL (8INCHES X 3INCHES X 1/2 INCHES)  
(DEFECTS NOT FOUND 9/23/22)

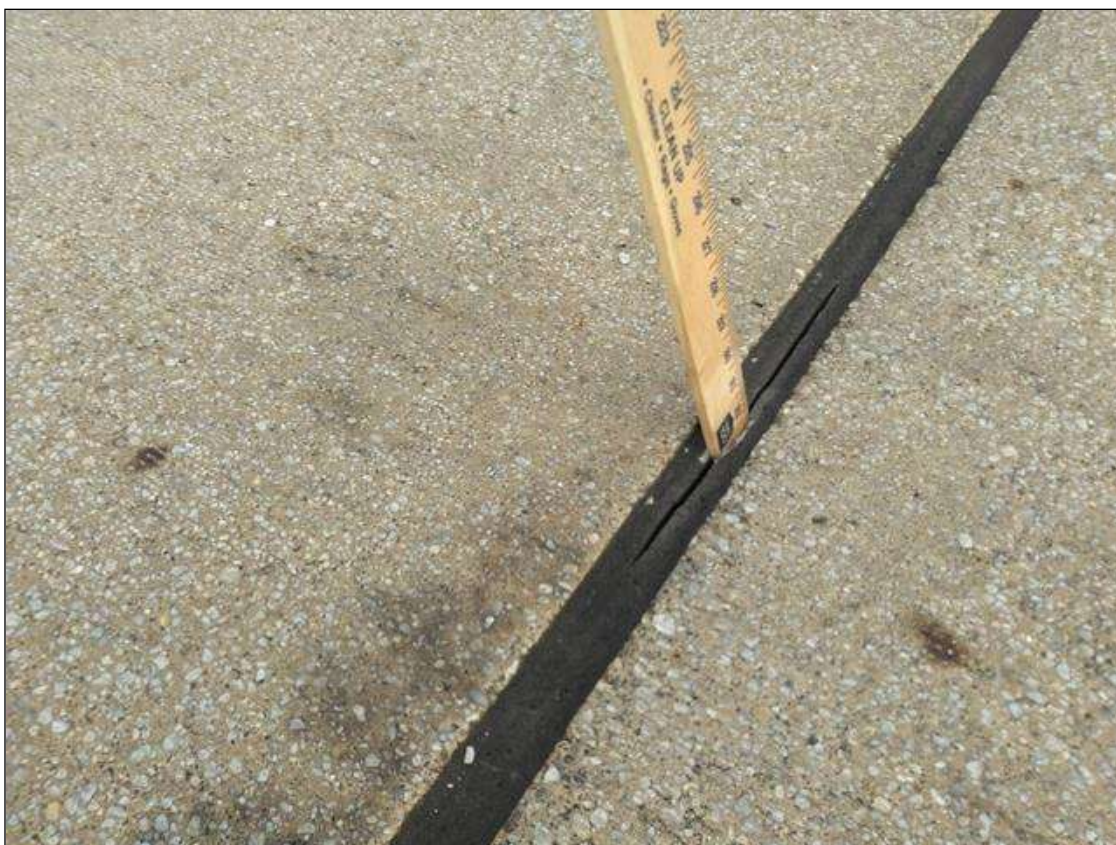
Span 105 Expansion Joint Bent 104: THROUGHOUT BOTH LANES, SEAL DAMAGED AND TORN

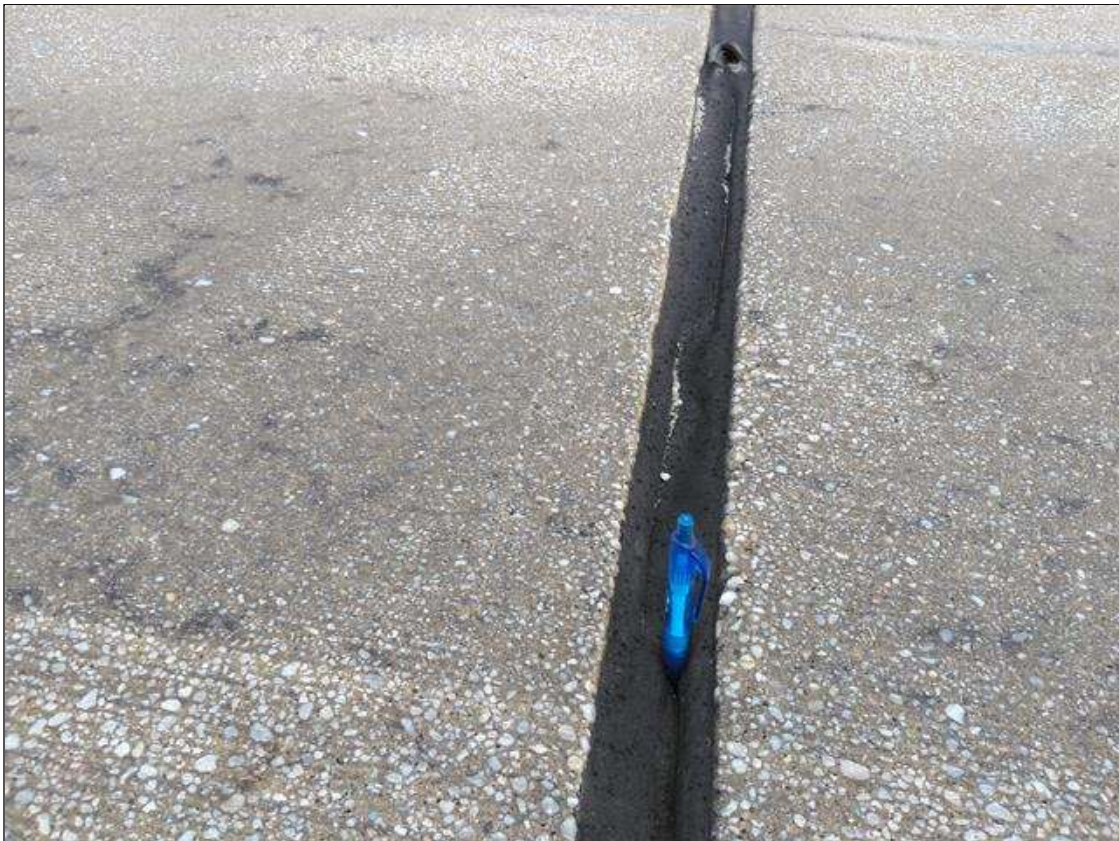
Span 103 Expansion Joint Bent 102: BOTH LANES SCATTERED THROUGHOUT, LOSS OF ADHESION (5FEET X FULL DEPTH)

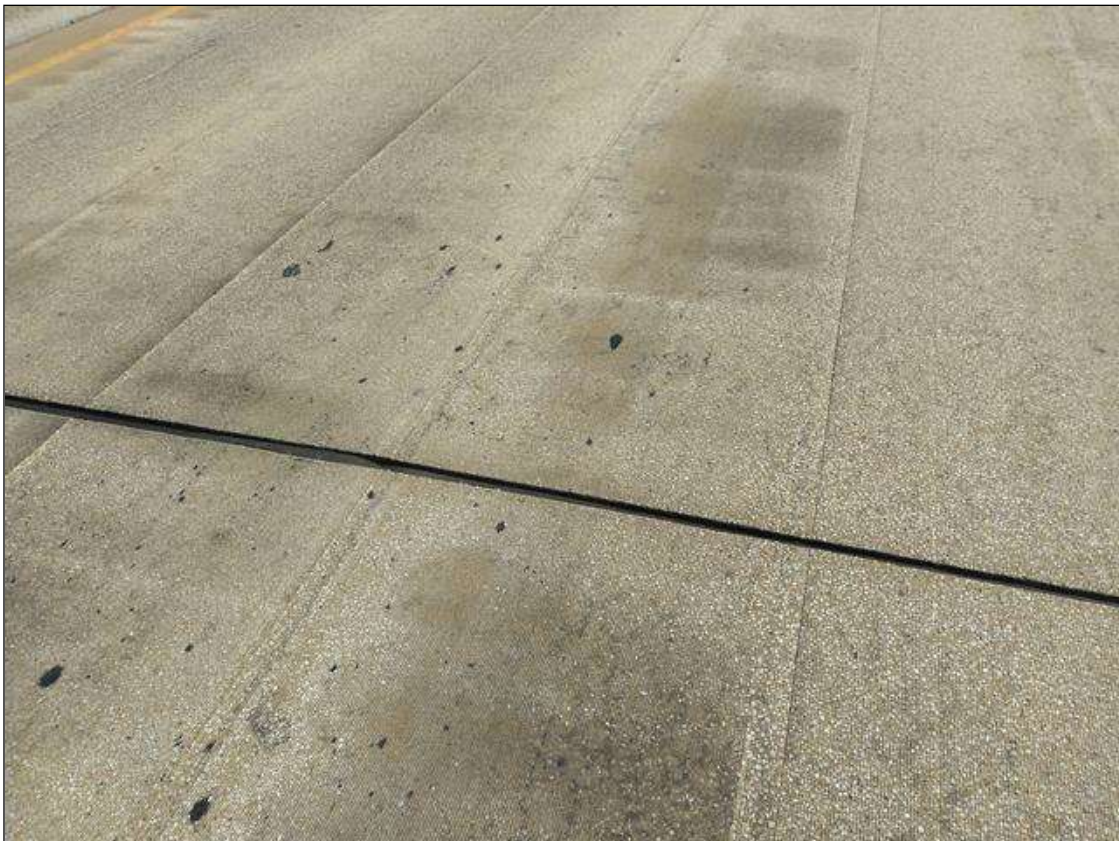
Span 118 Expansion Joint Bent 117: BENT 117, 1 INCH LONG FULL DEPTH CRACK LEFT LANE
