NC DEPARTMENT OF TRANSPORTATION  
DIVISION OF HIGHWAYS  
STRUCTURE MANAGEMENT UNIT

## Structure Safety Report

### Routine Element Inspection - Contract

STRUCTURE NUMBER: 260016 SAP STRUCTURE NO: 0270016 FHWA STRUCTURE NO: 000000000530016  
DIVISION: 1 COUNTY: CURRITUCK INSPECTION DATE: 09/21/2022 FREQUENCY: 24 MONTHS  
FACILITY CARRIED: US158E MILE POST: \_\_\_\_\_  
LOCATION: .01 MI.E.JCT.SR1187  
FEATURE INTERSECTED: CURRITUCK SOUND  
LATITUDE: 36° 5' 11.69" LONGITUDE: 75° 46' 0.21"  
SUPERSTRUCTURE: RC FLOOR ON PPC GIRDERS & CORED SLAB  
SUBSTRUCTURE: EBTS:RC CAP/PPC PILES;IBTS:RCP&B & RC CAPS/PPC PILES  
SPANS: 248 SPANS. SEE SPAN PROFILE SHEET FOR SPAN DETAILS  
☐ FRACTURE CRITICAL ☐ TEMPORARY SHORING ☐ SCOUR CRITICAL ☐ SCOUR PLAN OF ACTION  
GRADES: (Inspector/NBI Coding) DECK 6 / 6 SUPERSTRUCTURE 5 / 5 SUBSTRUCTURE 6 / 6 CULVERT N / N  
POSTED SV: Not Posted POSTED TTST: Not Posted  
OTHER SIGNS PRESENT: None

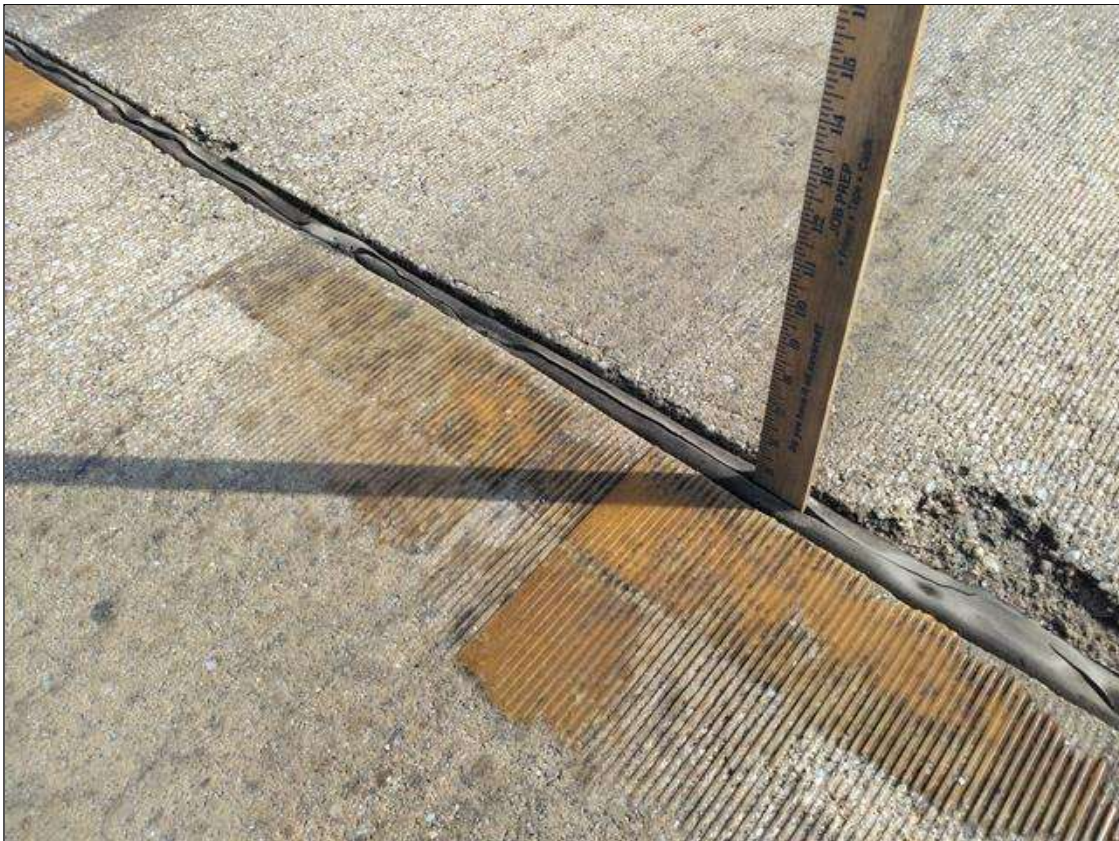
Span 118 Expansion Joint Bent 117: RIGHT LANE NEAR CENTERLINE OF ROADWAY, (3) PATCHED AREAS (3FEET X 3 INCHES) (NOT FOUND 9/13/22)

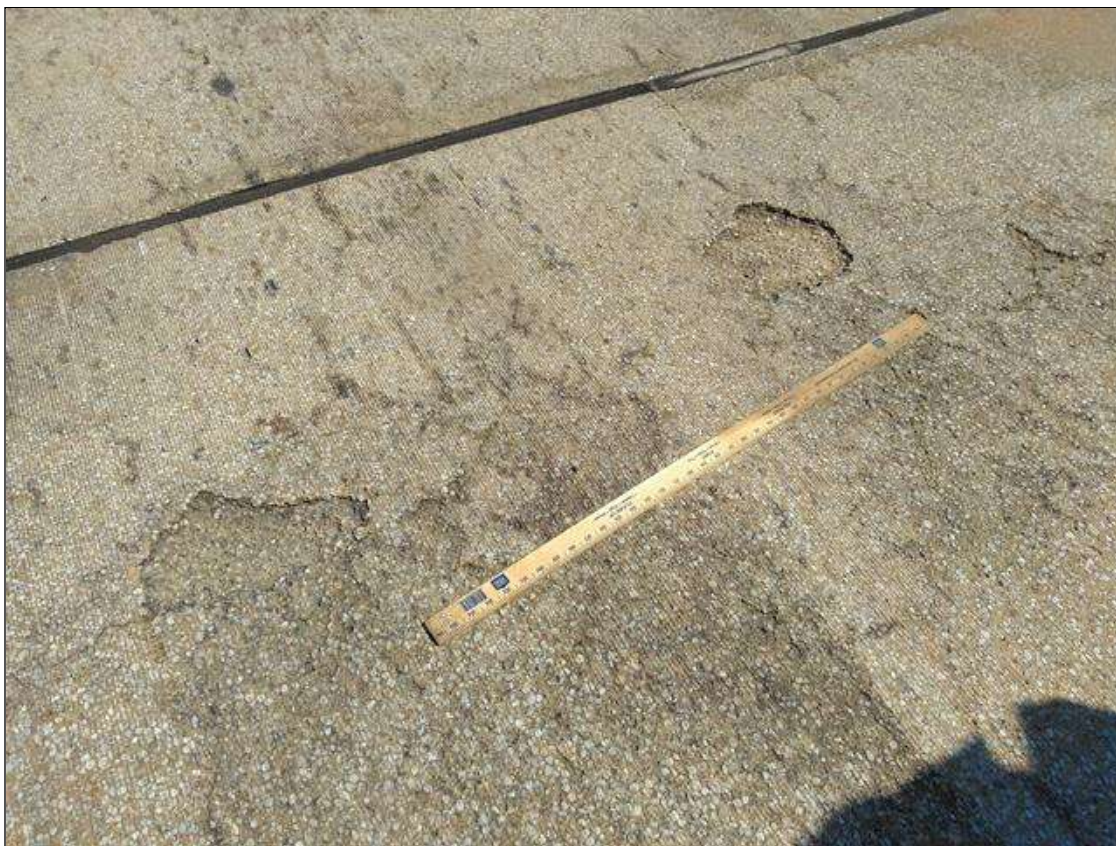
Span 119 Expansion Joint Bent 118: BENT 118, FULL WIDTH CRACK THROUGHOUT

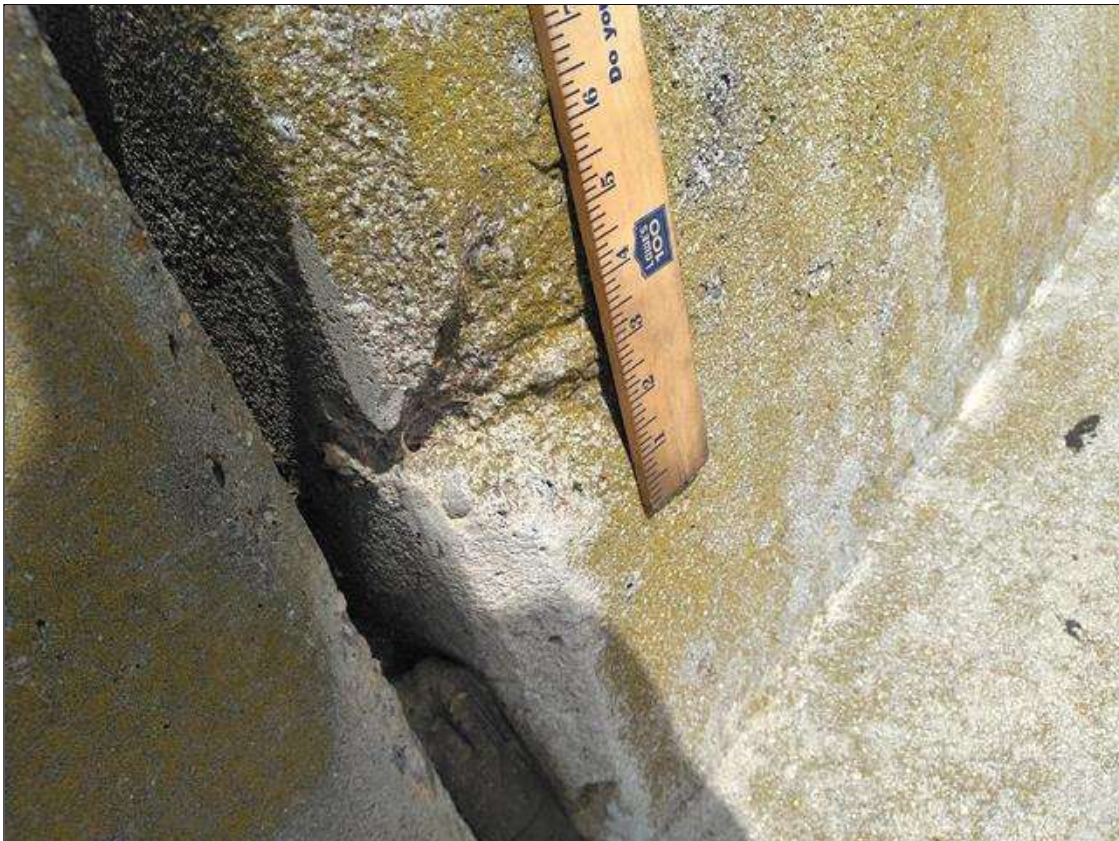
Span 195 Right Bridge Rail: AT FIRST RAIL POST (OUTSIDE) SPALL 16 INCH X 7 INCHES HIGH X 1.5 INCHES DEEP

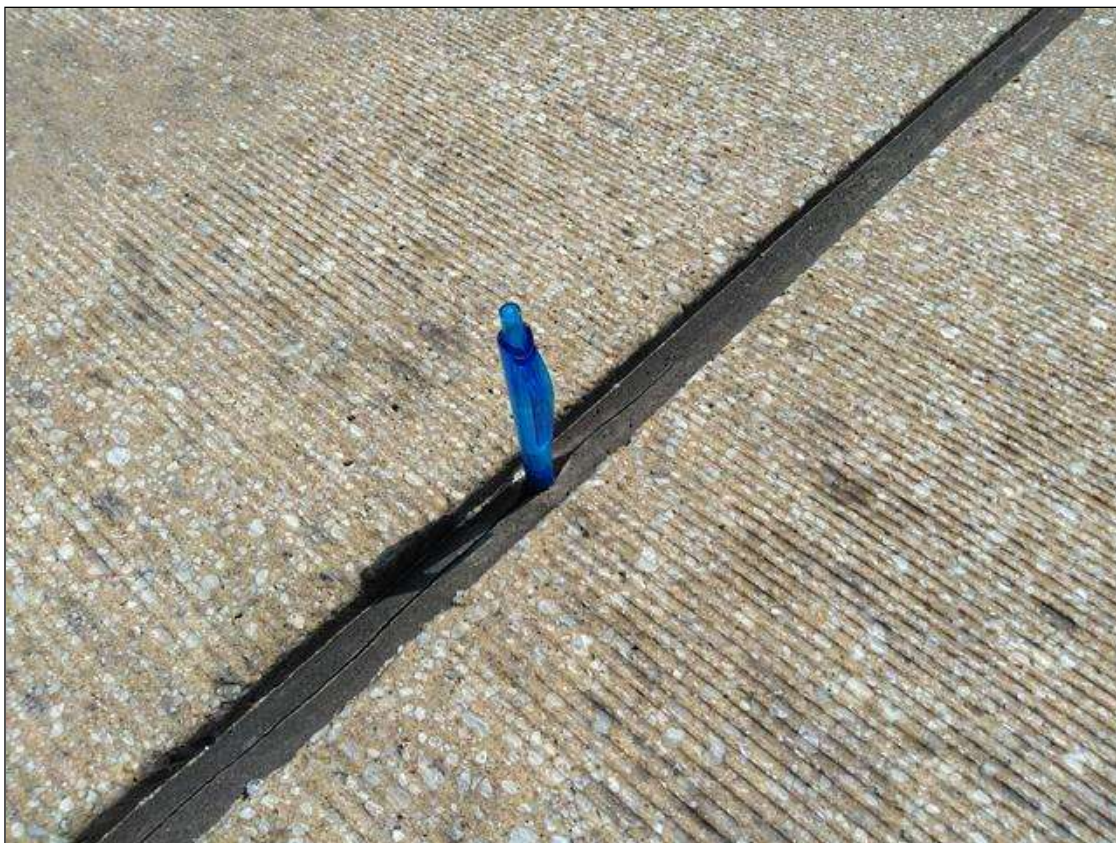
Span 163 Expansion Joint Bent 162: AT BENT 162, RIGHT LANE DELAMINATION 4 FEET WIDE X 3 INCH LONG

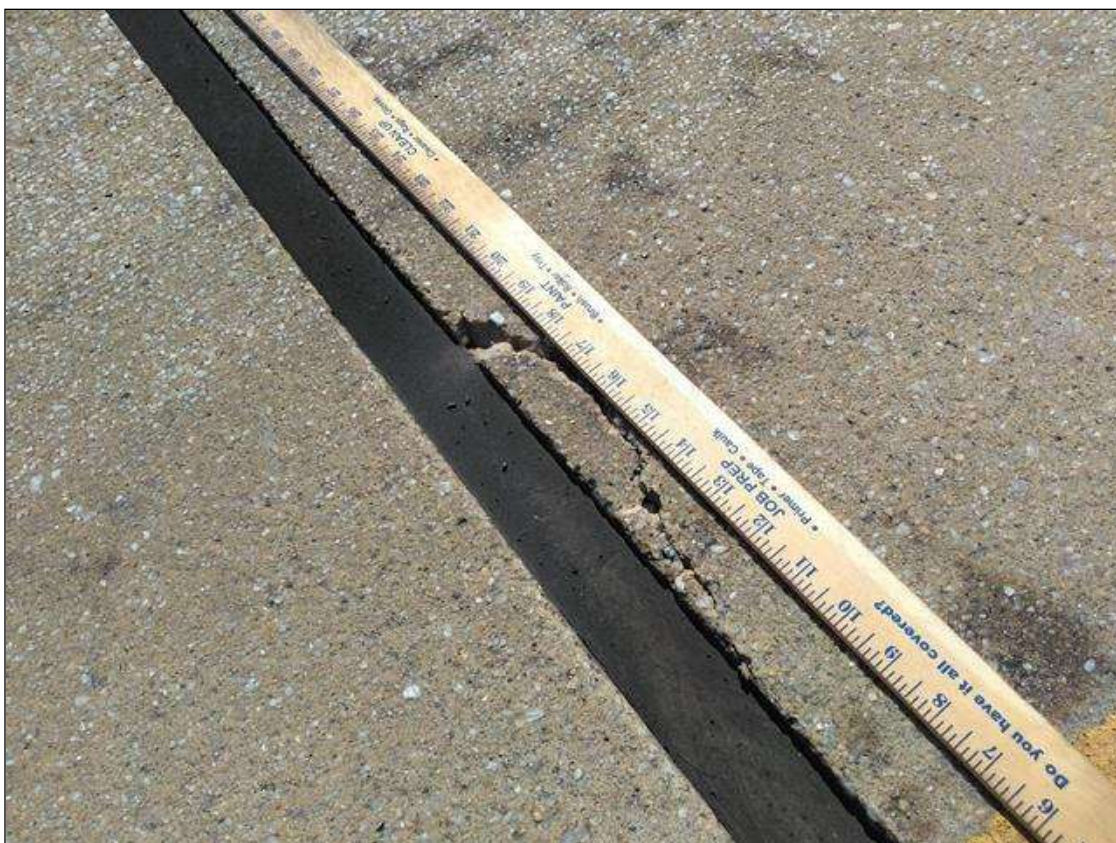
Span 178 Expansion Joint Bent 177: AT BENT 177, PARTIAL DEPTH CRACK AT LEFT SHOULDER AND CENTER

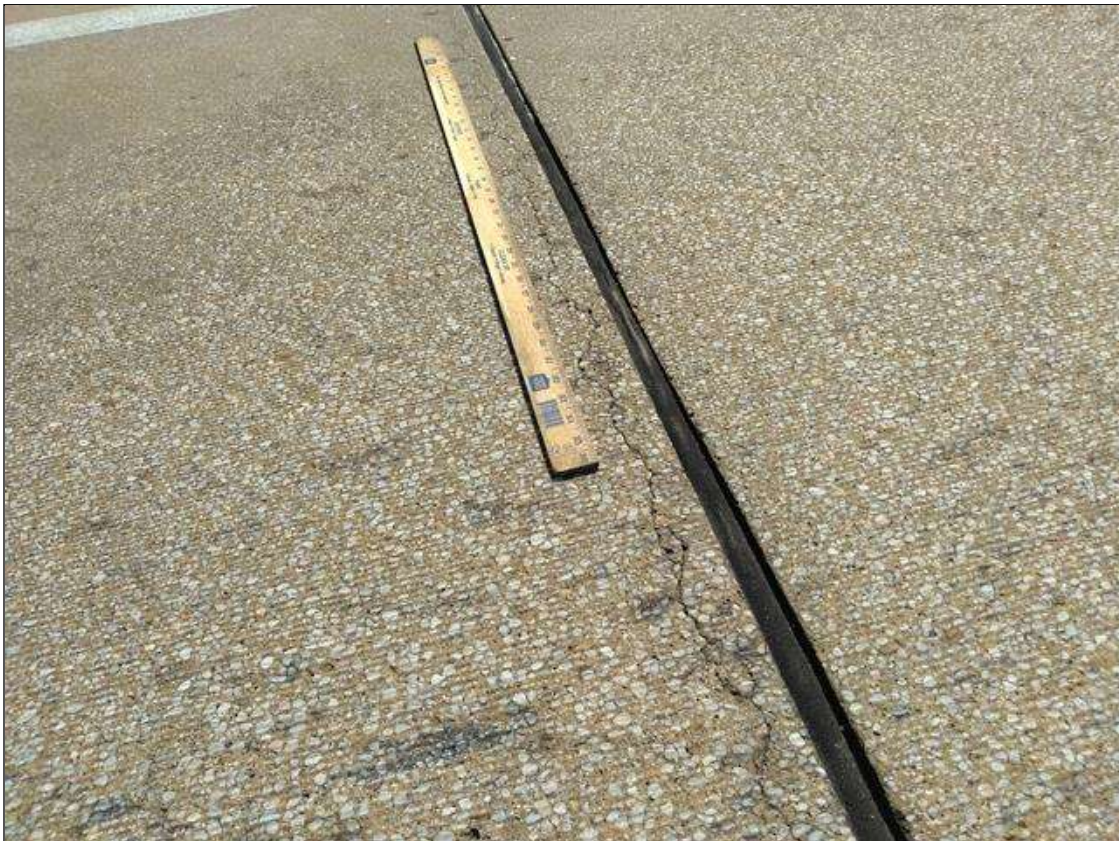
Span 179 Expansion Joint Bent 178: AT BENT 178, RIGHT LANE 5 INCH WIDE X 1 INCH LONG SPALL WITH NO JOINT SEAL ADHESION

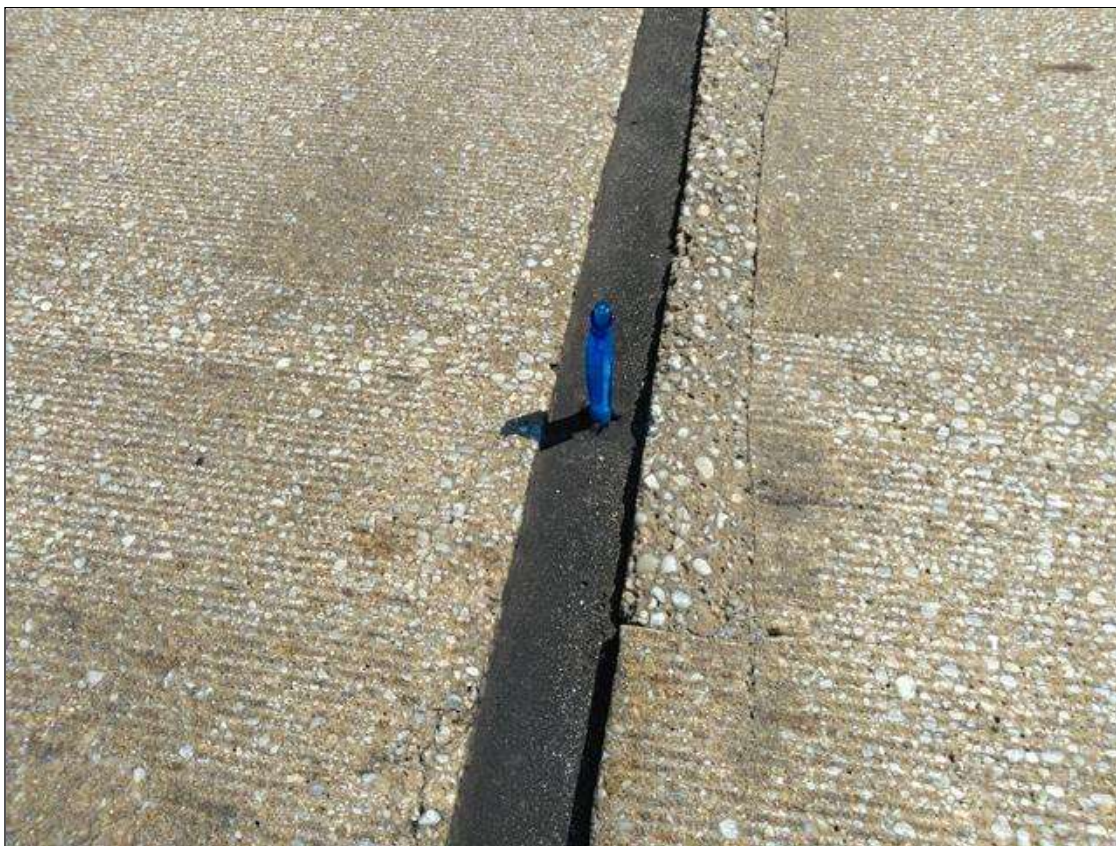
Span 180 Expansion Joint Bent 179: AT BENT 179, THROUGHOUT RIGHT LANE, EDGE DELAMINATIONS

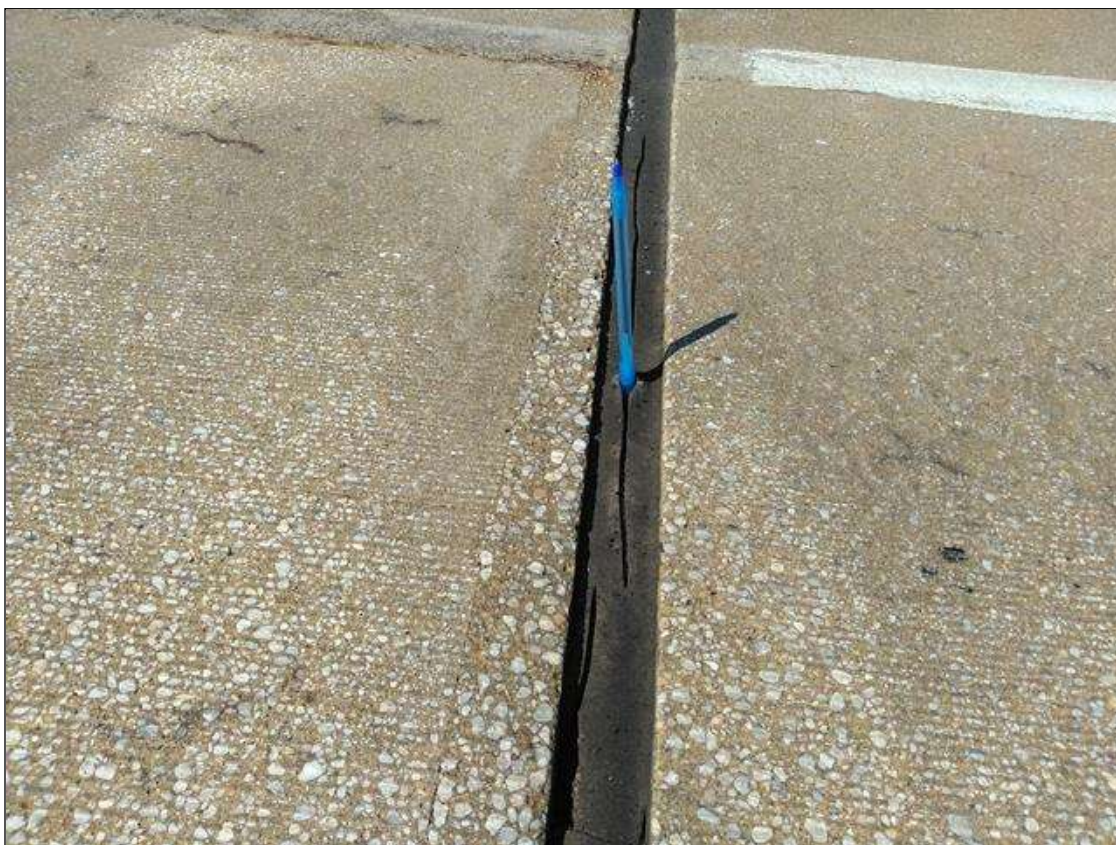
Span 194 Expansion Joint Bent 193: AT BENT 193, CENTER OF RIGHT LANE CRACK PARTIAL DEPTH 2 INCHES WIDE

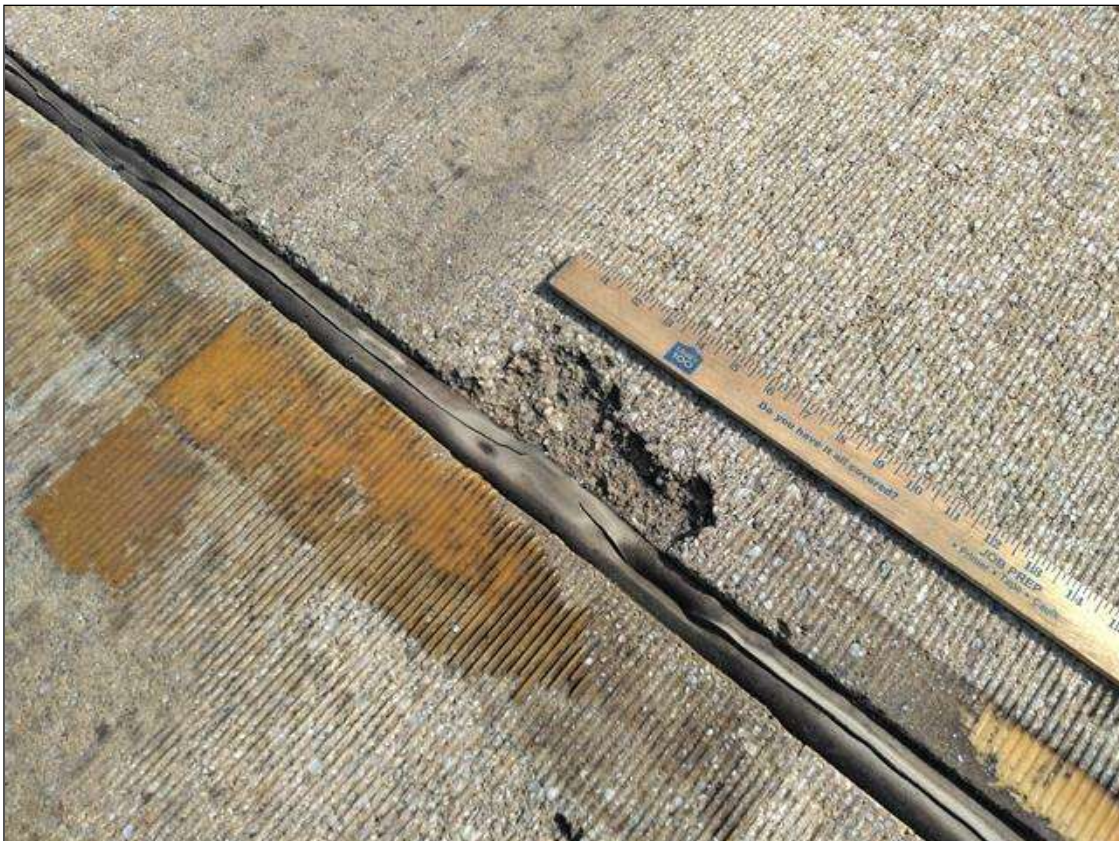
Span 200 Expansion Joint Bent 199: AT BENT 199, PARTIAL DEPTH CRACKS INTERMITTENT THROUGHOUT

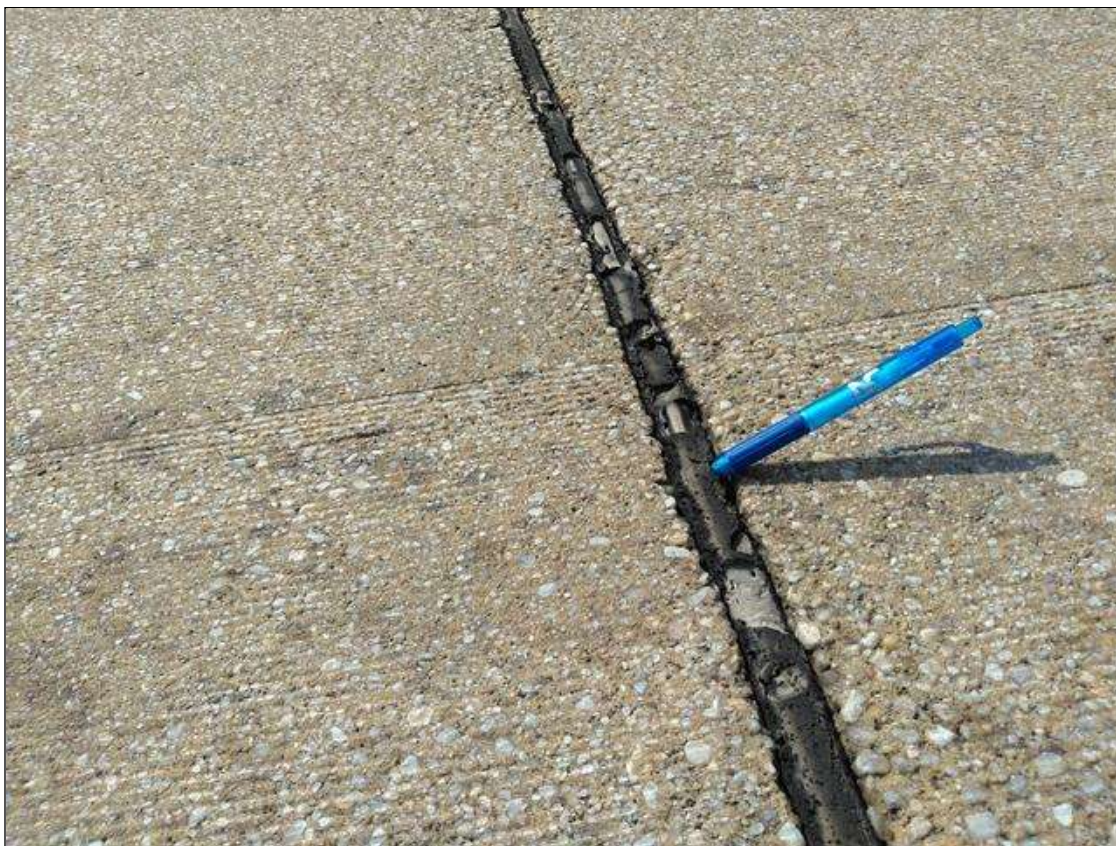
Span 119 Expansion Joint Bent 118: RIGHT LANE NEAR CENTERLINE OF ROADWAY, SPALL (6INCHES X 2INCHES X 1/2 INCHES)

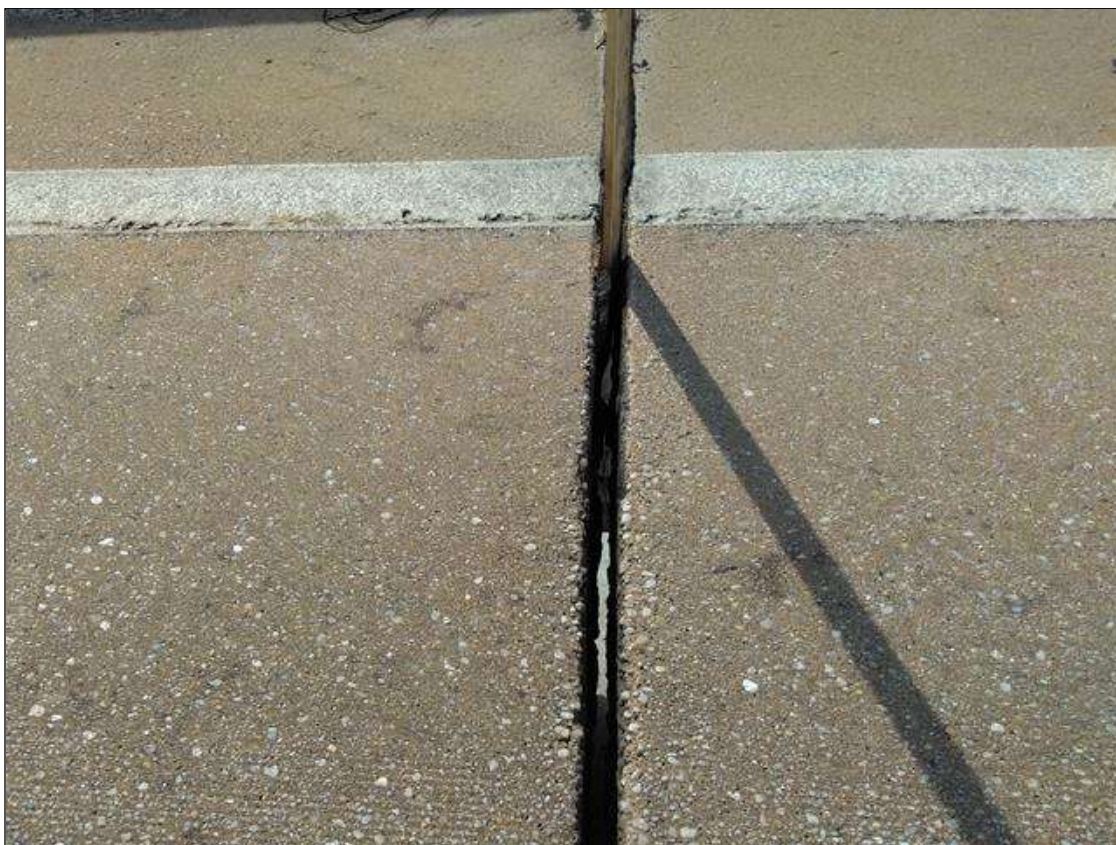
Span 126 Expansion Joint Bent 125: SCATTERED THROUGHOUT BOTH LANES, SEAL DAMAGED AND TORN (10 FEET)

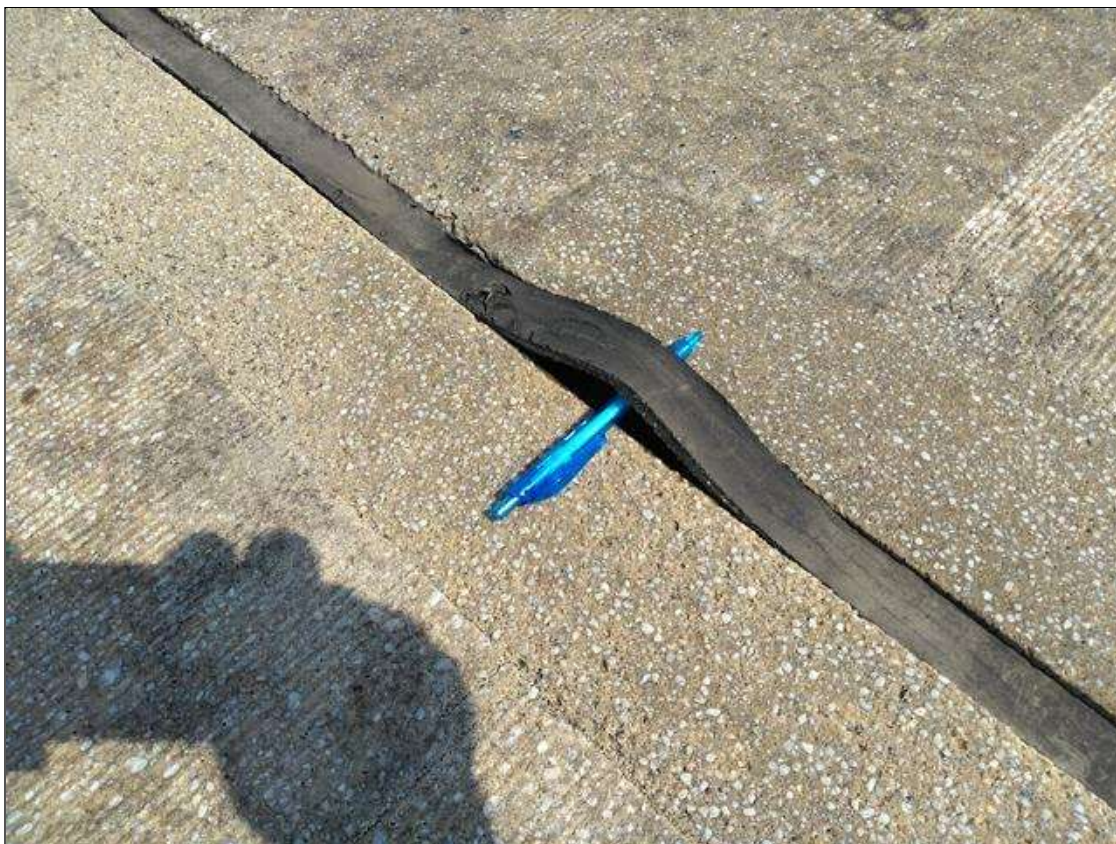
Span 131 Expansion Joint Bent 130: FULL WIDTH CRACKED, TORN, OR MISSING

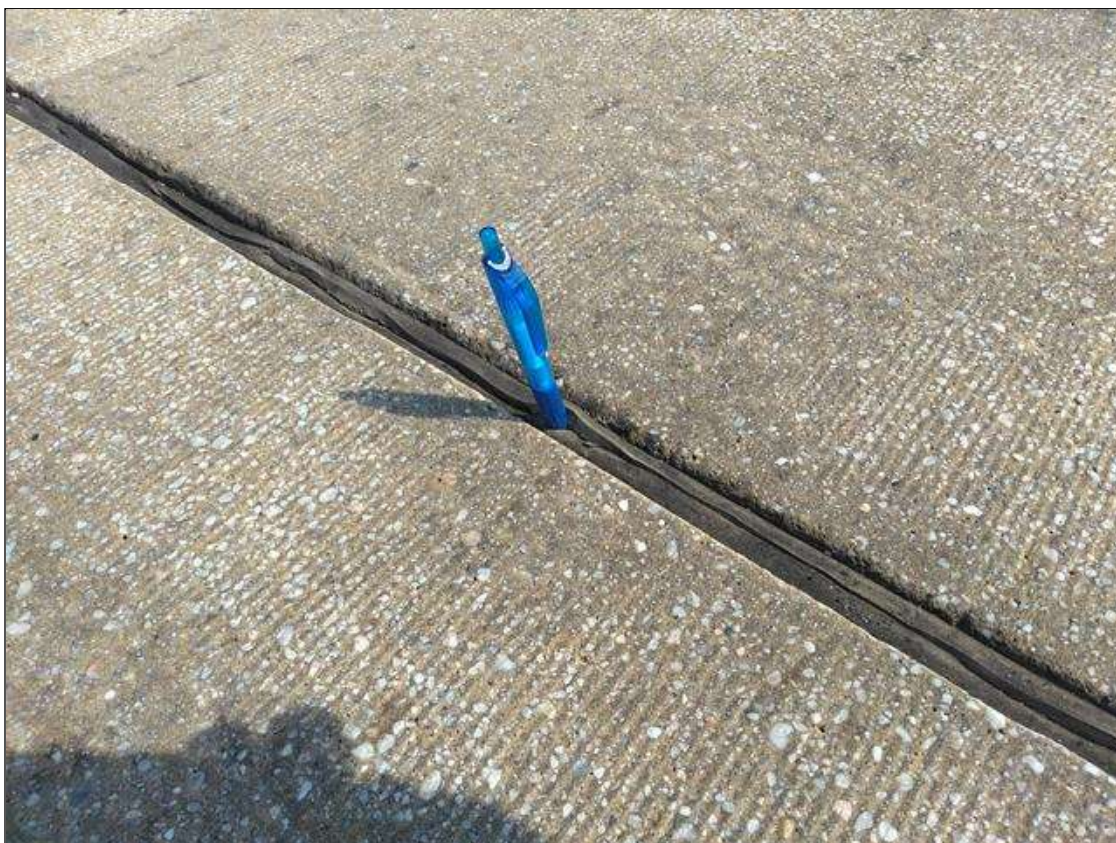
Span 145 Expansion Joint Bent 144: LEFT LANE NEAR CENTERLINE OF ROADWAY, PATCHED AREA (4FEET X 4 INCHES), NO JOINT ADHESION AT PATCH

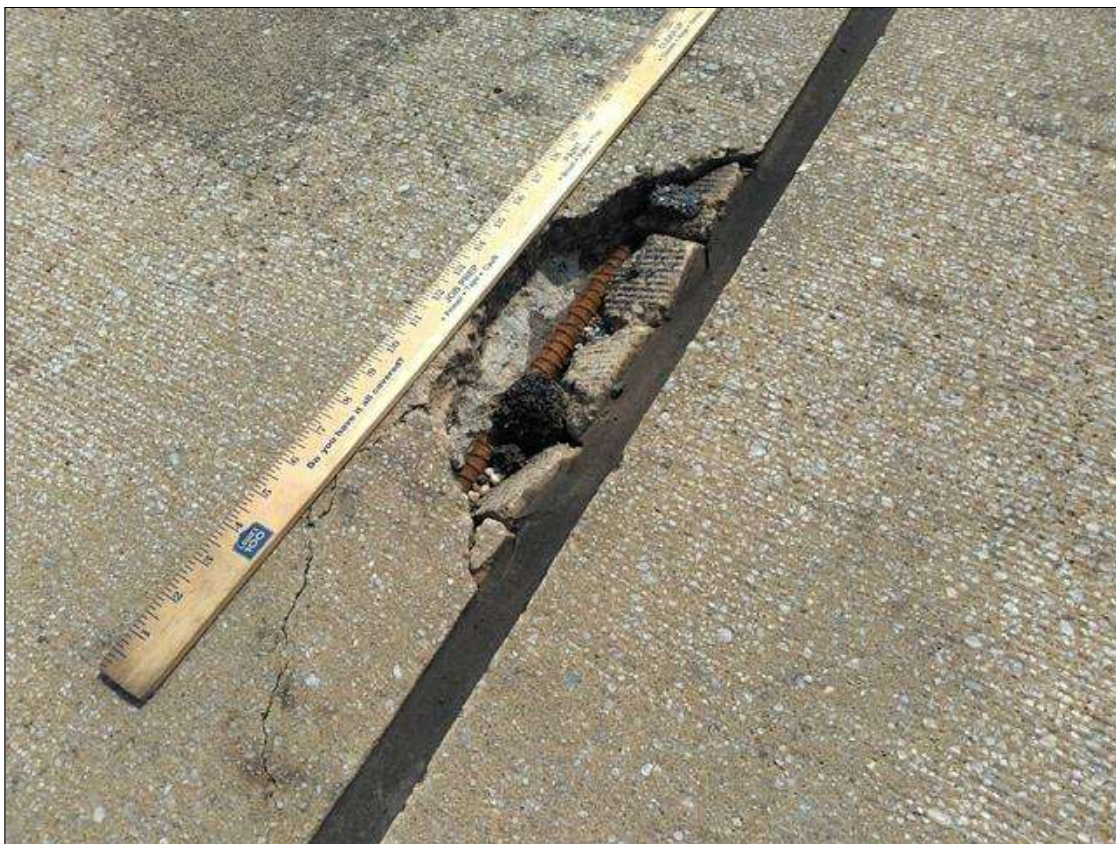
Span 151 Expansion Joint Bent 150: FULL WIDTH, SEAL DAMAGED AND TORN (24 FEET)

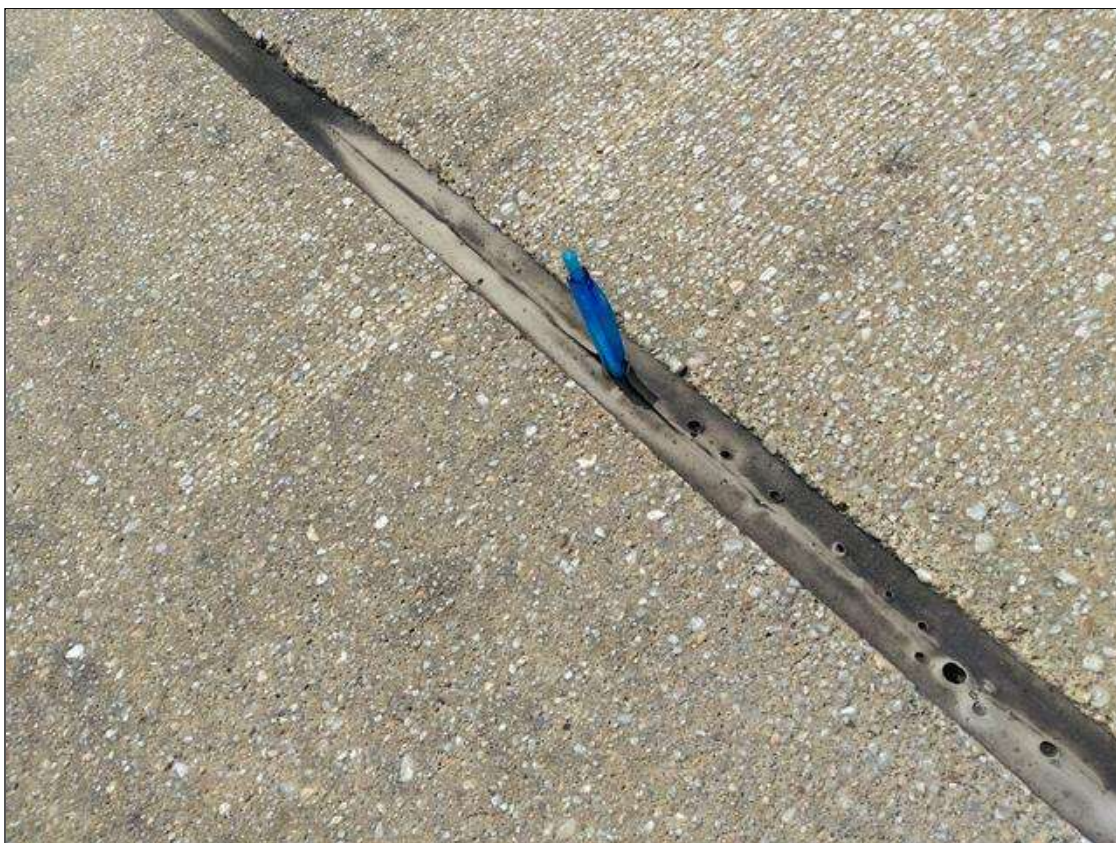
Span 156 Expansion Joint Bent 155: (PAR) LEFT LANE NEAR INCHES LEFT WHEEL PATH, SPALL (17INCHES X 5INCHES X 4 INCHES) WITH EXPOSED RUSTED REBAR

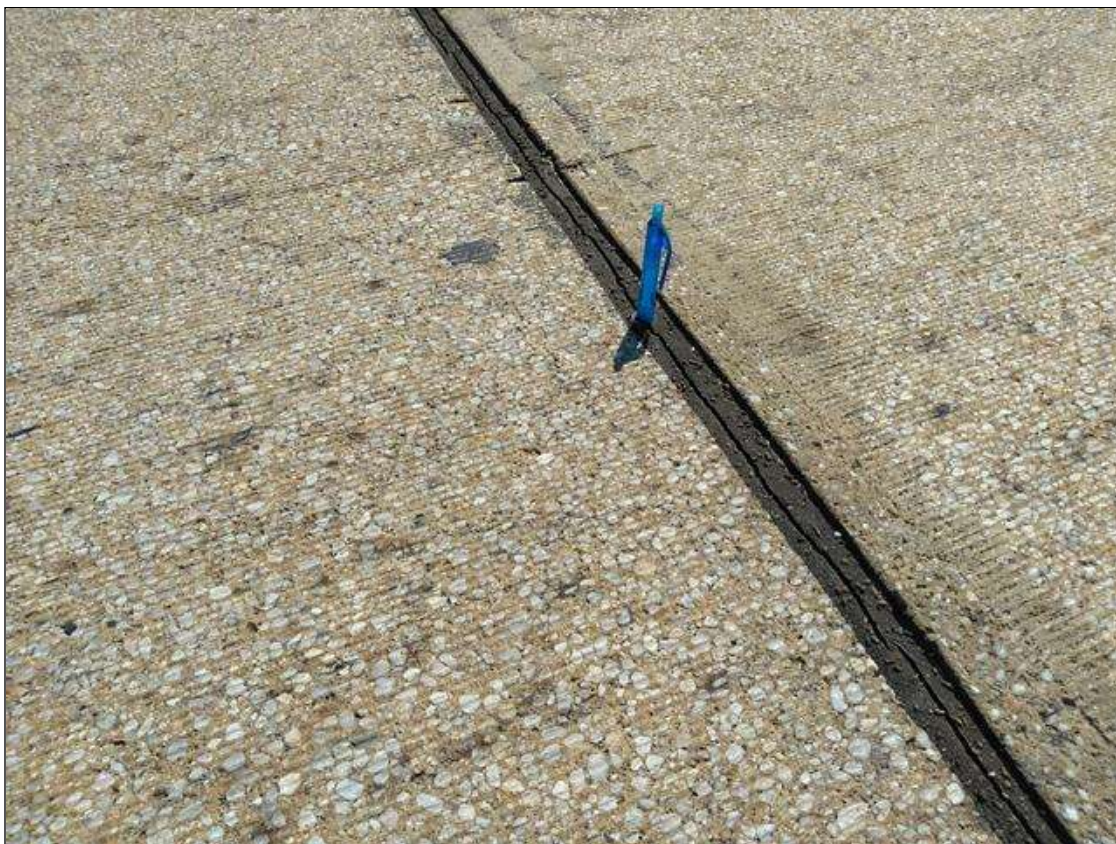
Span 171 Expansion Joint Bent 170: AT BENT 170, INTERMITTENT FULL DEPTH CRACKING THROUGHOUT

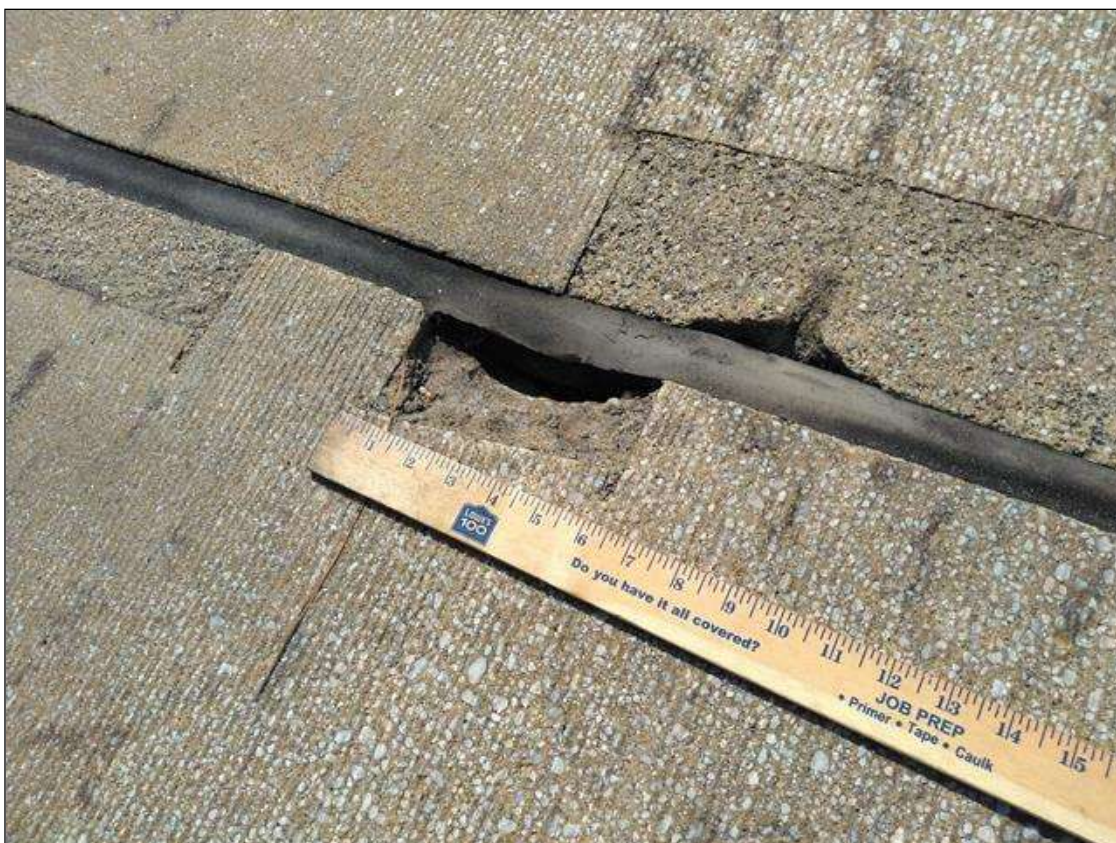
Span 182 Expansion Joint Bent 181: AT BENT 181, FULL WIDTH AND DEPTH CRACKING

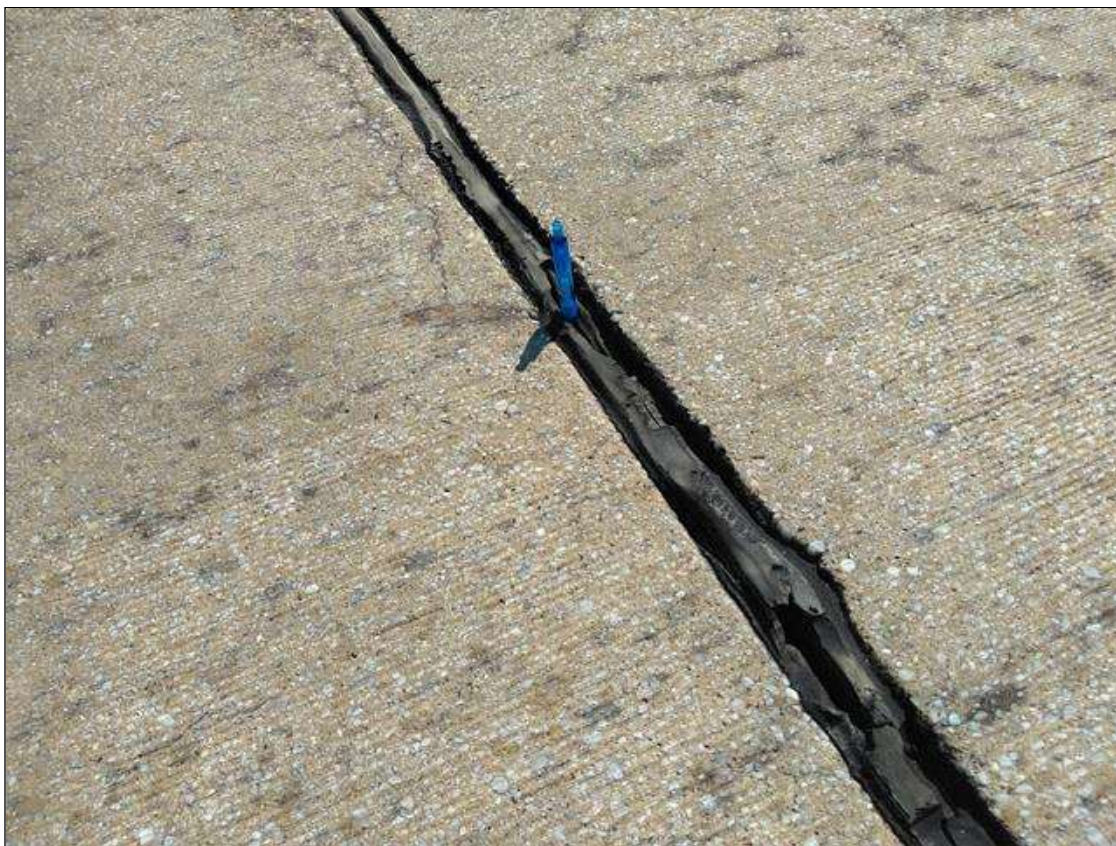
Span 188 Expansion Joint Bent 187: RIGHT RAIL ALONG JOINT, UNSOUND PATCHED AREAS (6INCHES X 3 INCHES)

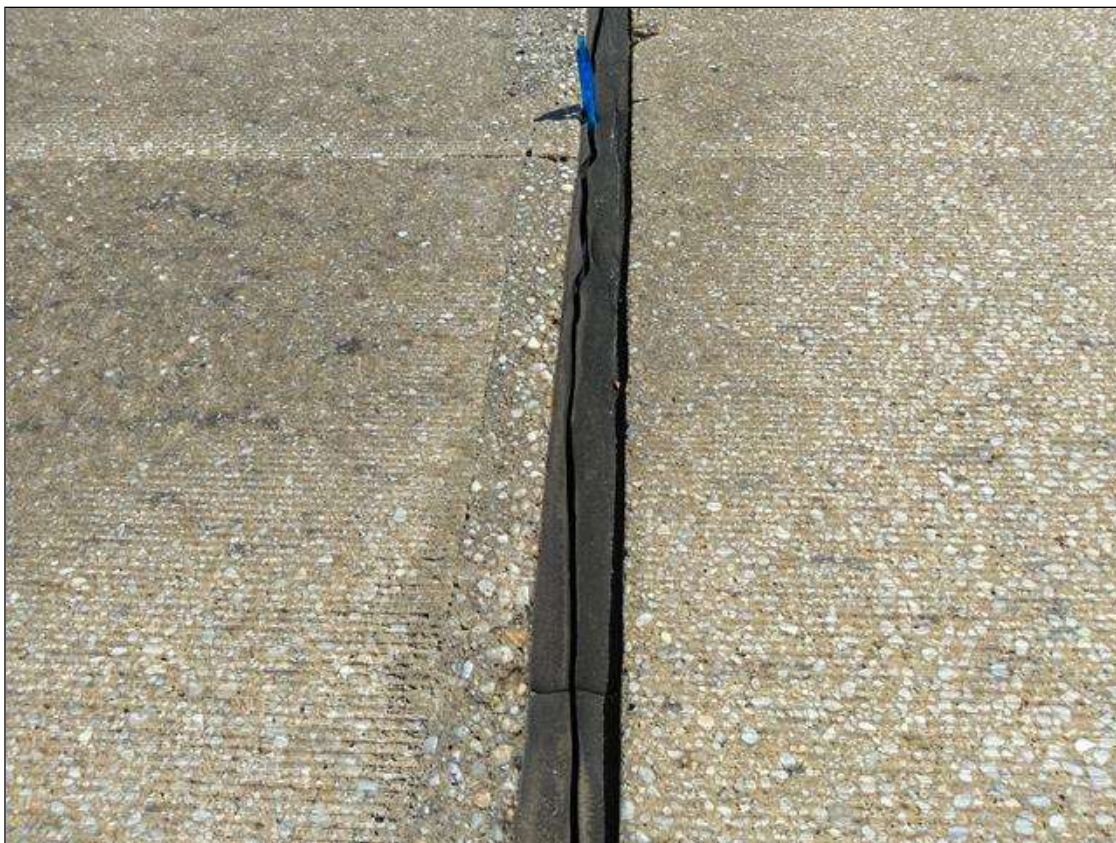
Span 189 Expansion Joint Bent 188: BENT 188, FULL DEPTH X FULL WIDTH TORN JOINT

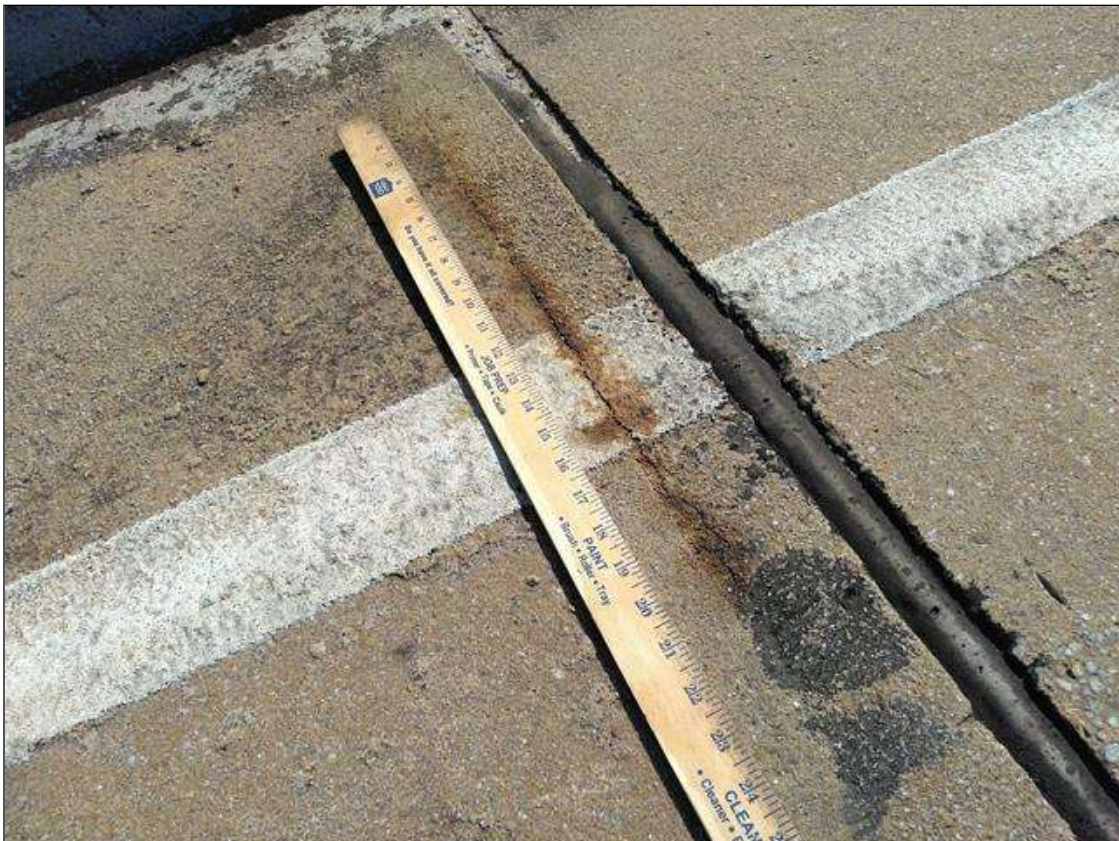
Span 192 Expansion Joint Bent 191: BENT 191, JOINT FULL WIDTH CRACKING AND TORN FULL DEPTH

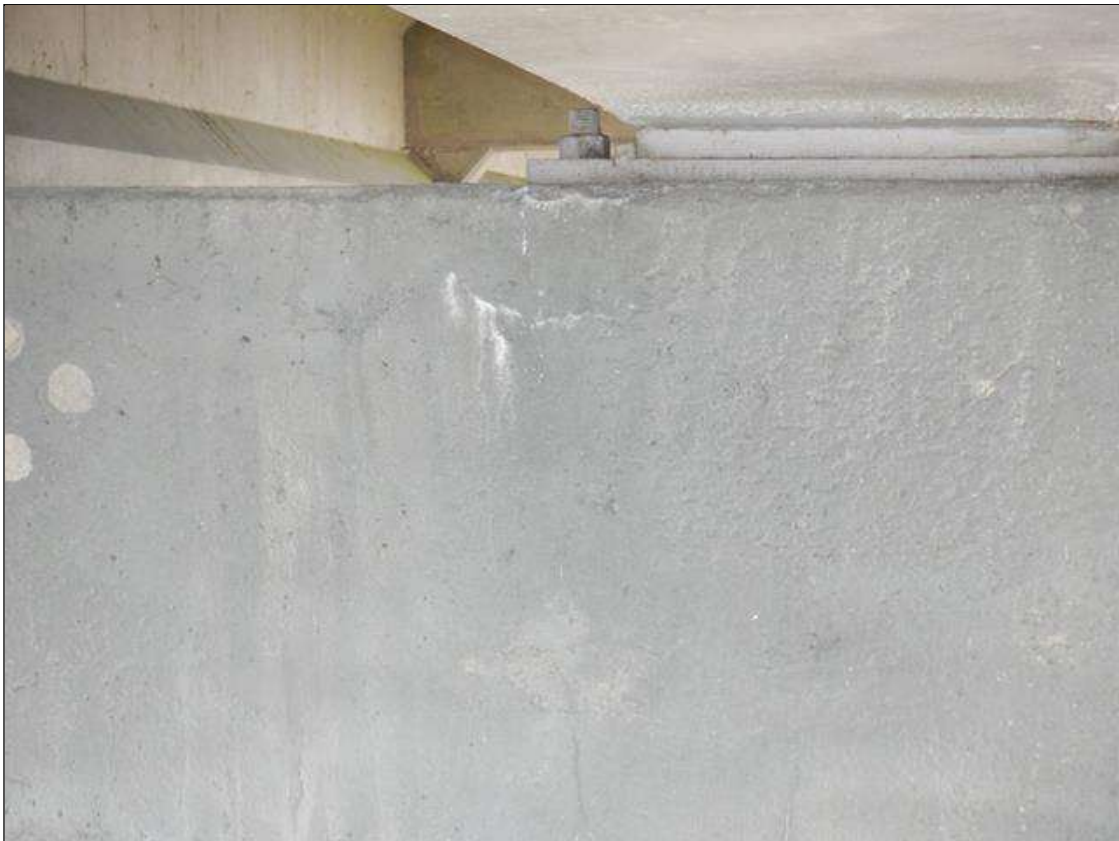
Bent 14 Cap 1: 6 INCHES X 6 INCHES DELAMINATION INCHES TOP EAST FACE CAP NEAR BEAM 2 , DID NOT FIND 9/12/22

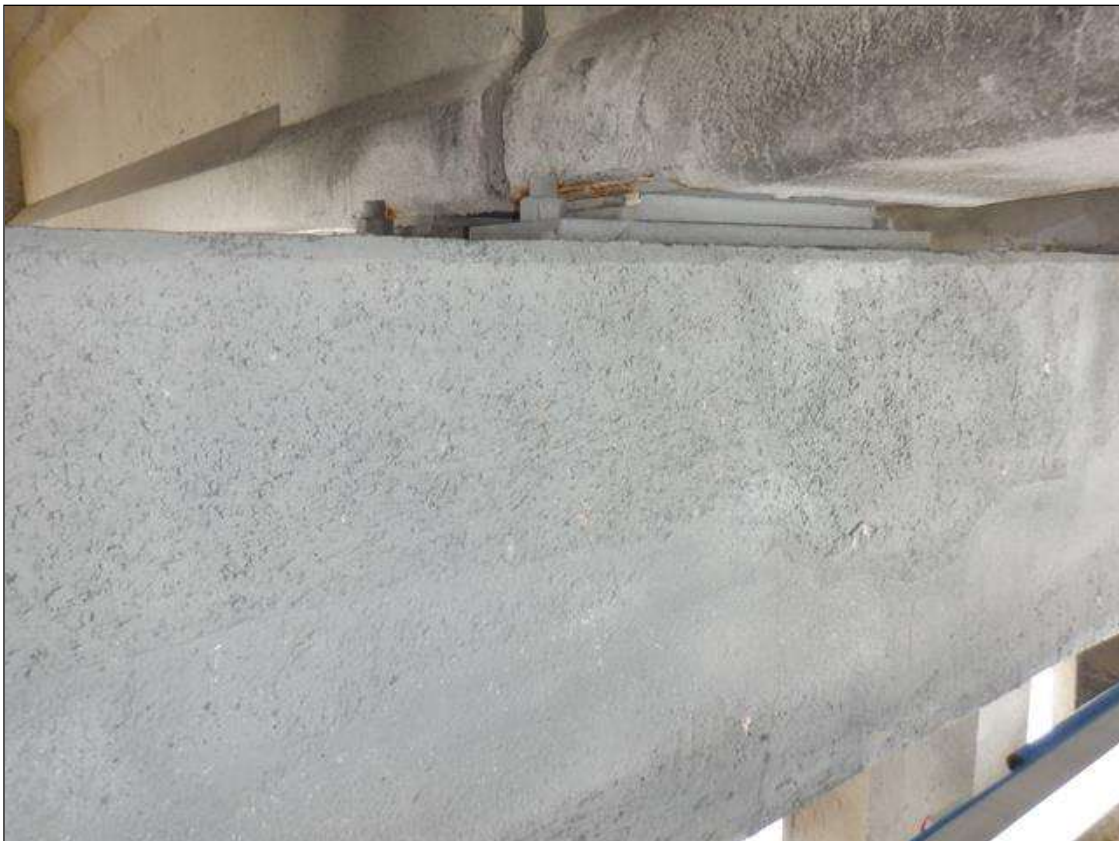
Bent 15 Cap 1: 5 FEET LONG X 1 FEET HIGH DELAMINATION ON TOP CAP STARTING AT BEAM 2

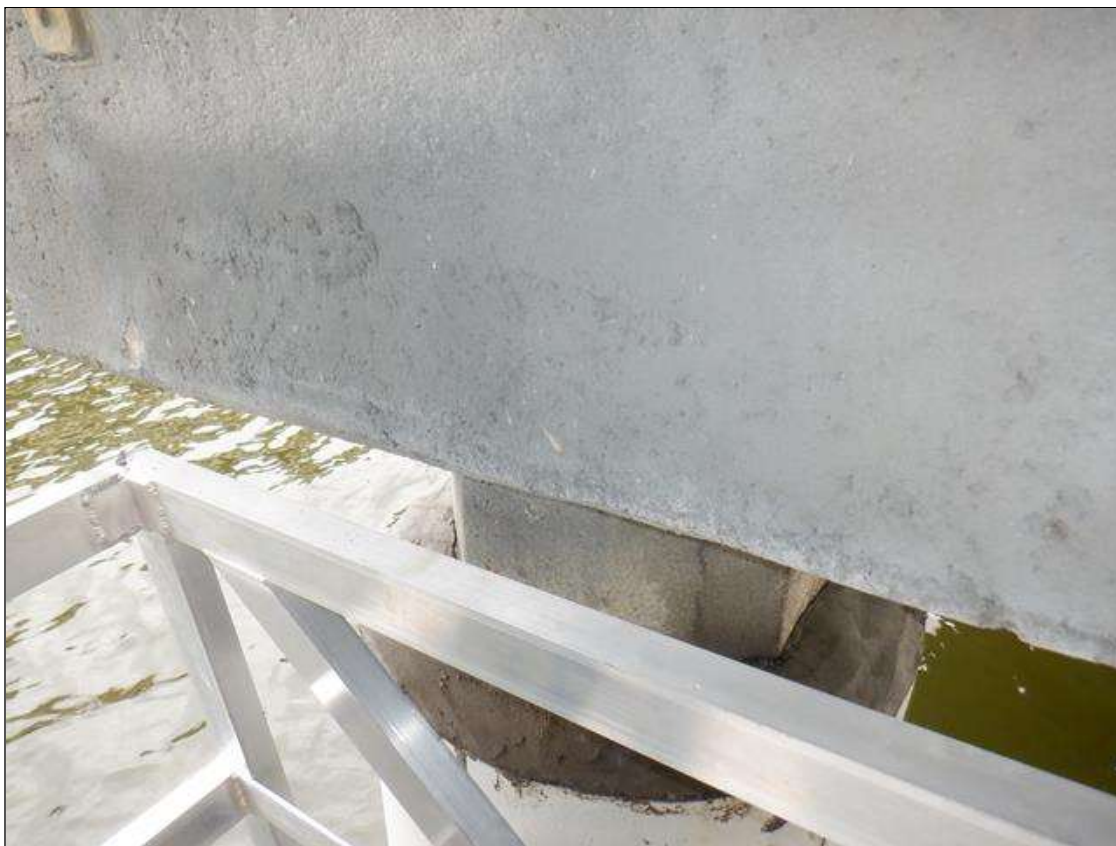
Bent 15 Cap 1: 4 FEET LONG X 1.25 FEET HIGH DELAMINATION ON TOP OF CAP UNDER BEAM 3
