NC DEPARTMENT OF TRANSPORTATION  
DIVISION OF HIGHWAYS  
STRUCTURE MANAGEMENT UNIT

## Structure Safety Report

### Routine Element Inspection - Contract

STRUCTURE NUMBER: 260016 SAP STRUCTURE NO: 0270016 FHWA STRUCTURE NO: 000000000530016  
DIVISION: 1 COUNTY: CURRITUCK INSPECTION DATE: 09/21/2022 FREQUENCY: 24 MONTHS  
FACILITY CARRIED: US158E MILE POST: \_\_\_\_\_  
LOCATION: .01 MI.E.JCT.SR1187  
FEATURE INTERSECTED: CURRITUCK SOUND  
LATITUDE: 36° 5' 11.69" LONGITUDE: 75° 46' 0.21"  
SUPERSTRUCTURE: RC FLOOR ON PPC GIRDERS & CORED SLAB  
SUBSTRUCTURE: EBTS:RC CAP/PPC PILES;IBTS:RCP&B & RC CAPS/PPC PILES  
SPANS: 248 SPANS. SEE SPAN PROFILE SHEET FOR SPAN DETAILS  
☐ FRACTURE CRITICAL ☐ TEMPORARY SHORING ☐ SCOUR CRITICAL ☐ SCOUR PLAN OF ACTION  
GRADES: (Inspector/NBI Coding) DECK 6 / 6 SUPERSTRUCTURE 5 / 5 SUBSTRUCTURE 6 / 6 CULVERT N / N  
POSTED SV: Not Posted POSTED TTST: Not Posted  
OTHER SIGNS PRESENT: None

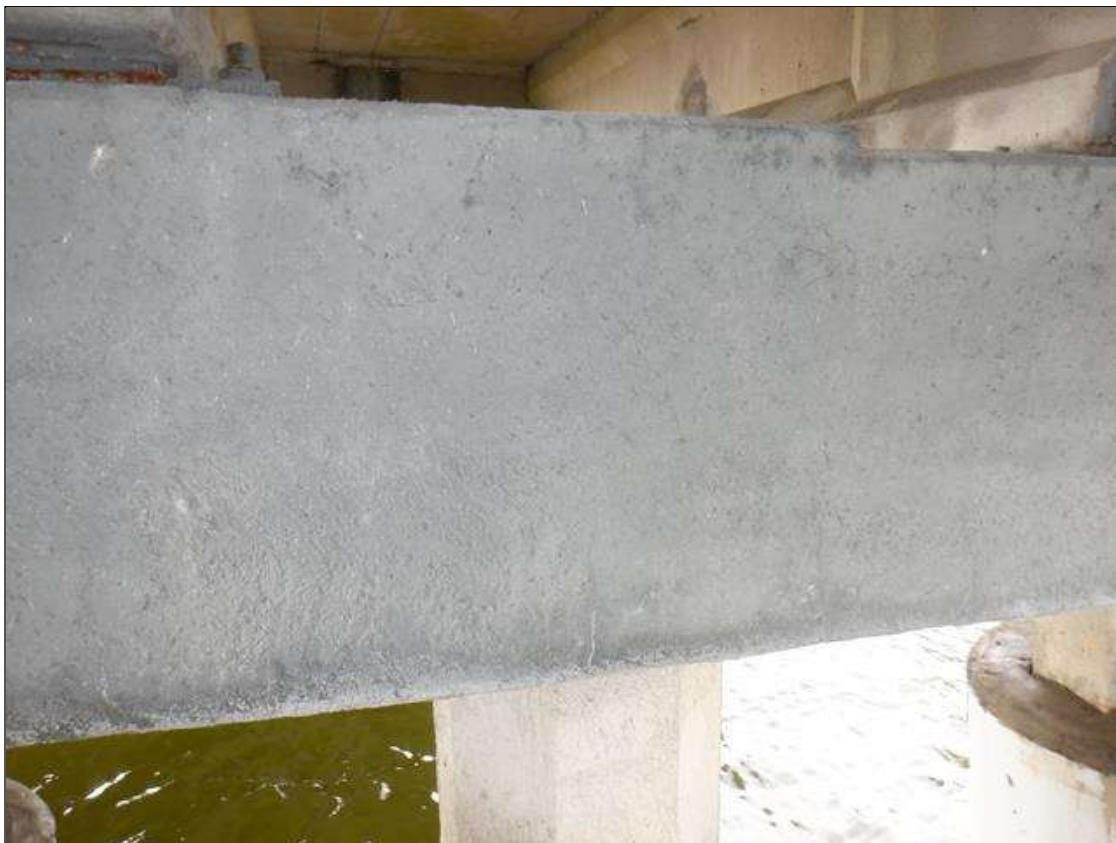
Bent 17 Cap 1: 3 FEET LONG 1/16 INCHES HORIZONTAL CRACK ON WEST FACE NEAR BOTTOM OF CAP OVER PILE 1 DID NOT FIND 9/12/22

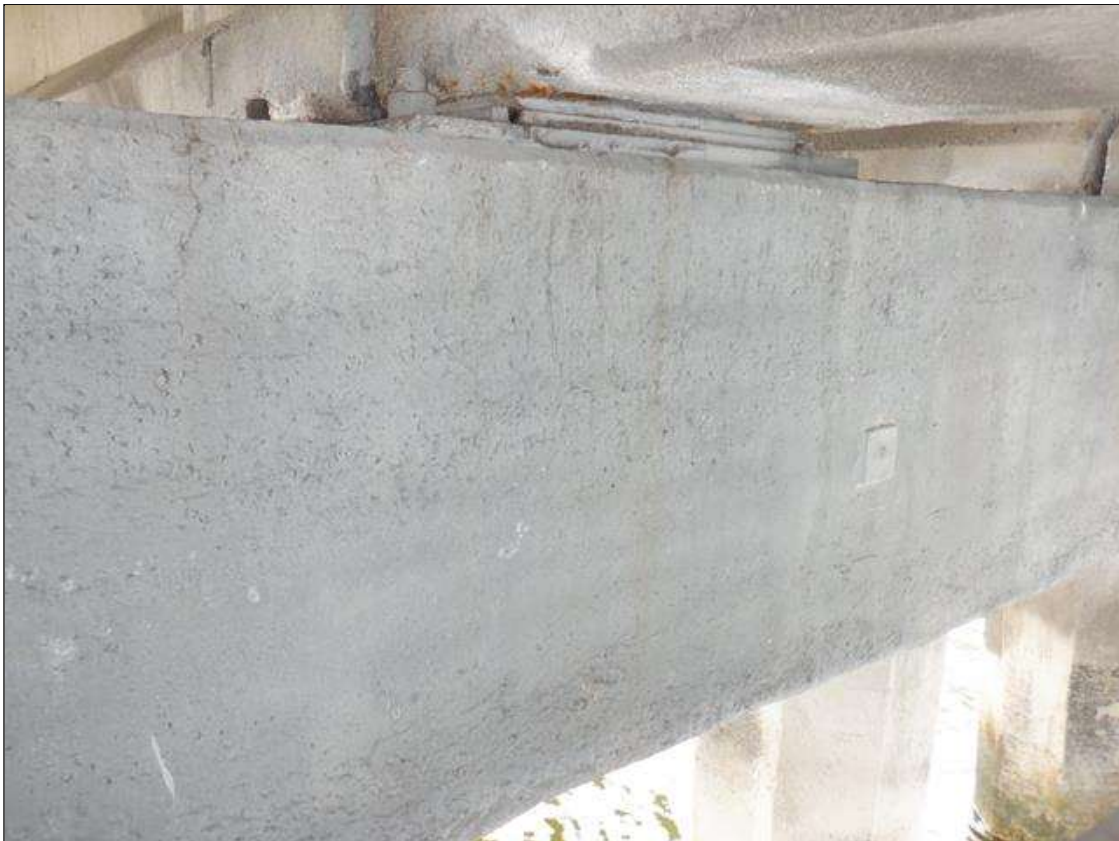
Bent 17 Cap 1: ALL FACES, SCATTERED PATCHED AREAS WITH MAP CRACKING (UP TO 1/32 INCHES), SOME WITH EFFLORESCENCE AND RUST STAIN

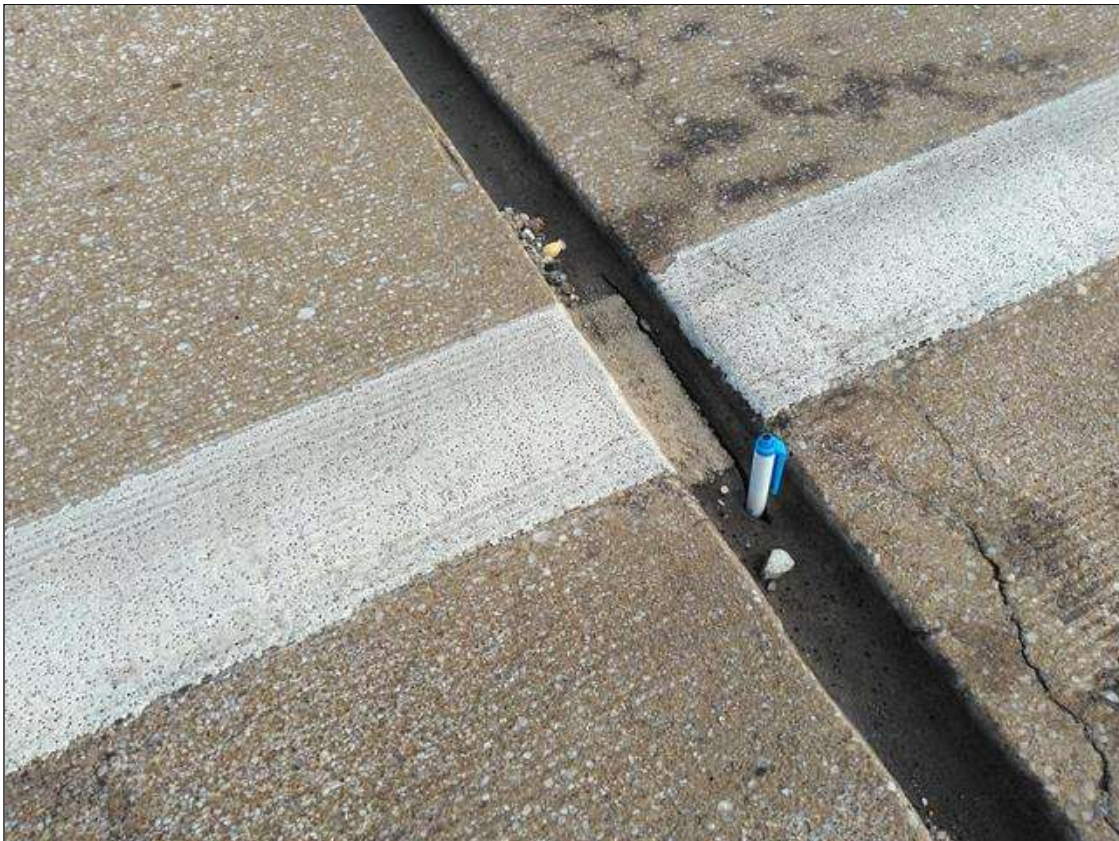
Span 202 Expansion Joint Bent 201: AT BENT 201, FULL DEPTH CRACKS AT BOTH SHOULDERS AND CENTERLINE

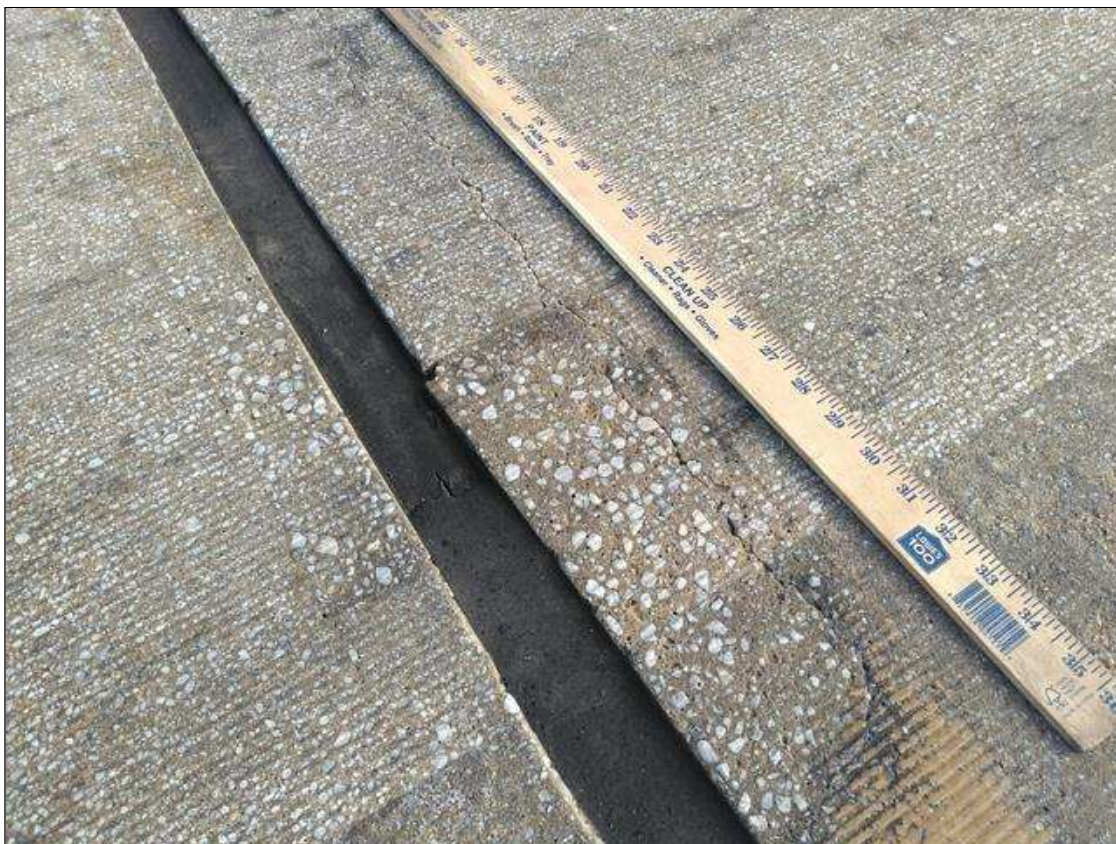
Span 202 Expansion Joint Bent 201: BENT 201, DELAMINATION WITH RUST STAINING AT RIGHT SHOULDER AND CENTERLINE. UP TO 4 FEET LONG X 4 INCH WIDE

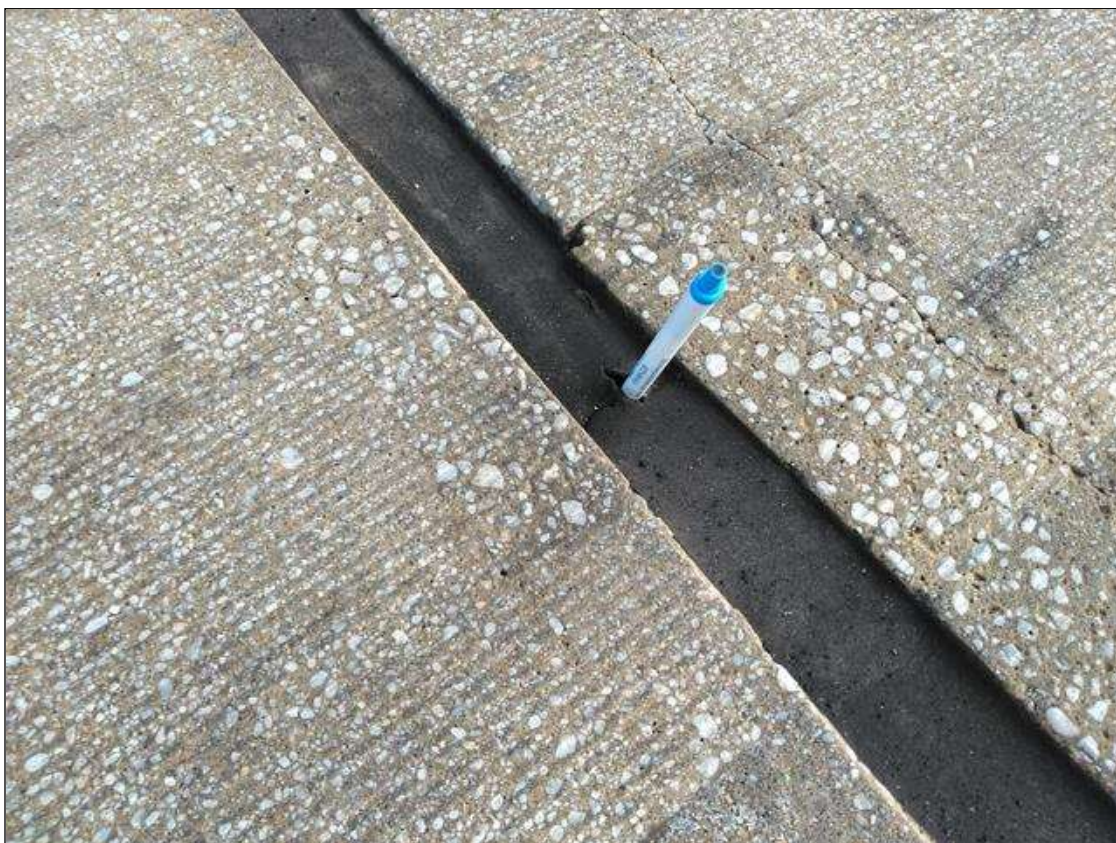
Span 203 Expansion Joint Bent 202: RIGHT LANE ALONG JOINT, PATCHED AREA (UP TO 10FEET X 4 INCHES).  
0.06 INCH CRACK AND DELAMINATION AT PATCHES

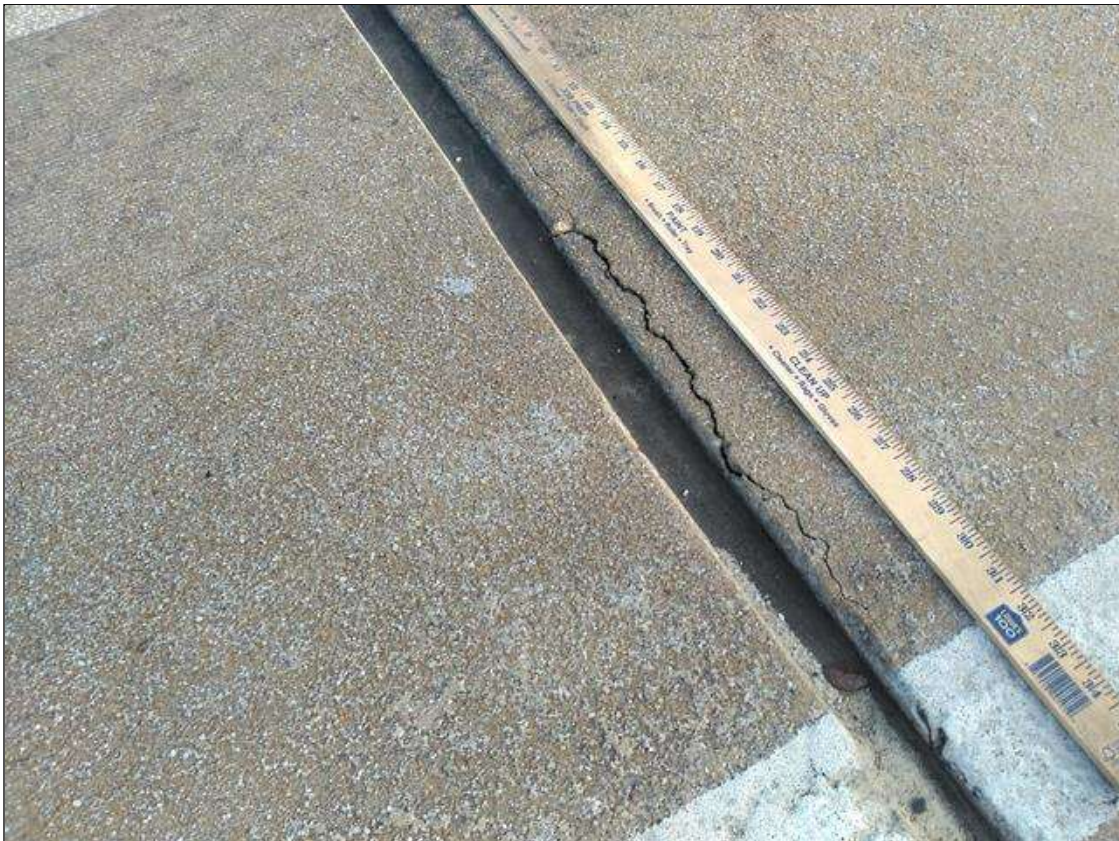
Span 205 Expansion Joint Bent 204: THROUGHOUT BOTH LANES, SEAL DAMAGED AND TORN FULL WIDTH X FULL DEPTH

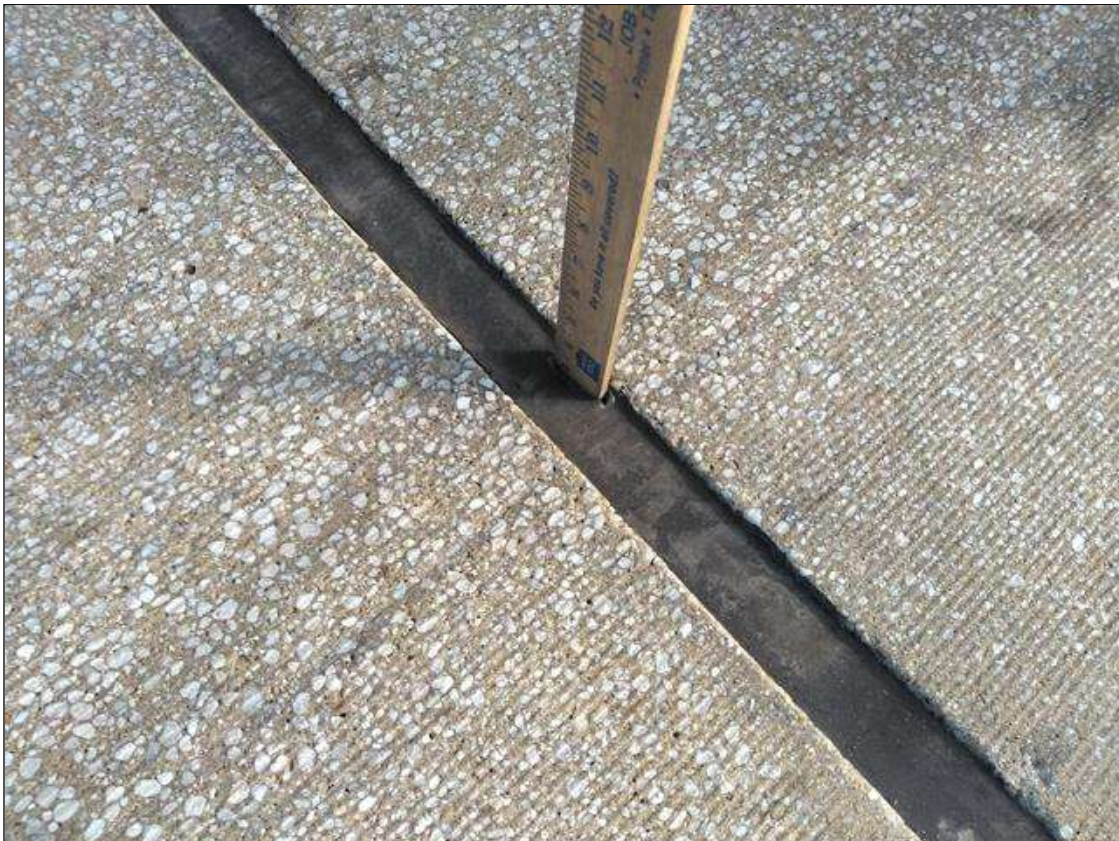
Span 208 Expansion Joint Bent 207: AT BENT 207, PARTIAL DEPTH CRACKING IN SHOULDERS AND CENTERLINE

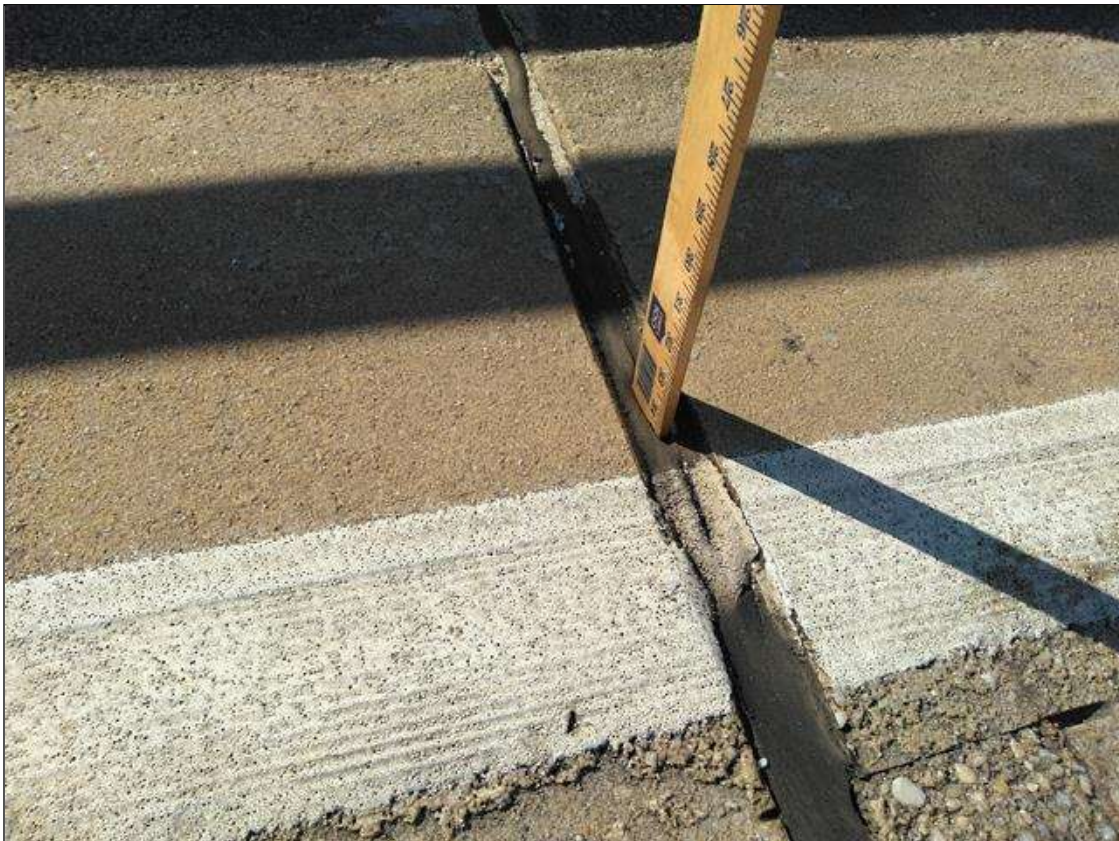
Span 213 Expansion Joint Bent 212: AT BENT 212, EDGD SPALLING IN RIGHT LANE ALONG JOINT, UP TO 7 FEET X 4 INCHES X PARTIAL DEPTH)

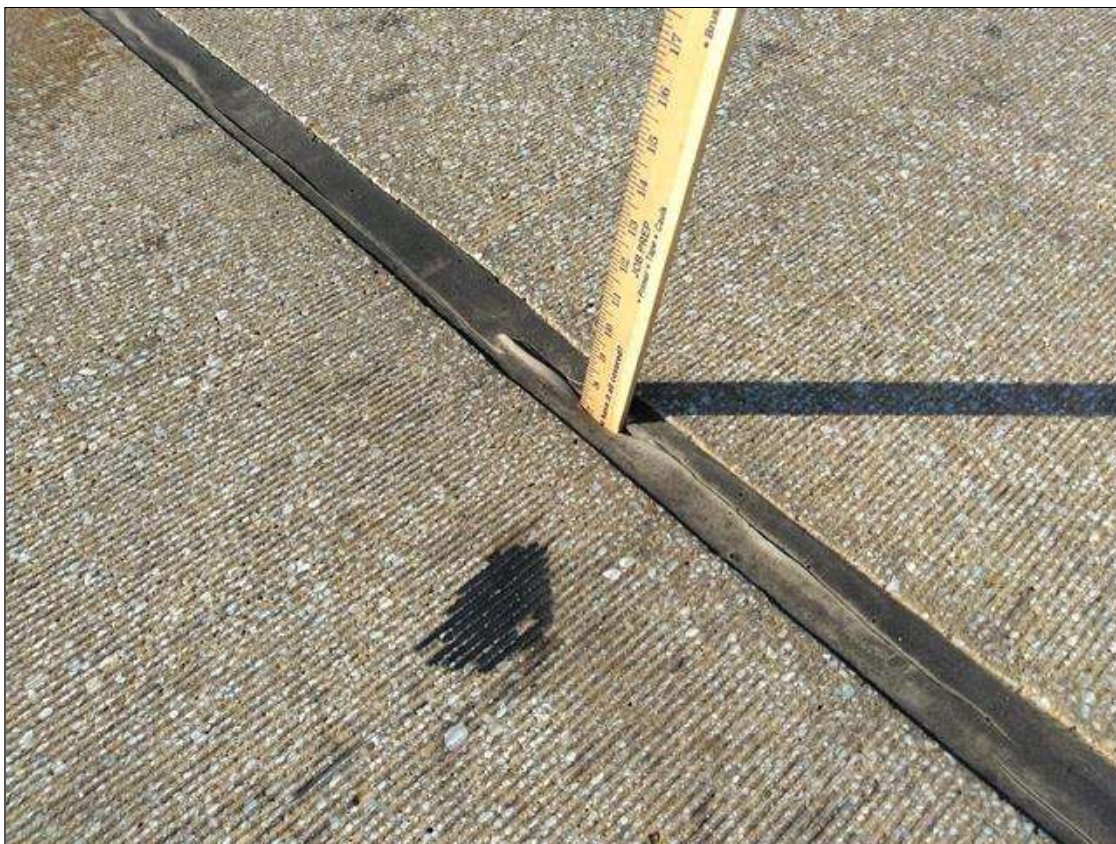
Span 214 Expansion Joint Bent 213: AT BENT 213, PARTIAL DEPTH CRACKING IN RIGHT LANE AND SHOULDER

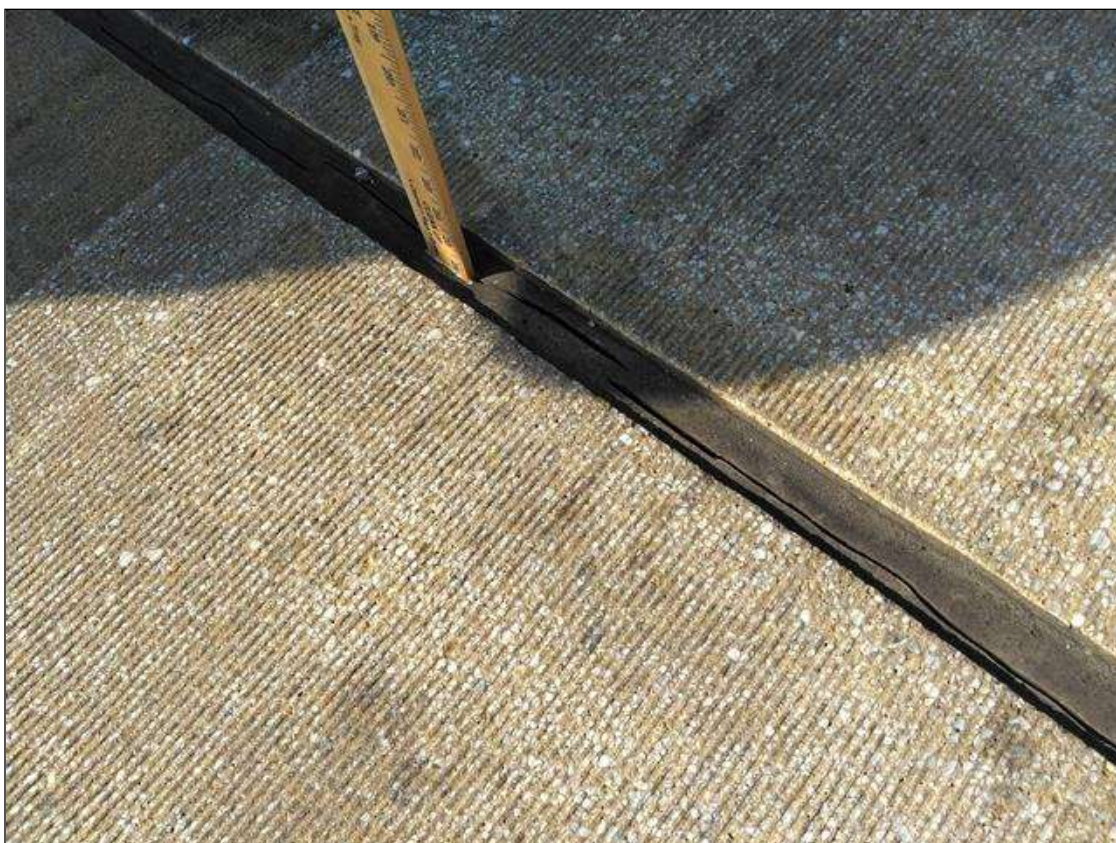
Span 216 Expansion Joint Bent 215: AT BENT 215, FULL WIDTH X FULL DEPTH CRACKING

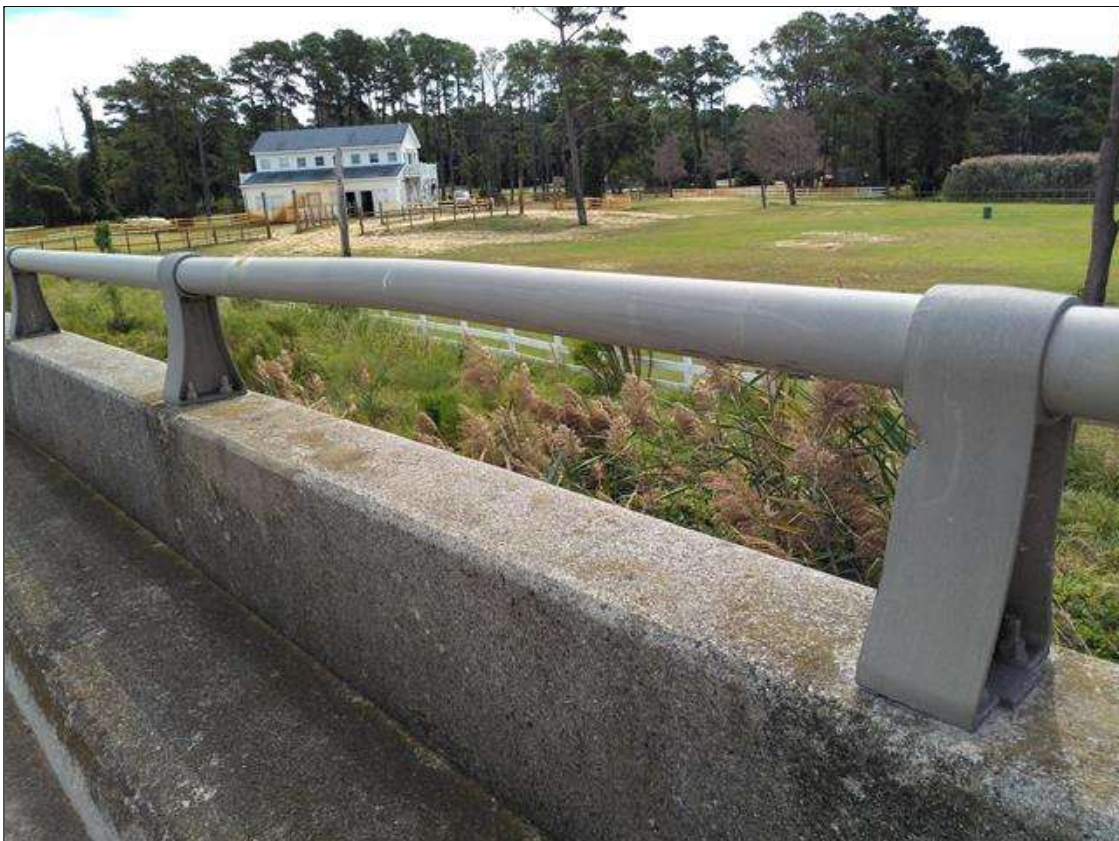
Span 245 Right Bridge Rail: POST 6, 2 INCH HIGH X 1 INCH LONG TEAR AND RAILING BETWEEN POSTS 6 AND 7 IS DEFLECTED 1 INCH AT MIDLENGTH

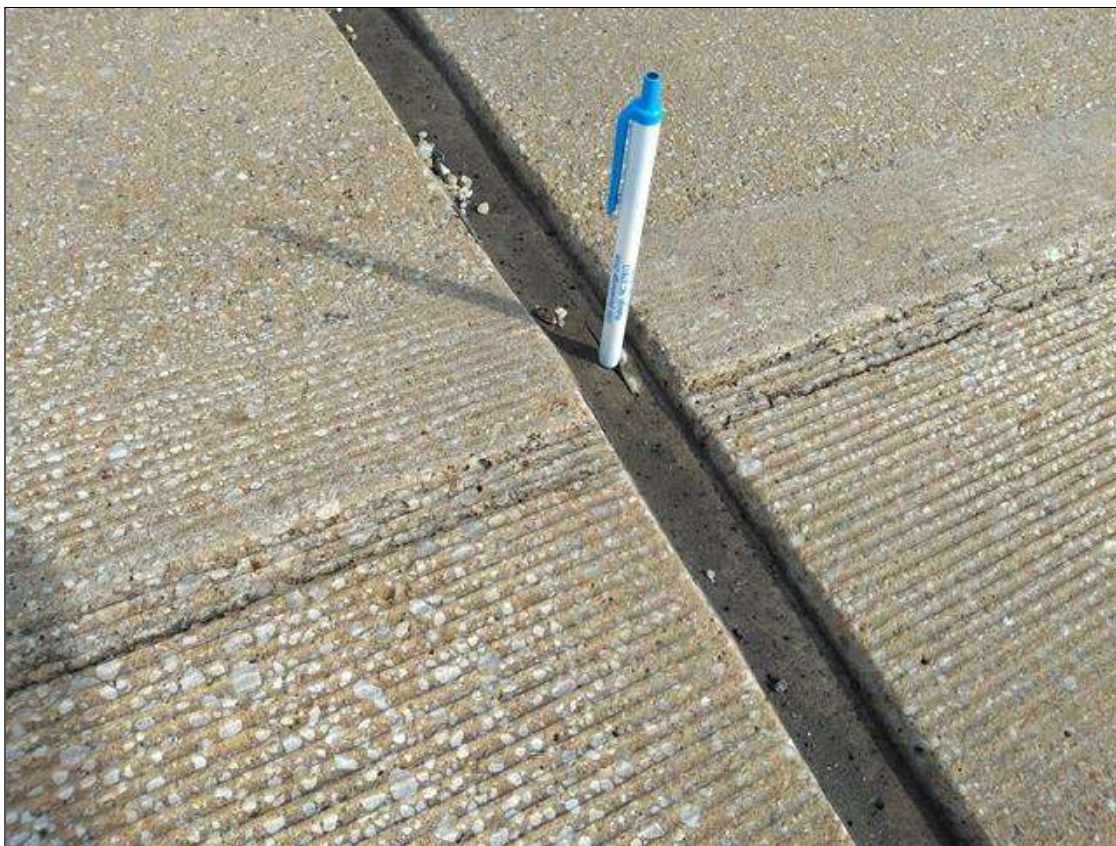
Span 219 Expansion Joint Bent 218: AT BENT 218, PARTIAL DEPTH CRACK AT CENTER 2 INCHES LONG

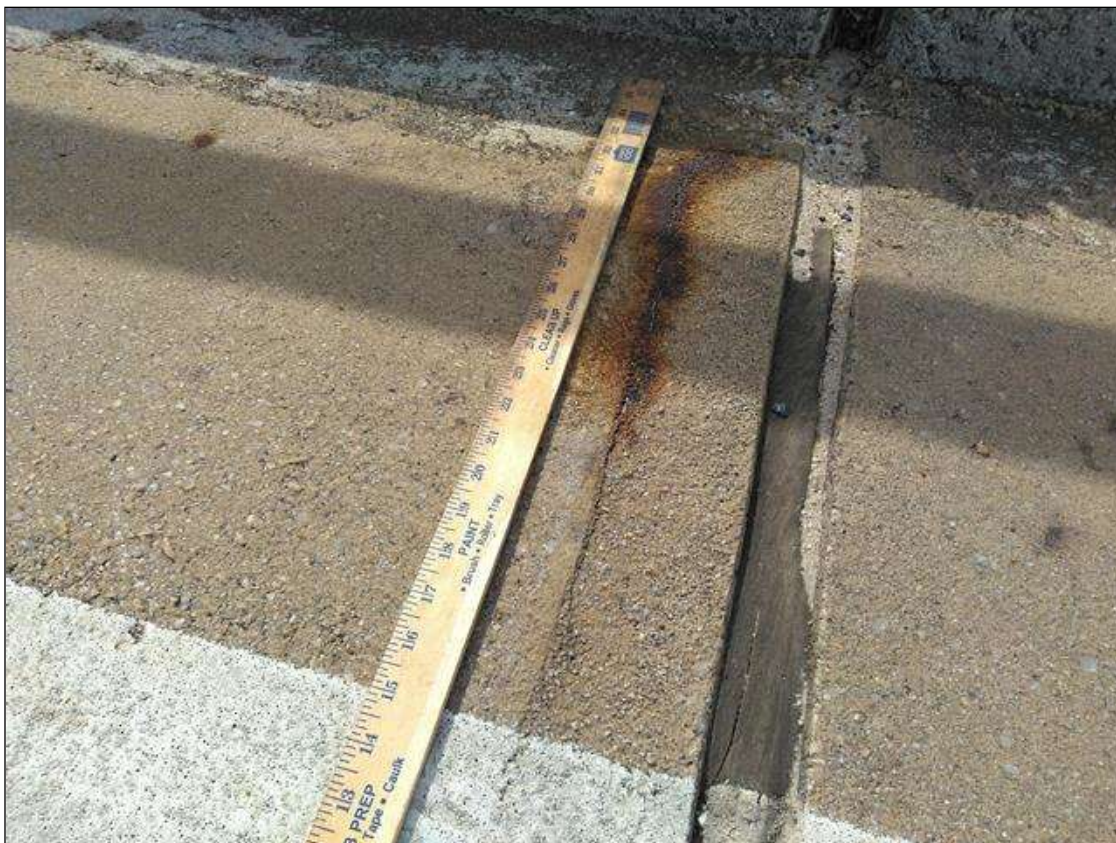
Span 221 Expansion Joint Bent 220: AT BENT 220, RIGHT SHOULDER, UNSOUND PATCH 2 FOOT X 4 INCH WITH RUST STAINING

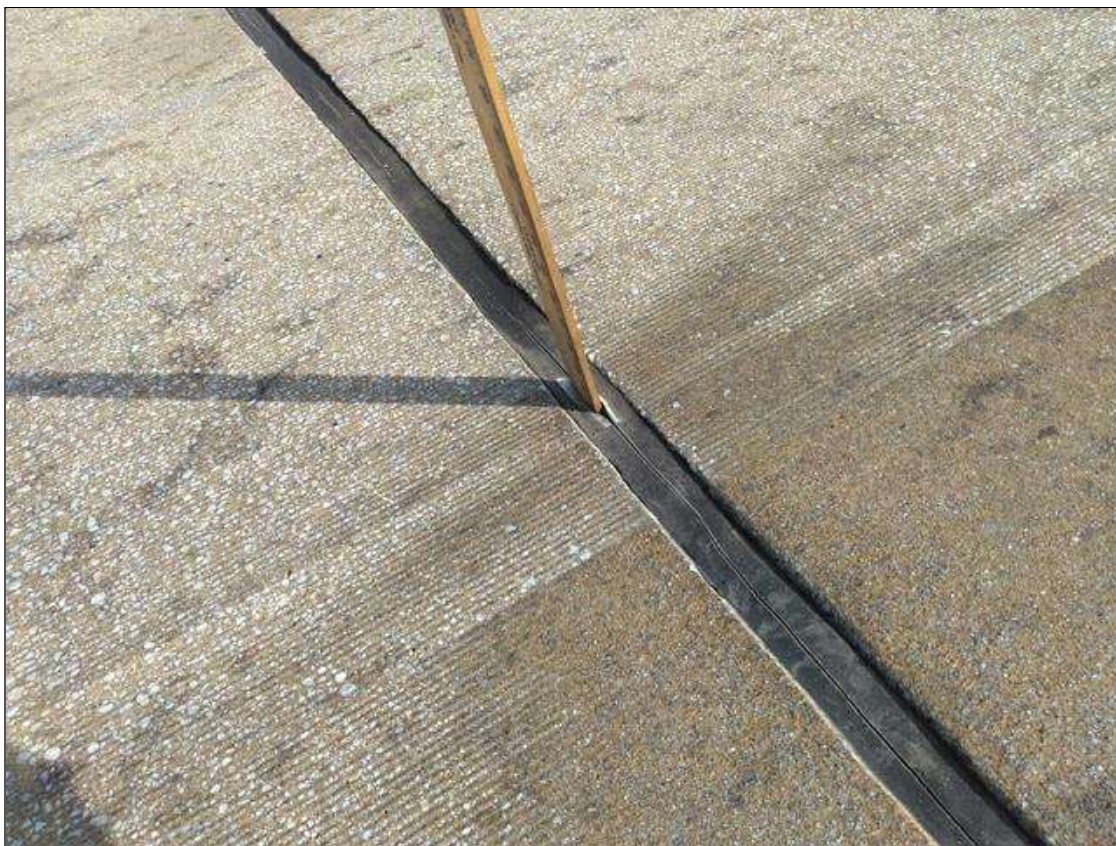
Span 221 Expansion Joint Bent 220: AT BENT 220, INTERMITTENT THROUGHOUT FULL DEPTH CRACK

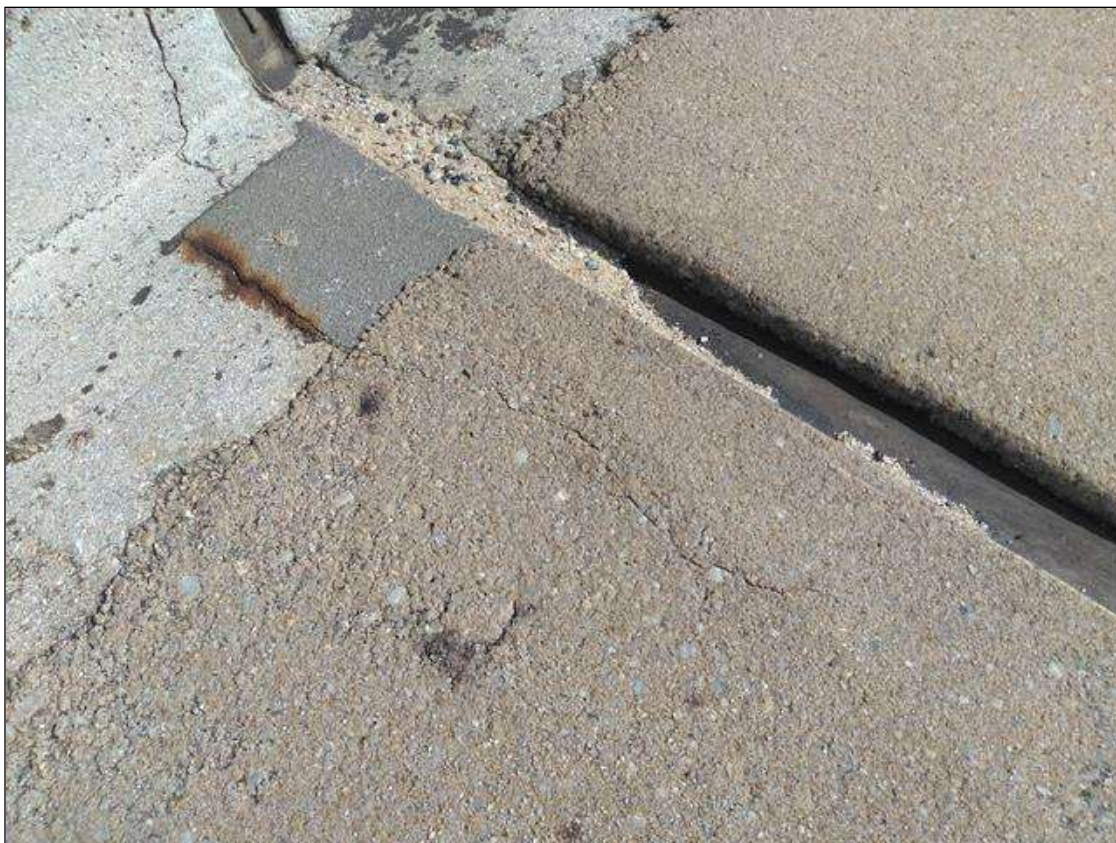
Span 223 Expansion Joint Bent 222: AT BENT 222, LEFT SHOULDER, DELAMINATION WITH RUST STAINING 2 FOOT X 4 INCH

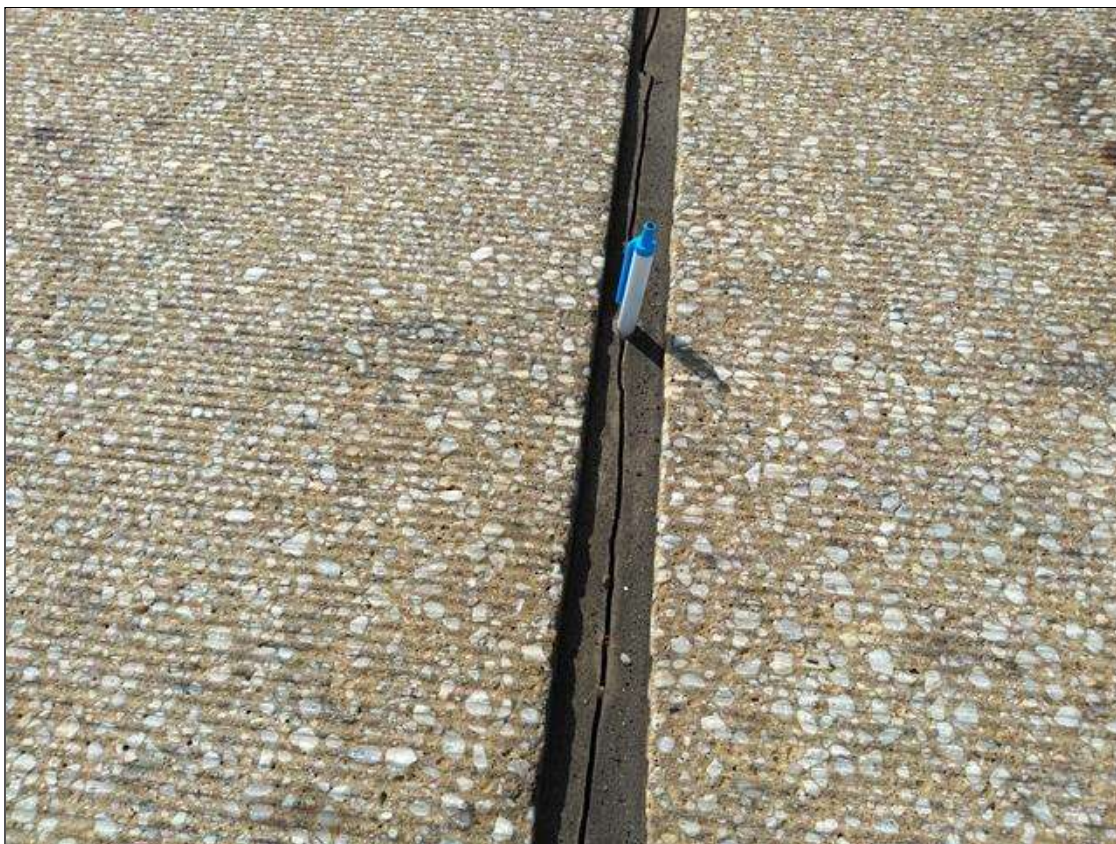
Span 224 Expansion Joint Bent 223: AT BENT 223 FULL DEPTH X FULL WIDTH CRACK

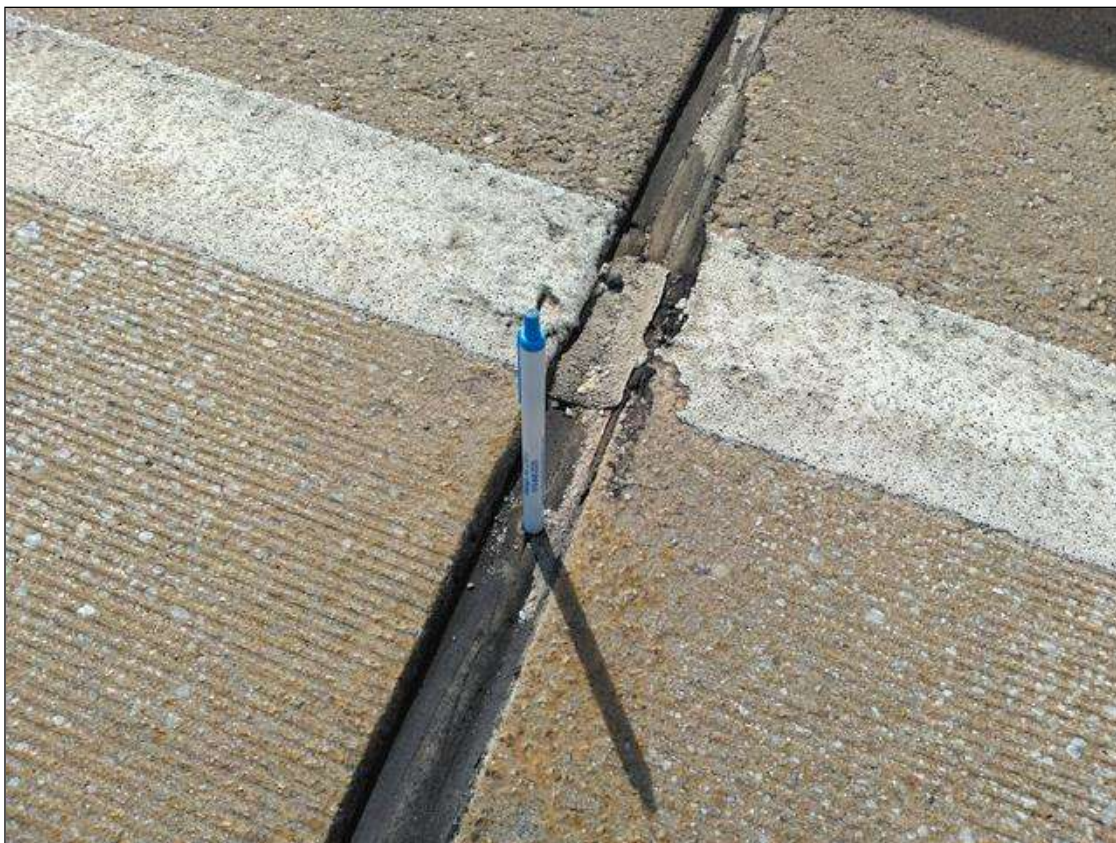
Span 225 Expansion Joint Bent 224: INTERMITTENT PARTIAL DEPTH CRACKING

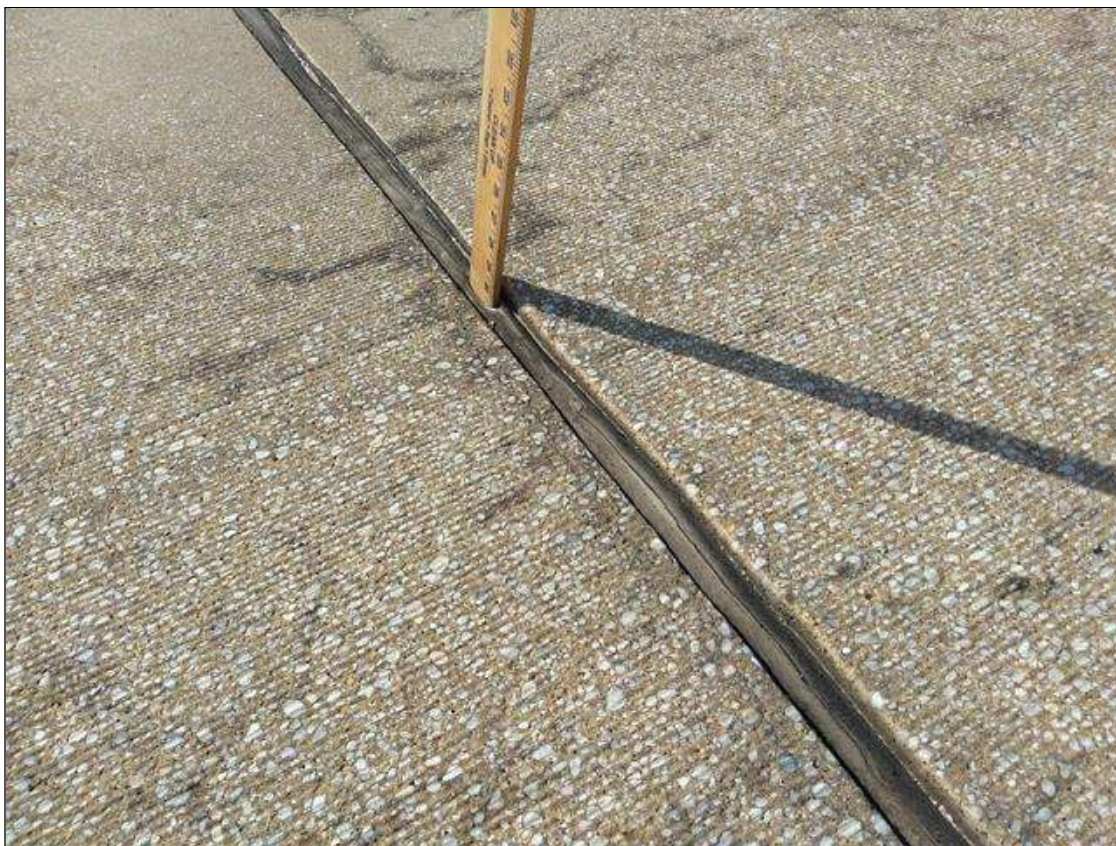
Span 229 Expansion Joint Bent 228: AT BENT 228, FULL WIDTH X FULL DEPTH CRACK

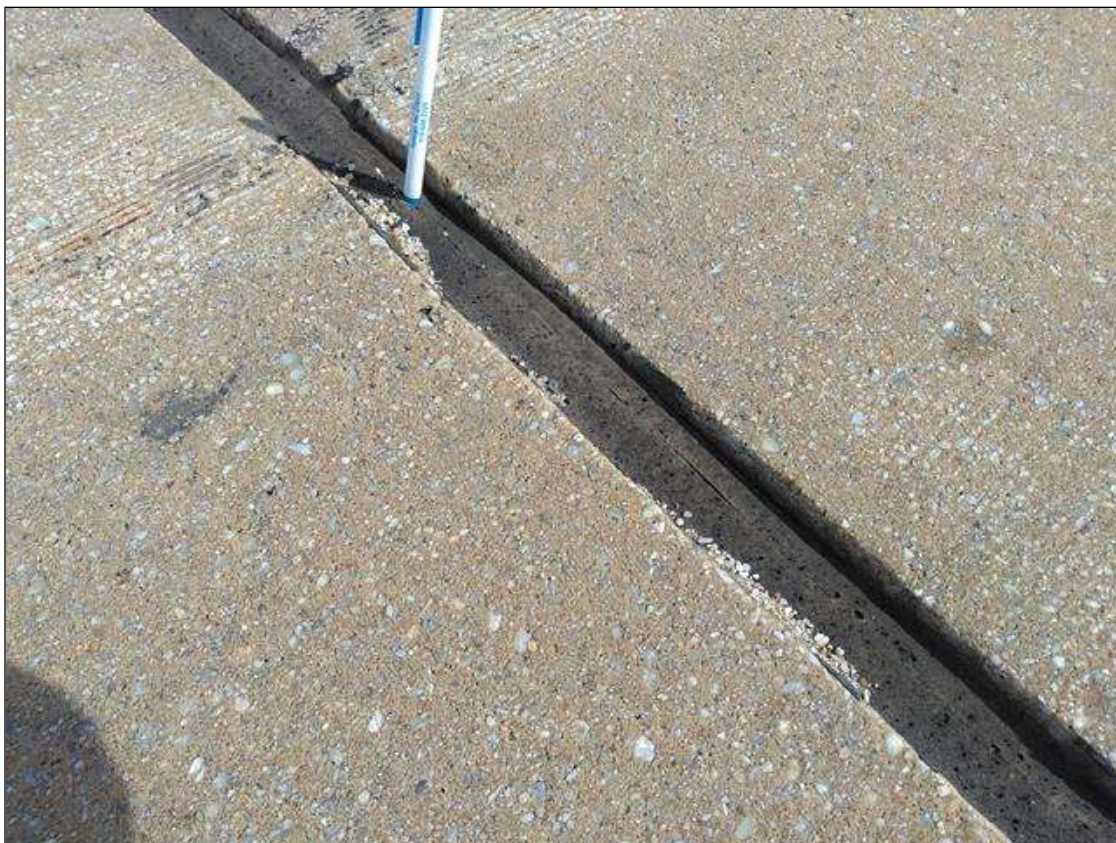
Span 232 Expansion Joint Bent 231: AT BENT 231, AT CENTER 2 FOOT LONG PARTIAL DEPTH CRACK

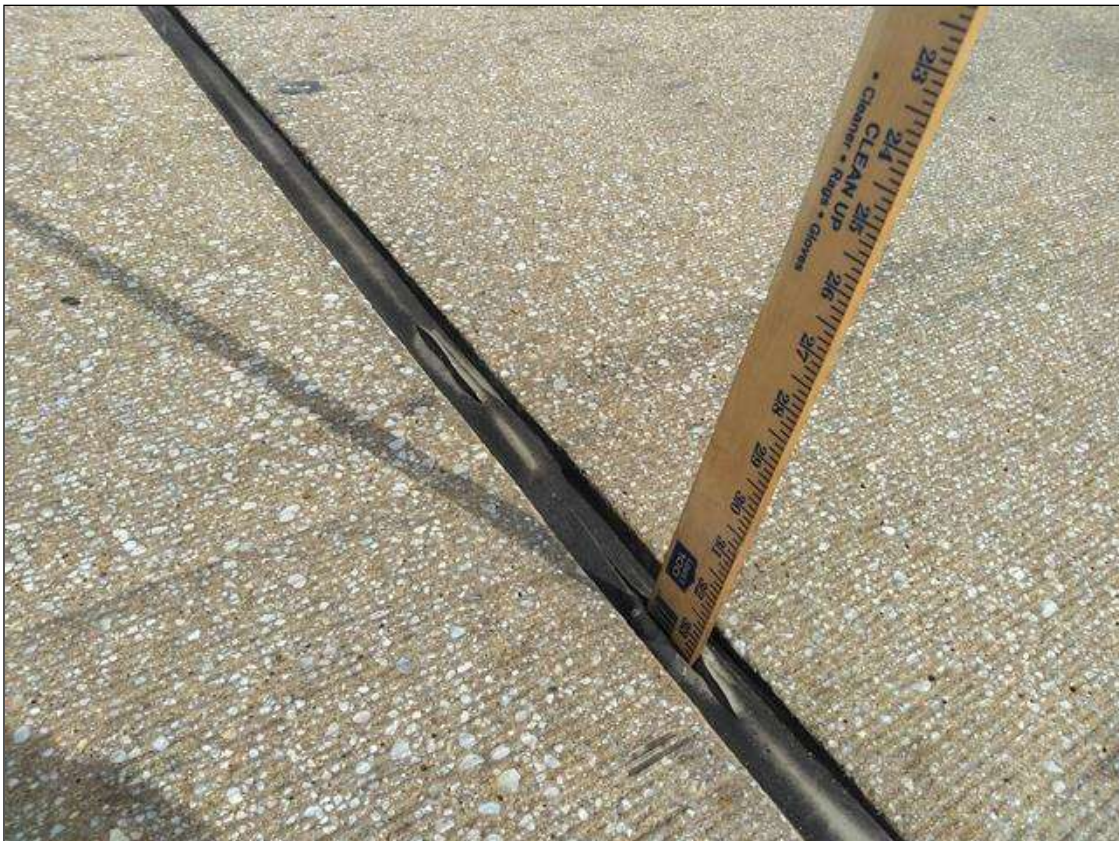
Span 240 Expansion Joint Bent 239: AT BENT 239, INTERMITTENT FULL DEPTH CRACKING THROUGHOUT

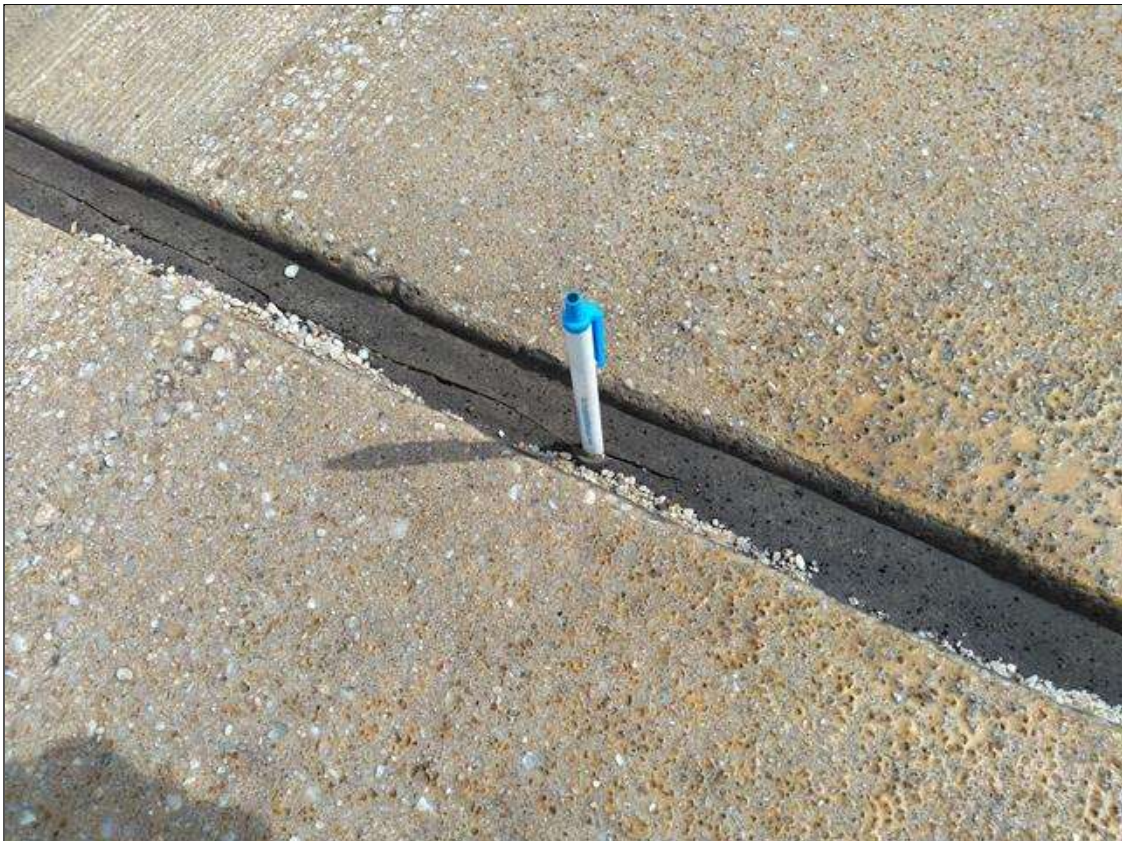
Span 246 Expansion Joint Bent 245: AT BENT 245, INTERMITTENT PARTIAL DEPTH CRACKING THROUGHOUT RIGHT LANE AND LEFT SHOULDER

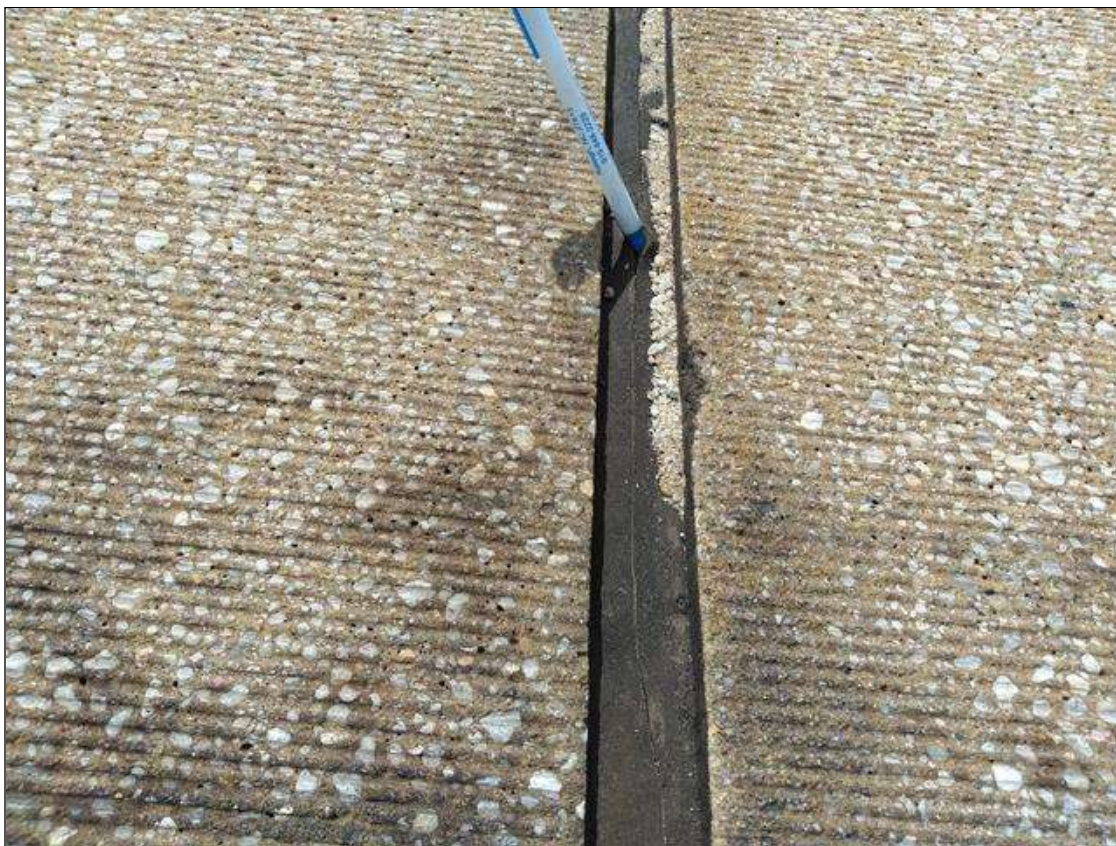
Span 248 Expansion Joint Bent 247: AT BENT 247 INTERMITTENT PARTIAL DEPTH CRACKS THROUGHOUT

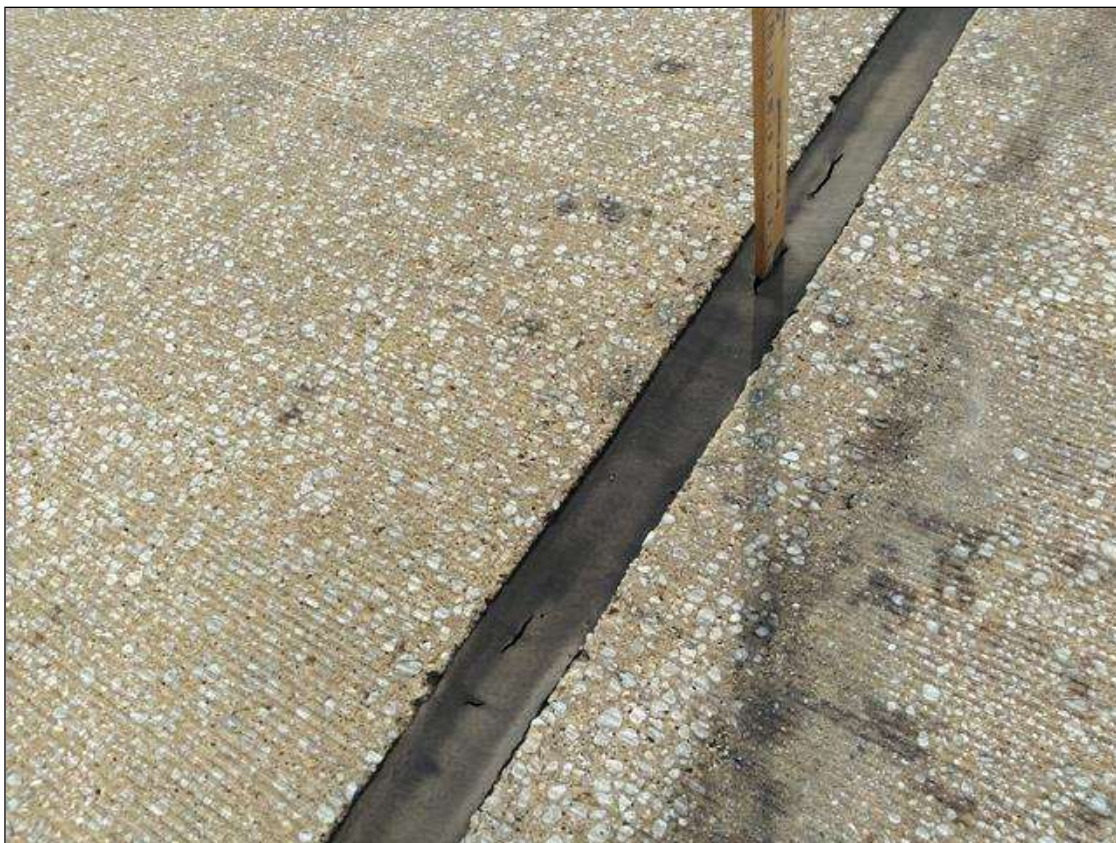
Span 248 Expansion Joint End Bent 2: AT END BENT 2, MULTIPLE FULL DEPTH CRACKS IN LEFT LANE
