NC DEPARTMENT OF TRANSPORTATION  
DIVISION OF HIGHWAYS  
STRUCTURE MANAGEMENT UNIT

## Structure Safety Report

### Routine Element Inspection - Contract

STRUCTURE NUMBER: 260016 SAP STRUCTURE NO: 0270016 FHWA STRUCTURE NO: 000000000530016  
DIVISION: 1 COUNTY: CURRITUCK INSPECTION DATE: 09/21/2022 FREQUENCY: 24 MONTHS  
FACILITY CARRIED: US158E MILE POST: \_\_\_\_\_  
LOCATION: .01 MI.E.JCT.SR1187  
FEATURE INTERSECTED: CURRITUCK SOUND  
LATITUDE: 36° 5' 11.69" LONGITUDE: 75° 46' 0.21"  
SUPERSTRUCTURE: RC FLOOR ON PPC GIRDERS & CORED SLAB  
SUBSTRUCTURE: EBTS:RC CAP/PPC PILES;IBTS:RCP&B & RC CAPS/PPC PILES  
SPANS: 248 SPANS. SEE SPAN PROFILE SHEET FOR SPAN DETAILS  
☐ FRACTURE CRITICAL ☐ TEMPORARY SHORING ☐ SCOUR CRITICAL ☐ SCOUR PLAN OF ACTION  
GRADES: (Inspector/NBI Coding) DECK 6 / 6 SUPERSTRUCTURE 5 / 5 SUBSTRUCTURE 6 / 6 CULVERT N / N  
POSTED SV: Not Posted POSTED TTST: Not Posted  
OTHER SIGNS PRESENT: None

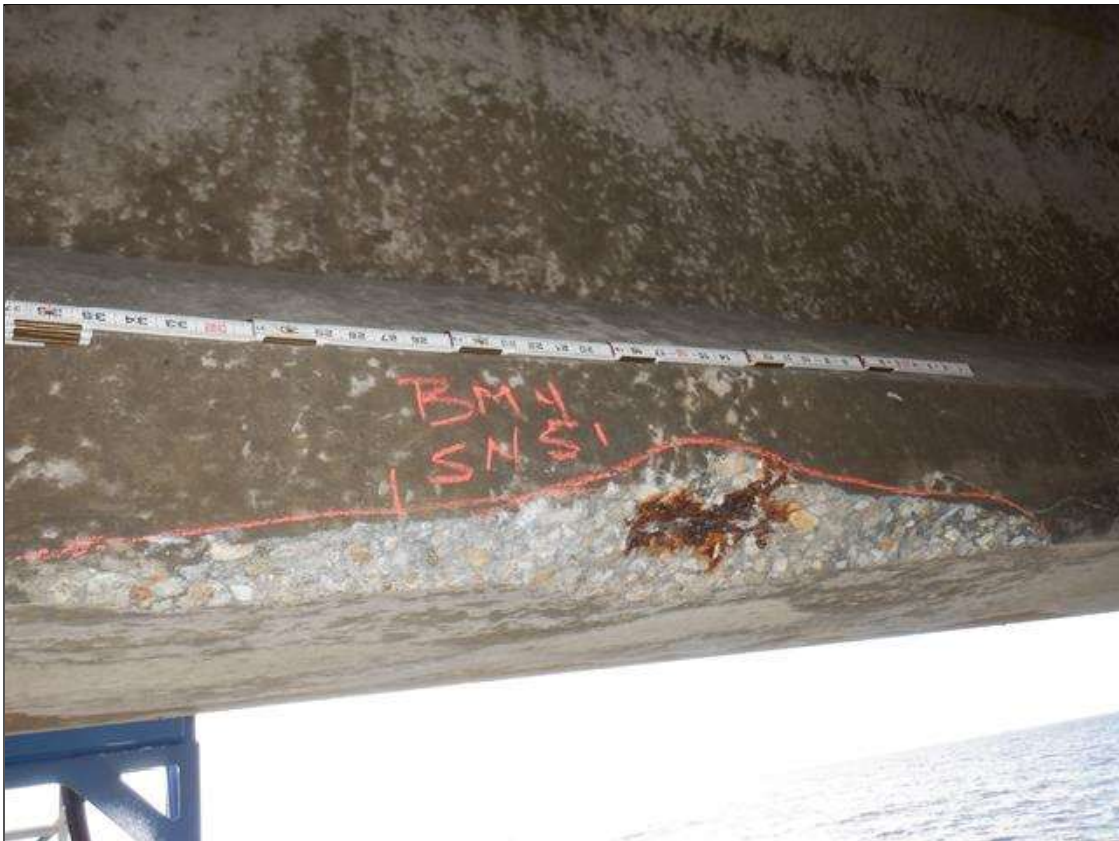
Span 51 Beam 4: (PAR) BOTTOM FLANGE NORTH FACE, 10 FEET FROM BENT 51, SPALL (36 INCHES LONG X 4 INCHES HIGH X 2 INCHES DEEP) WITH EXPOSED RUSTED STRANDS (10 PERCENT SECTION LOSS)

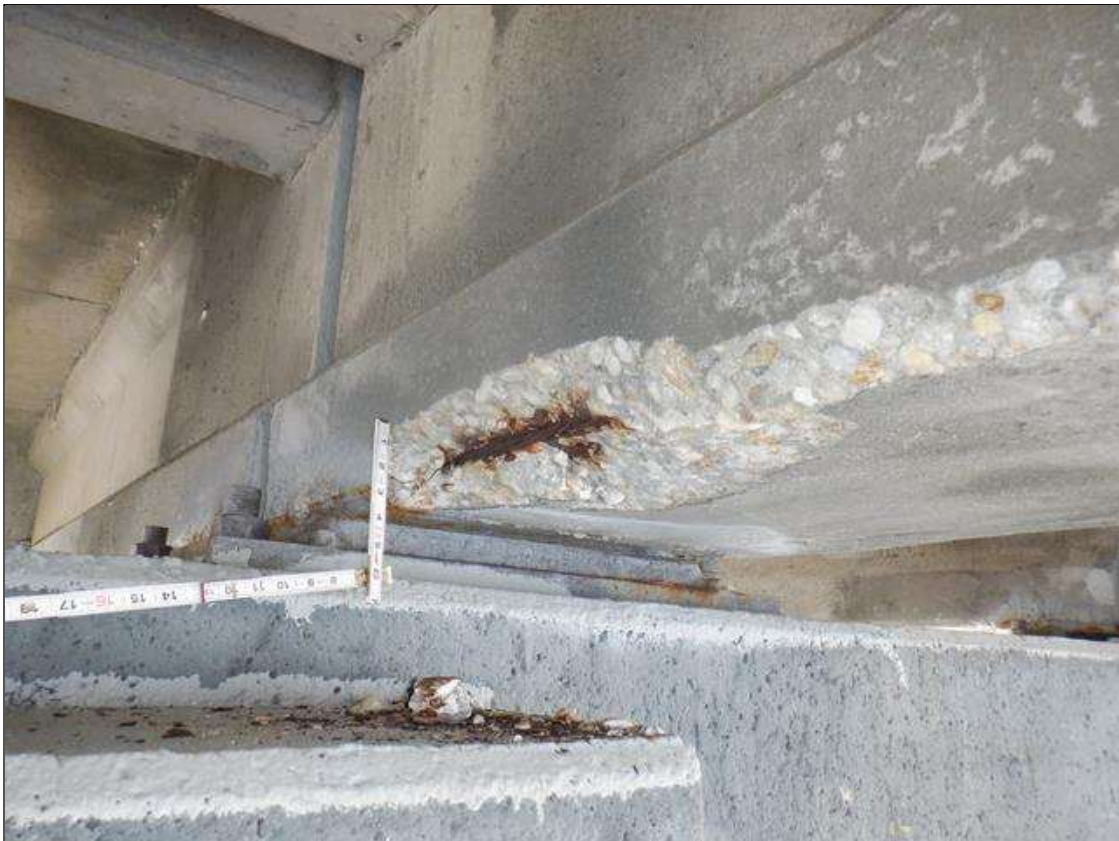
Span 52 Beam 2: (PAR) NORTH FACE OF BOTTOM FLANGE AT 1FEET FROM BENT 52, SPALL (29INCHES X UP TO 6INCHES X 2IN) WITH EXPOSED STRAND (10 PERCENT SECTION LOSS)

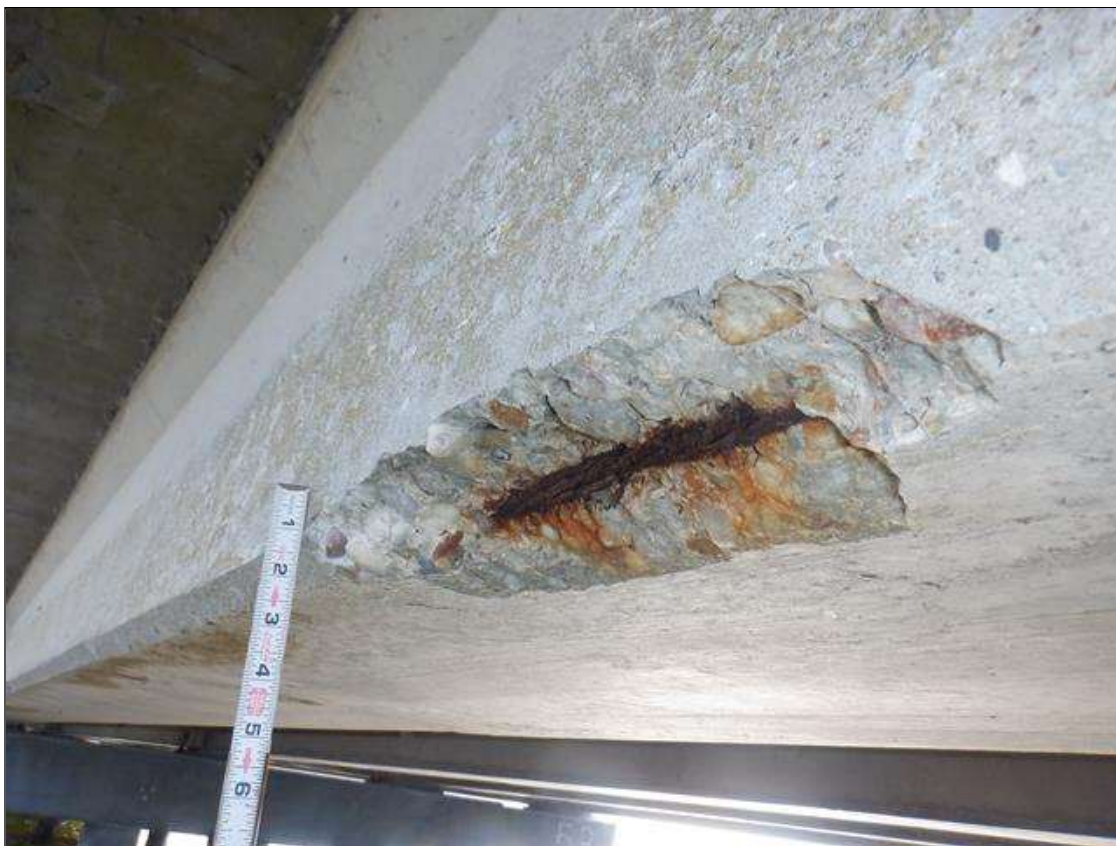
Span 53 Beam 1: (PAR) NORTH FACE OF BOTTOM FLANGE, AT 22FEET FROM BENT 52, SPALL (15INCHES X 4INCHES X 2 INCHES) WITH EXPOSED RUSTED STRAND, SECTION LOSS (20 PERCENT)

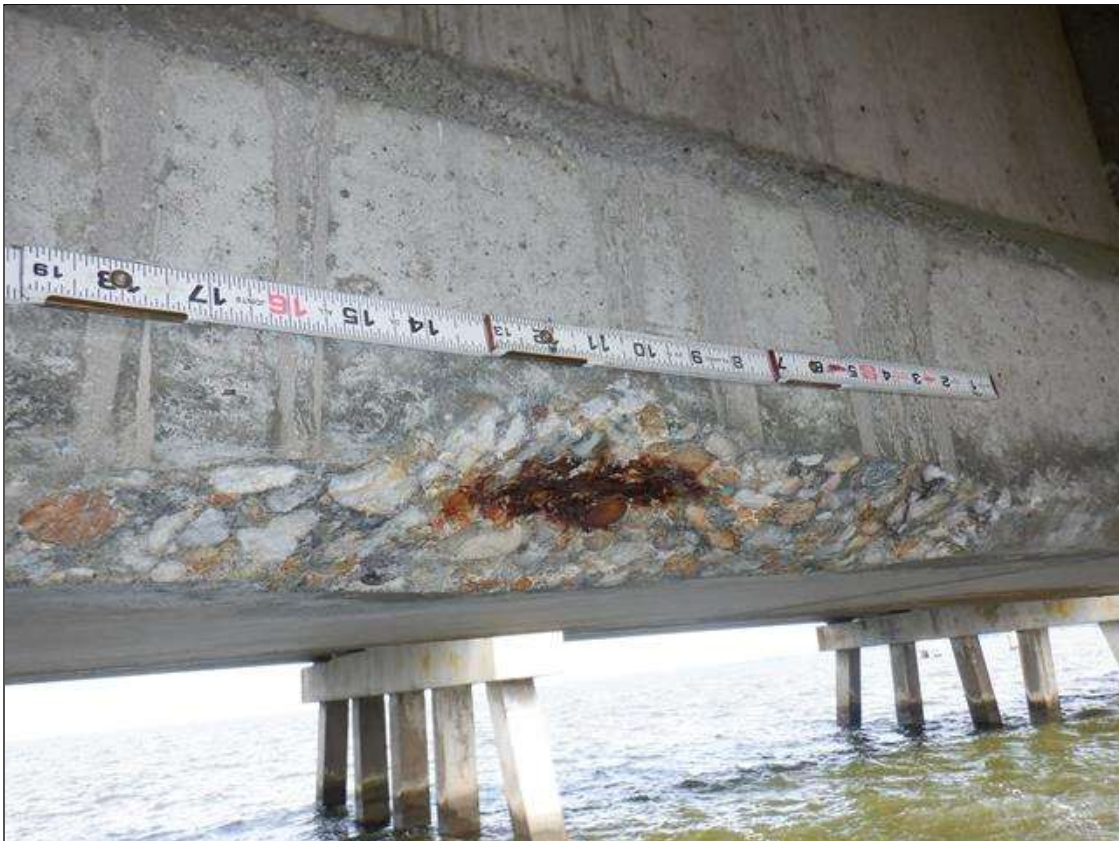
Span 67 Beam 1: (PAR) BOTTOM FLANGE SOUTH FACE AT 20 FEET FROM BENT 67, SPALL (18 INCHES LONG X 3 INCHES HIGH X UP TO 2 INCHES DEEP) WITH EXPOSED RUSTED STRANDS (10 PERCENT SECTION LOSS)

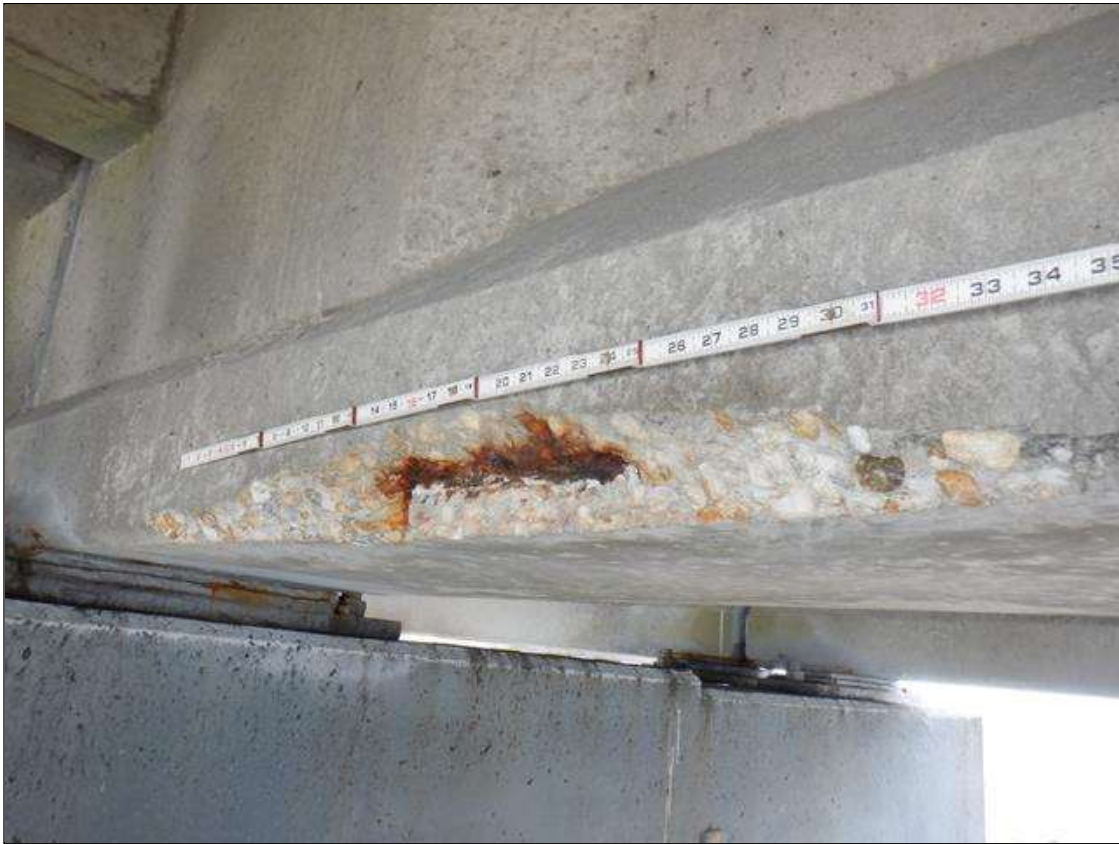
Span 67 Beam 2: (PAR) BOTTOM FLANGE SOUTH FACE AT 2 FEET FROM BENT 67, SPALL (36 INCHES LONG X 4 INCHES HIGH X 2 INCHES DEEP) WITH EXPOSED RUSTED STRANDS (10 PERCENT SECTION LOSS)

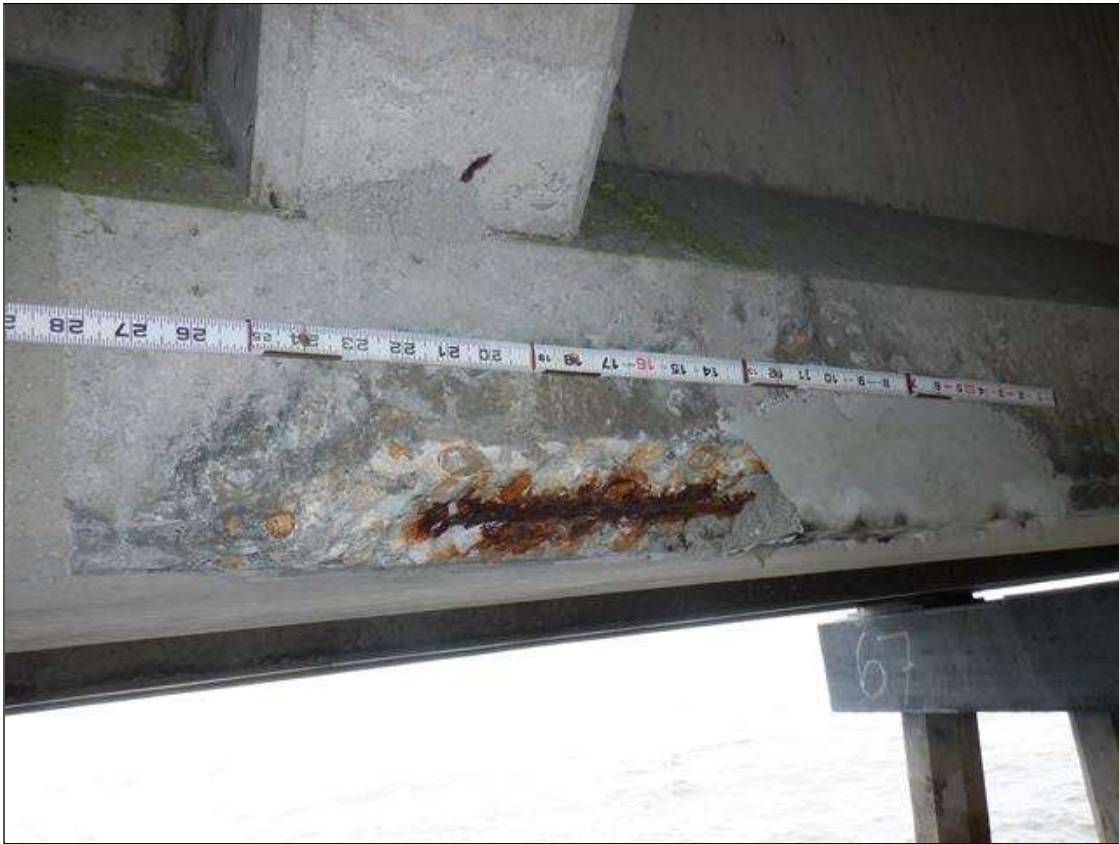
Span 68 Beam 2: (PAR) BOTTOM FLANGE NORTH FACE, 12 FEET FROM BENT 67, FAILED PATCH/SPALL (24 INCHES LONG X 4 INCHES HIGH X 2 INCHES DEEP) WITH EXPOSED RUSTED STRANDS (25 PERCENT SECTION LOSS)

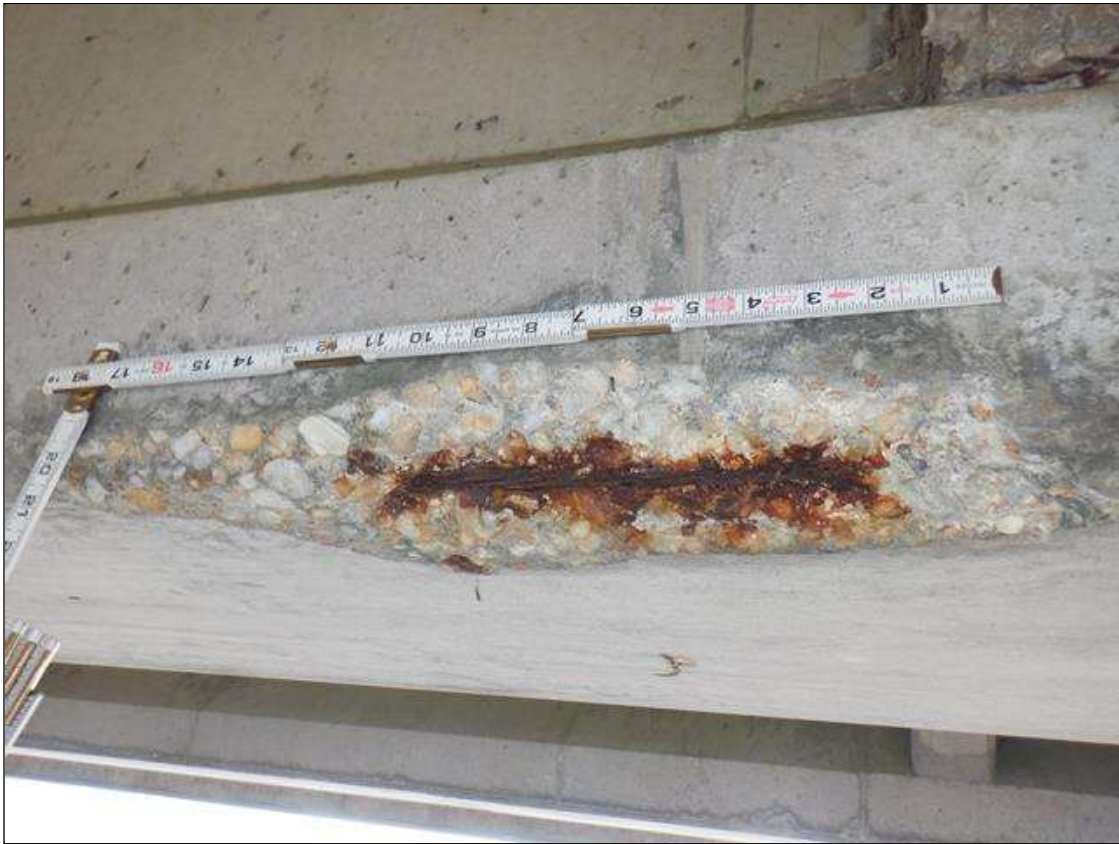
Span 69 Beam 2: (PAR) NORTH FACE OF BOTTOM FLANGE, AT 20 FEET FROM BENT 68, SPALL (16 INCHES X 3 INCHES X 2 INCHES) WITH EXPOSED STRANDS (30 PERCENT SECTION LOSS) ON STRAND

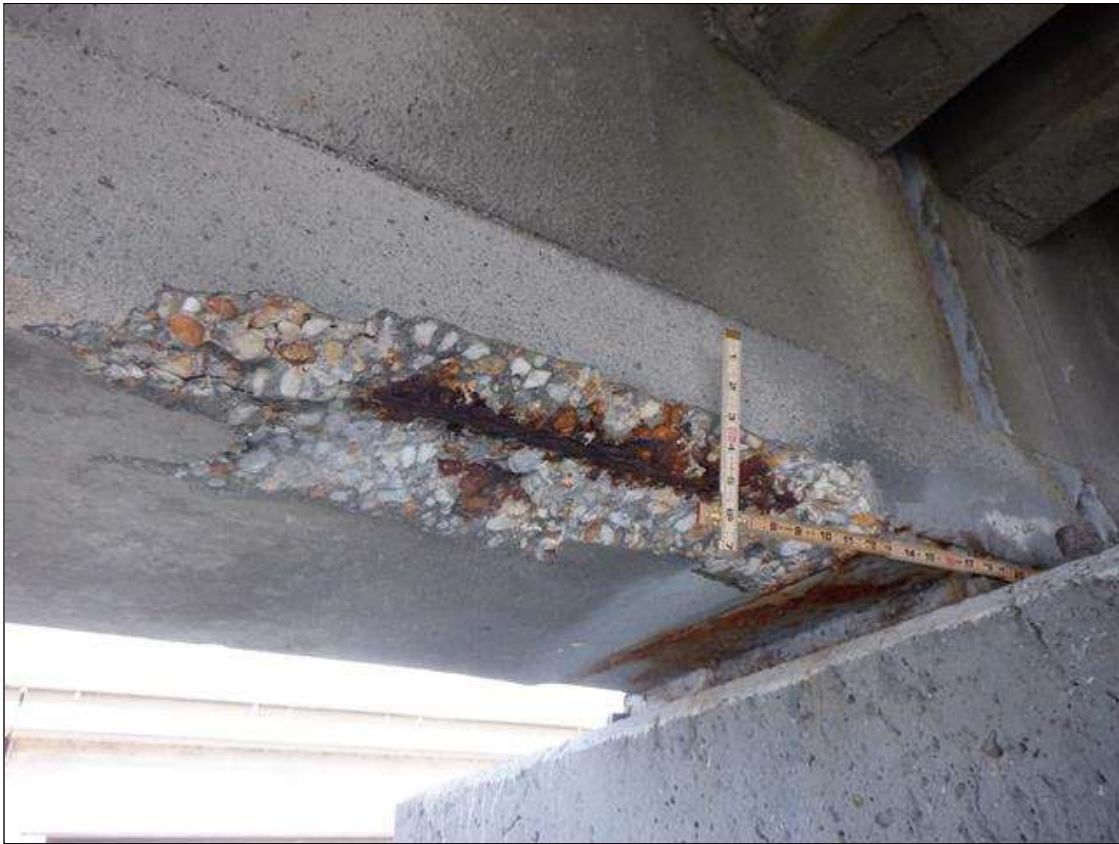
Span 111 Beam 1: (PAR) SOUTH FACE OF BOTTOM FLANGE AT BENT 111, DELAMINATION (20 INCHES X 3 INCHES) SOUTH FACE OF BOTTOM FLANGE AT BENT 111, SPALL (28 INCHES LONG X 4 INCHES HIGH X 8 INCHES ON BOTTOM X 1 1/2 INCHES DEEP) WITH (2) EXPOSED AND SEVERED STRANDS

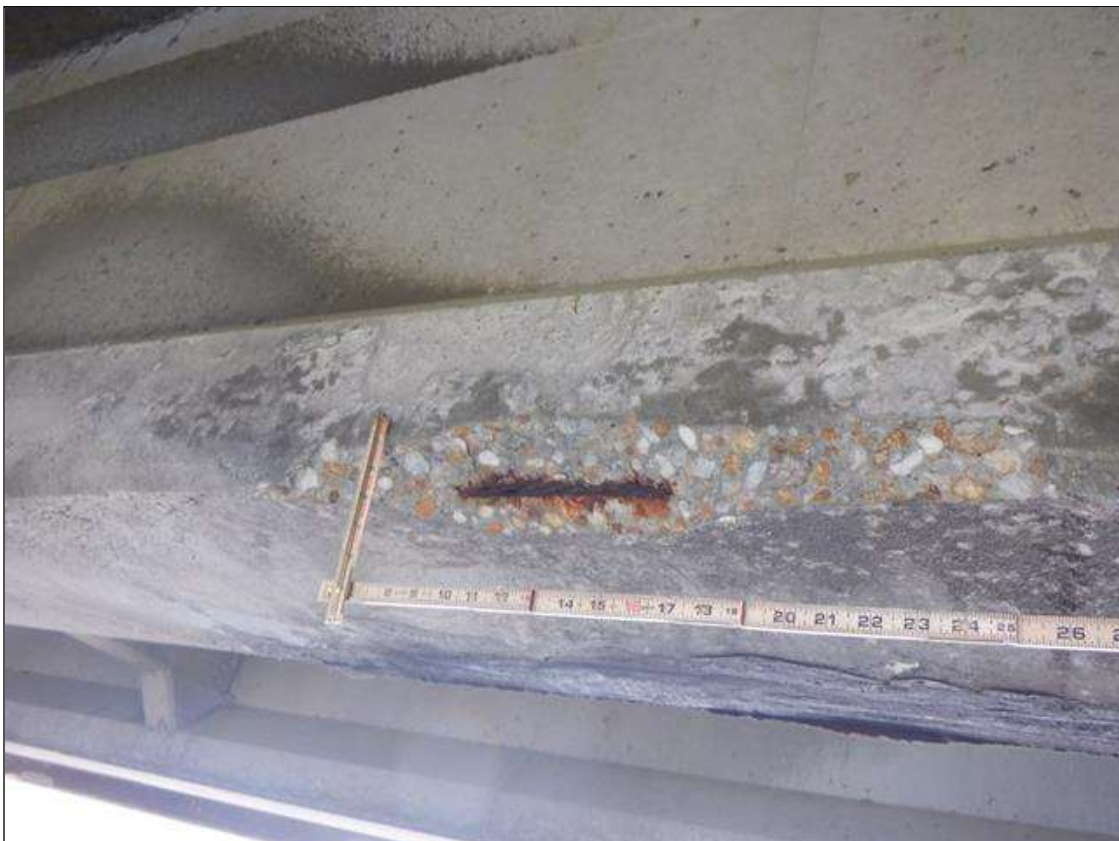
Span 114 Beam 2: (PAR) NORTH FACE OF BOTTOM FLANGE AT MIDSPAN, SPALL (26 INCHES LONG X 3 INCHES HIGH X 2 INCHES DEEP) WITH (1) EXPOSED STRAND (5 PERCENT LOSS)

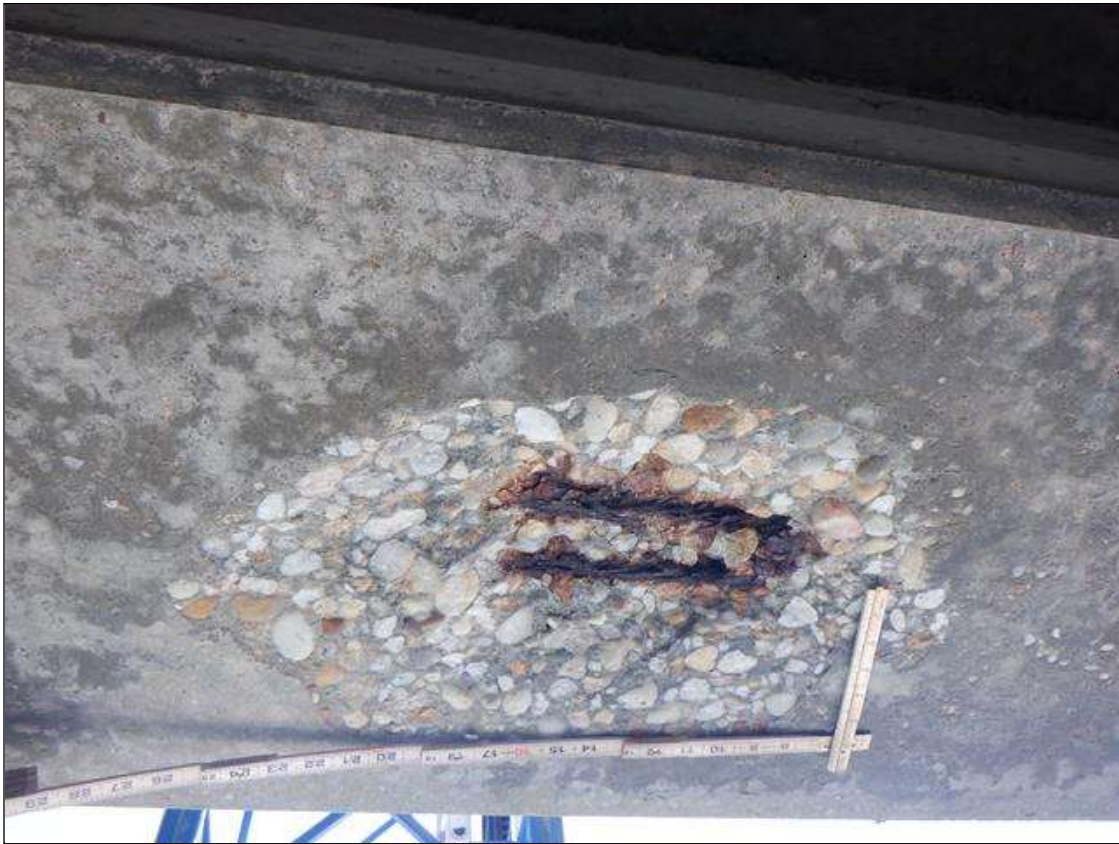
Span 112 Beam 4: (PAR) UNDERSIDE OF BOTTOM FLANGE 23 FEET FROM BENT 112, SPALL (20 INCHES LONG X 12 INCHES WIDE X 1 1/2 INCHES DEEP WITH (2) EXPOSED AND SEVERED STRANDS (10 PERCENT SECTION LOSS)

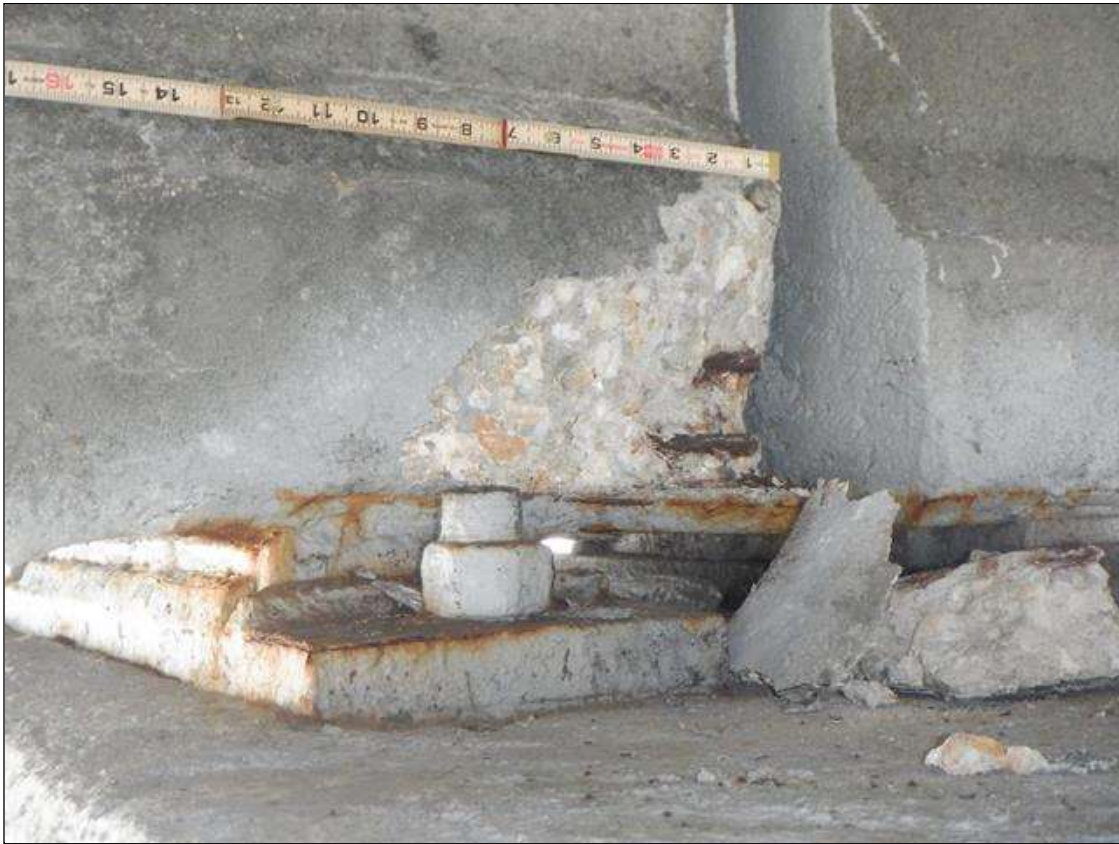
Span 101 Beam 3: (PAR) NORTH FACE OF BOTTOM FLANGE AT BENT 101, SPALL (11 INCHES LONG X 8 INCHES HIGH X 2 1/2 INCHES DEEP WITH (2) EXPOSED STRANDS (NO LOSS)

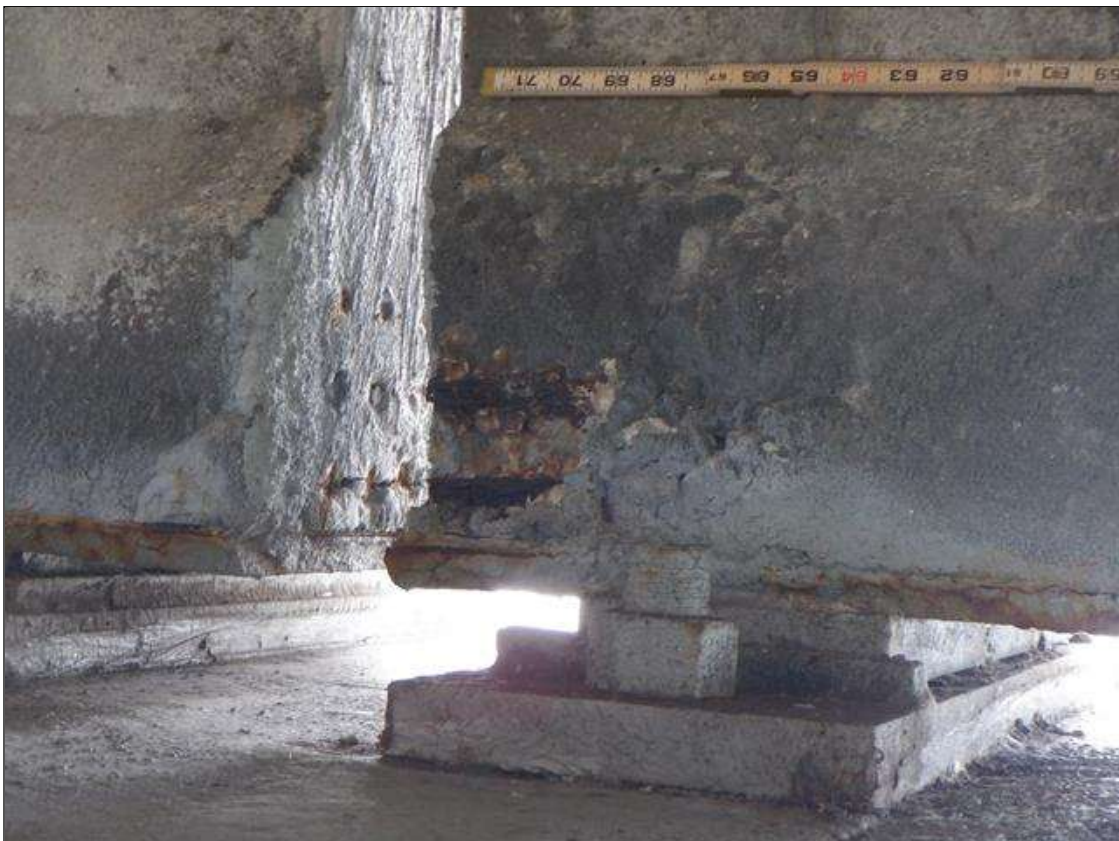
Span 102 Beam 4: (PAR) NORTH FACE OF BOTTOM FLANGE AT BENT 102, SPALL (10 INCHES LONG X 7 INCHES HIGH X 2 INCHES DEEP WITH (2) EXPOSED STRANDS (NO LOSS)

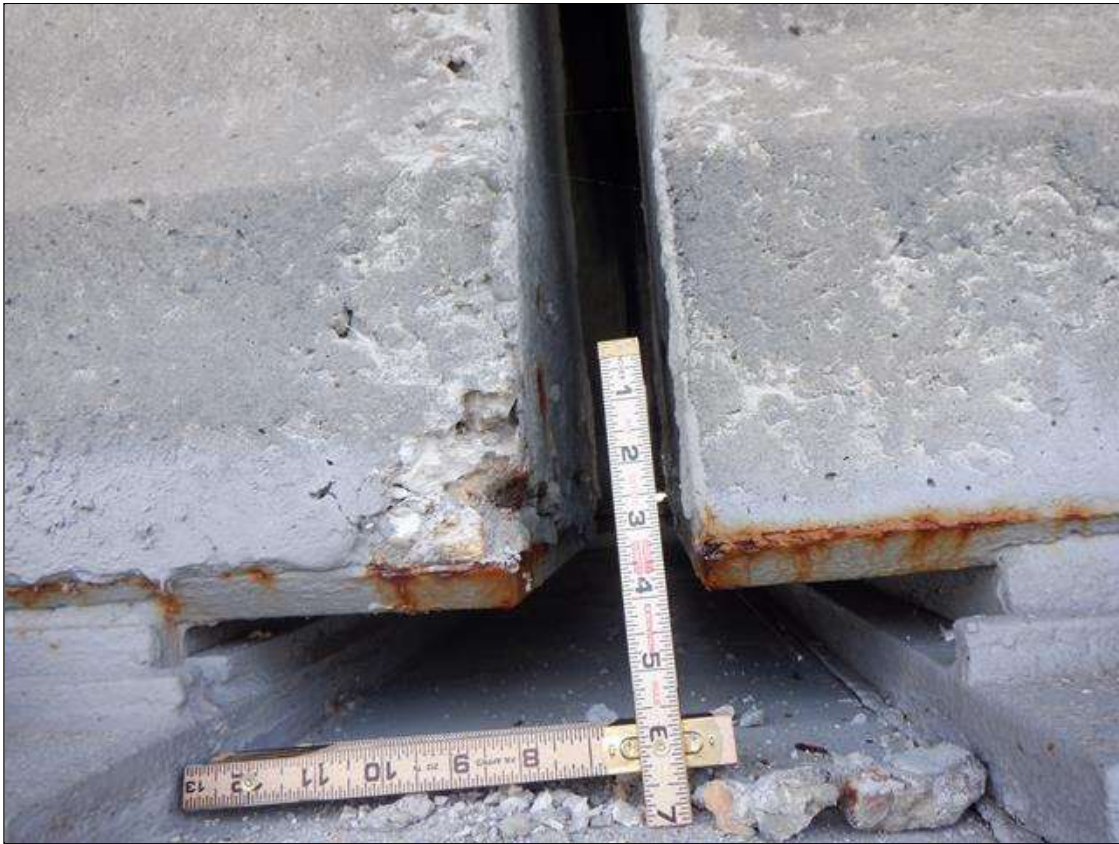
Span 103 Beam 1: (PAR) SOUTH FACE OF BOTTOM FLANGE AT BENT 103, SPALL (3 INCHES LONG X 3 INCHES HIGH X 2 INCHES DEEP WITH (1) EXPOSED STRAND (NO LOSS)

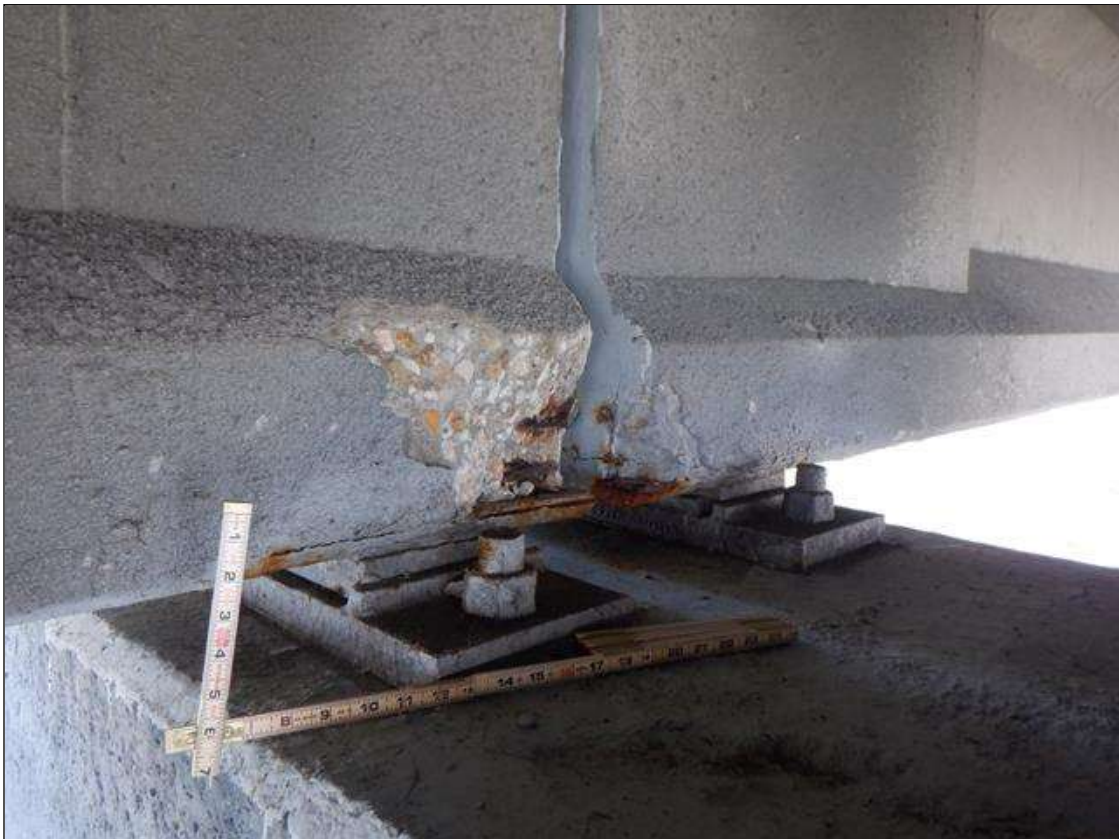
Span 109 Beam 1: (PAR) SOUTH FACE OF BOTTOM FLANGE AT BENT 109, SPALL (12 INCHES X 7 INCHES X 2.5 INCHES) WITH EXPOSED STRANDS (5 PERCENT SECTION LOSS) ON STRANDS

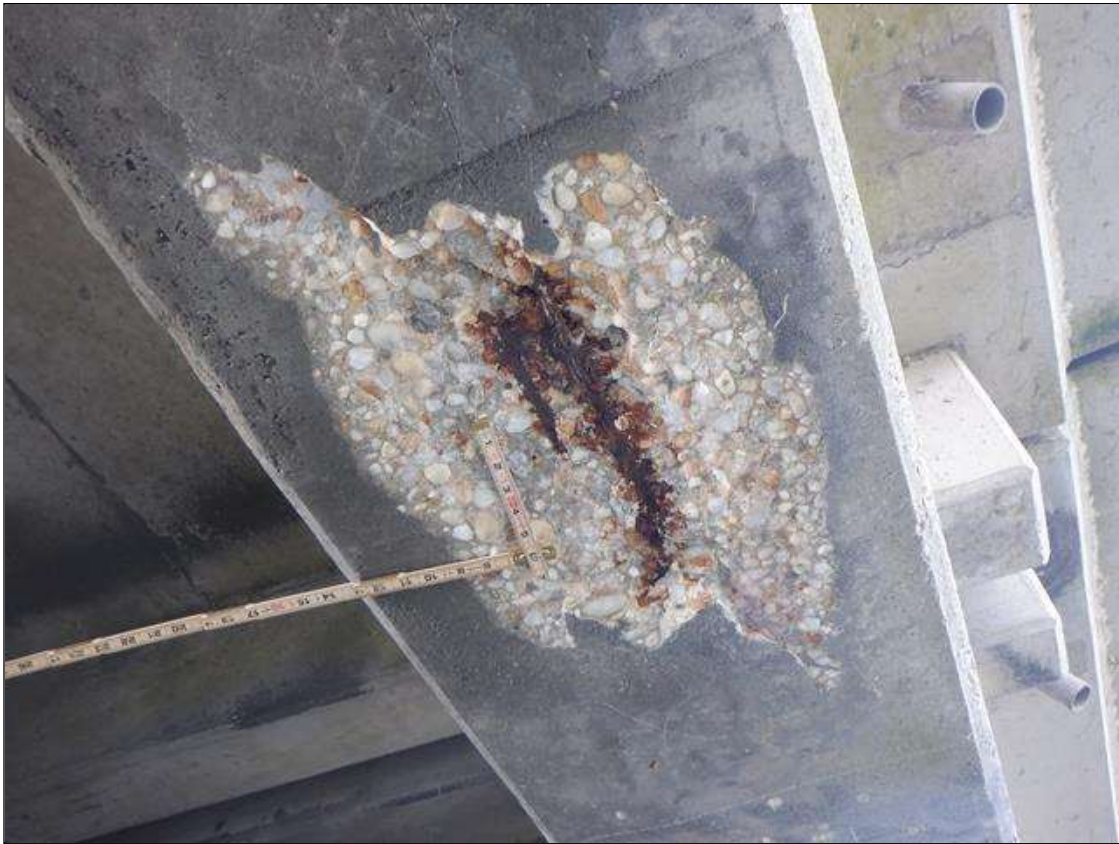
Span 104 Beam 1: (PAR) UNDERSIDE OF BOTTOM FLANGE 4 FEET FROM BENT 103, SPALL (66 INCHES X 14 INCHES X 1.5 INCHES) WITH EXPOSED STRANDS AND (1) BROKEN STRAND

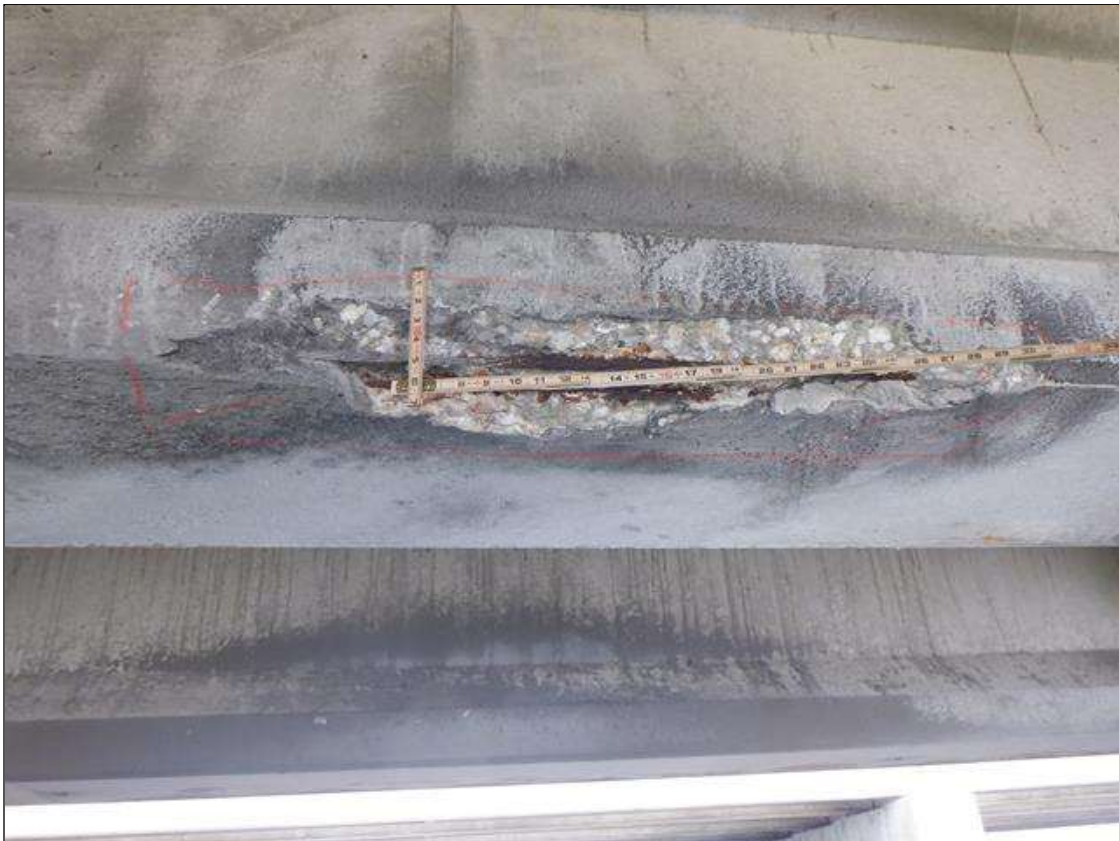
Span 104 Beam 2: (PAR) SOUTH FACE OF BOTTOM FLANGE NEAR MIDSPAN, SPALL (42 INCHES X 4 INCHES X 9 INCHES ON BOTTOM X 2 INCHES DEEP WITH (2) EXPOSED AND BROKEN STRANDS

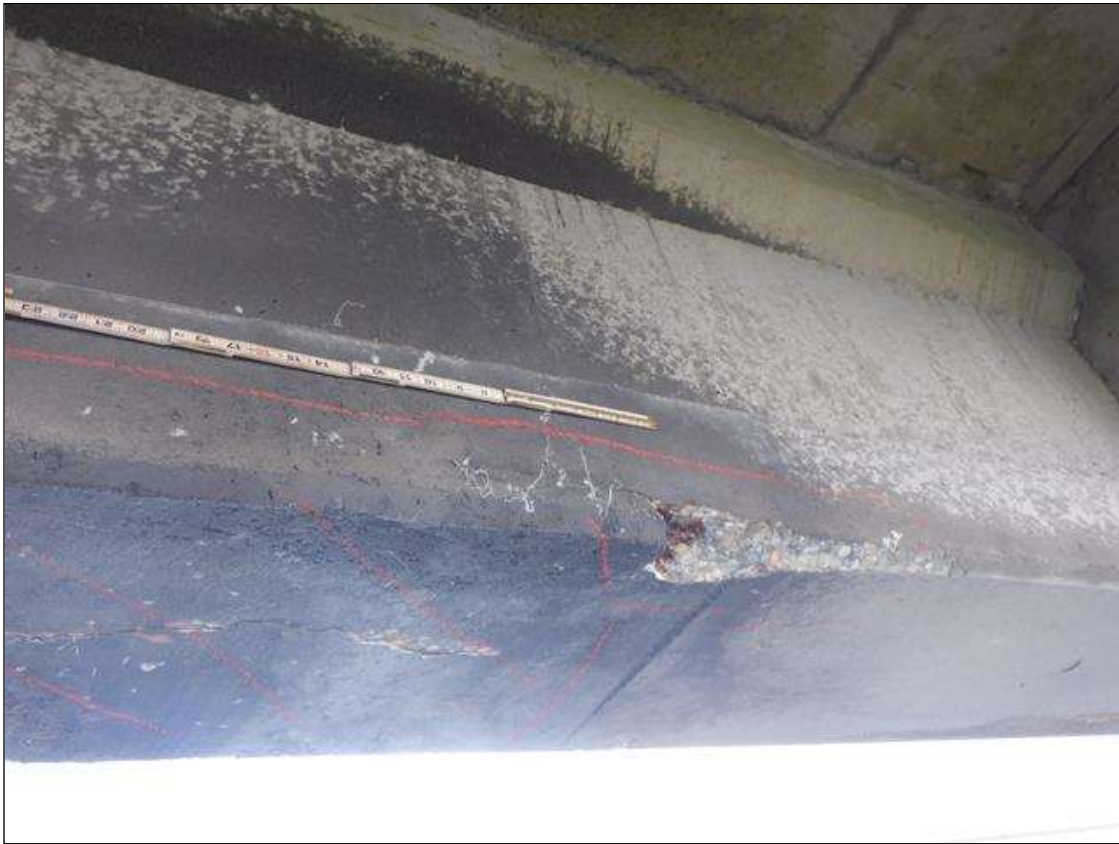
Span 104 Beam 3: (PAR) NORTH FACE OF BOTTOM FLANGE NEAR MIDSPAN, SPALL (40INCHES X 3INCHES X 12 INCHES ON BOTTOM X 2 INCHES DEEP) WITH (2) EXPOSED RUSTED STRANDS

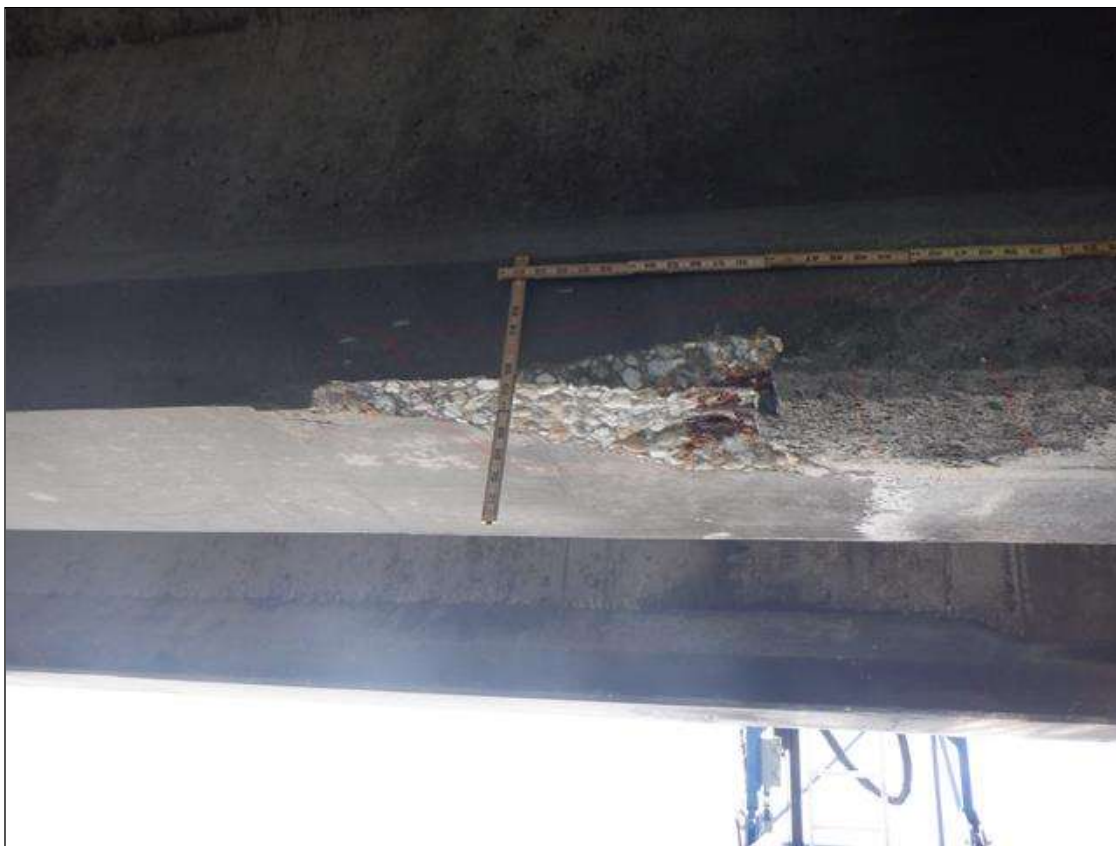
Span 104 Beam 3: UNDERSIDE OF BOTTOM FLANGE 6FEET FROM BENT 103, DELAMINATION/SPALL (48INCHES LONG X 5 INCHES HIGH X 11 INCHES ON BOTTOM X 1.5 INCHES DEEP) WITH (3) EXPOSED STRANDS (NO LOSS)

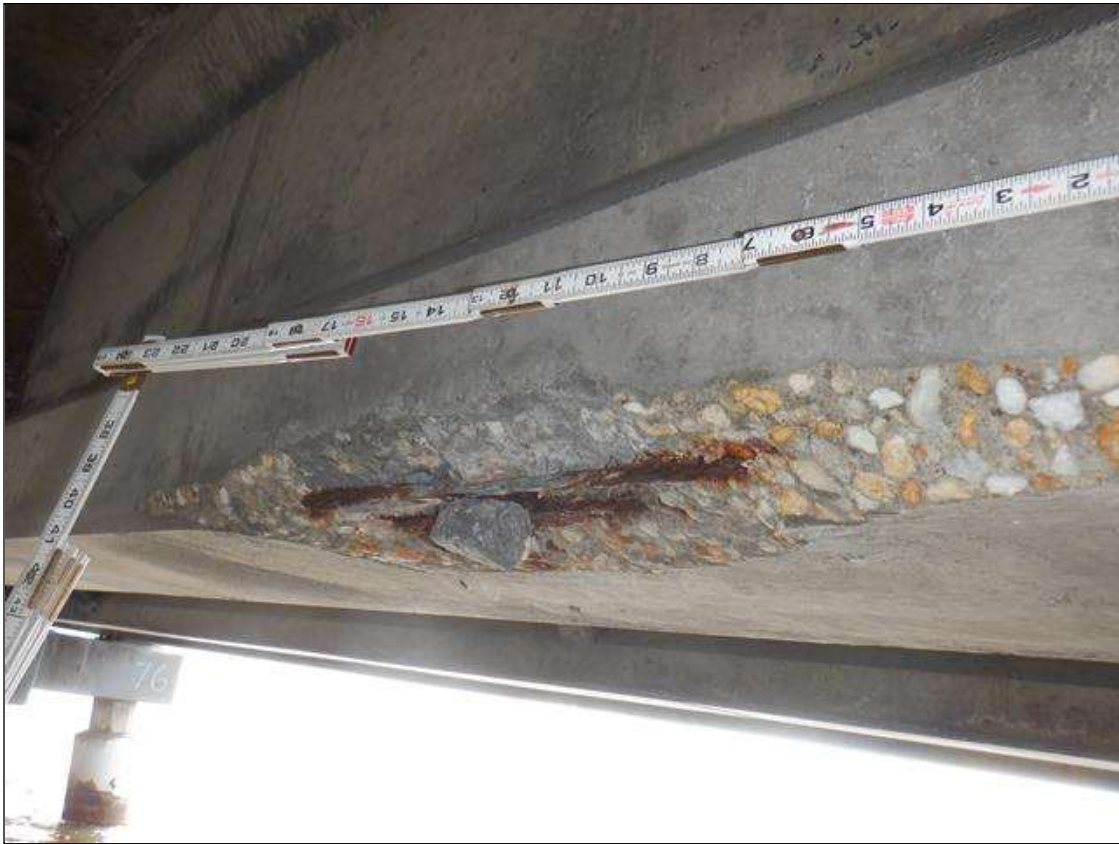
Span 76 Beam 2: (PAR) NORTH FACE OF BOTTOM FLANGE, AT 12 FEET FROM BENT 75, FAILED PATCH/SPALL (36 INCHES X 3 INCHES X 1 INCHES) WITH EXPOSED STRANDS (50 PERCENT SECTION LOSS)

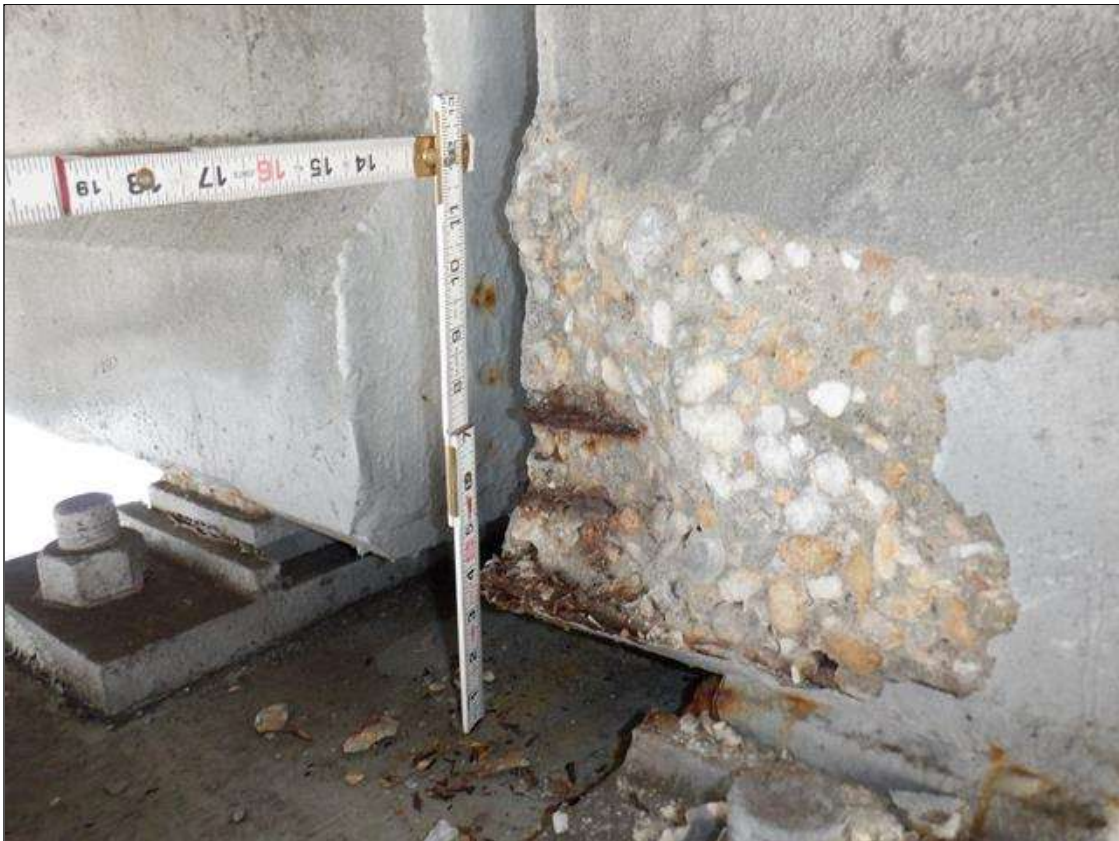
Span 76 Beam 2: (PAR) BOTTOM FLANGE SOUTH FACE AT BENT 75, SPALL (10 INCHES X 8 INCHES X 2 INCHES DEEP) WITH EXPOSED RUSTED STRANDS (10 PERCENT SECTION LOSS)

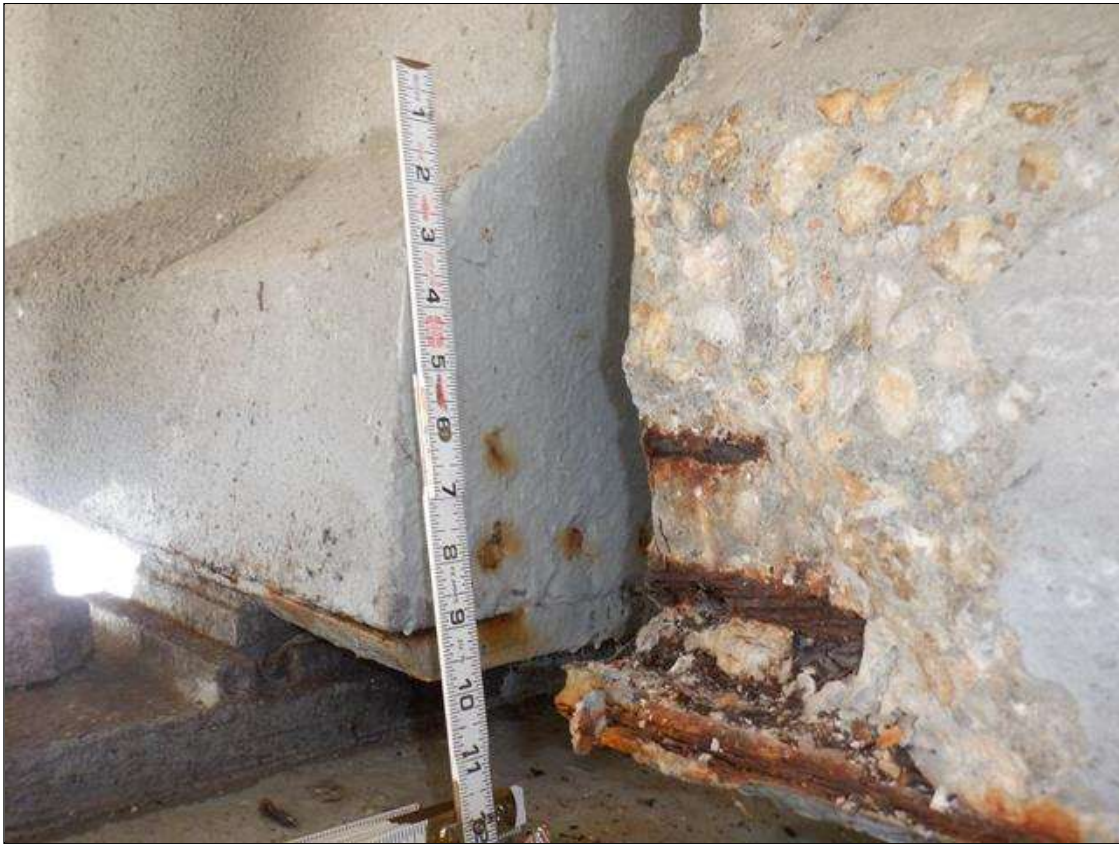
Span 77 Beam 3: (PAR) NORTH FACE OF BOTTOM FLANGE, AT BENT 77, SPALL (6 INCHES X 8 INCHES X 2 INCHES) WITH EXPOSED STRANDS (10 PERCENT SECTION LOSS)

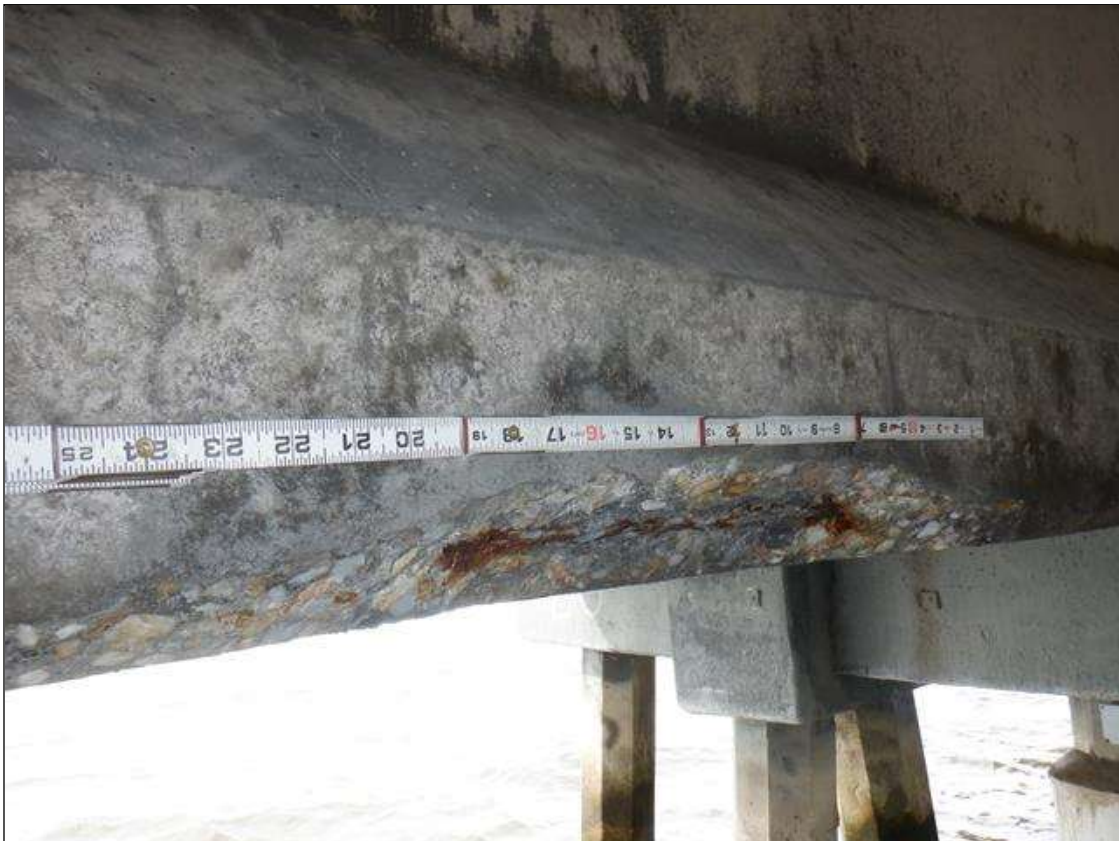
Span 81 Beam 2: (PAR) BOTTOM FLANGE NORTH FACE AT 16 FEET FROM BENT 80, FAILED PATCH/SPALL (24 INCHES X 4 INCHES X 2 INCHES DEEP) WITH EXPOSED RUSTED STRANDS (30 PERCENT SECTION LOSS)

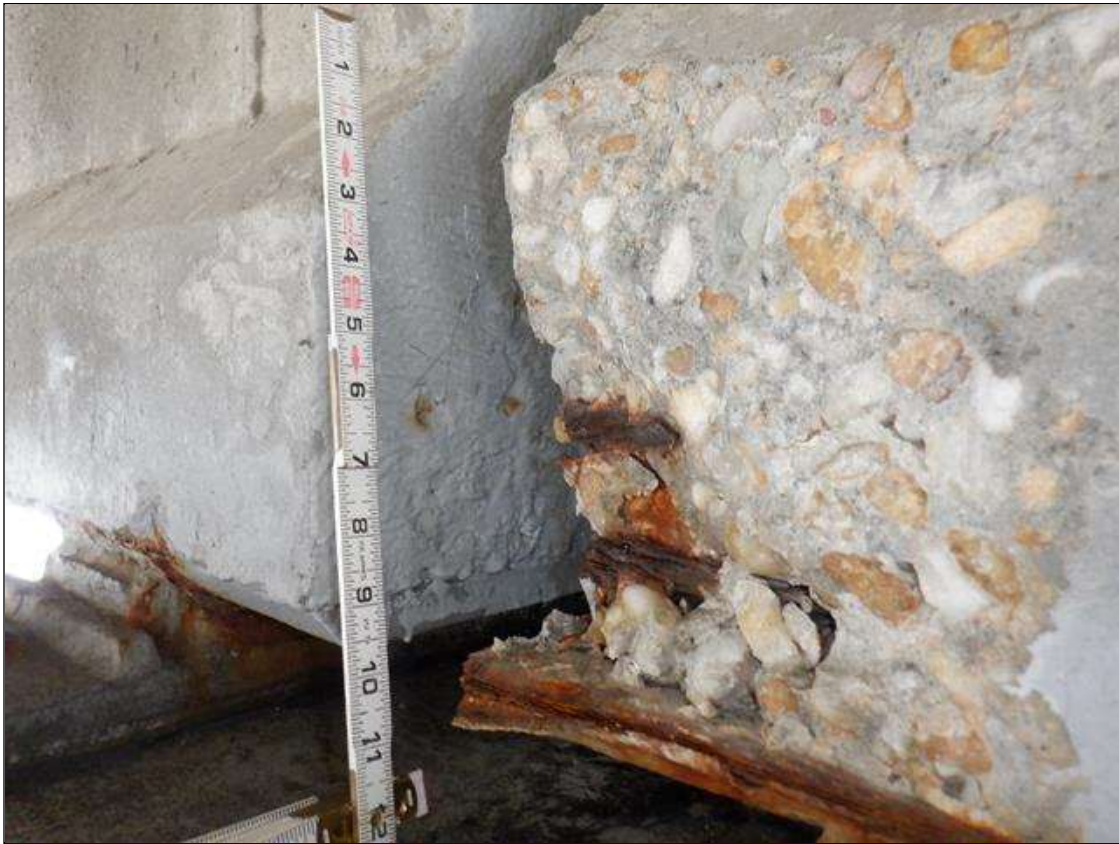
Span 82 Beam 3: (PAR) NORTH FACE OF BOTTOM FLANGE, AT BENT 82, SPALL (7INCHES X 9INCHES X 2 INCHES) WITH EXPOSED STRANDS (10 PERCENT SECTION LOSS)
