NC DEPARTMENT OF TRANSPORTATION  
DIVISION OF HIGHWAYS  
STRUCTURE MANAGEMENT UNIT

## Structure Safety Report

### Routine Element Inspection - Contract

STRUCTURE NUMBER: 260016 SAP STRUCTURE NO: 0270016 FHWA STRUCTURE NO: 000000000530016  
DIVISION: 1 COUNTY: CURRITUCK INSPECTION DATE: 09/21/2022 FREQUENCY: 24 MONTHS  
FACILITY CARRIED: US158E MILE POST: \_\_\_\_\_  
LOCATION: .01 MI.E.JCT.SR1187  
FEATURE INTERSECTED: CURRITUCK SOUND  
LATITUDE: 36° 5' 11.69" LONGITUDE: 75° 46' 0.21"  
SUPERSTRUCTURE: RC FLOOR ON PPC GIRDERS & CORED SLAB  
SUBSTRUCTURE: EBTS:RC CAP/PPC PILES;IBTS:RCP&B & RC CAPS/PPC PILES  
SPANS: 248 SPANS. SEE SPAN PROFILE SHEET FOR SPAN DETAILS  
☐ FRACTURE CRITICAL ☐ TEMPORARY SHORING ☐ SCOUR CRITICAL ☐ SCOUR PLAN OF ACTION  
GRADES: (Inspector/NBI Coding) DECK 6 / 6 SUPERSTRUCTURE 5 / 5 SUBSTRUCTURE 6 / 6 CULVERT N / N  
POSTED SV: Not Posted POSTED TTST: Not Posted  
OTHER SIGNS PRESENT: None

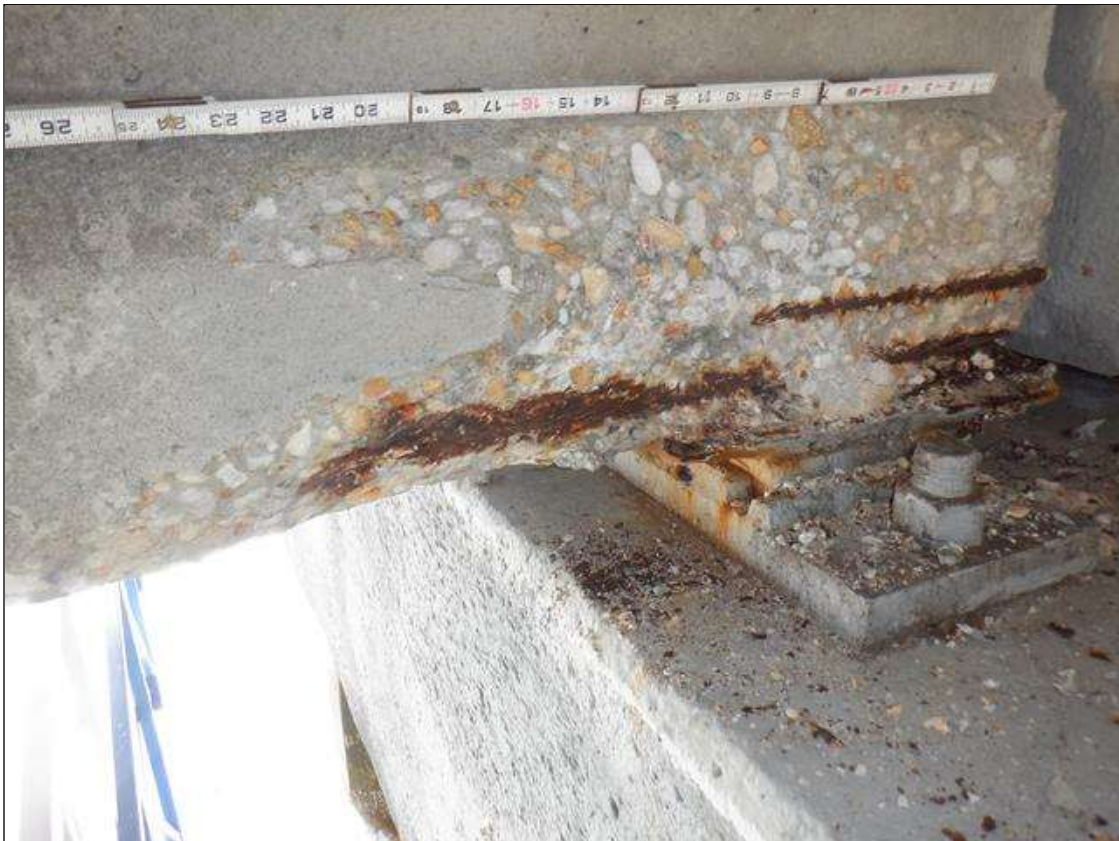
Span 87 Beam 3: (PAR) NORTH FACE OF BOTTOM FLANGE, AT BENT 86, SPALL (36 INCHES LONG X 9 INCHES HIGH X 2 INCHES DEEP) WITH TWO (2) EXPOSED RUSTED STRANDS (20 PERCENT SECTION LOSS)

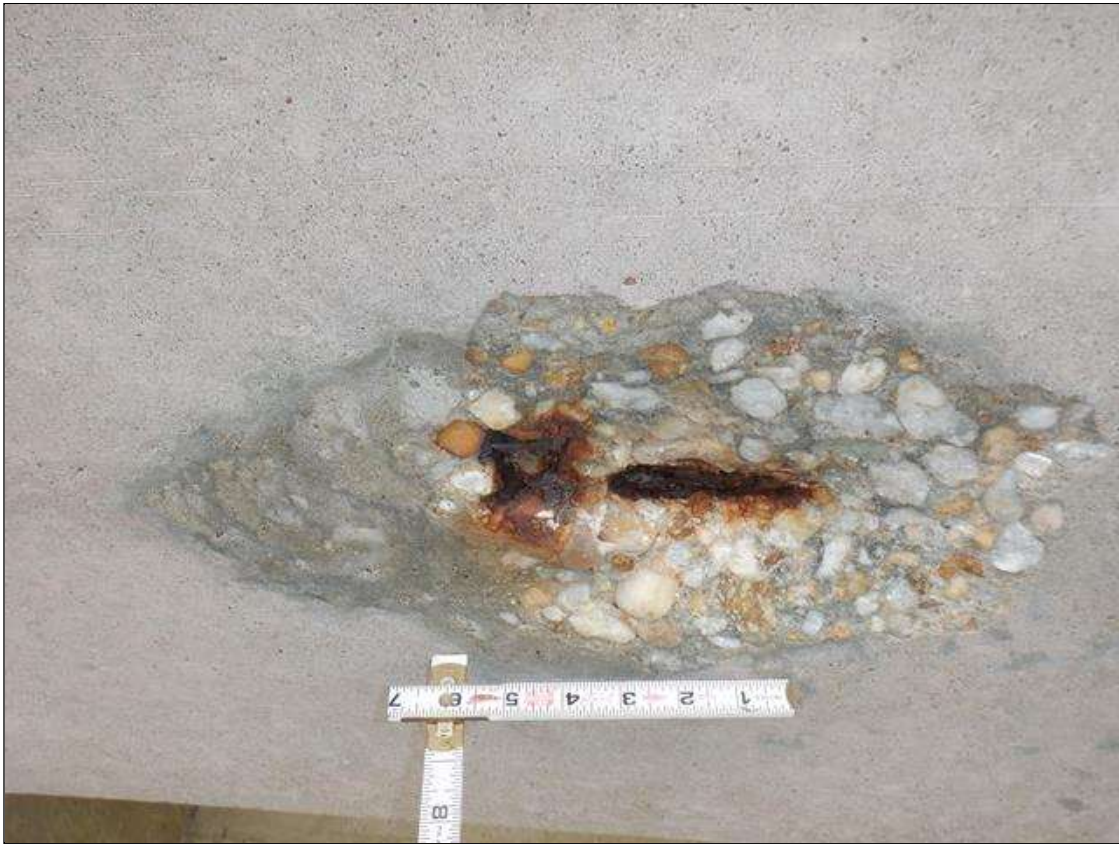
Span 92 Beam 3: (PAR) UNDERSIDE OF BOTTOM FLANGE AT 24 FEET FROM BENT 91, SPALL (9 INCHES X 8 INCHES X 1.5 INCHES) WITH EXPOSED STRAND (10 PERCENT SECTION LOSS)

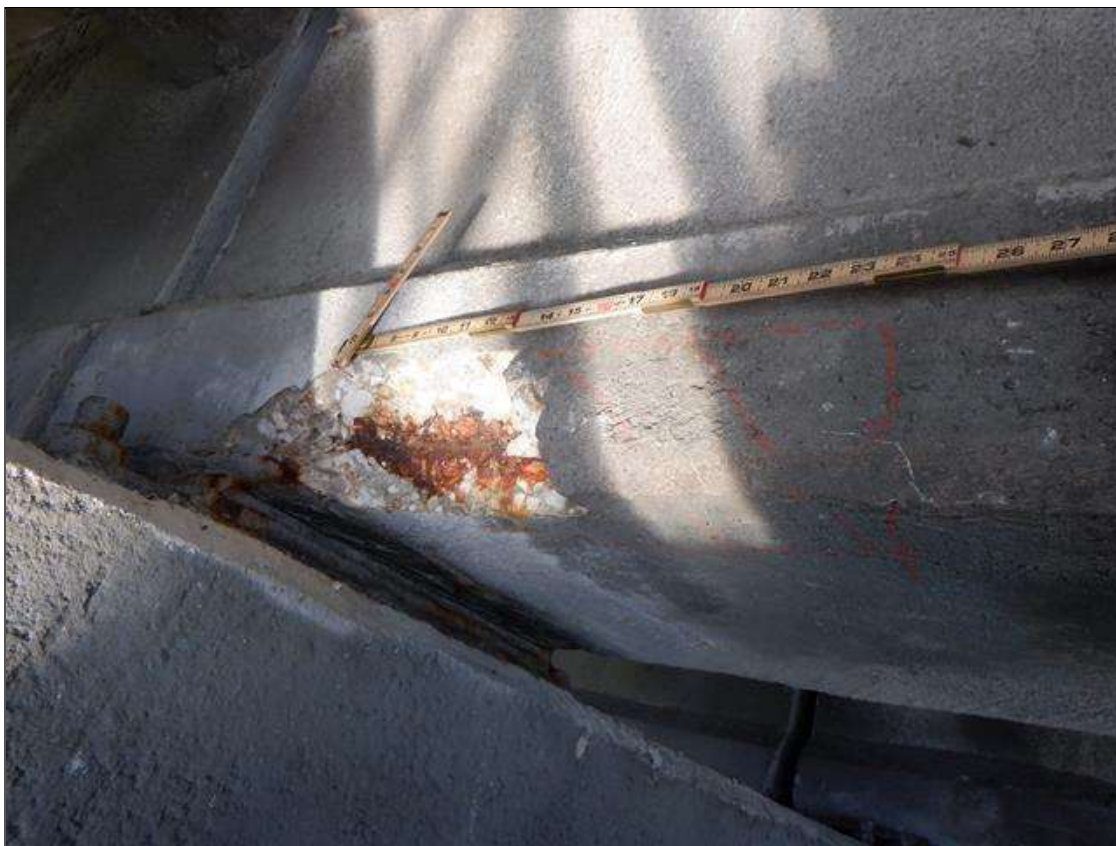
Span 104 Beam 3: (PAR) SOUTH FACE OF BOTTOM FLANGE AT BENT 103, DELAMINATION/SPALL (24 INCHES LONG X 4 INCHES HIGH X 4 INCHES ON BOTTOM FACE X 2 INCHES DEEP) WITH (1) EXPOSED STRAND (NO LOSS)

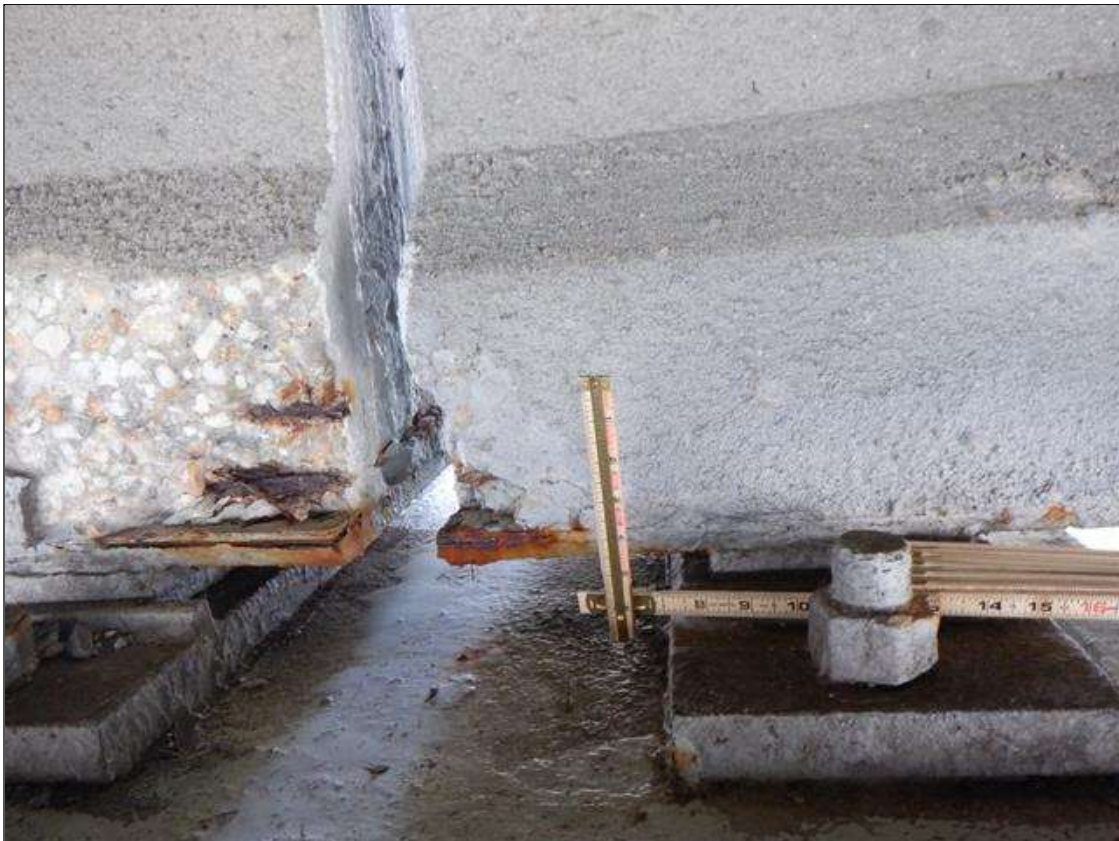
Span 109 Beam 3: (PAR) SOUTH FACE OF BOTTOM FLANGE 4 FEET FROM BENT 109, DELAMINATION/SPALL (40 INCHES LONG X 5 INCHES HIGH X 2 INCHES DEEP WITH (1) EXPOSED AND SEVERED STRAND

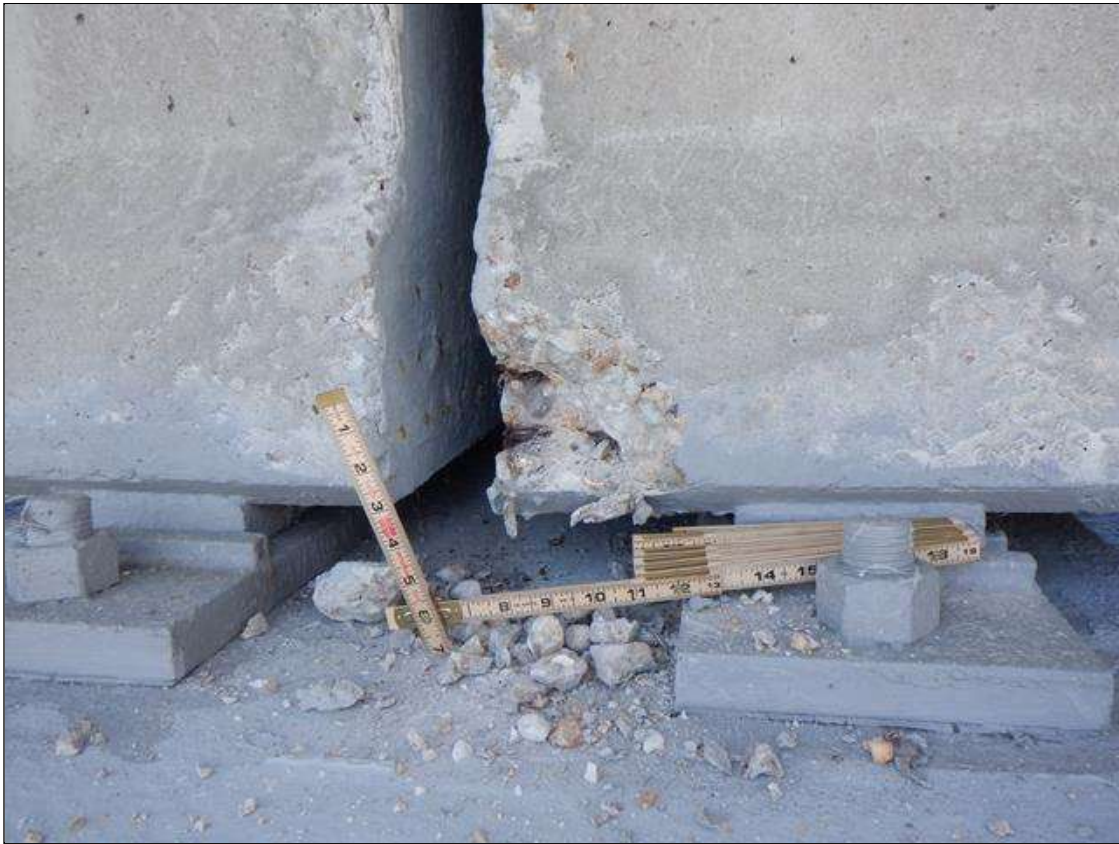
Span 110 Beam 1: (PAR) SOUTH FACE OF BOTTOM FLANGE AT BENT 109, SPALL (5 INCHES LONG X 5 INCHES HIGH X 2 INCHES DEEP) WITH (1) EXPOSED STRAND (NO LOSS)

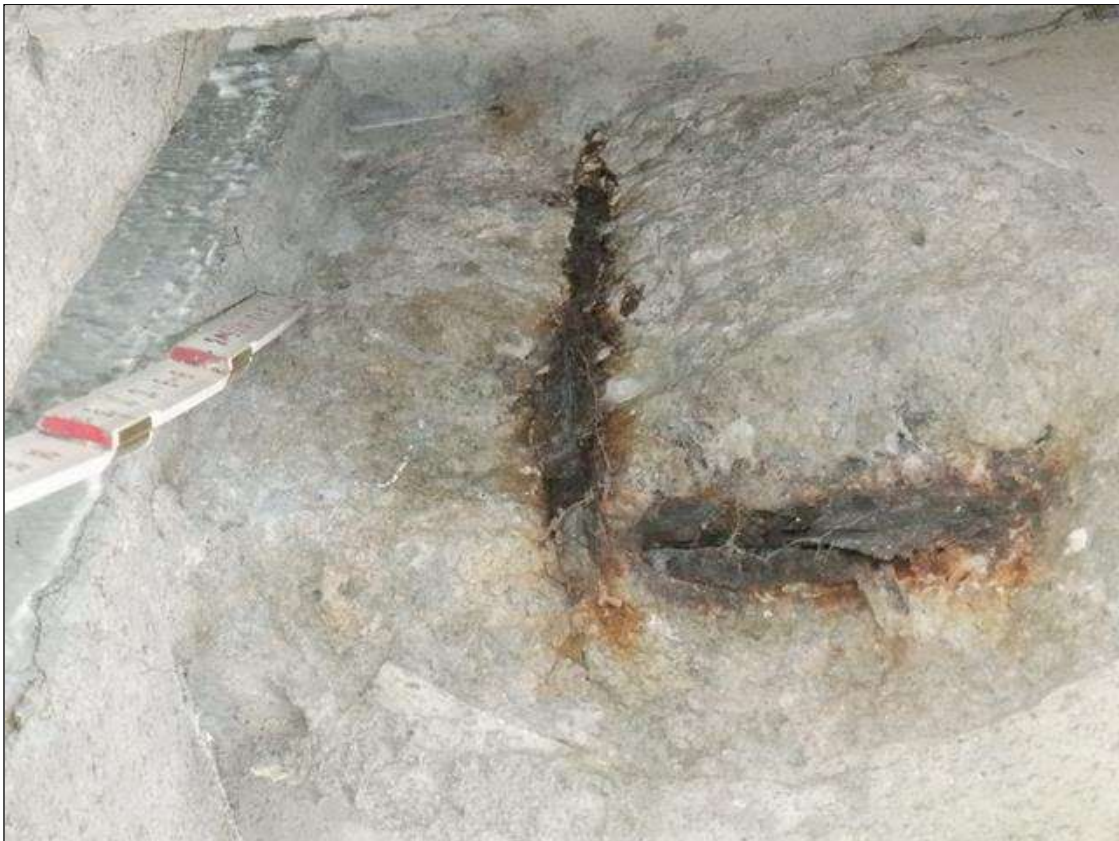
Span 110 Beam 4: (PAR) SOUTH FACE OF BOTTOM FLANGE AT BENT 109, SPALL (5 INCHES LONG X 5 INCHES HIGH X 2 INCHES DEEP) WITH (1) EXPOSED STRAND (NO LOSS)

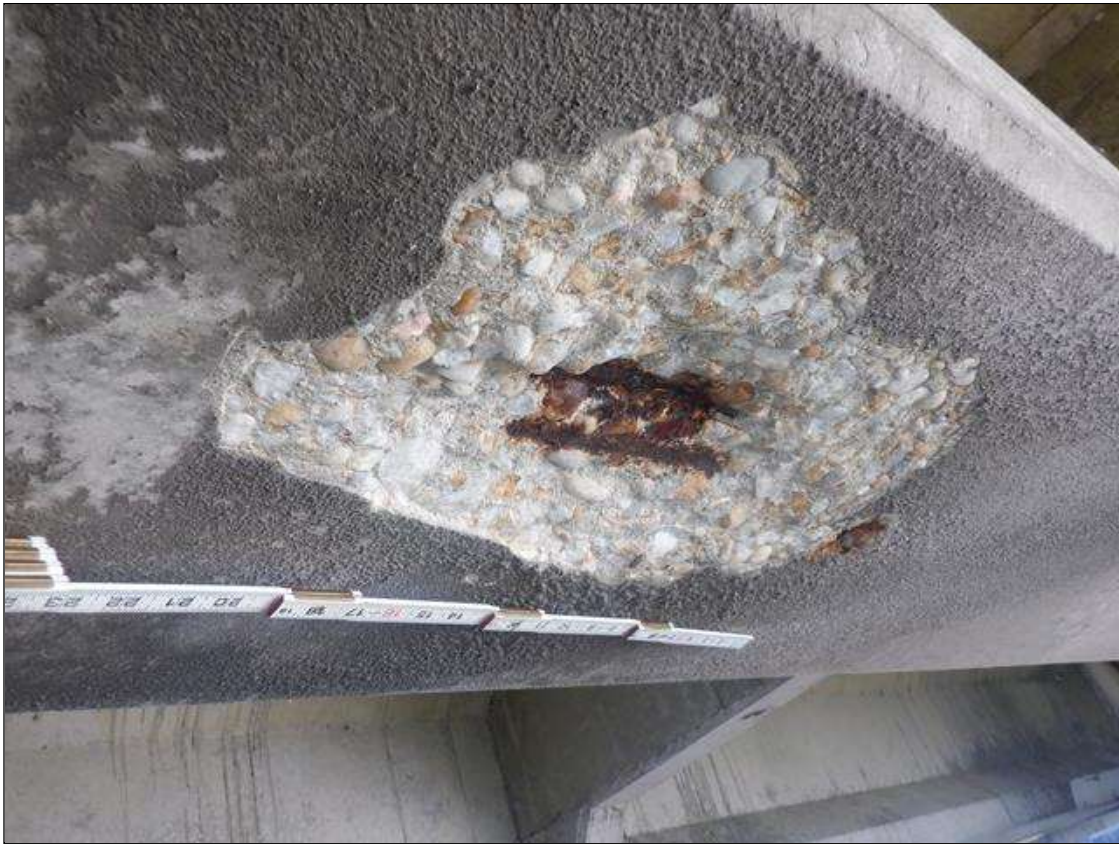
Span 21 Beam 4: END DIAPHRAGM, BAY 3 NEXT TO GIRDER 4 AT BENT 21, SPALL (12 INCHES X 15 INCHES X 2 INCHES) WITH EXPOSED RUSTED REINFORCING

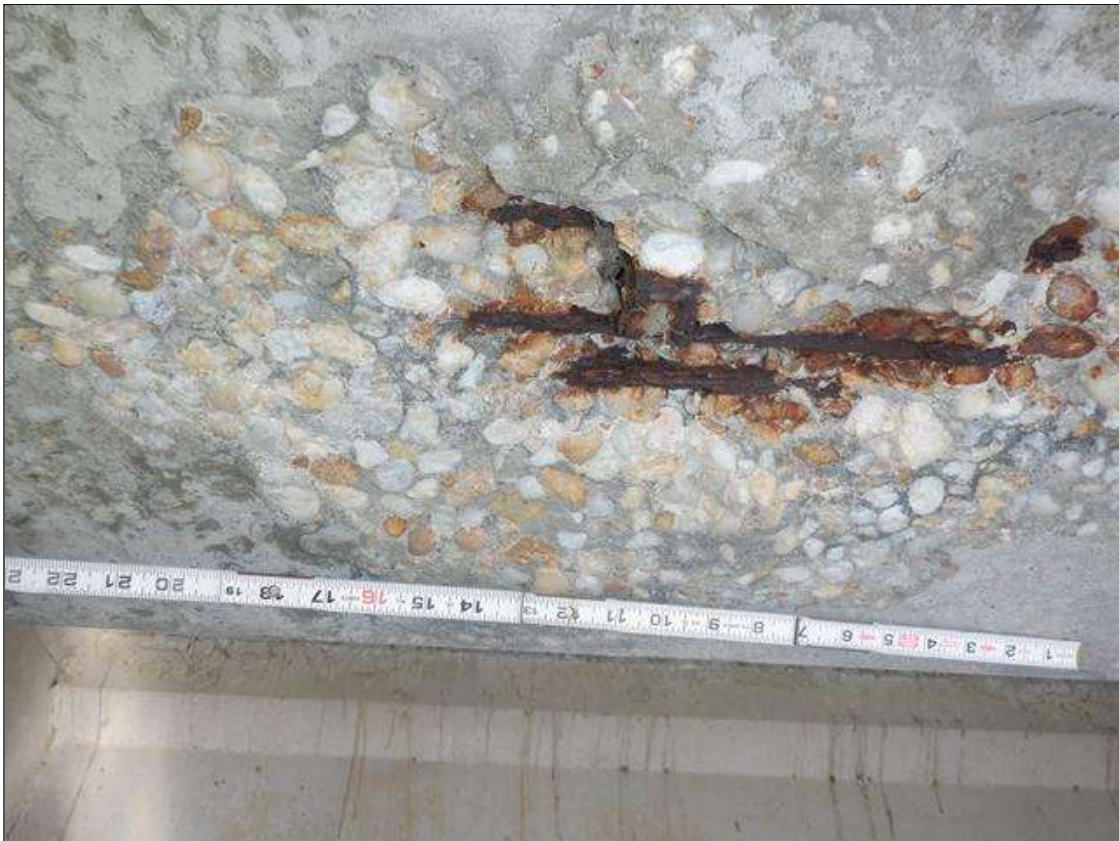
Span 97 Beam 2: (PAR) BOTTOM FLANGE AT 24 FEET FROM BENT 97, SPALL (19 INCHES X 12 INCHES X 1 INCHES) WITH EXPOSED STRANDS (10 PERCENT SECTION LOSS) ON STRAND

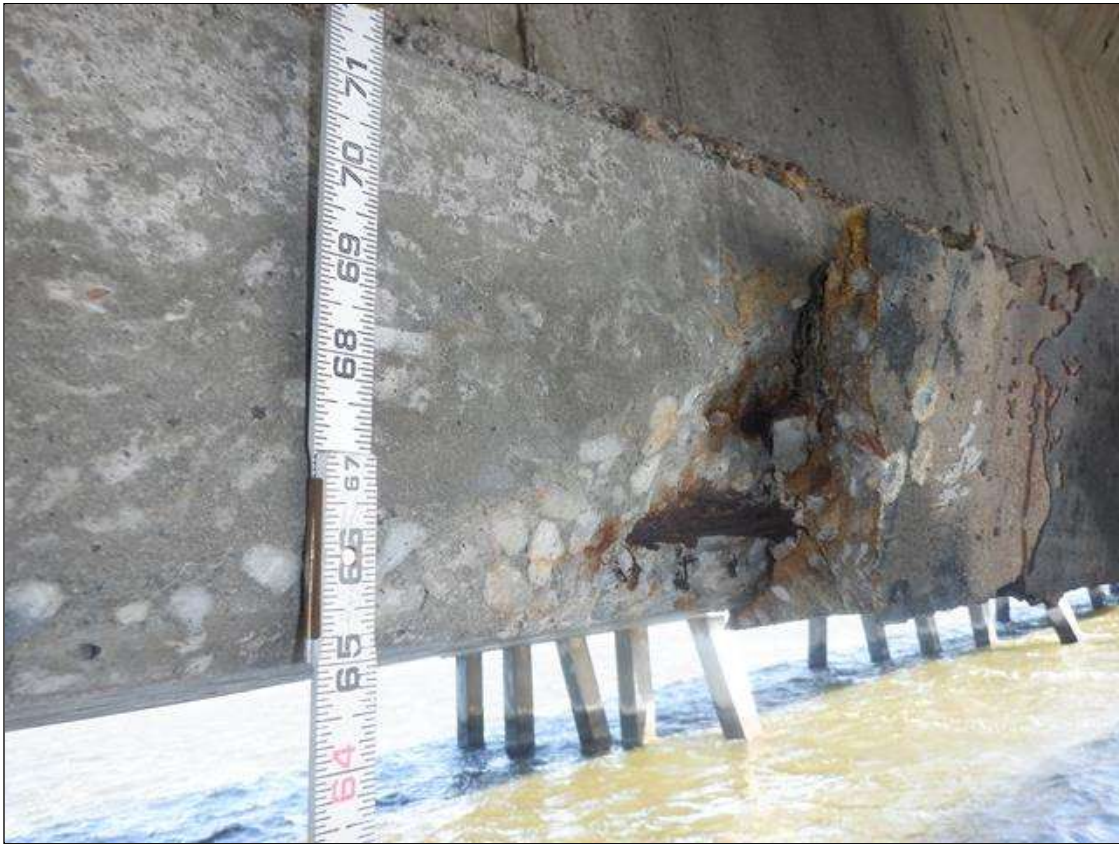
Span 99 Beam 4: (PAR) UNDERSIDE OF BOTTOM FLANGE AT 23 FEET FROM BENT 98, SPALL (21 INCHES X 11 INCHES X UP TO 2 INCHES) WITH EXPOSED STRANDS WITH (20 PERCENT SECTION LOSS) ON STRANDS

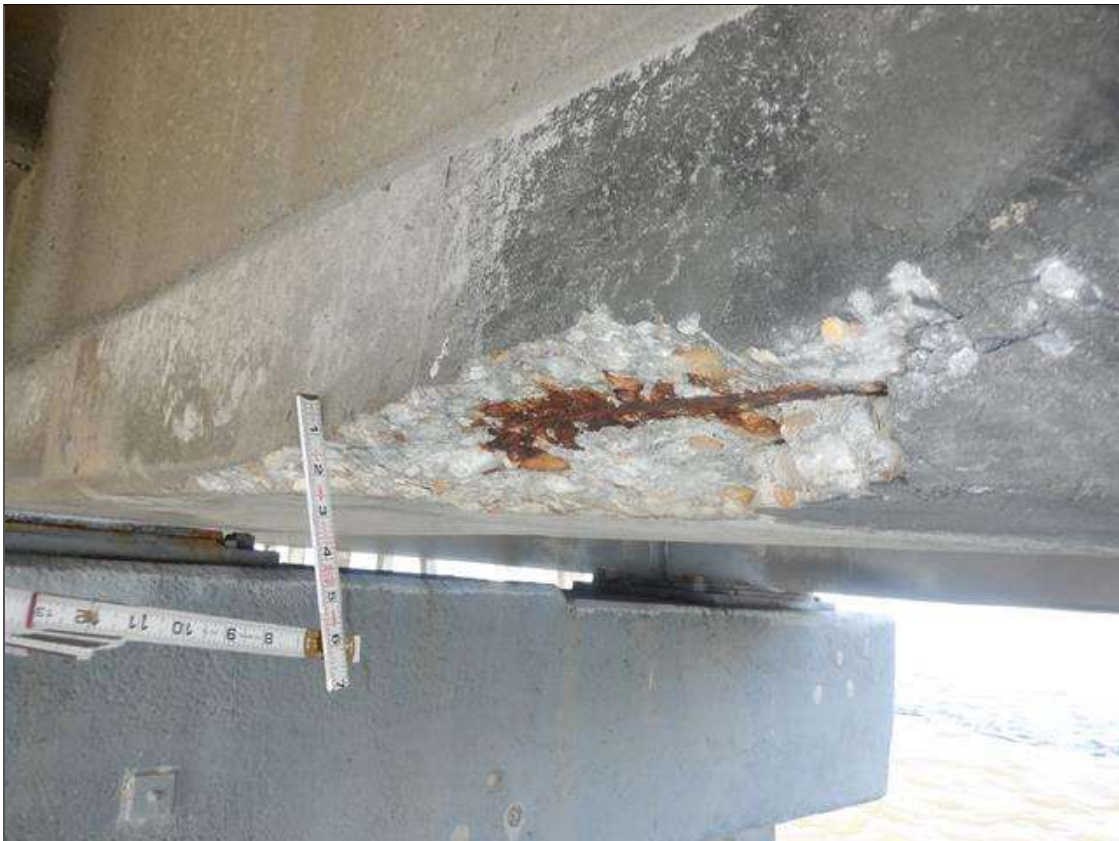
Span 100 Beam 1: (PAR) SOUTH FACE OF BOTTOM FLANGE AT 8 FEET FROM BENT 99, FAILED PATCHED ARE.  
(48 INCHES X 7 INCHES X UP TO 2 INCHES DEEP)

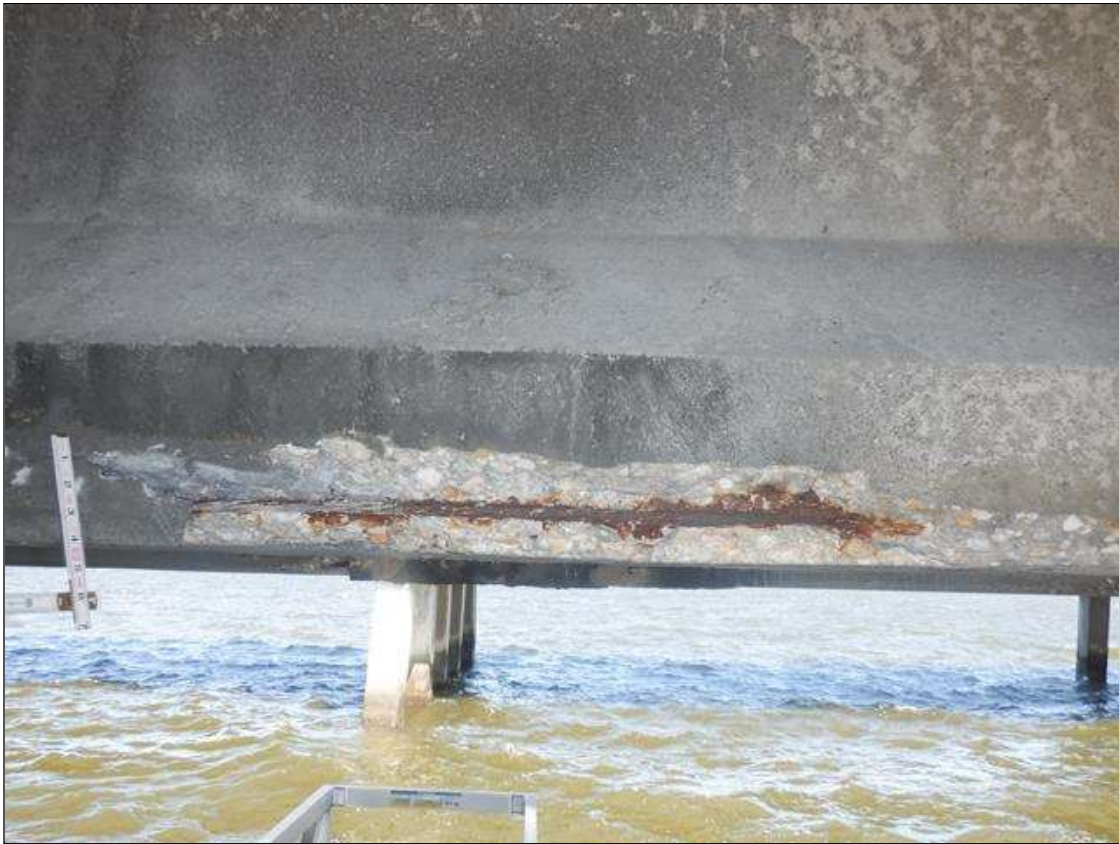
Span 100 Beam 2: (PAR) STARTING 5 FEET FROM BENT 99, SPALL/DELAMINATION (8 FEET X UP TO 9 INCHES  
X UP TO 2 INCHES DEEP) WITH DEBONDED STRAND

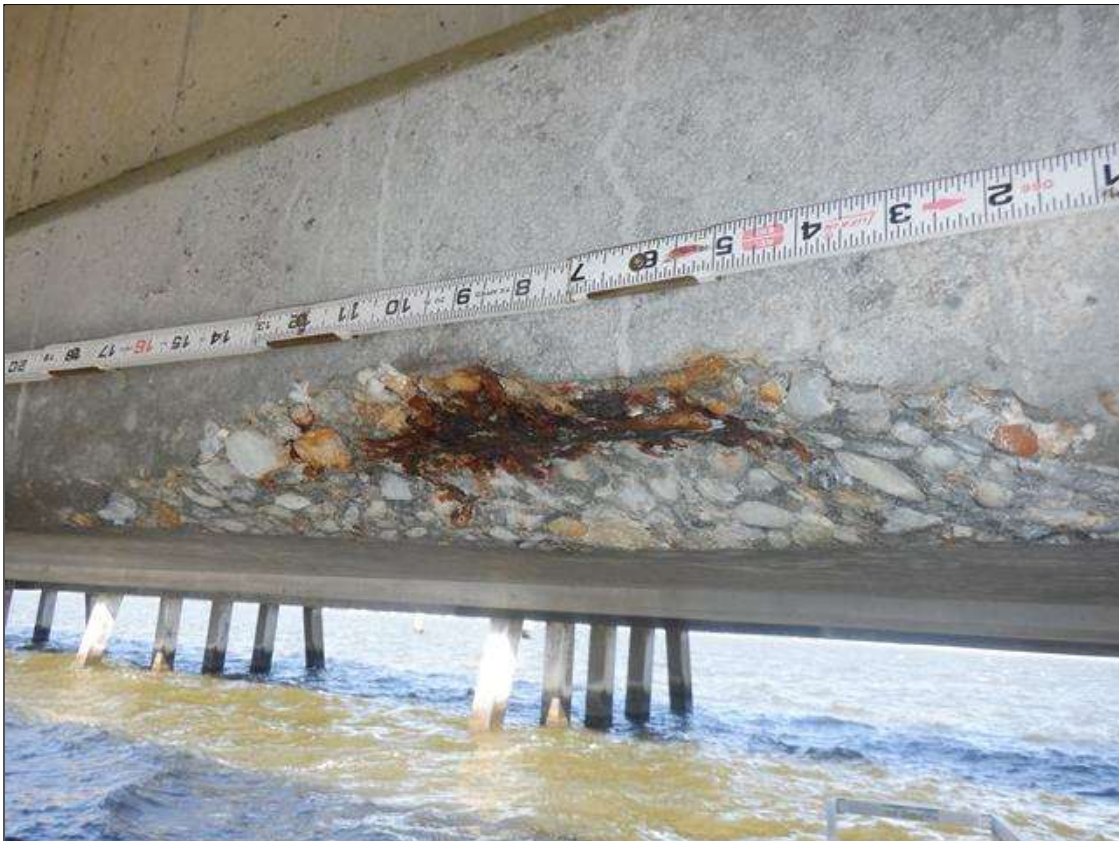
Span 100 Beam 2: (PAR) STARTING 5 FEET FROM BENT 99, SPALL/DELAMINATION (8 FEET X UP TO 9 INCHES X UP TO 2 INCHES DEEP) WITH DEBONDED STRAND

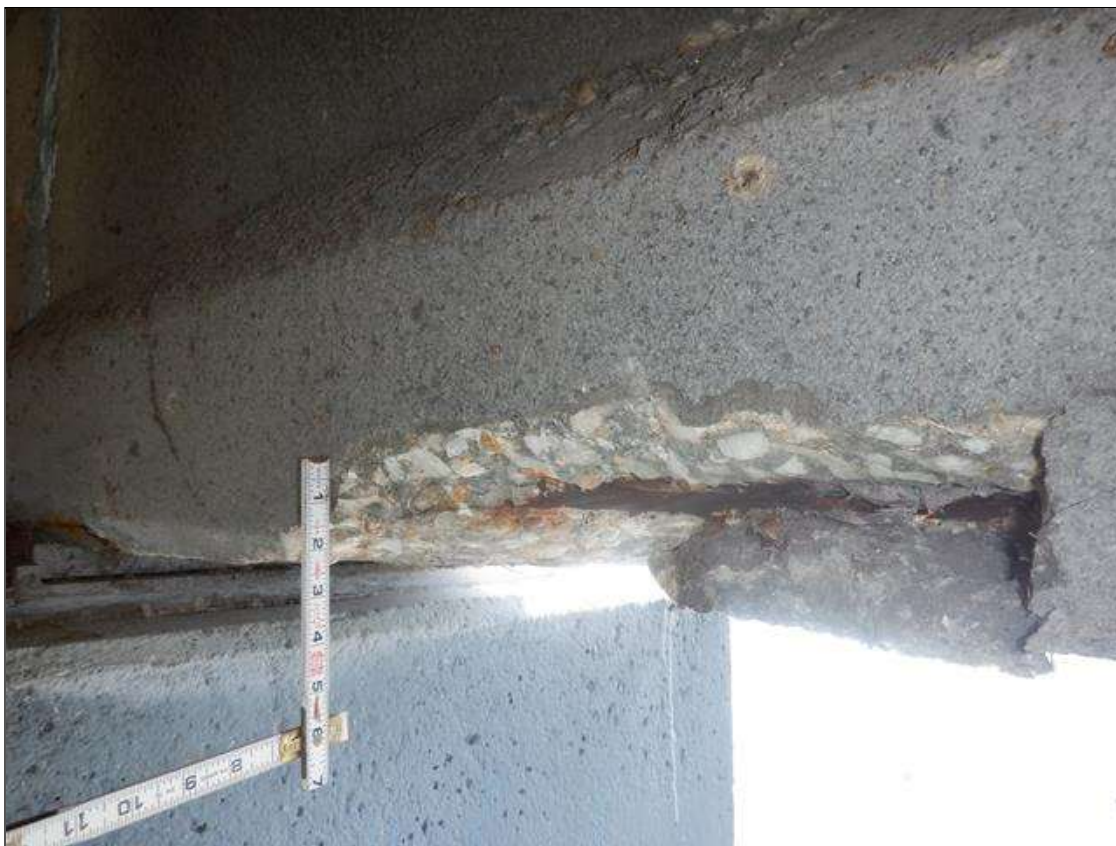
Span 100 Beam 3: (PAR) SOUTH FACE OF BOTTOM FLANGE AT 12 FEET FROM BENT 100, SPALL ( 20 INCHES X 2 INCHES X 2 INCHES DEEP) WITH 1 AREA EXPOSED RUSTED REINFORCING (10 PERCENT SECTION LOSS)

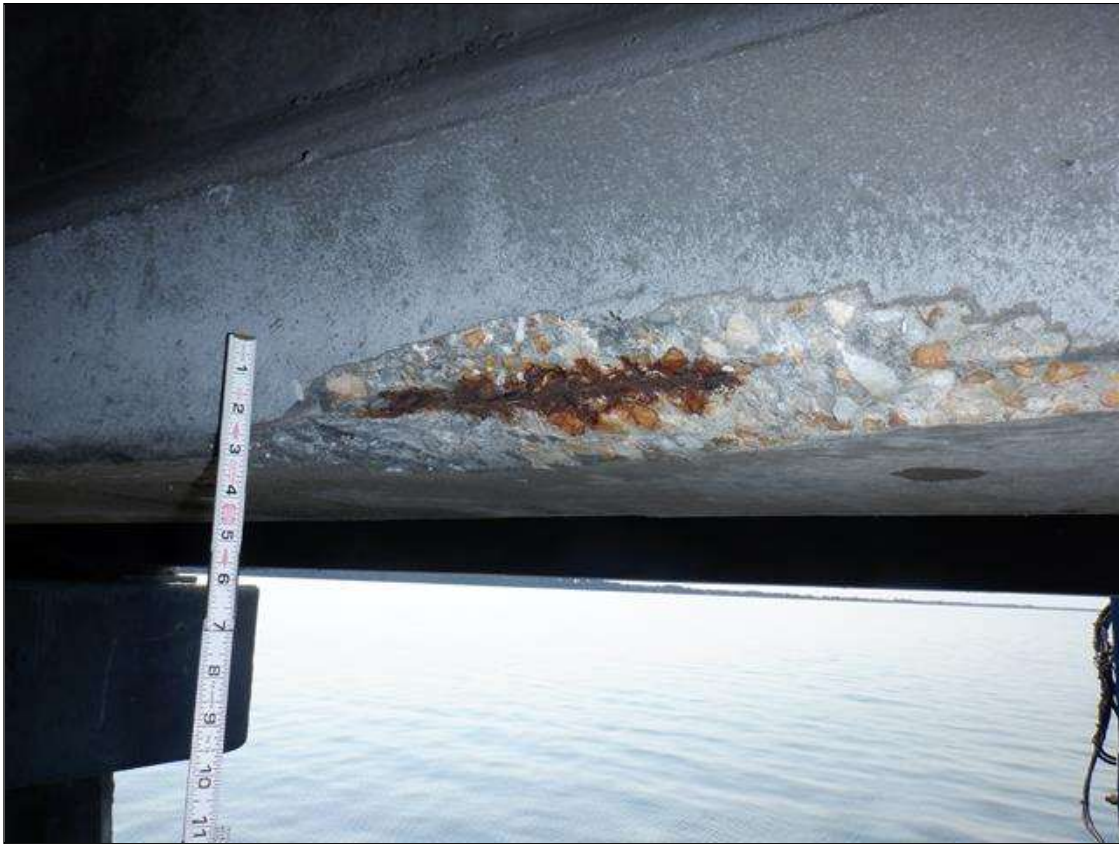
Span 100 Beam 4: (PAR) NORTH FACE BOTTOM FLANGE, AT 4 FEET FROM BENT 100, SPALL (19 INCHES X 10 INCHES X 2 INCHES) WITH EXPOSED STRANDS (5 PERCENT SECTION LOSS ON STRAND), DEBONDED (100 PERCENT LOSS)

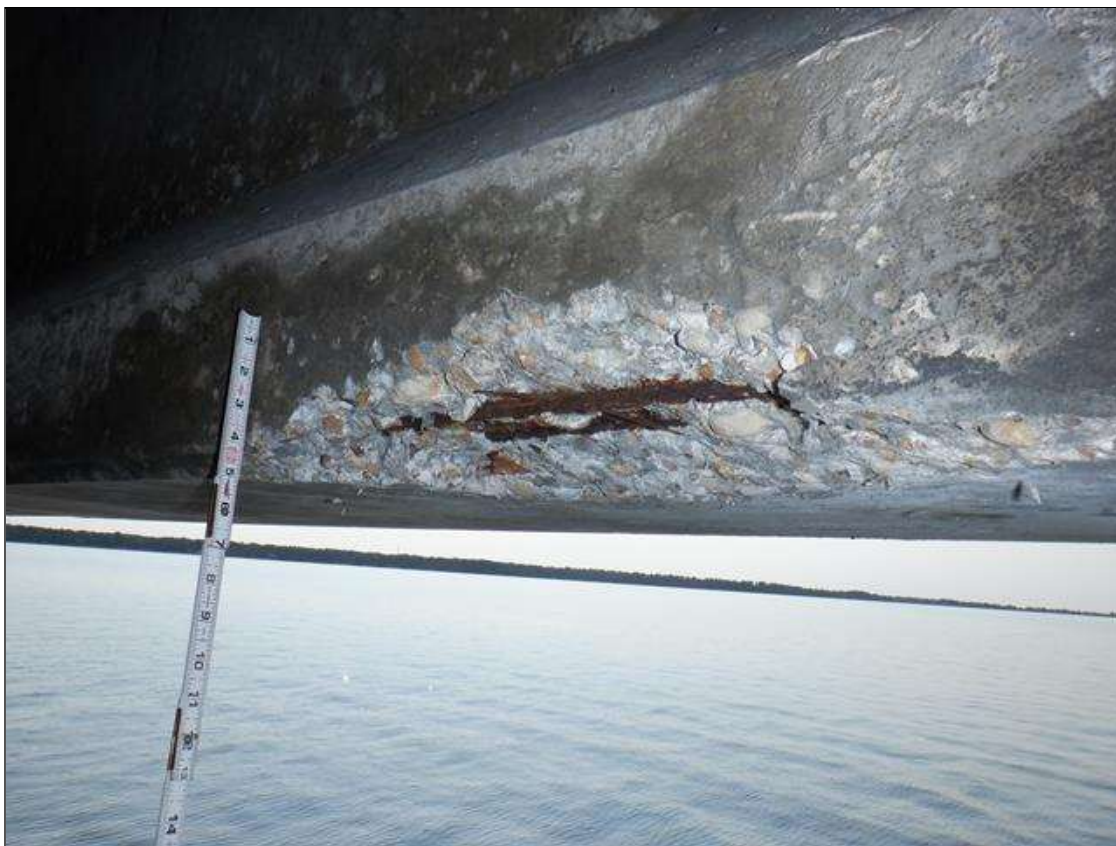
Span 155 Beam 4: (PAR) BOTTOM FLANGE NORTH FACE AT 10 FEET FROM BENT 155, SPALL (18 INCHES LONG X 5 INCHES HIGH X 1.5 INCHES DEEP) WITH EXPOSED RUSTED STRANDS (10 PERCENT SECTION LOSS)

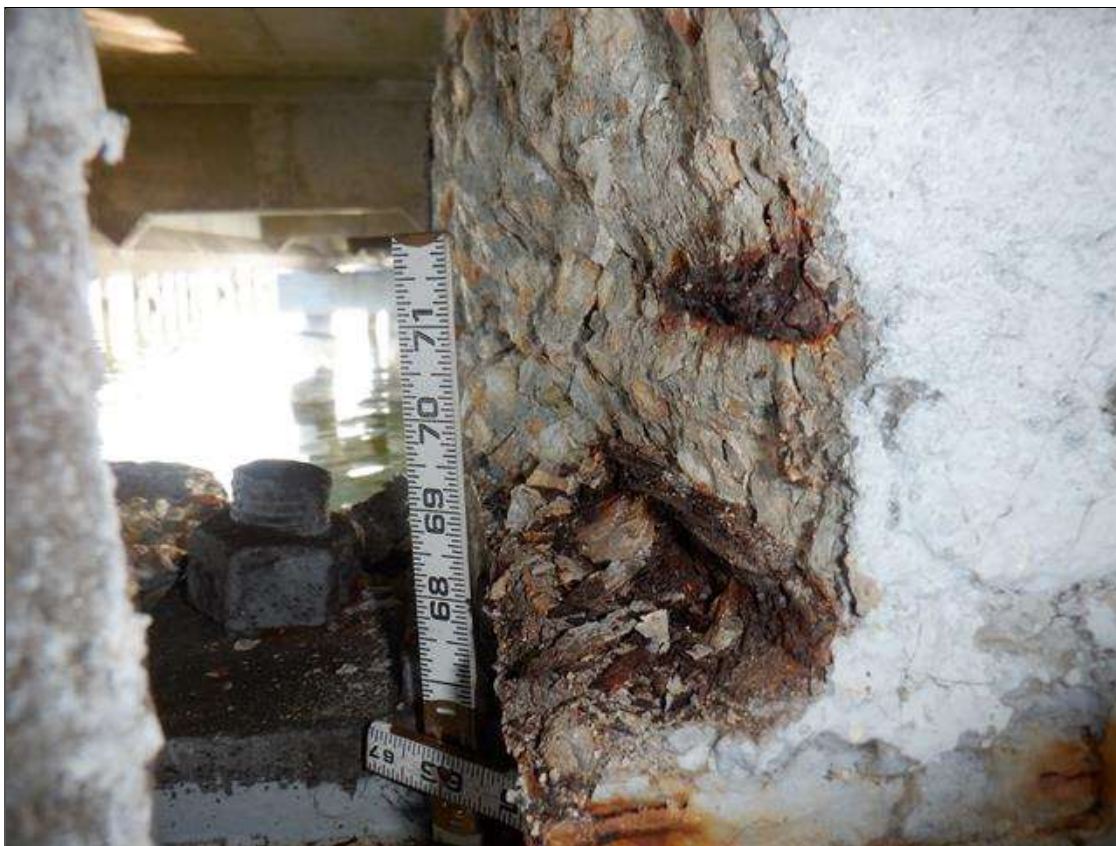
Span 155 Beam 5: (PAR) BOTTOM FLANGE NORTH FACE AT 25 FEET FROM BENT 154, SPALL (24 INCHES LONG X 4 INCHES HIGH X 2 INCHES DEEP) WITH (2) TWO EXPOSED RUSTED STRANDS (30 PERCENT SECTION LOSS)

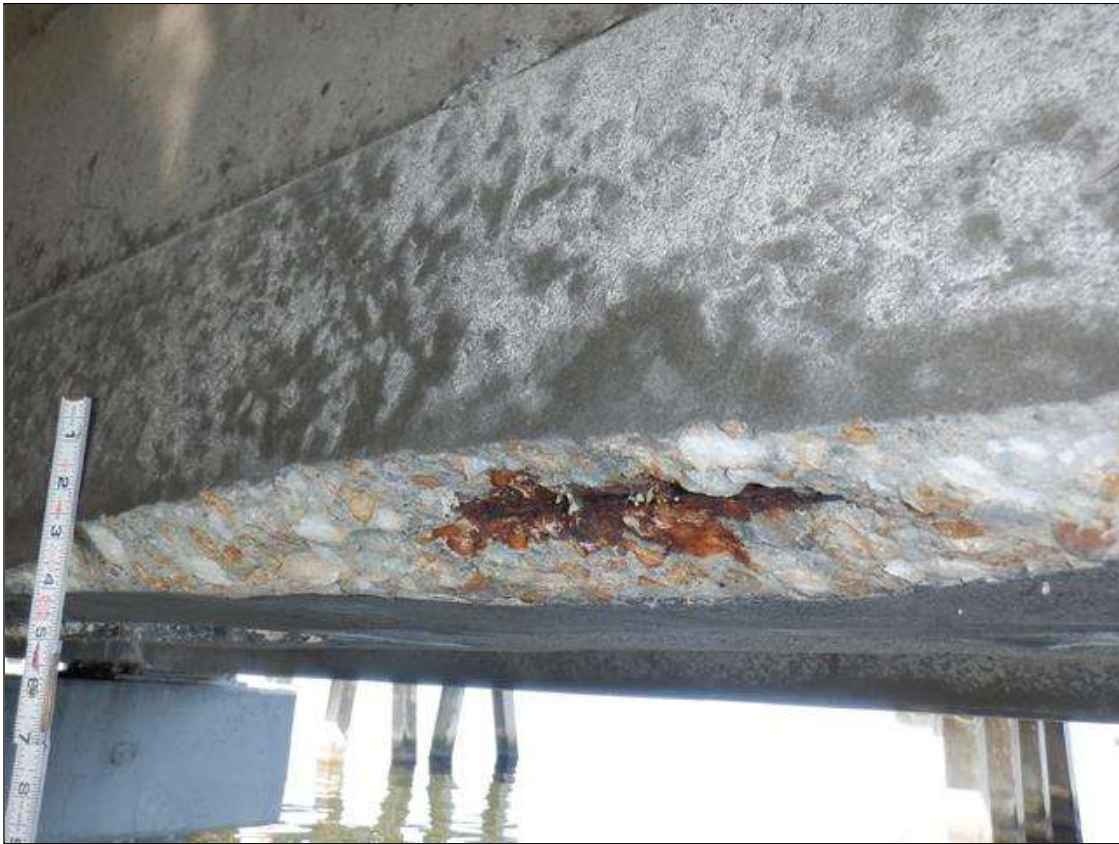
Span 156 Beam 2: (PAR) BOTTOM FLANGE NORTH FACE AT BENT 155, SPALL (15 INCHES LONG X 6 INCHES HIGH X UP TO 2 INCHES DEEP) WITH (2) TWO EXPOSED RUSTED STRANDS (10 PERCENT SECTION LOSS)

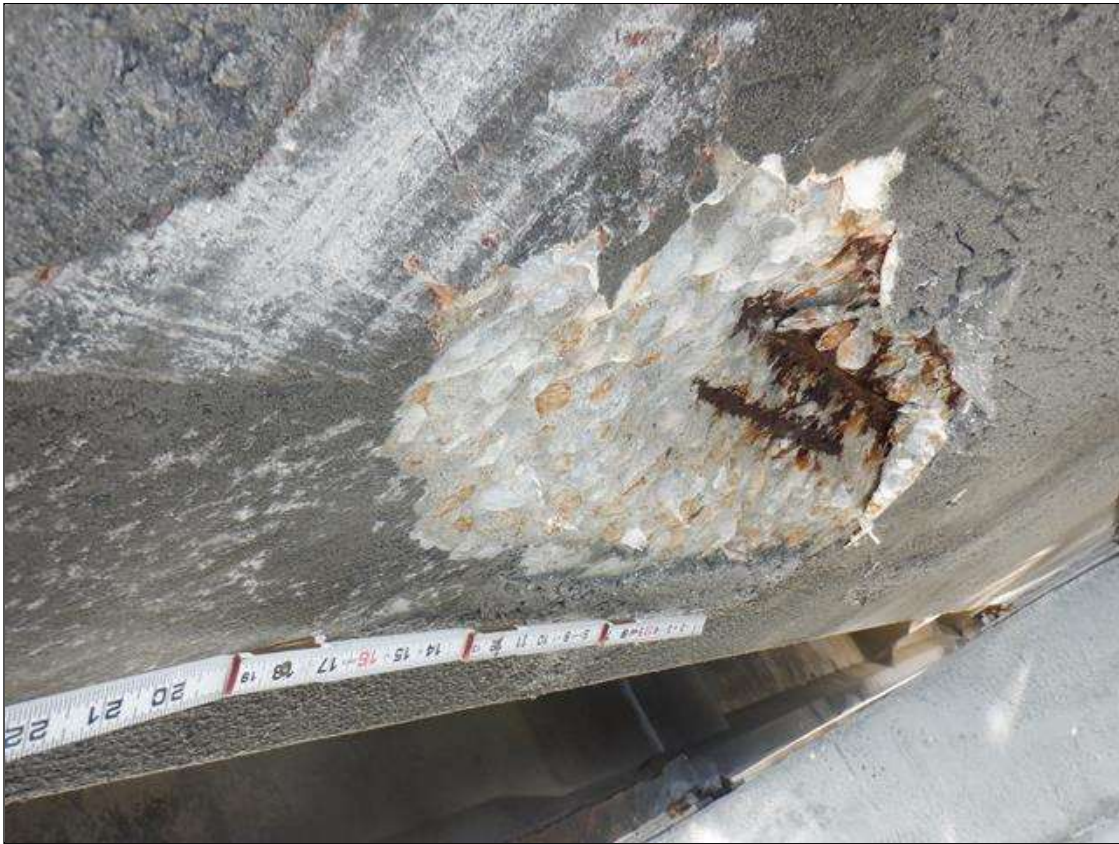
Span 157 Beam 2: (PAR) BOTTOM FLANGE ALL FACES, STARTING AT BENT 156, FAILED PATCH WITH MULTIPLE SPALLS (UP TO 2 FEET LONG X UP TO 12 INCHES WIDE X UP TO 2 INCHES DEEP) WITH EXPOSED RUSTED STRANDS (10 PERCENT SECTION LOSS)

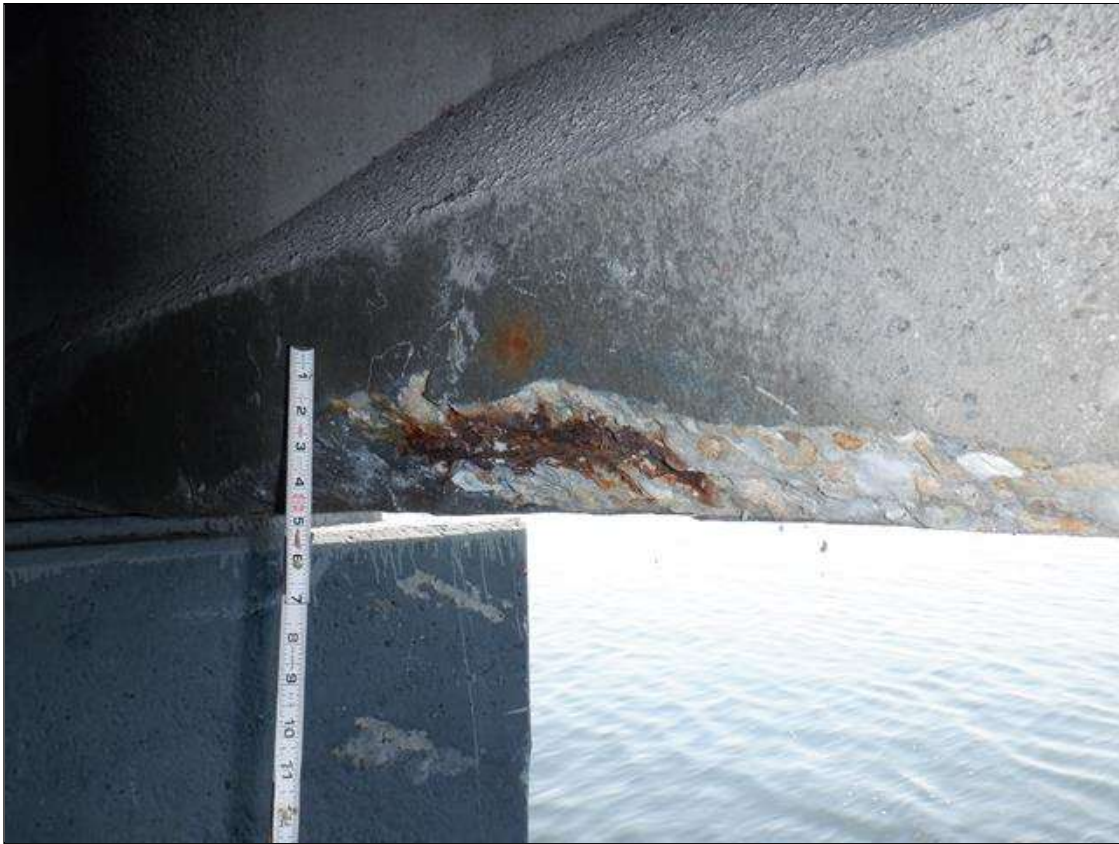
Span 157 Beam 2: (PAR) BOTTOM FLANGE ALL FACES, STARTING AT BENT 156, FAILED PATCH WITH MULTIPLE SPALLS (UP TO 2 FEET LONG X UP TO 12 INCHES WIDE X UP TO 2 INCHES DEEP) WITH EXPOSED RUSTED STRANDS (10 PERCENT SECTION LOSS)

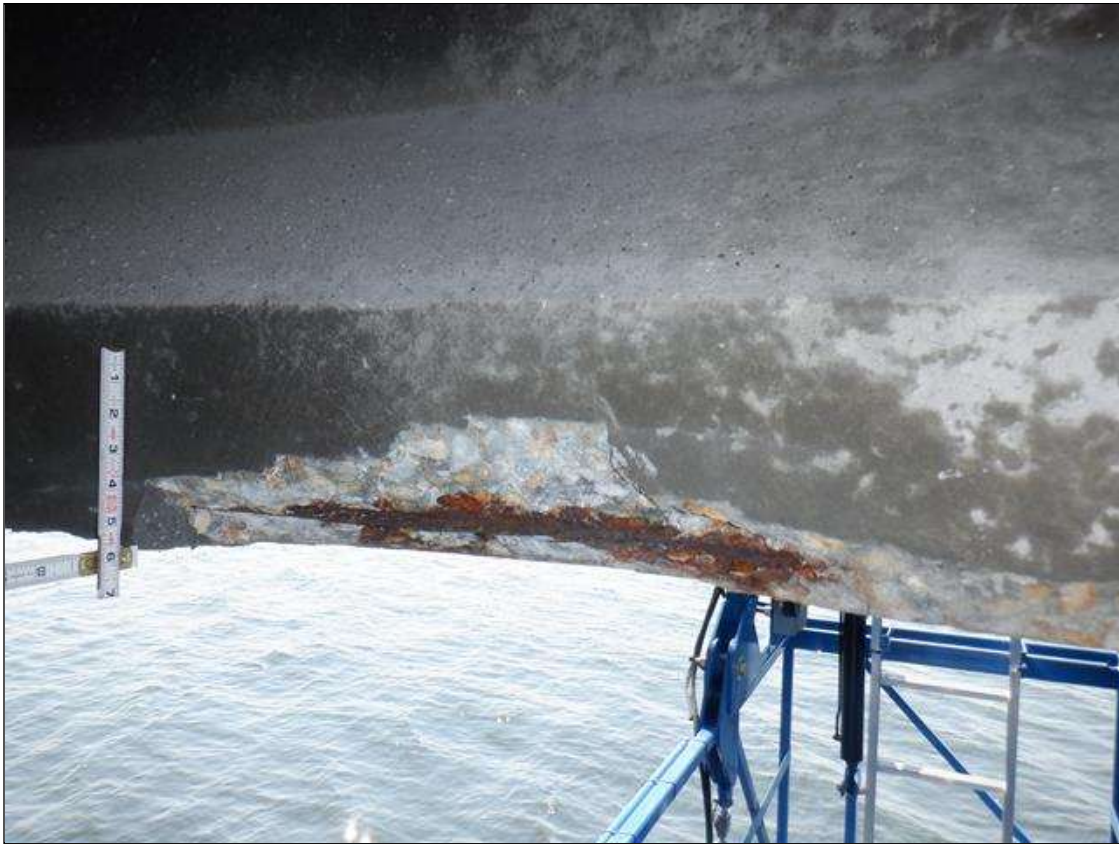
Span 157 Beam 4: (PAR) NORTH FACE OF BOTTOM FLANGE AT 4 FEET FROM BENT 157, FAILED PATCH/SPALL (36 INCHES X 4 INCHES HIGH X UP TO 2 INCHES DEEP) WITH EXPOSED RUSTED STRANDS (10 PERCENT SECTION LOSS)

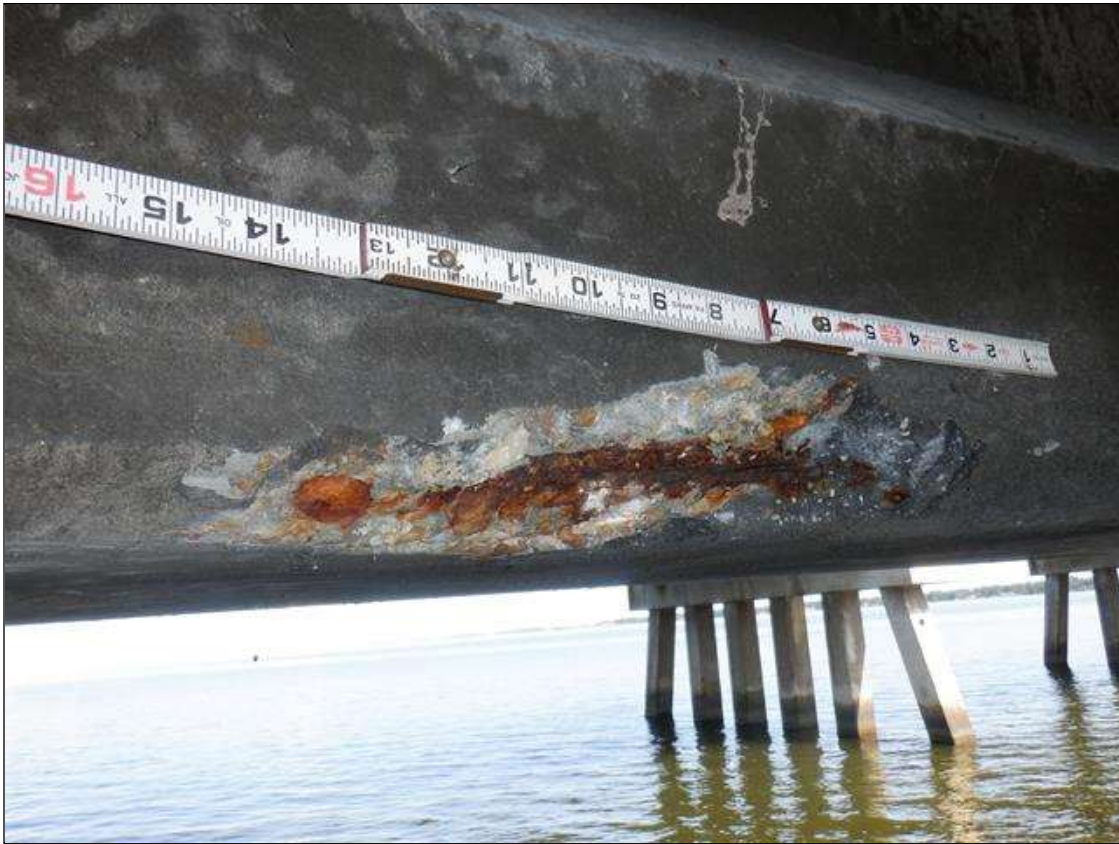
Span 159 Beam 4: (PAR) BOTTOM FLANGE NORTH FACE AT 12 FEET FROM BENT 159, FAILED PATCH/SPALL (32 INCHES LONG X 4 INCHES HIGH X UP TO 2 INCHES DEEP) WITH EXPOSED RUSTED STRANDS (20 PERCENT SECTION LOSS)

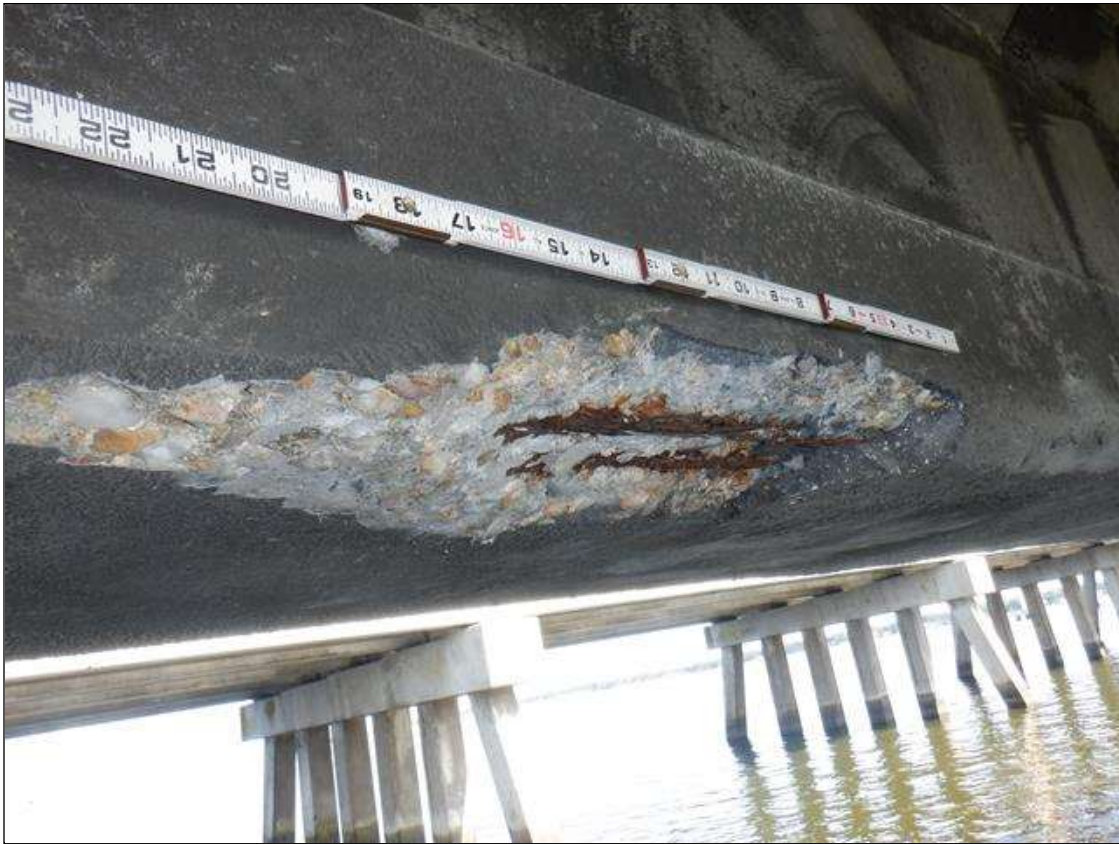
Span 160 Beam 1: (PAR) SOUTH FACE OF BOTTOM FLANGE AT 10 FEET FROM BENT 159, FAILED PATCH/SPALL (12 INCHES X 2 INCHES HIGH X 2 INCHES DEEP) WITH EXPOSED RUSTED STRANDS (10 PERCENT SECTION LOSS)

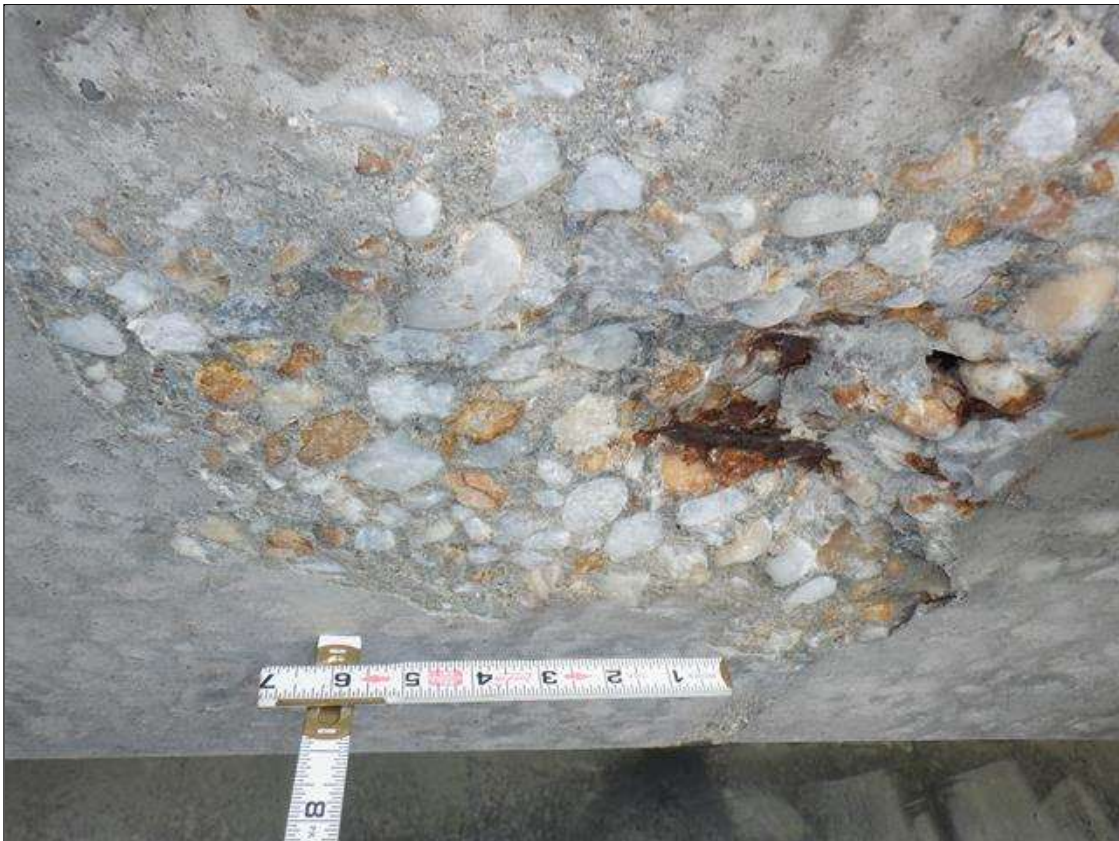
Span 160 Beam 1: (PAR) BOTH FACES OF BOTTOM FLANGE AT MIDSPAN, FAILED PATCH/SPALL (84 INCHES X 8 INCHES HIGH X UP TO 2 INCHES DEEP) WITH EXPOSED RUSTED STRANDS (30 PERCENT SECTION LOSS)
