NC DEPARTMENT OF TRANSPORTATION  
DIVISION OF HIGHWAYS  
STRUCTURE MANAGEMENT UNIT

## Structure Safety Report

### Routine Element Inspection - Contract

STRUCTURE NUMBER: 260016 SAP STRUCTURE NO: 0270016 FHWA STRUCTURE NO: 000000000530016  
DIVISION: 1 COUNTY: CURRITUCK INSPECTION DATE: 09/21/2022 FREQUENCY: 24 MONTHS  
FACILITY CARRIED: US158E MILE POST: \_\_\_\_\_  
LOCATION: .01 MI.E.JCT.SR1187  
FEATURE INTERSECTED: CURRITUCK SOUND  
LATITUDE: 36° 5' 11.69" LONGITUDE: 75° 46' 0.21"  
SUPERSTRUCTURE: RC FLOOR ON PPC GIRDERS & CORED SLAB  
SUBSTRUCTURE: EBTS:RC CAP/PPC PILES;IBTS:RCP&B & RC CAPS/PPC PILES  
SPANS: 248 SPANS. SEE SPAN PROFILE SHEET FOR SPAN DETAILS  
☐ FRACTURE CRITICAL ☐ TEMPORARY SHORING ☐ SCOUR CRITICAL ☐ SCOUR PLAN OF ACTION  
GRADES: (Inspector/NBI Coding) DECK 6 / 6 SUPERSTRUCTURE 5 / 5 SUBSTRUCTURE 6 / 6 CULVERT N / N  
POSTED SV: Not Posted POSTED TTST: Not Posted  
OTHER SIGNS PRESENT: None

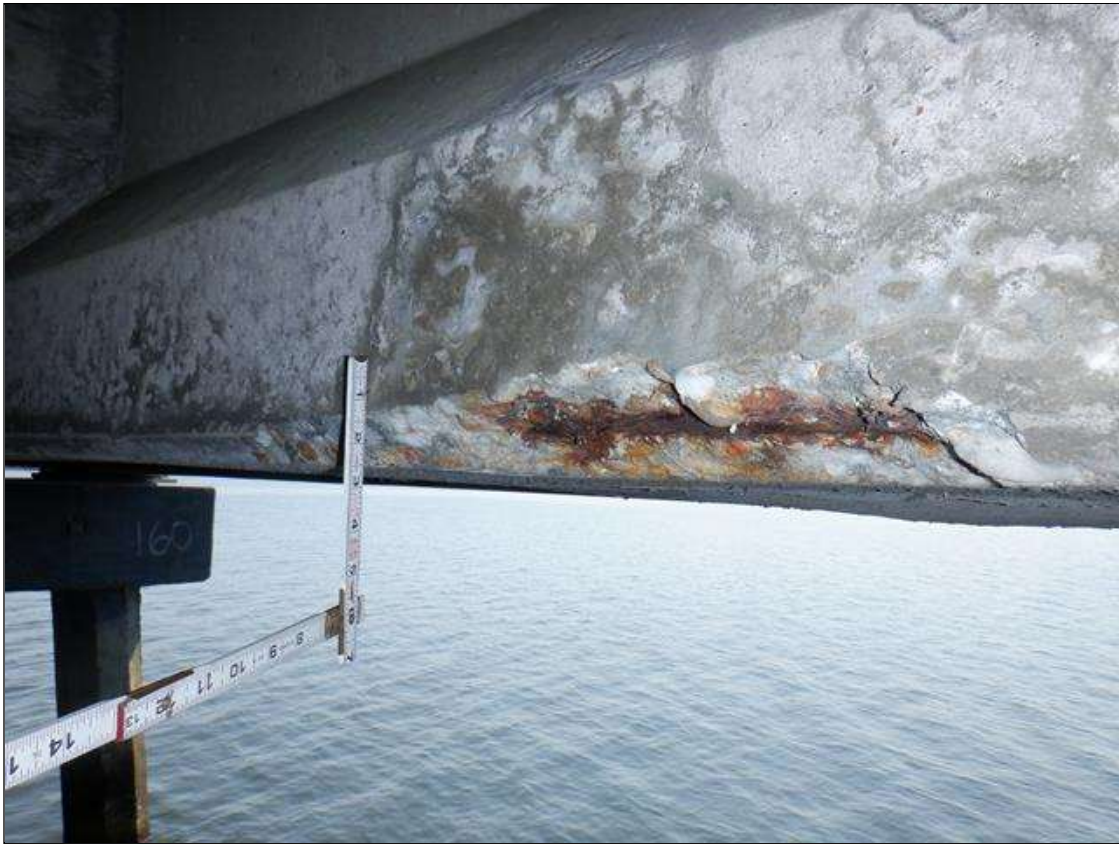
Span 160 Beam 2: (PAR) BOTTOM OF BOTTOM FLANGE 22 FEET FROM BENT 159, SPALL (10 INCH DIAMETER X UP TO 1 INCH DEEP) WITH EXPOSED RUSTED STRANDS (10 PERCENT SECTION LOSS)

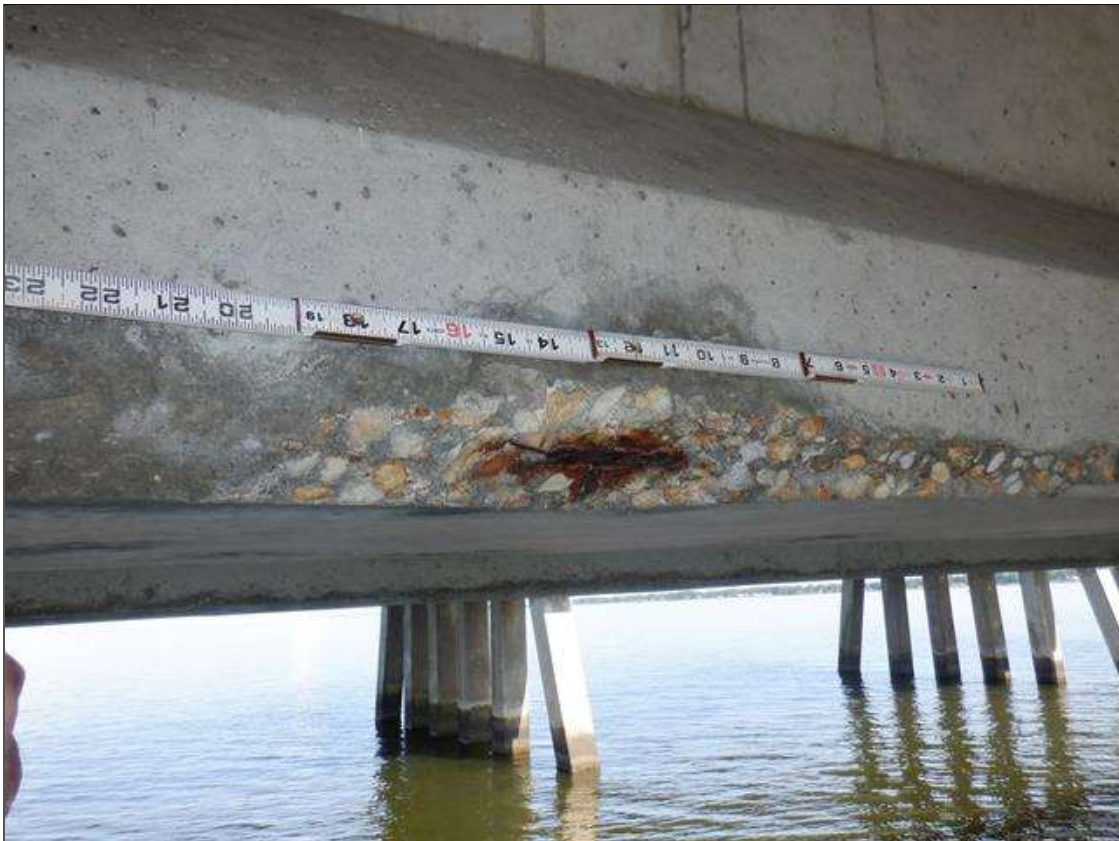
Span 160 Beam 3: (PAR) NORTH FACE OF BOTTOM FLANGE, AT 22FEET FROM BENT 160, SPALL (24INCHES X 6INCHES X 2 INCHES) WITH EXPOSED STRANDS (5 PERCENT SECTION LOSS) ON STRAND

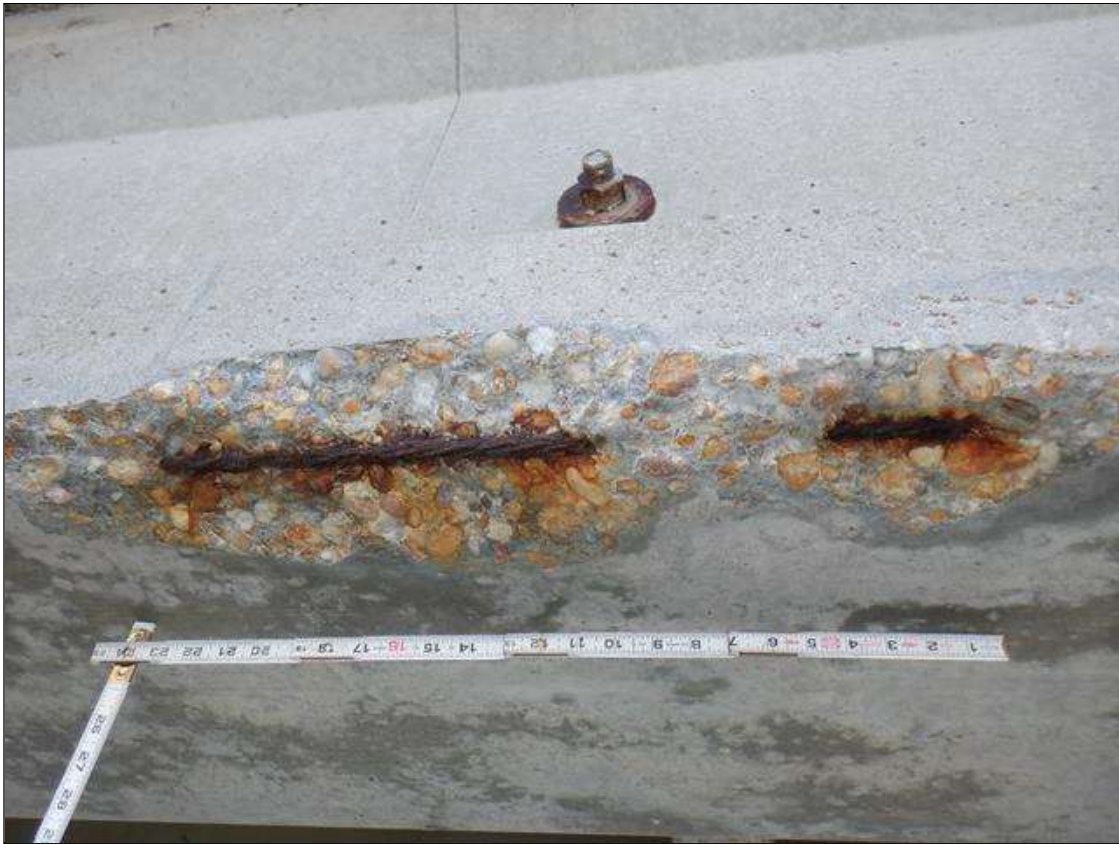
Span 161 Beam 2: (PAR) SOUTH FACE OF BOTTOM FLANGE AT MIDSPAN, SPALL (24INCHES X 4INCHES X 2 INCHES) WITH EXPOSED STRANDS (5 PERCENT SECTION LOSS) ON STRAND

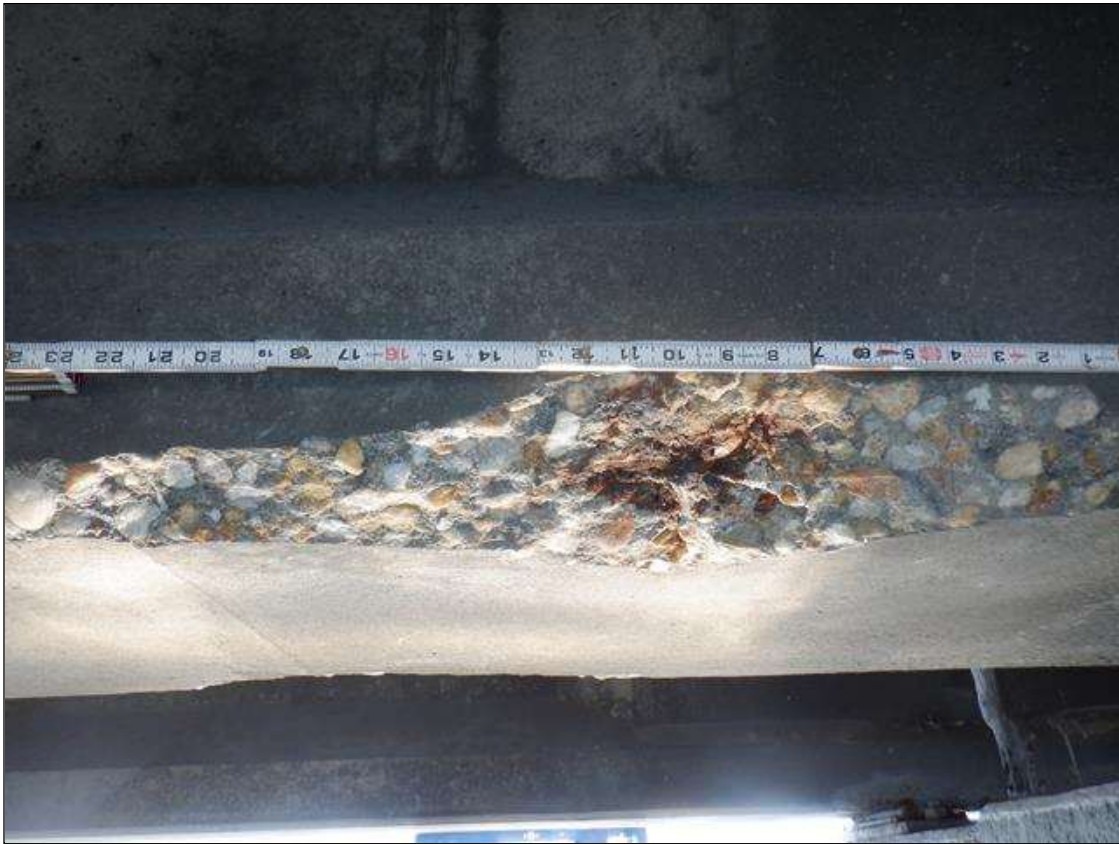
Span 162 Beam 1: (PAR) NORTH FACE OF BOTTOM FLANGE AT 20 FEET FROM BENT 161, SPALL (30 INCHES X 6 INCHES X 3 INCHES) WITH EXPOSED STRANDS (5 PERCENT SECTION LOSS) ON STRAND

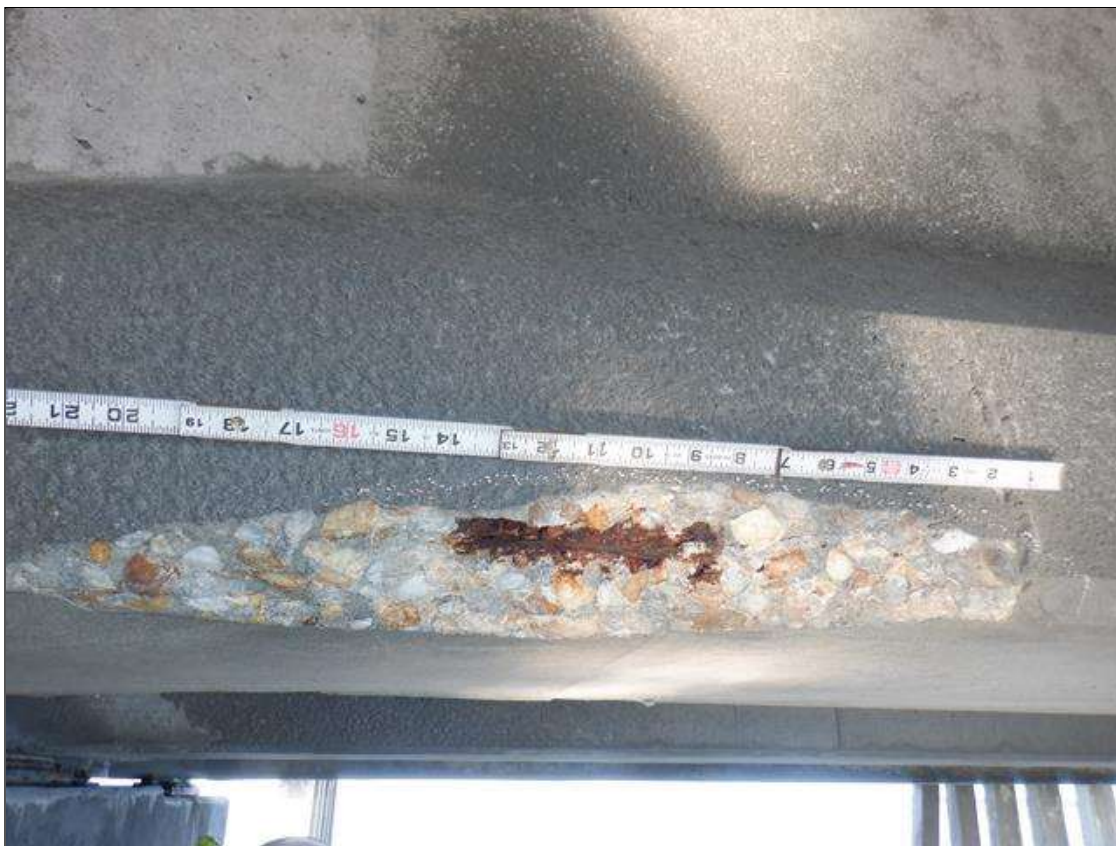
Span 162 Beam 3: (PAR) BOTTOM FLANGE BOTH FACES 5 FEET FROM BENT 161, (2) TWO SPALLS (28 INCHES LONG X 5 INCHES WIDE X 1.5 INCHES DEEP) WITH EXPOSED RUSTED STRANDS (10 PERCENT SECTION LOSS)

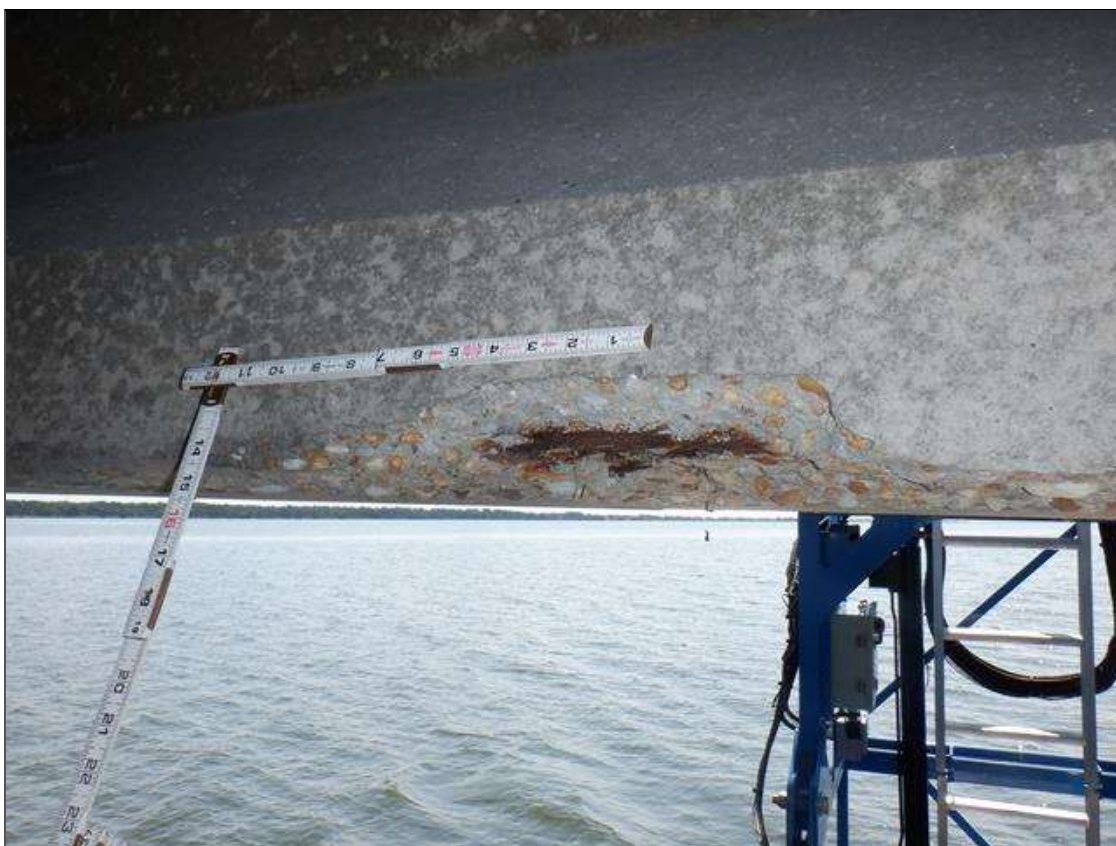
Span 162 Beam 3: (PAR) BOTTOM FLANGE BOTH FACES 5 FEET FROM BENT 161, (2) TWO SPALLS (28 INCHES LONG X 5 INCHES WIDE X 1.5 INCHES DEEP) WITH EXPOSED RUSTED STRANDS (10 PERCENT SECTION LOSS)

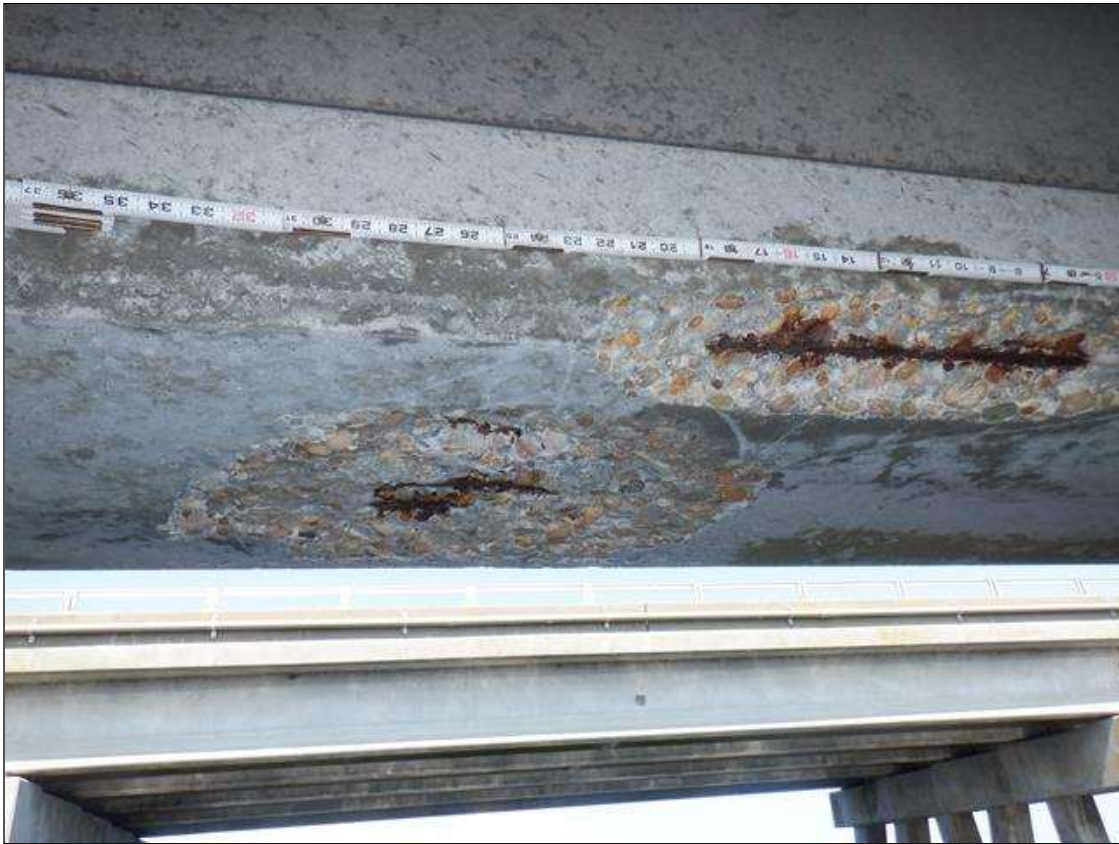
Span 162 Beam 4: (PAR) NORTH FACE OF BOTTOM FLANGE AT 12 FEET FROM BENT 161, SPALL (24 INCHES X 8 INCHES X 3 INCHES) WITH EXPOSED STRANDS (20 PERCENT SECTION LOSS) ON STRAND

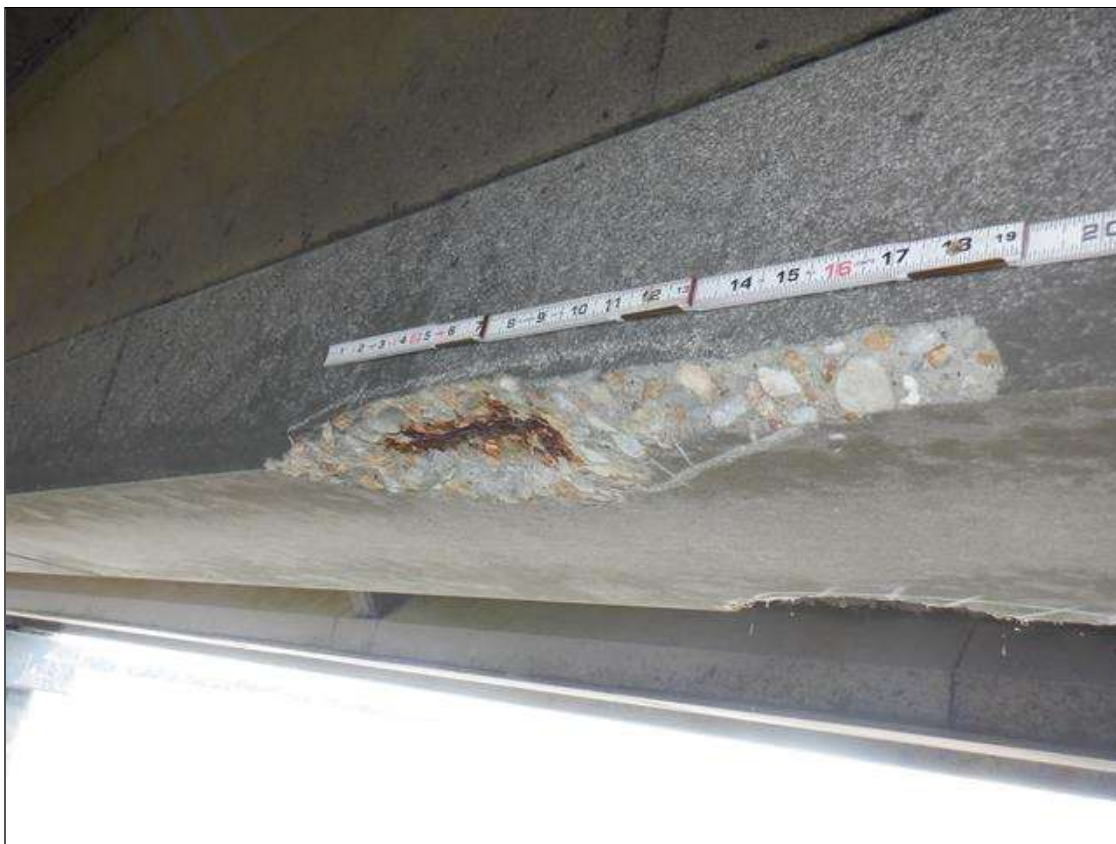
Span 163 Beam 2: (PAR) BOTTOM FLANGE, SOUTH AND BOTTOM FACES, 7 FEET FROM BENT 162, SPALL (24 INCHES X 6 INCHES X 1 INCH DEEP) WITH EXPOSED RUSTED STRANDS (10 PERCENT SECTION LOSS)

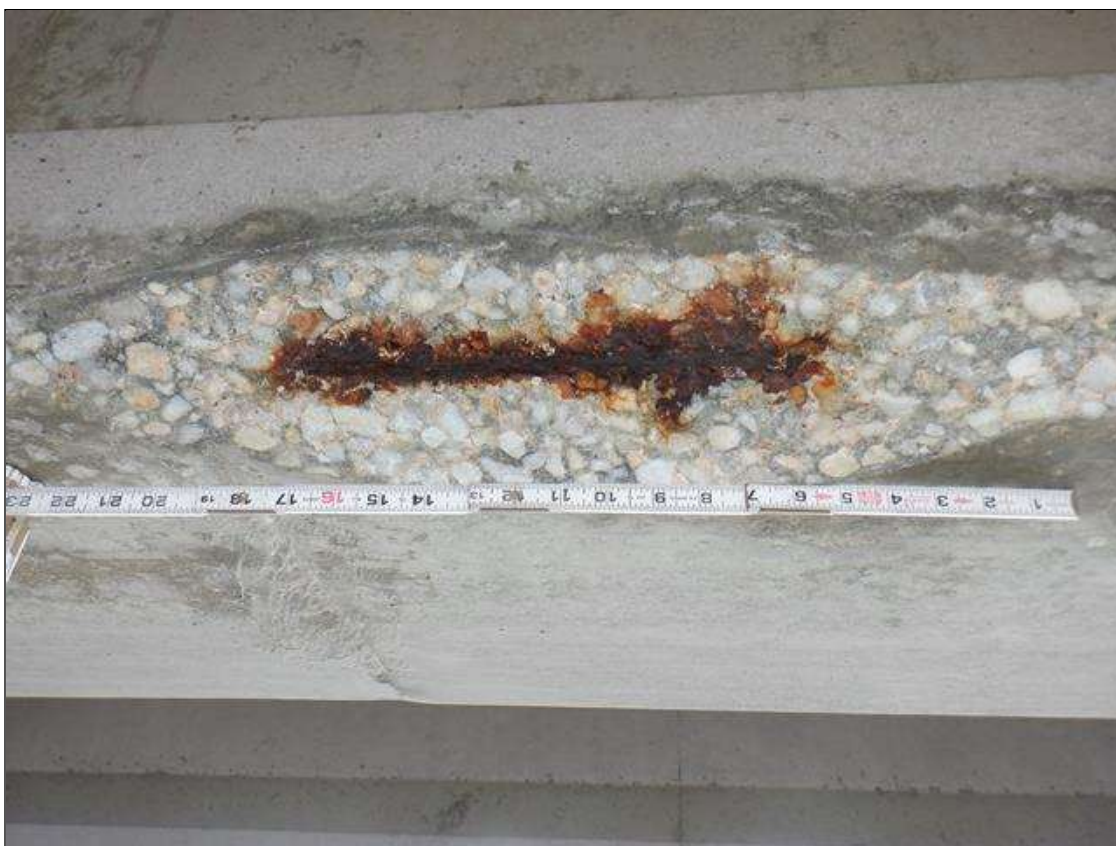
Span 163 Beam 2: (PAR) BOTTOM FLANGE, NORTH AND BOTTOM FACES, 7 FEET FROM BENT 162, SPALL (21 INCHES LONG X 5 INCHES HIGH X 1 INCH DEEP) WITH EXPOSED RUSTED STRANDS (10 PERCENT SECTION LOSS)

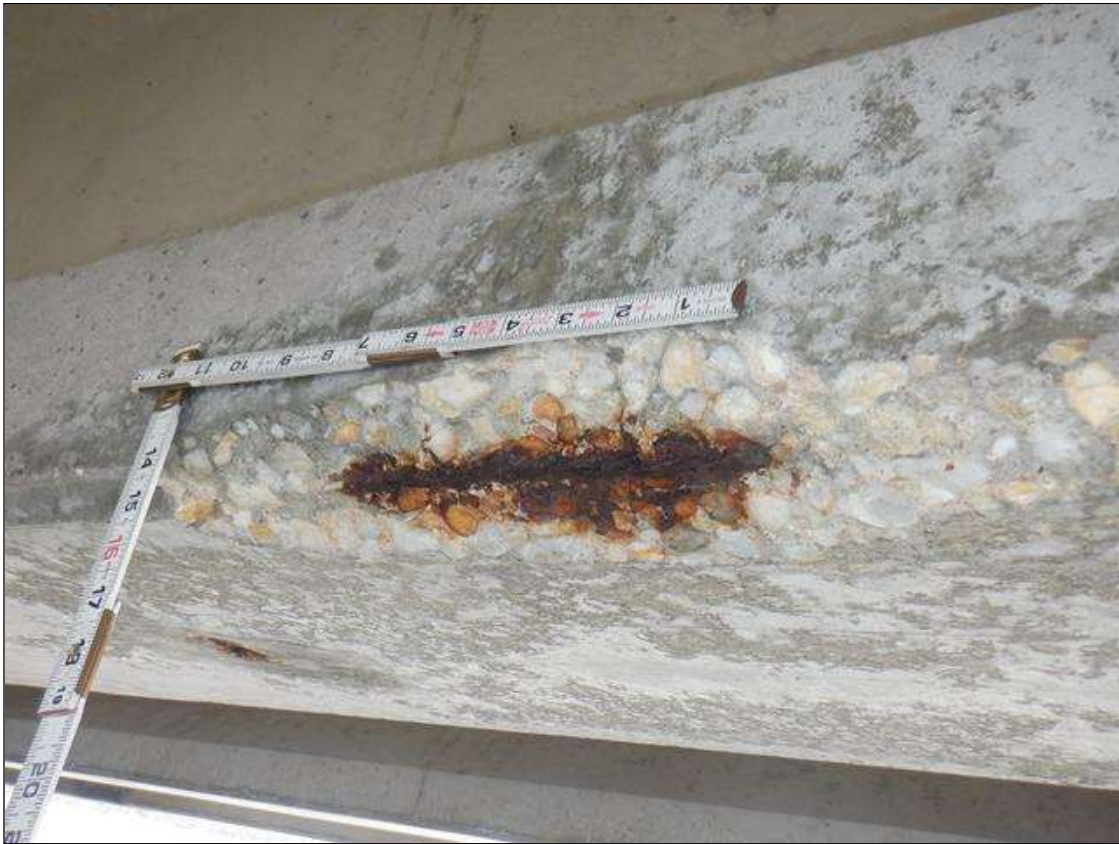
Span 203 Beam 3: (PAR) NORTH FACE OF BOTTOM FLANGE AT 13 FEET FROM BENT 202, FAILED PATCHED AREA (21 INCHES X 7 INCHES) WITH SPALL (4 INCHES X 3 INCHES X 1.5 INCHES DEEP) WITH EXPOSED RUSTED STRANDS (10 PERCENT SECTION LOSS)

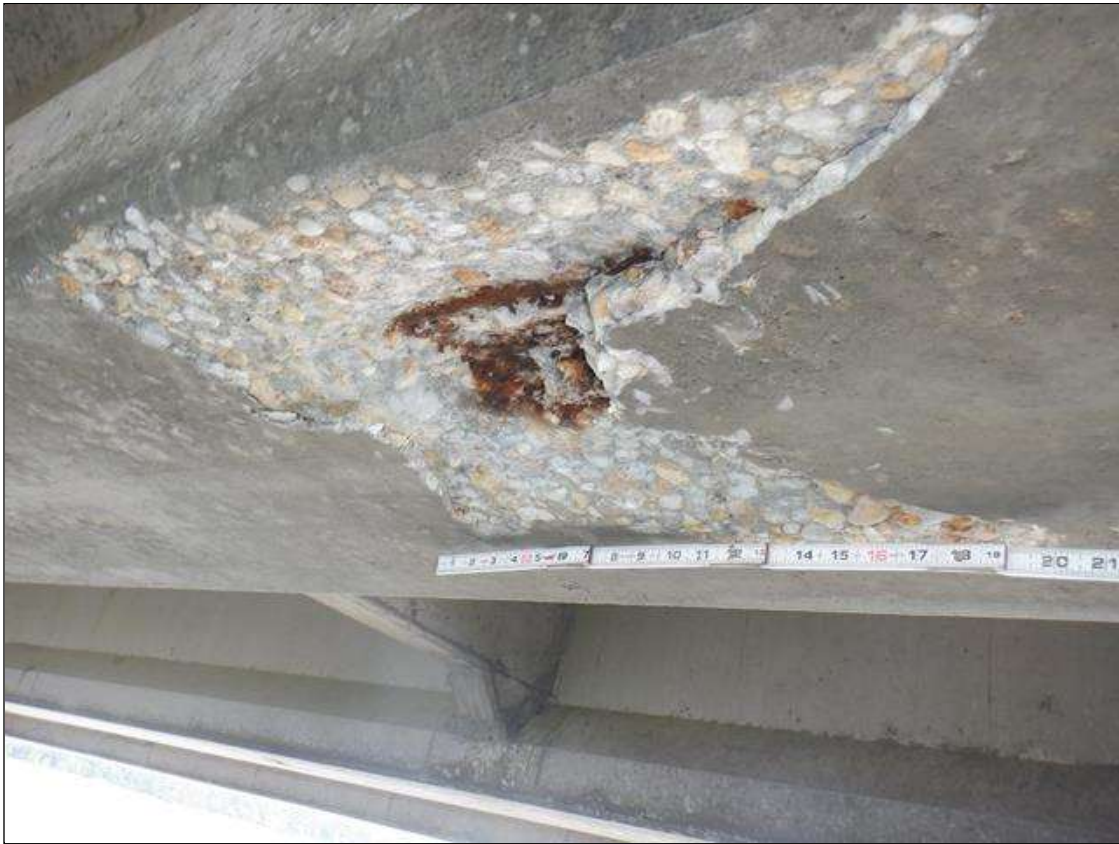
Span 205 Beam 2: (PAR) NORTH FACE OF BOTTOM FLANGE, AT 22FEET FROM BENT 204, SPALL (24INCHES X 5INCHES X 2 INCHES) WITH EXPOSED STRANDS (10 PERCENT SECTION LOSS) ON STRAND

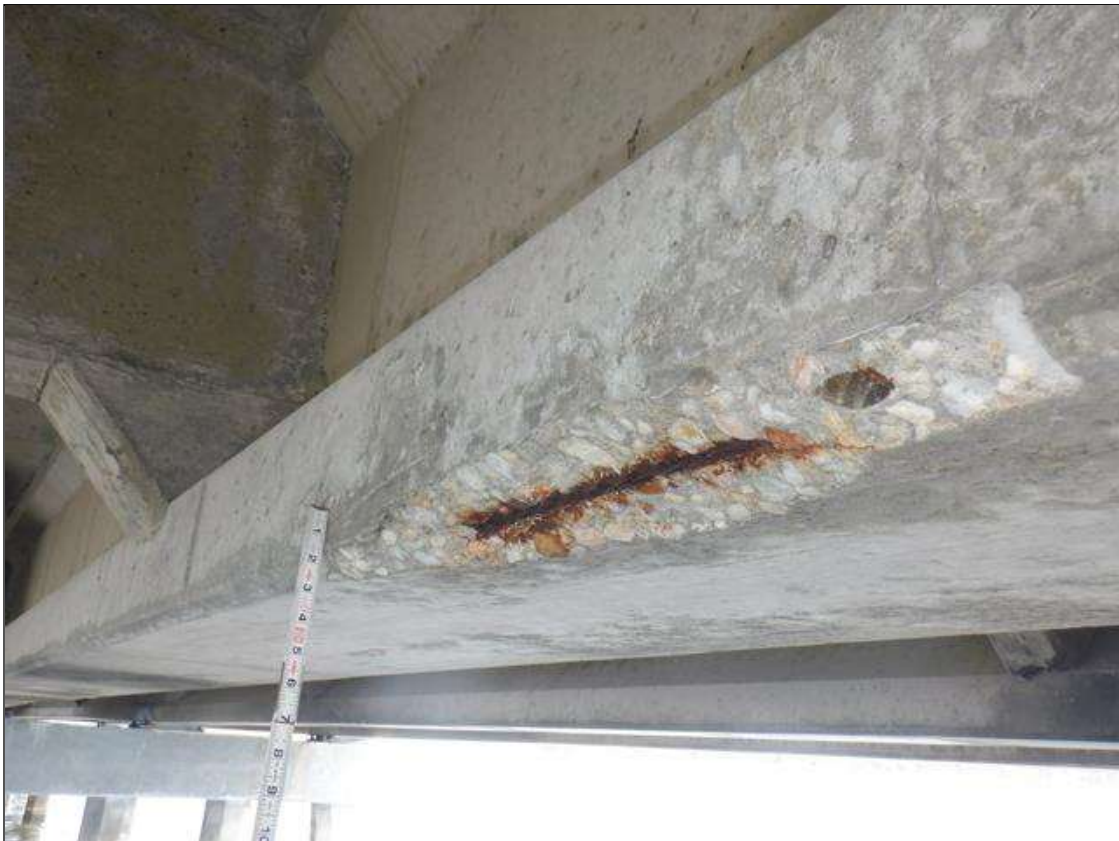
Span 210 Beam 2: (PAR) BOTTOM OF BOTTOM FLANGE AT 10 FEET FROM BENT 209, SPALL (18 INCHES LONG X 5 INCHES WIDE X 1.5 INCHES DEEP) WITH EXPOSED RUSTED STRANDS (10 PERCENT SECTION LOSS)

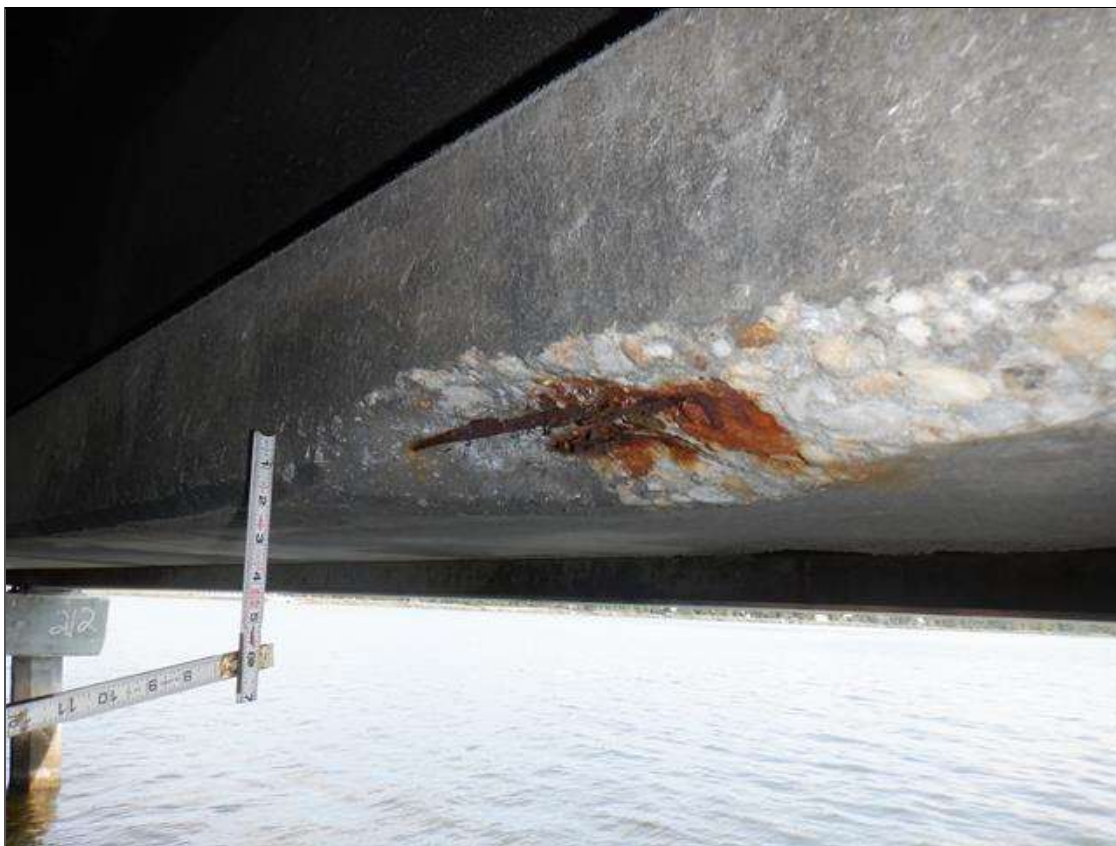
Span 212 Beam 2: (PAR) NORTH FACE OF BOTTOM FLANGE AT 15 FEET FROM BENT 211, SPALL (24 INCHES X 5 INCHES X 1.5 INCHES) WITH EXPOSED RUSTED STRANDS (10 PERCENT SECTION LOSS) ON STRANDS

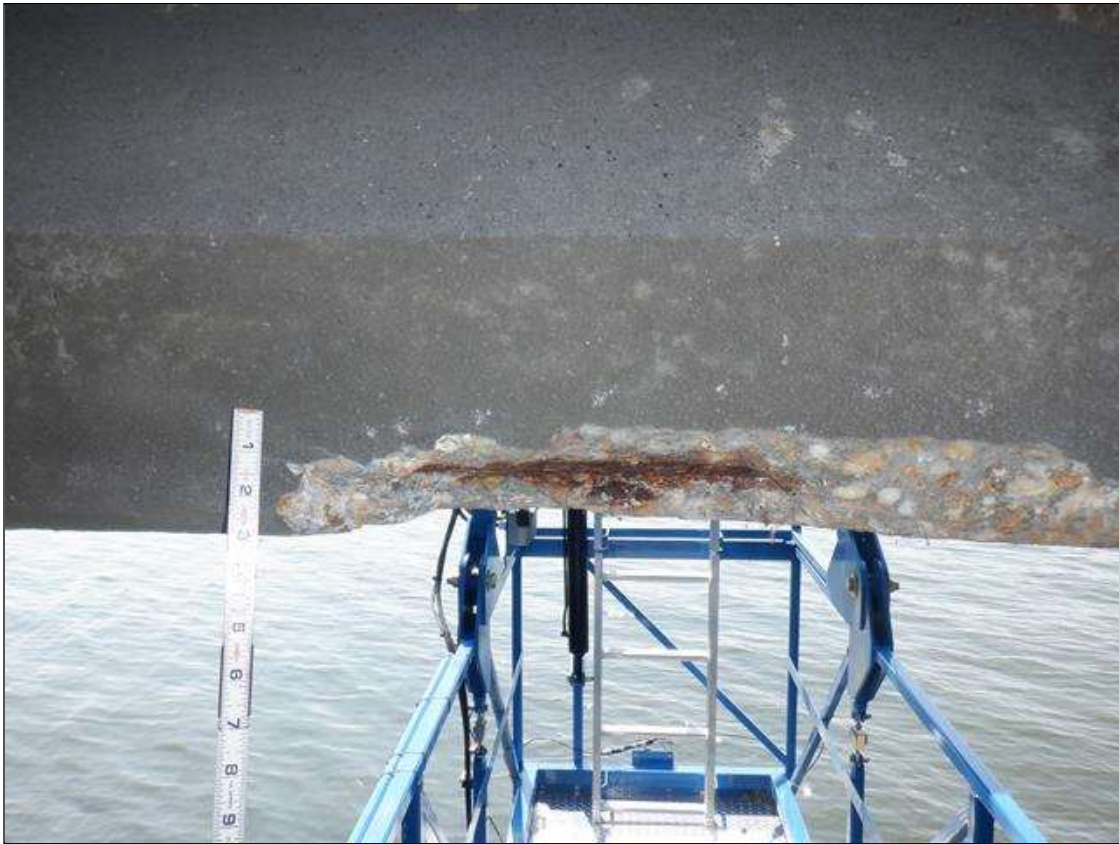
Span 212 Beam 3: (PAR) NORTH FACE OF BOTTOM FLANGE AT 13FEET FROM BENT 211, SPALL (21 INCHES X 8 INCHES X 2 INCHES) WITH (2) EXPOSED RUSTED STRANDS (75 PERCENT SECTION LOSS) ON BOTTOM LEFT STRAND AT FAILED PATCHED AREA

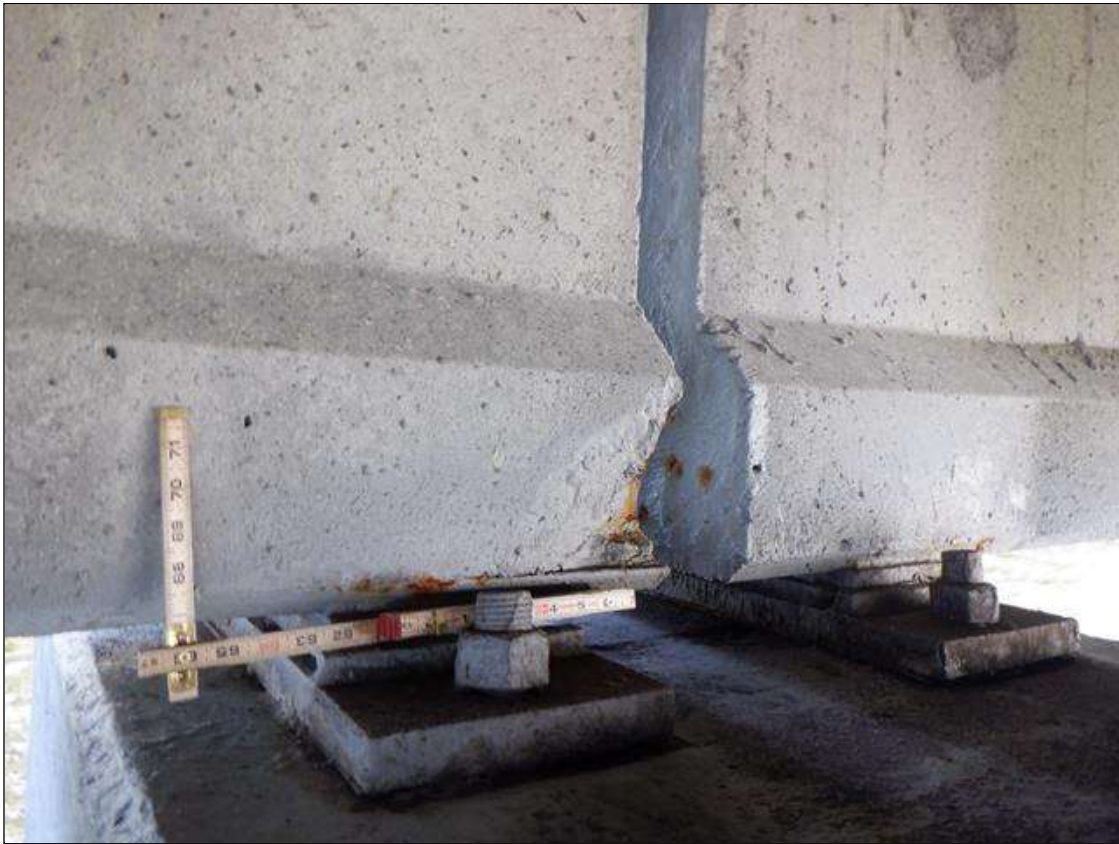
Span 161 Beam 4: (PAR) BOTTOM FLANGE NORTH FACE AT 3 FEET FROM BENT 160, SPALL (32 INCHES LONG X 5 INCHES WIDE X UP TO 2 INCHES DEEP) WITH EXPOSED RUSTED STRANDS (10 PERCENT SECTION LOSS)

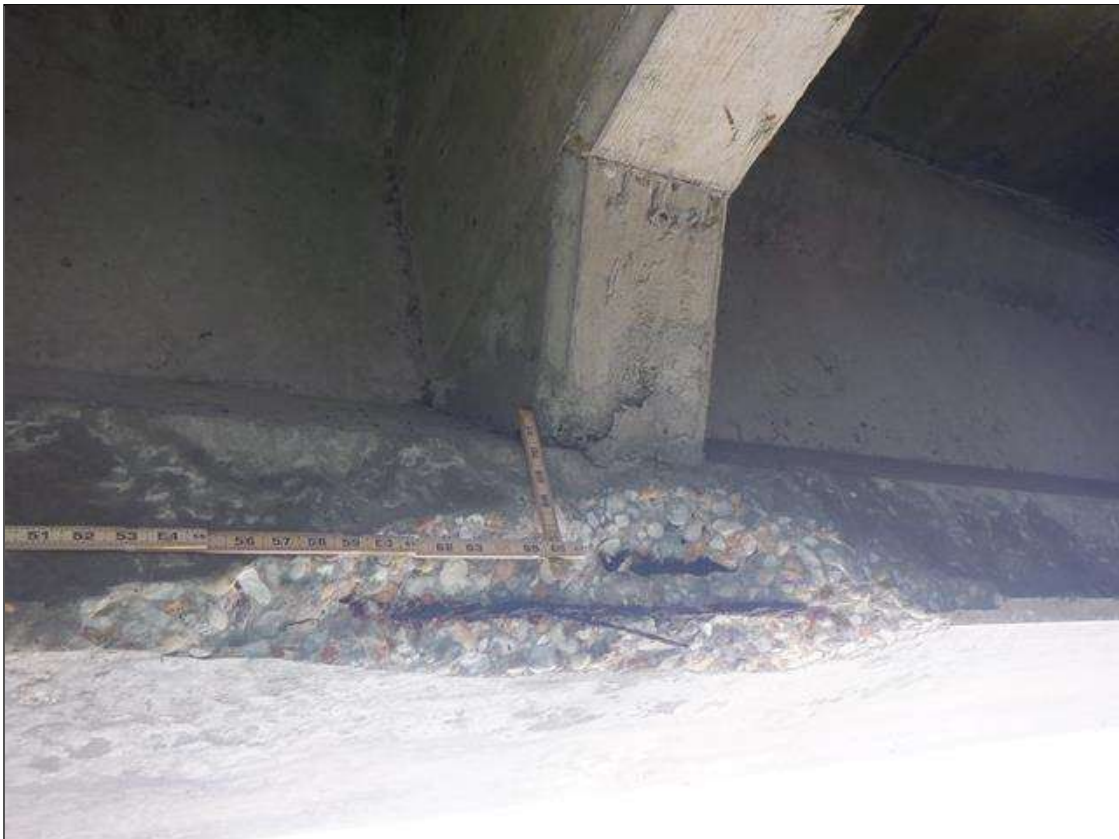
Span 116 Beam 1: (PAR) SOUTH FACE OF BOTTOM FLANGE, AT BENT 116, SPALL (7 INCHES X 7 INCHES X 3 INCHES) WITH EXPOSED STRANDS (5 PERCENT SECTION LOSS) ON STRAND

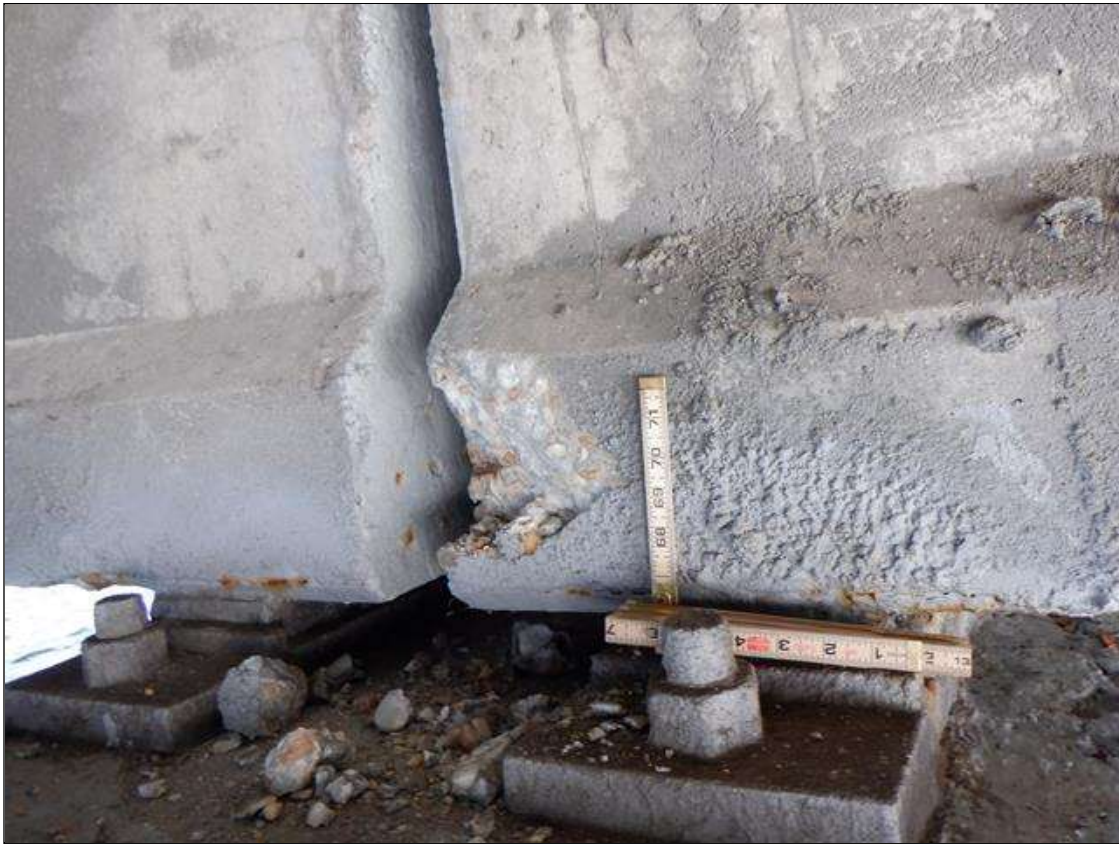
Span 116 Beam 4: (PAR) NORTH FACE OF BOTTOM FLANGE AT 20 FEET FROM BENT 115, SPALL (24 INCHES X 6 INCHES X 4 INCHES) WITH BROKEN STRANDS (100 PERCENT SECTION LOSS) ON STRAND

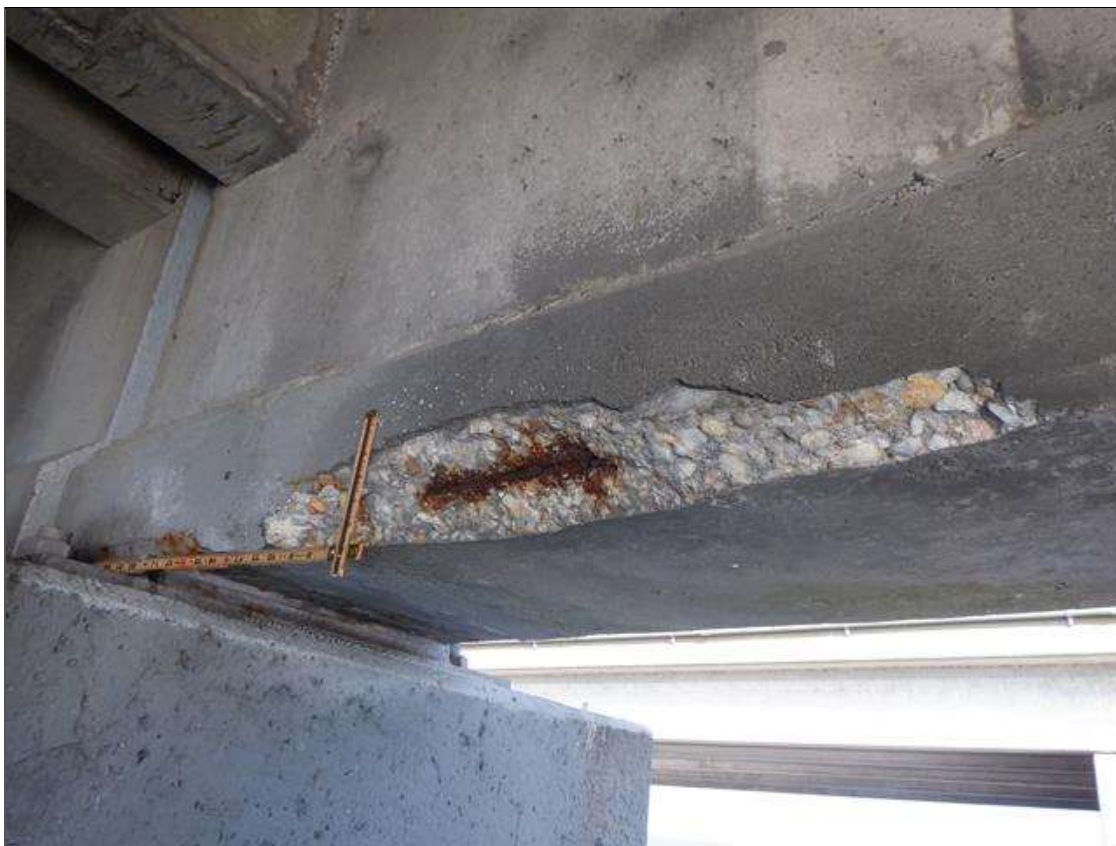
Span 118 Beam 3: (PAR) BOTTOM FLANGE SOUTH FACE AT BENT 117, SPALL (6 INCHES LONG X 6 INCHES HIGH X 1.5 INCHES DEEP) WITH (1) ON EXPOSED RUSTED STRAND (NO LOSS)

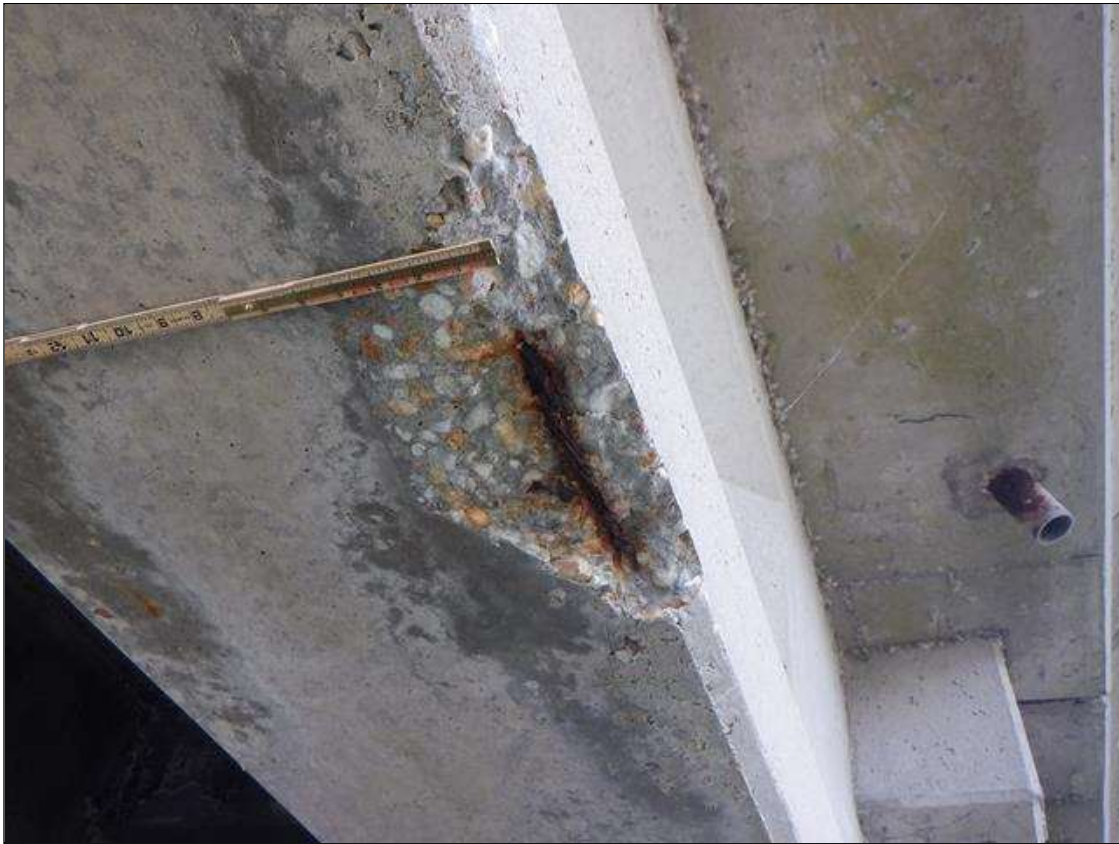
Span 121 Beam 2: (PAR) BOTTOM OF BOTTOM FLANGE AT MIDSPAN, SPALL/DELAMINATION (20 INCHES LONG X 3 INCHES HIGH X 5 INCHES WIDE X 1.5 INCHES DEEP) WITH (1) EXPOSED RUSTED STRAND (10 PERCENT SECTION LOSS)

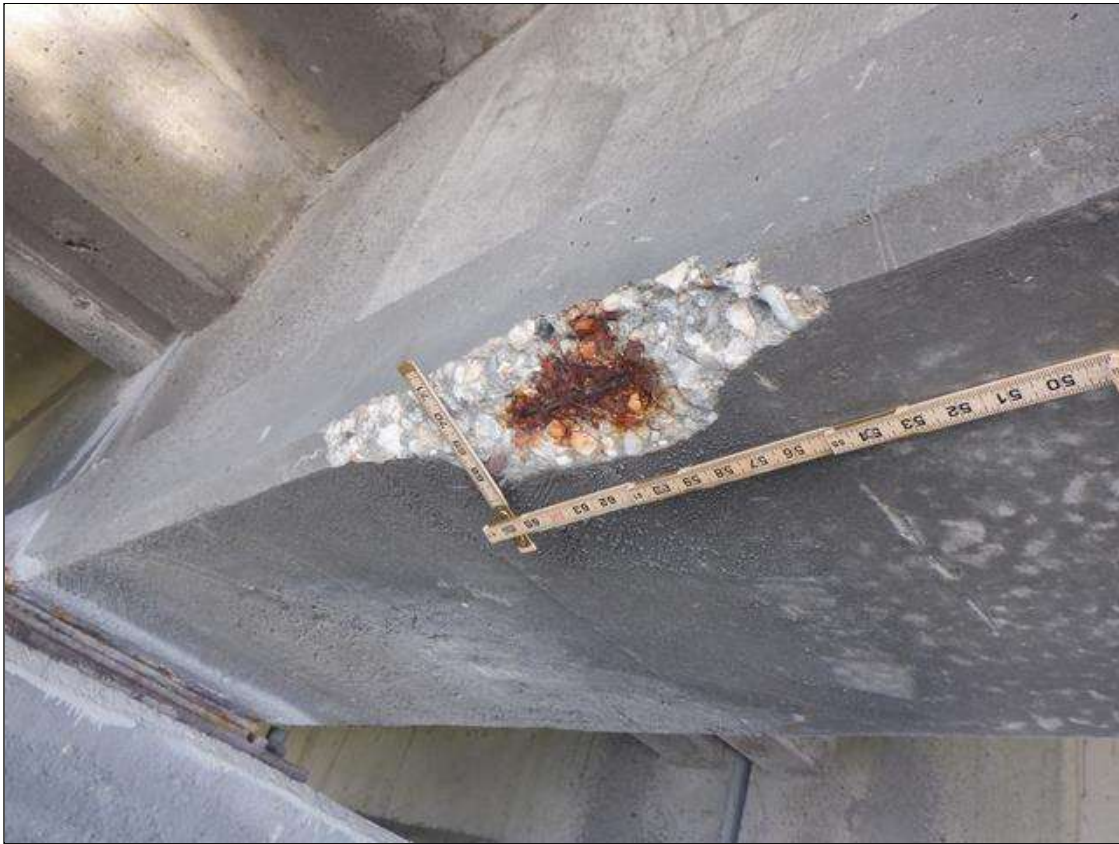
Span 122 Beam 1: (PAR) NORTH FACE OF BOTTOM FLANGE AT 6 FEET FROM BENT 121, SPALL (18 INCHES X 6 INCHES X 2 INCHES) WITH EXPOSED STRANDS (10 PERCENT SECTION LOSS) ON STRAND

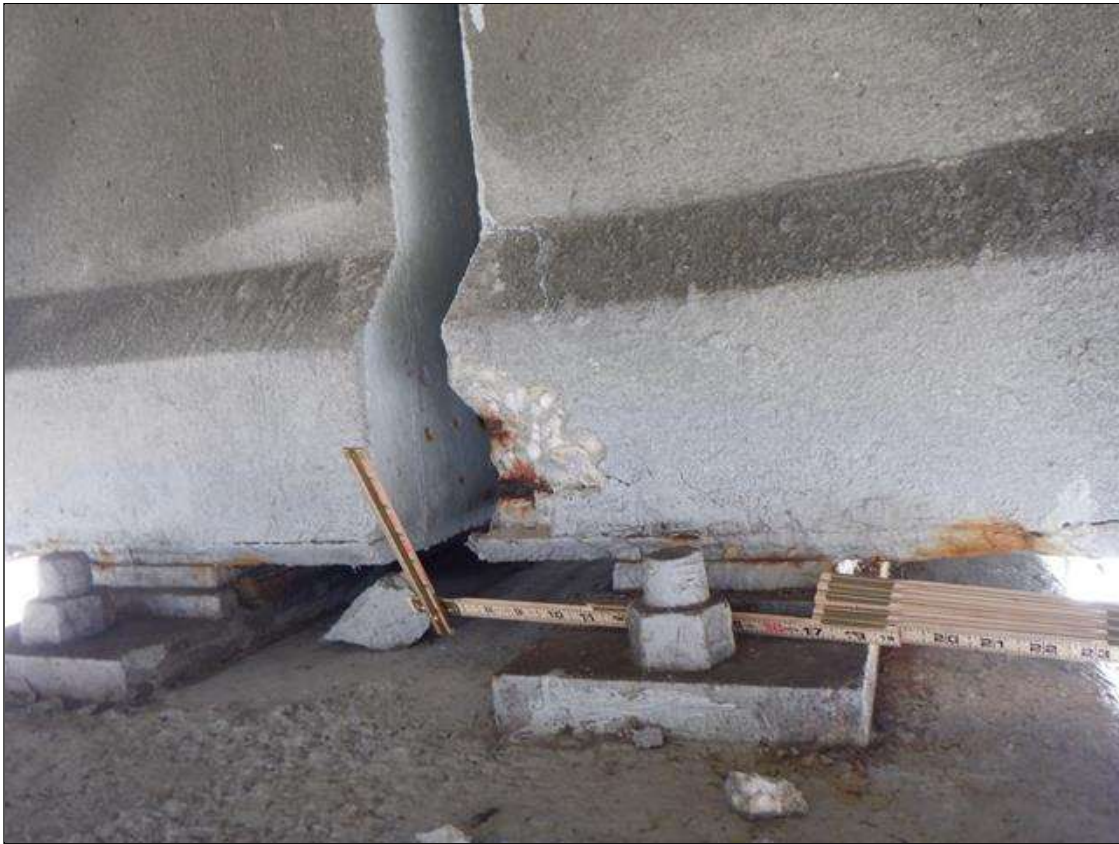
Span 122 Beam 2: (PAR) SOUTH FACE OF BOTTOM FLANGE AT 8 FEET FROM BENT 121, SPALL (16 INCHES LONG X 3 INCHES HIGH X 4 INCHES WIDE X 1.5 INCHES DEEP) WITH (1) EXPOSED RUSTED STRAND (10 PERCENT SECTION LOSS)

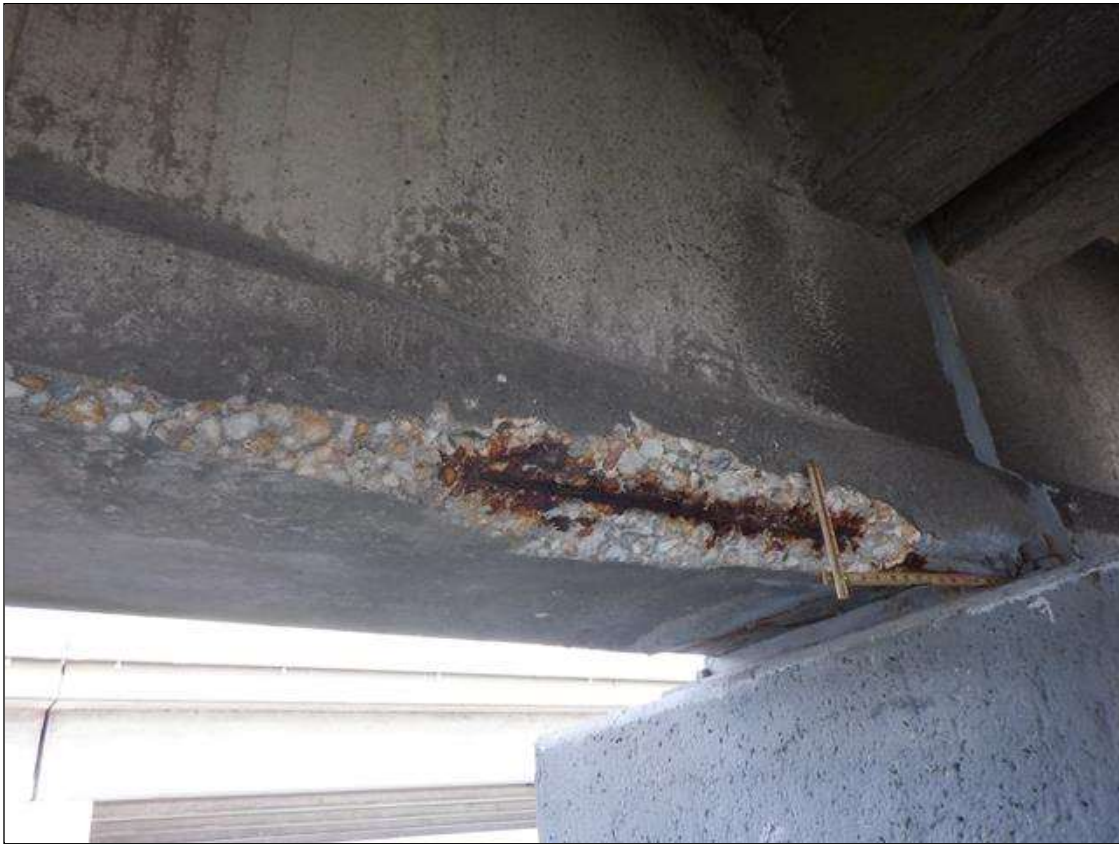
Span 124 Beam 2: (PAR) NORTH FACE OF BOTTOM FLANGE 10 FEET FROM BENT 124, UNSOUND PATCHED AREA (30 INCHES X 4 INCHES) WITH SPALL (16 INCHES X 5 INCHES X 2 INCHES X 1.5 INCHES DEEP) WITH (1) EXPOSED RUSTED STRAND (10 PERCENT SECTION LOSS)

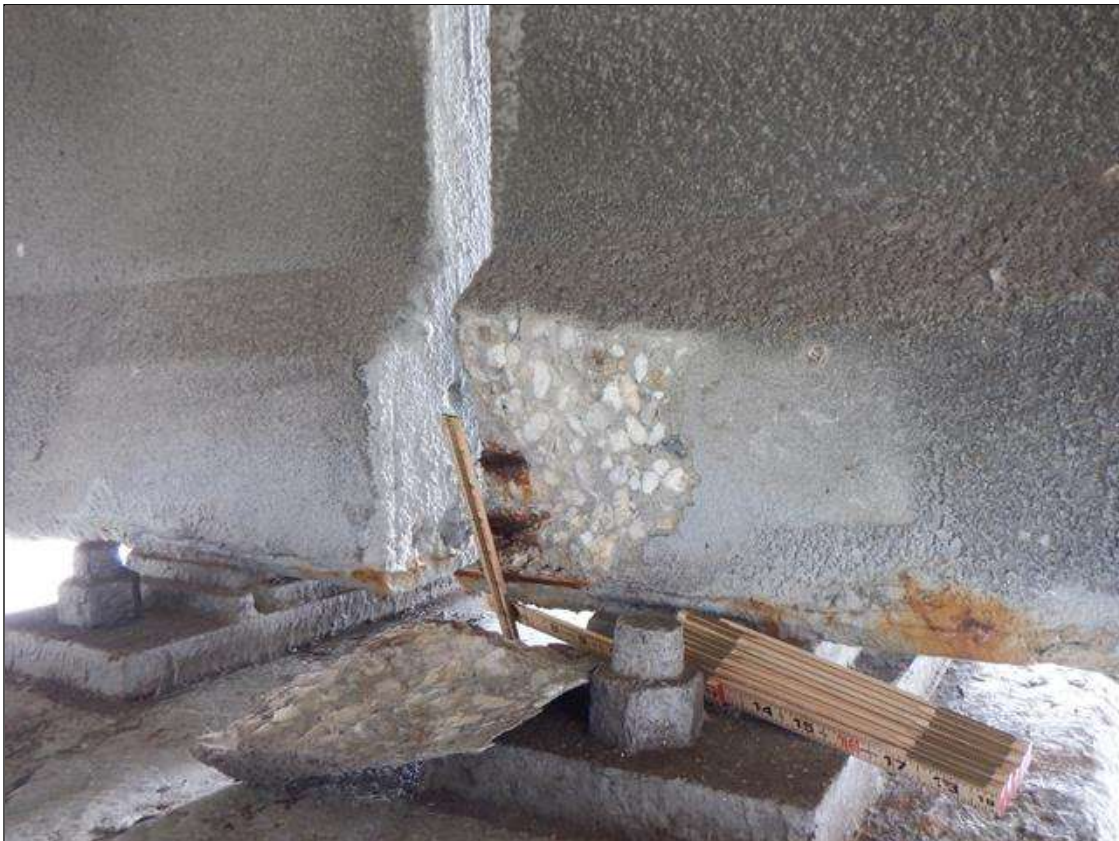
Span 126 Beam 1: (PAR) SOUTH FACE OF BOTTOM FLANGE AT 2 FEET FROM BENT 126, SPALL (48 INCHES LONG X 5 INCHES HIGH X 7 INCHES WIDE X 1.5 INCHES DEEP) WITH (1) ONE SEVERED STRAND
