NC DEPARTMENT OF TRANSPORTATION  
DIVISION OF HIGHWAYS  
STRUCTURE MANAGEMENT UNIT

## Structure Safety Report

### Routine Element Inspection - Contract

STRUCTURE NUMBER: 260016 SAP STRUCTURE NO: 0270016 FHWA STRUCTURE NO: 000000000530016  
DIVISION: 1 COUNTY: CURRITUCK INSPECTION DATE: 09/21/2022 FREQUENCY: 24 MONTHS  
FACILITY CARRIED: US158E MILE POST: \_\_\_\_\_  
LOCATION: .01 MI.E.JCT.SR1187  
FEATURE INTERSECTED: CURRITUCK SOUND  
LATITUDE: 36° 5' 11.69" LONGITUDE: 75° 46' 0.21"  
SUPERSTRUCTURE: RC FLOOR ON PPC GIRDERS & CORED SLAB  
SUBSTRUCTURE: EBTS:RC CAP/PPC PILES;IBTS:RCP&B & RC CAPS/PPC PILES  
SPANS: 248 SPANS. SEE SPAN PROFILE SHEET FOR SPAN DETAILS  
☐ FRACTURE CRITICAL ☐ TEMPORARY SHORING ☐ SCOUR CRITICAL ☐ SCOUR PLAN OF ACTION  
GRADES: (Inspector/NBI Coding) DECK 6 / 6 SUPERSTRUCTURE 5 / 5 SUBSTRUCTURE 6 / 6 CULVERT N / N  
POSTED SV: Not Posted POSTED TTST: Not Posted  
OTHER SIGNS PRESENT: None

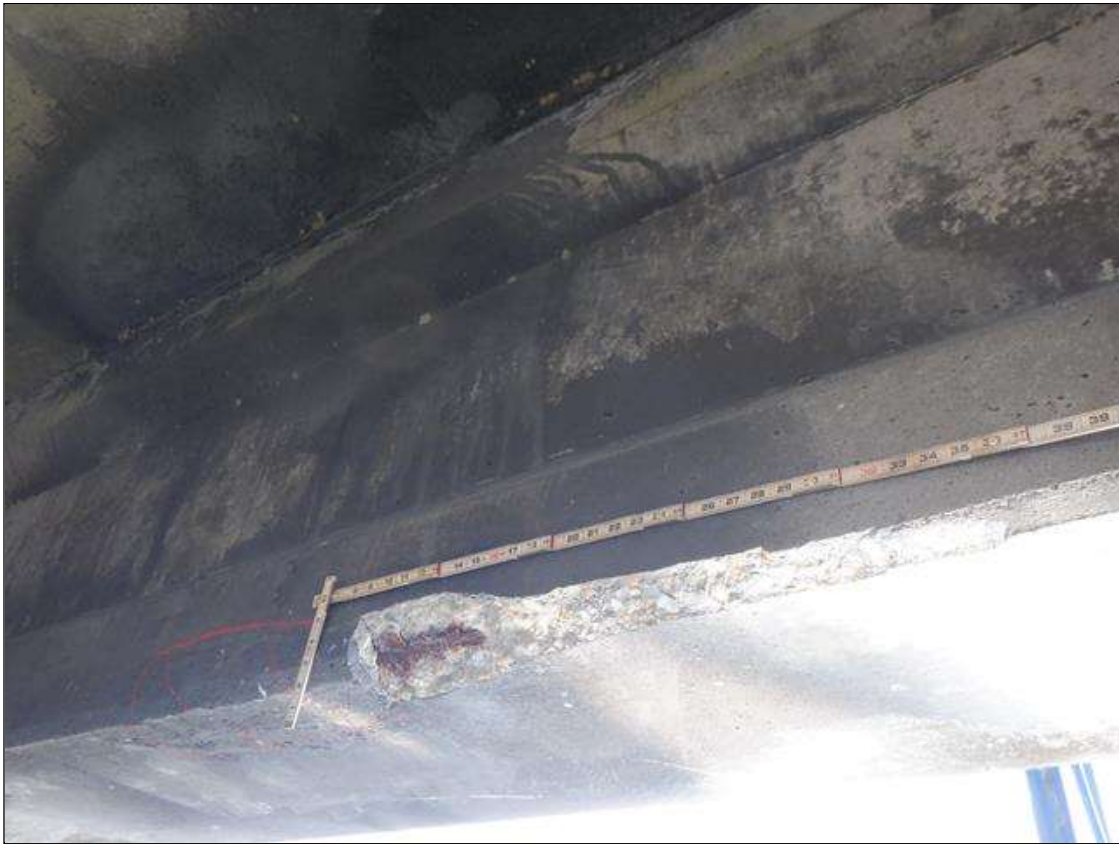
Span 130 Beam 3: (PAR) SOUTH FACE OF BOTTOM FLANGE AT 16 FEET FROM BENT 129, FAILED PATCH/SPALL (22 INCHES LONG X 3 INCHES HIGH X 4 INCHES WIDE X 1.5 INCHES DEEP) WITH (1) EXPOSED RUSTED STRAND (10 PERCENT SECTION LOSS)

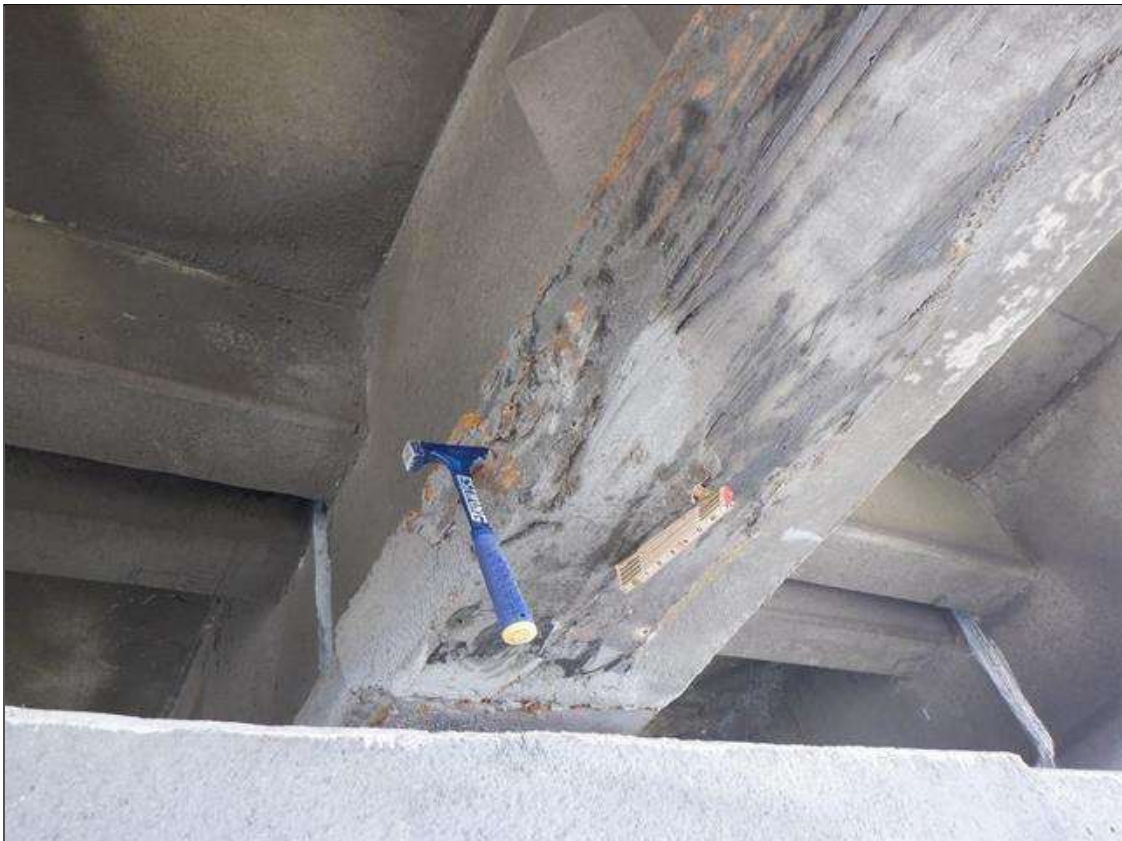
Span 133 Beam 3: (PAR) NORTH FACE OF BOTTOM FLANGE AT MIDSPAN, (2) TWO ADJACENT SPALLS (UP TO 24 INCHES X 6 INCHES X 2 INCHES) WITH BROKEN STRANDS (100 PERCENT SECTION LOSS) ON STRAND

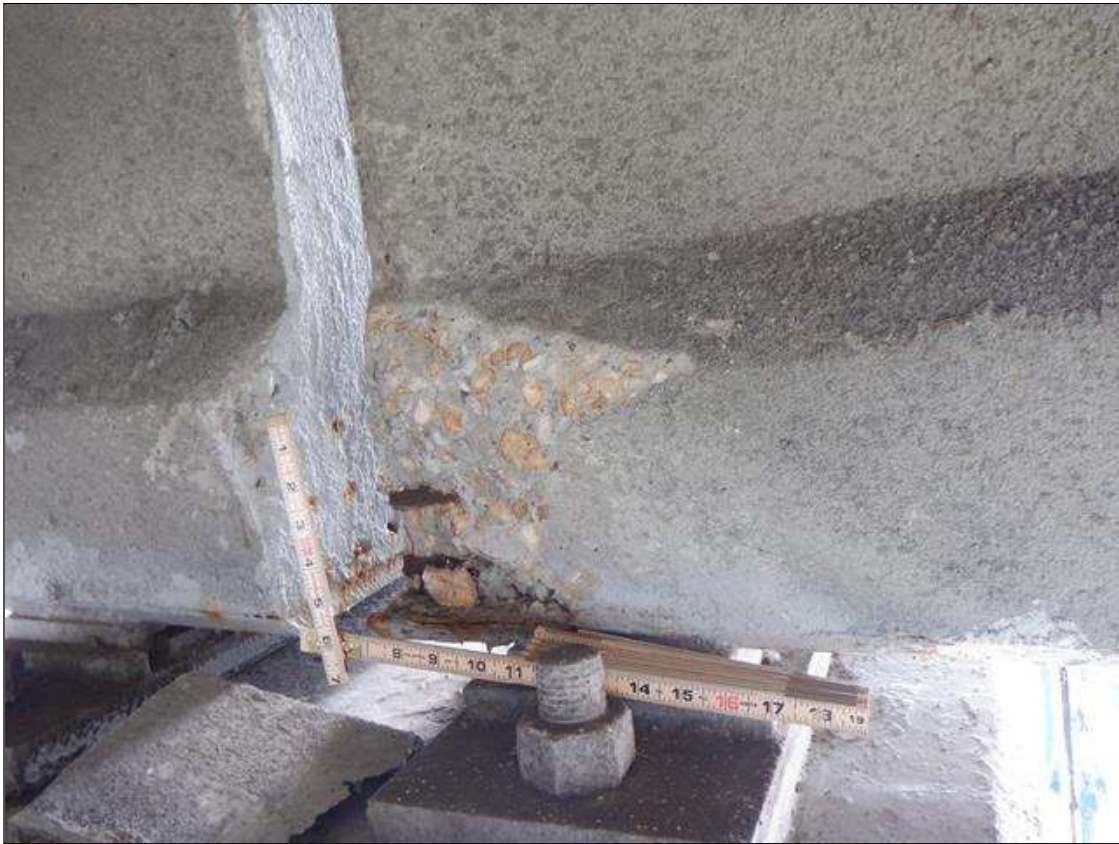
Span 134 Beam 3: (PAR) NORTH FACE AND BOTTOM OF BOTTOM FLANGE AT BENT 134, DELAMINATION (32 INCHES LONG X 7 INCHES HIGH X 10 INCHES WIDE) WITH CRACKS (UP TO 1/2 INCH WIDE)

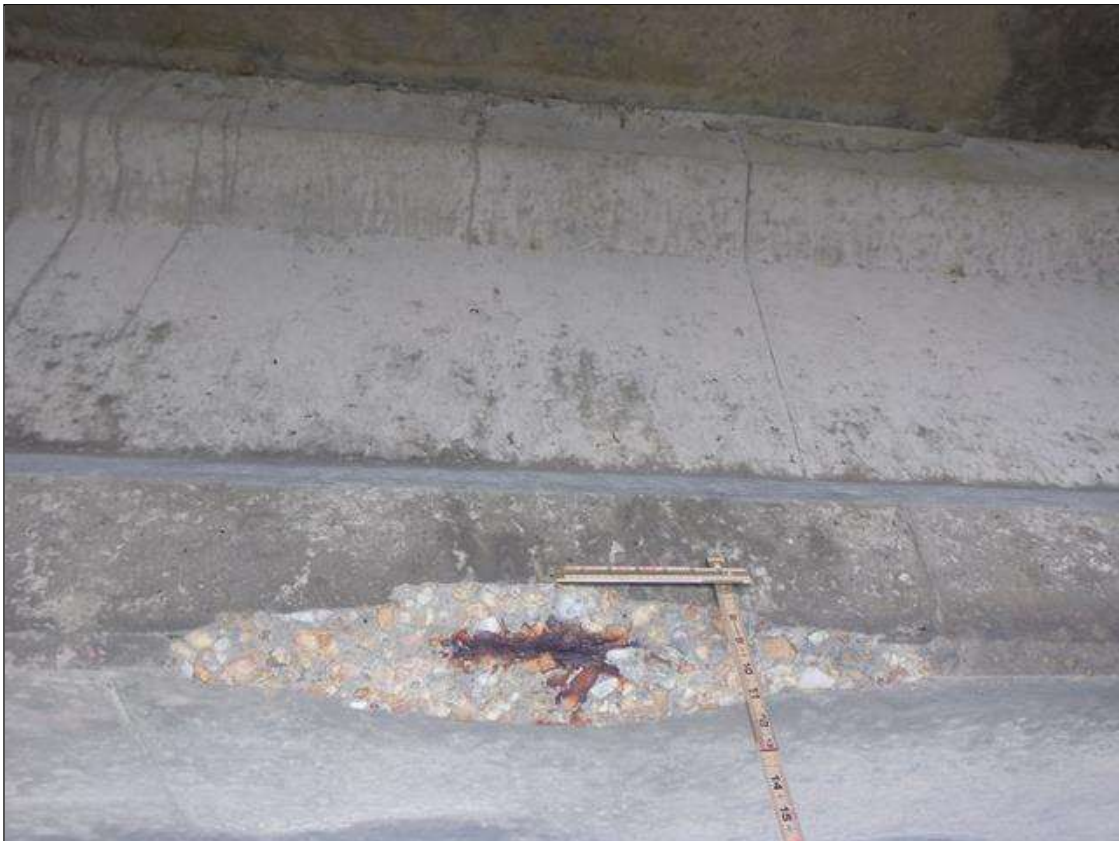
Span 135 Beam 4: (PAR) NORTH FACE OF BOTTOM FLANGE AT BENT 135, SPALL (10 INCHES X 9 INCHES X 2 INCHES) WITH (2) TWO EXPOSED STRANDS (10 PERCENT SECTION LOSS)

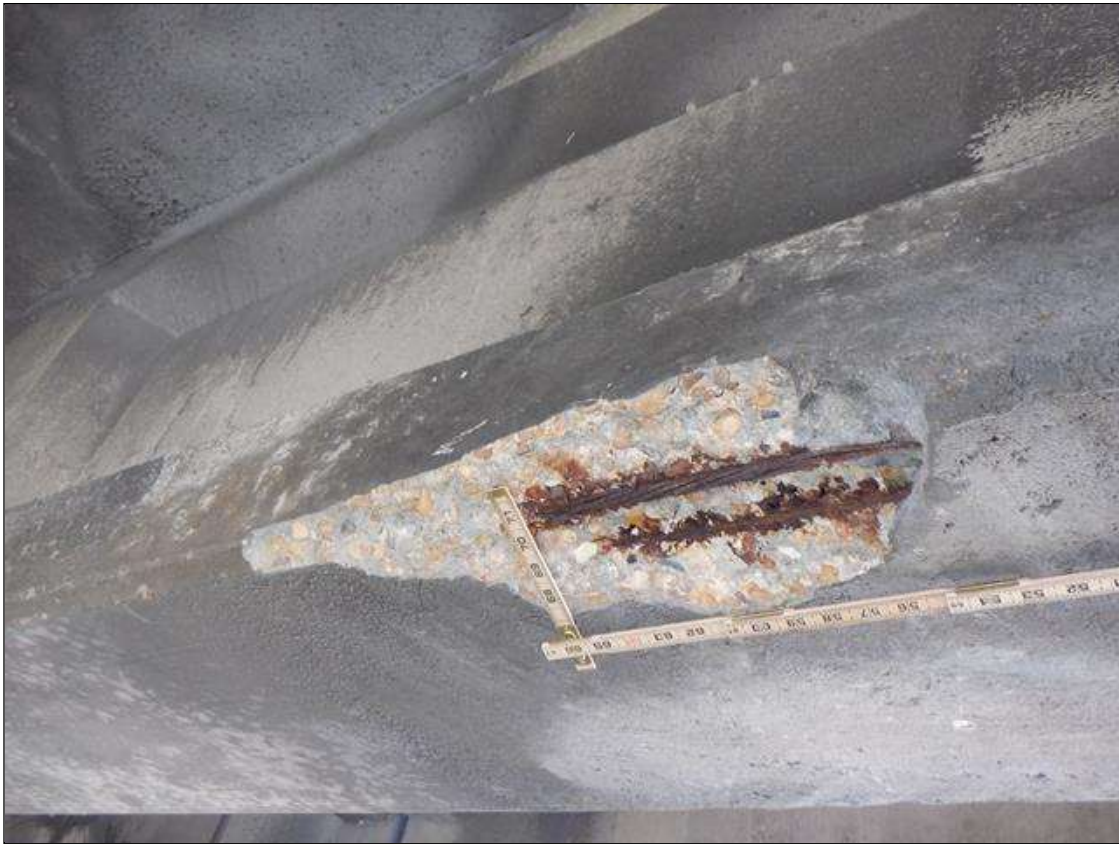
Span 136 Beam 1: (PAR) SOUTH FACE OF BOTTOM FLANGE AT 12FEET FROM BENT 135, SPALL (25INCHES X 5INCHES X 2 INCHES) WITH EXPOSED STRANDS (10 PERCENT SECTION LOSS) ON STRAND

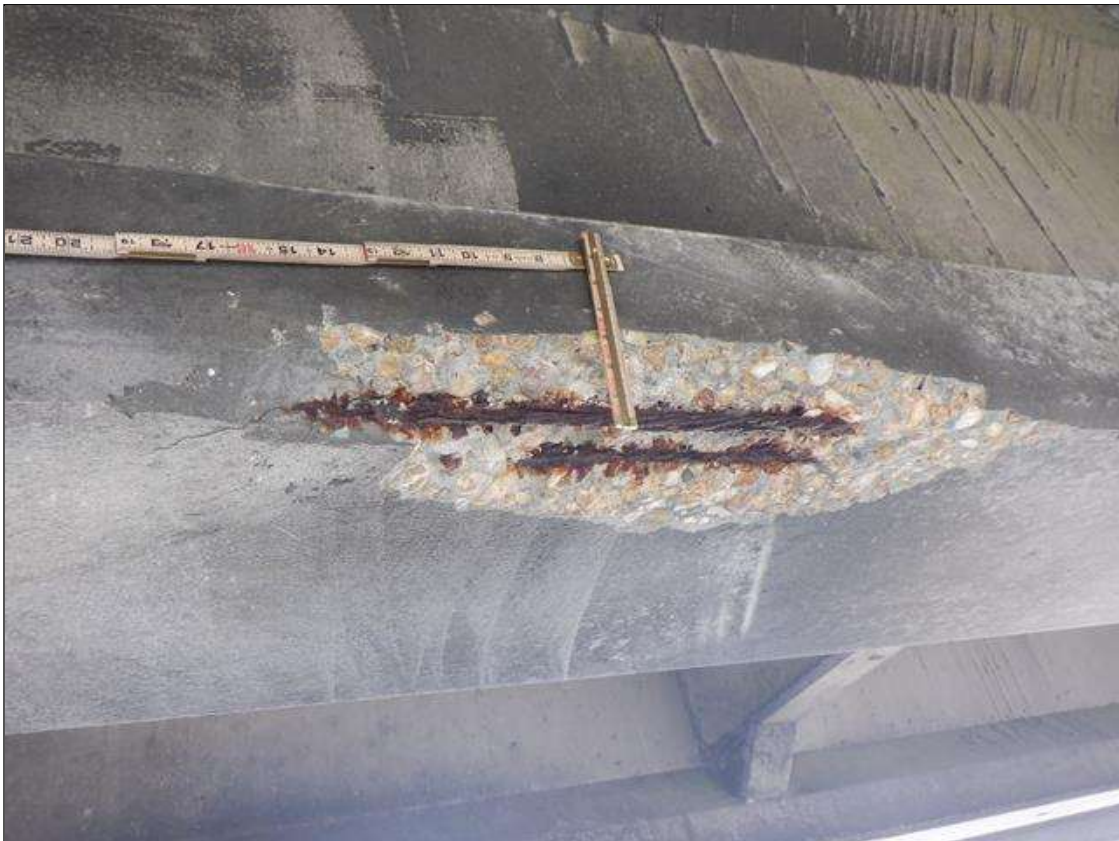
Span 137 Beam 2: (PAR) NORTH FACE OF BOTTOM FLANGE AT 10FEET FROM BENT 137, SPALL (20INCHES X 4INCHES X 2 INCHES) WITH (2) TWO EXPOSED AND SEVERED STRANDS (20 PERCENT SECTION LOSS)

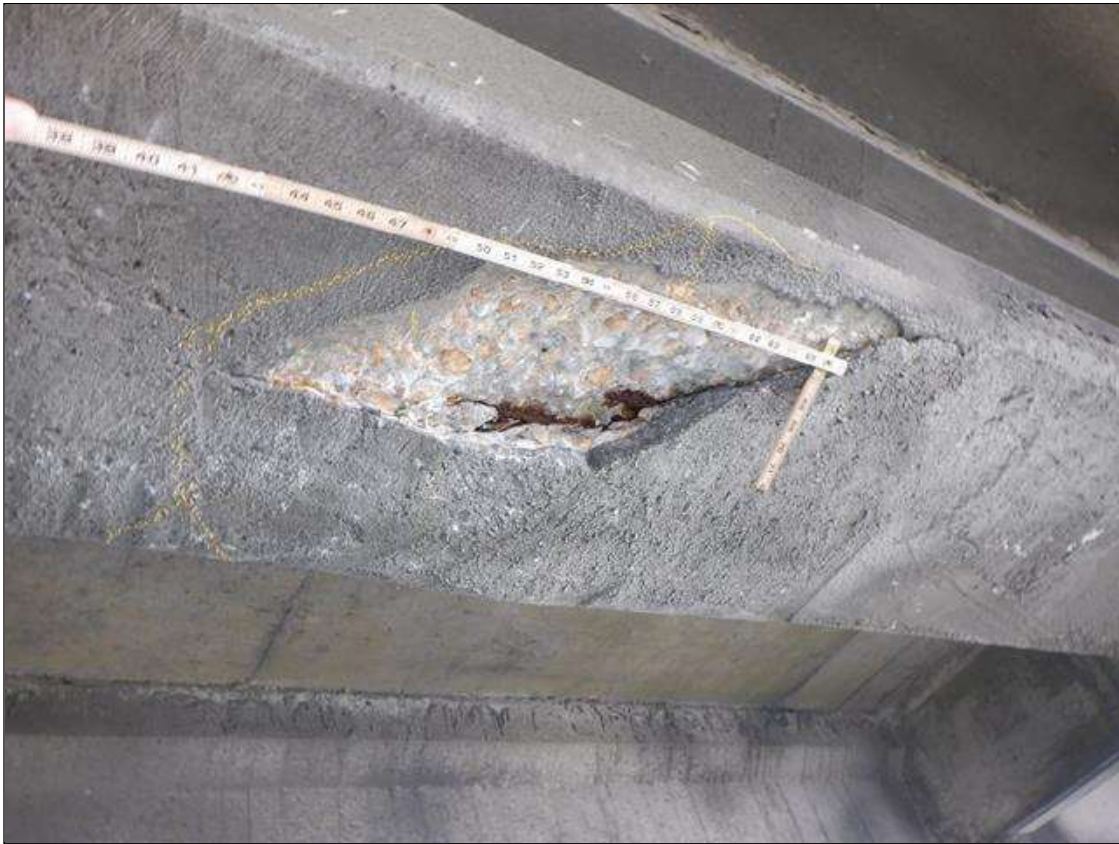
Span 137 Beam 2: (PAR) NORTH FACE OF BOTTOM FLANGE AT 16FEET FROM BENT 137, SPALL (27 INCHES X 8 INCHES X 2 INCHES) WITH (2) TWO EXPOSED STRANDS (20 PERCENT SECTION LOSS) ON STRAND

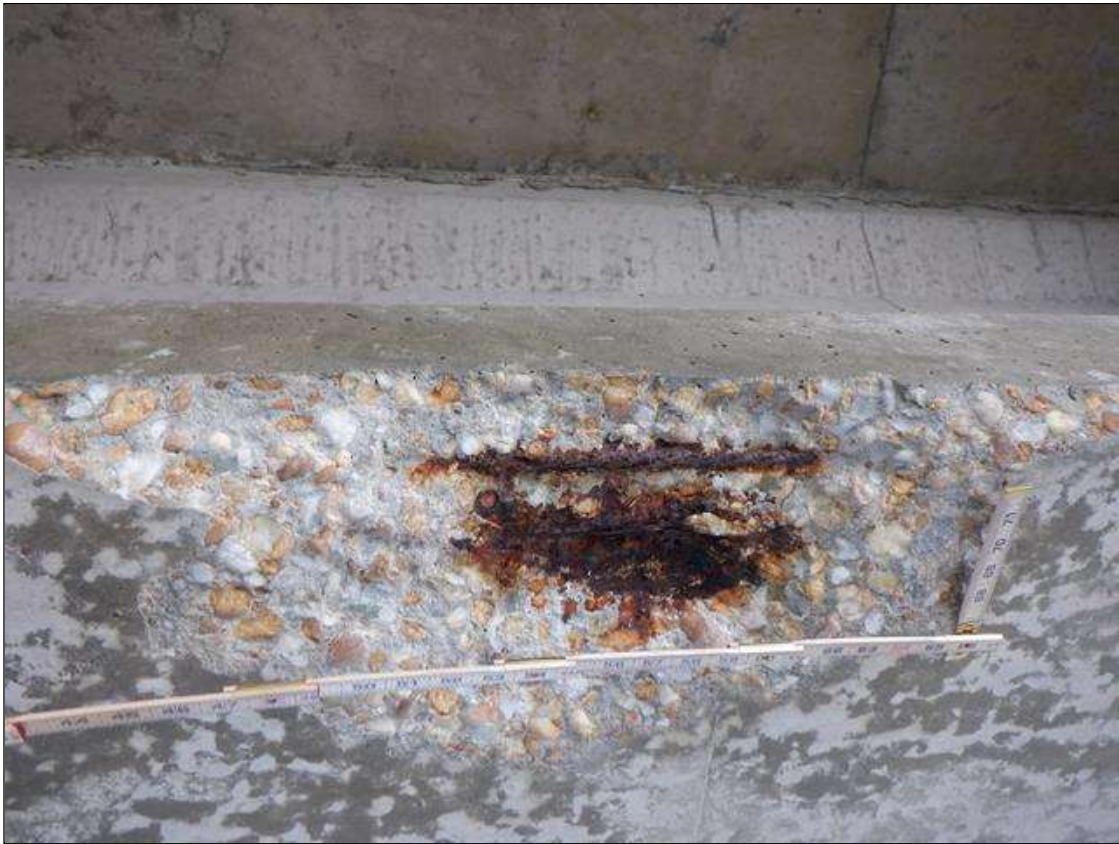
Span 138 Beam 2: (PAR) BOTTOM OF BOTTOM FLANGE AT 7 FEET FROM BENT 137, SPALL/DELAMINATION (37 INCHES LONG X FULL WIDTH X 2 INCHES DEEP) WITH (2) TWO EXPOSED STRANDS (10 PERCENT SECTION LOSS)

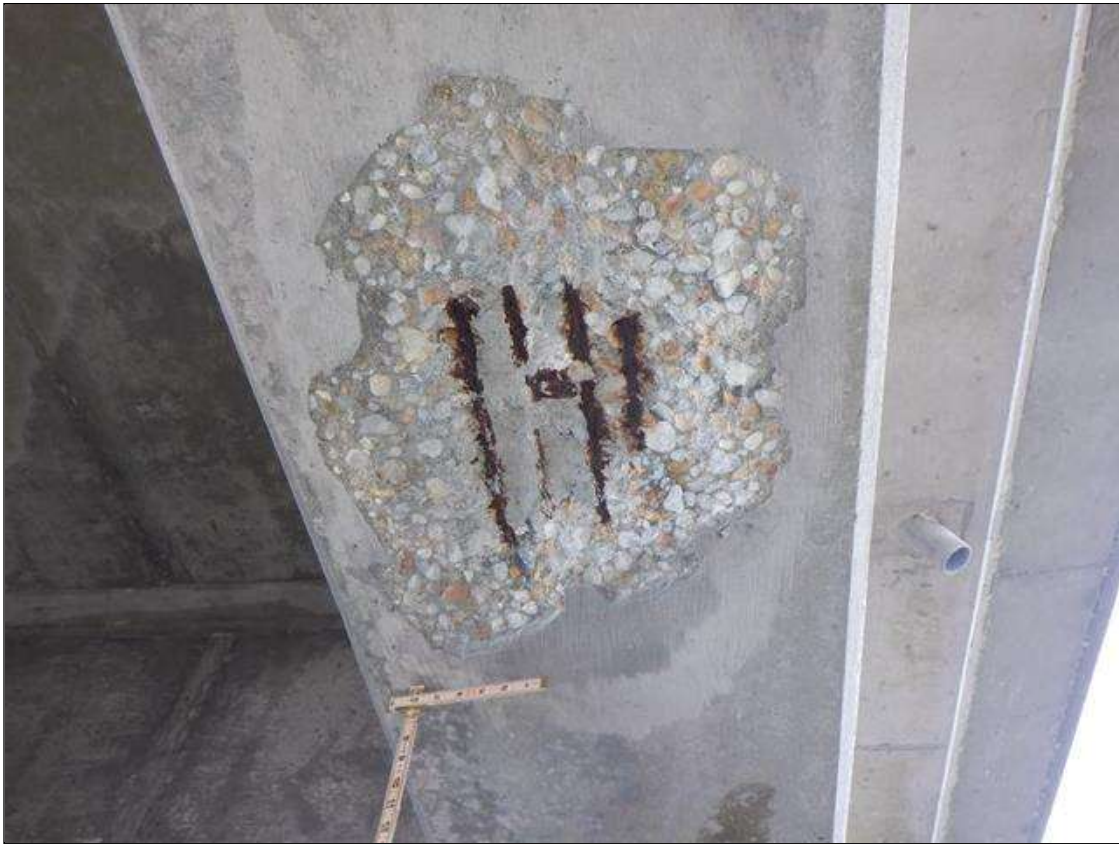
Span 139 Beam 2: (PAR) UNDERSIDE AND SOUTH FACE OF BOTTOM FLANGE AT 17 FEET FROM BENT 138, SPALL (30 INCHES X 12 INCHES X 2 INCHES) WITH (4) FOUR EXPOSED STRANDS (20 PERCENT SECTION LOSS) ON STRAND

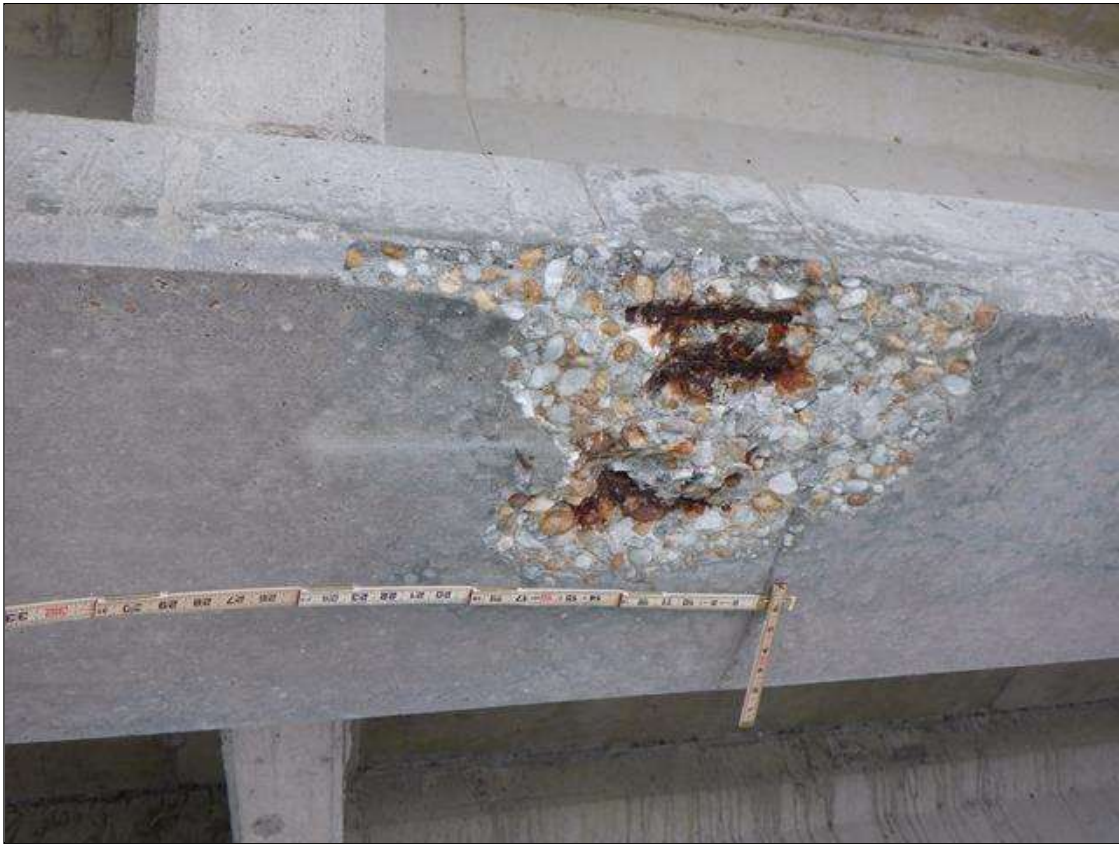
Span 143 Beam 2: (PAR) NORTH FACE OF BOTTOM FLANGE AT BENT 142, SPALL (3 INCHES X 2 INCHES X 2 INCHES) WITH EXPOSED STRANDS (5 PERCENT SECTION LOSS) ON STRAND

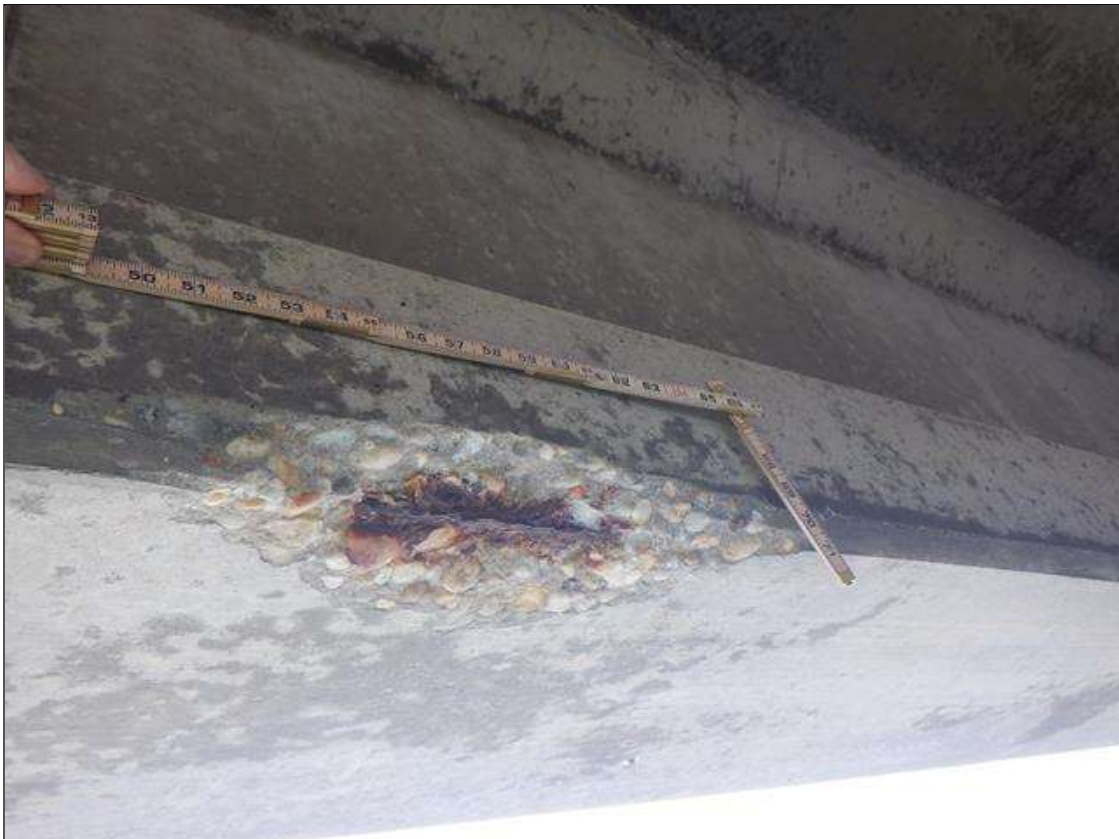
Span 143 Beam 2: (PAR) BOTTOM OF BOTTOM FLANGE AT MIDSPAN, (22 INCHES LONG X 13 INCHES WIDE X 1.5 INCHES DEEP) WITH (3) THREE EXPOSED STRANDS (10 PERCENT LOSS)

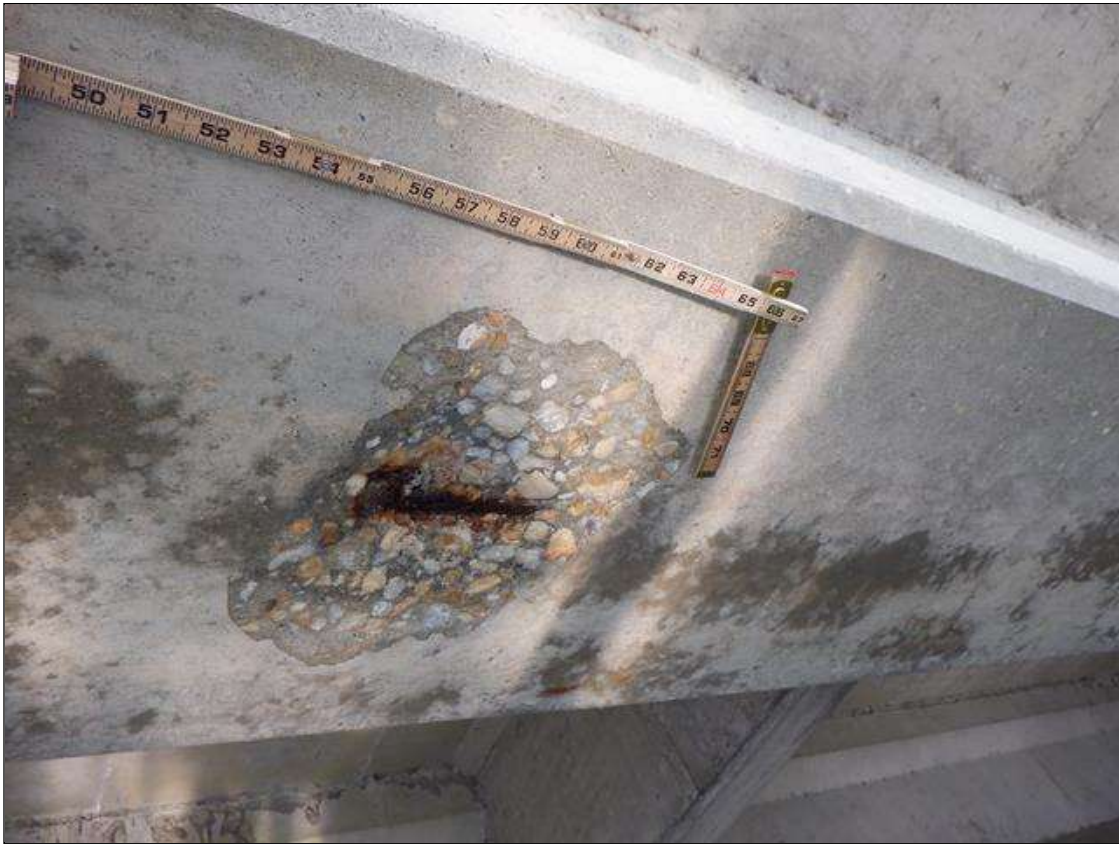
Span 148 Beam 4: (PAR) NORTH FACE OF BOTTOM FLANGE AT MIDSPAN, SPALL (16 INCHES X 4 INCHES X 2 INCHES) WITH EXPOSED STRANDS (5 PERCENT SECTION LOSS) ON STRAND

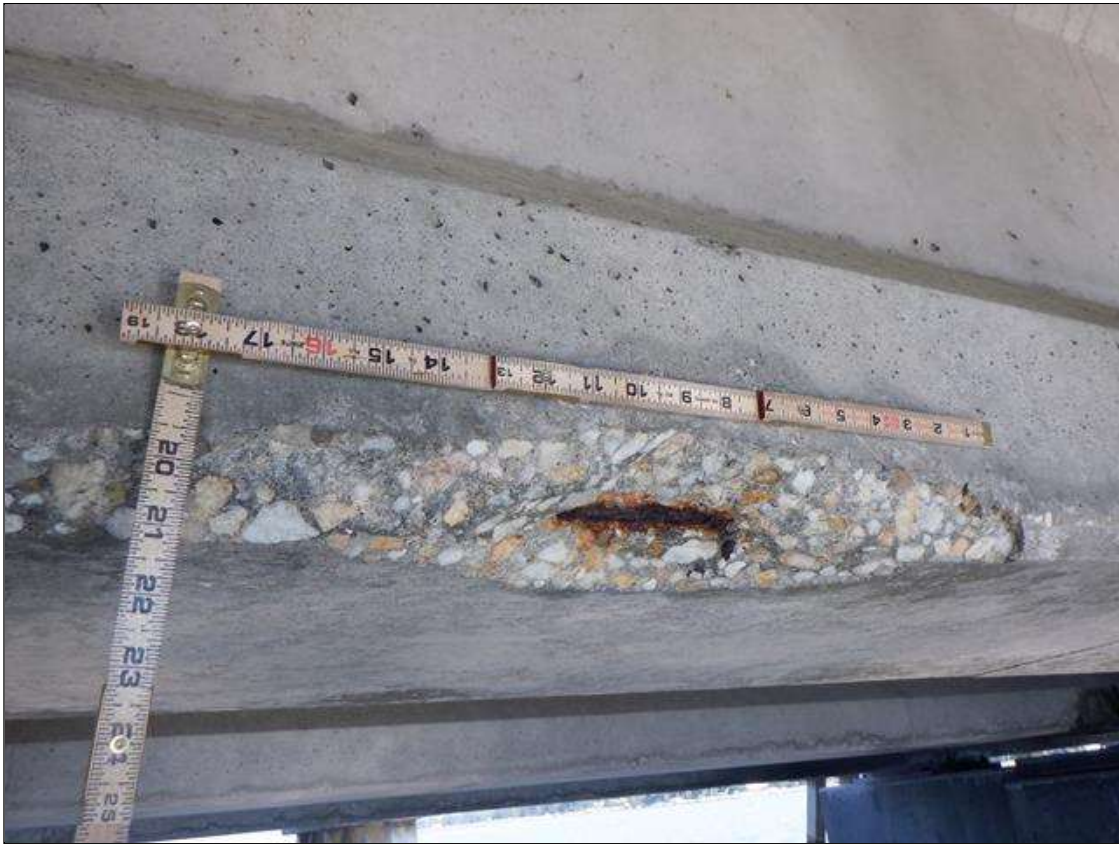
Span 221 Beam 3: (PAR) NORTH FACE OF BOTTOM FLANGE AT 20 FEET BENT 220, FAILED PATCHED/SPALL (30 INCHES X 2.5 INCHES HIGH X 4 INCHES WIDE X 1.5 INCH DEEP) WITH EXPOSED RUSTED STRANDS (20 PERCENT SECTION LOSS)

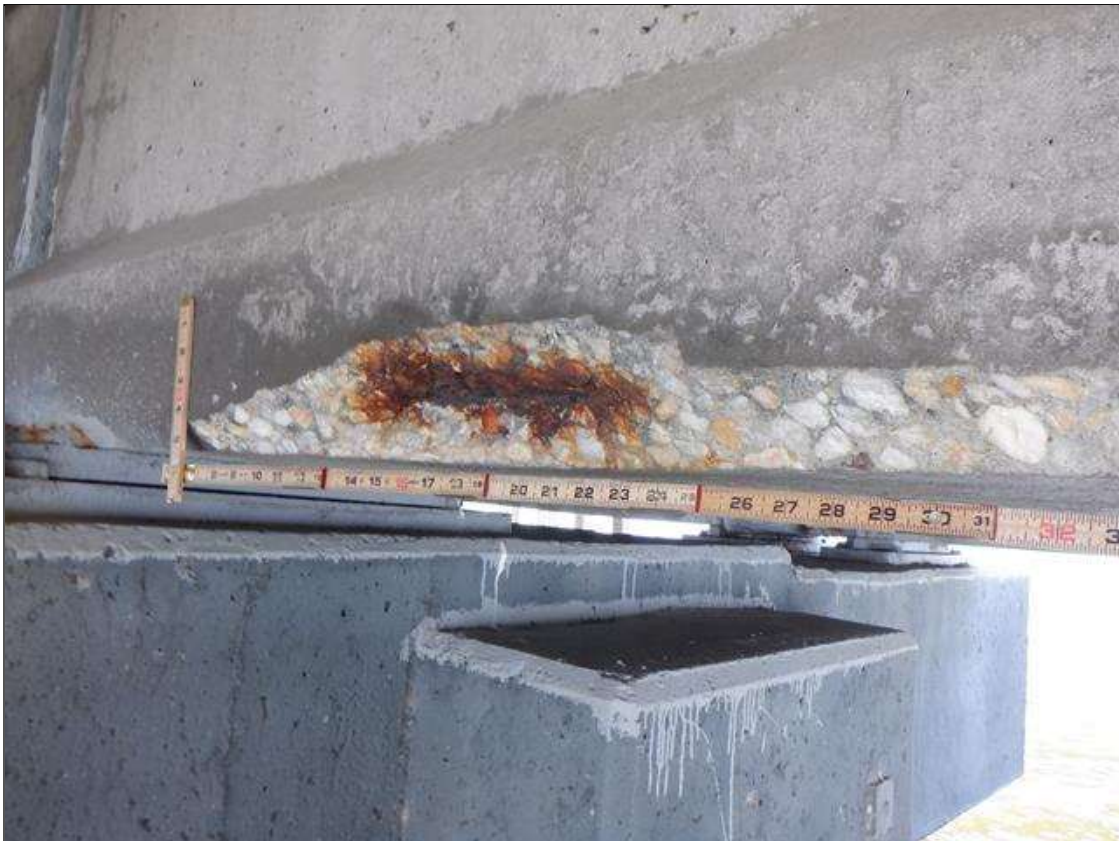
Span 222 Beam 3: (PAR) SOUTH FACE OF BOTTOM FLANGE, AT 18 FEET BENT 222, SPALL (18 INCHES X 5 INCHES X 2 INCHES) WITH EXPOSED RUSTED STRAND (10 PERCENT SECTION LOSS)

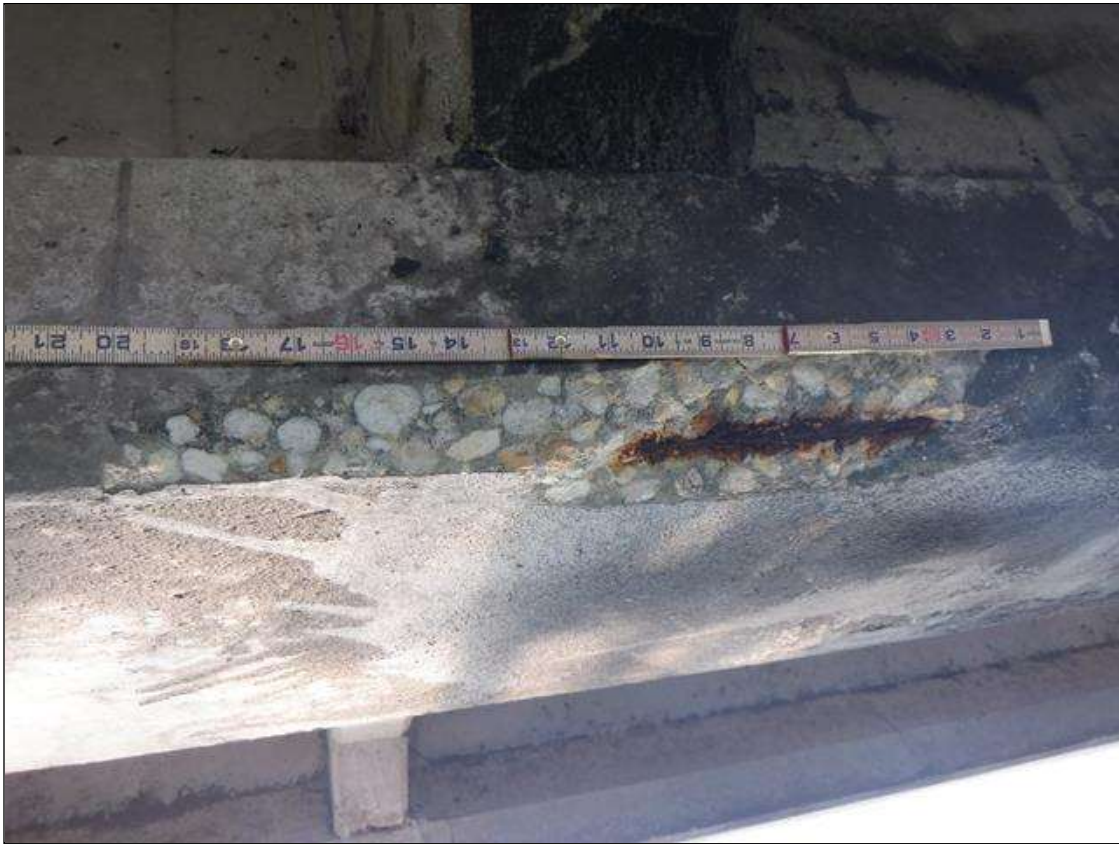
Span 223 Beam 2: (PAR) BOTTOM FLANGE SOUTH FACE AT 2 FEET FROM BENT 222, SPALL (38 INCHES LONG X 4 INCHES HIGH X 2 INCHES DEEP) WITH EXPOSED RUSTED STRANDS (20 PERCENT SECTION LOSS)

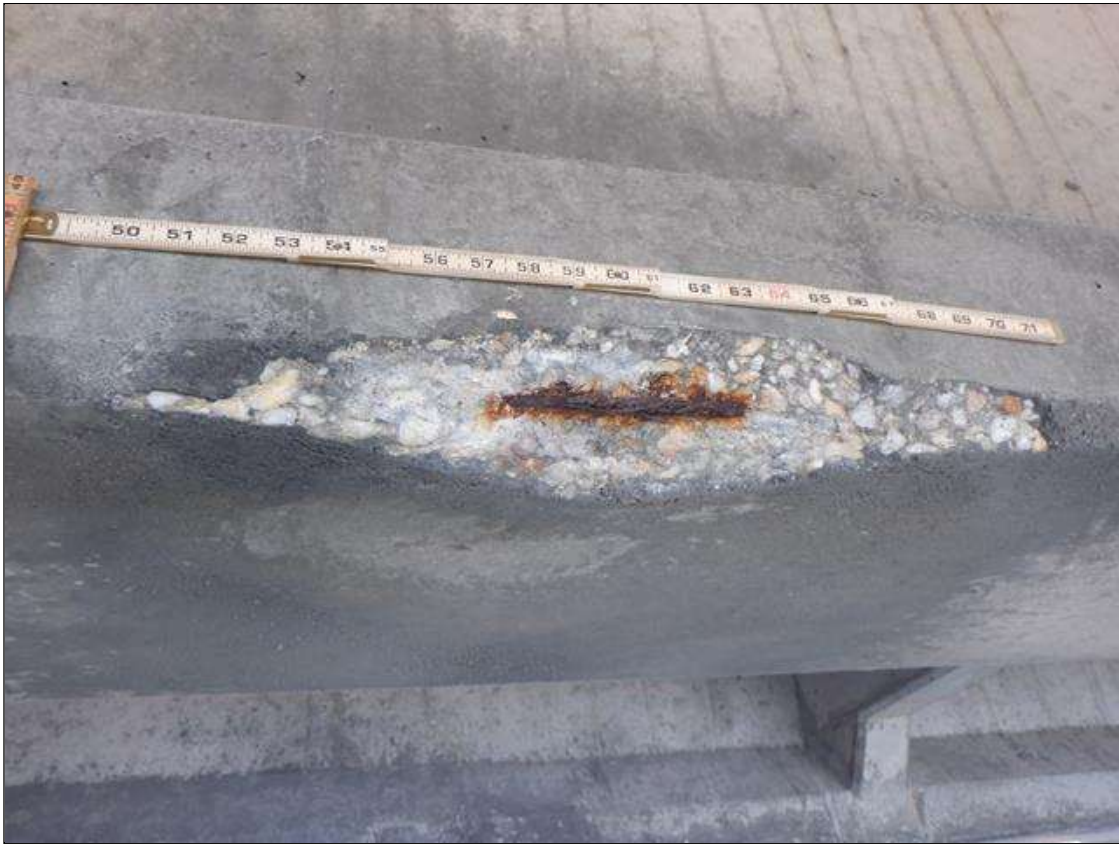
Span 223 Beam 3: (PAR) BOTTOM FLANGE NORTH FACE AT 18 FEET FROM BENT 223, SPALL (22 INCHES LONG X 2.5 INCHES HIGH X 3 INCHES WIDE X 1 INCH DEEP) WITH EXPOSED RUSTED STRANDS (10 PERCENT SECTION LOSS)

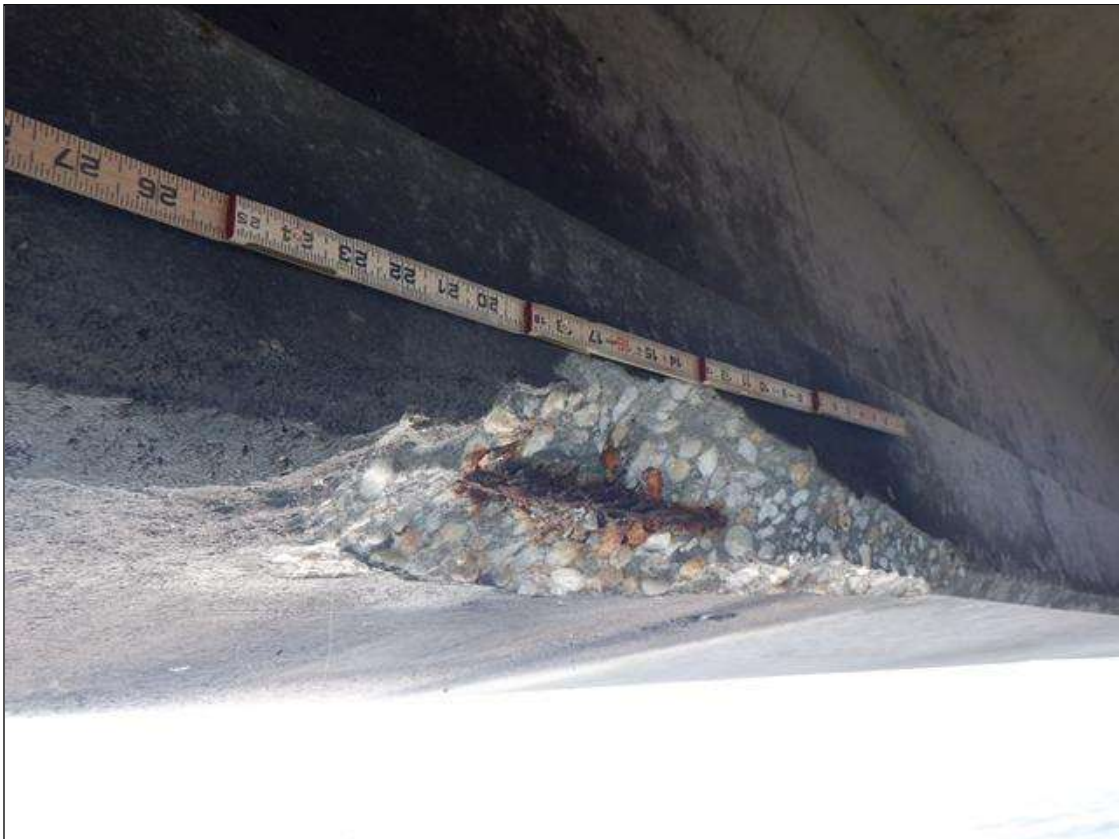
Span 224 Beam 2: (PAR) SOUTH FACE OF WEB, AT 16 FEET FROM BENT 223, SPALL (18 INCHES X 5 INCHES X 2 INCHES) WITH EXPOSED RUSTED STRAND (10 PERCENT SECTION LOSS) ON STRAND

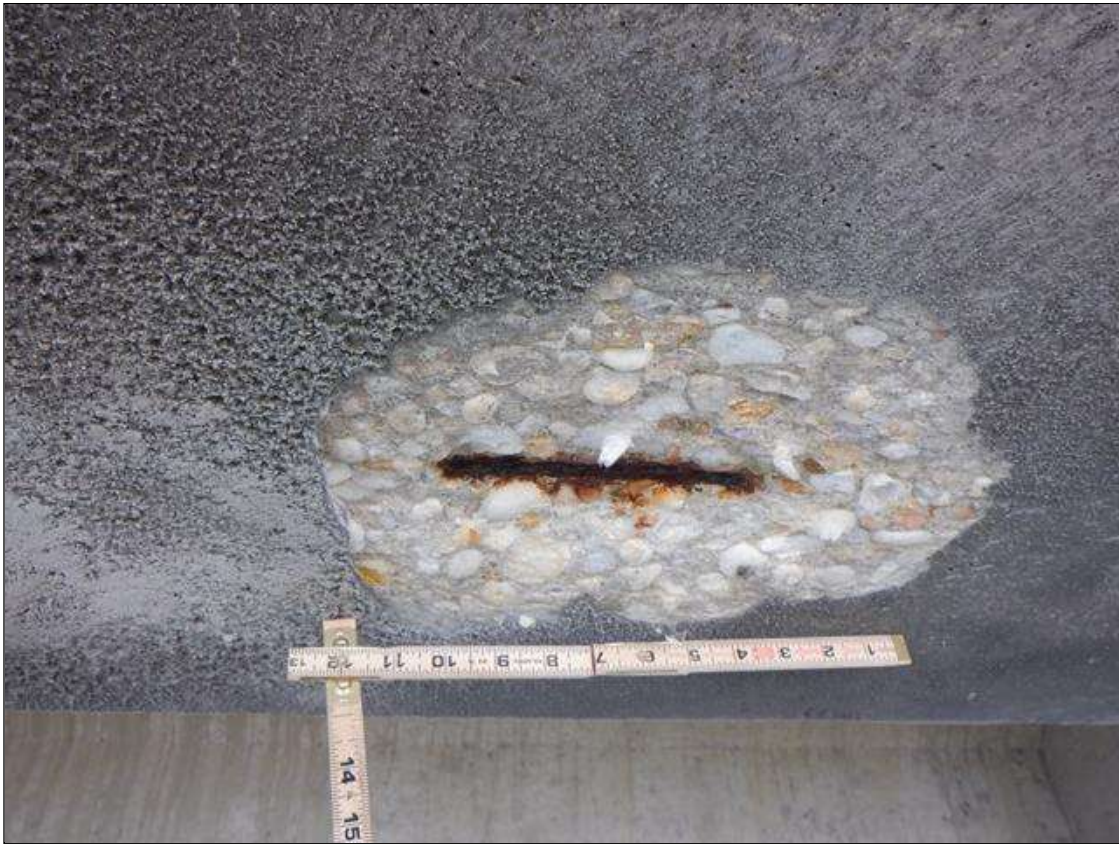
Span 224 Beam 4: (PAR) NORTH FACE OF BOTTOM FLANGE, AT 6 FEET FROM BENT 224, SPALL (30 INCHES X 8 INCHES X 2 INCHES) WITH EXPOSED STRANDS (10 PERCENT SECTION LOSS)

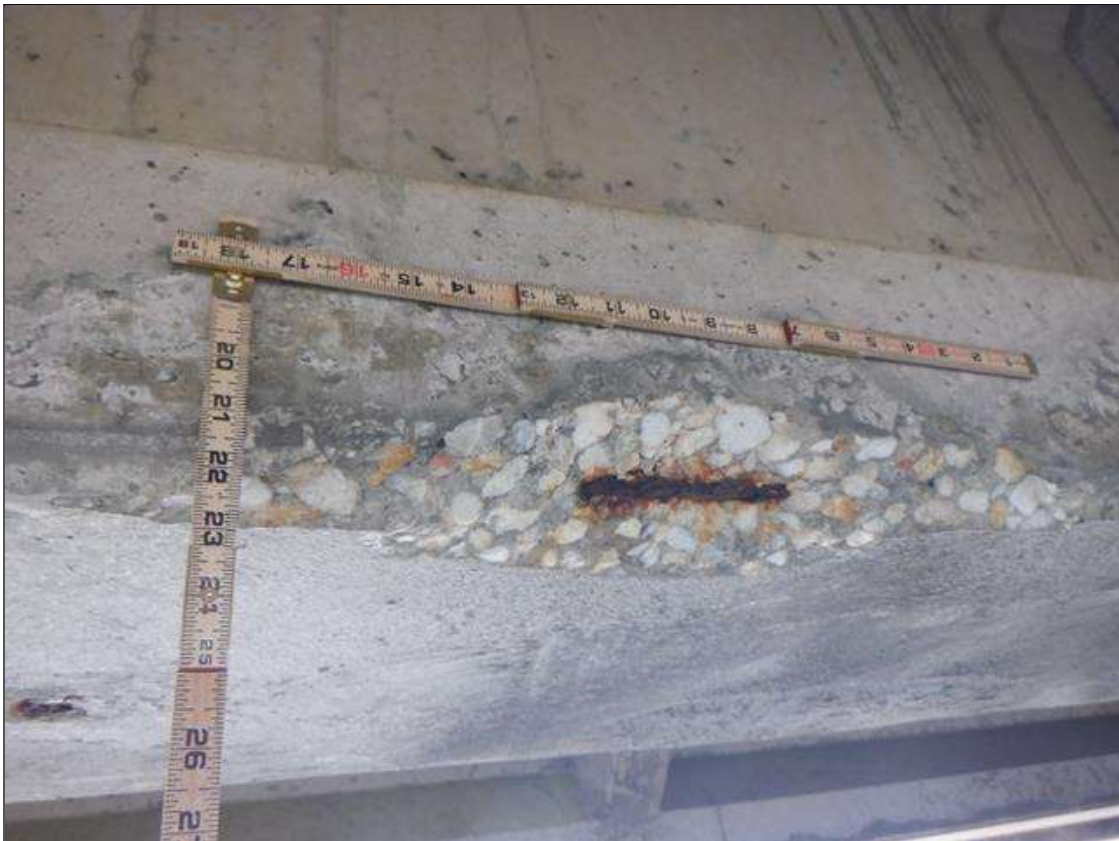
Span 228 Beam 2: (PAR) BOTTOM OF BOTTOM FLANGE AT 24 FEET FROM BENT 228, FAILED PATCH/SPALL (12 INCH DIAMETER X 1 INCH DEEP) WITH EXPOSED RUSTED STRAND (10 PERCENT SECTION LOSS)

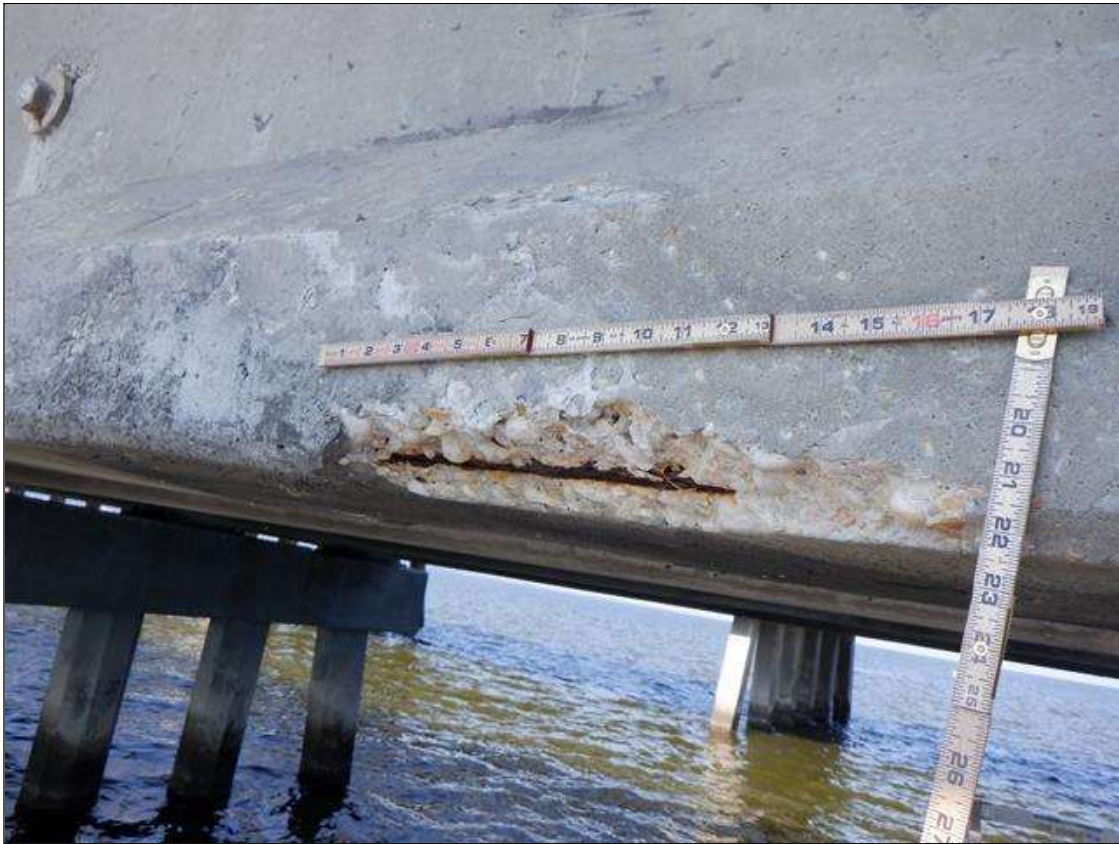
Span 229 Beam 2: (PAR) NORTH FACE OF BOTTOM FLANGE AT 22 FEET FROM BENT 228, SPALL (18 INCHES X 5 INCHES X 2 INCHES) WITH EXPOSED STRAND (10 PERCENT SECTION LOSS) ON STRAND

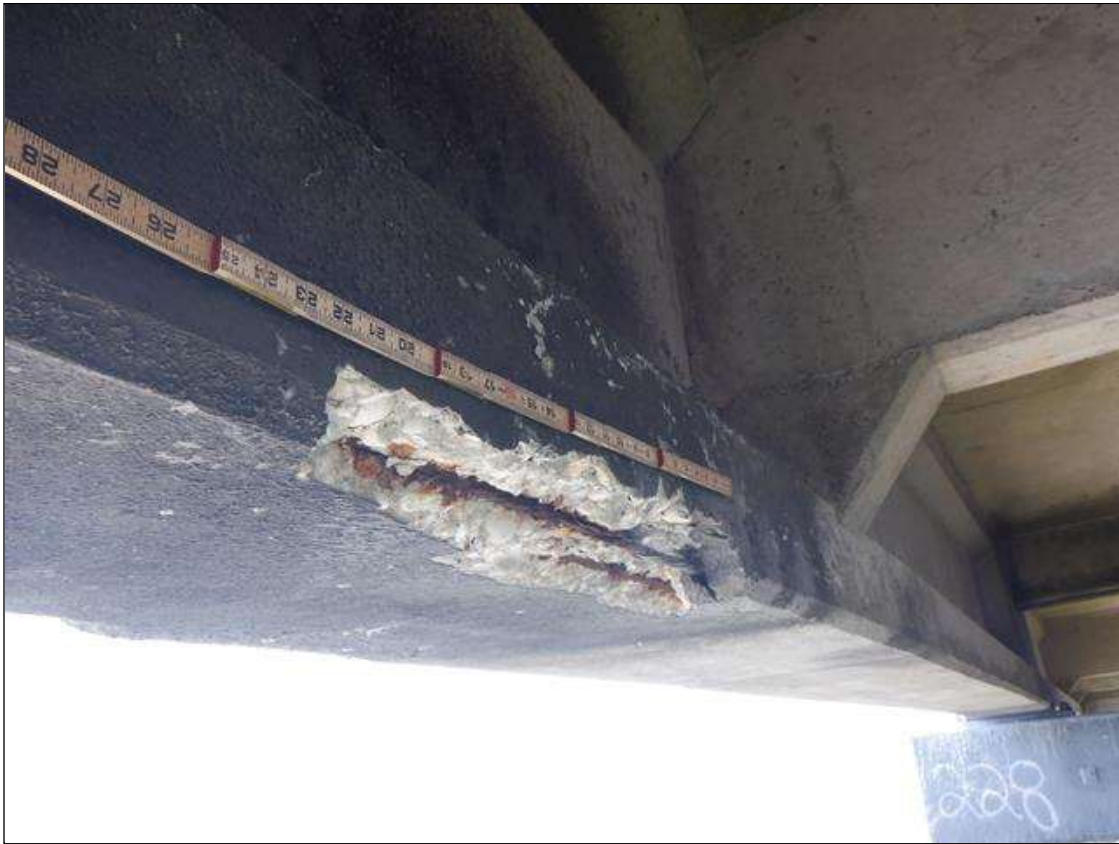
Span 229 Beam 4: (PAR) SOUTH FACE OF BOTTOM FLANGE AT 22 FEET FROM BENT 228, SPALL (18 INCHES X 5 INCHES X 2 INCHES) WITH EXPOSED STRAND (10 PERCENT SECTION LOSS)

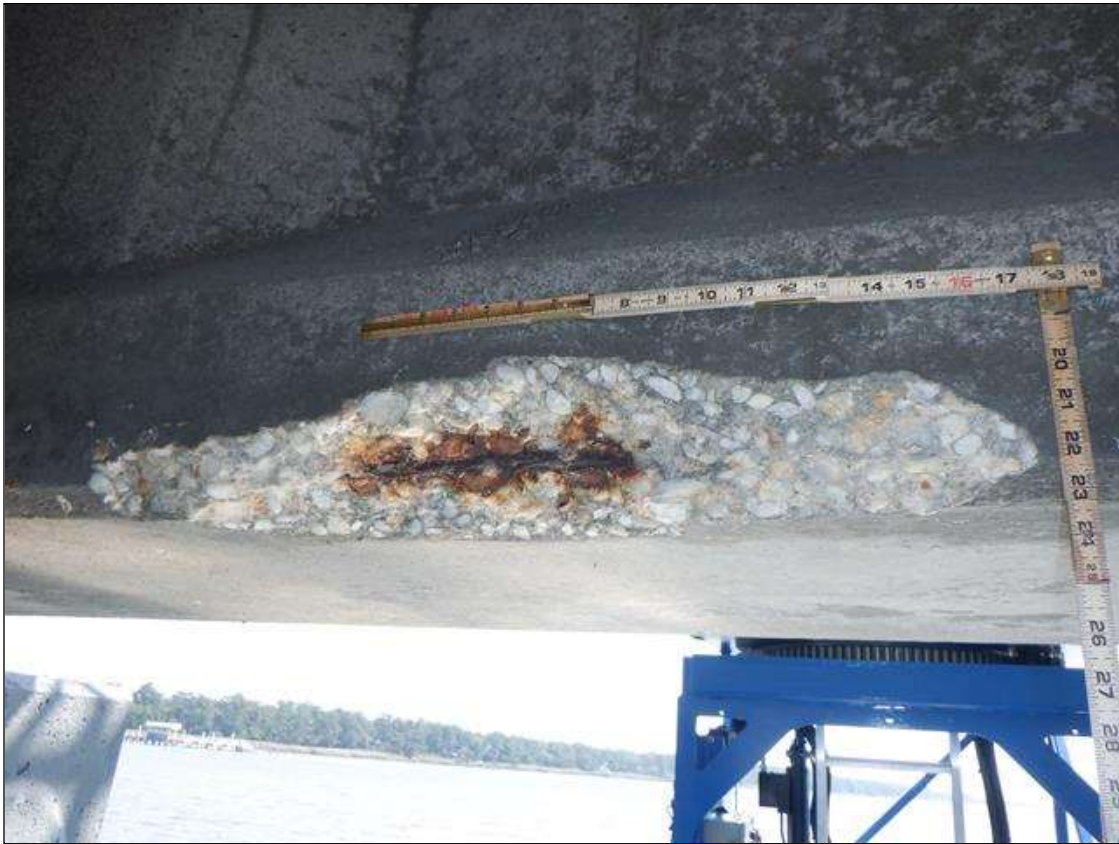
Span 229 Beam 4: (PAR) BOTTOM FLANGE NORTH FACE AT 5 FEET FROM BENT 228, SPALL (32 INCHES LONG X 3 INCHES HIGH X 5 INCHES WIDE X UP TO 1.5 INCHES DEEP) WITH EXPOSED RUSTED STRAND (20 PERCENT SECTION LOSS)

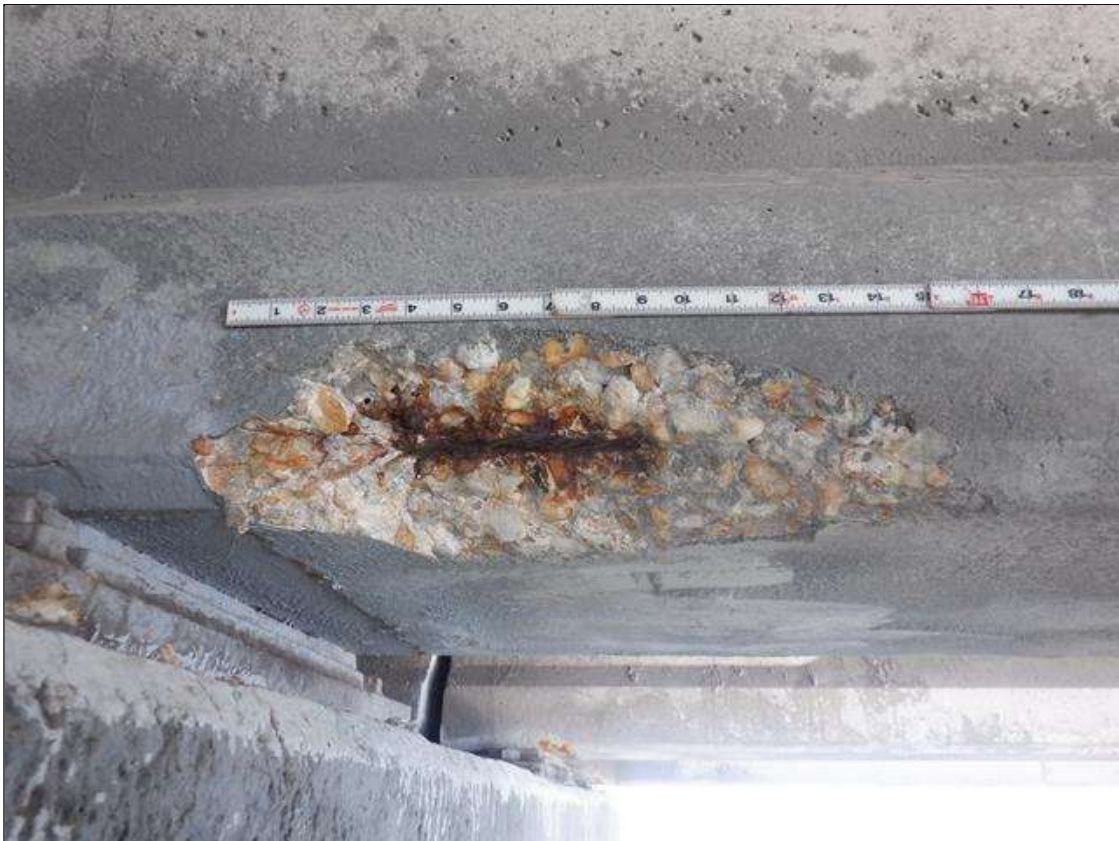
Span 230 Beam 4: (PAR) NORTH FACE OF BOTTOM FLANGE, AT 4 FEET FROM BENT 230, SPALL (24 INCHES X 6 INCHES X 2 INCHES) WITH EXPOSED RUSTED STRAND (20 PERCENT SECTION LOSS)
