NC DEPARTMENT OF TRANSPORTATION  
DIVISION OF HIGHWAYS  
STRUCTURE MANAGEMENT UNIT

## Structure Safety Report

### Routine Element Inspection - Contract

STRUCTURE NUMBER: 260016 SAP STRUCTURE NO: 0270016 FHWA STRUCTURE NO: 000000000530016  
DIVISION: 1 COUNTY: CURRITUCK INSPECTION DATE: 09/21/2022 FREQUENCY: 24 MONTHS  
FACILITY CARRIED: US158E MILE POST: \_\_\_\_\_  
LOCATION: .01 MI.E.JCT.SR1187  
FEATURE INTERSECTED: CURRITUCK SOUND  
LATITUDE: 36° 5' 11.69" LONGITUDE: 75° 46' 0.21"  
SUPERSTRUCTURE: RC FLOOR ON PPC GIRDERS & CORED SLAB  
SUBSTRUCTURE: EBTS:RC CAP/PPC PILES;IBTS:RCP&B & RC CAPS/PPC PILES  
SPANS: 248 SPANS. SEE SPAN PROFILE SHEET FOR SPAN DETAILS  
☐ FRACTURE CRITICAL ☐ TEMPORARY SHORING ☐ SCOUR CRITICAL ☐ SCOUR PLAN OF ACTION  
GRADES: (Inspector/NBI Coding) DECK 6 / 6 SUPERSTRUCTURE 5 / 5 SUBSTRUCTURE 6 / 6 CULVERT N / N  
POSTED SV: Not Posted POSTED TTST: Not Posted  
OTHER SIGNS PRESENT: None

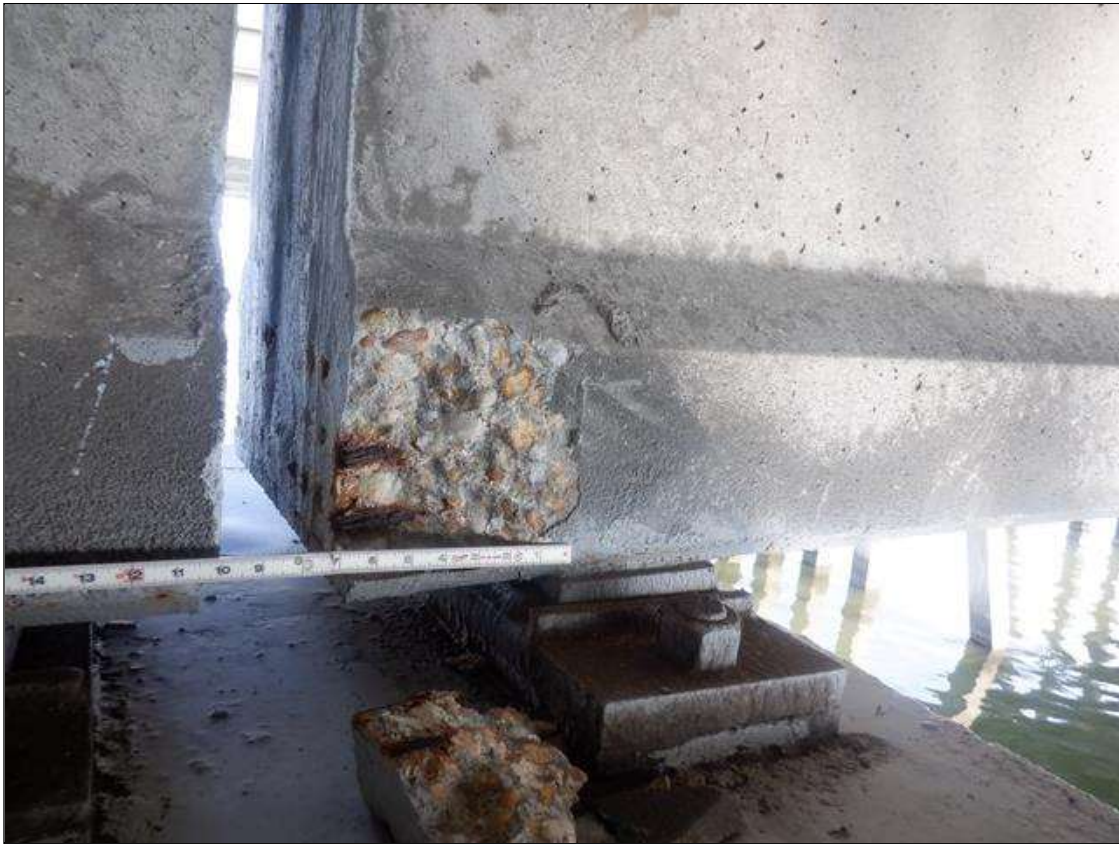
Span 166 Beam 3: (PAR) SOUTH FACE OF BOTTOM FLANGE AT 1FEET FROM BENT 165, SPALL (15 INCHES X 6 INCHES X 3 INCHES) WITH EXPOSED STRANDS (25 PERCENT SECTION LOSS) ON STRAND

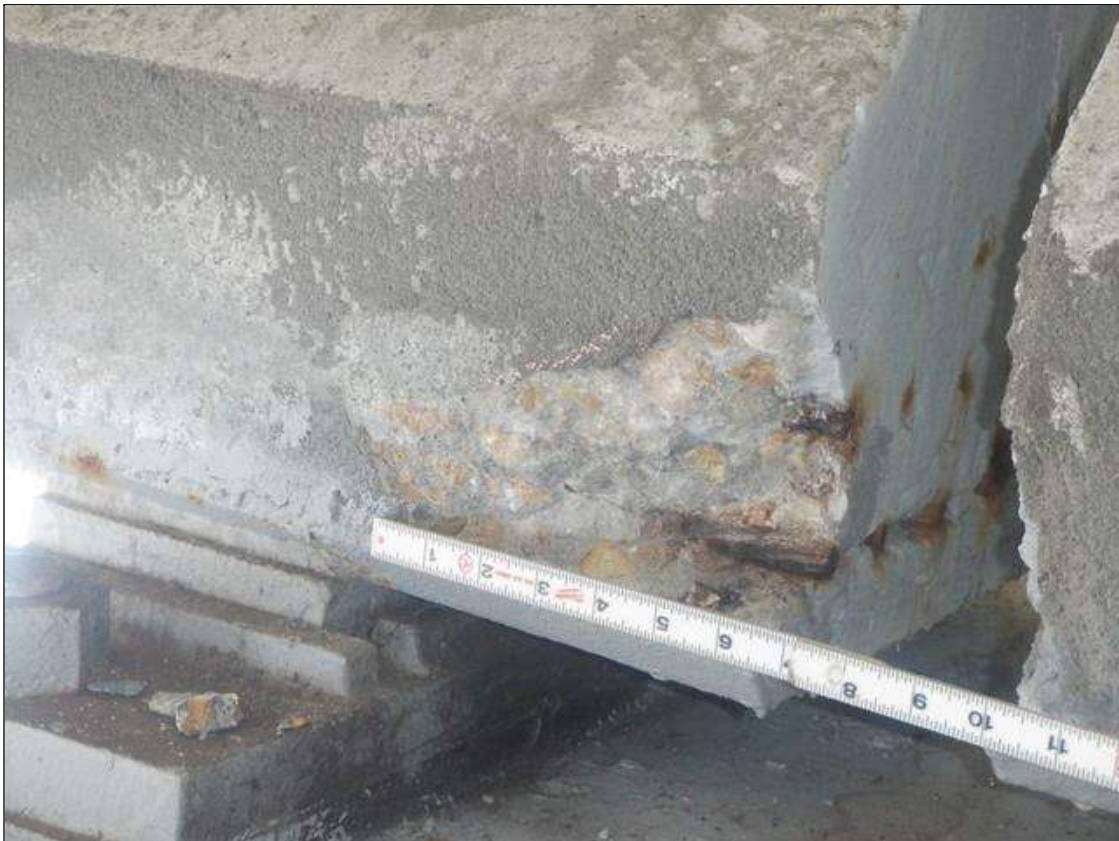
Span 169 Beam 1: (PAR) SOUTH FACE OF BOTTOM FLANGE BENT 168, SPALL (7 INCHES X 7 INCHES X 2.5 INCHES) WITH 2 (TWO) EXPOSED STRANDS (5 PERCENT SECTION LOSS) ON STRAND

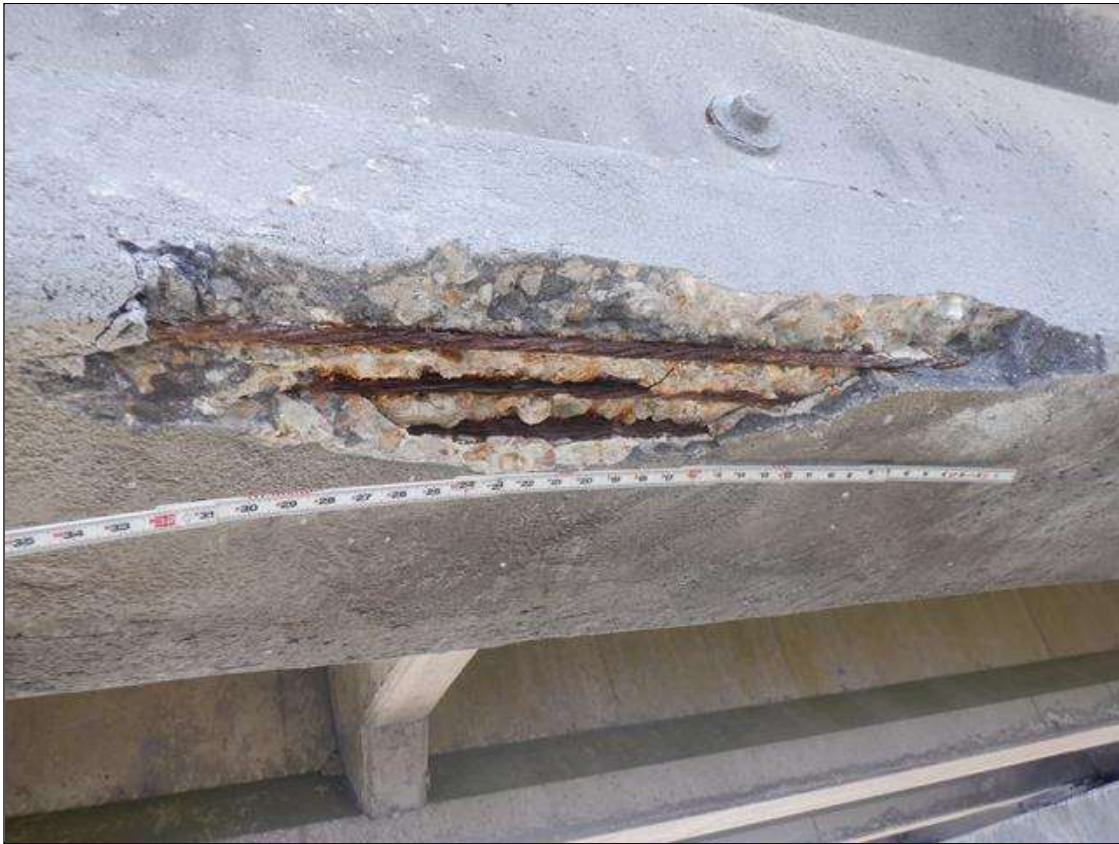
Span 169 Beam 2: (PAR) NORTH FACE OF BOTTOM FLANGE AT BENT 168, SPALL (6 INCHES X 5 INCHES UP TO 2 INCHES DEEP) WITH TWO (2) EXPOSED STRANDS (NO SECTION LOSS)

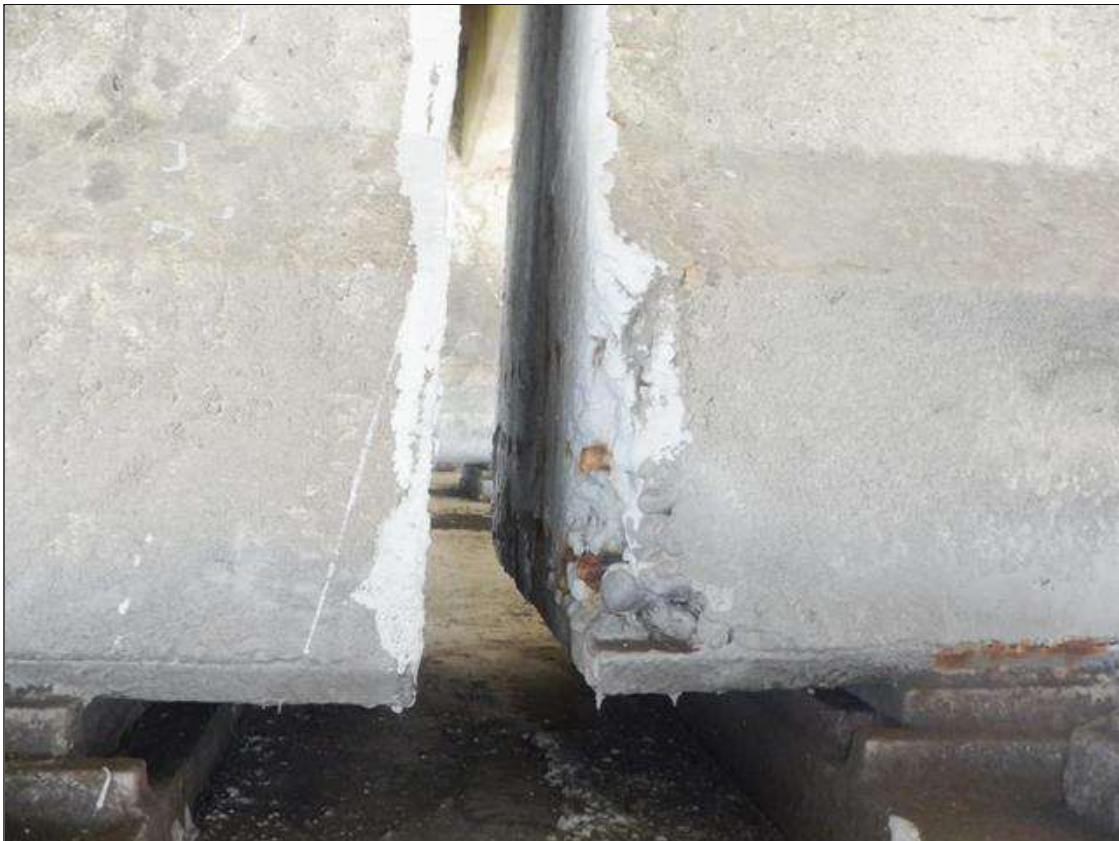
Span 171 Beam 1: (PAR) NORTH FACE AND UNDERSIDE, SPALL (2 1/2 INCHES X 6 INCHES X UP TO 2 INCHES DEEP) WITH FOUR EXPOSED STARNDs (50 PERCENT LOSS)

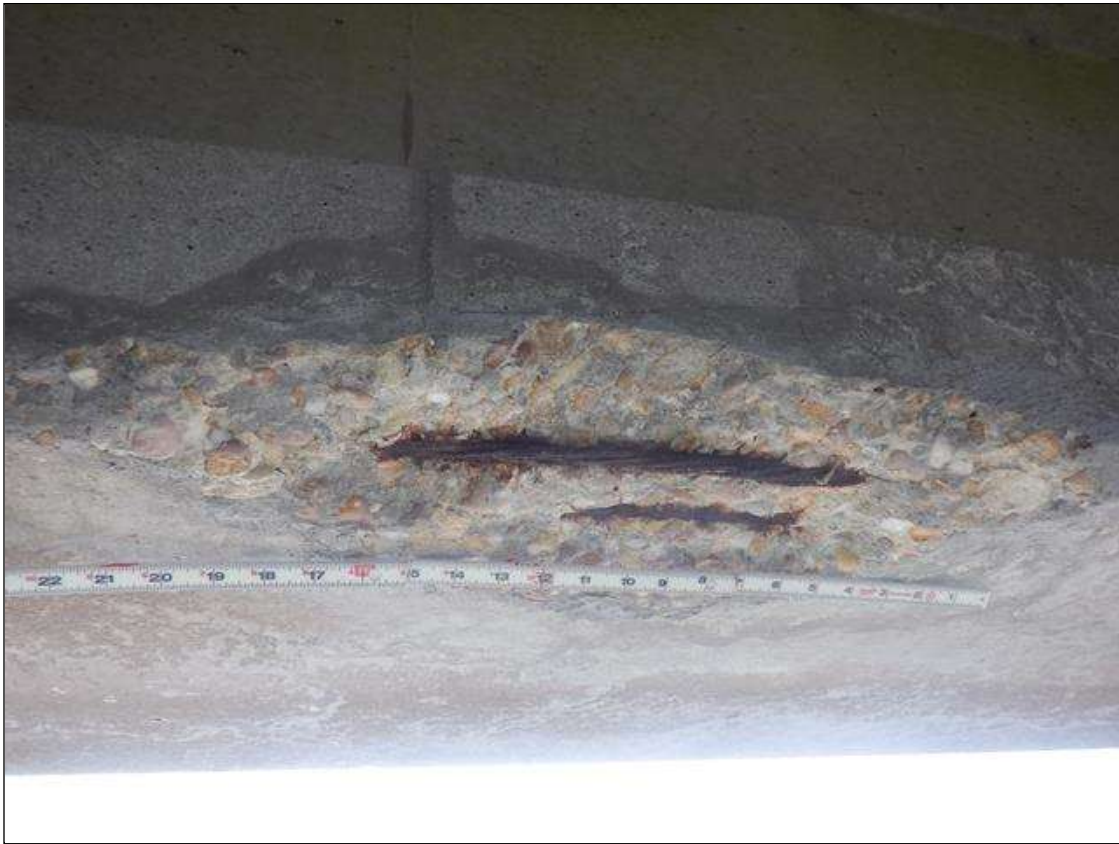
Span 171 Beam 3: (PAR) SOUTH FACE OF BOTTOM FLANGE AT BENT 170, SPALL (3 INCHES X 7 INCHES X 1 INCHES) WITH EXPOSED STRANDS (10 PERCENT SECTION LOSS) ON STRAND

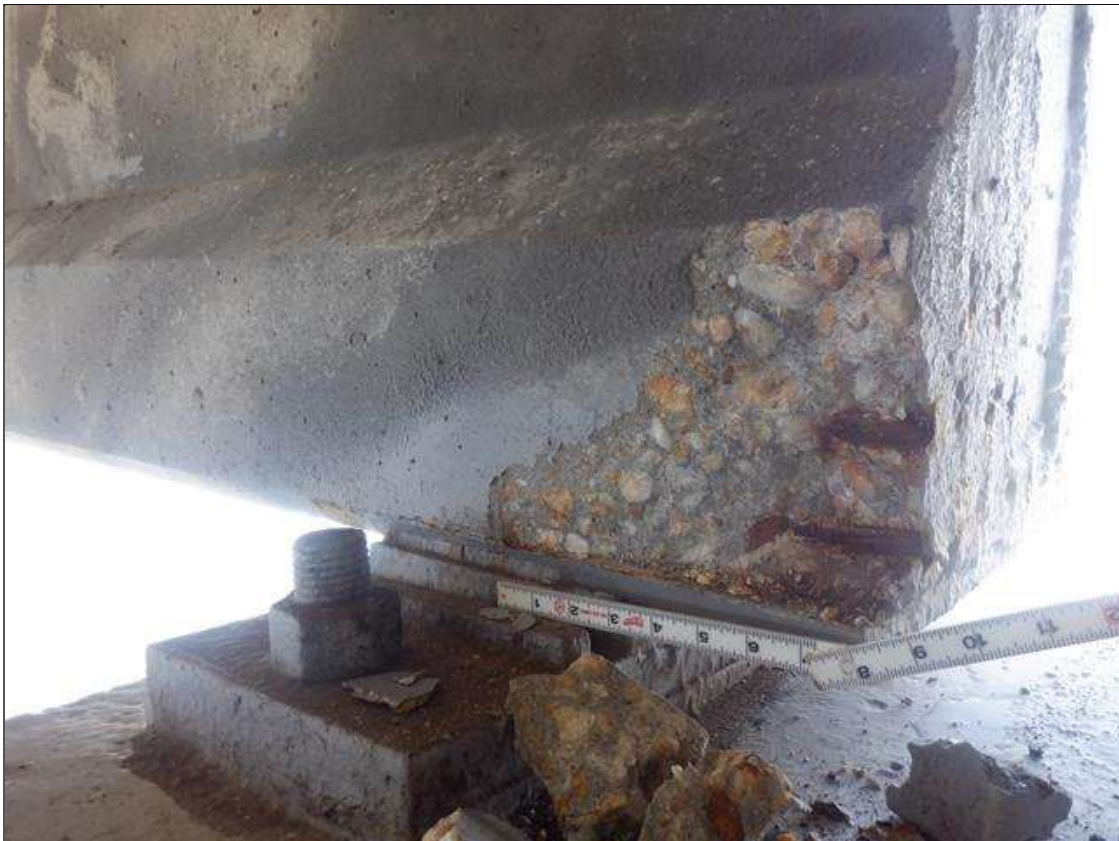
Span 171 Beam 4: (PAR) NORTH FACE OF BOTTOM FLANGE AT 10 FEET FROM BENT 171, SPALL (20 INCHES X 8 INCHES X 2 INCHES) WITH TWO (2) EXPOSED STRANDS (50 PERCENT SECTION LOSS) ON STRAND

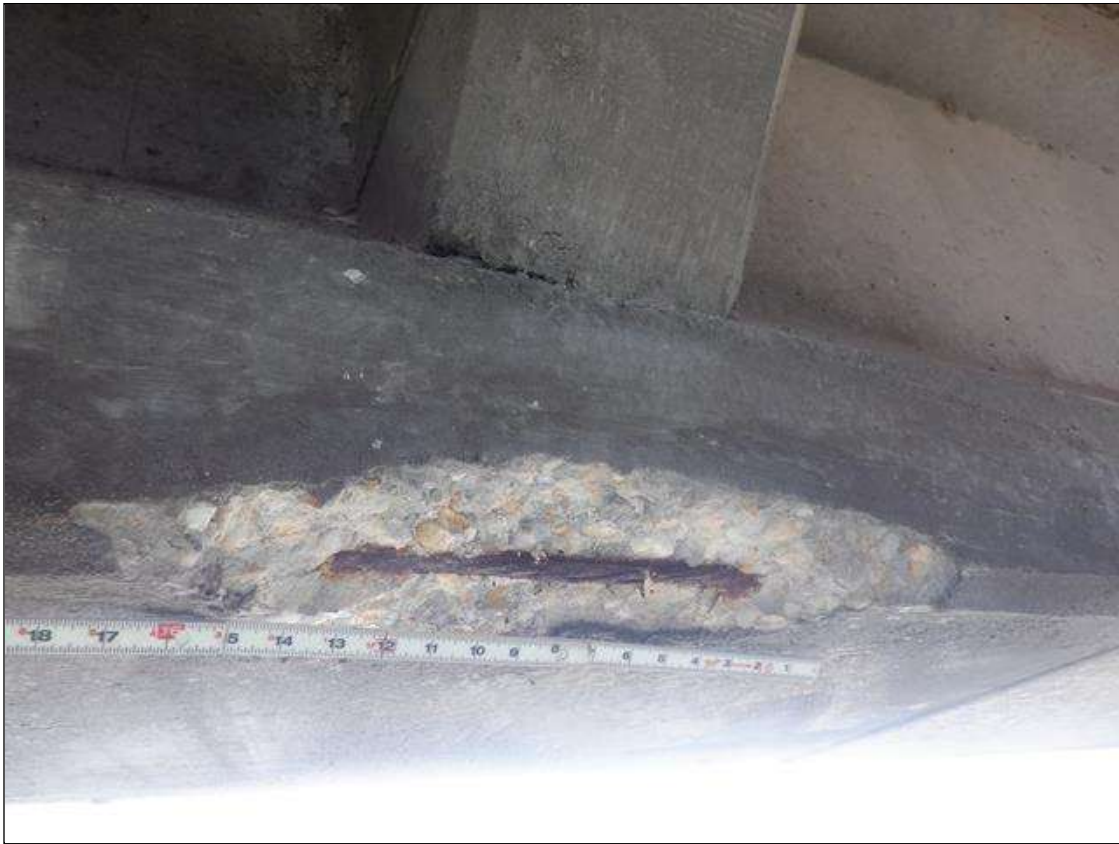
Span 173 Beam 4: (PAR) NORTH FACE AT BENT 172, SPALL (8 INCHES 6 INCHES X 2 INCHES DEEP) WITH TWO (2) EXPOSED STANDS (10 PERCENT LOSS)

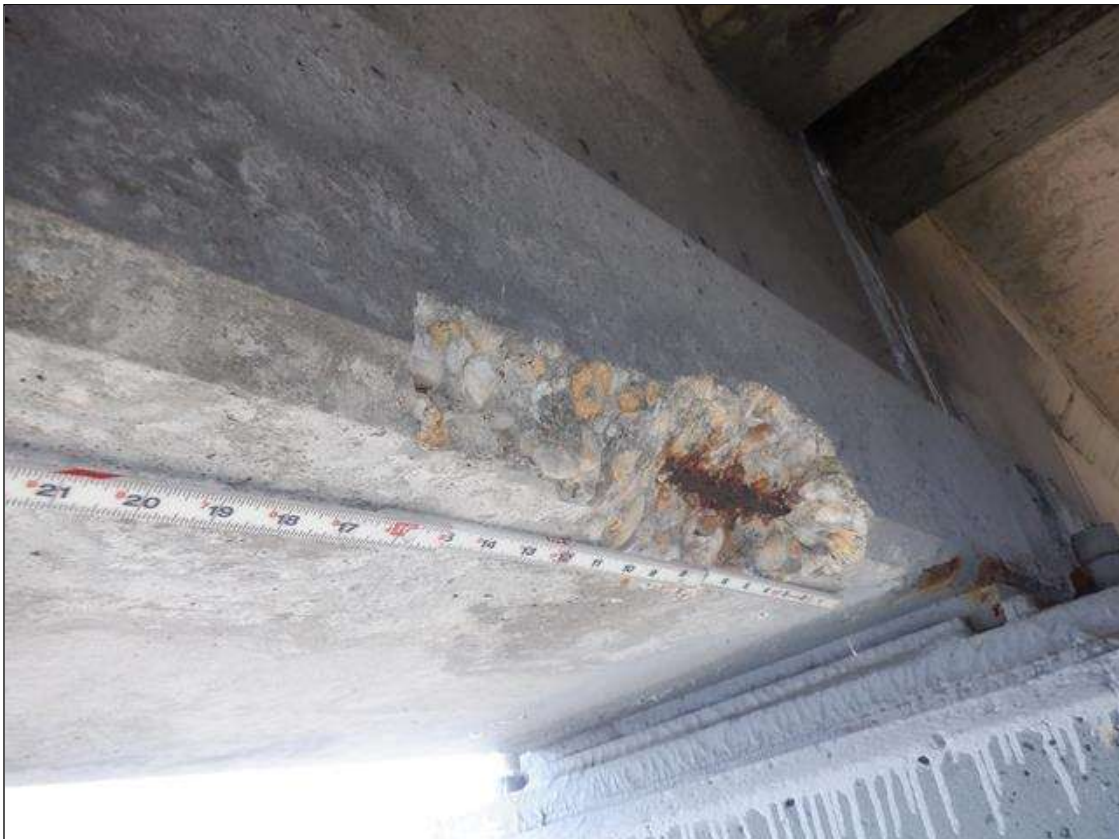
Span 174 Beam 4: (PAR) NORTH FACE OF BOTTOM FLANGE AT 20 FEET FROM BENT 173, SPALL (18 INCHES X 4 1/2 INCHES X 2 1/2 INCHES) WITH TWO (2) EXPOSED STRANDS (20 PERCENT SECTION LOSS) ON STRAND

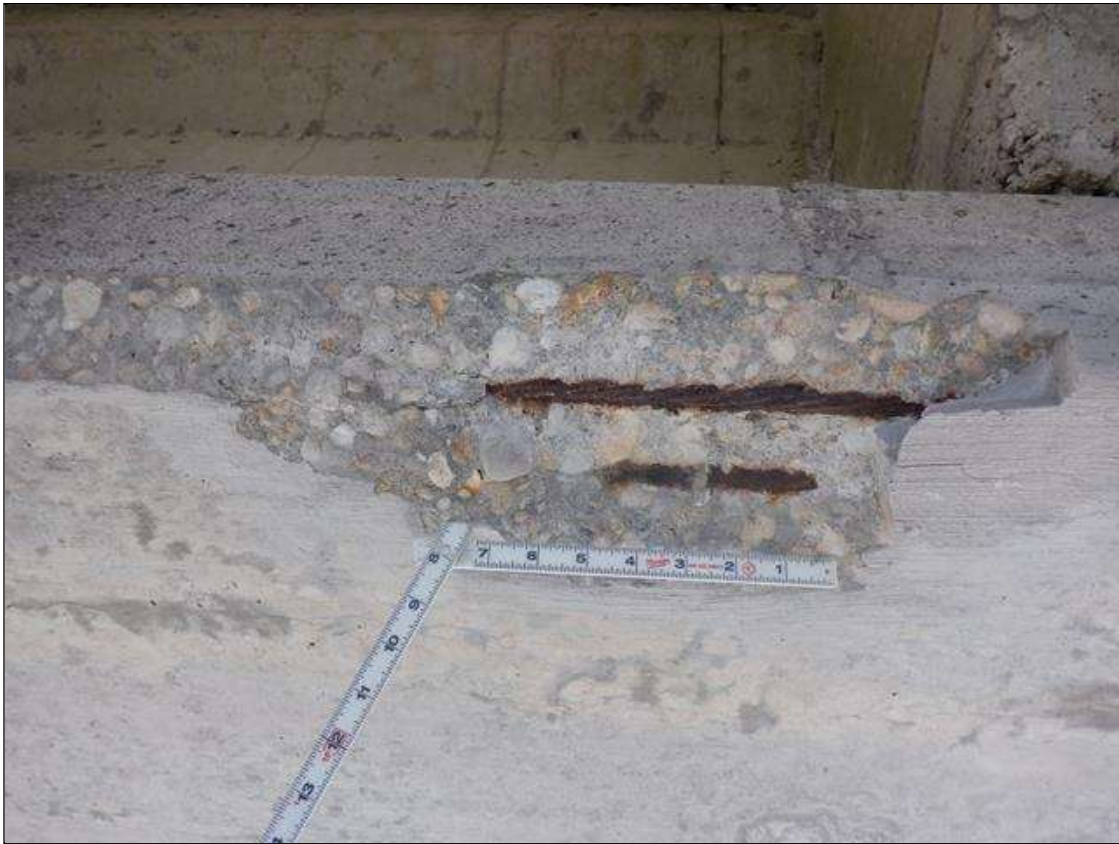
Span 174 Beam 4: (PAR) NORTH FACE 2 FEET EAST OF BENT 173, SPALL (1 1/2 FEET X 3 INCHES X 2 INCHES DEEP) WITH ONE (1) EXPOSED STARND (10 PERCENT LOSS)

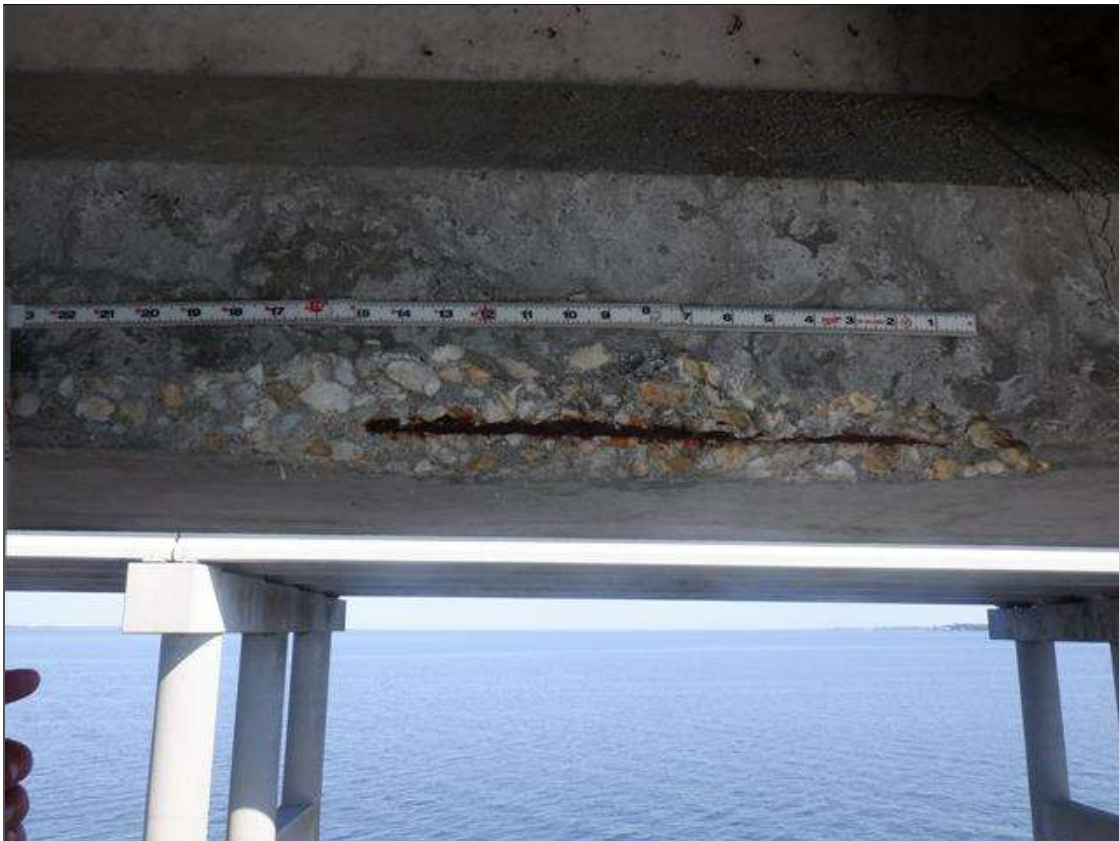
Span 178 Beam 3: (PAR) NORTH FACE OF BOTTOM FLANGE AT 21 FEET FROM BENT 177, SPALL (42 INCHES X 6 INCHES X 3 INCHES) WITH TWO (2) EXPOSED STRANDS (10 PERCENT SECTION LOSS) ON STRAND

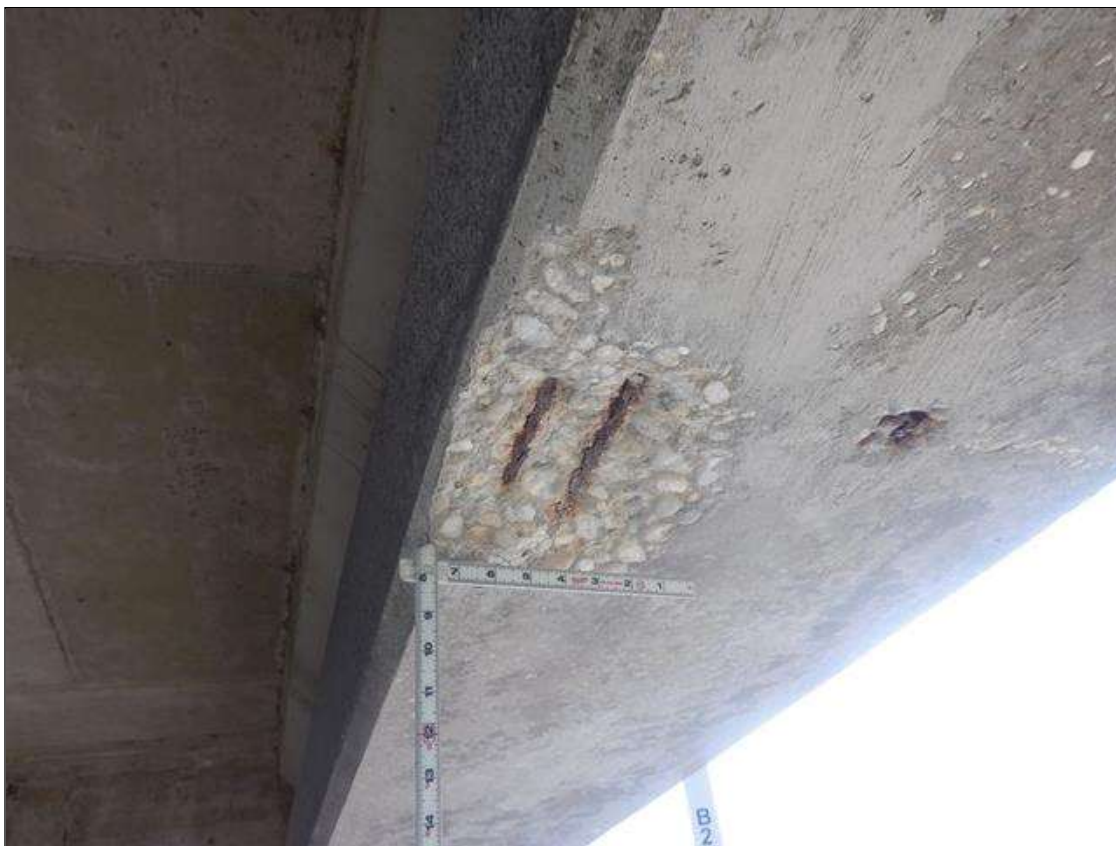
Span 183 Beam 1: (PAR) BOTTOM FLANGE SOUTH FACE 24 FEET EAST OF BENT 182, SPALL (2 FEET X 4 INCHES X 1 1/2 INCHES DEEP) WITH ONE (1) EXPOSED STRAND (10 PERCENT LOSS)

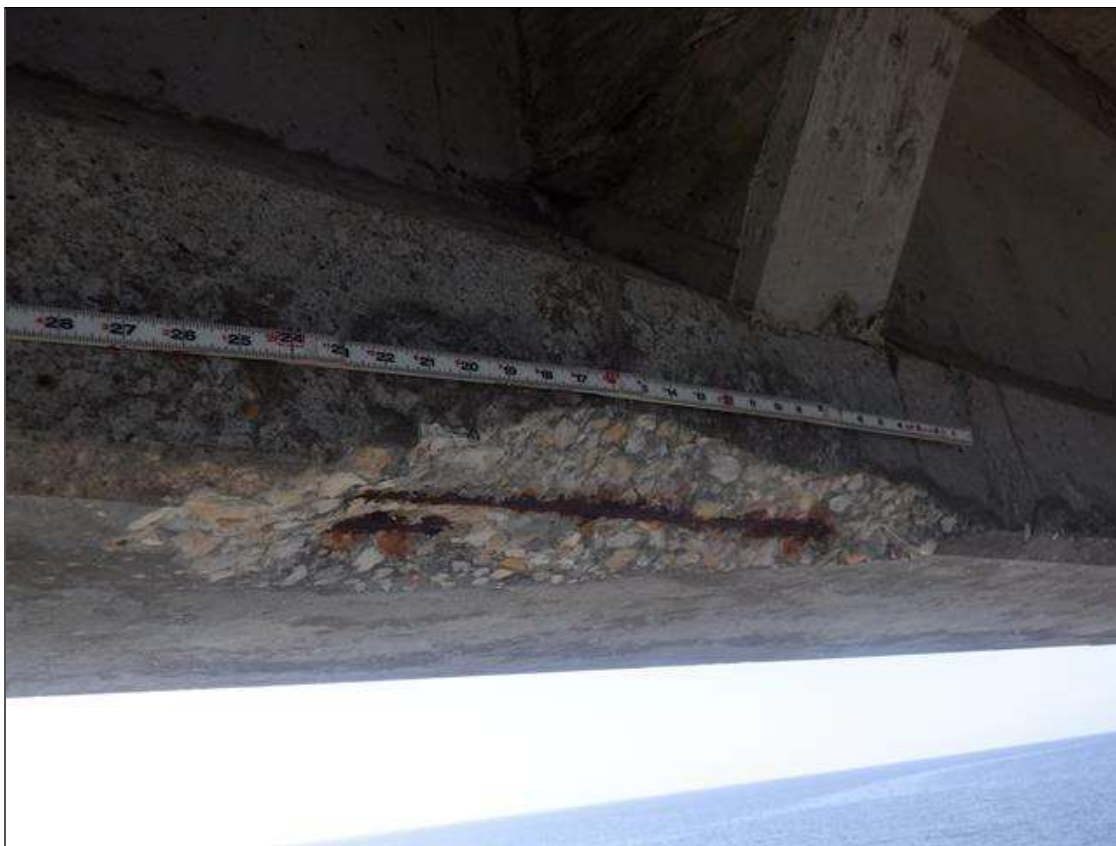
Span 184 Beam 4: (PAR) UNDERSIDE OF BOTTOM FLANGE AT MIDSPAN, SPALL (12 INCHES X 6 INCHES X 1 INCH) WITH TWO (2) EXPOSED STRANDS (15 PERCENT LOSS) ON STRANDS

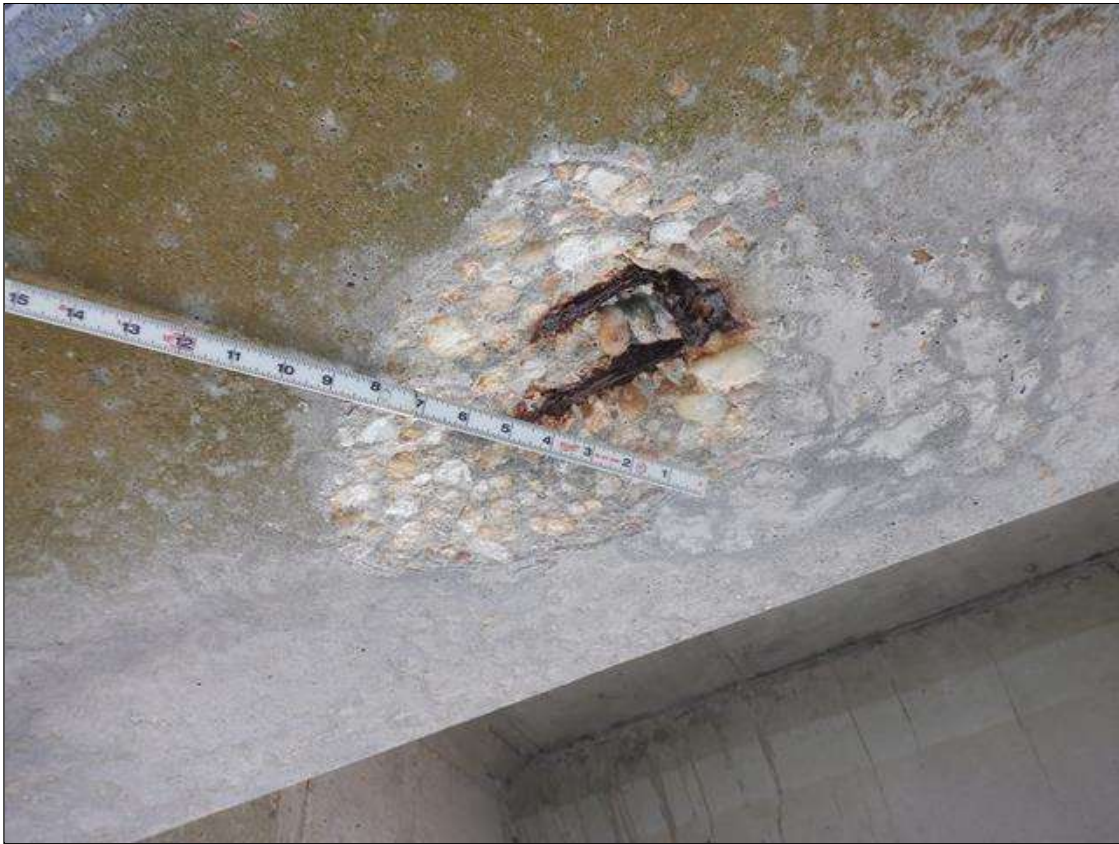
Span 184 Beam 4: (PAR) UNDERSIDE OF BOTTOM FLANGE AT 24 FEET FROM BENT 183, DELAMINATION/SPALL (2 FEET X 6 INCHES X 1 1/2 INCHES DEEP) WITH TWO (2) EXPOSED STRANDS (10 PERCENT LOSS)

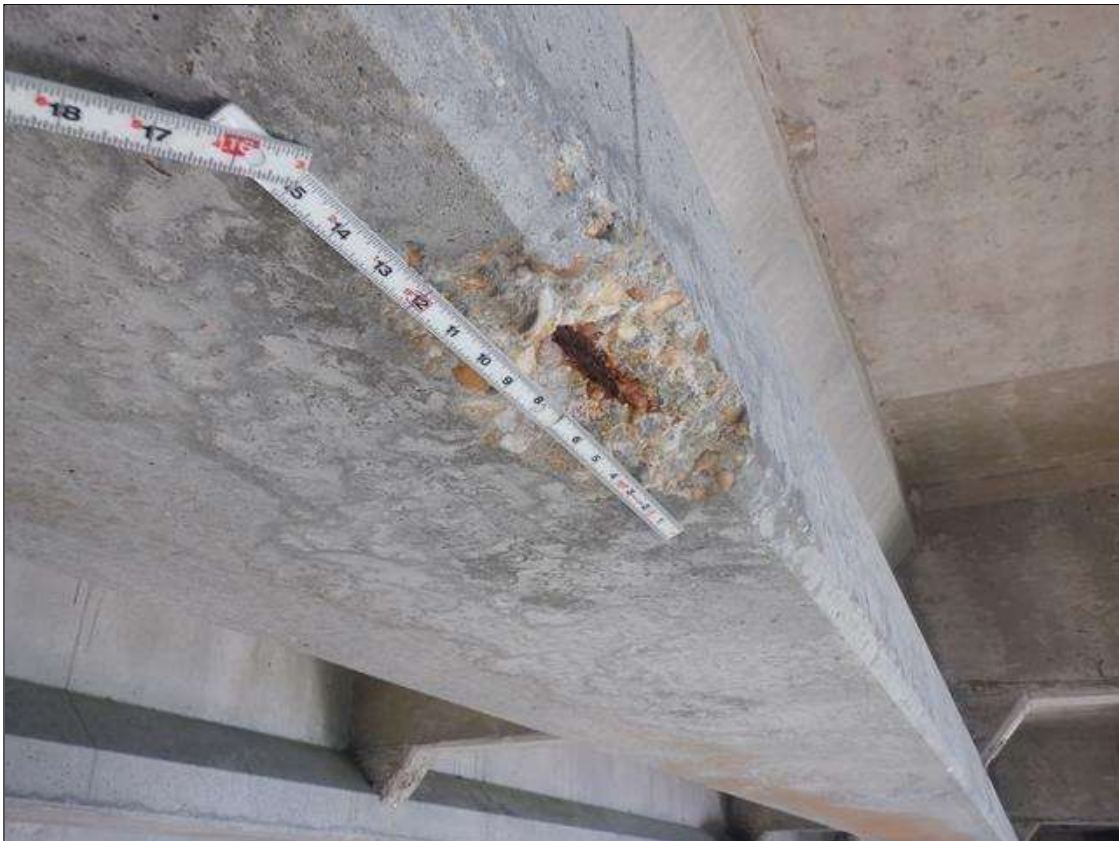
Span 185 Beam 1: (PAR) UNDERSIDE OF BOTTOM FLANGE NEAR MIDSPAN, SPALL (8 INCHES DIAMETER X 1 1/2 INCHES DEEP) WITH TWO (2) EXPOSED STRANDS (25 PERCENT LOSS)

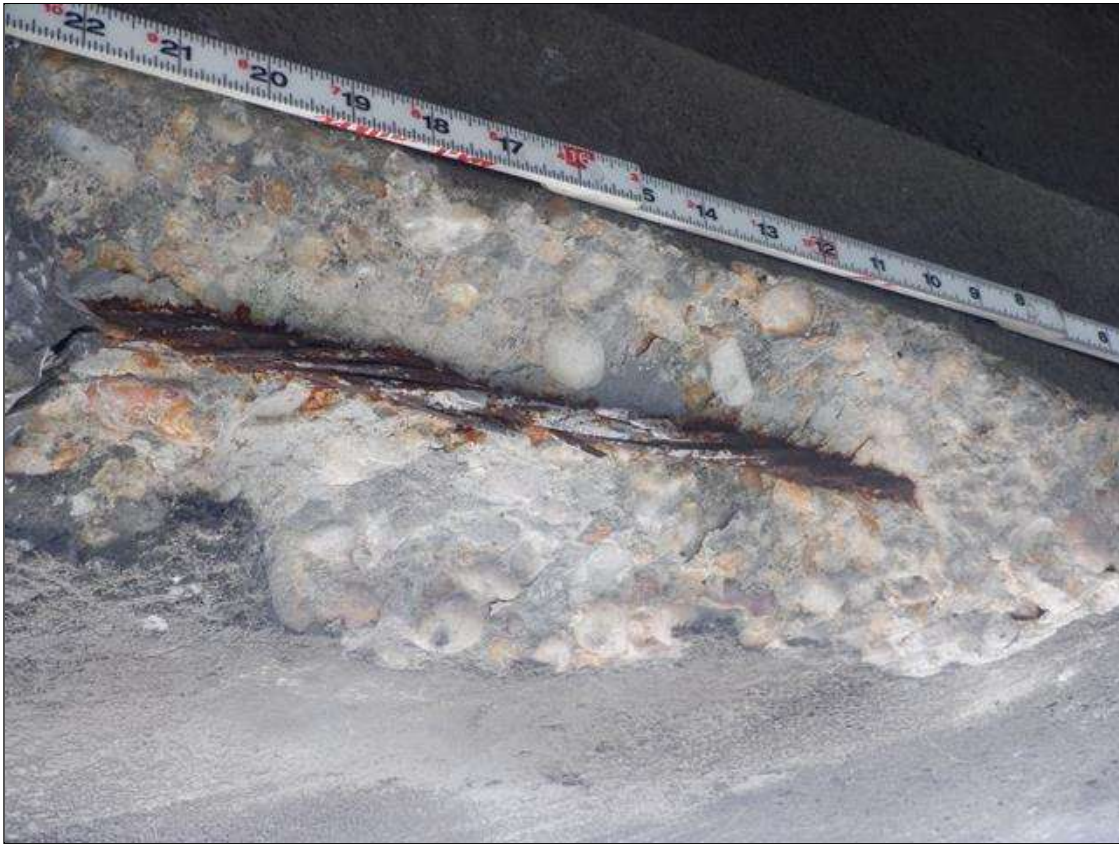
Span 186 Beam 3: (PAR) SOUTH FACE OF BOTTOM FLANGE AT 10 FEET FROM BENT 185, SPALL (1 FOOT X 4 INCHES X 1 1/2 INCHES DEEP)

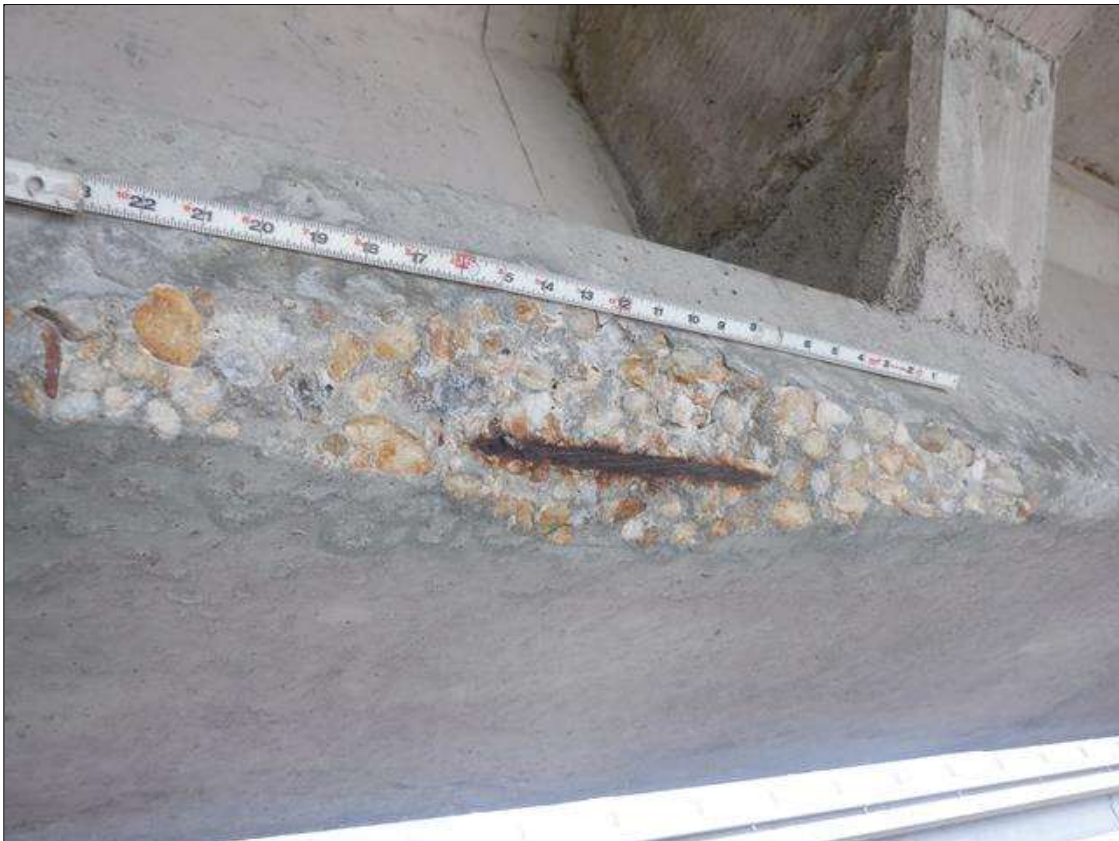
Span 187 Beam 4: (PAR) NORTH FACE OF BOTTOM FLANGE AT 2 FEET FROM BENT 186, SPALL (2 FEET X 6 INCHES X 2 INCHES DEEP) WITH ONE (1) EXPOSED AND PARTIALLY SEVERED STRAND

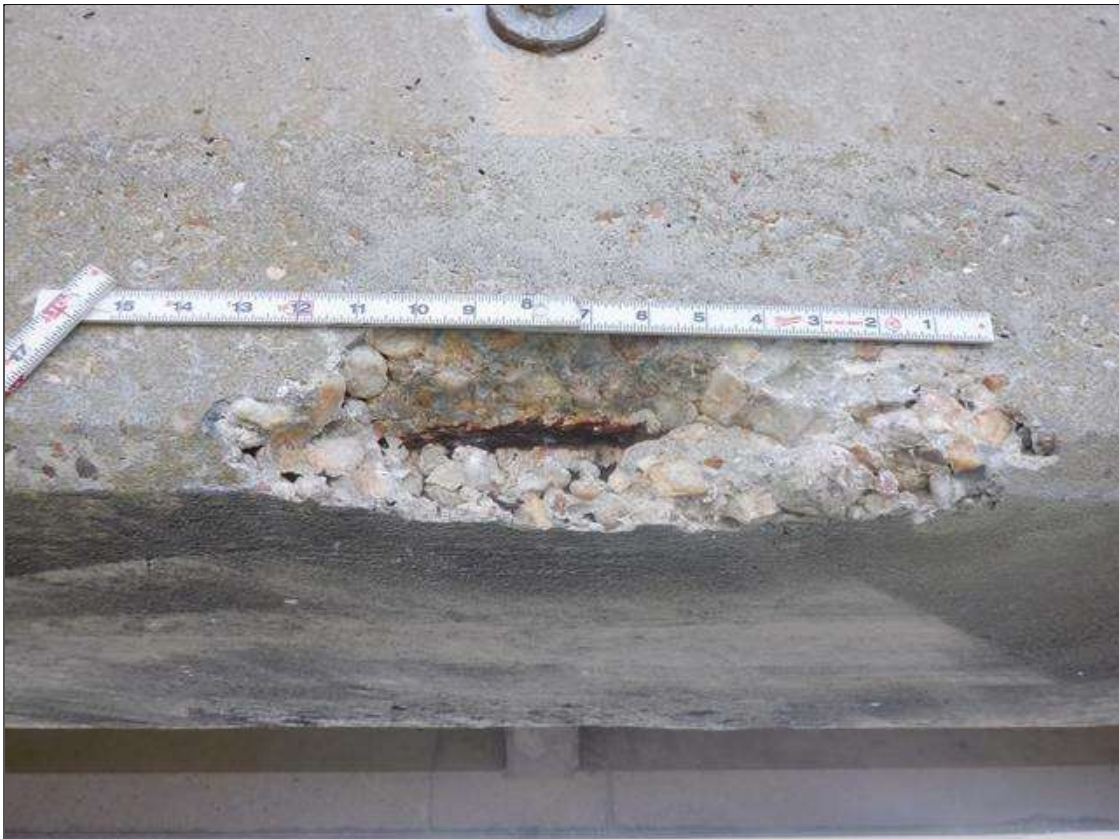
Span 192 Beam 1: (PAR) NORTH FACE BOTTOM FLANGE AT BEAM END, SPALL (3 INCHES DIAMETER X 2 INCHES DEEP) WITH ONE (1) EXPOSED STARND (25 PERCENT LOSS)

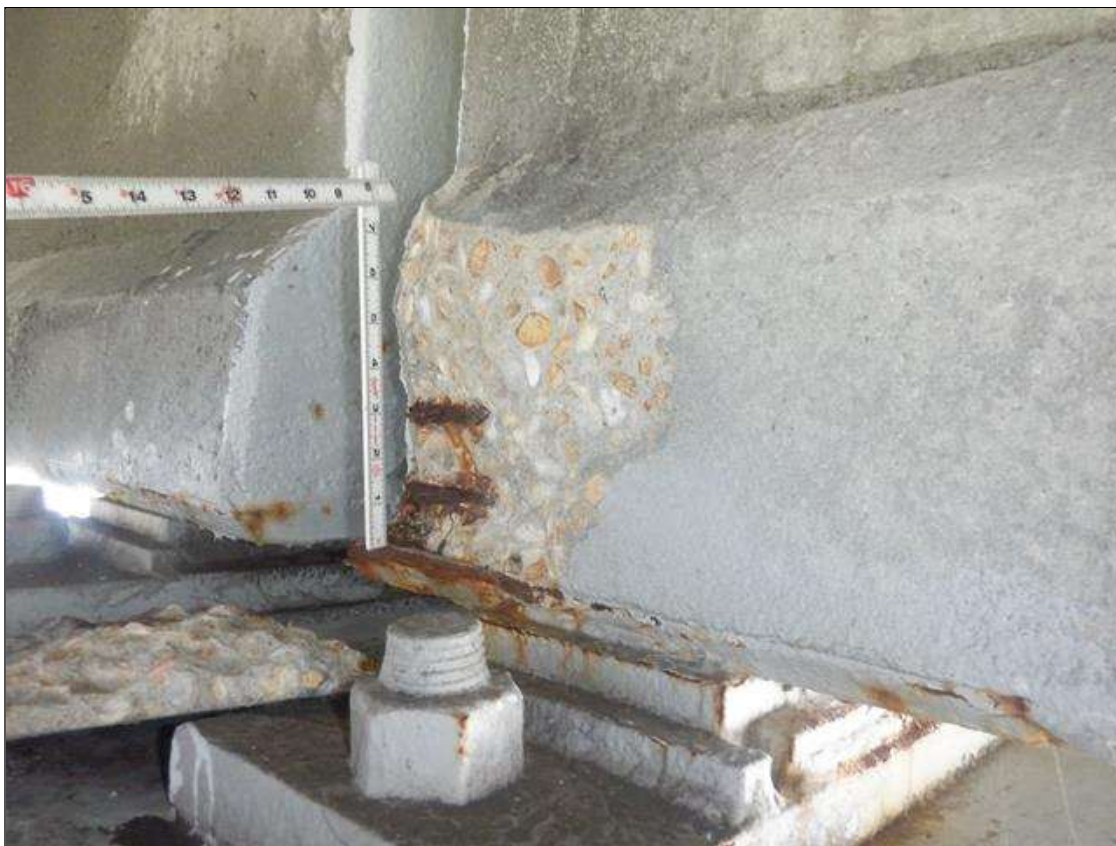
Span 193 Beam 1: (PAR) NORTH FACE BOTTOM FLANGE AT MIDSPAN, SPALL (1 FOOT X 2 INCHES X 2 INCHES DEEP) WITH ONE (1) EXPOSED STARND (25 PERCENT LOSS)

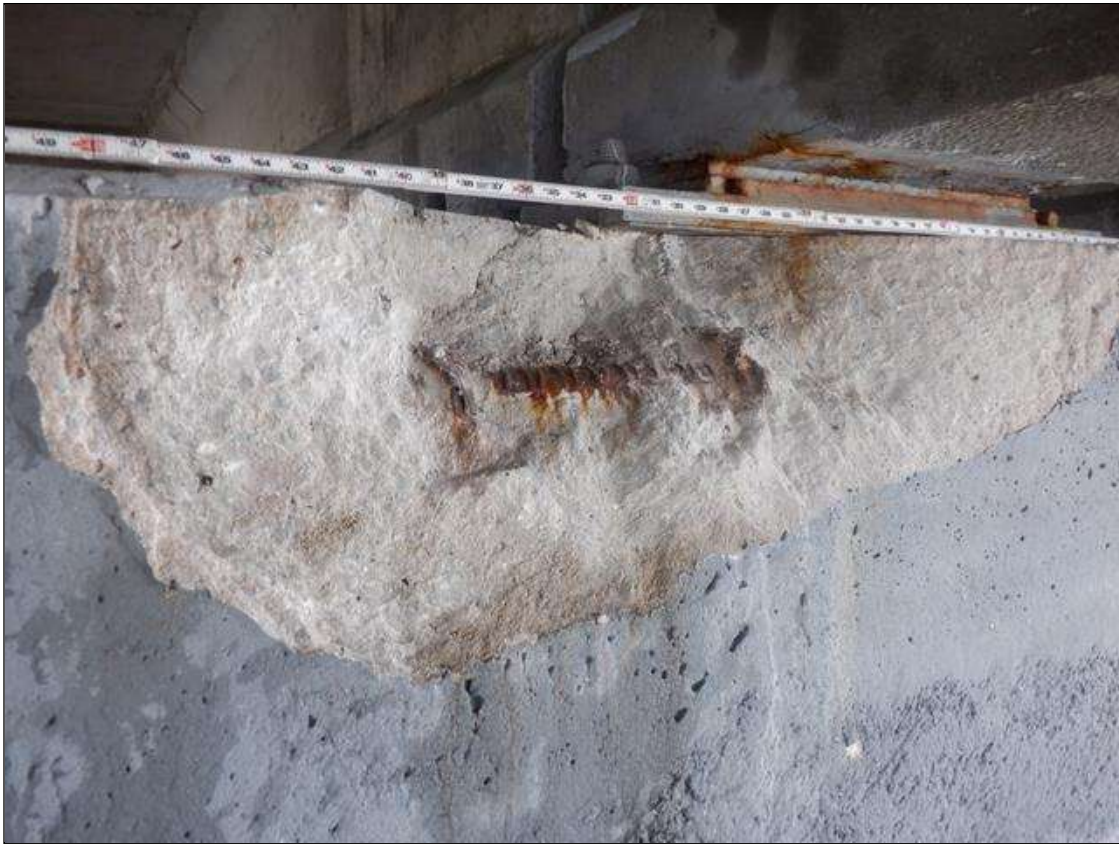
Span 198 Beam 2: (PAR) NORTH FACE OF BOTTOM FLANGE AT BENT 198, SPALL (9 INCHES X 9 INCHES X 2 1/2 INCHES DEEP) WITH TWO (2) EXPOSED STRANDS (10 PERCENT LOSS)

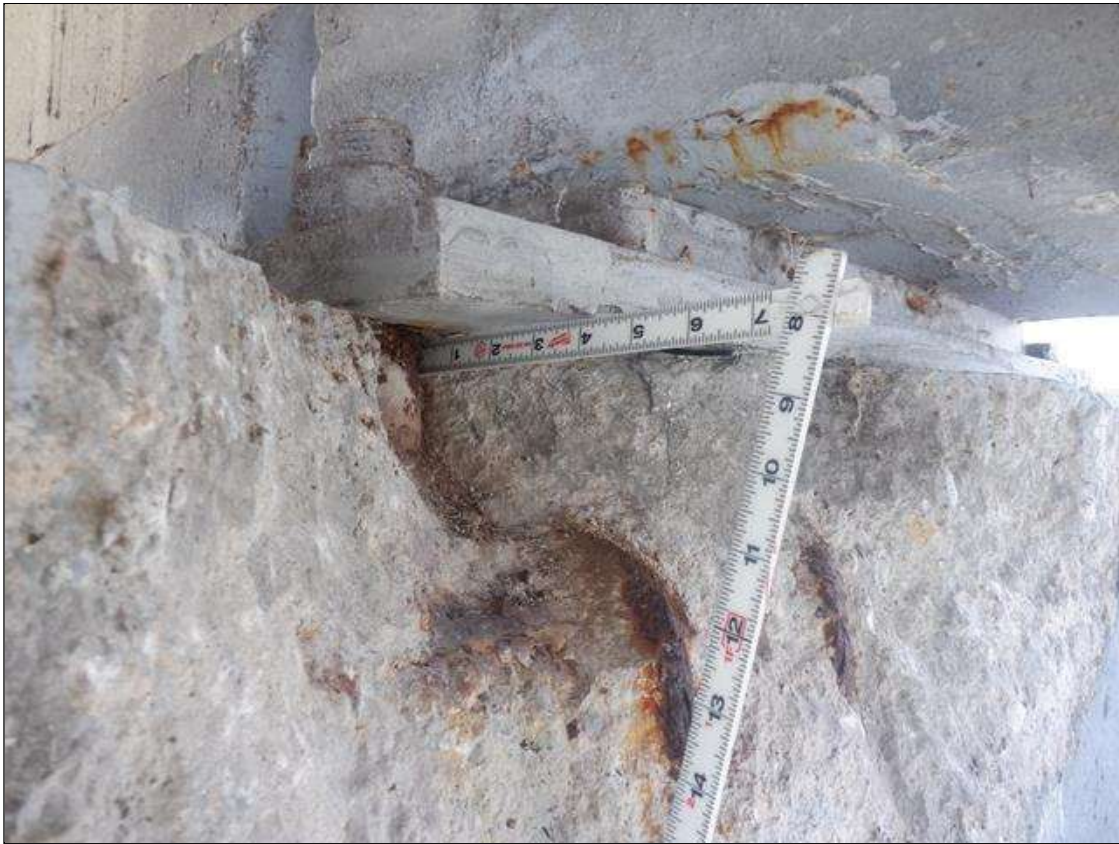
Bent 199 Cap 1: (PAR) WEST FACE BELOW BEAM 2, SPALL (4 FEET X 1 FOOT X UP TO 8 INCHES DEEP) WITH ONE (1) EXPOSED PRIMARY REBAR (NO SECTION LOSS), UNDERMINING OF BEARING (8 INCHES X 2 INCHES AVERAGE)

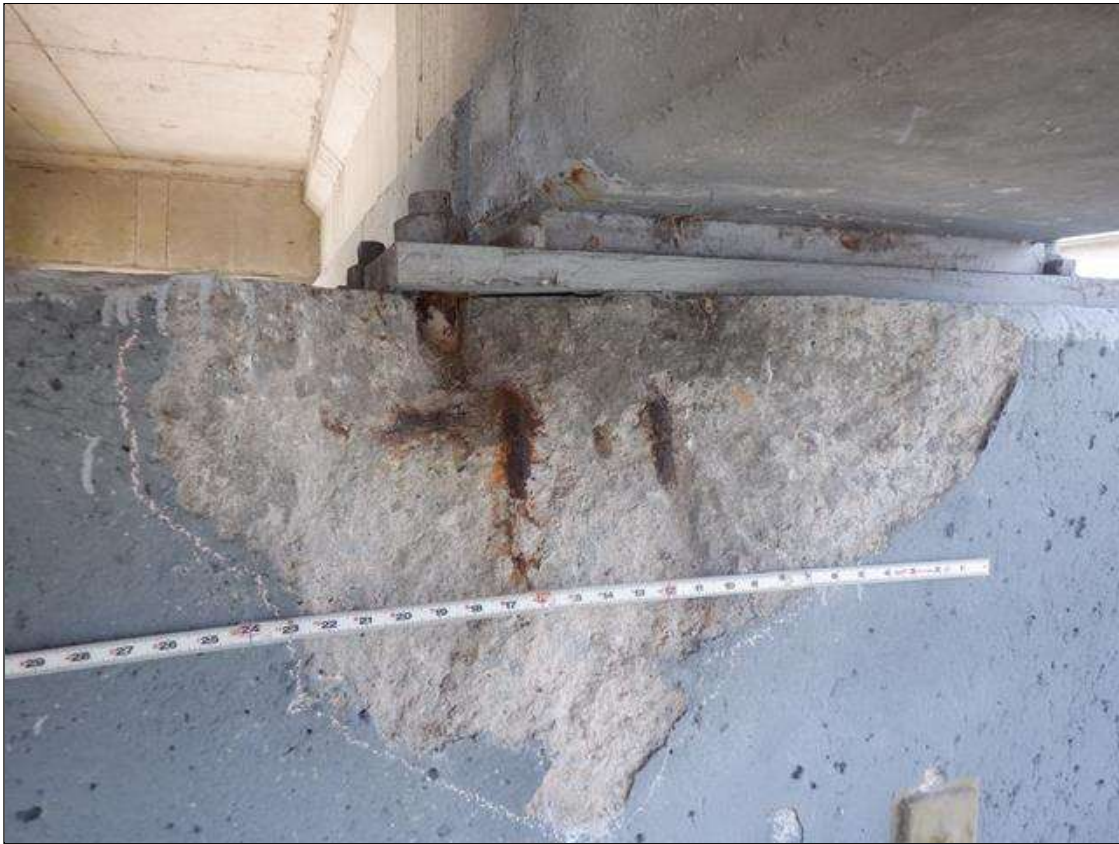
Bent 179 Cap 1: (PAR) TOP OF EAST FACE BELOW GIRDER 1, SPALL (30 INCHES X 16 INCHES X UP TO 8 INCHES DEEP) WITH TWO (2) EXPOSED STIRRUPS AND ONE (1) EXPOSED ANCHOR BOLT, EXTENDING BELOW BEARING (UP TO 10 PERCENT) WITH UNDERMINING OF MASONRY PLATE (7 INCHES X 3 INCHES AVERAGE)

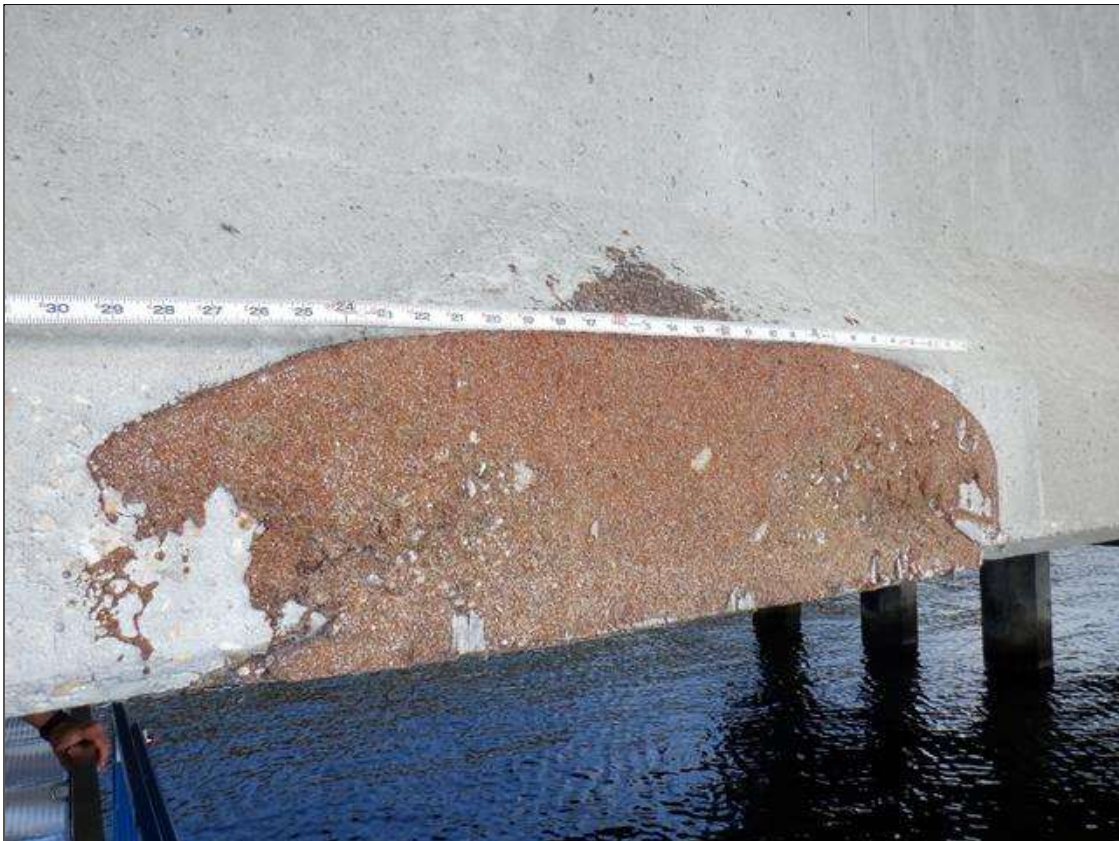
Span 237 Beam 1: (PAR) UNDERSIDE OF BOTTOM FLANGE, AT 24 FEET FROM BENT 237, SPALL (18 INCHES X 8 INCHES X 1 IN) WITH (2) EXPOSED RUSTED STRANDS (10 PERCENT SECTION LOSS) ON STRAND

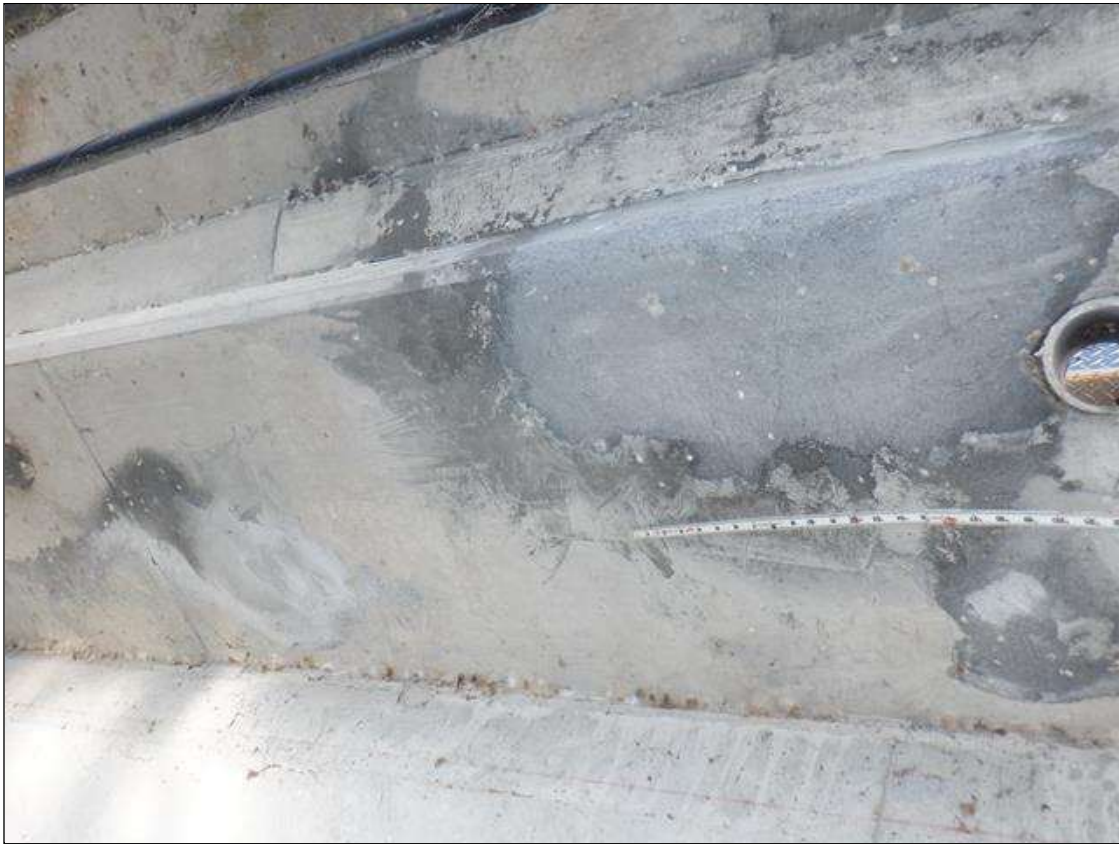
Span 3 Beam 4: SOUTH FACE OF BOTTOM FLANGE AT 25 FEET FROM BENT 2, PATCHED AREA (24 INCHES X 15 INCHES)
