NC DEPARTMENT OF TRANSPORTATION  
DIVISION OF HIGHWAYS  
STRUCTURE MANAGEMENT UNIT

## Structure Safety Report

### Routine Element Inspection - Contract

STRUCTURE NUMBER: 260016 SAP STRUCTURE NO: 0270016 FHWA STRUCTURE NO: 000000000530016  
DIVISION: 1 COUNTY: CURRITUCK INSPECTION DATE: 09/21/2022 FREQUENCY: 24 MONTHS  
FACILITY CARRIED: US158E MILE POST: \_\_\_\_\_  
LOCATION: .01 MI.E.JCT.SR1187  
FEATURE INTERSECTED: CURRITUCK SOUND  
LATITUDE: 36° 5' 11.69" LONGITUDE: 75° 46' 0.21"  
SUPERSTRUCTURE: RC FLOOR ON PPC GIRDERS & CORED SLAB  
SUBSTRUCTURE: EBTS:RC CAP/PPC PILES;IBTS:RCP&B & RC CAPS/PPC PILES  
SPANS: 248 SPANS. SEE SPAN PROFILE SHEET FOR SPAN DETAILS  
☐ FRACTURE CRITICAL ☐ TEMPORARY SHORING ☐ SCOUR CRITICAL ☐ SCOUR PLAN OF ACTION  
GRADES: (Inspector/NBI Coding) DECK 6 / 6 SUPERSTRUCTURE 5 / 5 SUBSTRUCTURE 6 / 6 CULVERT N / N  
POSTED SV: Not Posted POSTED TTST: Not Posted  
OTHER SIGNS PRESENT: None

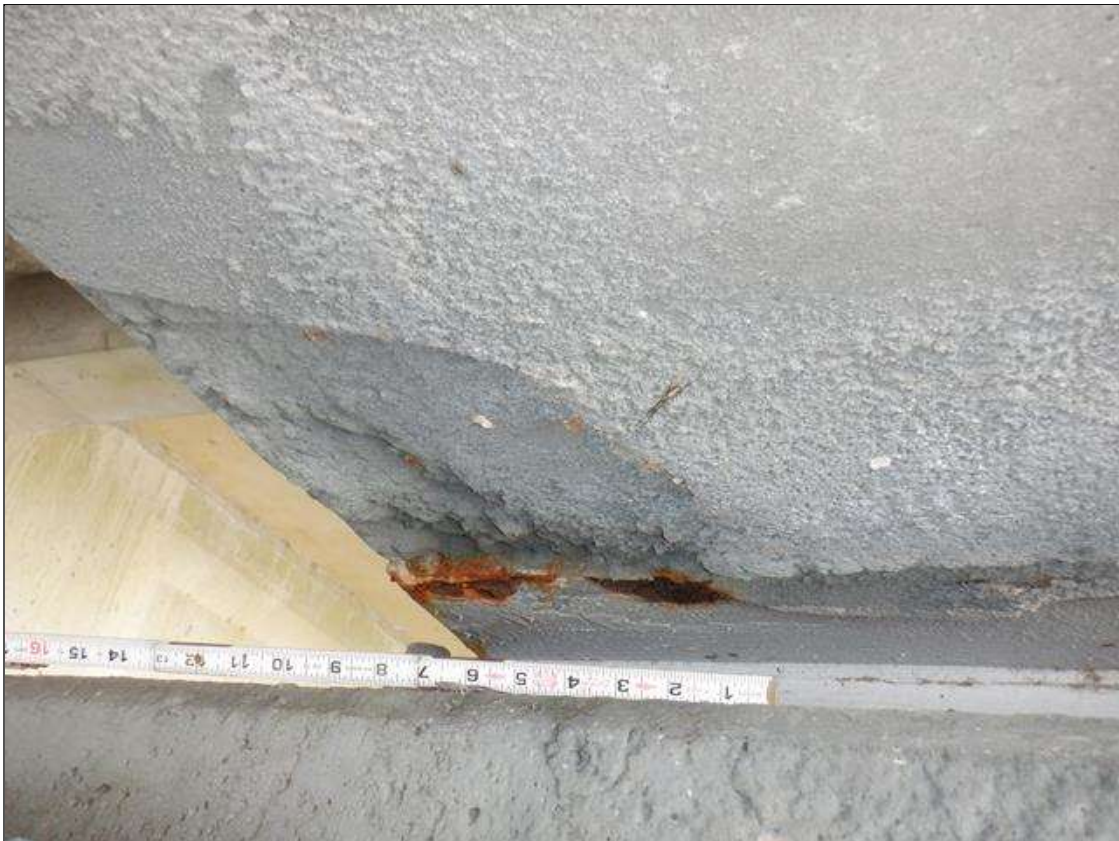
Span 4 Deck: UNDERSIDE OF DECK, SOUTH OVERHANG AT 20 FEET FROM BENT 3, 2 (TWO) PATCHED AREAS (UP TO 24 INCHES X UP TO 18 INCHES)

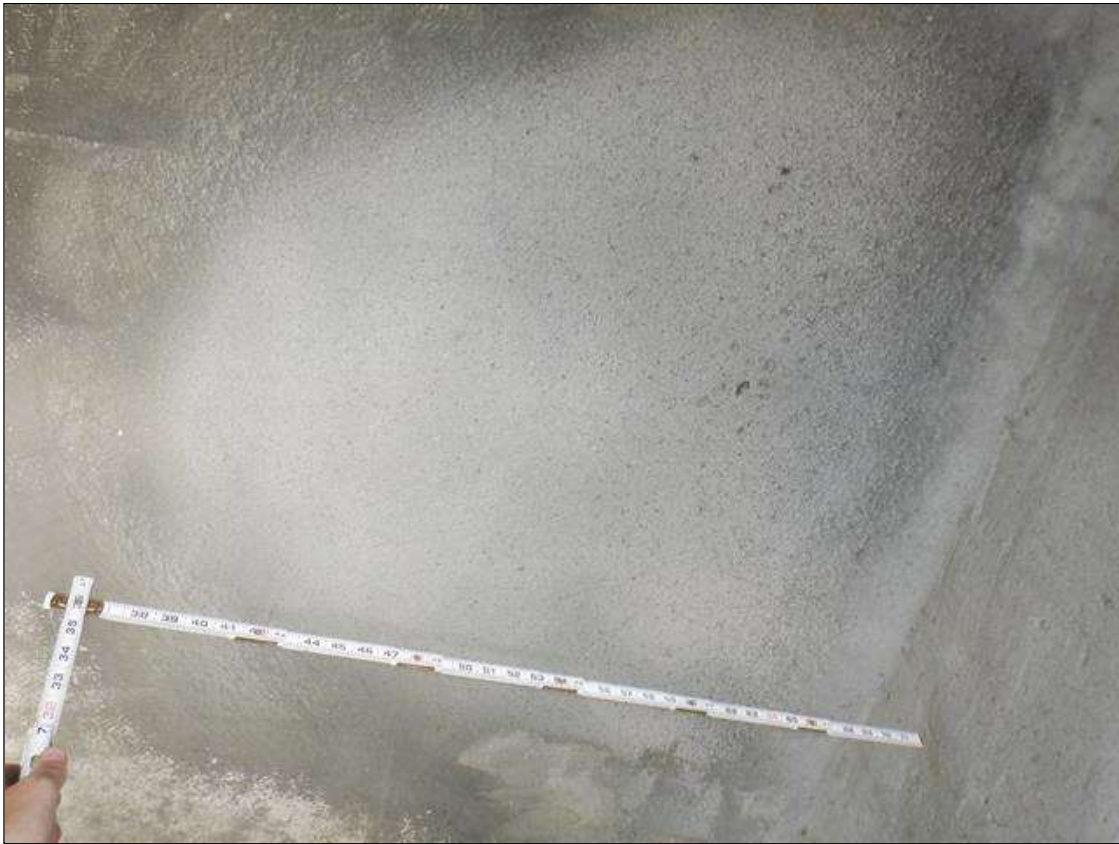
Span 4 Beam 2: 9 INCHES X 9 INCHES X 1 INCHES DEEP SPALL INCHES BOTTOM FLANGE AT PIER 4

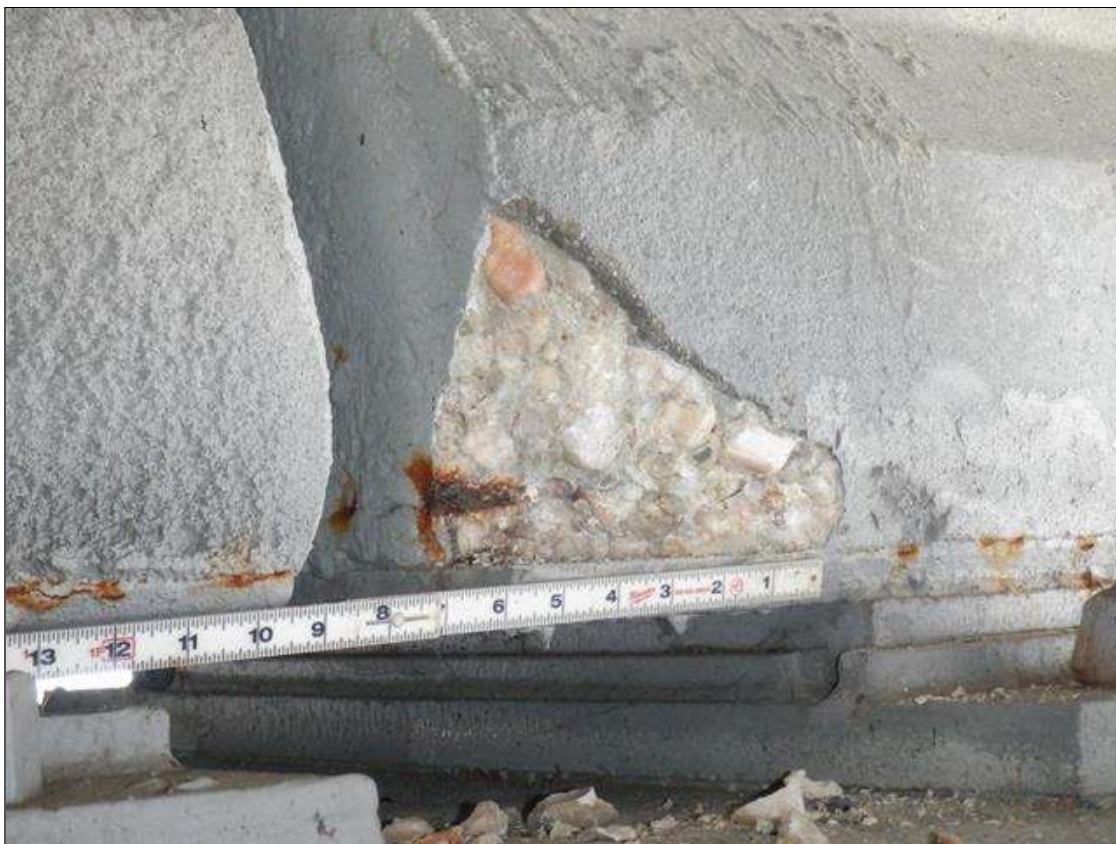
Span 8 Beam 3: NORTH FACE BOTTOM FLANGE AT BENT 7, SPALL (13 INCHES LONG X 5 INCHES HIGH X UP TO 1 INCH DEEP)

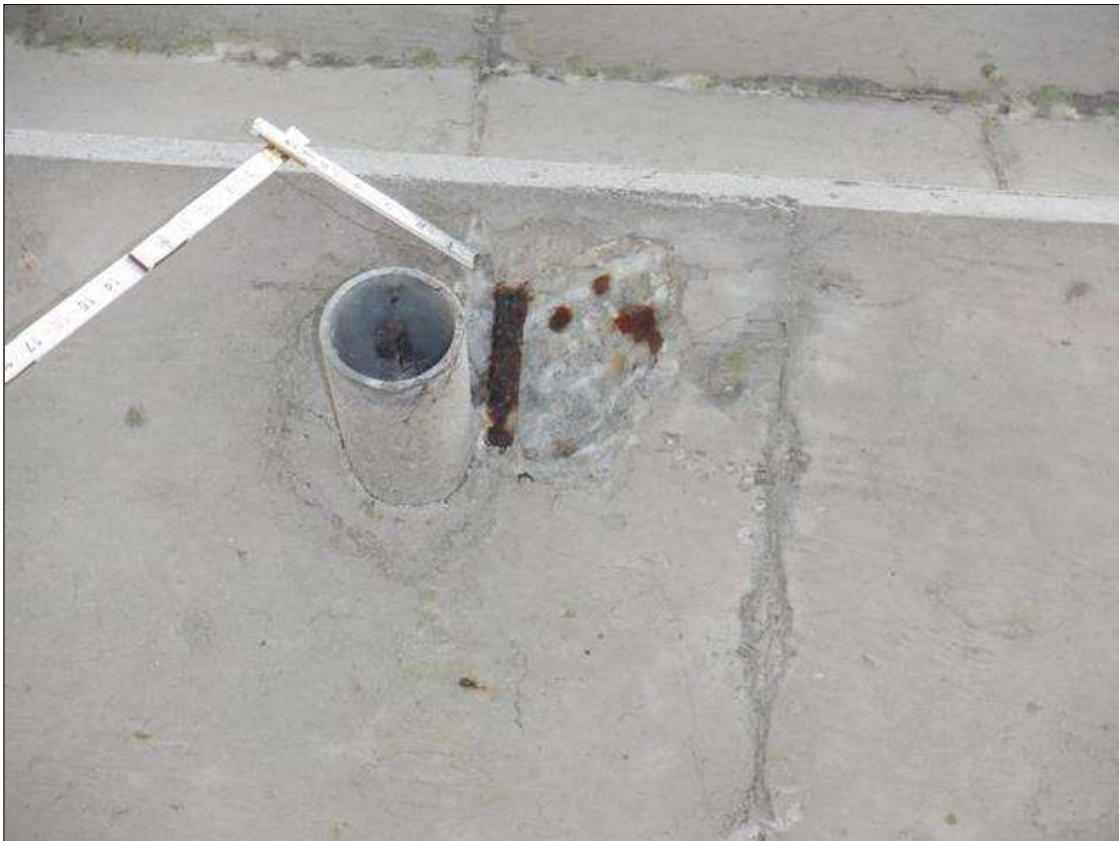
Span 16 Deck: UNDERSIDE OF RIGHT OVERHANG AT DRAIN DOWNSPOUT NEAR MIDSPAN, SPALL (6 INCH DIAMETER X 1/2 INCH DEEP) WITH EXPOSED RUSTED REINFORCING (NO SECTION LOSS)

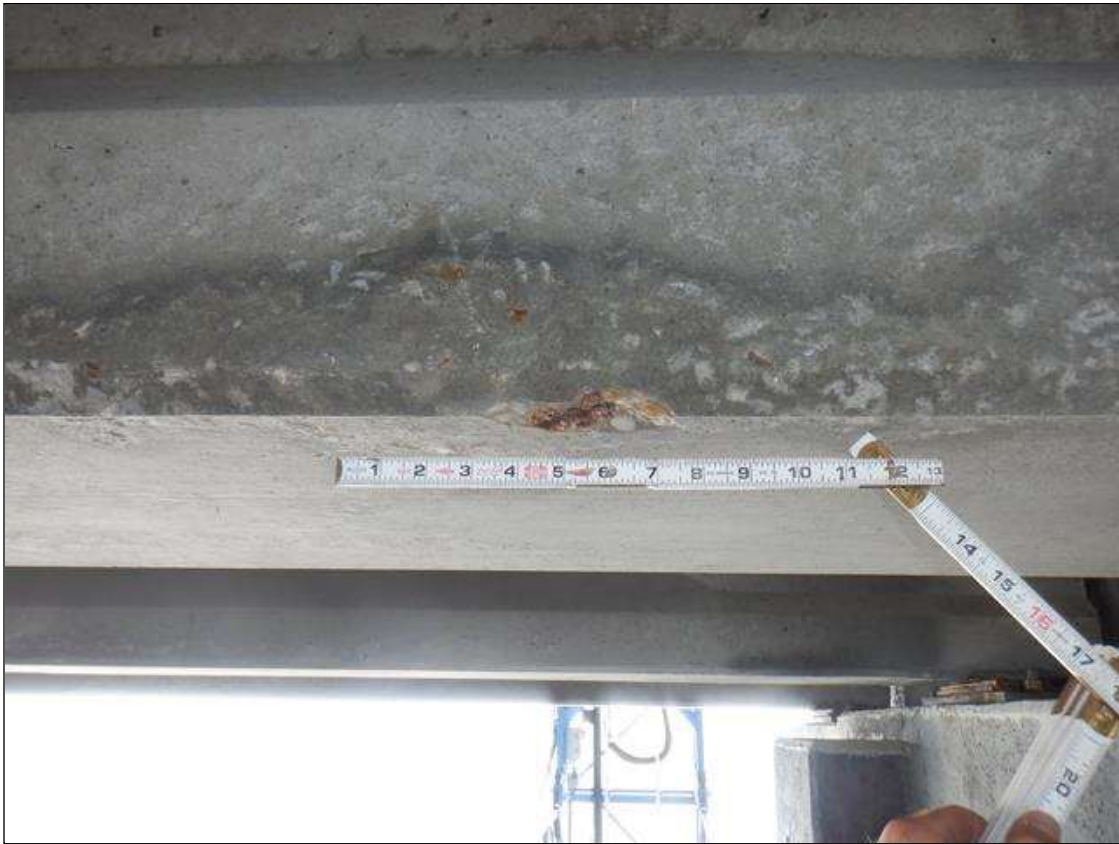
Span 25 Beam 3: BOTTOM FLANGE NORTH FACE AT BENT 25, DELAMINATION (36 INCHES X 7 INCHES)

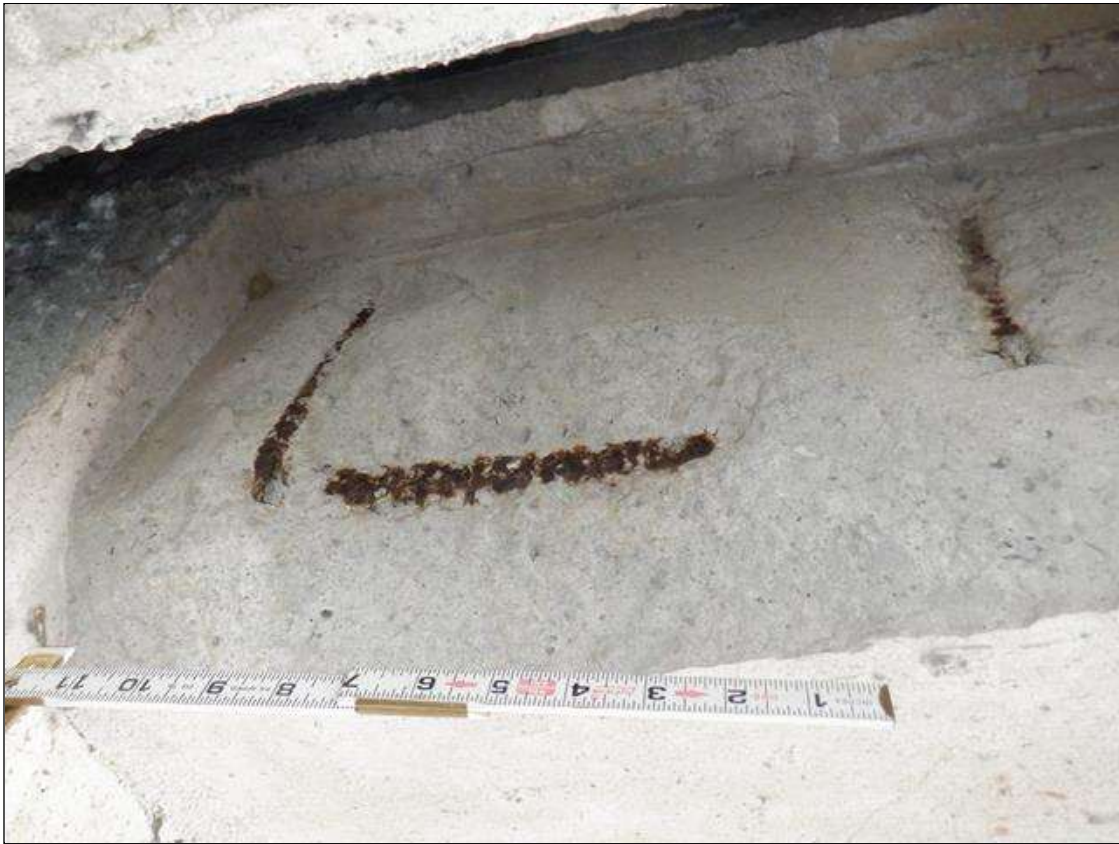
Span 29 Beam 2: BOTTOM FLANGE NORTH FACE, 3 FEET FROM BENT 28 HORIZONTAL CRACK (HAIRLINE X 6 INCHES LONG) WITH RUST STAIN AND SPALL/DELAMINATION (2 INCHES X 1 INCH X 1/2 INCH DEEP) WITH EXPOSED RUSTED REINFORCING (NO LOSS)

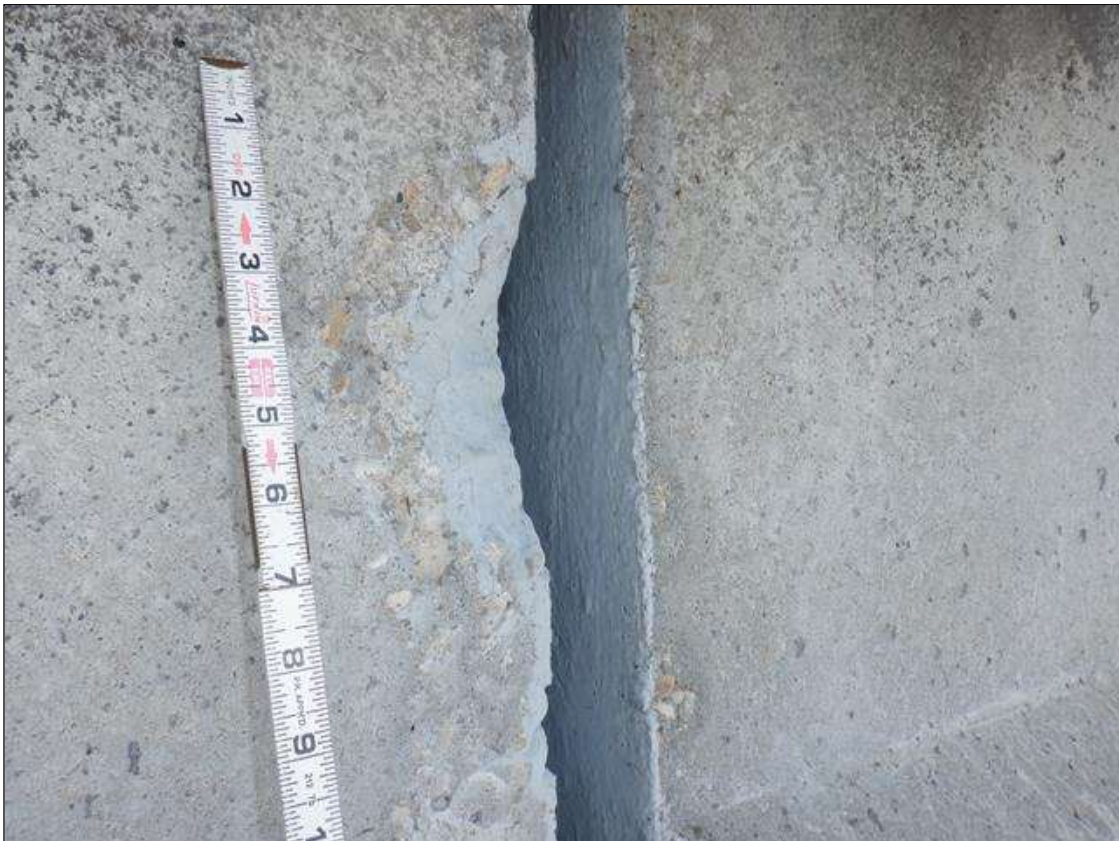
Span 32 Beam 1: END DIAPHRAGM OVER BENT 31, SPALL (11 INCHES HIGH X 30 INCHES WIDE X 2 INCHES DEEP) WITH (4) FOUR EXPOSED RUSTED REINFORCING (NO LOSS)

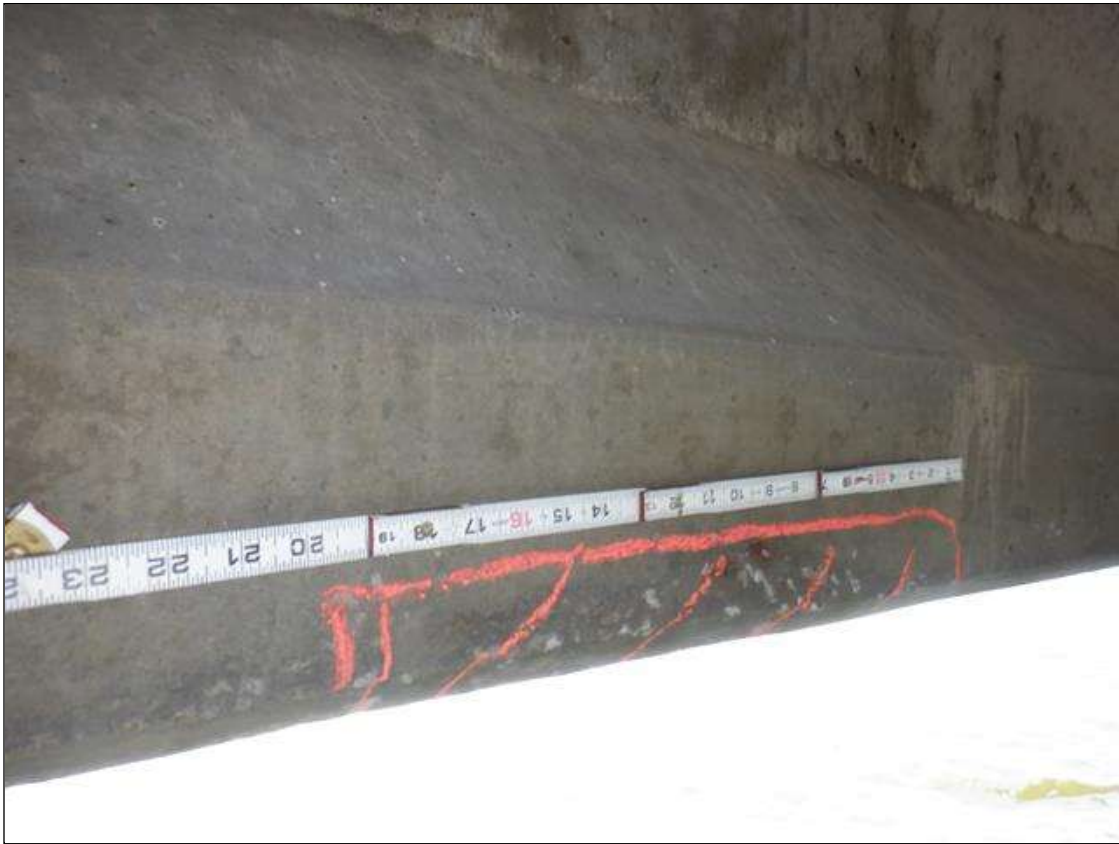
Span 35 Beam 4: SOUTH FACE OF BOTTOM FLANGE, AT BENT 35, SPALL (5 INCHES X 4 INCHES X 1 1/2 INCHES)

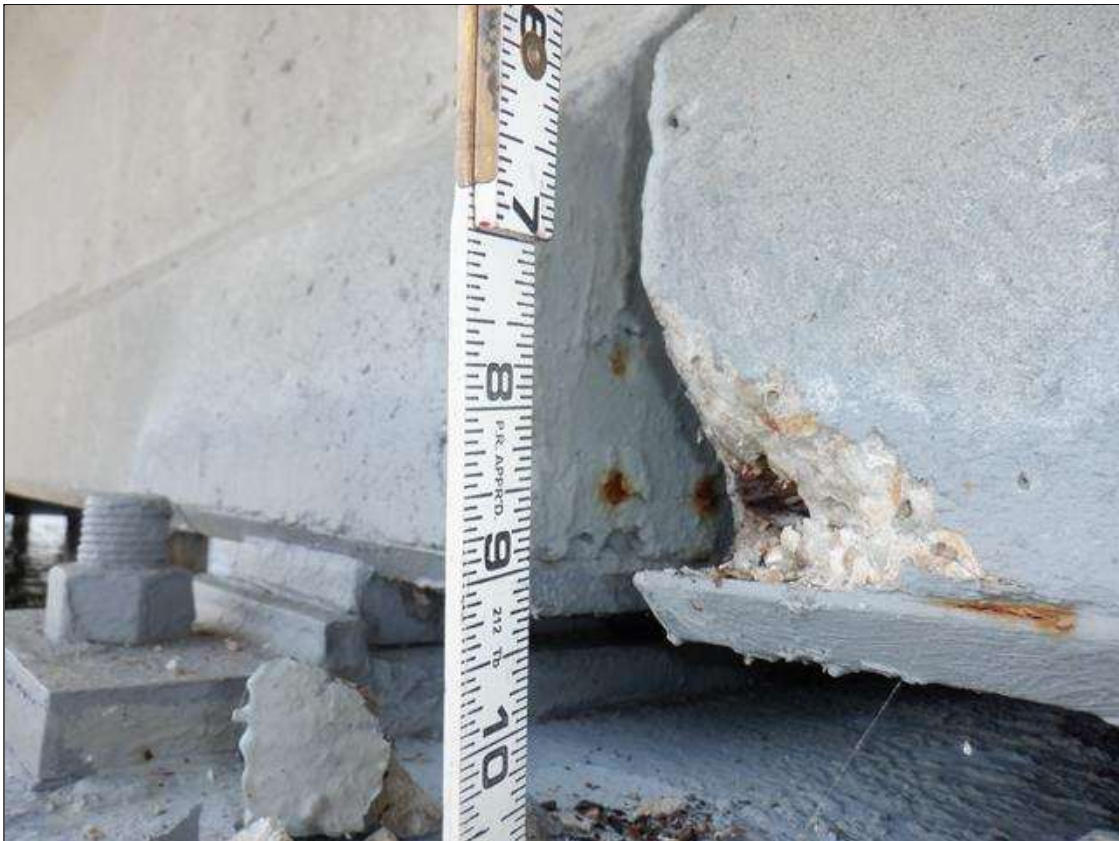
Span 37 Beam 3: BOTTOM FLANGE NORTH FACE AT 6 FEET FROM BENT 37, HORIZONTAL CRACK (UP TO 1/32 INCH) WITH RUST STAIN AND ASSOCIATED DELAMINATION (20 INCHES X 3 INCHES)

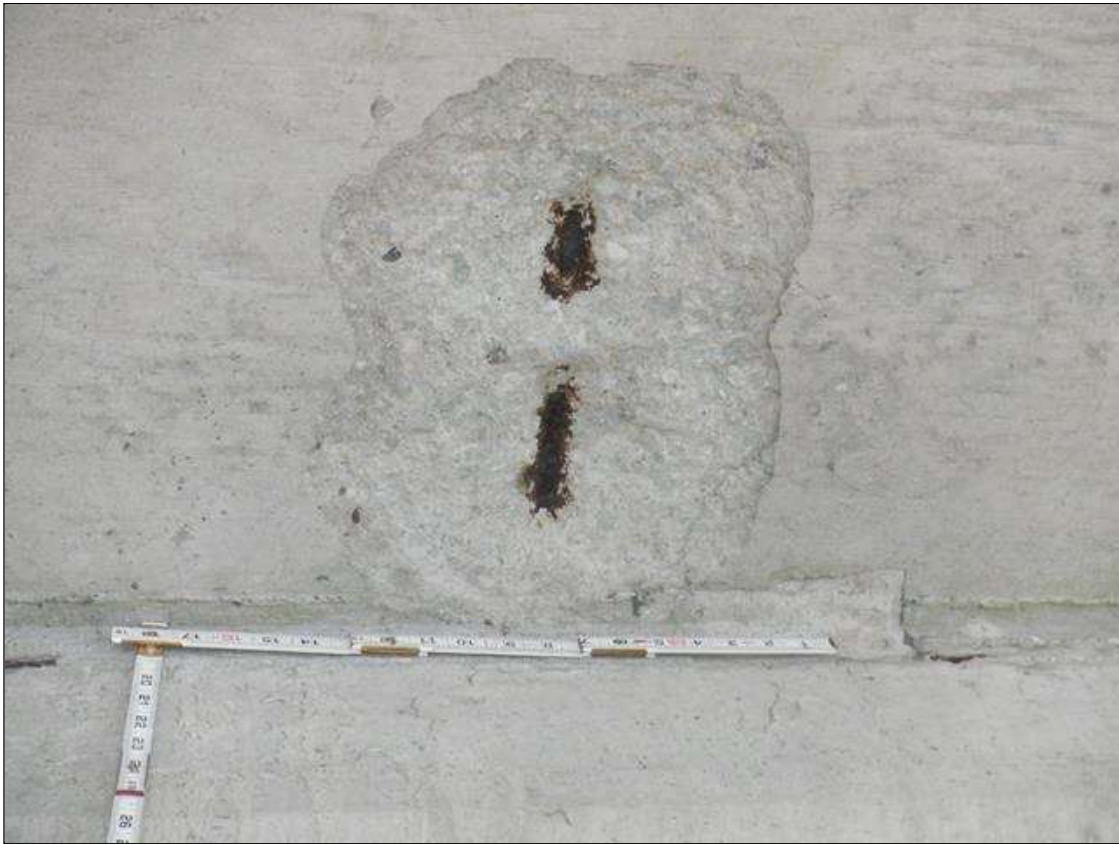
Span 42 Beam 4: BOTTOM FLANGE SOUTH FACE AT BENT 41, SPALL (3 INCHES X 3 INCHES X 2 INCHES DEEP, WITH EXPOSED RUSTED STRAND (10 PERCENT SECTION LOSS)

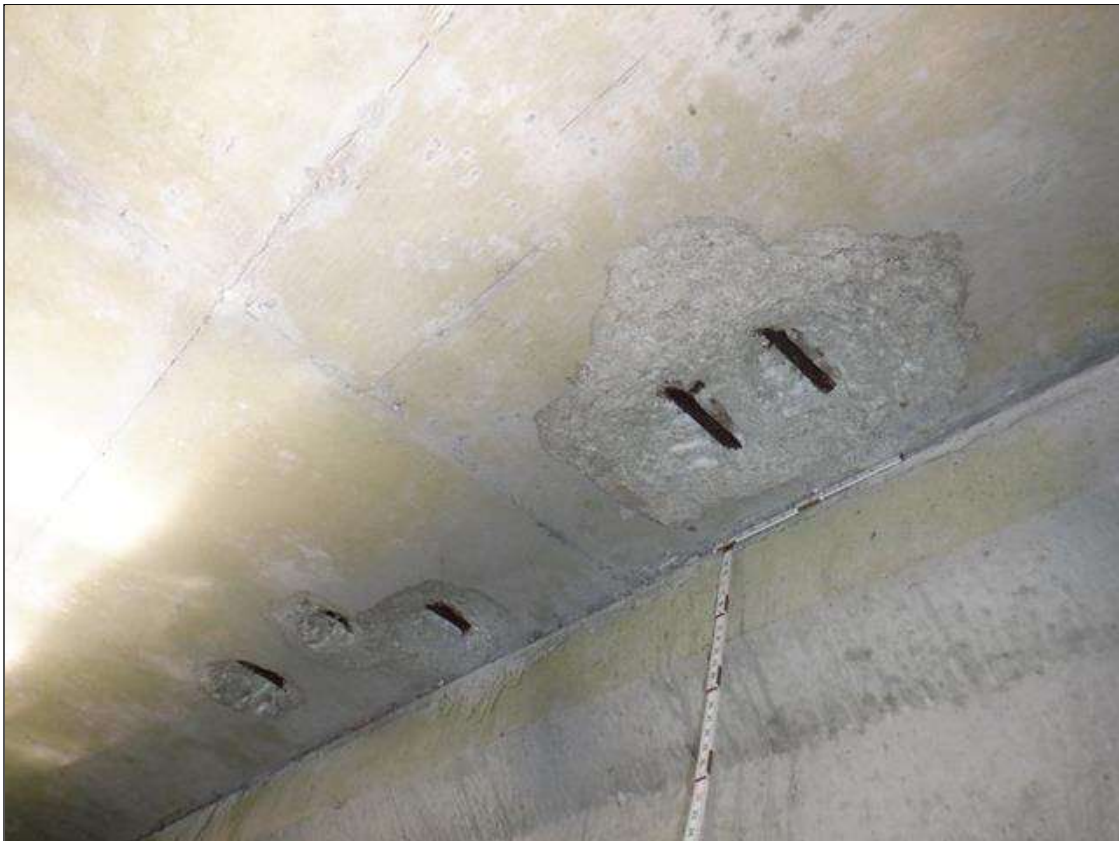
Span 44 Deck: UNDERSIDE OF DECK, BAY 2 NEXT TO BEAM 3 AT 7 FEET FROM BENT 44, SPALL (15 INCHES X 12 INCHES X 1/2 INCHES) WITH EXPOSED RUSTED REBAR

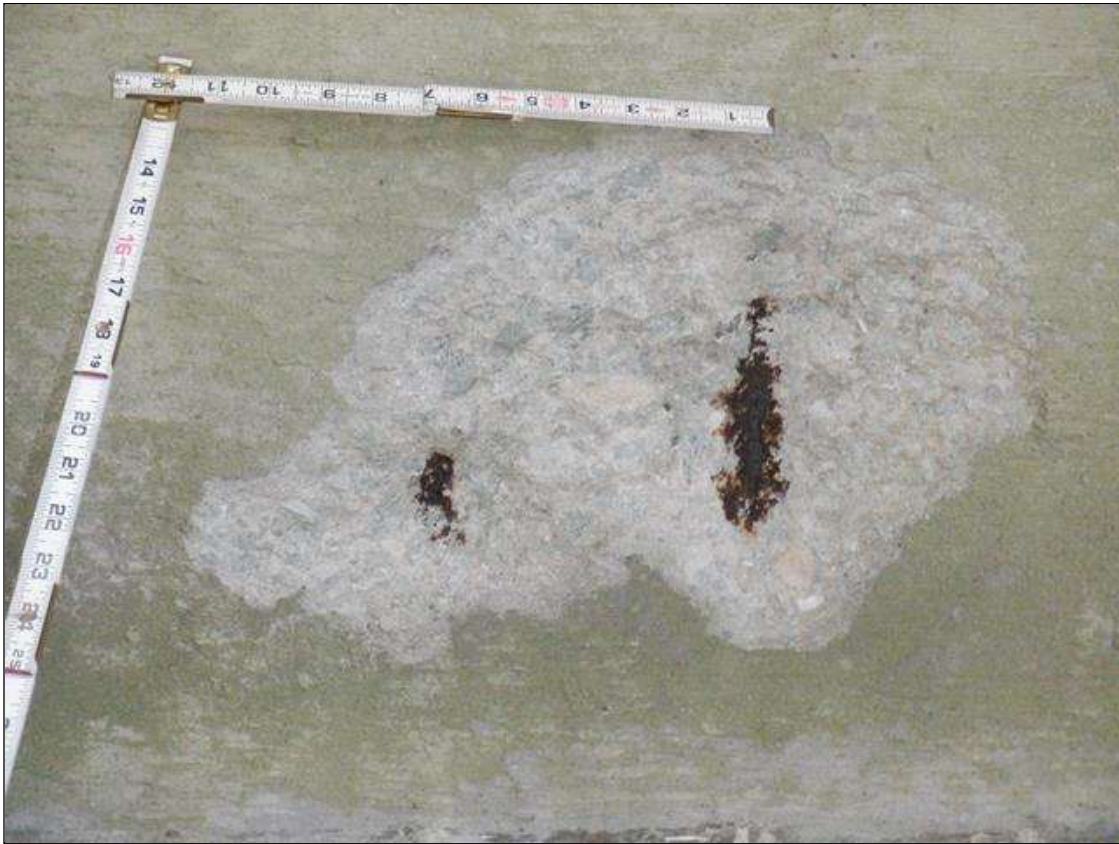
Span 45 Deck: UNDERSIDE OF DECK, BAY 3 NEXT TO BEAM 4, AT 10 FEET FROM BENT 45, (4) SPALLS (UP TO 2 FEET X 18 INCHES X UP TO 2 INCHES) WITH EXPOSED RUSTED REBAR

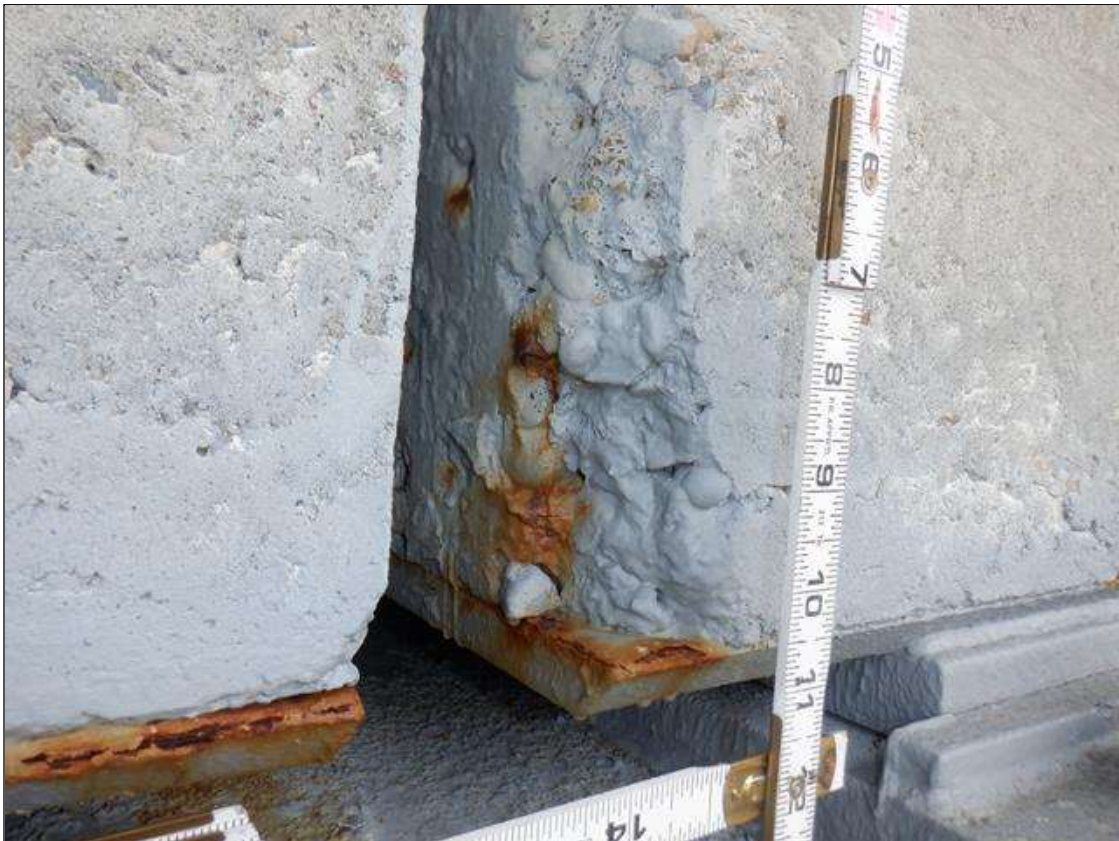
Span 51 Deck: UNDERSIDE OF DECK 5 FEET FROM BENT 51, SPALL (16 INCHES DIAMETER X 2 INCHES DEEP) WITH TWO (2) EXPOSED RUSTED REINFORCING (10 PERCENT SECTION LOSS)

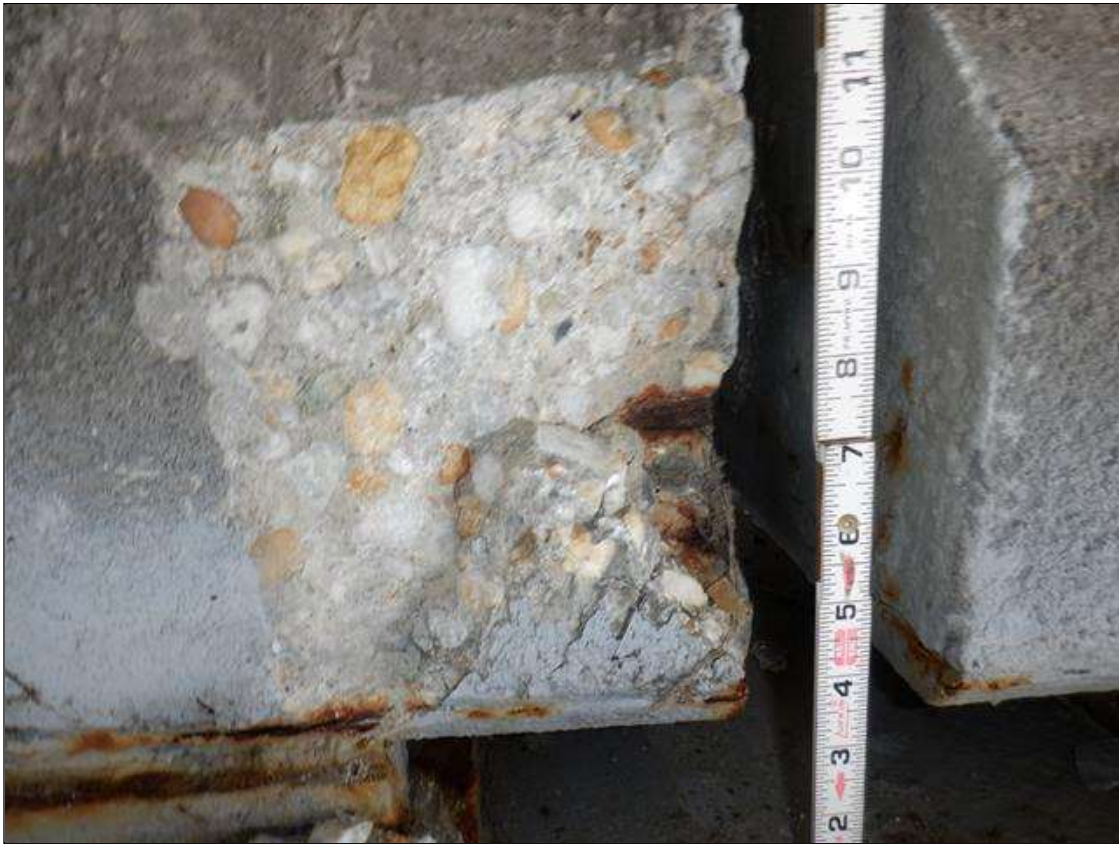
Span 67 Beam 1: NORTH FACE OF BOTTOM FLANGE , AT BENT 67, SPALL (3 INCHES X 6 INCHES X 2 INCHES) WITH EXPOSED STRANDS (NO SECTION LOSS)

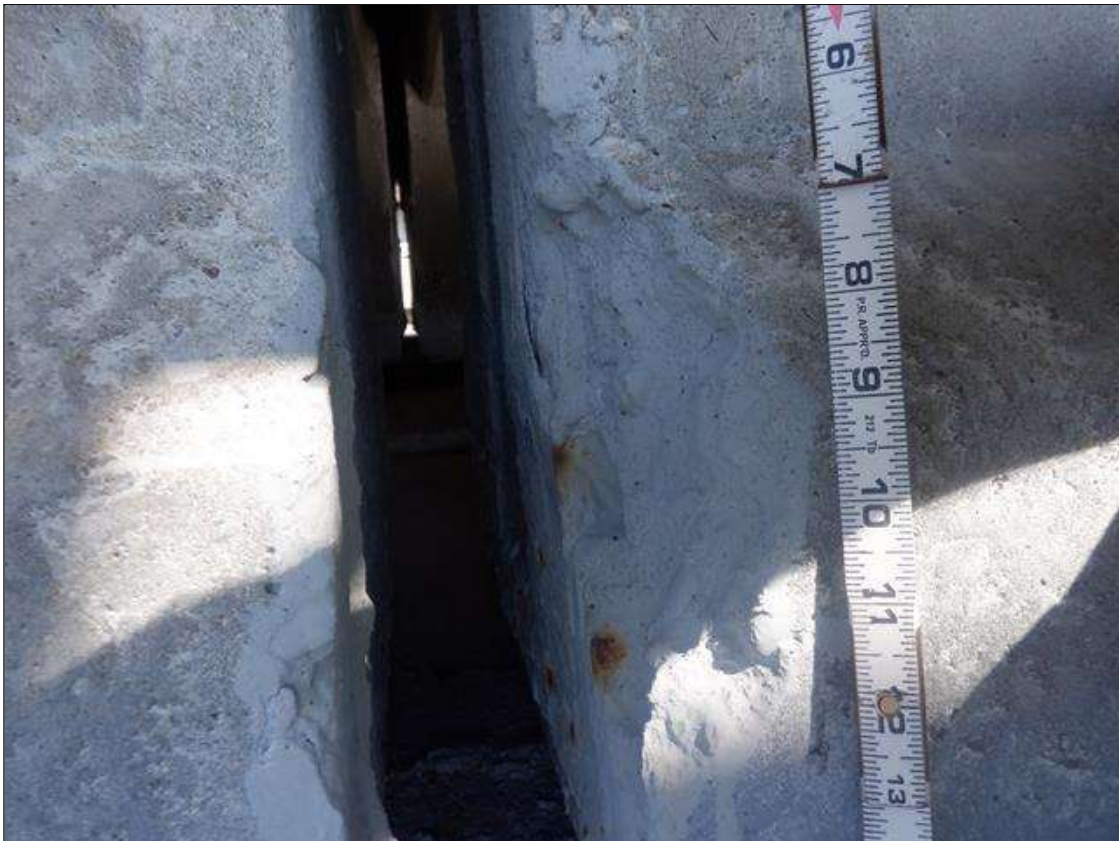
Span 85 Beam 2: SOUTH FACE OF BOTTOM FLANGE, BENT 85, SPALL (7 INCHES X 7 INCHES X 2 INCHES)  
WITH EXPOSED RUSTED STRANDS (NO SECTION LOSS)

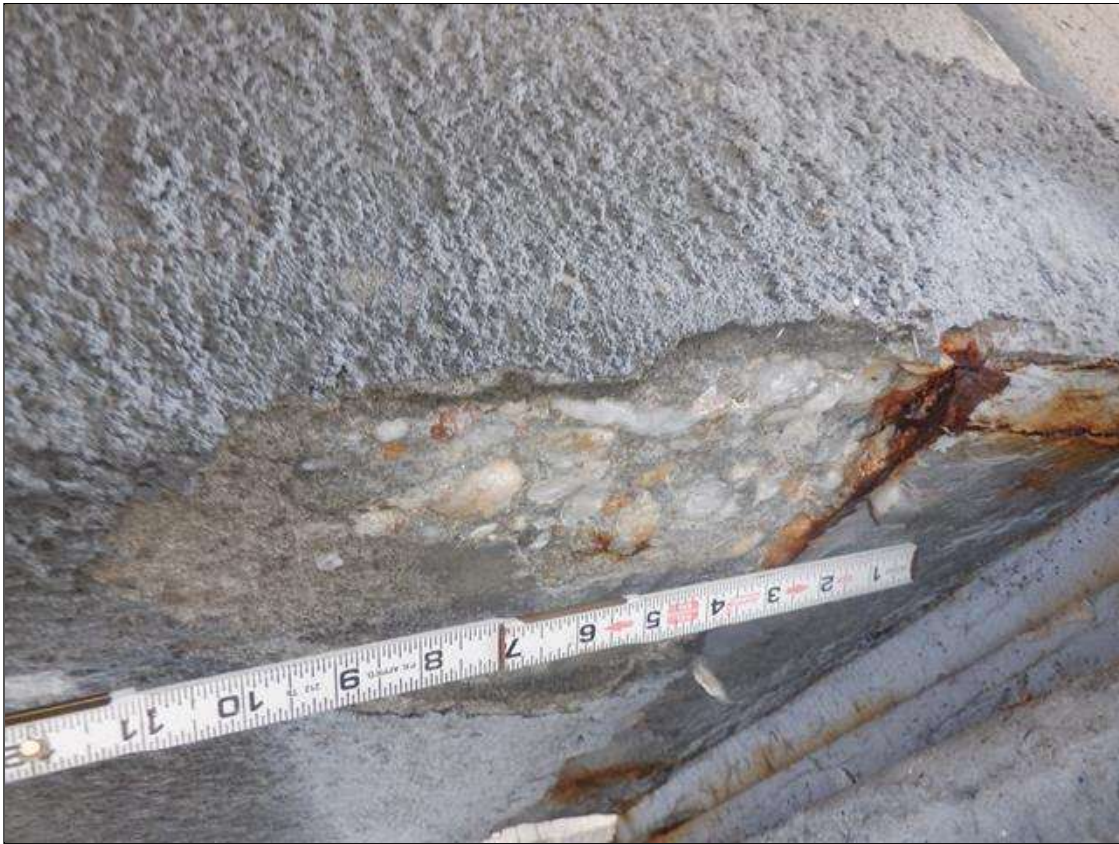
Span 98 Beam 4: BOTTOM FLANGE SOUTH FACE, AT BENT 97, SPALL (3 INCHES X 8 INCHES X 2 INCHES)  
WITH EXPOSED STRANDS (NO SECTION LOSS)

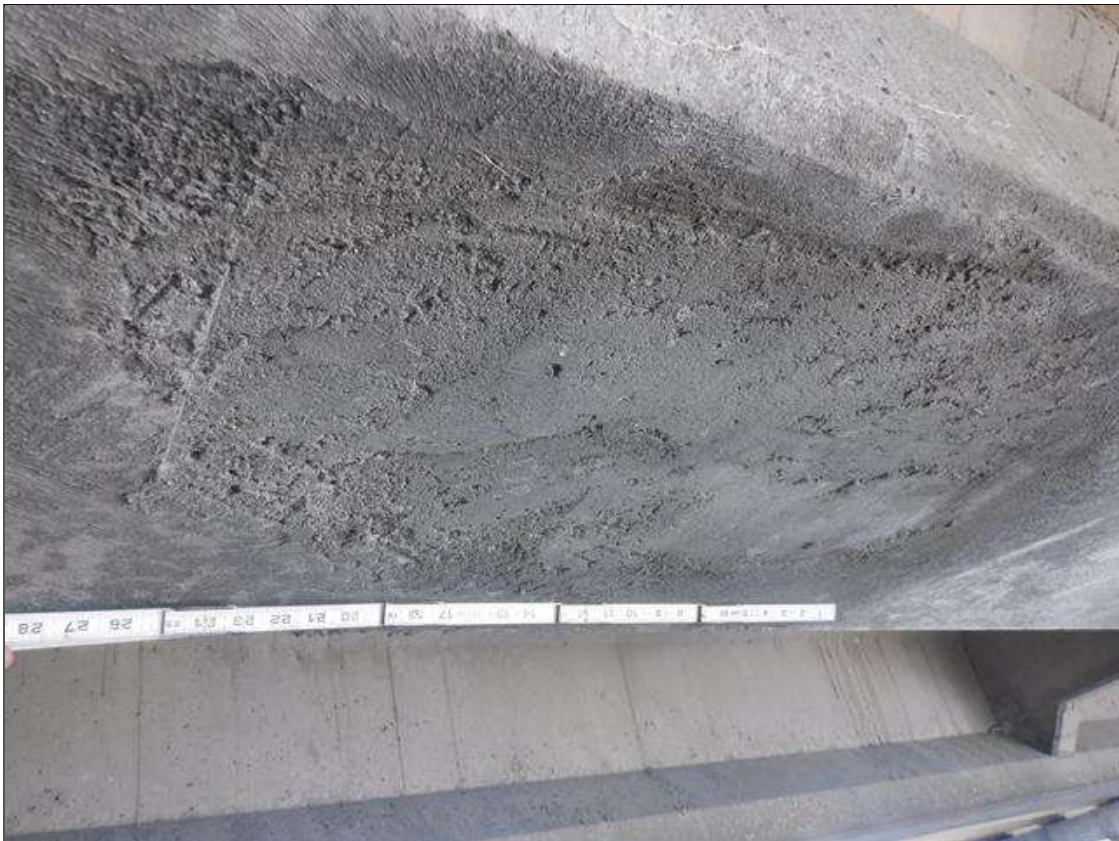
Span 98 Beam 3: UNDERSIDE OF BOTTOM FLANGE AT BENT 98, SPALL (6 INCHES X 3 INCHES X UP TO 1 INCH DEEP)

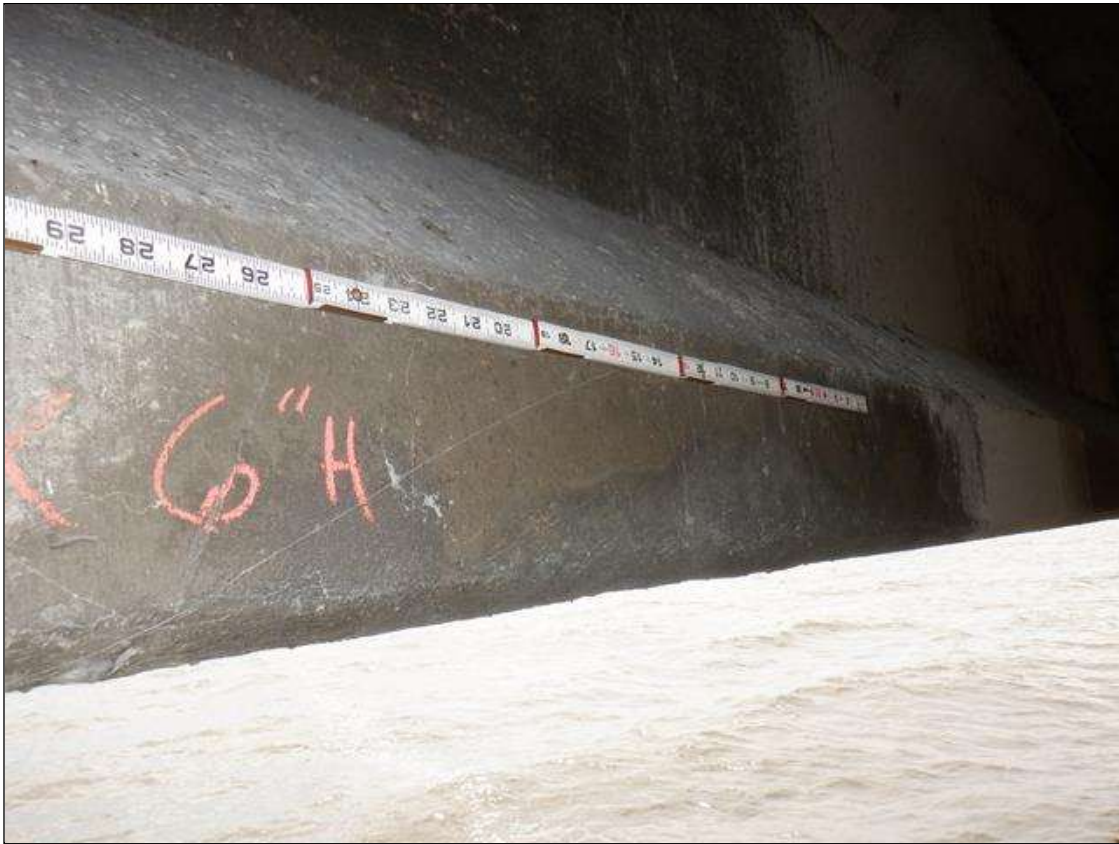
Span 98 Beam 2: UNDERSIDE OF BOTTOM FLANGE AT 6 FEET FROM BENT 97, UNSOUND PATCHED AREA (20 INCHES X 16 INCHES)

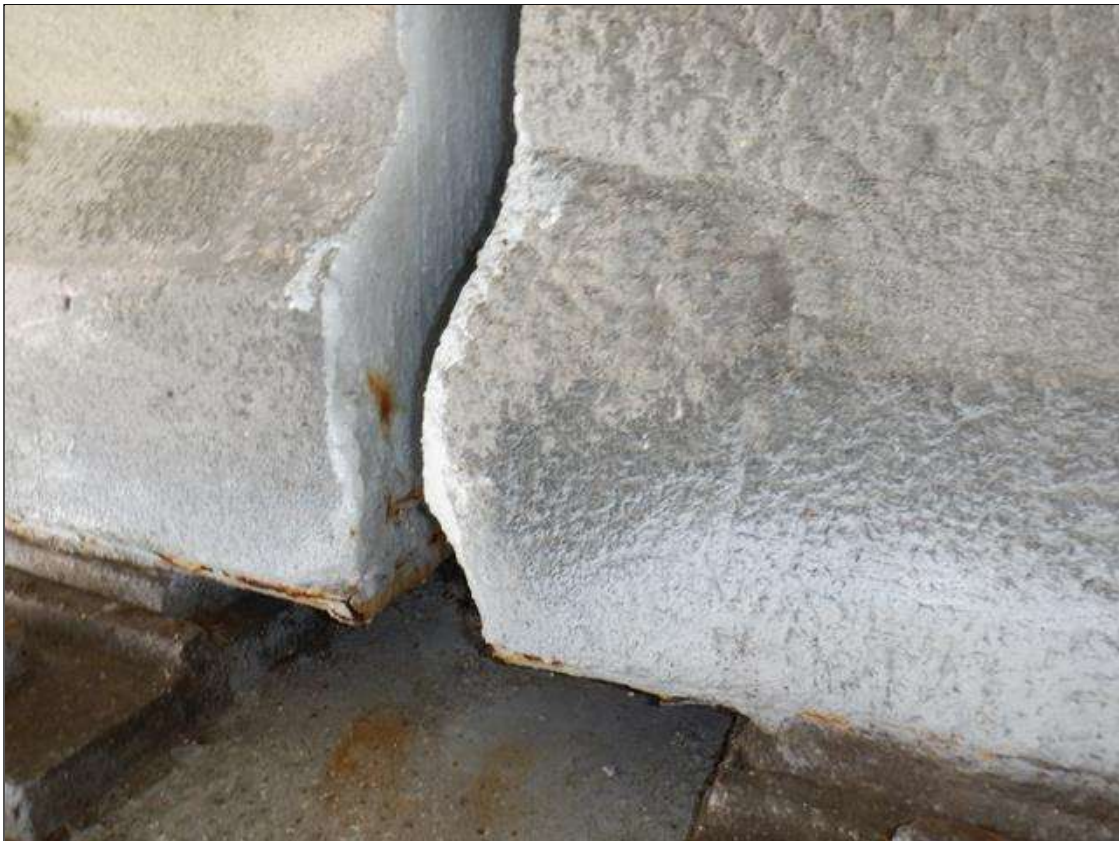
Span 71 Beam 4: NORTH FACE OF BOTTOM FLANGE AT 10 FEET FROM BENT 71, SOUND PATCH (36 INCHES X 6 INCHES)

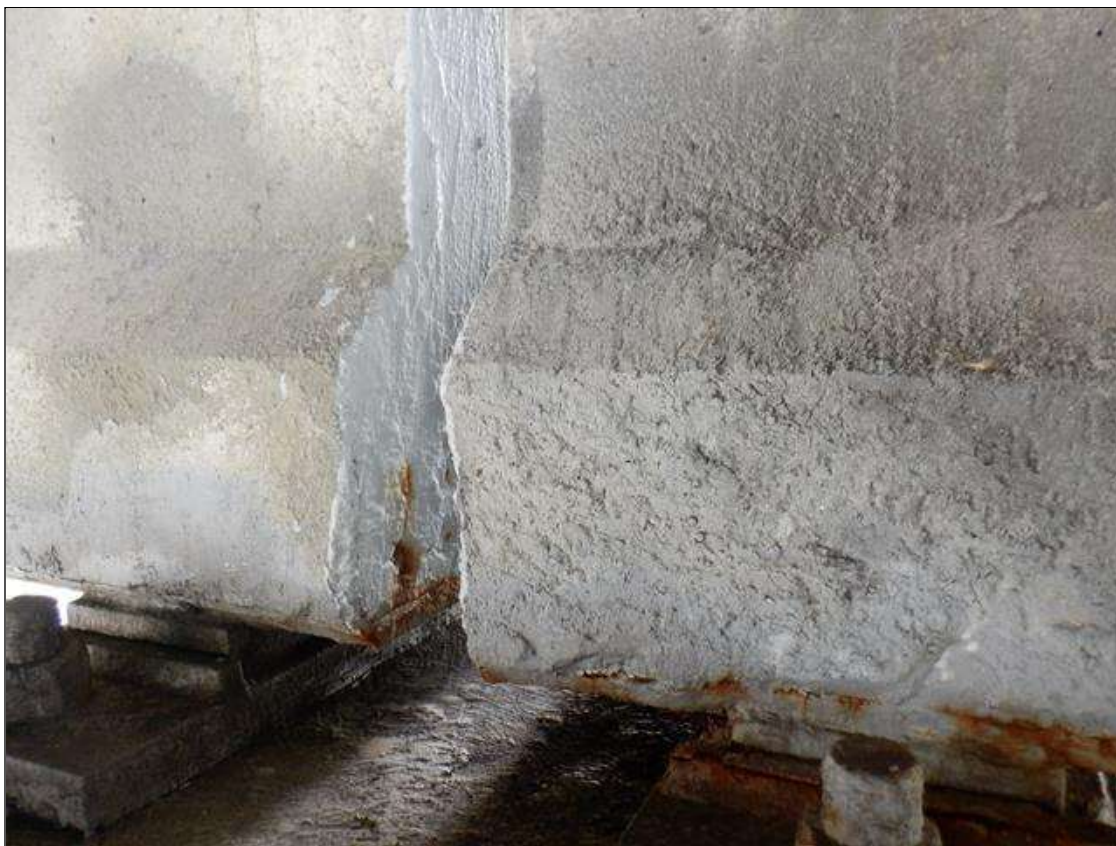
Span 69 Beam 3: SOUTH FACE OF BOTTOM FLANGE, AT BENT 68, SOUND PATCH (8 INCHES X 10 INCHES)

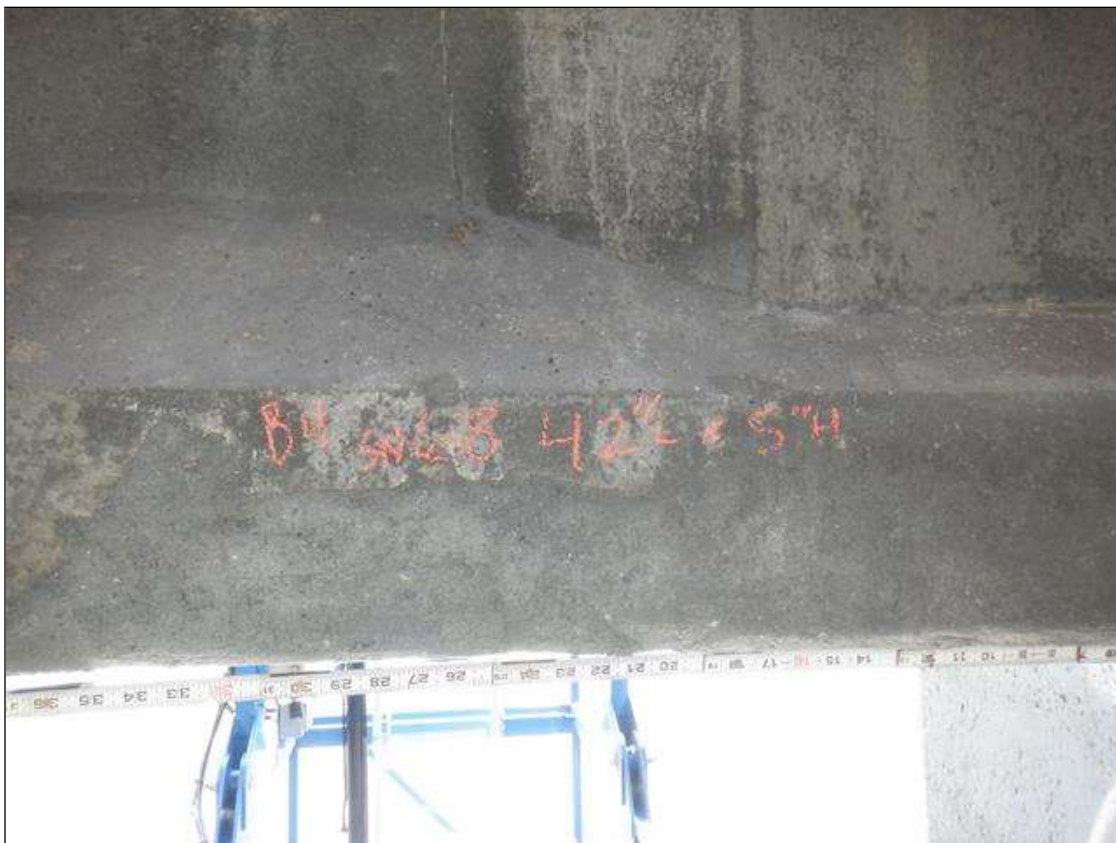
Span 69 Beam 1: SOUTH FACE OF BOTTOM FLANGE, AT BENT 68, SOUND PATCH (3 INCHES X 8 INCHES)

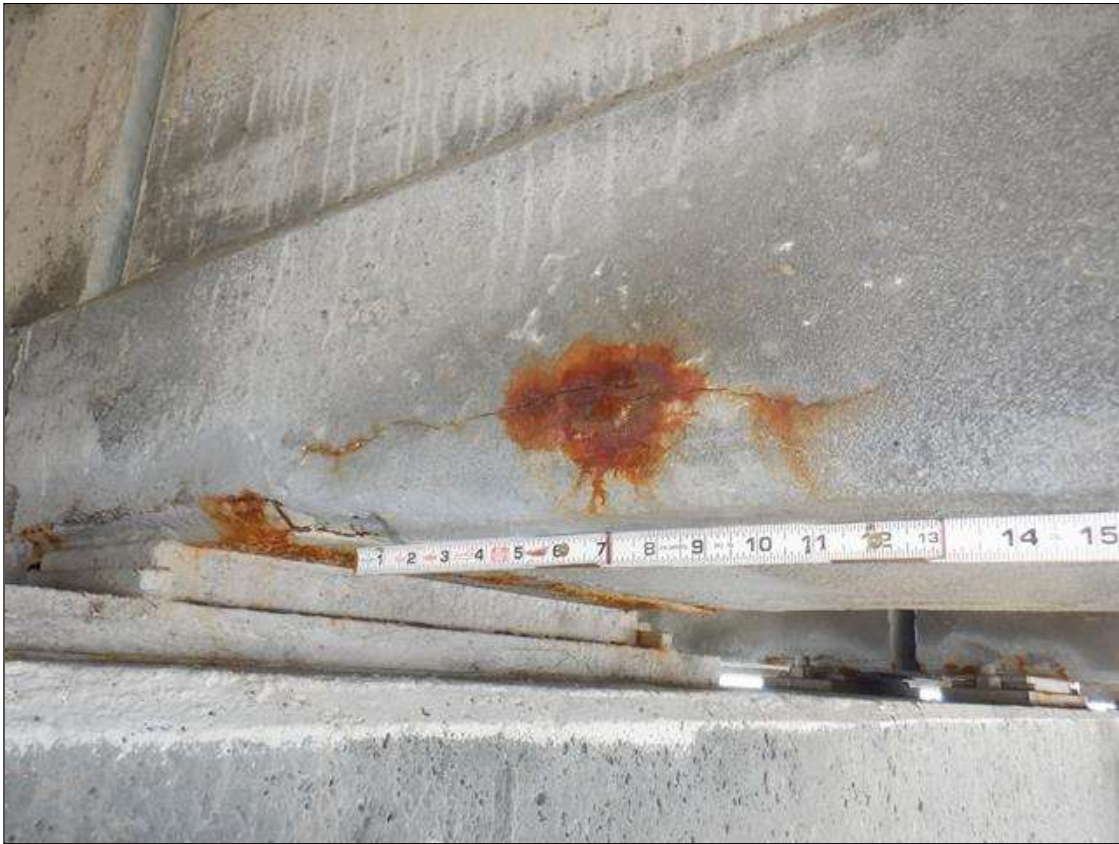
Span 68 Beam 4: NORTH FACE OF BOTTOM FLANGE AT BENT 67, SOUND PATCH (42 INCHES X 5 INCHES)

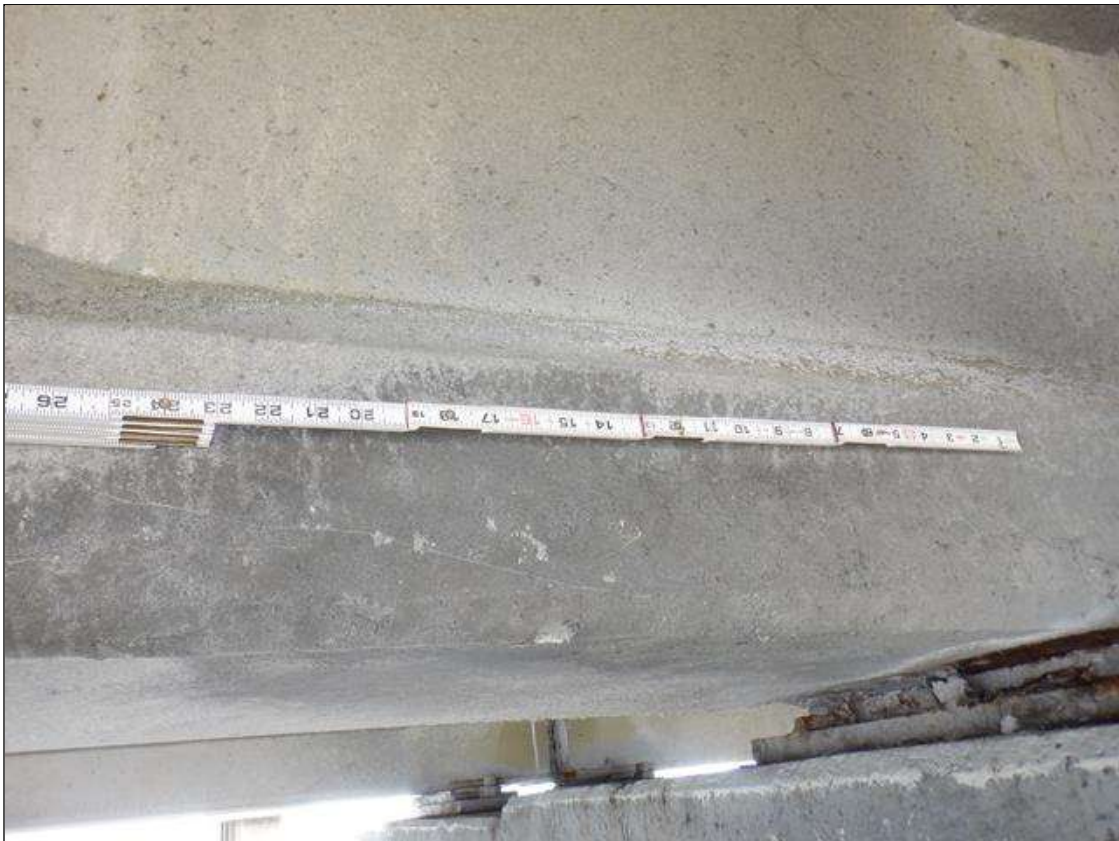
Span 68 Beam 2: NORTH FACE OF BOTTOM FLANGE AT BENT 68, HORIZONTAL CRACK (8 INCHES X 0.015 INCHES) WITH RUST STAIN
