NC DEPARTMENT OF TRANSPORTATION  
DIVISION OF HIGHWAYS  
STRUCTURE MANAGEMENT UNIT

## Structure Safety Report

### Routine Element Inspection - Contract

STRUCTURE NUMBER: 260016 SAP STRUCTURE NO: 0270016 FHWA STRUCTURE NO: 000000000530016  
DIVISION: 1 COUNTY: CURRITUCK INSPECTION DATE: 09/21/2022 FREQUENCY: 24 MONTHS  
FACILITY CARRIED: US158E MILE POST: \_\_\_\_\_  
LOCATION: .01 MI.E.JCT.SR1187  
FEATURE INTERSECTED: CURRITUCK SOUND  
LATITUDE: 36° 5' 11.69" LONGITUDE: 75° 46' 0.21"  
SUPERSTRUCTURE: RC FLOOR ON PPC GIRDERS & CORED SLAB  
SUBSTRUCTURE: EBTS:RC CAP/PPC PILES;IBTS:RCP&B & RC CAPS/PPC PILES  
SPANS: 248 SPANS. SEE SPAN PROFILE SHEET FOR SPAN DETAILS  
☐ FRACTURE CRITICAL ☐ TEMPORARY SHORING ☐ SCOUR CRITICAL ☐ SCOUR PLAN OF ACTION  
GRADES: (Inspector/NBI Coding) DECK 6 / 6 SUPERSTRUCTURE 5 / 5 SUBSTRUCTURE 6 / 6 CULVERT N / N  
POSTED SV: Not Posted POSTED TTST: Not Posted  
OTHER SIGNS PRESENT: None

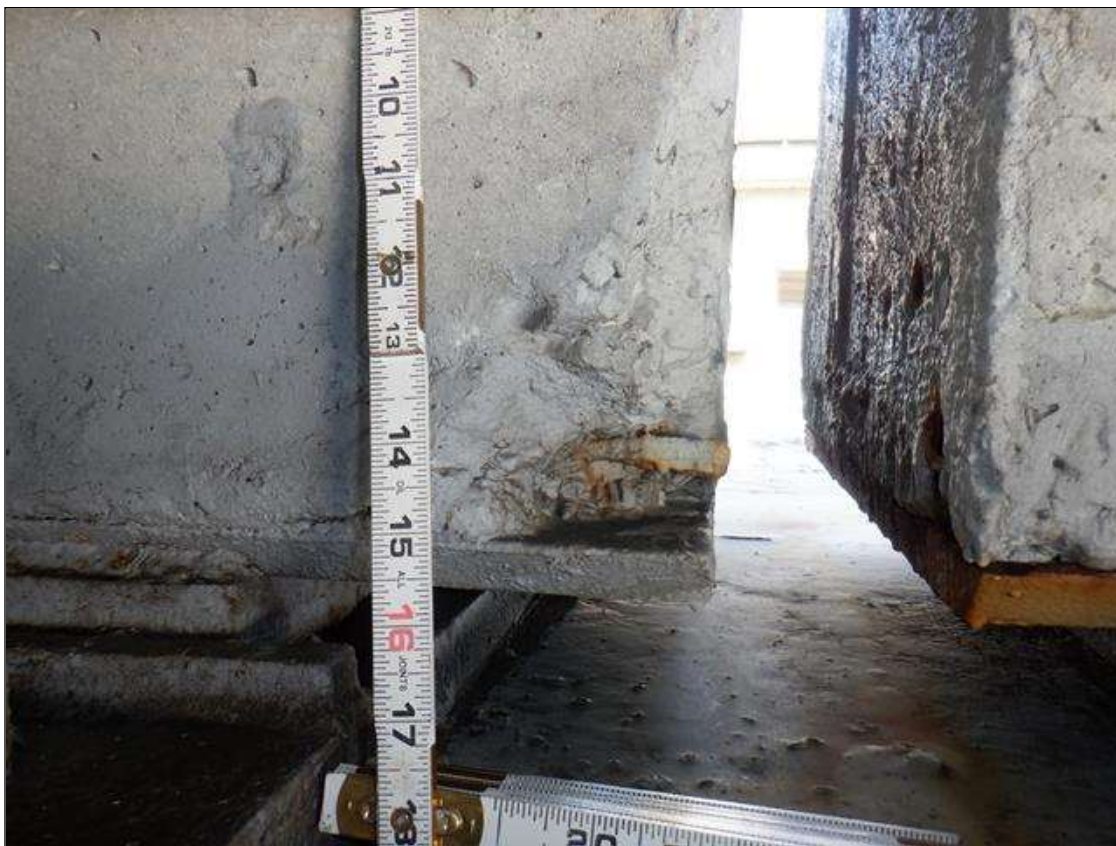
Span 66 Beam 2: SOUTH FACE OF BOTTOM FLANGE AT BENT 66, SOUND PATCH (2 FEET X 4 INCHES)

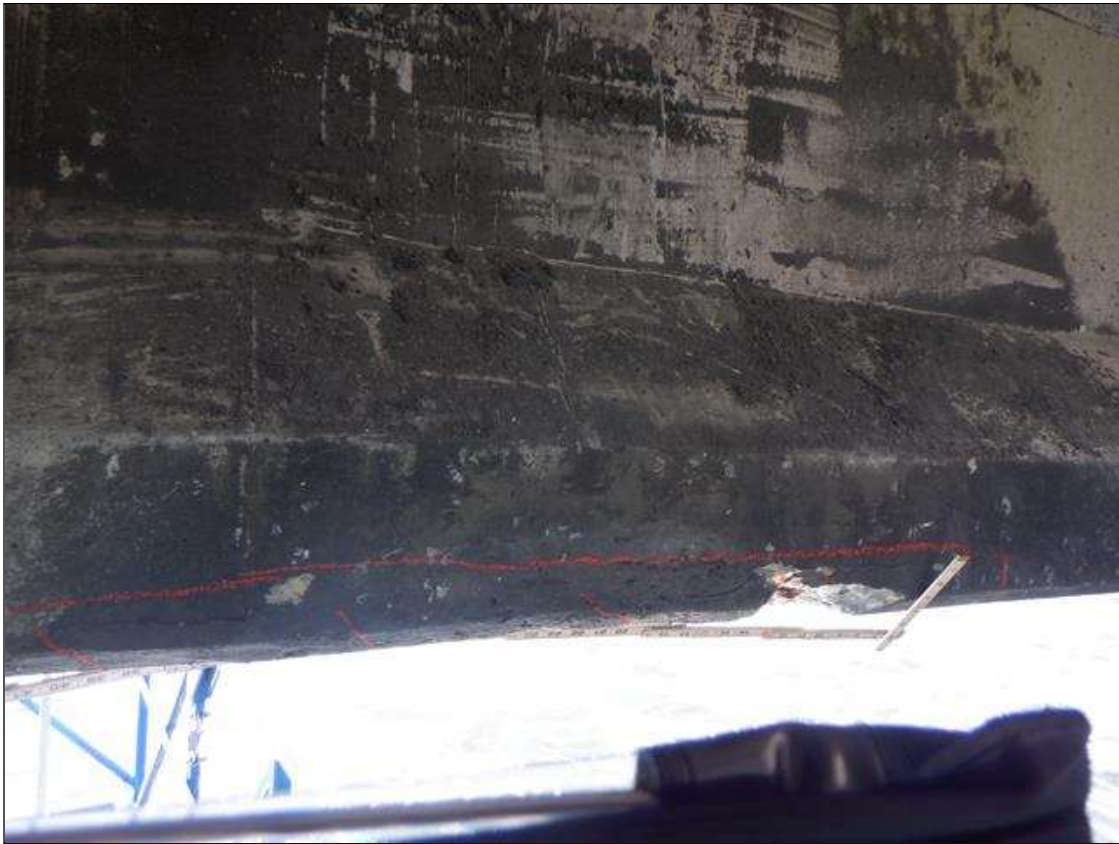
Span 78 Beam 1: SOUTH FACE OF BOTTOM FLANGE, AT BENT 78, SPALL (3 INCHES X 3 INCHES X 3 INCHES)  
WITH EXPOSED STRANDS (NO SECTION LOSS)

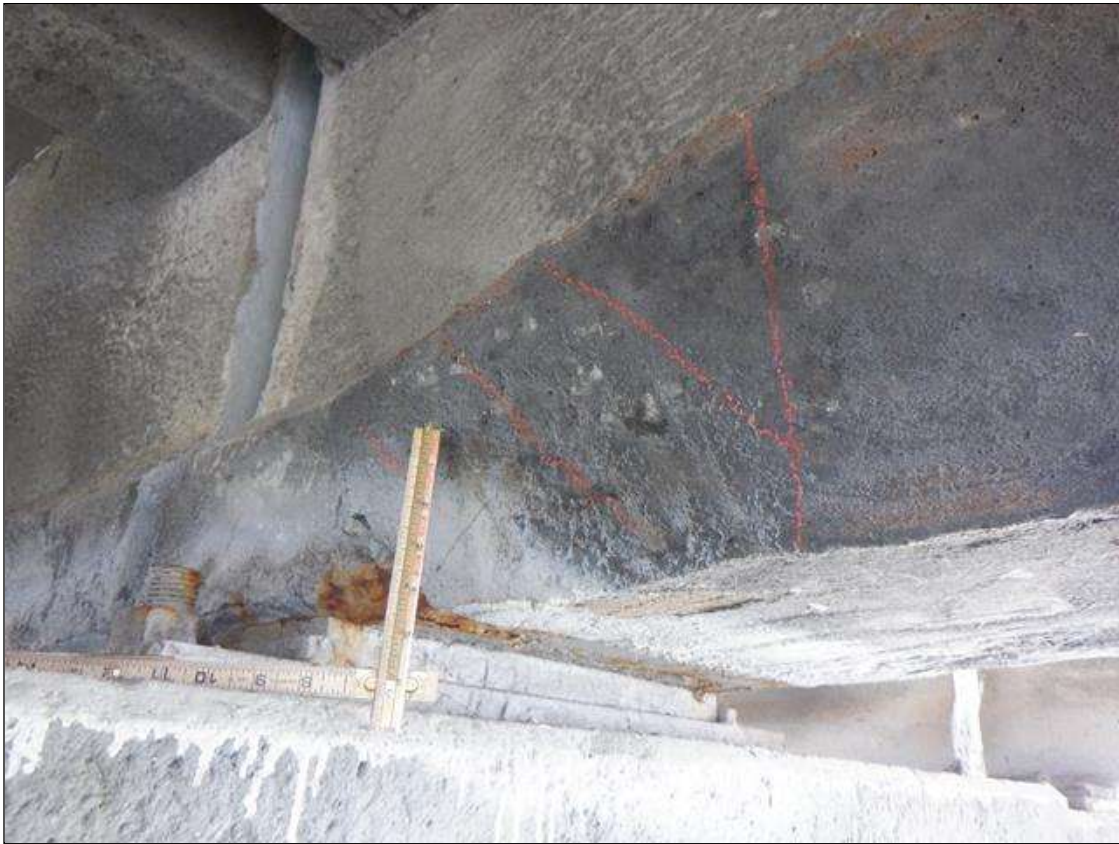
Span 103 Beam 4: (PAR) NORTH FACE OF BOTTOM FLANGE 25 FEET FROM BENT 103, DELAMINATION/SPALL (43 INCHES LONG X 4 INCHES HIGH X 8 INCHES ON BOTTOM FLANGE X 1 INCH DEEP WITH (1) EXPOSED REINFORCEMENT BAR (NO LOSS)

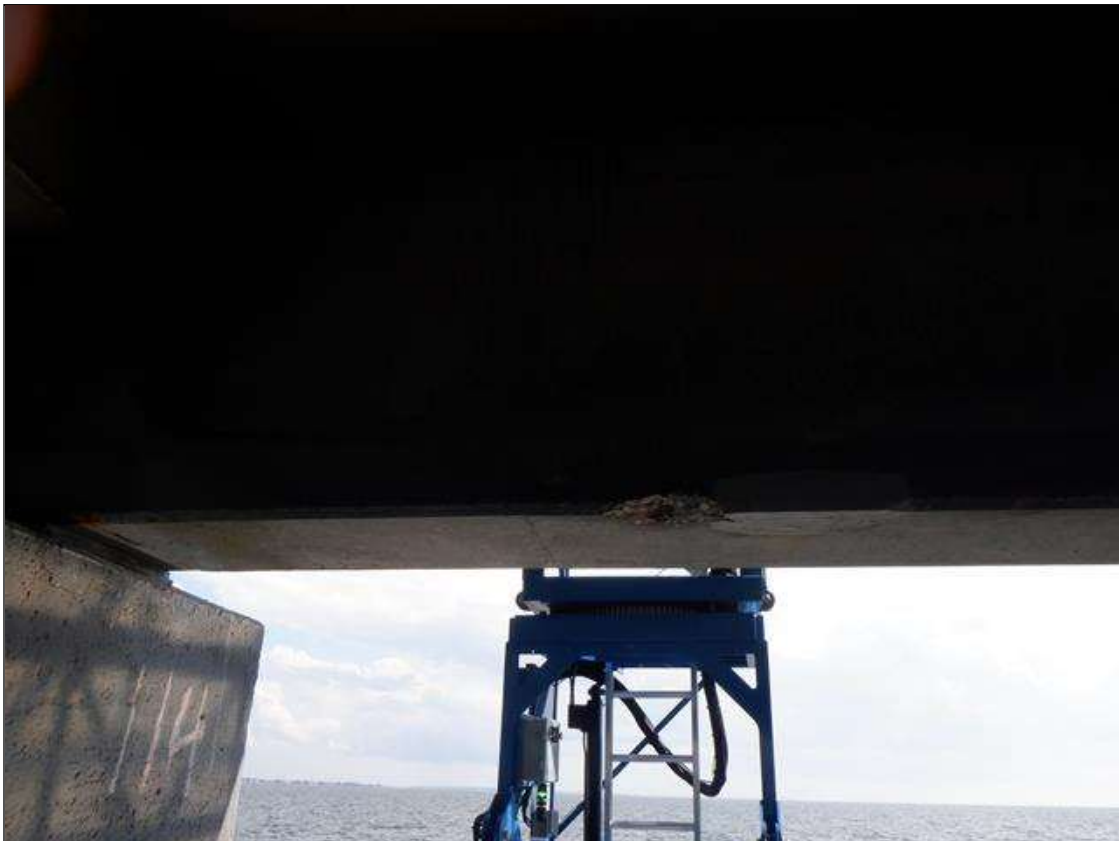
Span 106 Beam 3: NORTH FACE AT BENT 106, DELAMINATION/FAILED PATCH (12 INCHES X 8 INCHES X 2 INCHES)

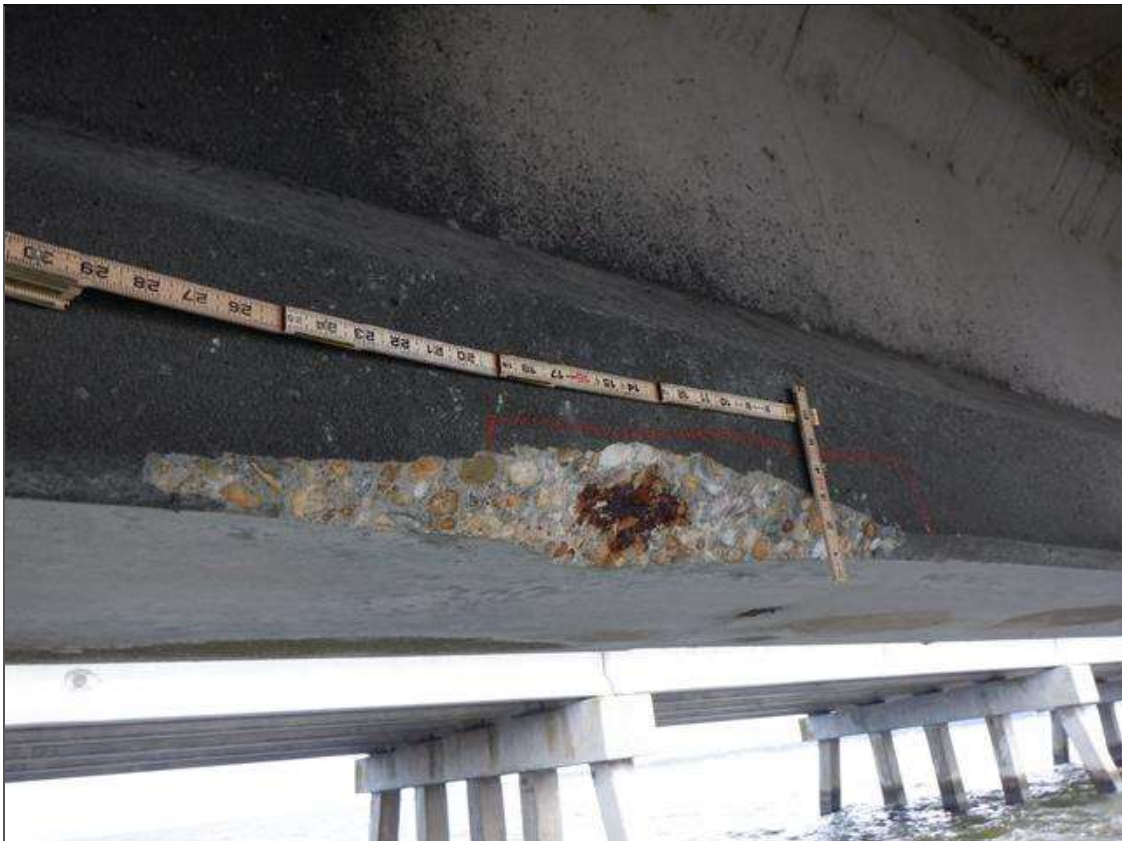
Span 117 Deck: UNDERSIDE OF DECK BAY 3 AT 16 FEET FROM BENT 117, (2) SPALLS (12 INCHES X 12 INCHES X 1 INCHES) WITH EXPOSED RUSTED REBAR

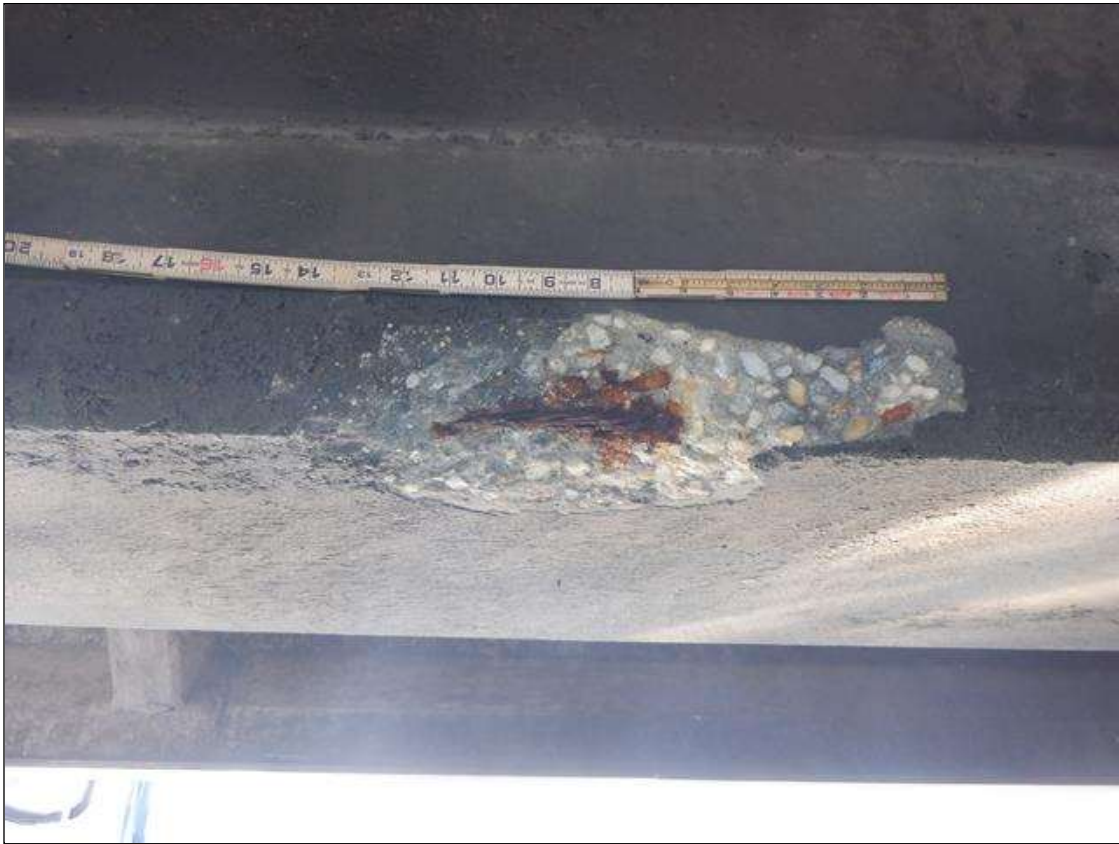
Span 207 Beam 1: SOUTH FACE OF BOTTOM FLANGE AT BENT 207, SPALL (6 INCHES X 6 INCHES X 2 INCHES DEEP) WITH EXPOSED RUSTED REINFORCING (NO MEASURABLE LOSS)

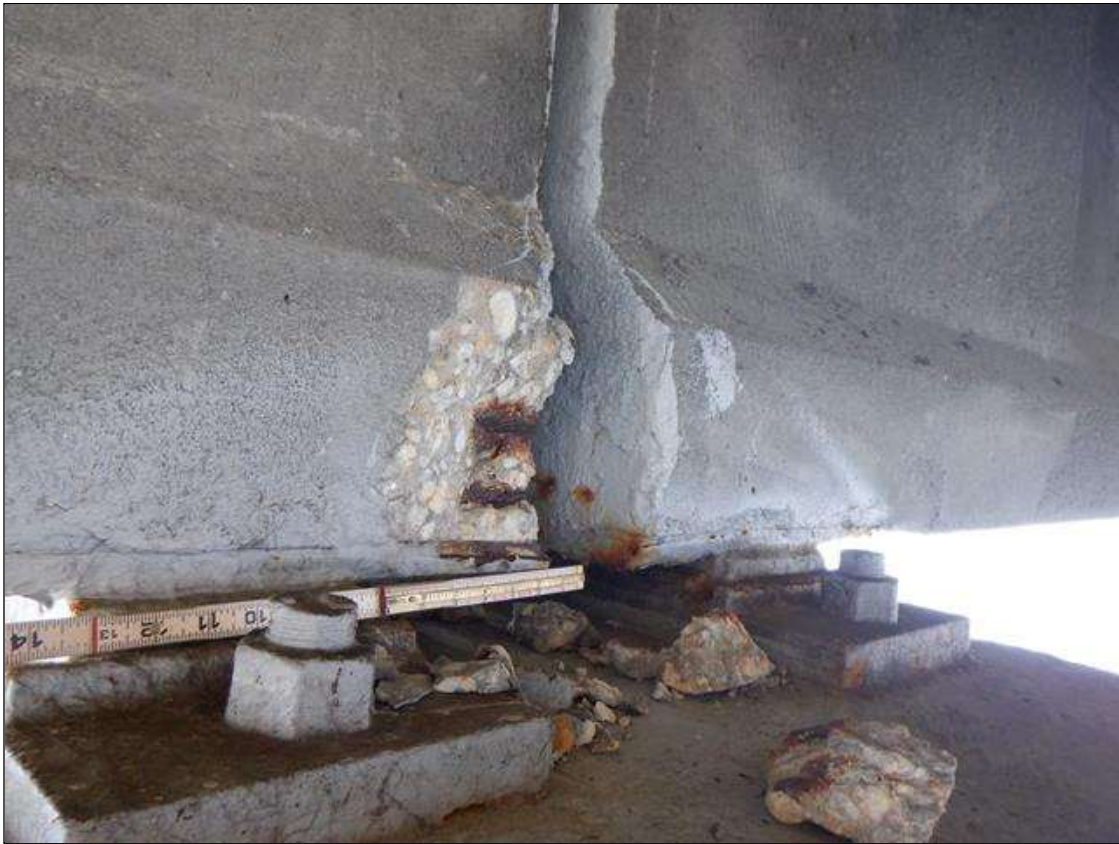
Span 215 Beam 3: (PAR) NORTH FACE OF BOTTOM FLANGE, 16 FEET FROM BENT 214, SPALL (15 INCHES X 7 INCHES X 2 INCHES DEEP X 5 INCHES OF BOTTOM FACE) WITH EXPOSED STRAND (40 PERCENT SECTION LOSS) ON STRAND AT FAILED PATCHED AREA

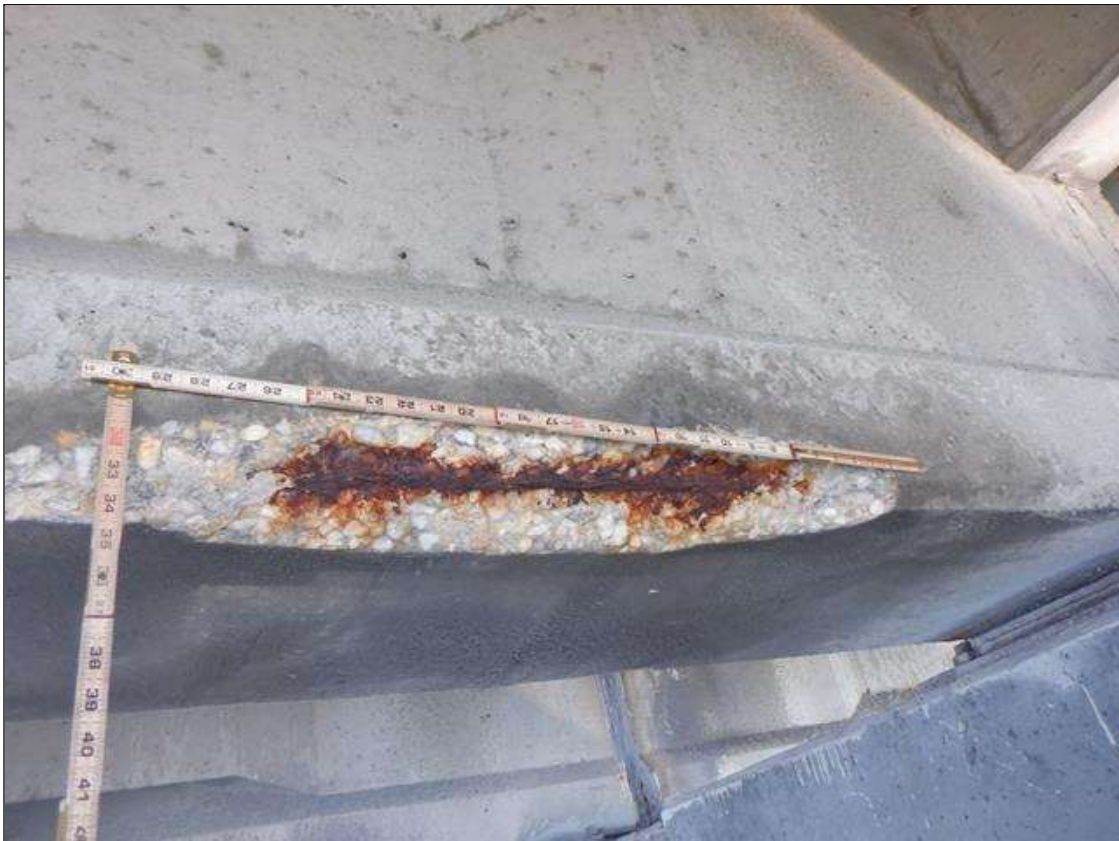
Span 215 Beam 3: (PAR) NORTH FACE OF BOTTOM FLANGE AT BENT 214, SPALL (7 INCHES X 7 INCHES X 2 INCHES) WITH (2) EXPOSED RUSTED STRANDS

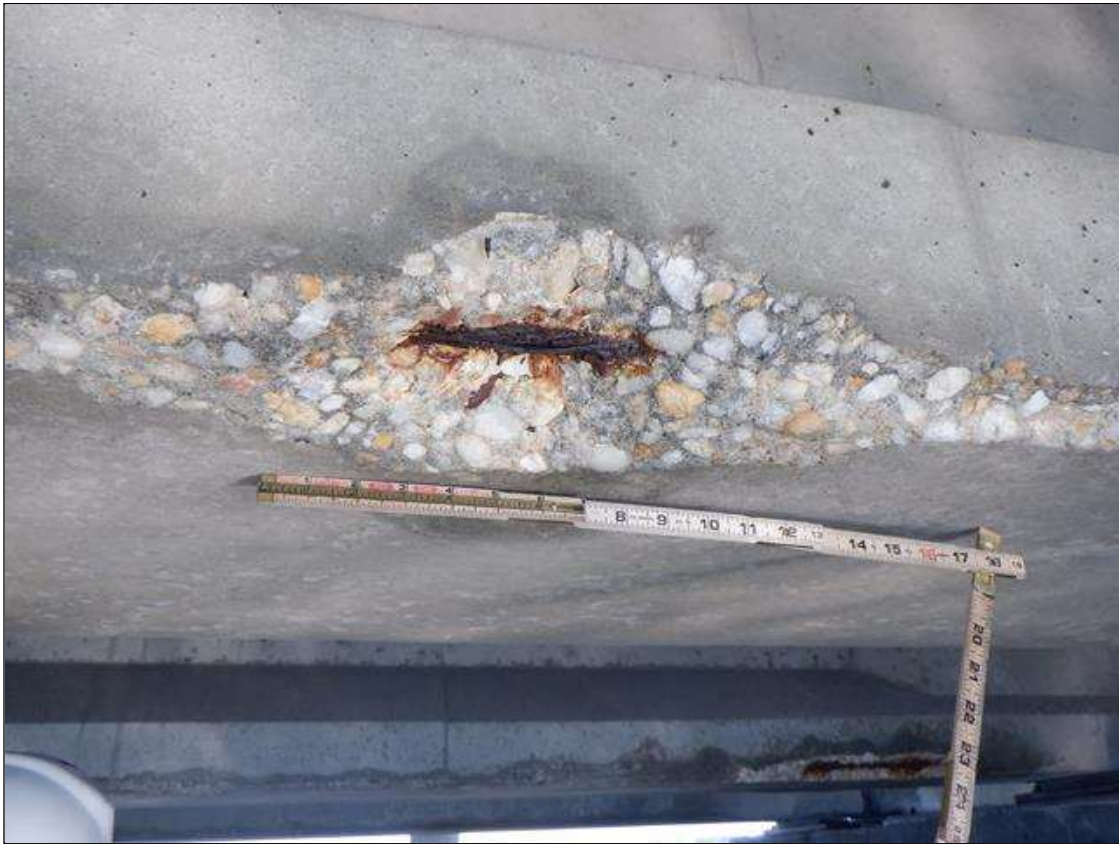
Span 216 Beam 2: (PAR) SOUTH FACE OF BOTTOM FLANGE, AT 4 FEET FROM BENT 216, SPALL (32 INCHES X 6 INCHES X 2 INCHES) WITH EXPOSED STRAND (10 PERCENT SECTION LOSS) ON STRAND

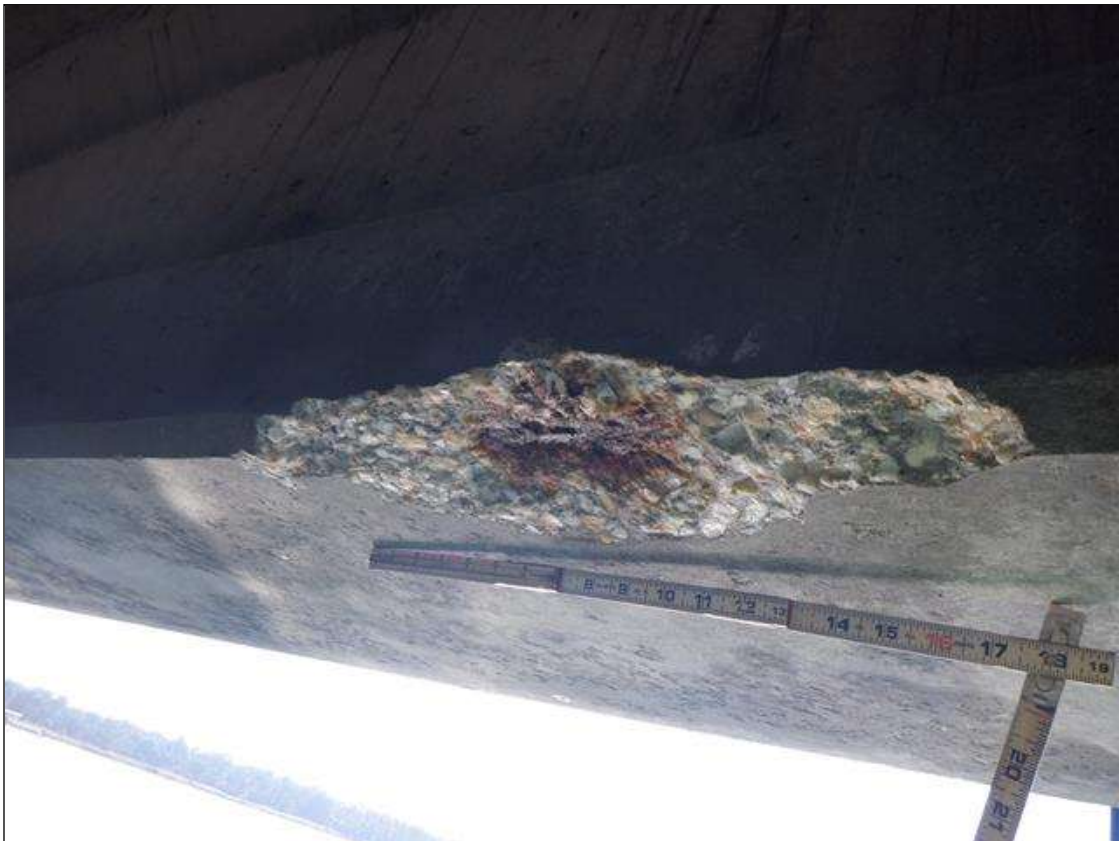
Span 216 Beam 3: (PAR) SOUTH FACE OF BOTTOM FLANGE, AT 9 FEET FROM BENT 216, SPALL (24 INCHES X 6 INCHES X 2 INCHES) WITH EXPOSED STRAND (30 PERCENT SECTION LOSS) ON STRAND

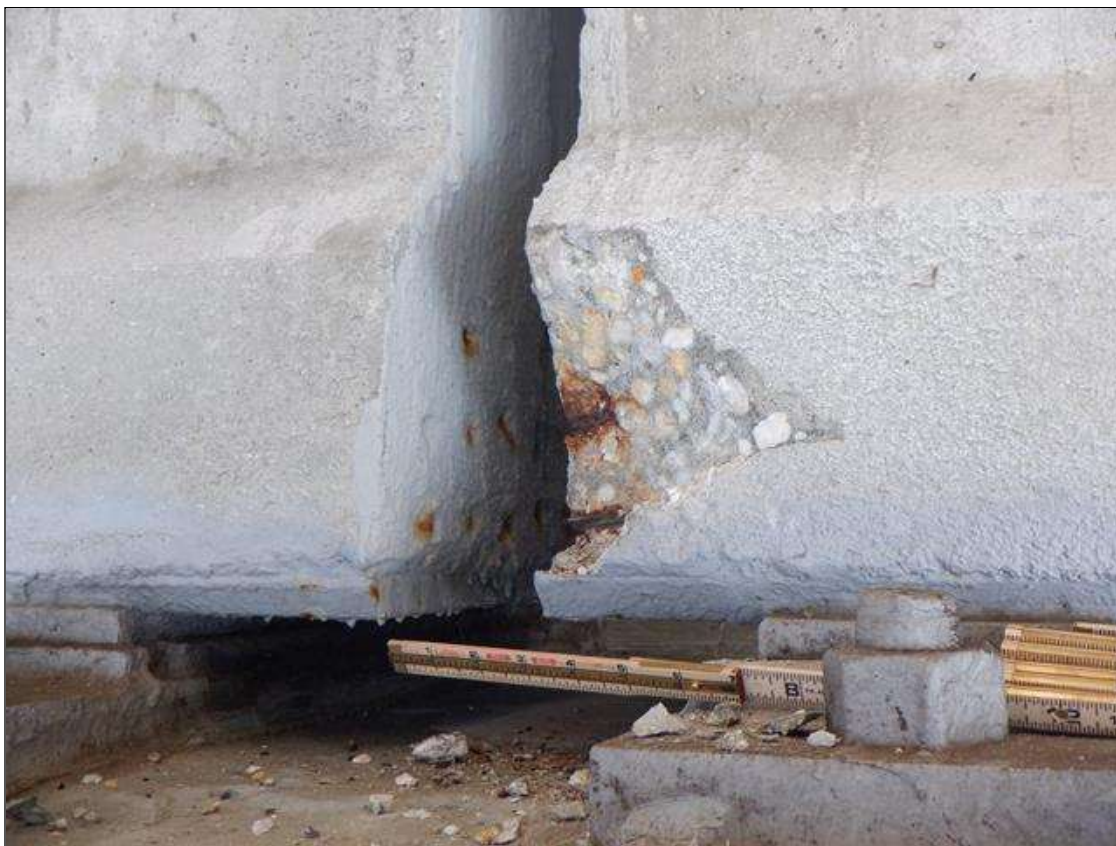
Span 217 Beam 4: (PAR) NORTH FACE OF BOTTOM FLANGE, AT 5 FEET FROM BENT 216, SPALL (18 INCHES X 4 INCHES X 2 INCHES) WITH EXPOSED STRANDS (10 PERCENT SECTION LOSS) ON STRAND

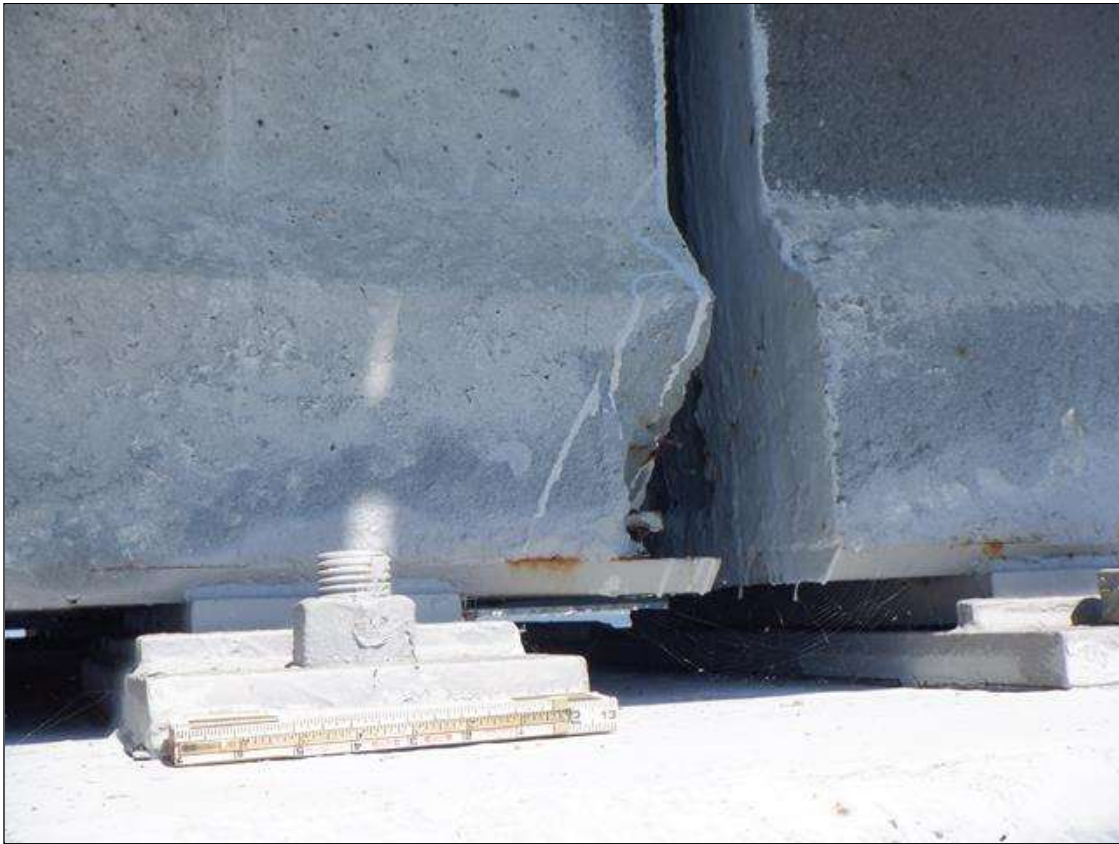
Span 219 Beam 3: SOUTH FACE OF BOTTOM FLANGE AT BENT 218, SPALL (6 INCHES LONG X 7 INCHES HIGH X 2 INCHES DEEP) WITH EXPOSED RUSTED REINFORCING (NO MEASURABLE SECTION LOSS)

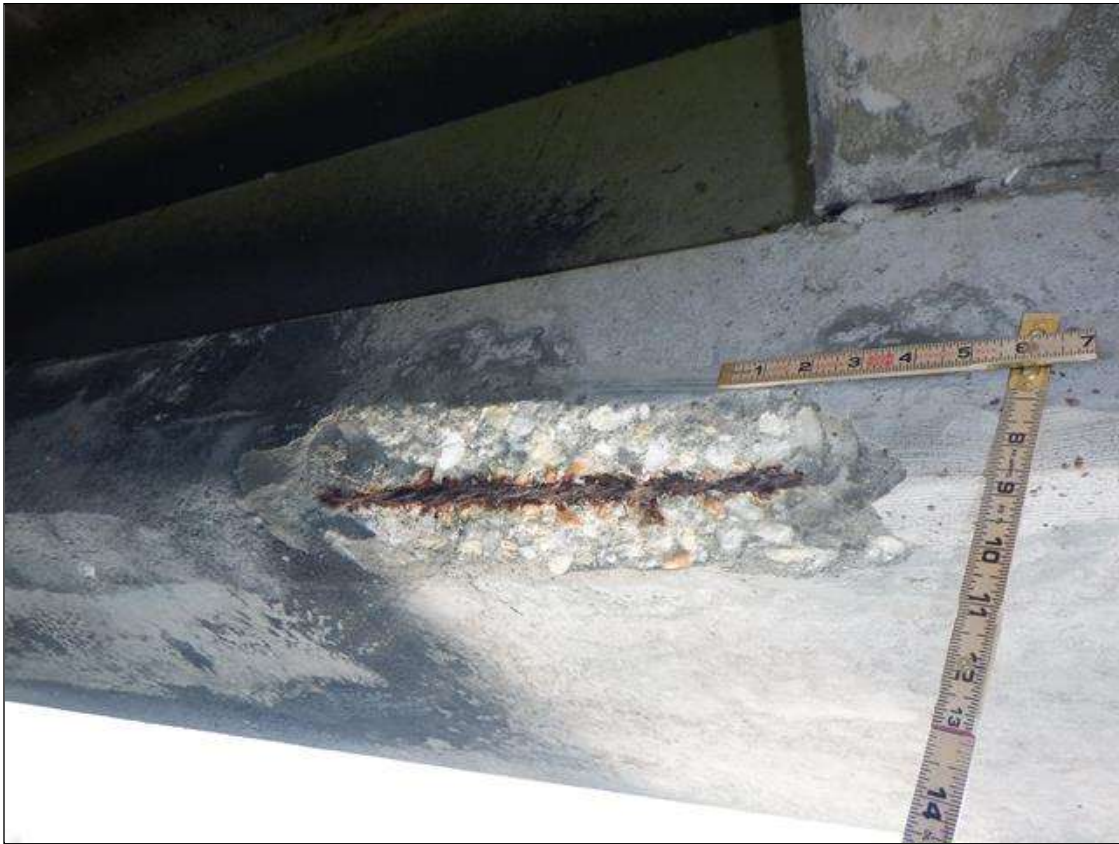
Span 225 Beam 1: (PAR) SOUTH FACE OF BOTTOM FLANGE, AT BENT 225, SPALL (7 INCHES X 8 INCHES X UP TO 3 INCHES) WITH (2) EXPOSED RUSTED STRANDS (UP TO 50 PERCENT SECTION LOSS) ON STRAND (NOT FOUND AT THIS LOCATION DURING 2022 INSPECTION)

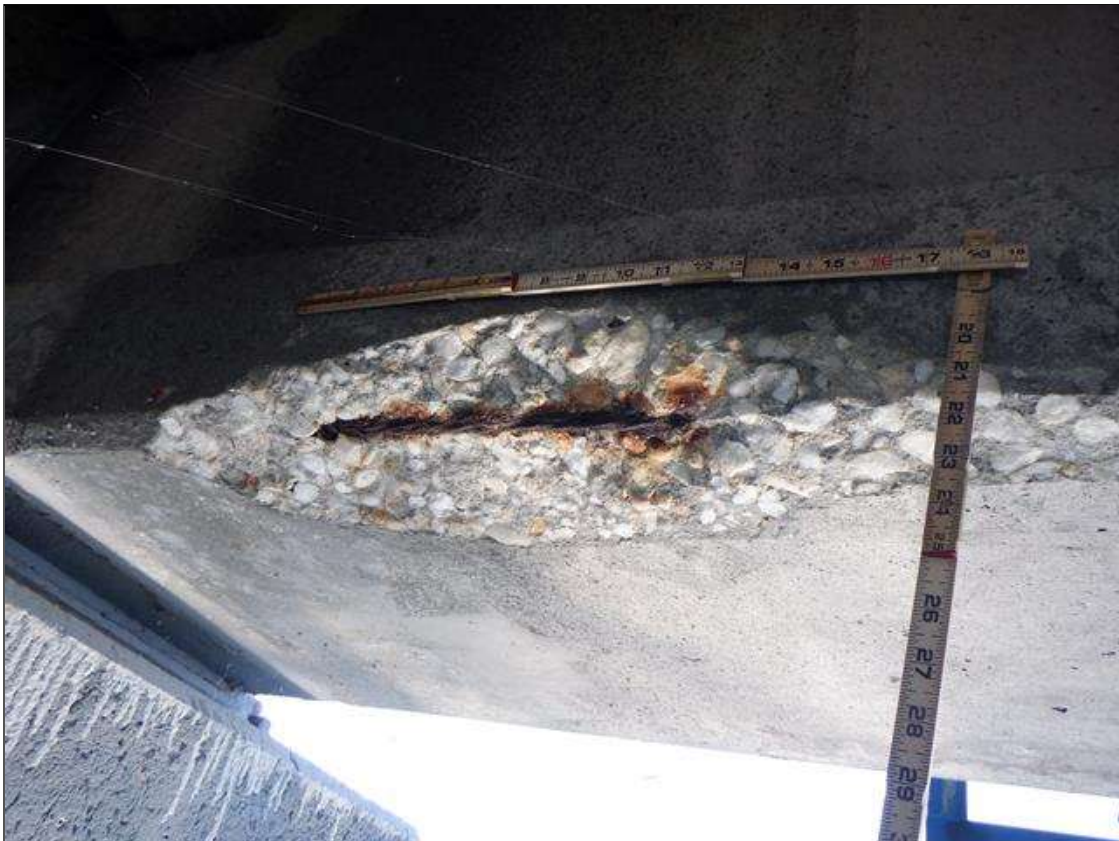
Span 231 Beam 4: (PAR) NORTH FACE OF BOTTOM FLANGE, AT 20 FEET FROM BENT 230, SPALL (18 INCHES X 5 INCHES X 2 INCHES) WITH EXPOSED STRAND (10 PERCENT SECTION LOSS) ON STRAND

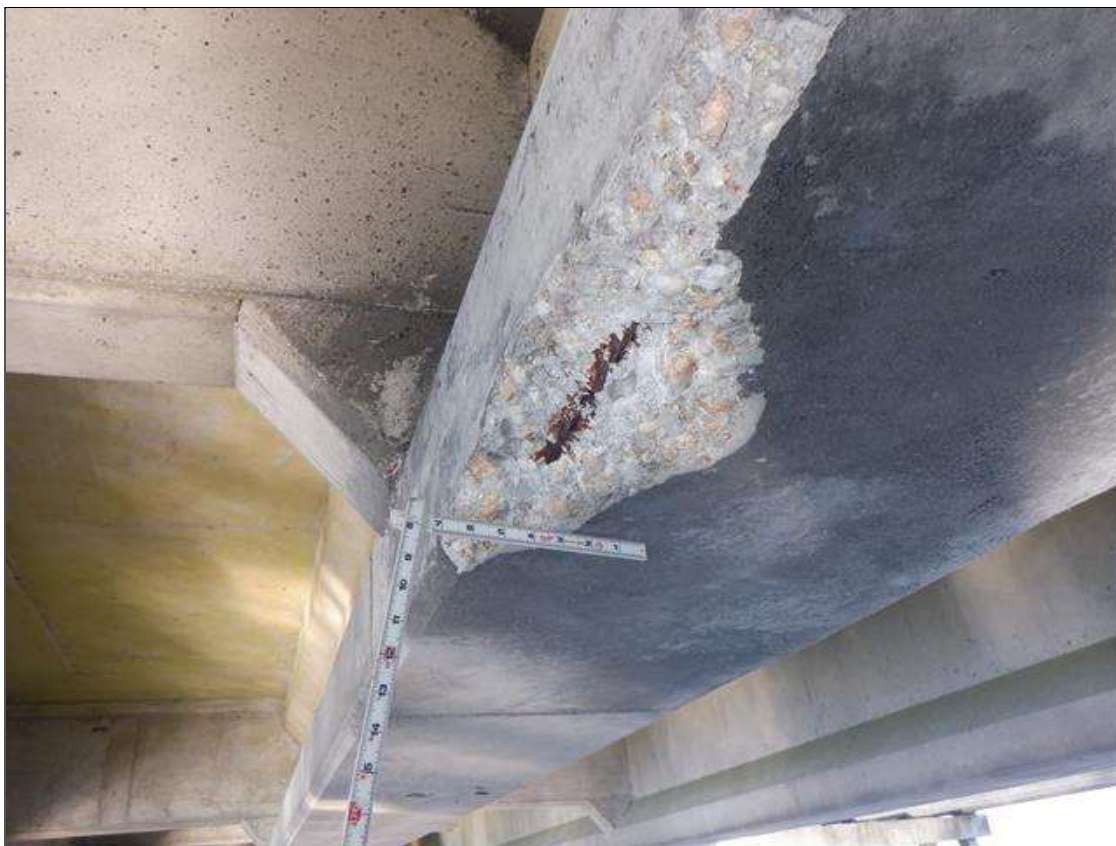
Span 233 Beam 4: (PAR) NORTH FACE OF BOTTOM FLANGE, AT 2 FEET FROM BENT 233, SPALL (30 INCHES X 6 INCHES X 2 INCHES) WITH EXPOSED STRAND (10 PERCENT SECTION LOSS) ON STRAND

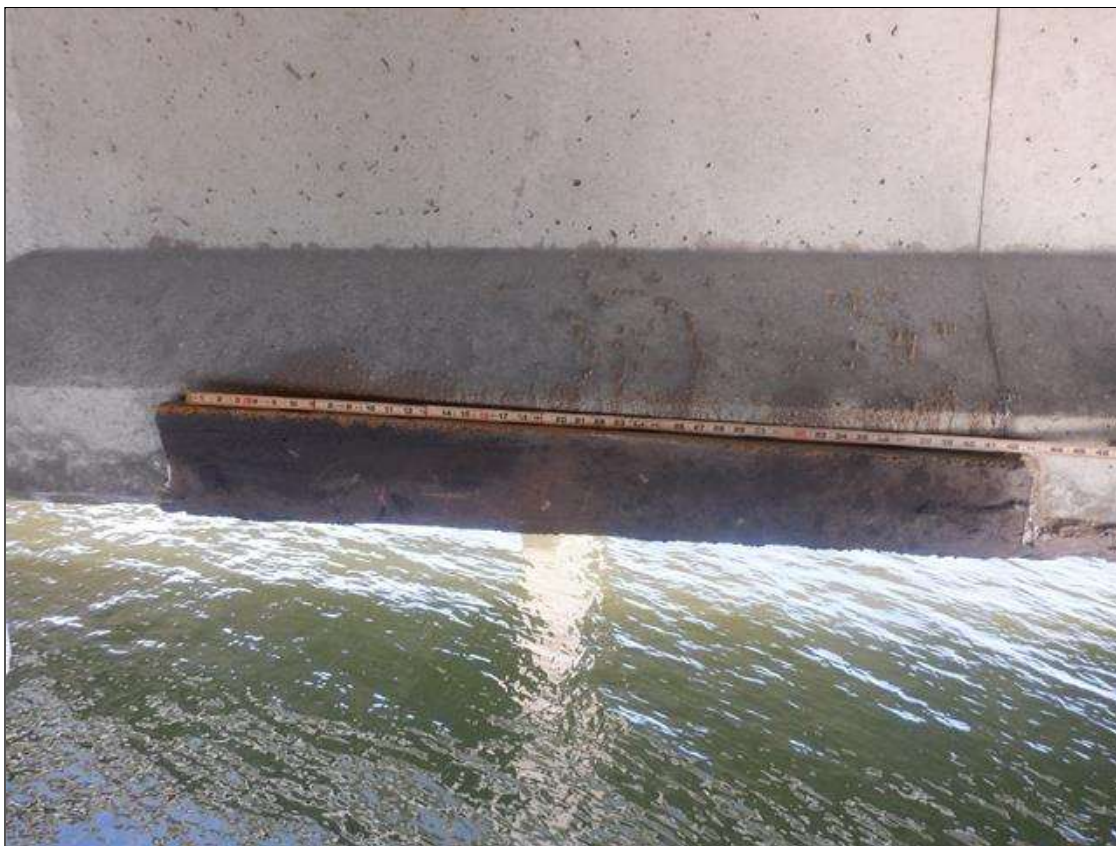
Span 238 Beam 2: (PAR) BOTH FACES OF BOTTOM FLANGE AT 20 FEET FROM BENT 238, PATCHED AREA (2 FEET LONG X 6 INCHES WIDE X 2 INCHES DEEP) WITH ONE (1) EXPOSED RUSTED STRAND (10 PERCENT SECTION LOSS)

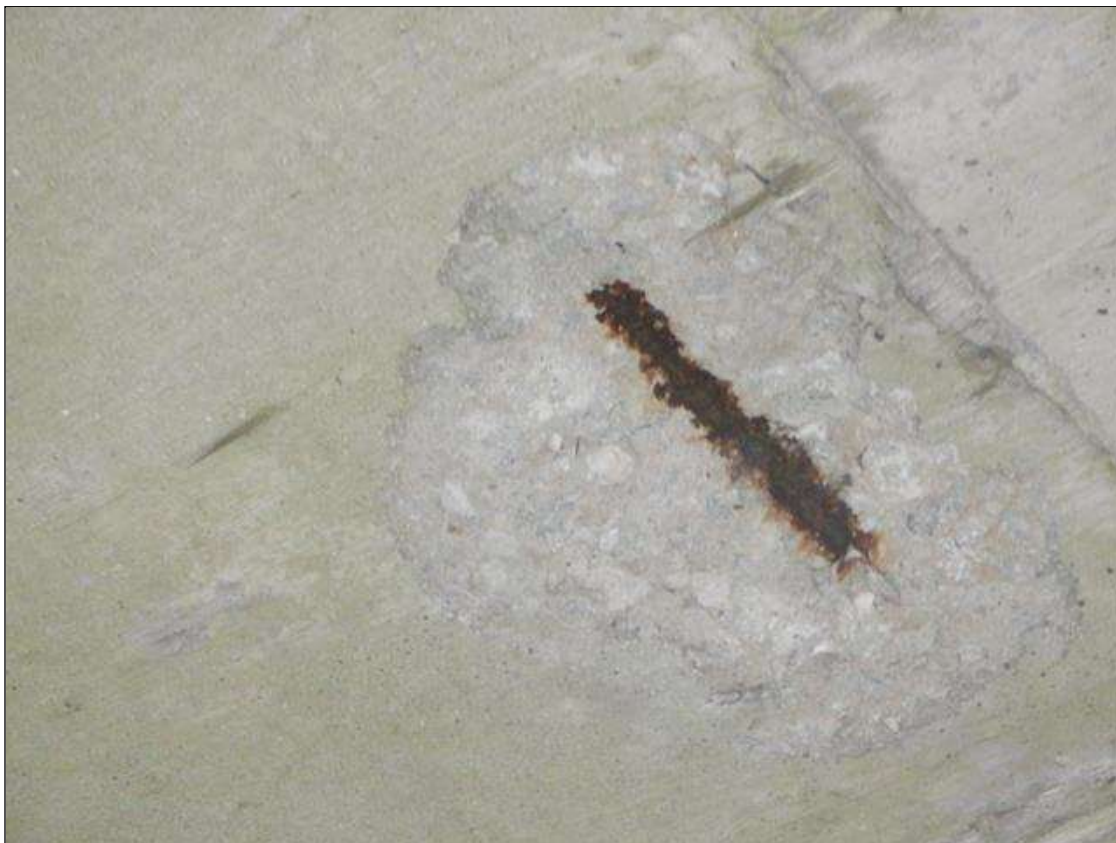
Span 165 Beam 1: BOTH FACES OF BOTTOM FLANGE AT 8 FEET FROM BENT 164, PATCHED AREA (48 INCHES X 7 INCHES)

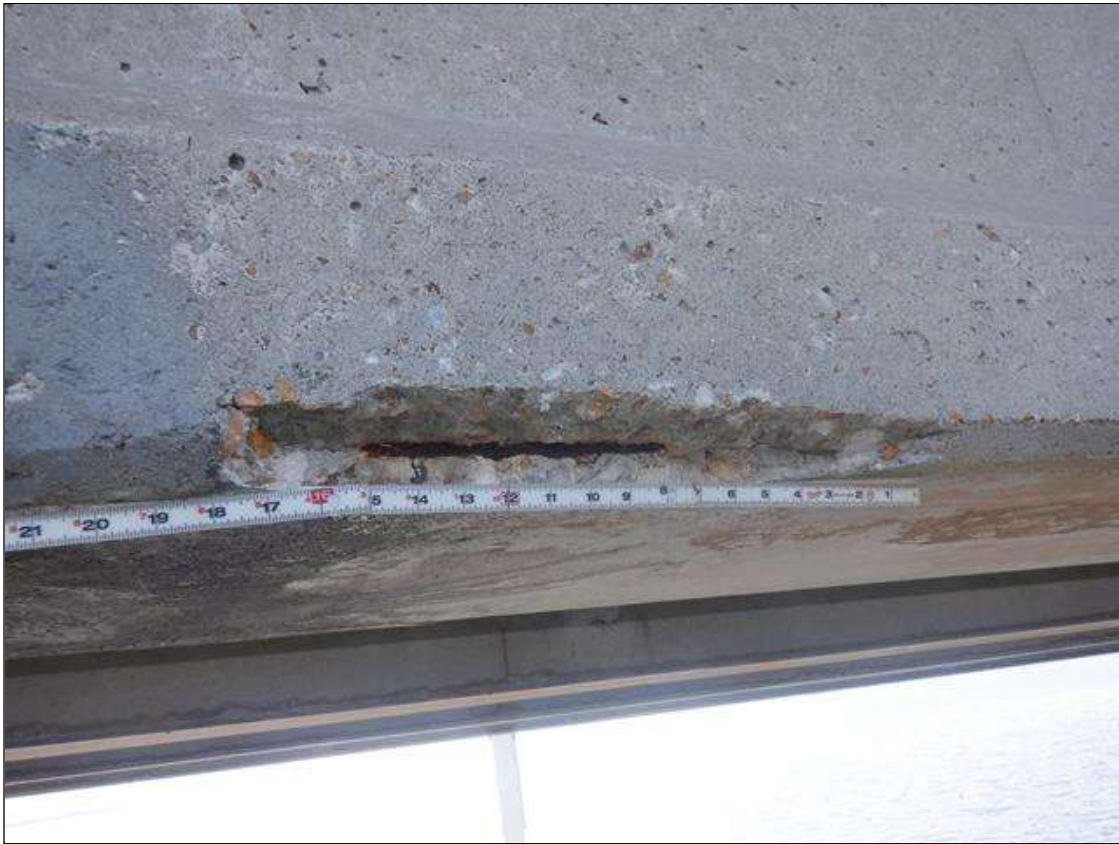
Span 167 Deck: 15 FEET FROM BENT 167 IN BAY 2, SPALL (1 FOOT DIAMETER X 1/2 INCH DEEP)

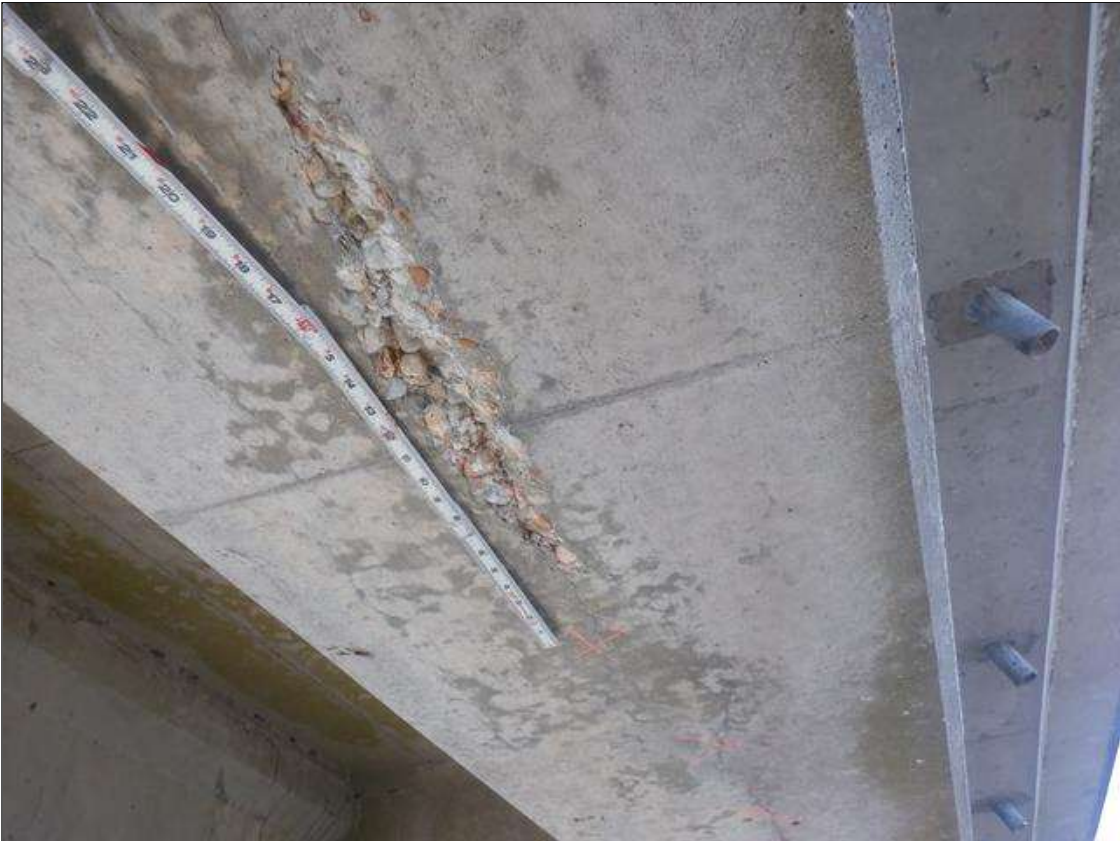
Span 174 Beam 3: BOTTOM OF BOTTOM FLANGE 20 FEET FROM BENT 174, LONGITUDINAL CRACK (10 FEET LONG X UP TO 0.012 INCHES WIDE) WITH ASSOCIATED EDGE SPALLING

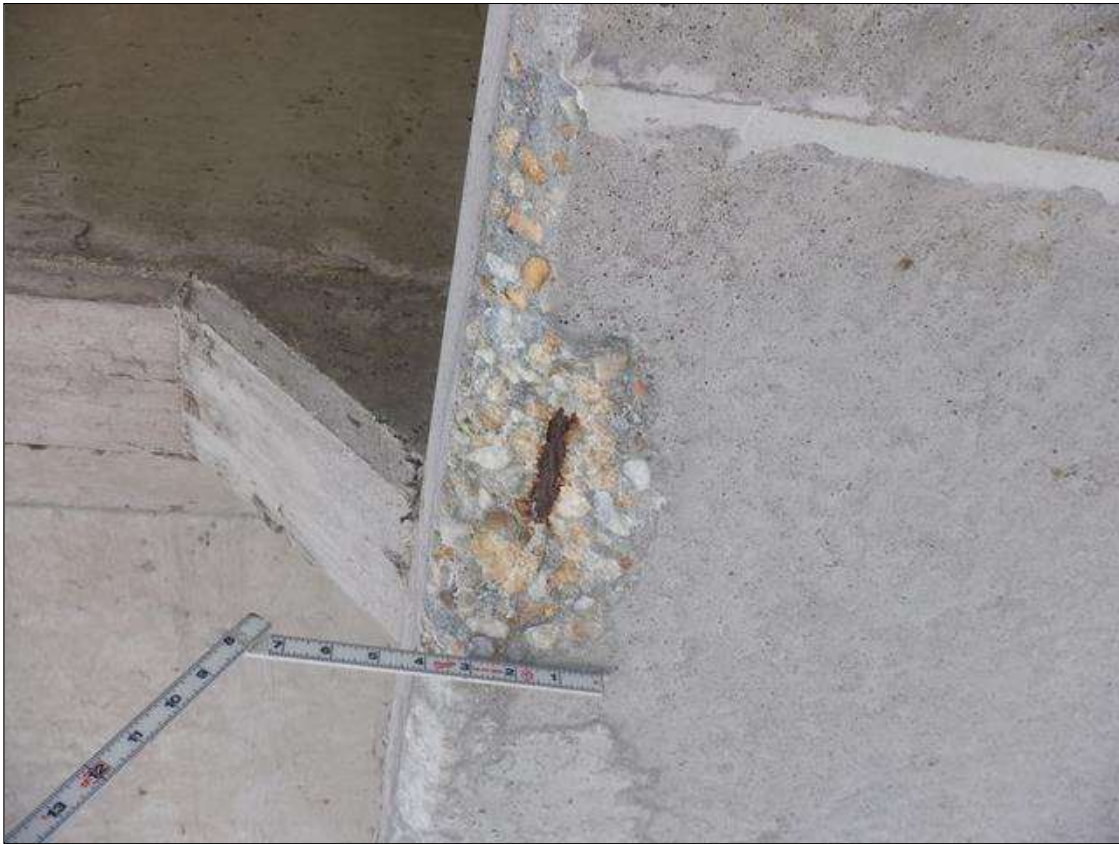
Span 175 Beam 1: UNDERSIDE OF BOTTOM FLANGE BEGINNING AT MIDSPAN, (2) LONGITUDINAL CRACKS (30 FEET X 0.01 INCHES) WITH ADJACENT SPALL (2 FEET X 1/2 INCH X 1/2 INCH DEEP)

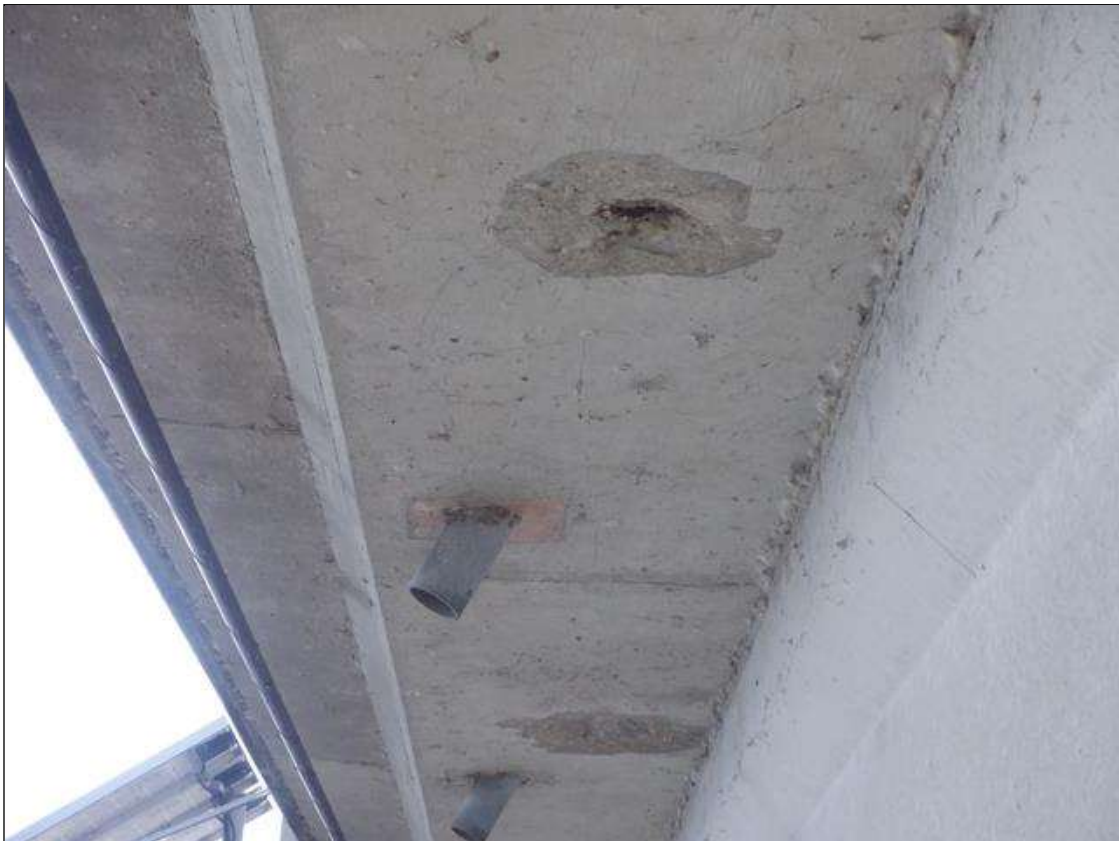
Span 177 Beam 3: SOUTH FACE OF BOTTOM FLANGE AT 23 FEET FROM BENT 177, SPALL (1 FOOT X 3 INCHES X 1 INCH DEEP) WITH ONE (1) EXPOSED RUSTED STRAND (NO SECTION LOSS)

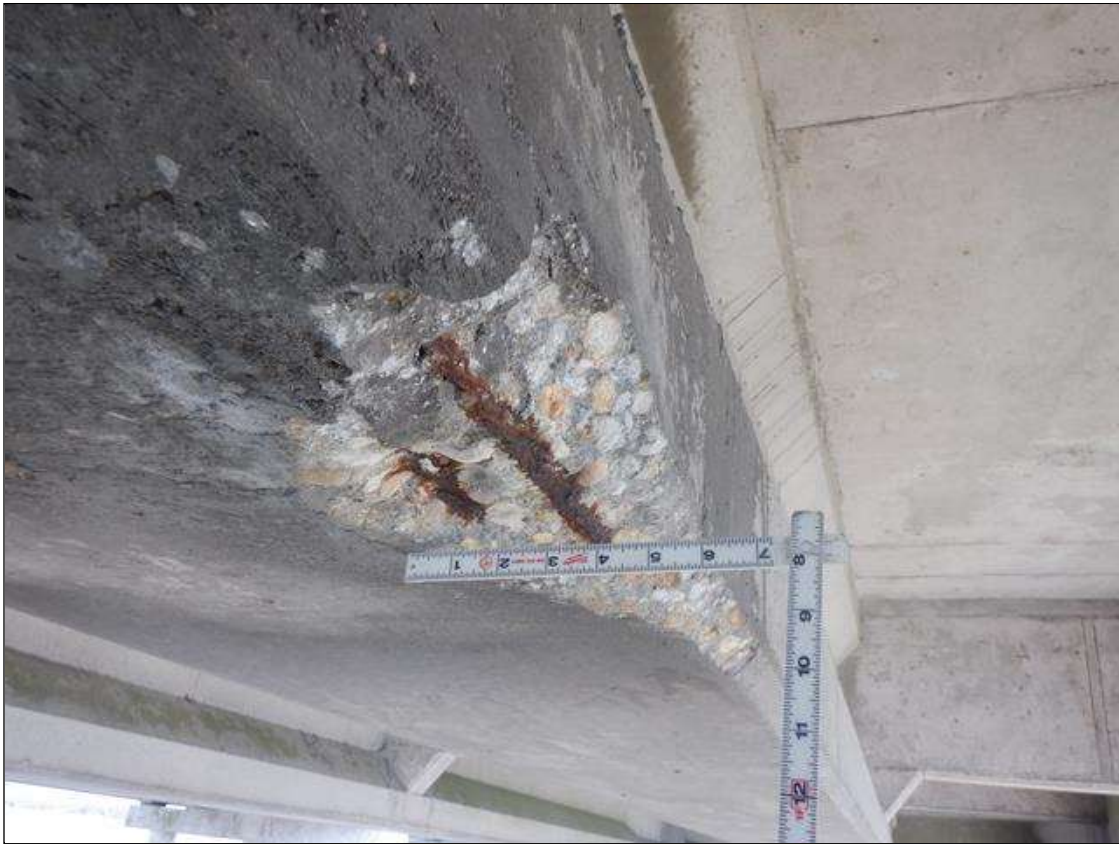
Span 180 Deck: UNDERSIDE OF DECK SOUTH OVERHANG AT MIDSPAN, (2) SPALLS (UP TO 16 INCHES DIAMETER X 2 INCHES) WITH EXPOSED RUSTED REBAR

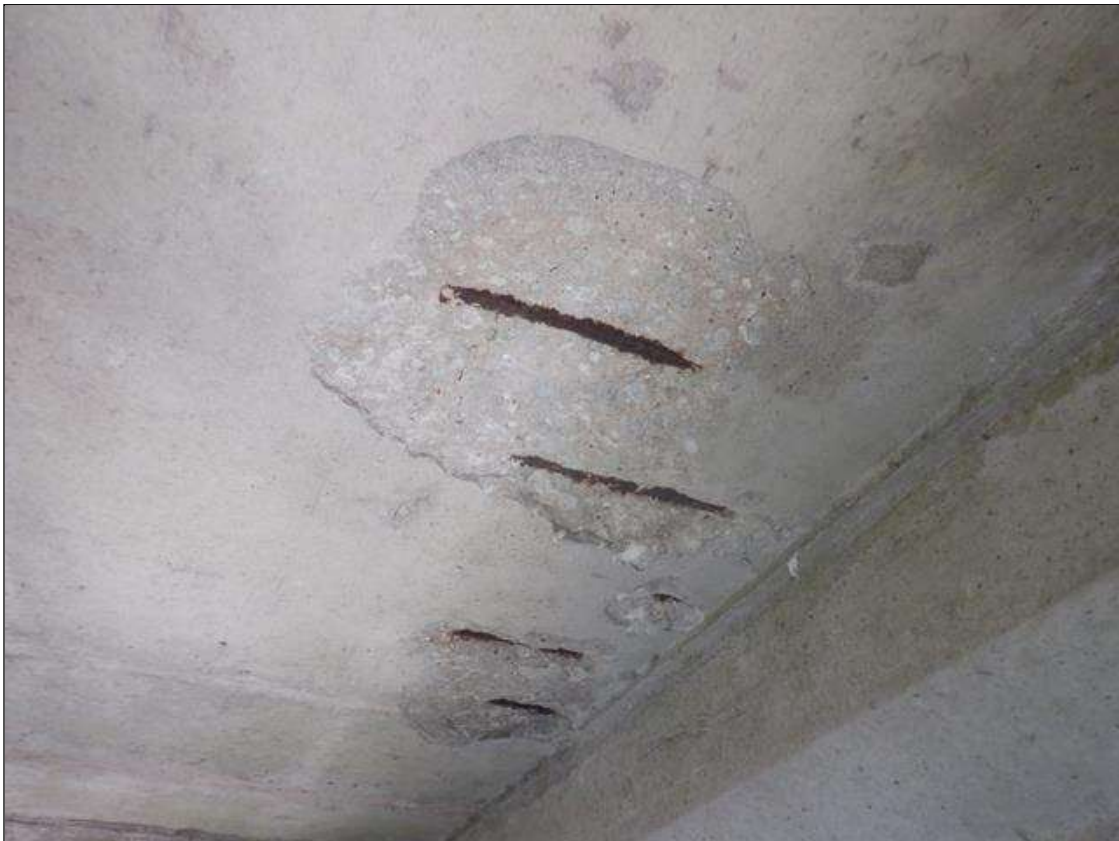
Span 180 Beam 2: (PAR) BOTTOM FLANGE SOUTH FACE AT 22 FEET FROM BENT 179, SPALL (12 INCHES X 6 INCHES X 1.5 INCHES DEEP) WITH TWO (2) EXPOSED RUSTED STRANDS (10 PERCENT SECTION LOSS)
