NC DEPARTMENT OF TRANSPORTATION  
DIVISION OF HIGHWAYS  
STRUCTURE MANAGEMENT UNIT

## Structure Safety Report

### Routine Element Inspection - Contract

STRUCTURE NUMBER: 260016 SAP STRUCTURE NO: 0270016 FHWA STRUCTURE NO: 000000000530016  
DIVISION: 1 COUNTY: CURRITUCK INSPECTION DATE: 09/21/2022 FREQUENCY: 24 MONTHS  
FACILITY CARRIED: US158E MILE POST: \_\_\_\_\_  
LOCATION: .01 MI.E.JCT.SR1187  
FEATURE INTERSECTED: CURRITUCK SOUND  
LATITUDE: 36° 5' 11.69" LONGITUDE: 75° 46' 0.21"  
SUPERSTRUCTURE: RC FLOOR ON PPC GIRDERS & CORED SLAB  
SUBSTRUCTURE: EBTS:RC CAP/PPC PILES;IBTS:RCP&B & RC CAPS/PPC PILES  
SPANS: 248 SPANS. SEE SPAN PROFILE SHEET FOR SPAN DETAILS  
☐ FRACTURE CRITICAL ☐ TEMPORARY SHORING ☐ SCOUR CRITICAL ☐ SCOUR PLAN OF ACTION  
GRADES: (Inspector/NBI Coding) DECK 6 / 6 SUPERSTRUCTURE 5 / 5 SUBSTRUCTURE 6 / 6 CULVERT N / N  
POSTED SV: Not Posted POSTED TTST: Not Posted  
OTHER SIGNS PRESENT: None

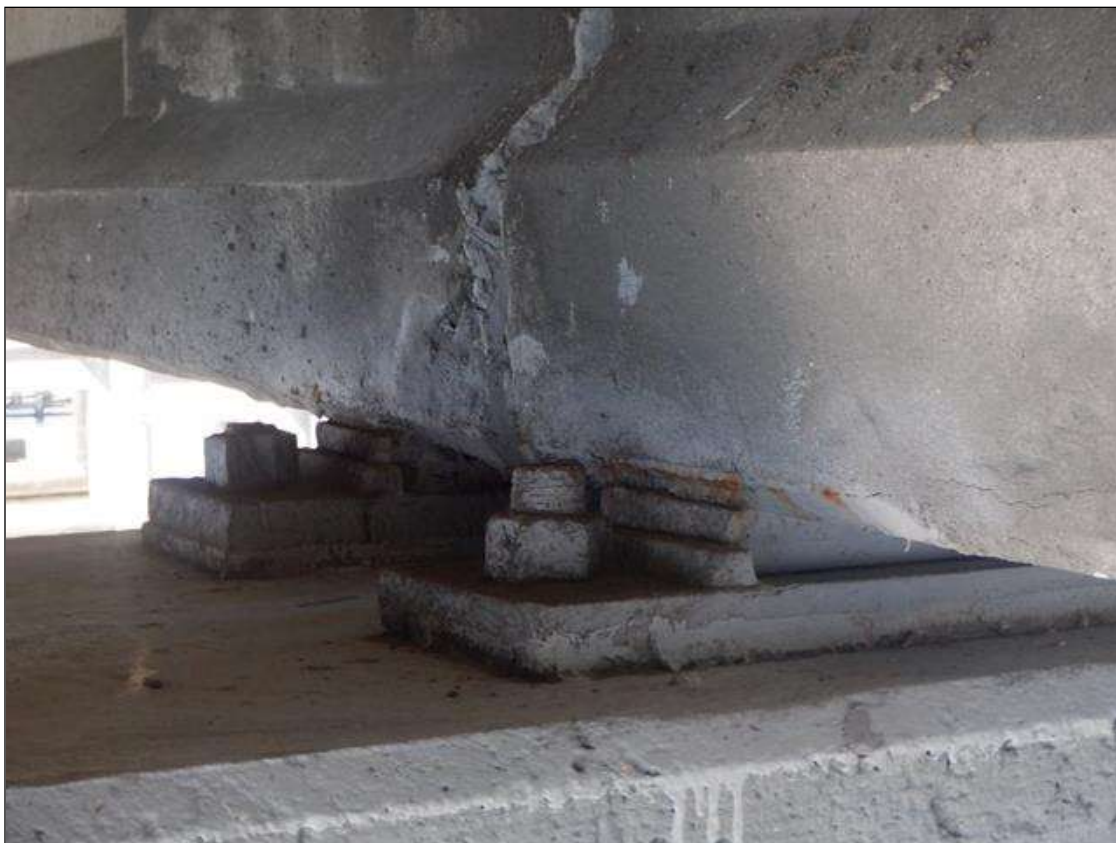
Span 182 Beam 2 - Far Bearing: SOUTH ANCHOR BOLT NUT, 25 PERCENT SECTION LOSS, AT BENT 182

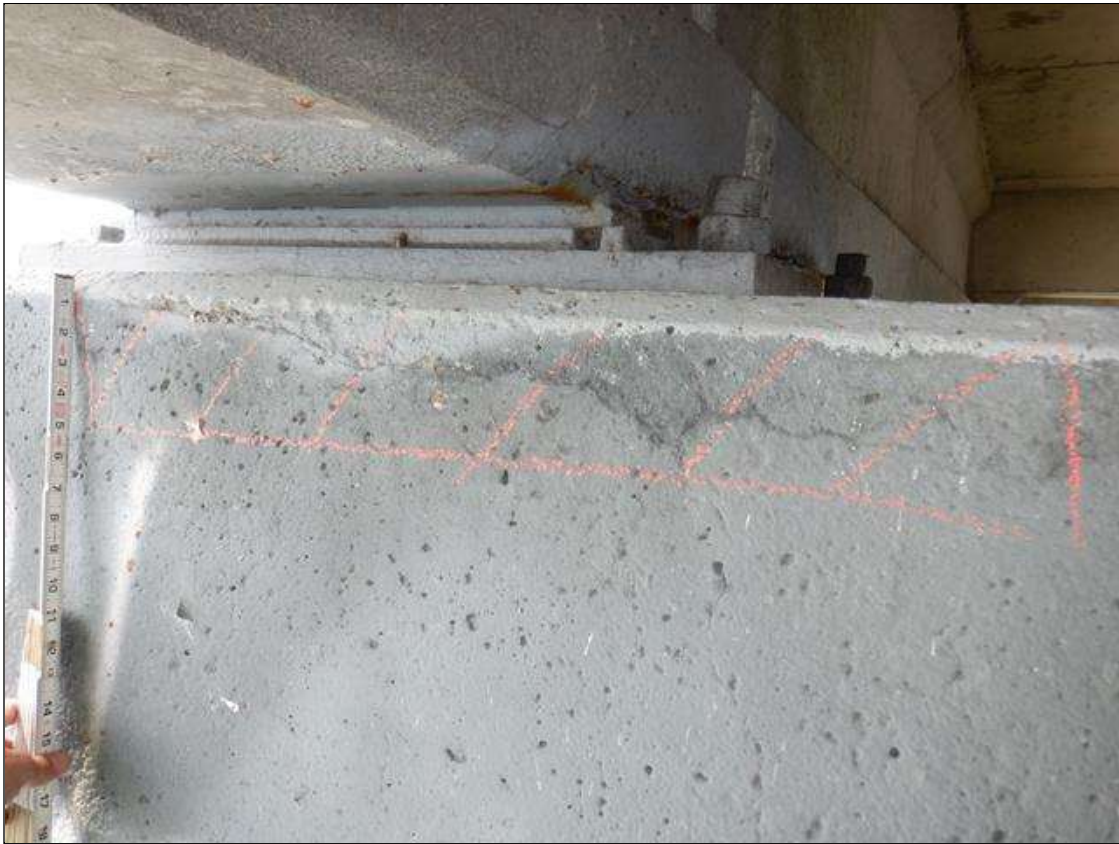
Bent 31 Cap 1: 1/16 INCHES HORIZONTAL CRACK 2 FEET LONG, 1/16 INCHES VERTICAL CRACK 9 INCHES LONG ON NORTH FACE OF CAP

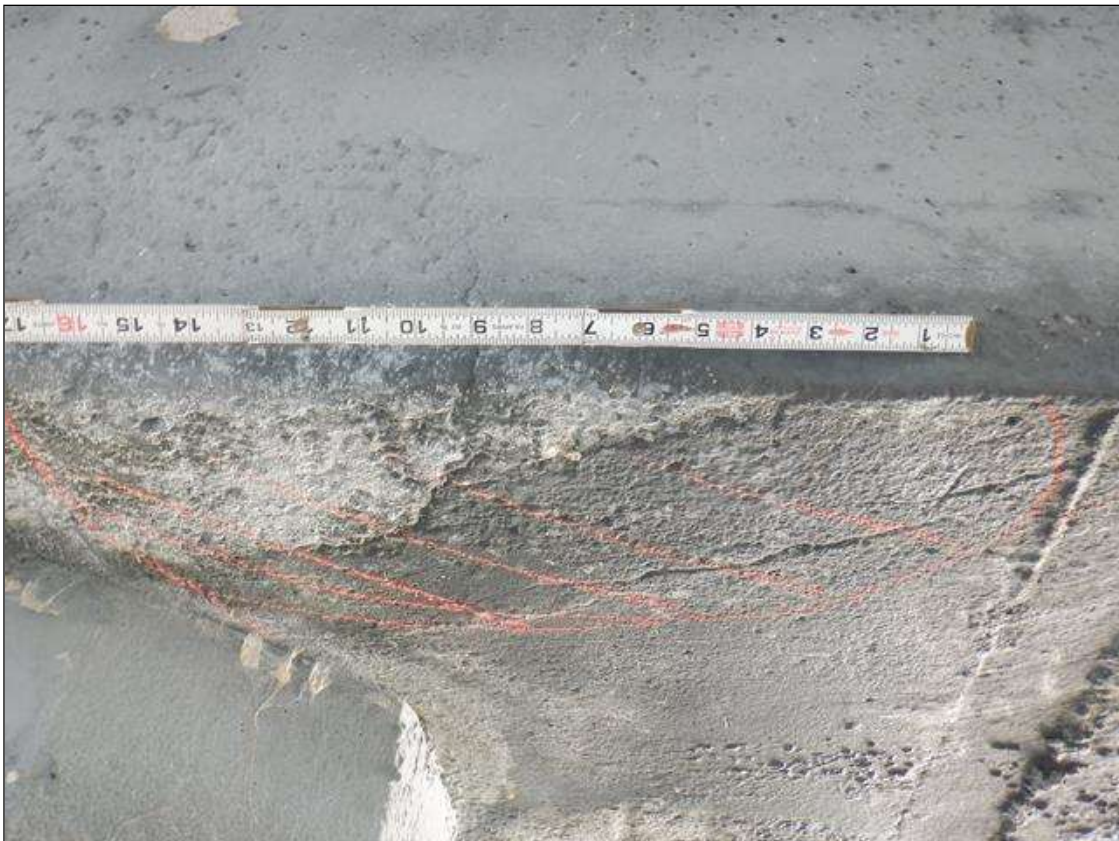
Bent 36 Cap 1: TOP OF EAST FACE AT BEAM 4, DELAMINATION (28 INCHES LONG X 5 INCHES HIGH)

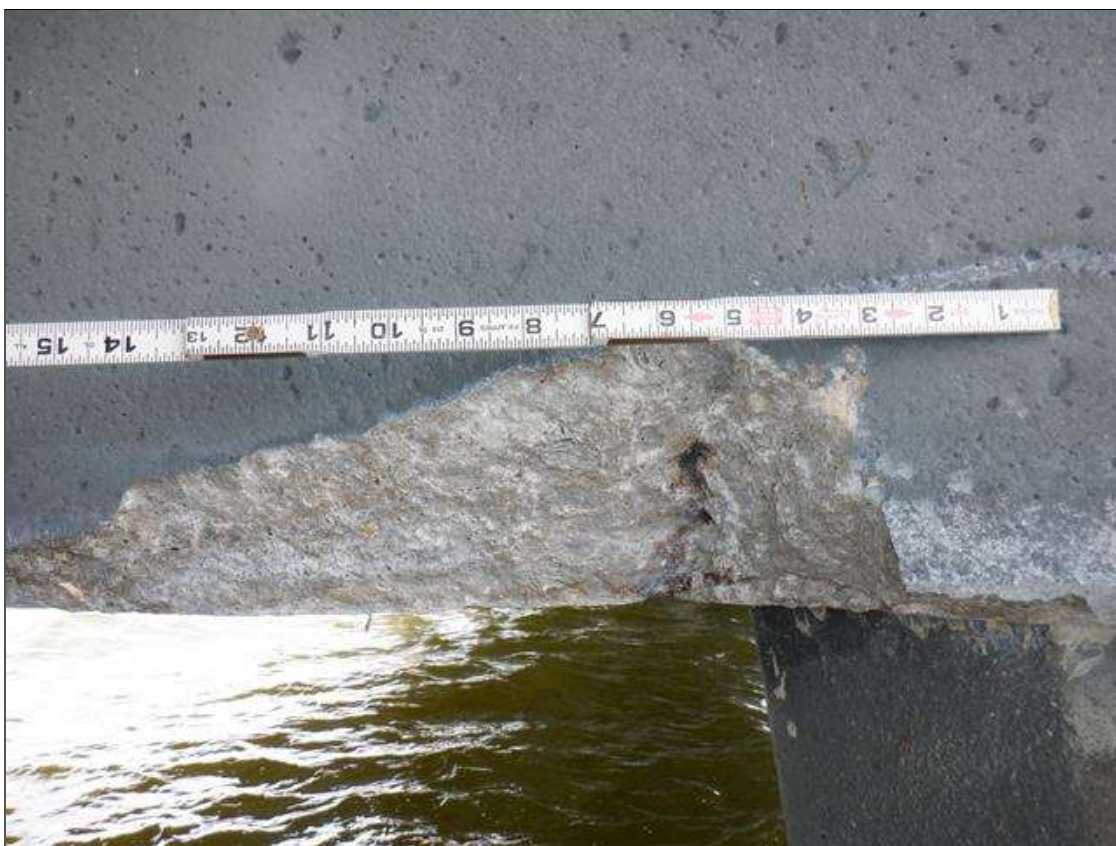
Bent 53 Cap 1: UNDERSIDE OF CAP IN PILE BAY 2, DELAMINATION (18 INCHES LONG X 10 INCHES WIDE)  
(SIMILAR IN PILE BAYS 4 AND 5)

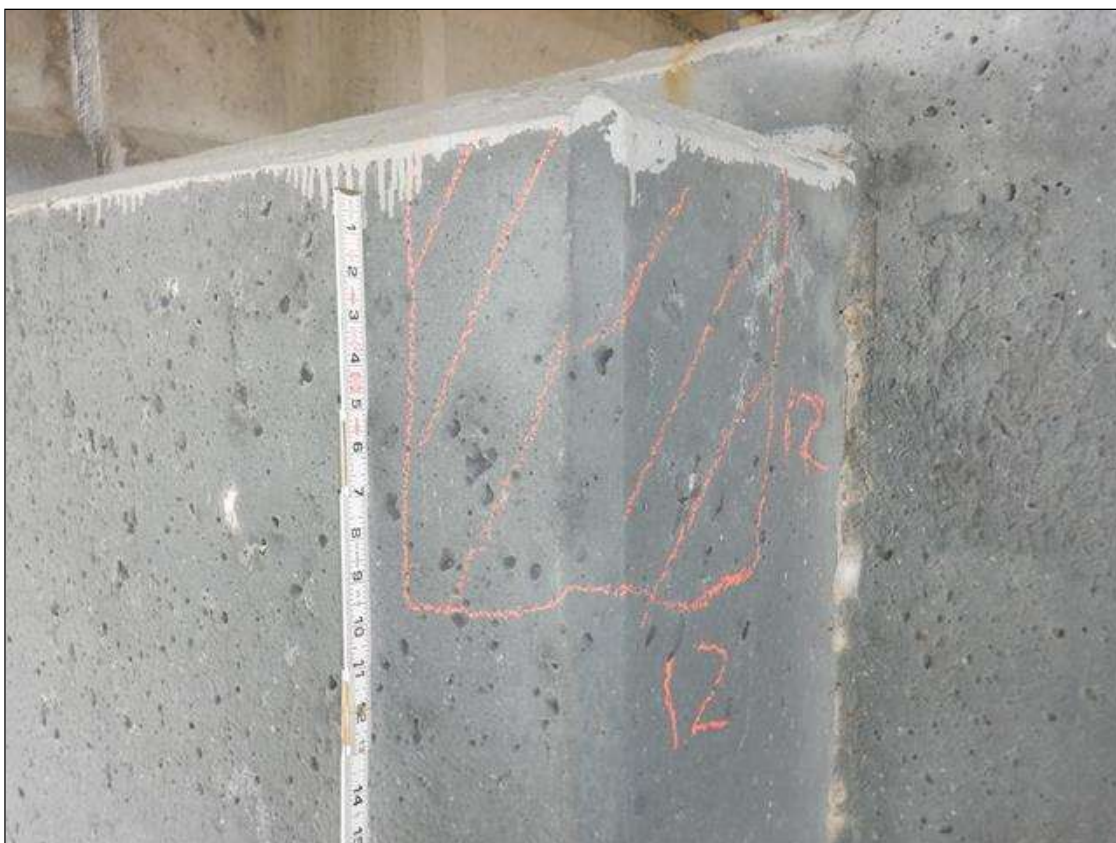
Bent 58 Cap 1: WEST FACE UNDER BEAM 2, SPALL (24 INCHES LONG X 8 INCHES HIGH)

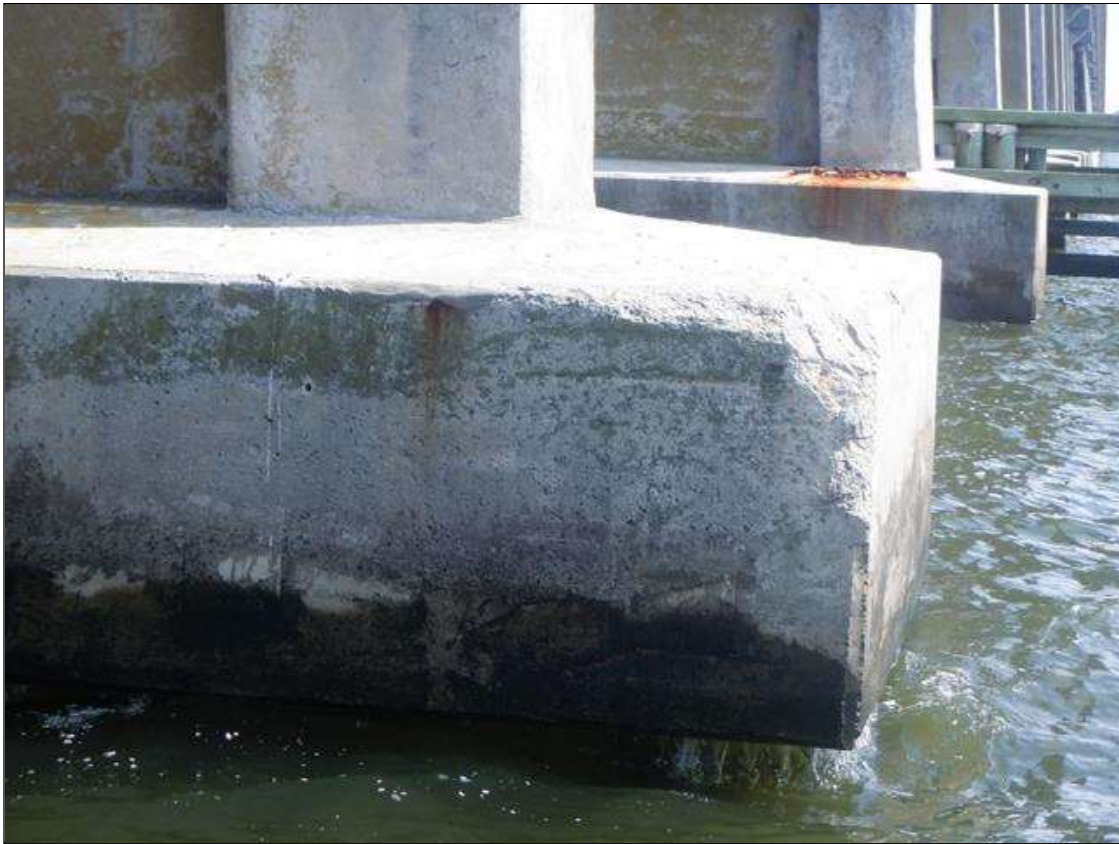
Bent 173 Footing: TOP OF WEST FACE, DELAMINATION (16FEET X UP TO 18 INCHES) SIMILAR ON EAST FACE (3FEET X 15 INCHES)

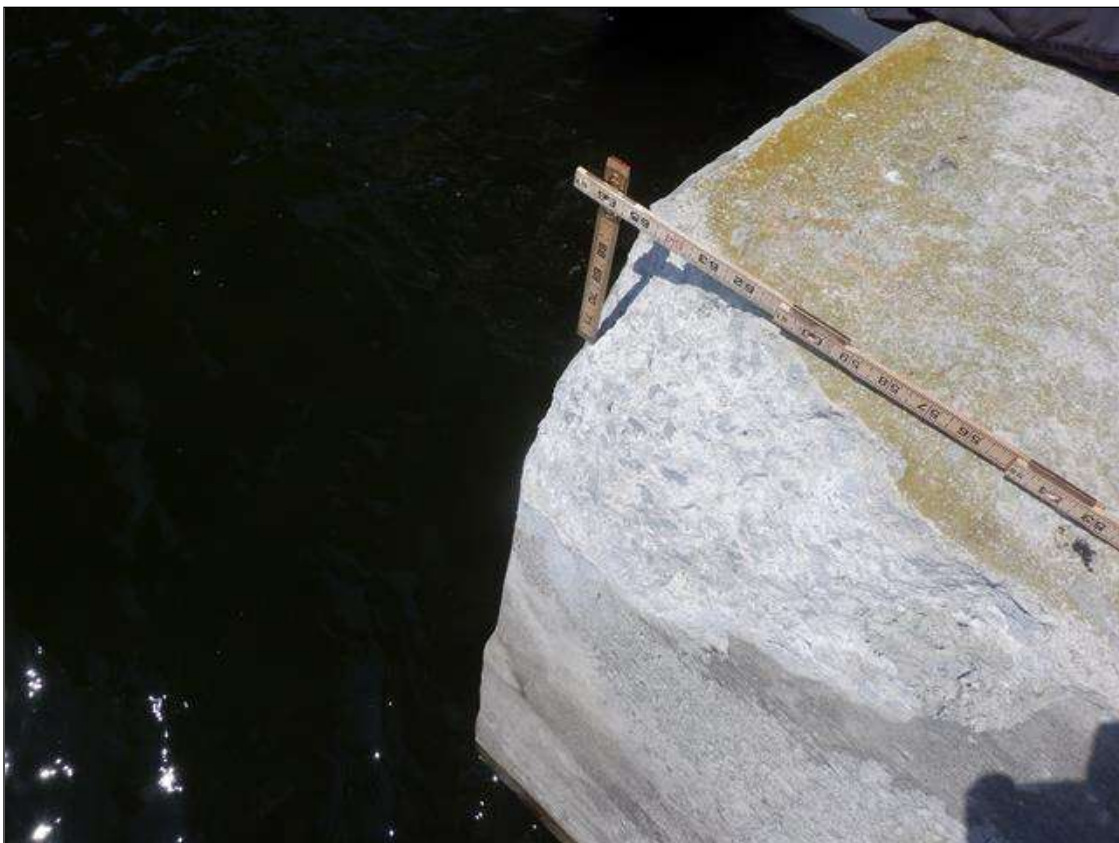
Bent 175 Footing: TOP WEST FACE NEAR SOUTH END, DELAMINATION (10 FEET X 1 FEET)

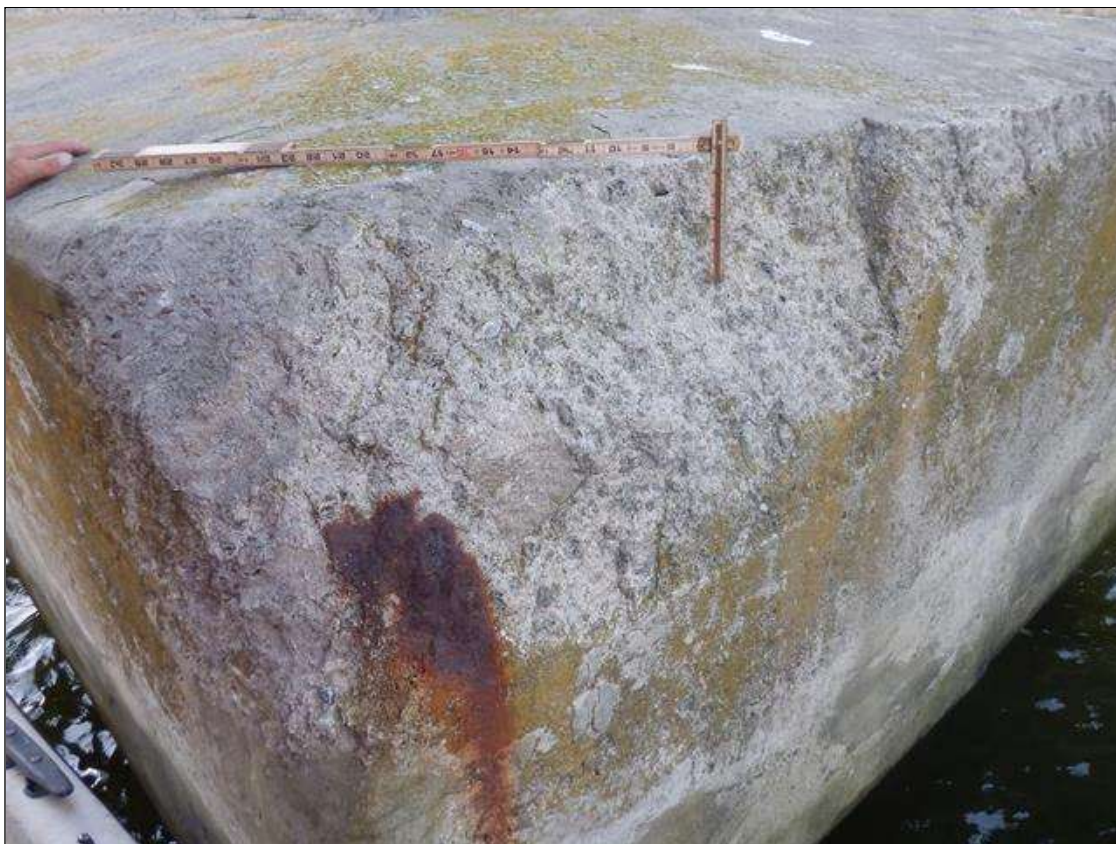
Bent 177 Footing: TOP SOUTHWEST CORNER, SPALL (32INCHES X 26INCHES X UP TO 4 INCHES)
