NC DEPARTMENT OF TRANSPORTATION
 DIVISION OF HIGHWAYS
 STRUCTURE MANAGEMENT UNIT

Structure Safety Report

Routine Element Inspection

STRUCTURE NUMBER: 100078 SAP STRUCTURE NO: 0110078 FHWA STRUCTURE NO: 00000000210078

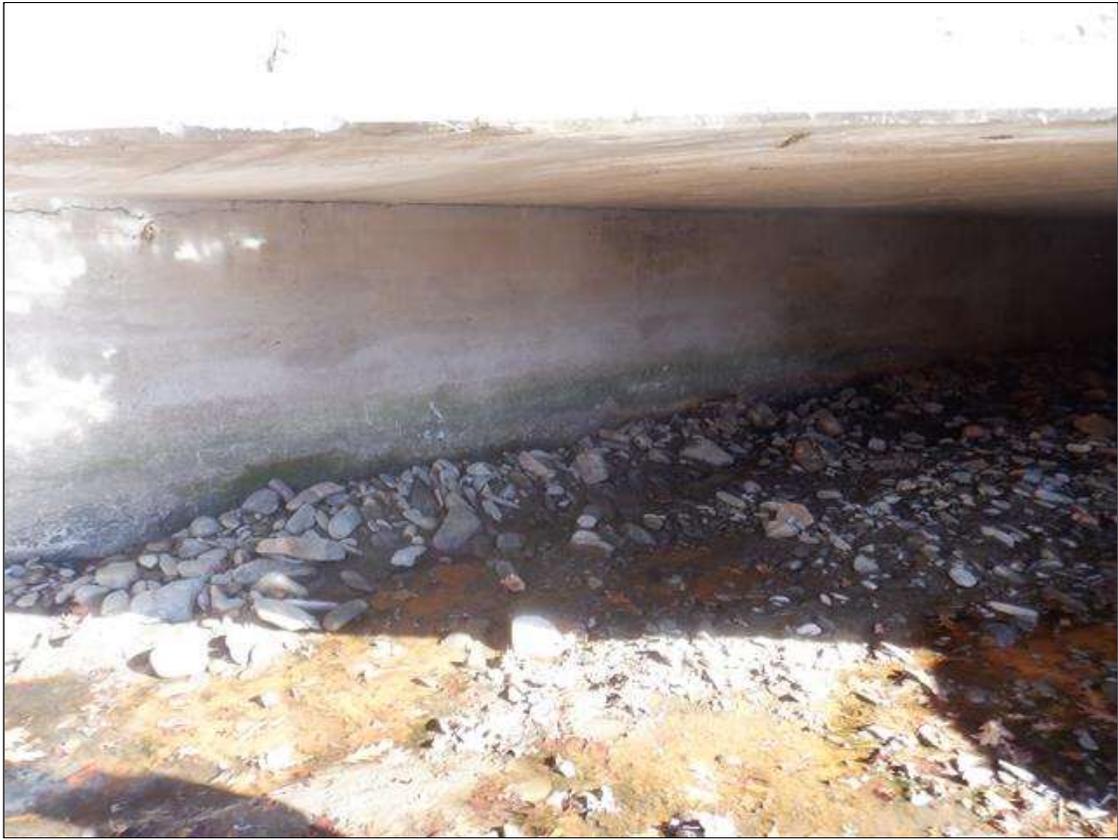
END BENT 1

Priority Level	Defect Type	Quantity	Defect Description
2	Cracking (RC and ...)	13	End Bent 1 Abutment: FULL HEIGHT X 0.5 INCH WIDE VERTICAL CRACK AND 13 FEET LONG X 0.5 INCH WIDE HORIZONTAL CRACK AT THE RIGHT END OF THE ABUTMENT. (PAR)
