BRIDGE SCOUR REPORT

COUNTY: BUNCOMBE BRIDGE: 154 ROUTE: SR 1003 STREAM CROSSED: BIG IVY CK

**Unknown Foundation Determination**  
**Substructure Report**  
**Buncombe 100154**  
**Paint Fork Rd. (SR 1003) over Big Ivy Creek**

FDH Project # 08-06077E

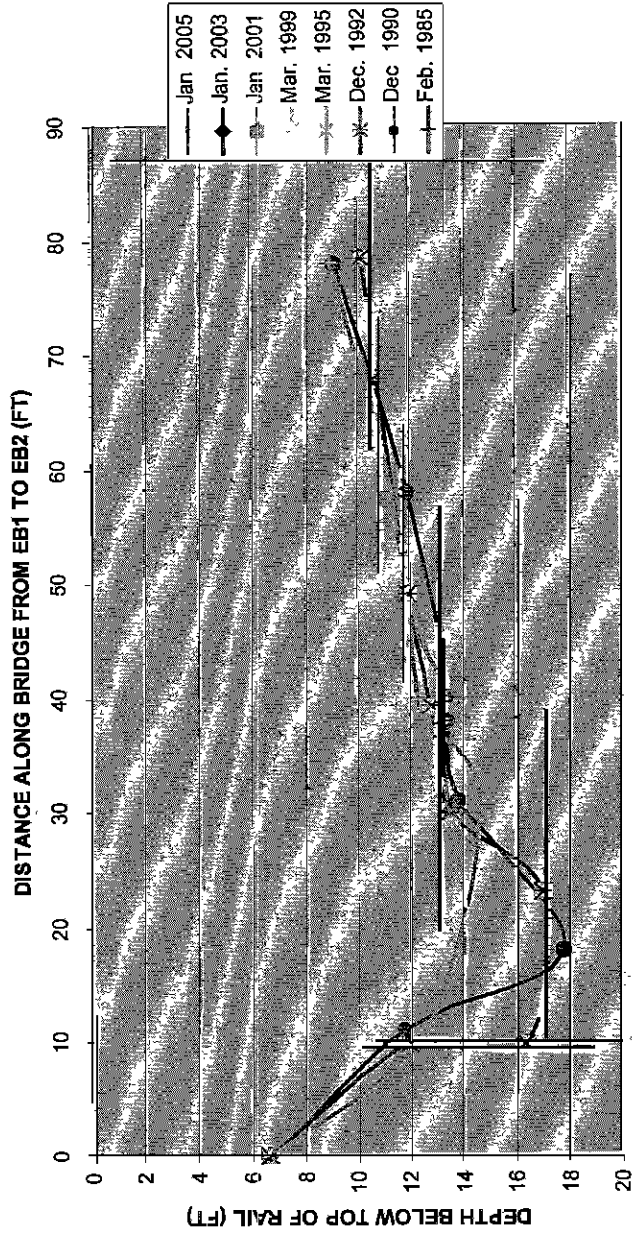
### DOWN STREAM BED SOUNDINGS

Foundation consists of concrete abutments with concrete footer and rock. We are unable to confirm the elevation of EB1 due to large rocks at the footer of the abutment (See Photos). B1 is 17.6 ft and EB2 is 14.1 ft from the top of rail to bottom of footer. Sounding data indicates EB2 is resting on material 50/1". B1 is resting on material too hard to penetrate with sounding rods.
