NC DEPARTMENT OF TRANSPORTATION  
 DIVISION OF HIGHWAYS  
 STRUCTURE MANAGEMENT UNIT

# Structure Safety Report

## Routine Element Inspection - Contract

STRUCTURE NUMBER: 100154      SAP STRUCTURE NO: 0110154      FHWA STRUCTURE NO: 00000000210154

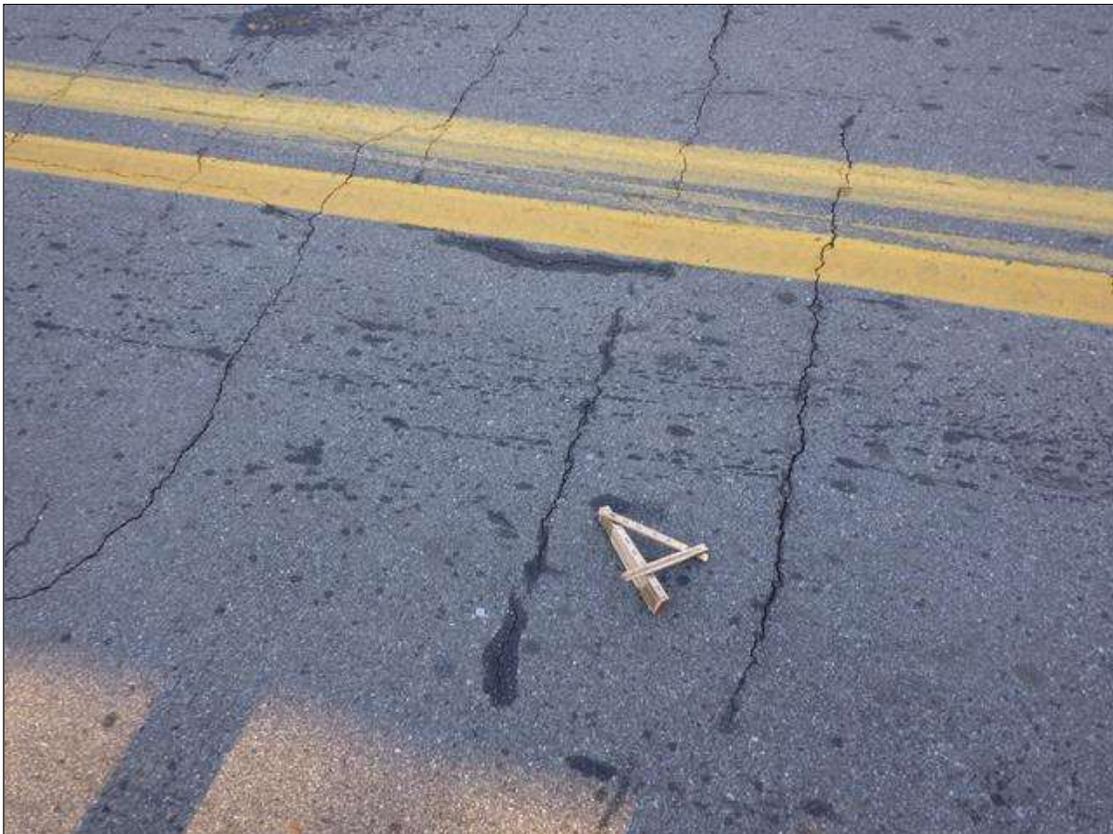
Span 2 Wearing Surface: TRANSVERSE CRACKS UP TO FULL WIDTH X 1/8 INCH WIDE AT LESS THAN 1 FOOT SPACING ALONG THE DECK BOARD EDGES THROUGHOUT

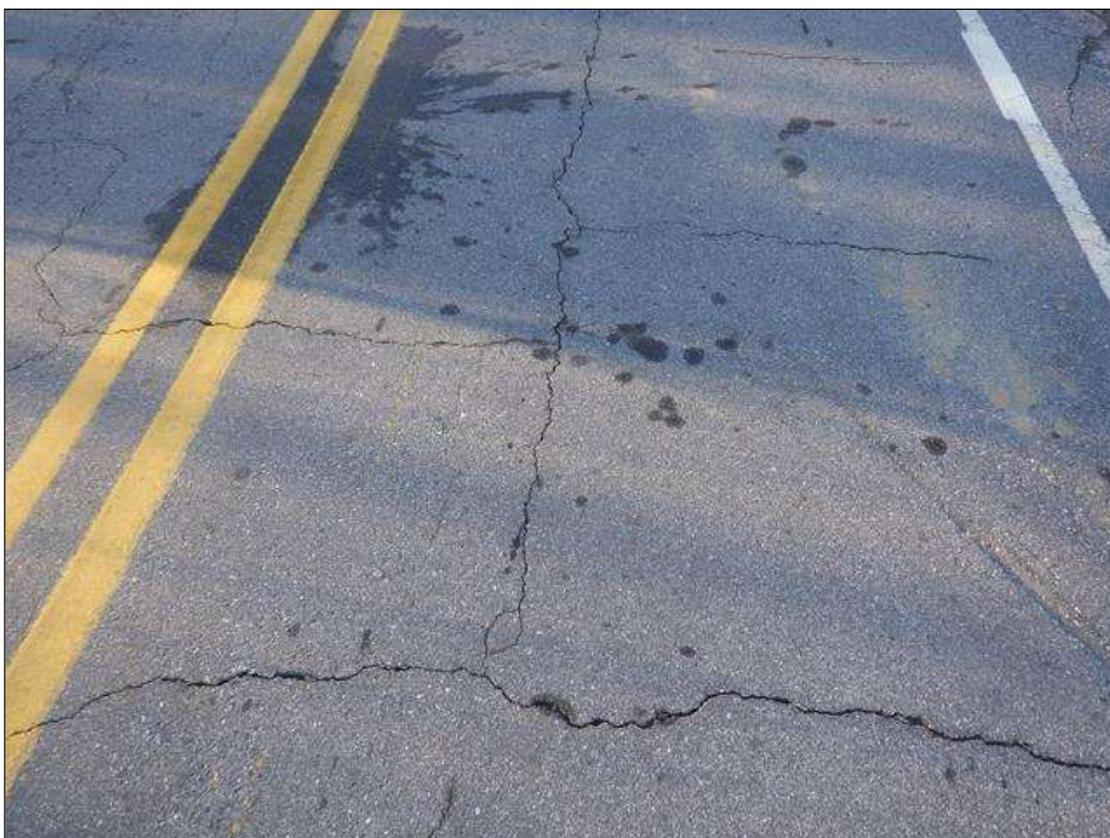
MAP CRACKING UP TO INTERMITTENT FULL WIDTH X GREATER THAN 150 FEET LONG X 1/8 INCH WIDE IN THE SOUTH APPROACH AT END BENT 1

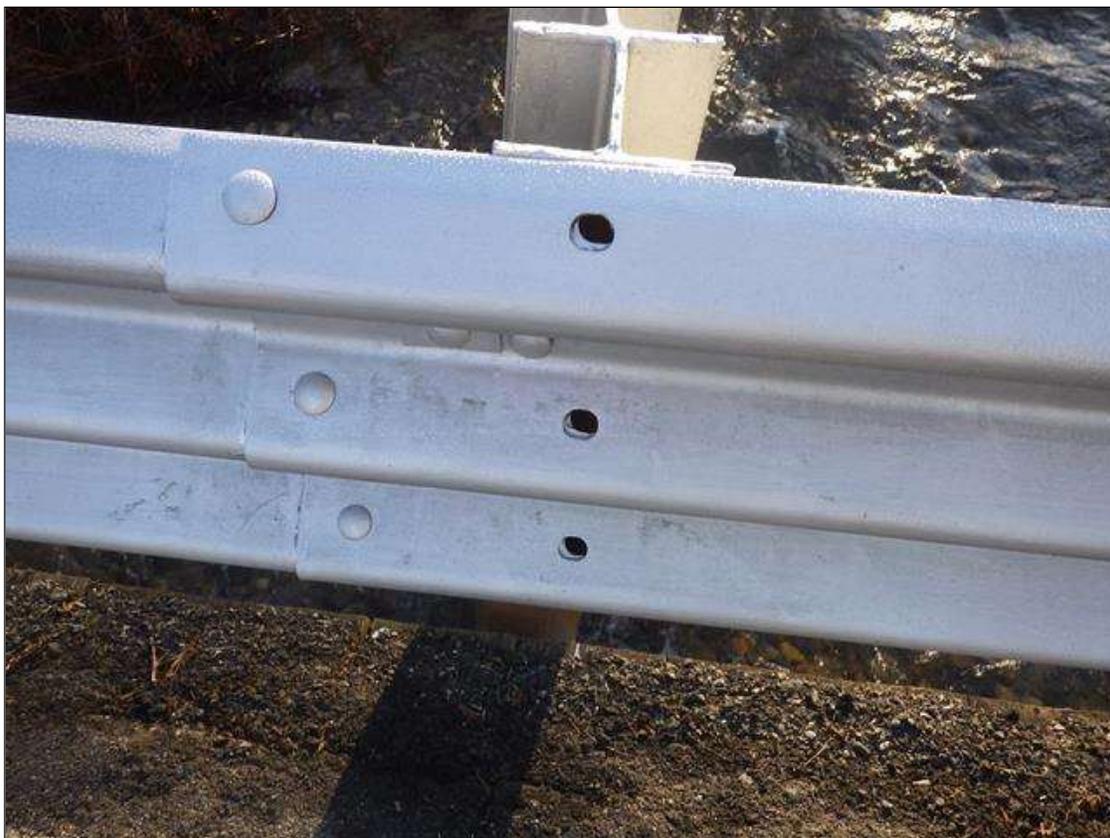
Span 1 Right Bridge Rail: MISSING (3) ANCHOR BOLTS AT POST 5 (PRIORITY ACTION REQUEST)

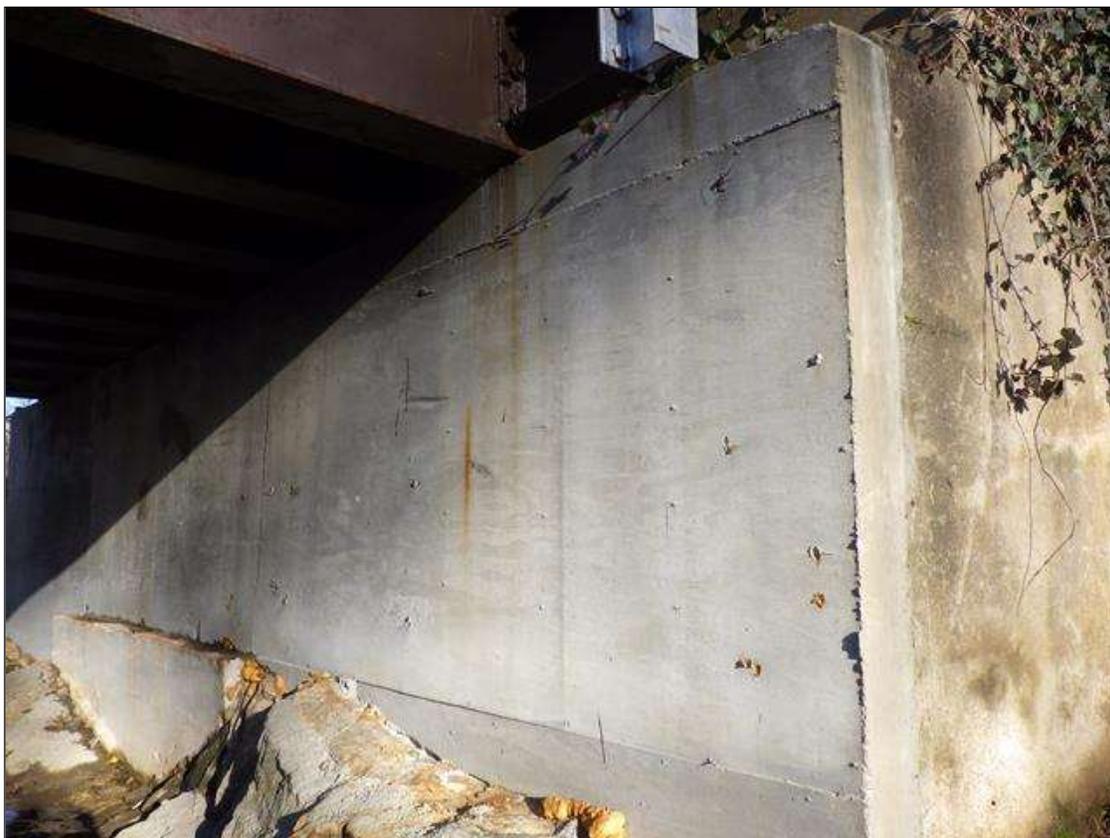
End Bent 2 Abutment: REPAIR PATCH AREA UP TO FULL LENGTH X 6 FEET HIGH X 6 INCHES THICK

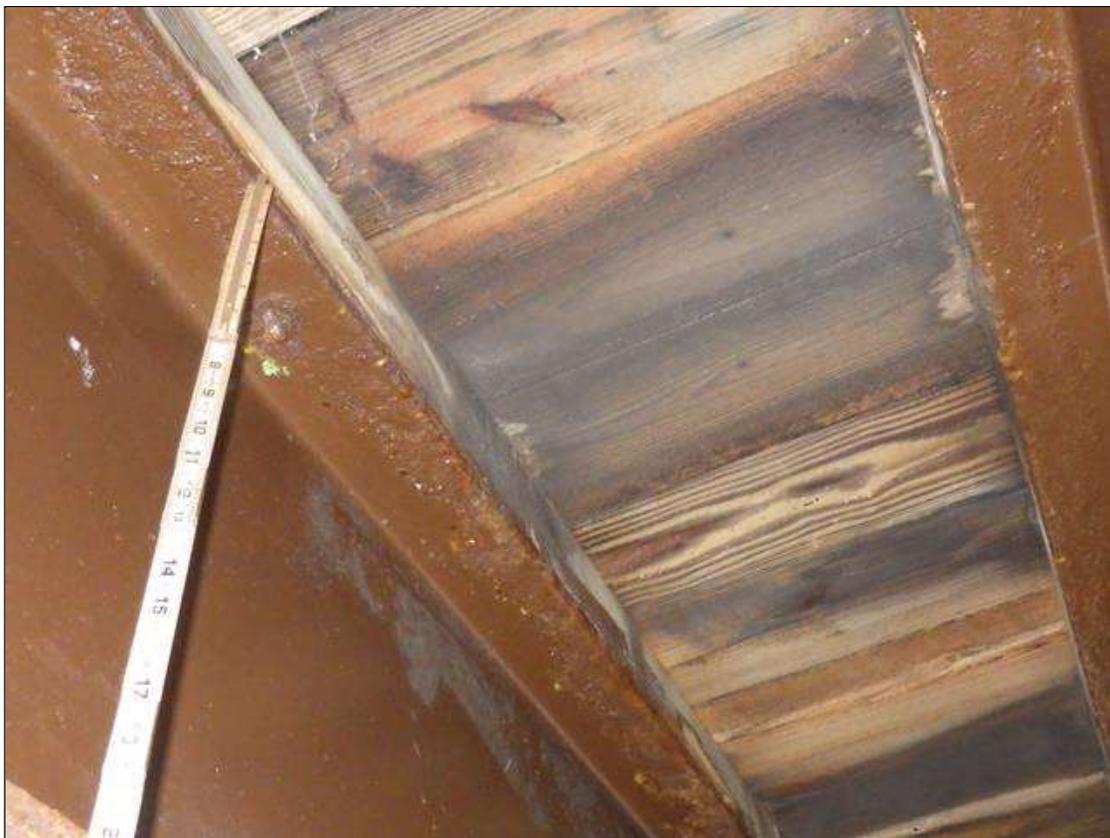
Span 2 Beam 6: ARRESTED CORROSION UP TO INTERMITTENT FULL LENGTH X FULL WIDTH WITH 7/16 INCH REMAINING (GREATER THAN OR EQUAL TO 1/16 INCH SECTION LOSS, LESS THAN 25 PERCENT SECTION LOSS) IN THE TOP FLANGE

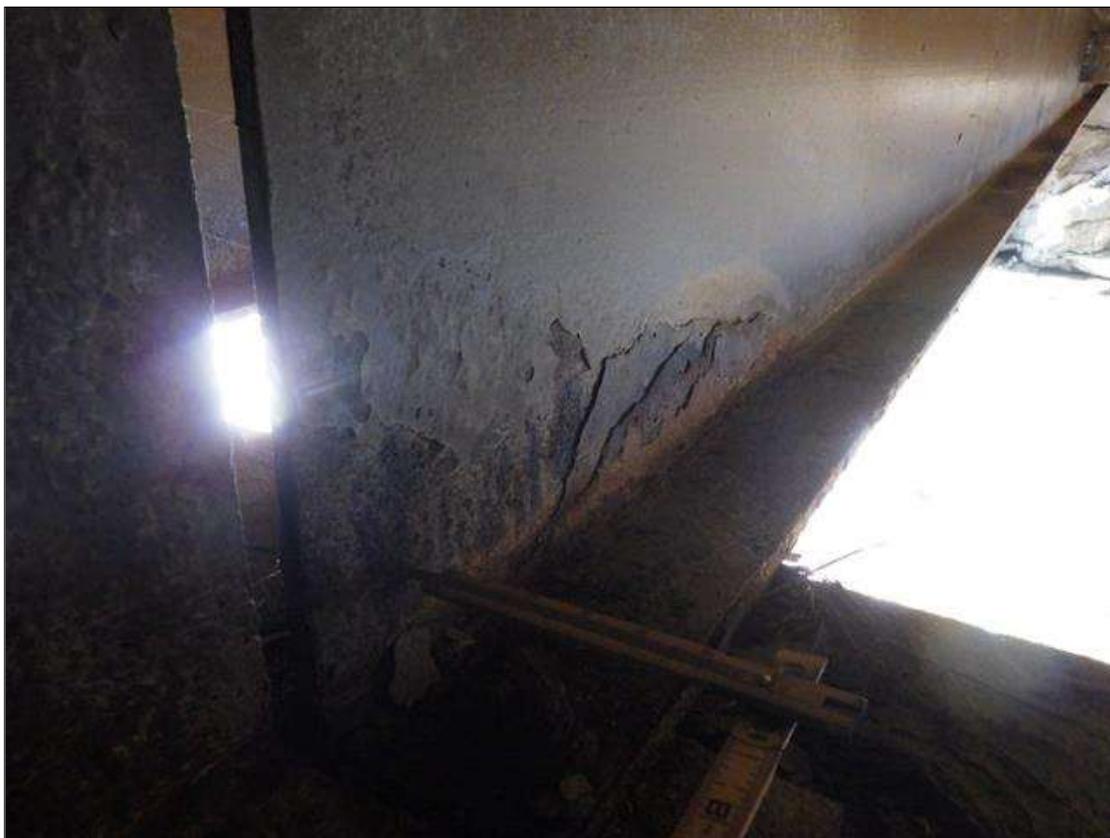
<input checked="" type="checkbox"/> 515	Effectiveness (Steel Protective Coatings)	CORROSION UP TO 1 FOOT 10 INCHES LONG X 8 INCHES HIGH WITH 1/32 INCH SECTION LOSS IN THE WEB AT BENT 1	4	2	2 Square Feet

Span 1 Beam 6: CORROSION UP TO 1 FOOT 10 INCHES LONG X 8 INCHES HIGH WITH 1/32 INCH SECTION LOSS IN THE WEB AT BENT 1

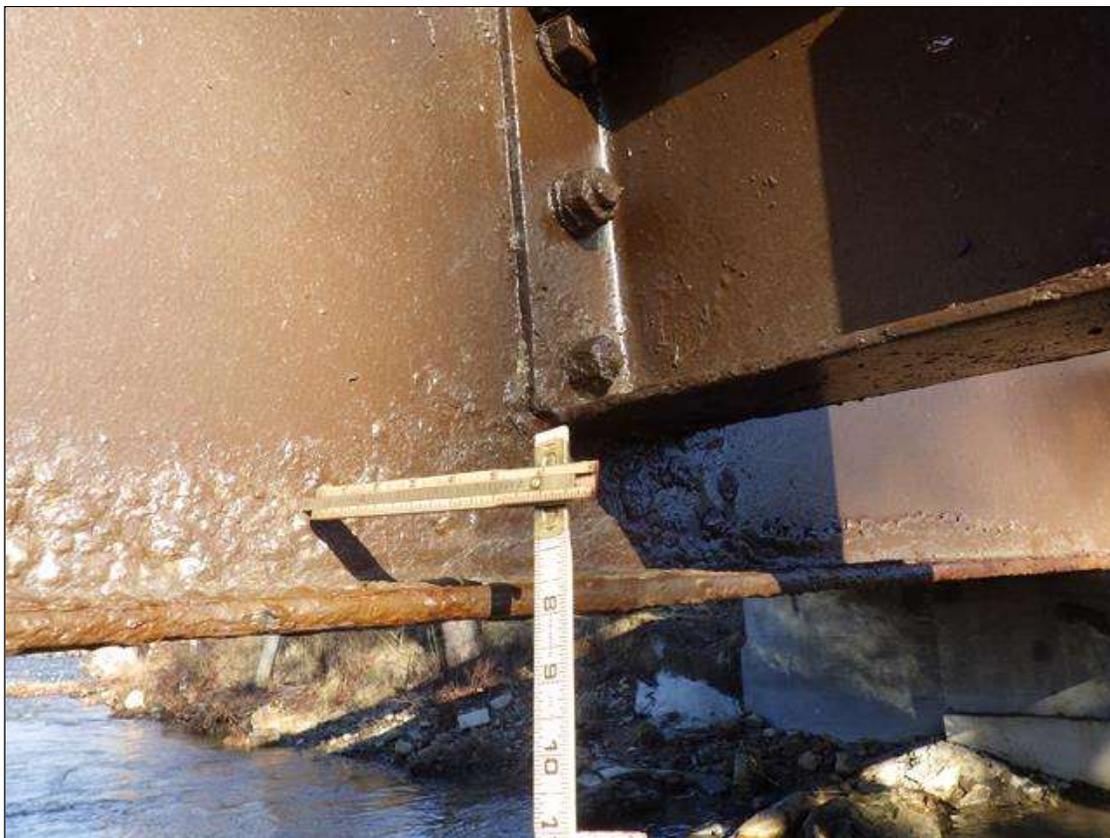
Span 2 Beam 9: ARRESTED CORROSION UP TO 32 FEET 4 INCHES INCHES LONG X 5 INCHES HIGH WITH 5/16 INCH REMAINING (GREATER THAN OR EQUAL TO 1/16 INCH SECTION LOSS, LESS THAN 25 PERCENT SECTION LOSS) IN THE WEB AT BENT 1

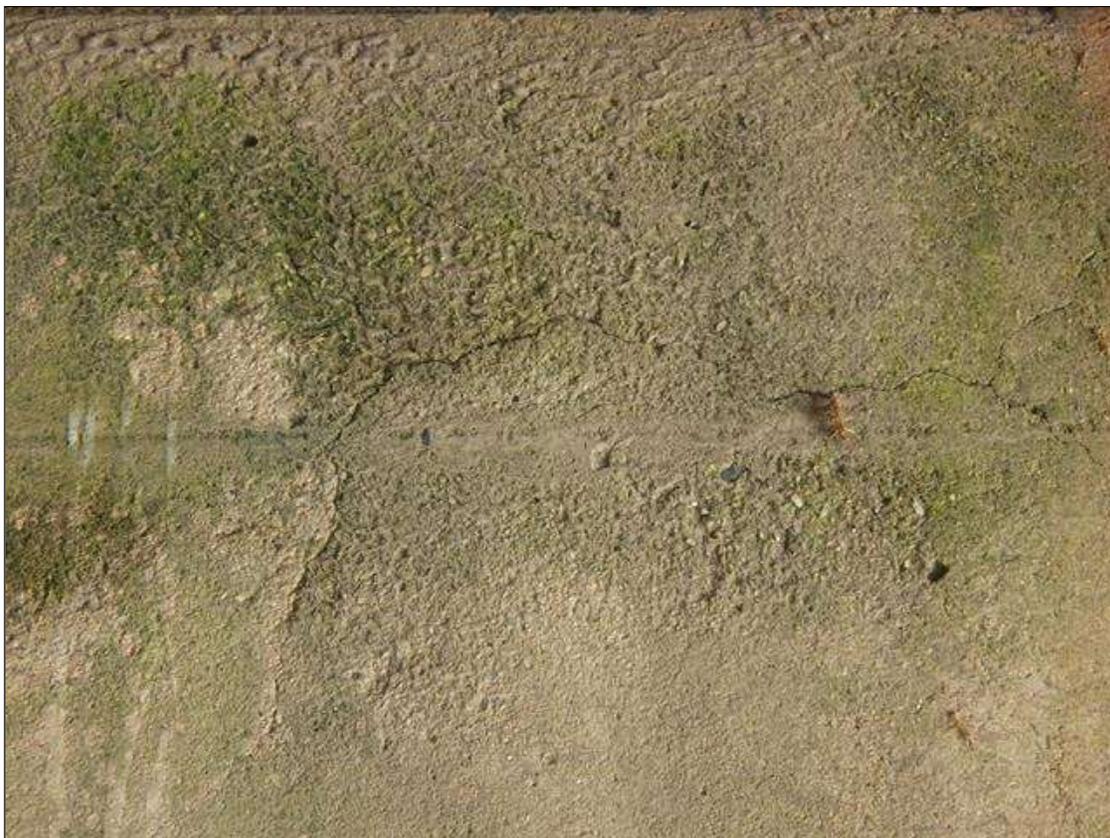
Bent 1 Cap 1: MAP CRACKING UP TO INTERMITTENT FULL LENGTH X FULL WIDTH X FULL HEIGHT X 1/32 INCH WIDE IN THE NORTH AND SOUTH FACES

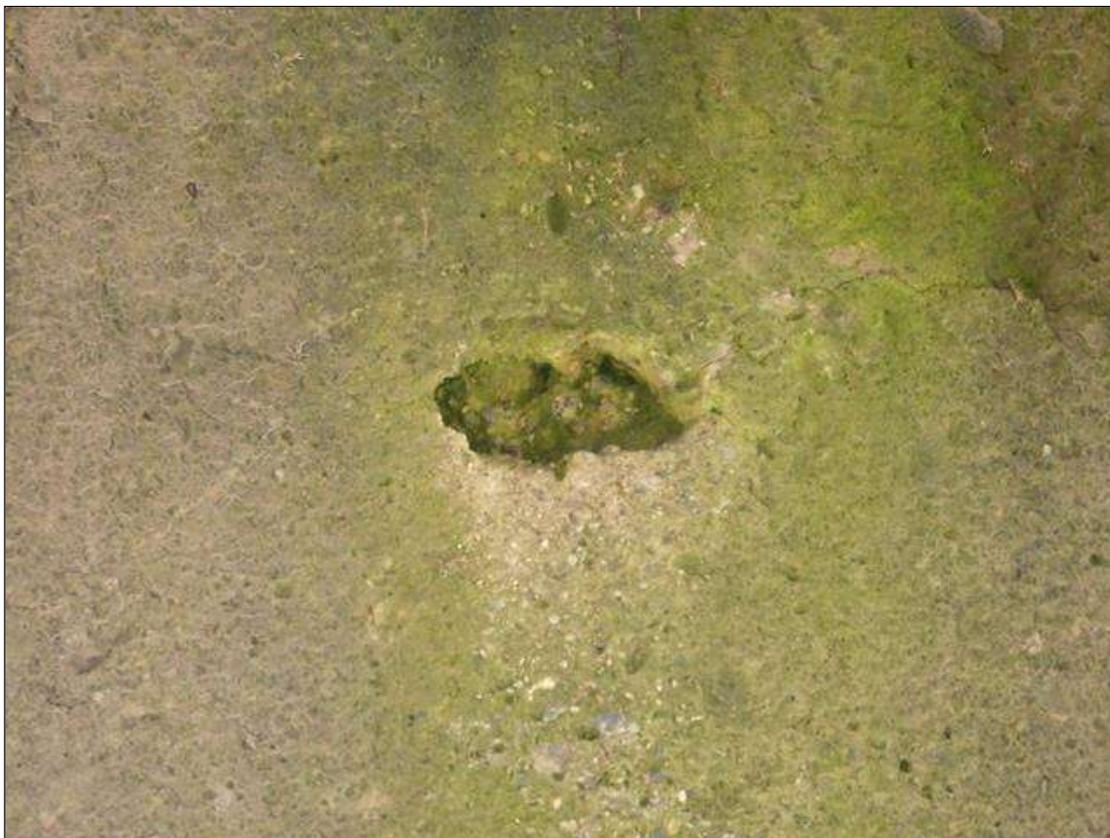
Bent 1 Cap 1: SPALLED AREA UP TO 3 INCHES LONG X 2 INCHES HIGH X 1 INCH DEEP IN THE NORTH FACE BELOW BEAM 4

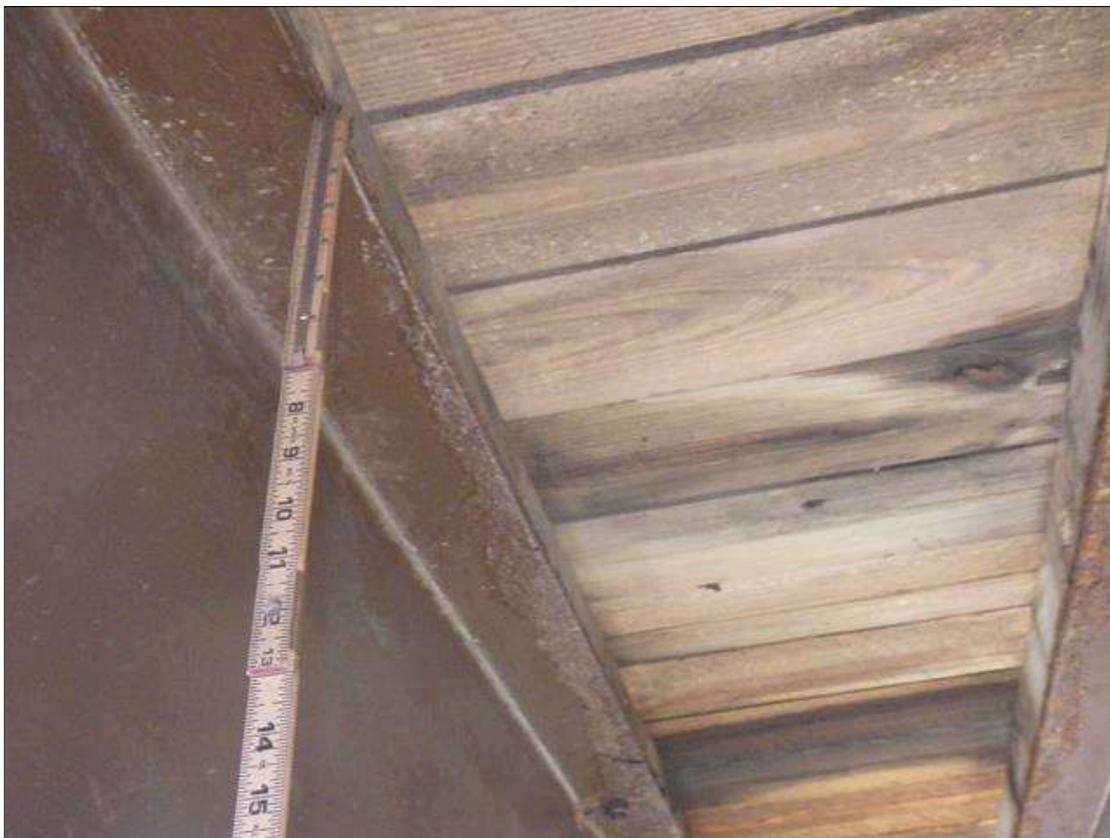
Span 1 Beam 8: ARRESTED CORROSION UP TO FULL LENGTH X FULL WIDTH WITH 7/16 INCH REMAINING (GREATER THAN OR EQUAL TO 1/16 INCH SECTION LOSS, LESS THAN 25 PERCENT SECTION LOSS) IN THE TOP FLANGE

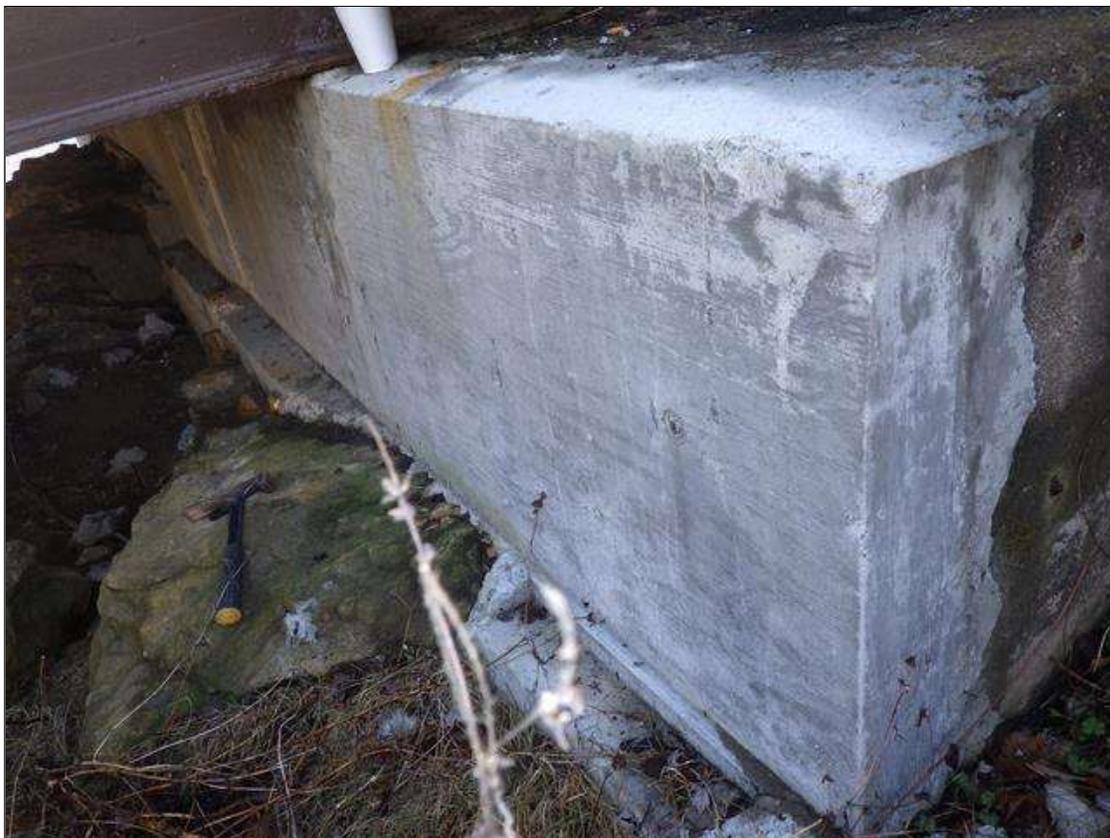
End Bent 1 Abutment: REPAIR PATCH AREA UP TO FULL LENGTH X 3 FEET HIGH X 7 INCHES THICK

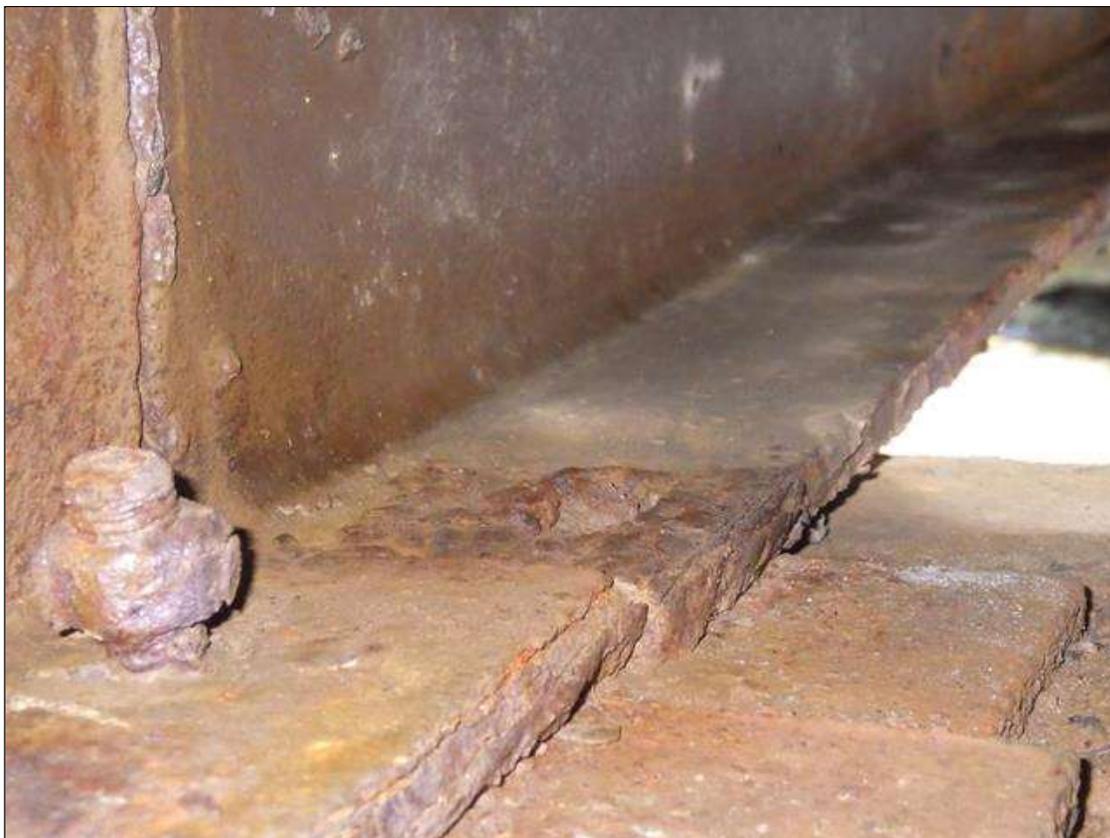
3334	Beam 2	Plate Girder		
Priority Level	Defect Type	Quantity	Defect Description	
2	Connection	1	Span 1 Near Bearing: MISSING LEFT ANCHOR BOLT IN BEAM 2 BEARING (PRIORITY ACTION REQUEST)	
3314	Beam 3	Plate Girder		
Priority Level	Defect Type	Quantity	Defect Description	
2	Corrosion	2	Span 1 Beam 3: ACTIVE CORROSION UP TO 1 FOOT 4 INCHES LONG X FULL WIDTH WITH 3/8 INCH REMAINING (GREATER THAN OR EQUAL TO 1/16 INCH SECTION LOSS, GREATER THAN 25 PERCENT SECTION LOSS) IN THE BOTTOM FLANGE AT END BENT 1 (PRIORITY ACTION REQUEST)	
2	Connection	1	Span 1 Near Bearing: MISSING LEFT ANCHOR BOLT NUT IN BEAM 3 BEARING (PRIORITY ACTION REQUEST)	
3334	Beam 4	Plate Girder		
Priority Level	Defect Type	Quantity	Defect Description	
2	Connection	1	Span 1 Near Bearing: MISSING LEFT ANCHOR BOLT AND ANCHOR BOLT NUT IN BEAM 4 BEARING (PRIORITY ACTION REQUEST)	
3334	Beam 5	Plate Girder		
Priority Level	Defect Type	Quantity	Defect Description

Span 1 Near Bearing: MISSING LEFT ANCHOR BOLT IN BEAM 2 BEARING (PRIORITY ACTION REQUEST)

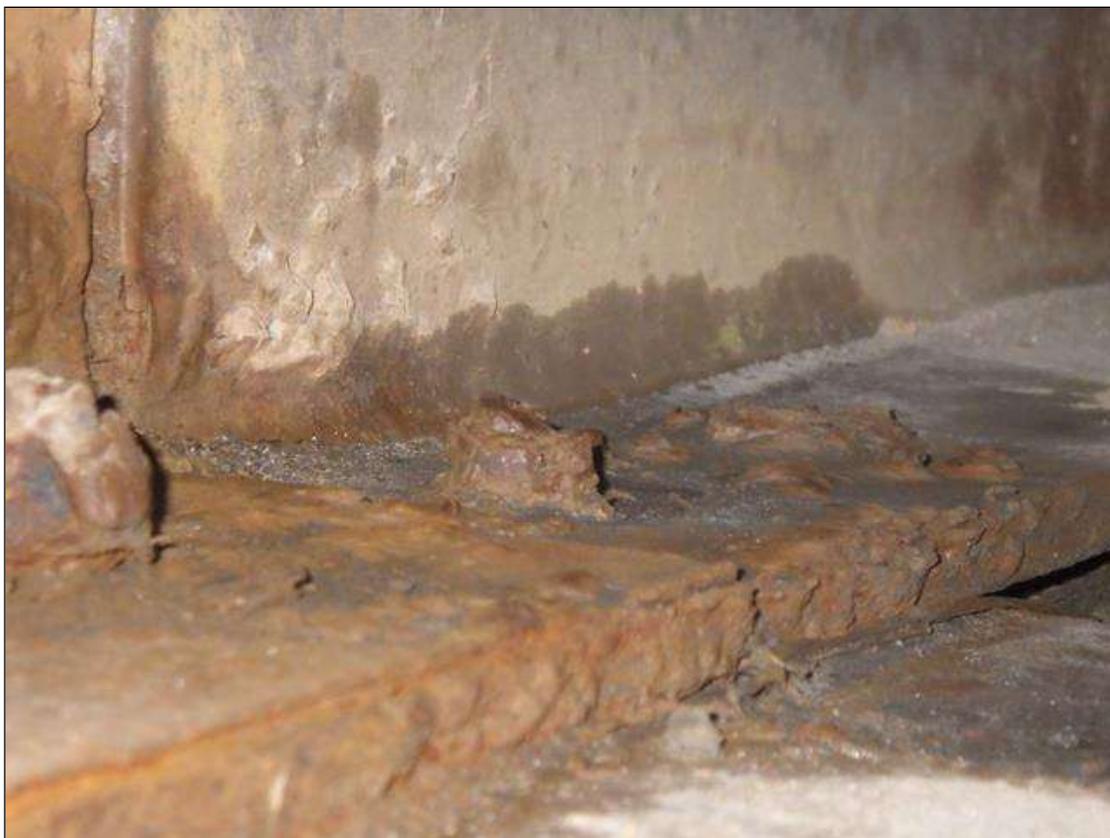
Span 1 Near Bearing: MISSING LEFT ANCHOR BOLT NUT IN BEAM 3 BEARING (PRIORITY ACTION REQUEST)

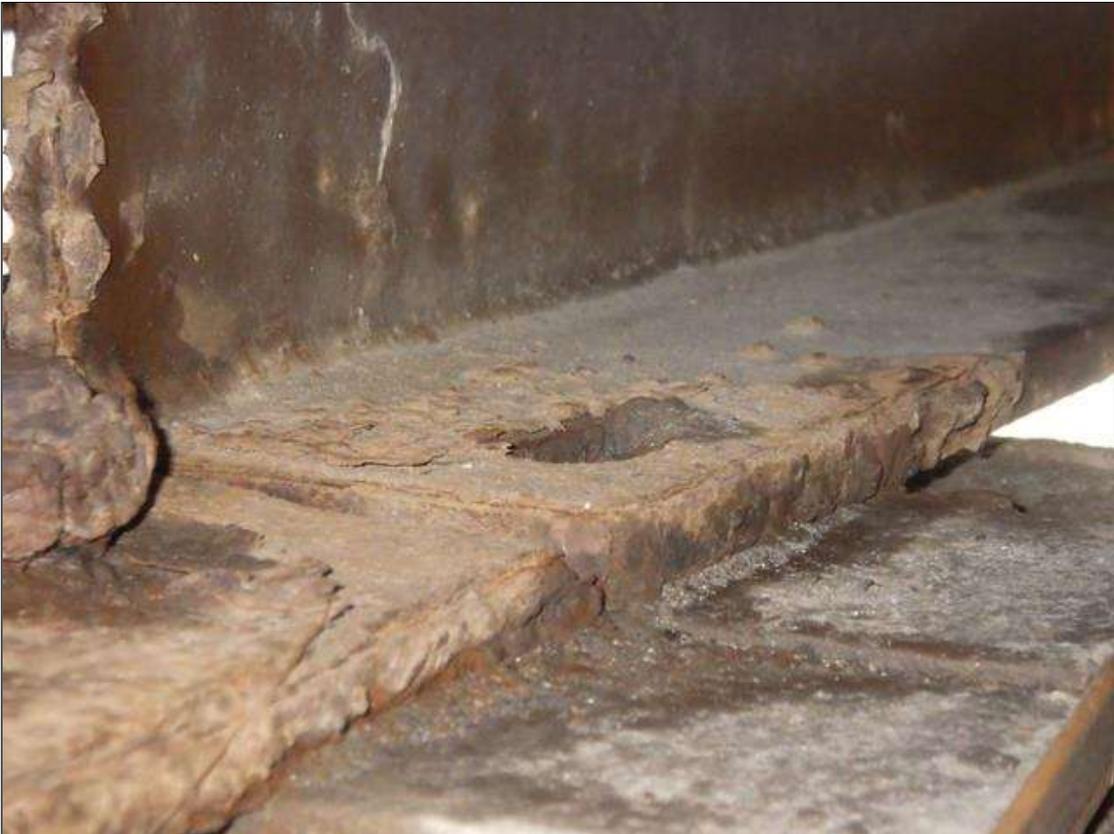
2	Connection	1	Span 1 Near Bearing: MISSING LEFT ANCHOR BOLT IN BEAM 5 BEARING (PRIORITY ACTION REQUEST)	
3322	Right Bridge Rail	Steel Rail		
Priority Level	Defect Type	Quantity	Defect Description	
2	Connection	1	Span 1 Right Bridge Rail: MISSING (1) ANCHOR BOLT AT POST 3 (PRIORITY ACTION REQUEST)	
2	Connection	3	Span 1 Right Bridge Rail: MISSING (3) ANCHOR BOLTS AT POST 5 (PRIORITY ACTION REQUEST)	
2	Damage	2	Span 1 Right Bridge Rail: IMPACT DAMAGE UP TO 2 FEET LONG WITH HOLE UP TO 3 INCHES LONG X 1 INCH HIGH IN THE SOUTH END TERMINAL (PRIORITY ACTION REQUEST)

Span 1 Near Bearing: MISSING LEFT ANCHOR BOLT IN BEAM 5 BEARING (PRIORITY ACTION REQUEST)

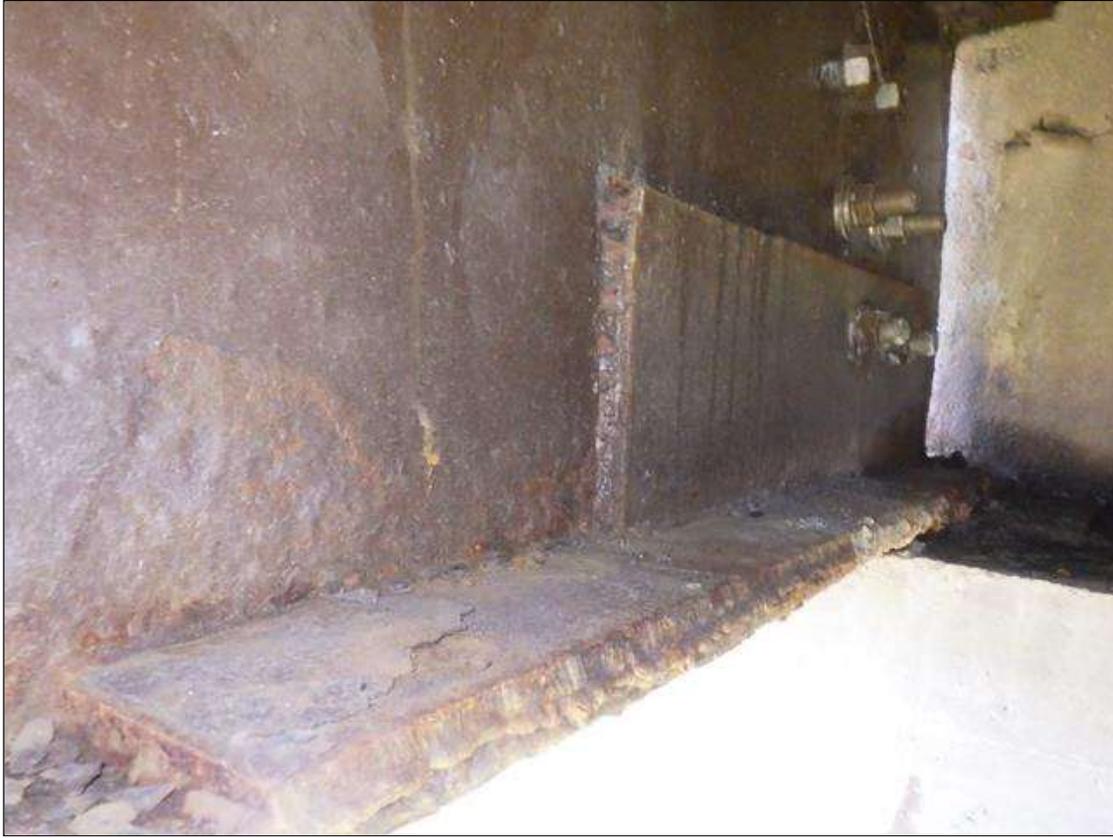
Span 1 Beam 9: (4) REPAIR PLATES (1) UP TO 3 FEET LONG X 3 1/2 INCHES WIDE X 1/2 INCH THICK IN THE LEFT BOTTOM FLANGE, (2) UP TO 2 FEET LONG X 7 INCHES HIGH X 3/4 INCH THICK IN THE LEFT AND RIGHT SIDES OF THE WEB, AND (1) UP TO 4 FEET LONG X 3 1/2 INCHES WIDE X 1/2 INCH THICK IN THE RIGHT BOTTOM FLANGE AT END BENT 1

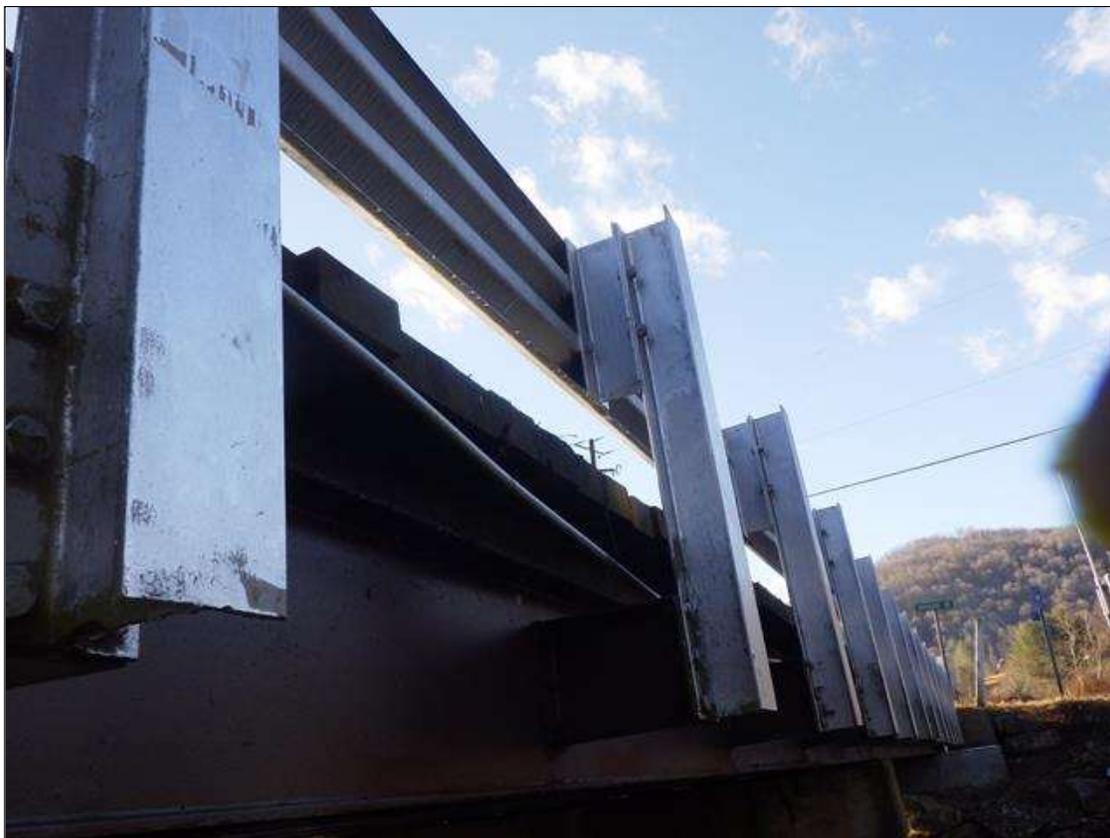
(1) 3/4 INCH DIAMETER POLYVINYL CHLORIDE CONDUIT UTILITY ALONG THE WEST OVERHANG

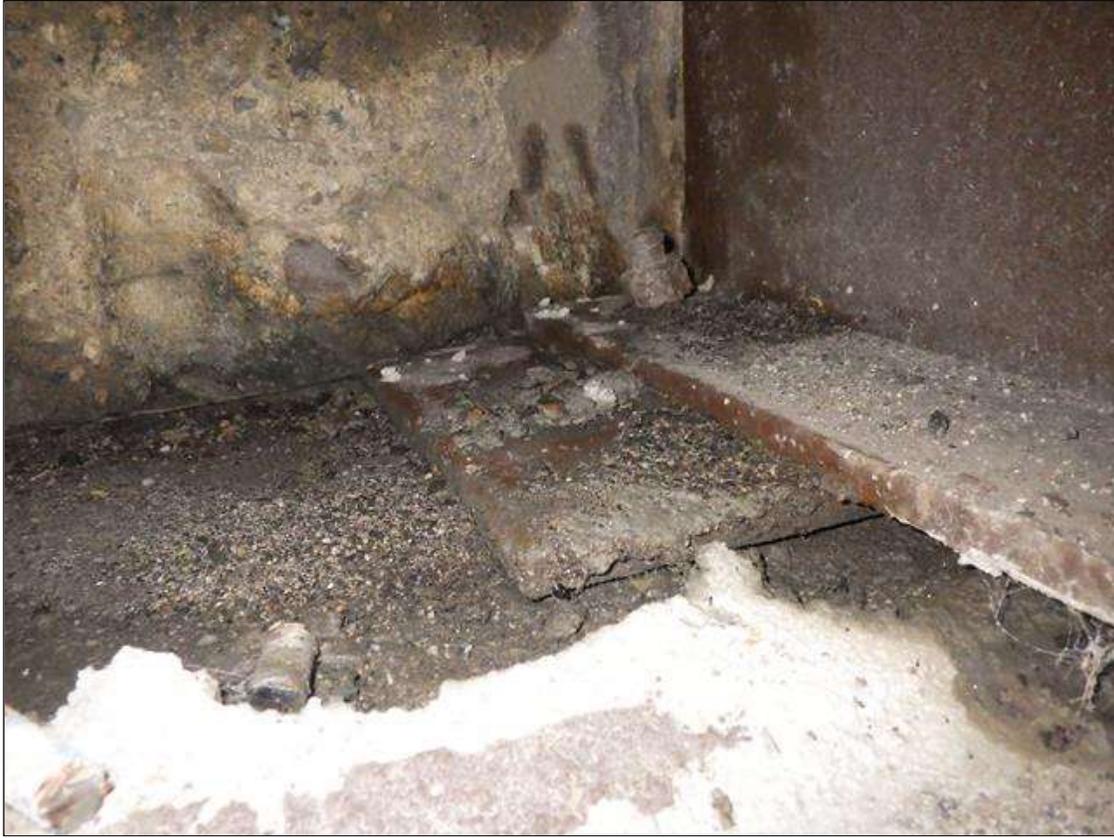
BEAM 8 BEARING AT END BENT 2 REPAINTED PRIOR TO 2023 INSPECTION CYCLE (OTHERS SIMILAR, OTHERS AT END BENT 1 SIMILAR)
