BRIDGE SCOUR REPORT

COUNTY: BUNCOMBE BRIDGE: 203 ROUTE: SR 2416 STREAM CROSSED: BEE TREE CR

**Unknown Foundation Determination**  
**Substructure Report**  
**Buncombe 100203**  
**Warren Wilson College Rd. over Bee Tree Creek**

March 23, 2009

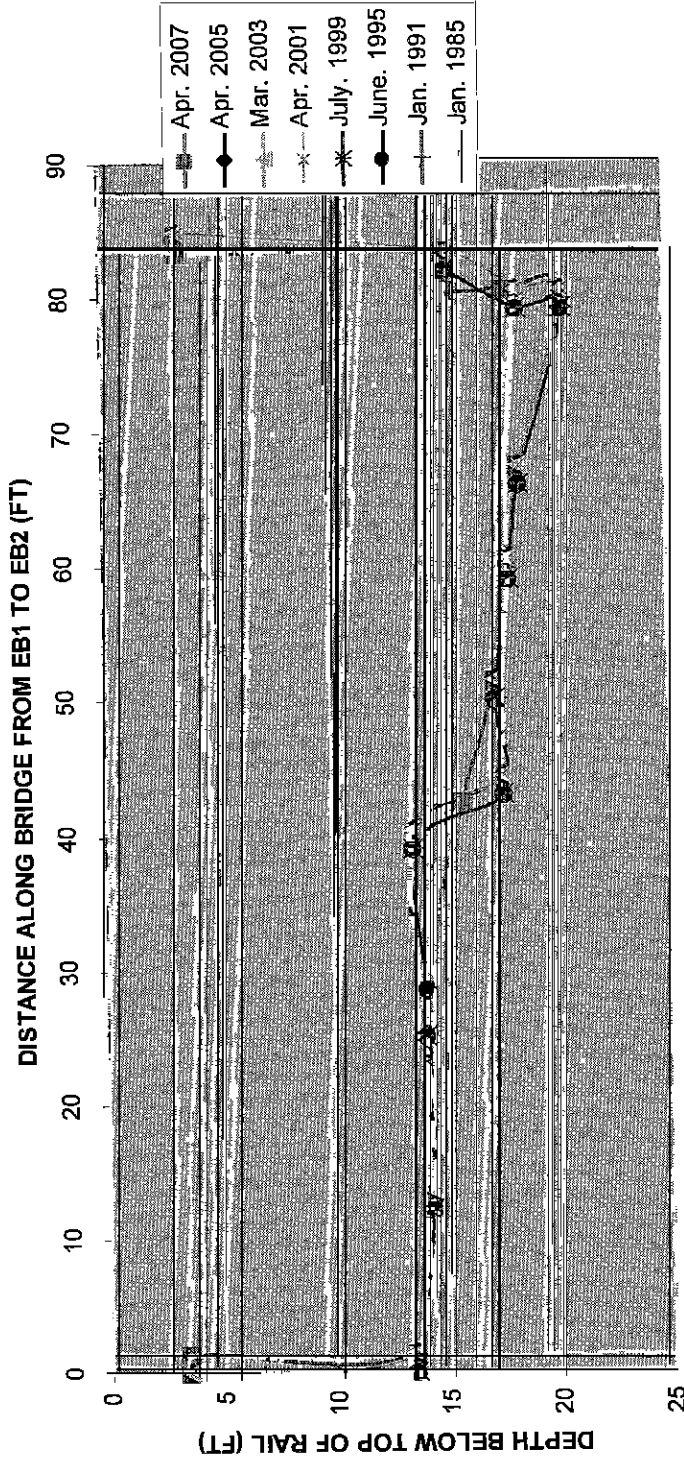
### DOWN STREAM BED SOUNDINGS

Foundation consists of concrete abutments with concrete footers. EB1 elevation was 18.5 ft and B1 elevation is 19.9 ft, EB2 elevation was 20.7 ft from top of rail to the bottom of footers. Sounding data indicates EB1 is resting on material too hard to penetrate with a sounding rod at BC1, BC2 and BC3. B1 is resting on material of 50 BPF. EB2 is resting on material soft enough to penetrate with on sounding rod using only the weight of the hammer (W.O.H) at BC5, 100/4" BPF at BC6 and 100/6" BPF at BC7. Sounding rods were inserted under EB2 at BC5, hard material was reached 2.0 ft below the bottom of footer. Possible slight scouring of 3"-6" has occurred at the bottom of the footer of EB2. The scour hole runs the length of the footer and begins sloping all the way across the water channel down to the edge of the footer, which would be 12 feet across.

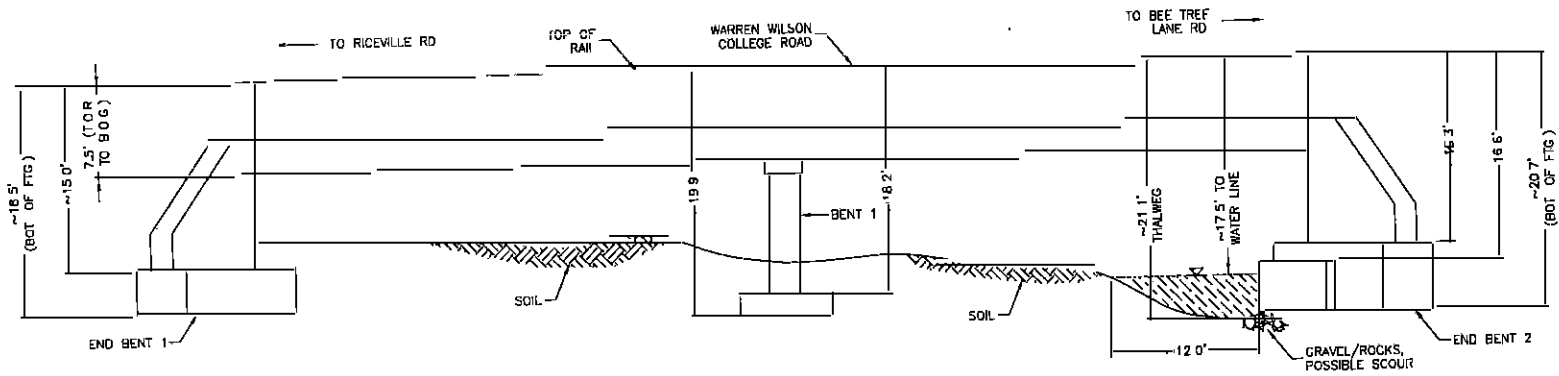
1 BRIDGE - ELEVATION  
A-1 NTS

Any Scouring Noted Scour at EB2

PLACE CONCRETE & CLASS II RIP RAP @ EB2 TO REPAIR SCOUR. SEE ATTACHED PLAN.
