NC DEPARTMENT OF TRANSPORTATION
 DIVISION OF HIGHWAYS
 STRUCTURE MANAGEMENT UNIT

Structure Safety Report

Routine Element Inspection

STRUCTURE NUMBER: 560531 SAP STRUCTURE NO: 0570531 FHWA STRUCTURE NO: 000000001150531

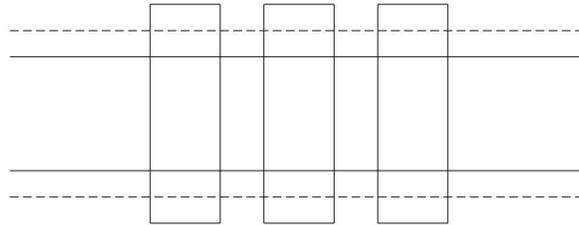
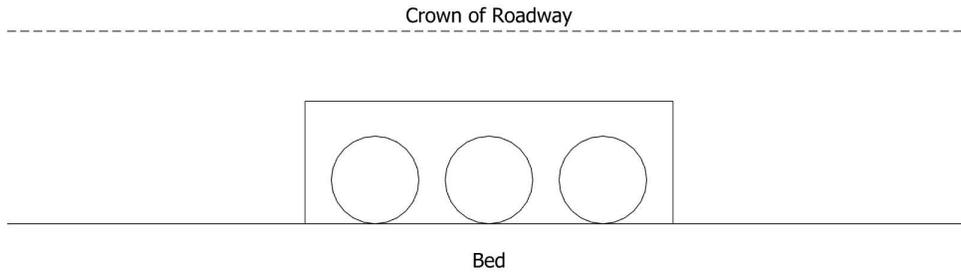
Title Pipe		Description Pipe Details		
Structure No: 560531	Drawn By: Dennis Wilson	Date: 5/9/2022	Filename: S000000001123.wes

Number of Barrels	Skew	Distance From Crown to Bed	Fill Depth
3	90°	54ft	44ft
Length Along Center Line of Pipe		Length Along Center Line of Roadway	
245ft		41.250ft	
Left Edge of Road to Culvert		Right Edge of Road to Culvert	
112.5ft		112.5ft

Barrel #	Width	Height	Distance From Previous Pipe	Type
1	10ft	10ft		Steel Round Structural Plate
2	10ft	10ft	5ft	Steel Round Structural Plate
3	10ft	10ft	5ft	Steel Round Structural Plate
