CONTRACT: DA00564 WBS PROJECT: 1BPR.10081

LOCATION: MAP 1 US 17 BRIDGE #38 ACROSS CHOWAN RIVER

TYPE OF WORK: SHOTCRETE REPAIRS

## **Index Sheet Bertie #38 Chowan River Bridge**

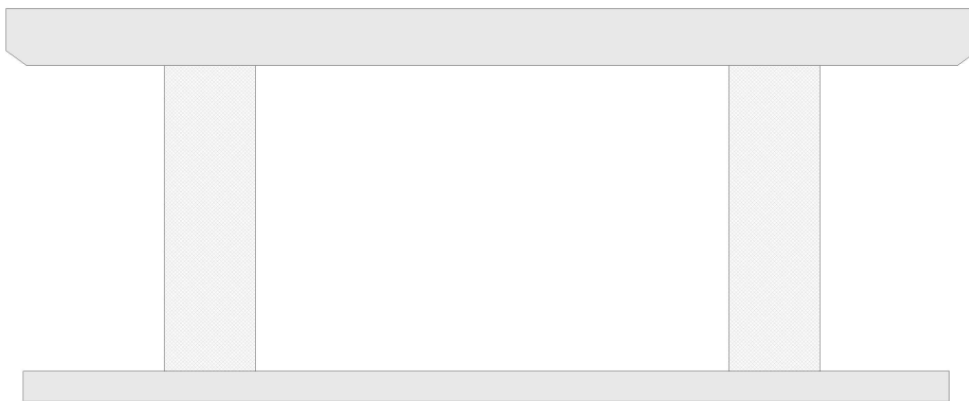
Title			Description		
BENT PROFILE 2			BENTS 10 AND 41		
Bridge No:	070038	Drawn By:	JMS	Date:	6/3/2014
				File Name:	S0534000108

Cap Information			Material Cast-in-Place Concrete							
Length 68.25 ft.	Width 5.25 ft.	Height 4.25 ft. **	Left Overhang 13.958 ft.	Right Overhang 13.958 ft.	Left Beam to End of Cap. 2.125 ft.*	Right Beam to End of Cap. 2.125 ft.*				
Subcap Information			Material							
Length	Width	Height	Left Overhang	Right Overhang	Left Pile to Splice.					
Footing Information			Material Cast-in-Place Concrete							
Length 62.67 ft.	Width 15.08 ft.	Height 6.58 ft.								
Pile #	Material	Spacing	Width/Dia.	Height	Length	Orientation	Driven?	Replacement?	Removed?	Collar?
1	Concrete	40.33 ft.	6.5 ft.	4.42 ft.		Vertical	No	No	No	No
2	Concrete		6.5 ft.	4.42 ft.		Vertical	No	No	No	No
Bent: 10			Similar Bent: 41

\*Measurements for PPC Girders in Spans 10 and 41; Measurements for Bulb Tees in Spans 11 and 42 = 3.125 ft.

Page 3: Bents 10, 41
