BRIDGE #7 ON NC 45 ACROSS ROANOKE, MIDDLE AND CASHIE RIVERS

TYPE OF WORK: BRIDGE PRESERVATION WITH CONCRETE SUPERSTRUCTURE & SUBSTRUCTURE REPAIR,

PILE ENCAPSULATION AND FENDER REPLACEMENT.

PROJECT NO. B-5941
BERTIE COUNTY
BRIDGE NO. 7

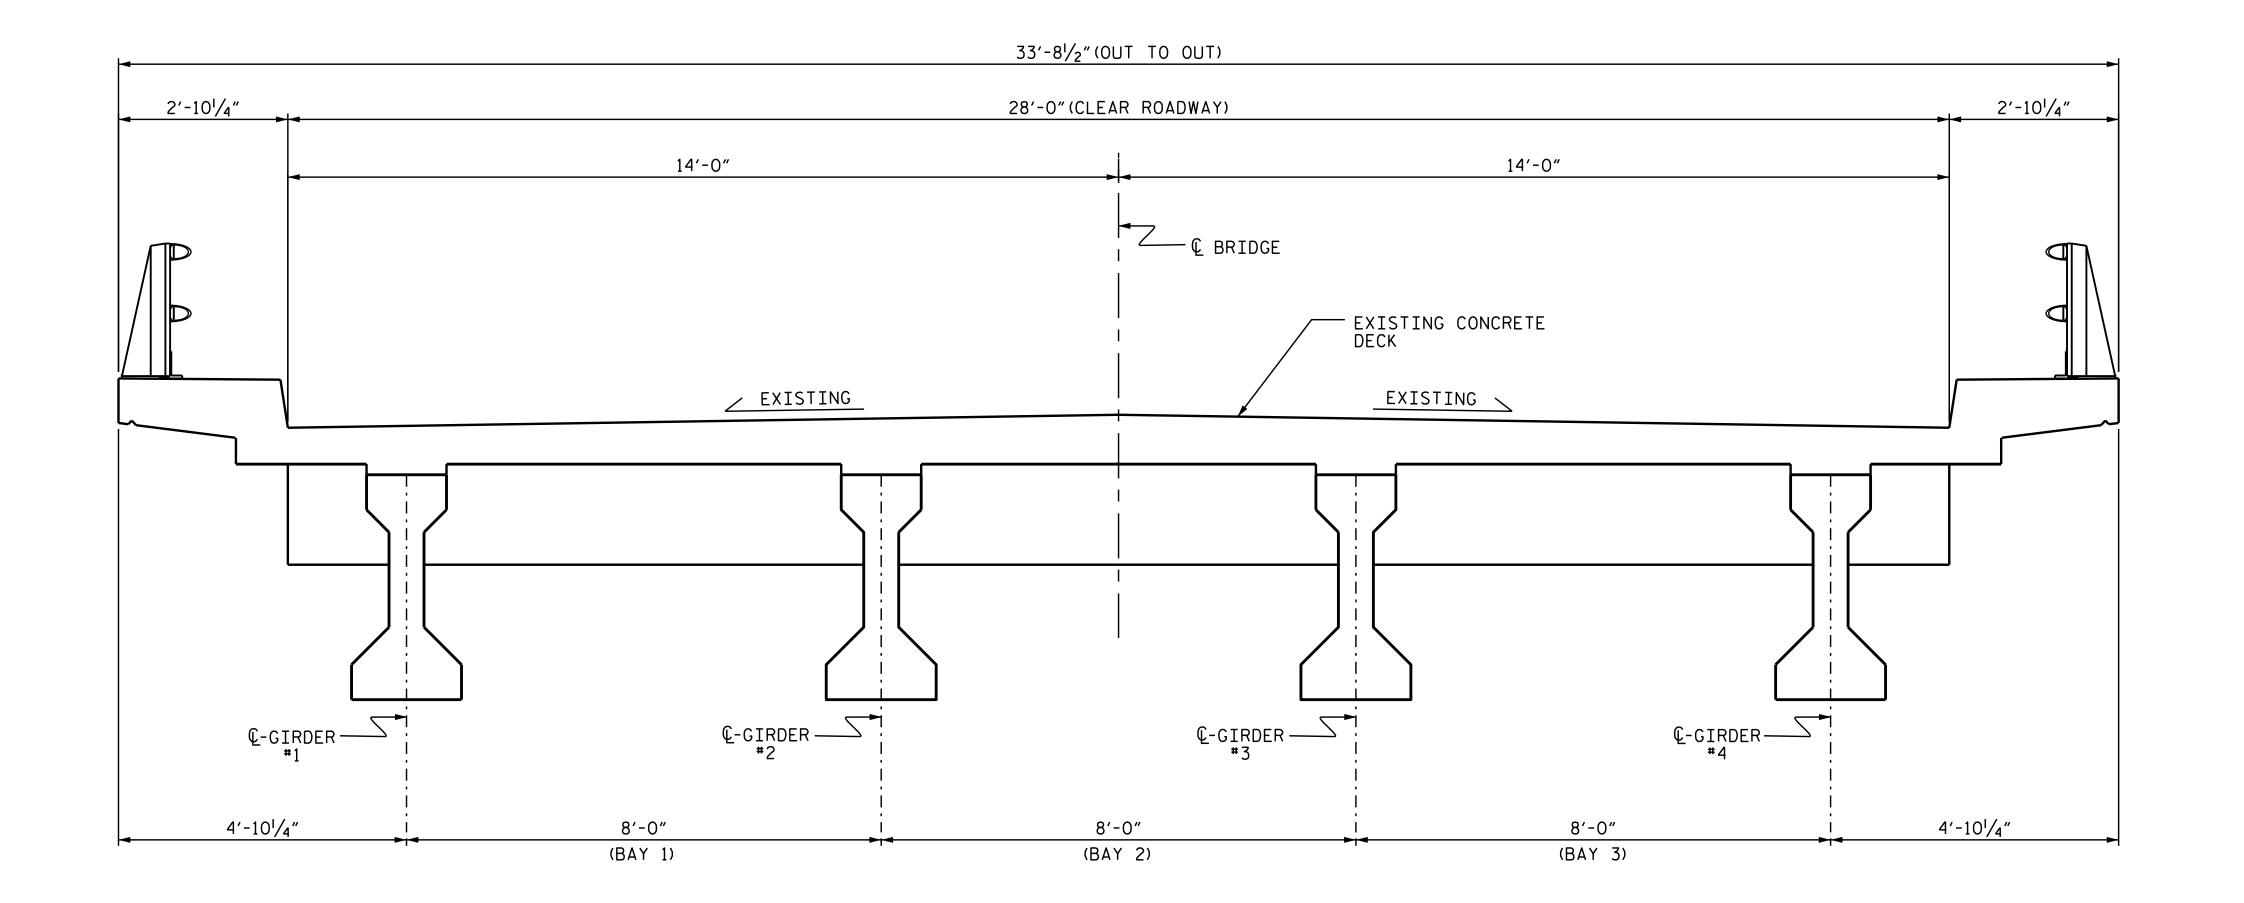
TYPICAL SECTION

(EXISTING) (LOOKING NORTH)
(SPANS 1-16 & 20-95, SPANS 17-19 SIMILAR)

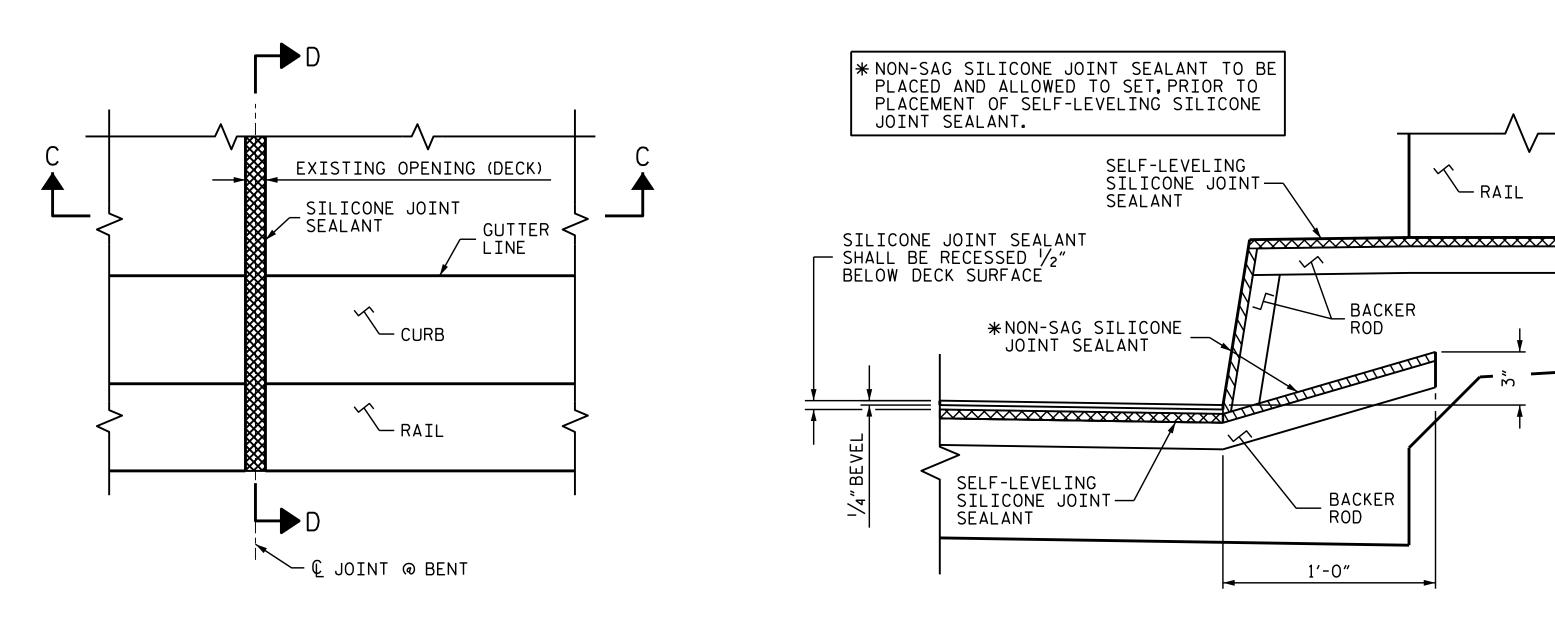
JOINT SEAL DETAIL AT BENT

FOR SILICONE JOINT SEALANT, SEE SPECIAL PROVISIONS.

TOTAL JOINT REPLACEMENT = 35 LF PER JOINT

PLAN

SECTION D-D (PROPOSED)

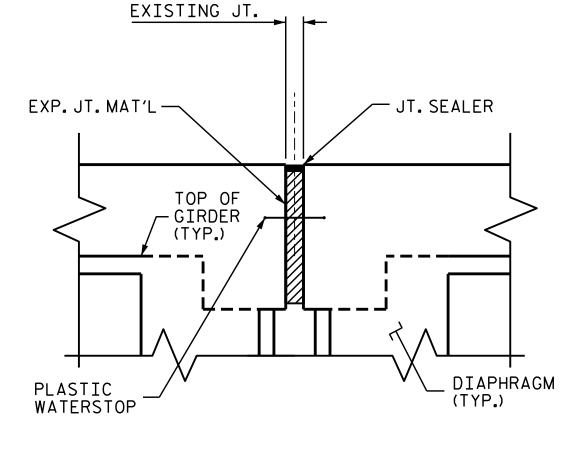
SECTION C-C (EXISTING)

IF THE EMBEDDED PORTION OF THE EXISTING PLASTIC WATERSTOP IS EXPOSED DURING REMOVAL OF UNSOUND CONCRETE, OR IF UNSOUND CONCRETE IS REMOVED WITHIN 2"OF THE WATERSTOP, THE ENTIRE CONCRETE DEPTH TO THE WATERSTOP SHALL BE REMOVED.

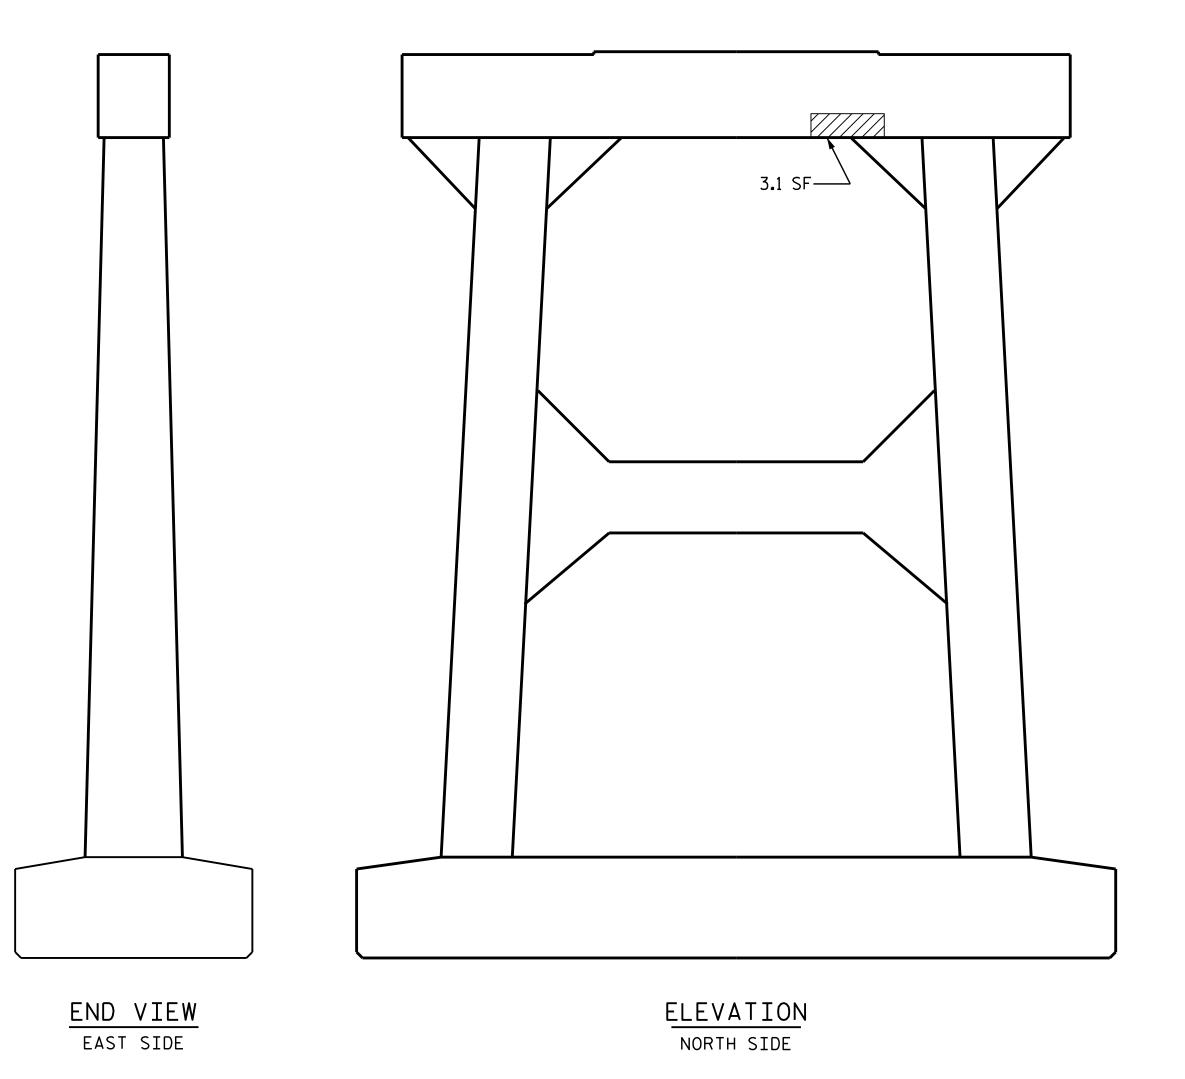
REPAIR QUANTITY TABLE							
REPAIRS BENT 10 QUANTITIES							
REPAIRS DENT TO	ESTI	MATE	ACTUAL				
SHOTCRETE REPAIRS	AREA SF	VOLUME CF	AREA SF	VOLUME CF			
CAP (VERTICAL FACE)	17.3	8.7					
COLUMN	7.5	3.8					
STRUT	0.0	0.0					
FOOTER	0.0	0.0

VALUES IN CHART REPRESENT ESTIMATED REPAIR TOTALS AFTER REMOVAL OF UNSOUND CONCRETE, MIN. OF 1"BEHIND REBAR AND MIN. 2"CL TO SAWCUT. SEE REPAIR DETAILS.

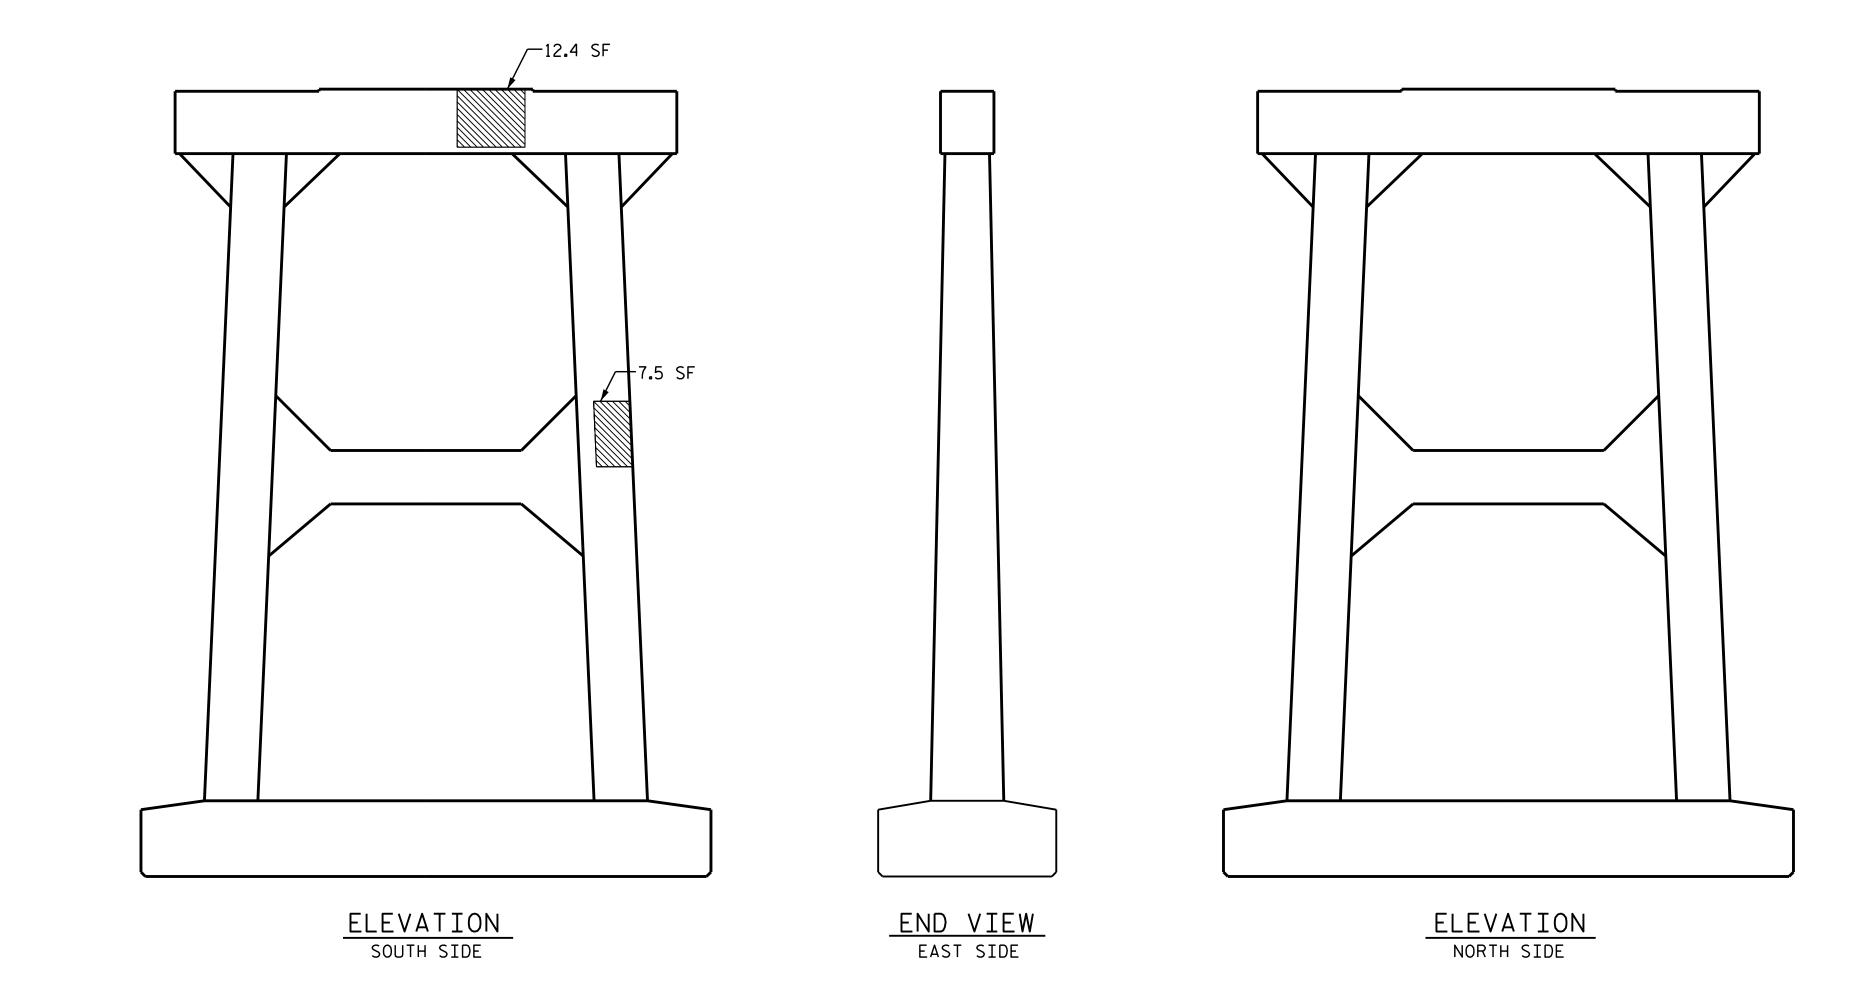
SPAN 11 SPAN 10

REPAIR QUANTITY TABLE							
REPAIRS BENT 11 QUANTITIES							
REPAIRS DENT II	ESTI	MATE	ACTUAL				
SHOTCRETE REPAIRS	AREA SF	VOLUME CF	AREA SF	VOLUME CF			
CAP	11.9	6.0					
COLUMN	0.0	0.0					
STRUT	0.0	0.0					
FOOTER	0.0	0.0

VALUES IN CHART REPRESENT ESTIMATED REPAIR TOTALS AFTER REMOVAL OF UNSOUND CONCRETE, MIN. OF 1"BEHIND REBAR AND MIN. 2"CL TO SAWCUT. SEE REPAIR DETAILS.

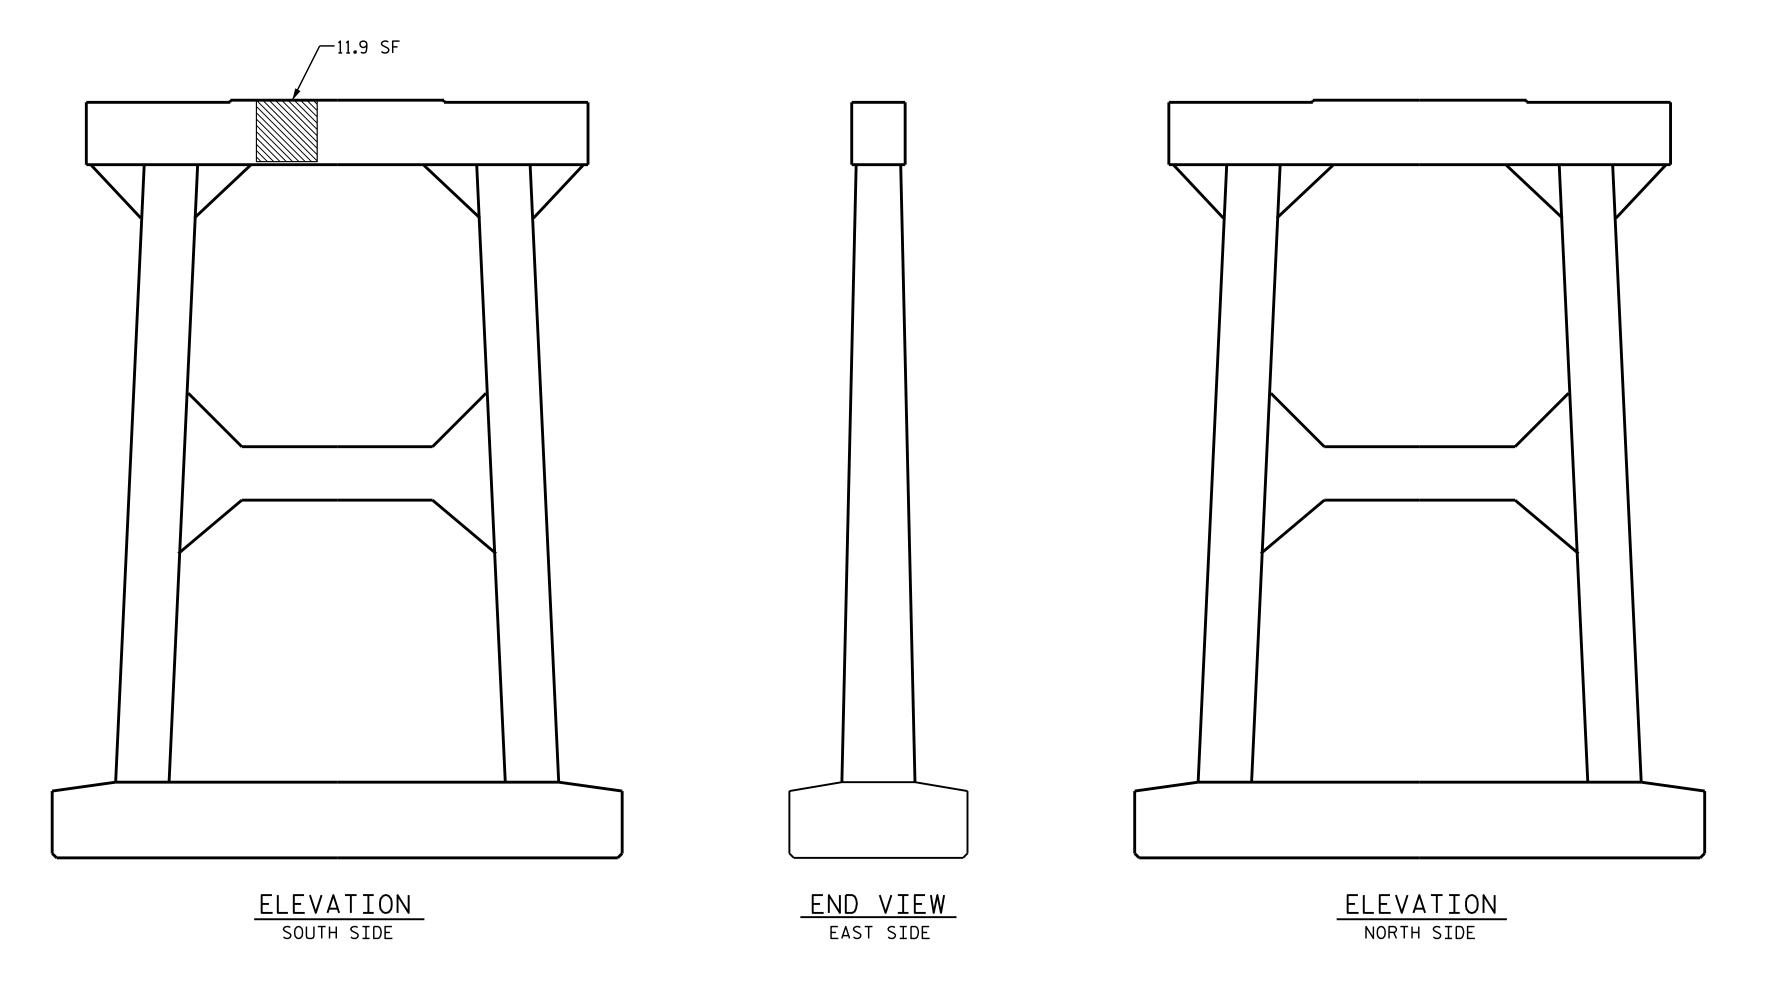
REPAIR QUANTITY TABLE							
REPAIRS BENT 12 QUANTITIES							
REPAIRS DENT 12	ESTI	MATE	ACTUAL				
SHOTCRETE REPAIRS	AREA SF	VOLUME CF	AREA SF	VOLUME CF			
CAP	15.4	7.7					
COLUMN	0.0	0.0					
STRUT	STRUT 0.0 0.0						
F00TER 0.0 0.0

VALUES IN CHART REPRESENT ESTIMATED REPAIR TOTALS AFTER REMOVAL OF UNSOUND CONCRETE, MIN. OF 1"BEHIND REBAR AND MIN. 2"CL TO SAWCUT. SEE REPAIR DETAILS.

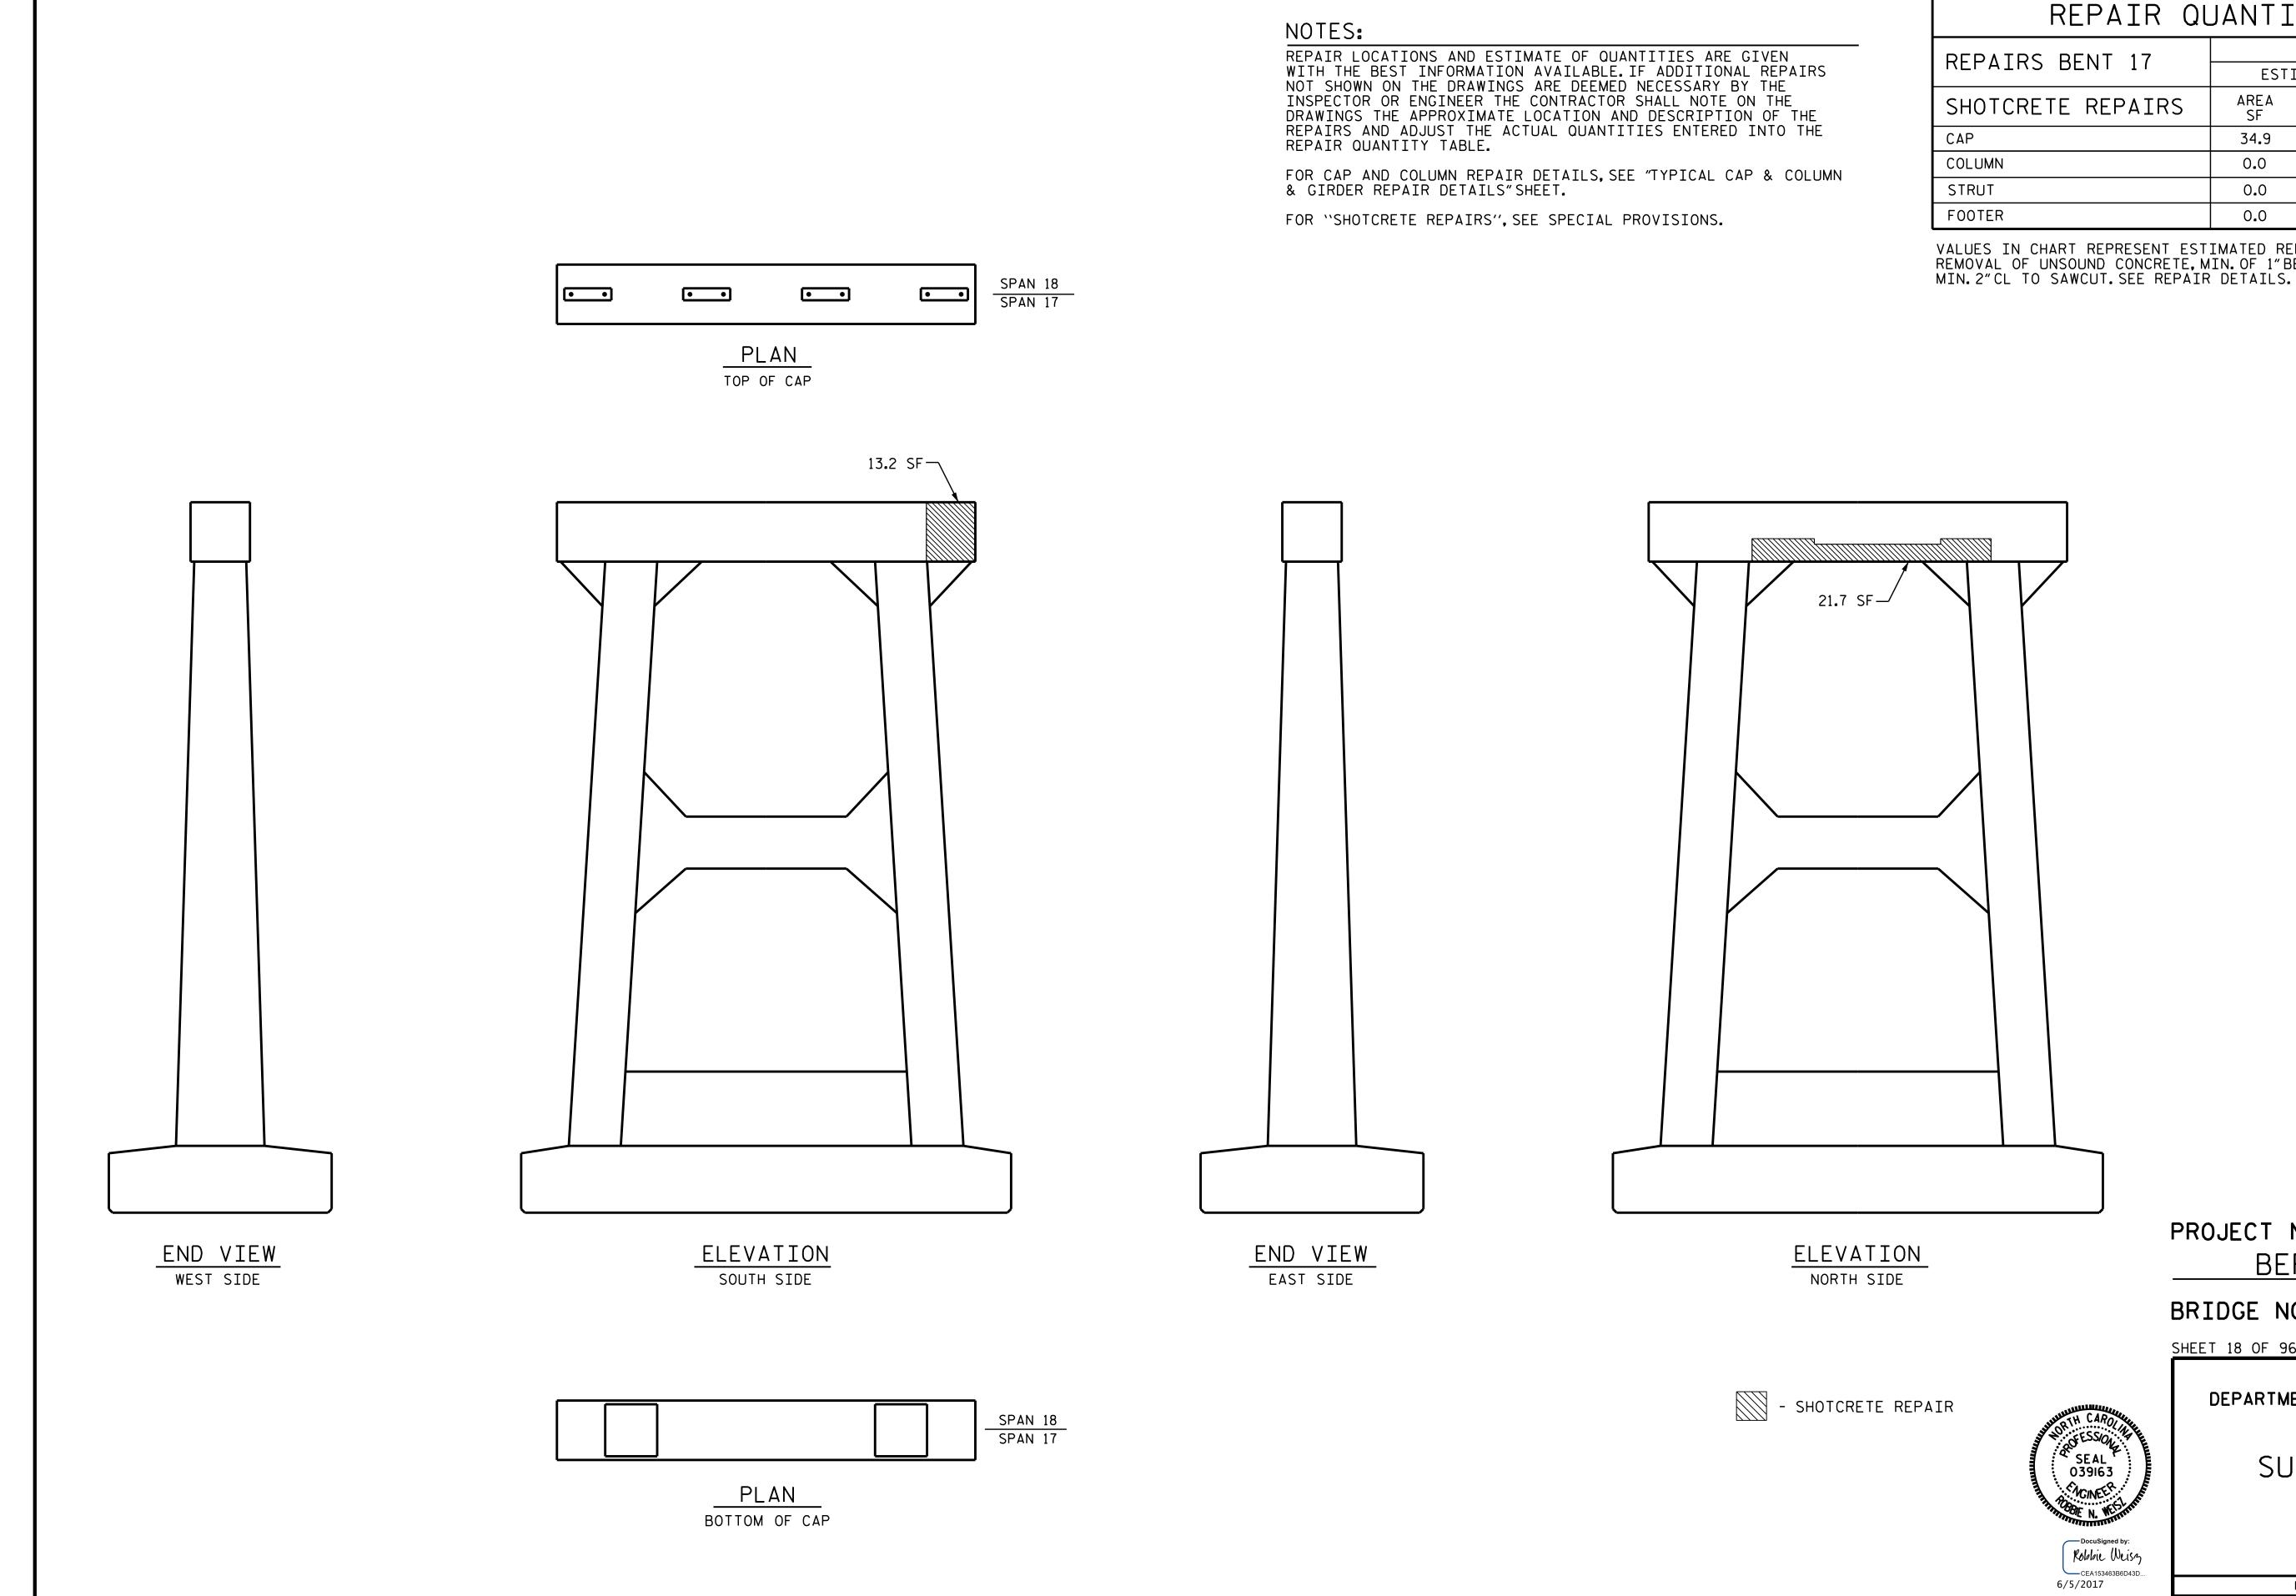
REPAIR QUANTITY TABLE						
REPAIRS BENT 17 QUANTITIES						
NEFAINS DENT IT	ESTI	ESTIMATE		UAL		
SHOTCRETE REPAIRS	AREA SF	VOLUME CF	AREA SF	VOLUME CF		
CAP	34.9	17 . 5	-			
COLUMN	0.0	0.0				
STRUT	0.0 0.0					
FOOTER	0.0	0.0

VALUES IN CHART REPRESENT ESTIMATED REPAIR TOTALS AFTER REMOVAL OF UNSOUND CONCRETE, MIN. OF 1"BEHIND REBAR AND

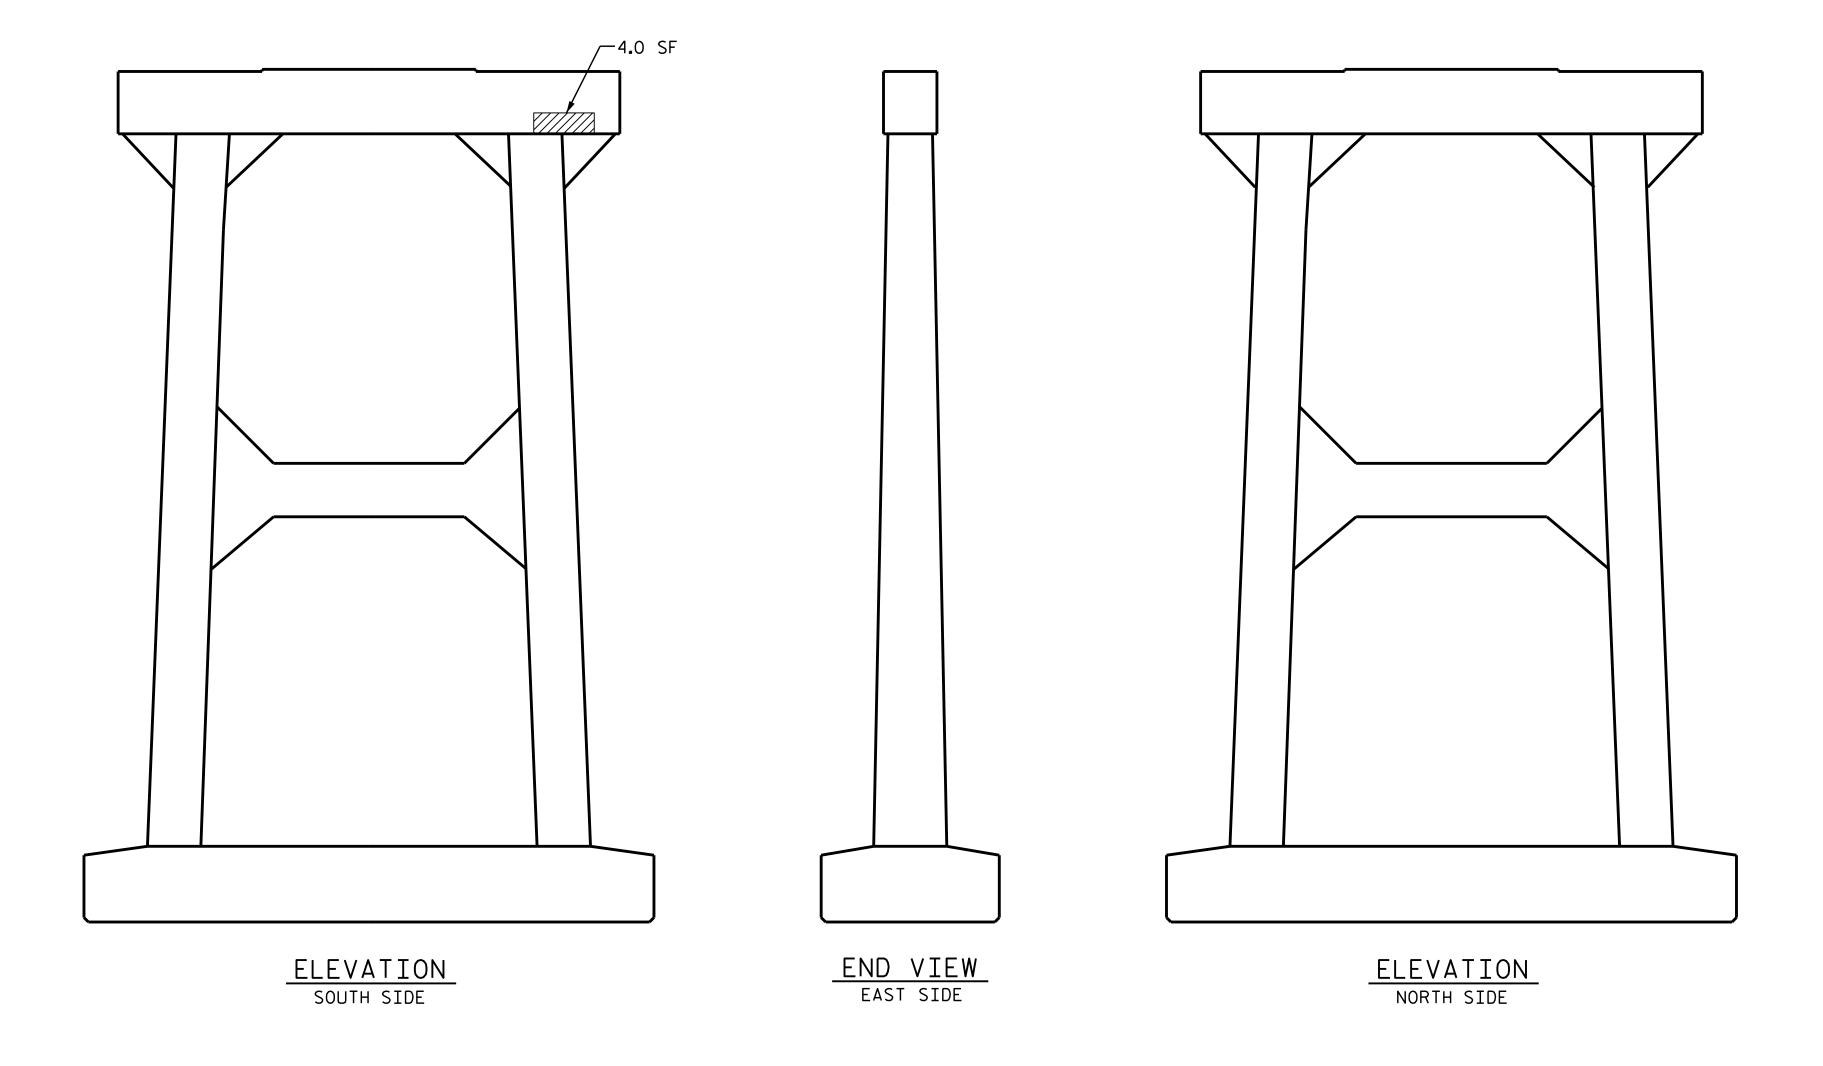
SPAN 21

REPAIR QUANTITY TABLE						
REPAIRS BENT 21 QUANTITIES						
MERAINS DENI ZI	ESTI	MATE	ACT	UAL		
SHOTCRETE REPAIRS	AREA SF	VOLUME CF	AREA SF	VOLUME CF		
CAP	17.6	8.8				
COLUMN	9.2	4.6				
STRUT	0.0	0.0				
FOOTER	0.0	0.0

VALUES IN CHART REPRESENT ESTIMATED REPAIR TOTALS AFTER REMOVAL OF UNSOUND CONCRETE, MIN. OF 1"BEHIND REBAR AND MIN. 2"CL TO SAWCUT. SEE REPAIR DETAILS.

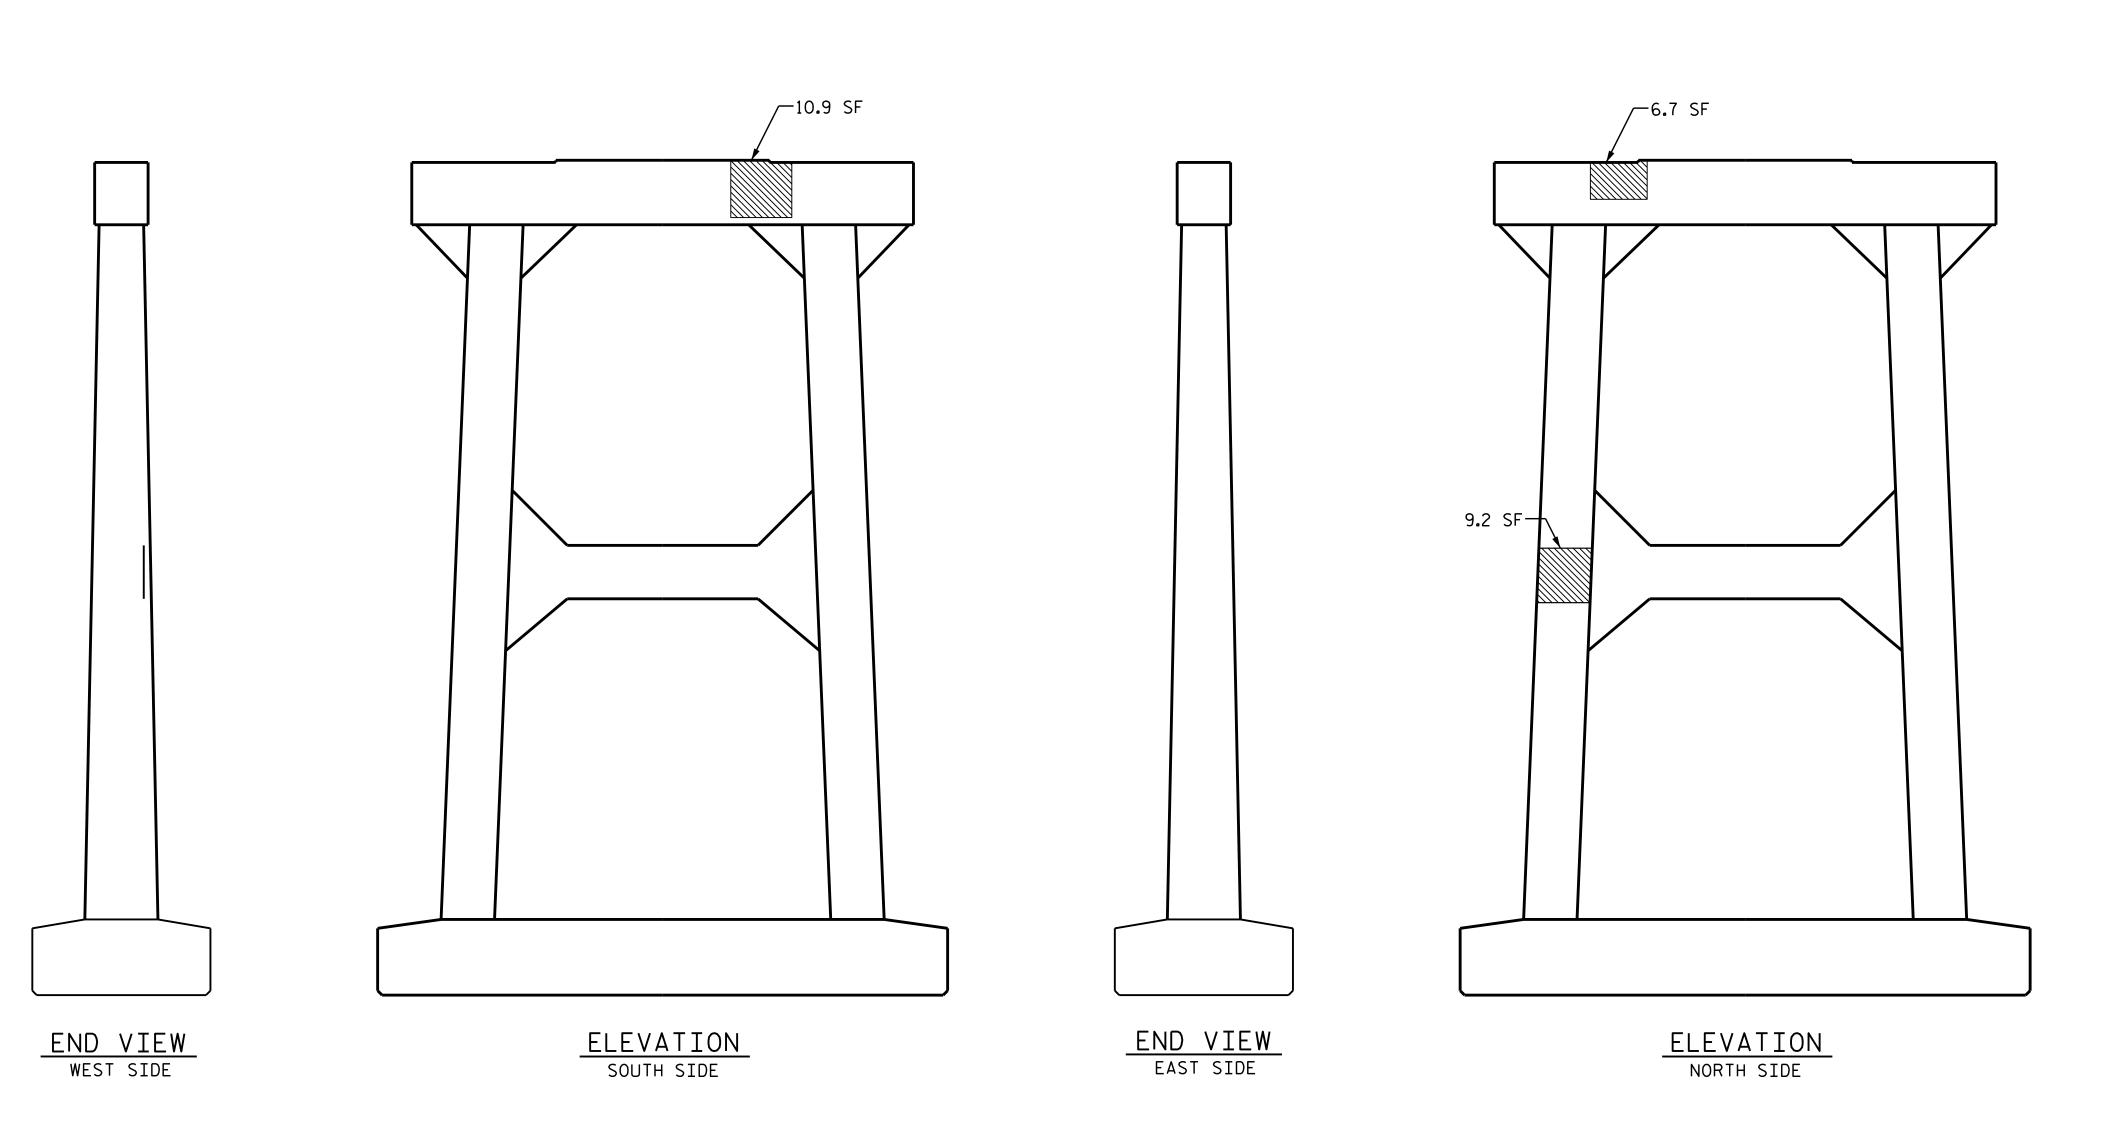
SPAN 22 SPAN 21

REPAIR QUANTITY TABLE						
DEDATES QUANTITIES						
REPAIRS BENT 22	ESTI	MATE	ACT	UAL		
SHOTCRETE REPAIRS	AREA SF	VOLUME CF	AREA SF	VOLUME CF		
CAP	7.5	3.8				
COLUMN	0.0	0.0				
STRUT	0.0	0.0				
FOOTER	0.0	0.0

VALUES IN CHART REPRESENT ESTIMATED REPAIR TOTALS AFTER REMOVAL OF UNSOUND CONCRETE, MIN. OF 1"BEHIND REBAR AND MIN. 2"CL TO SAWCUT. SEE REPAIR DETAILS.

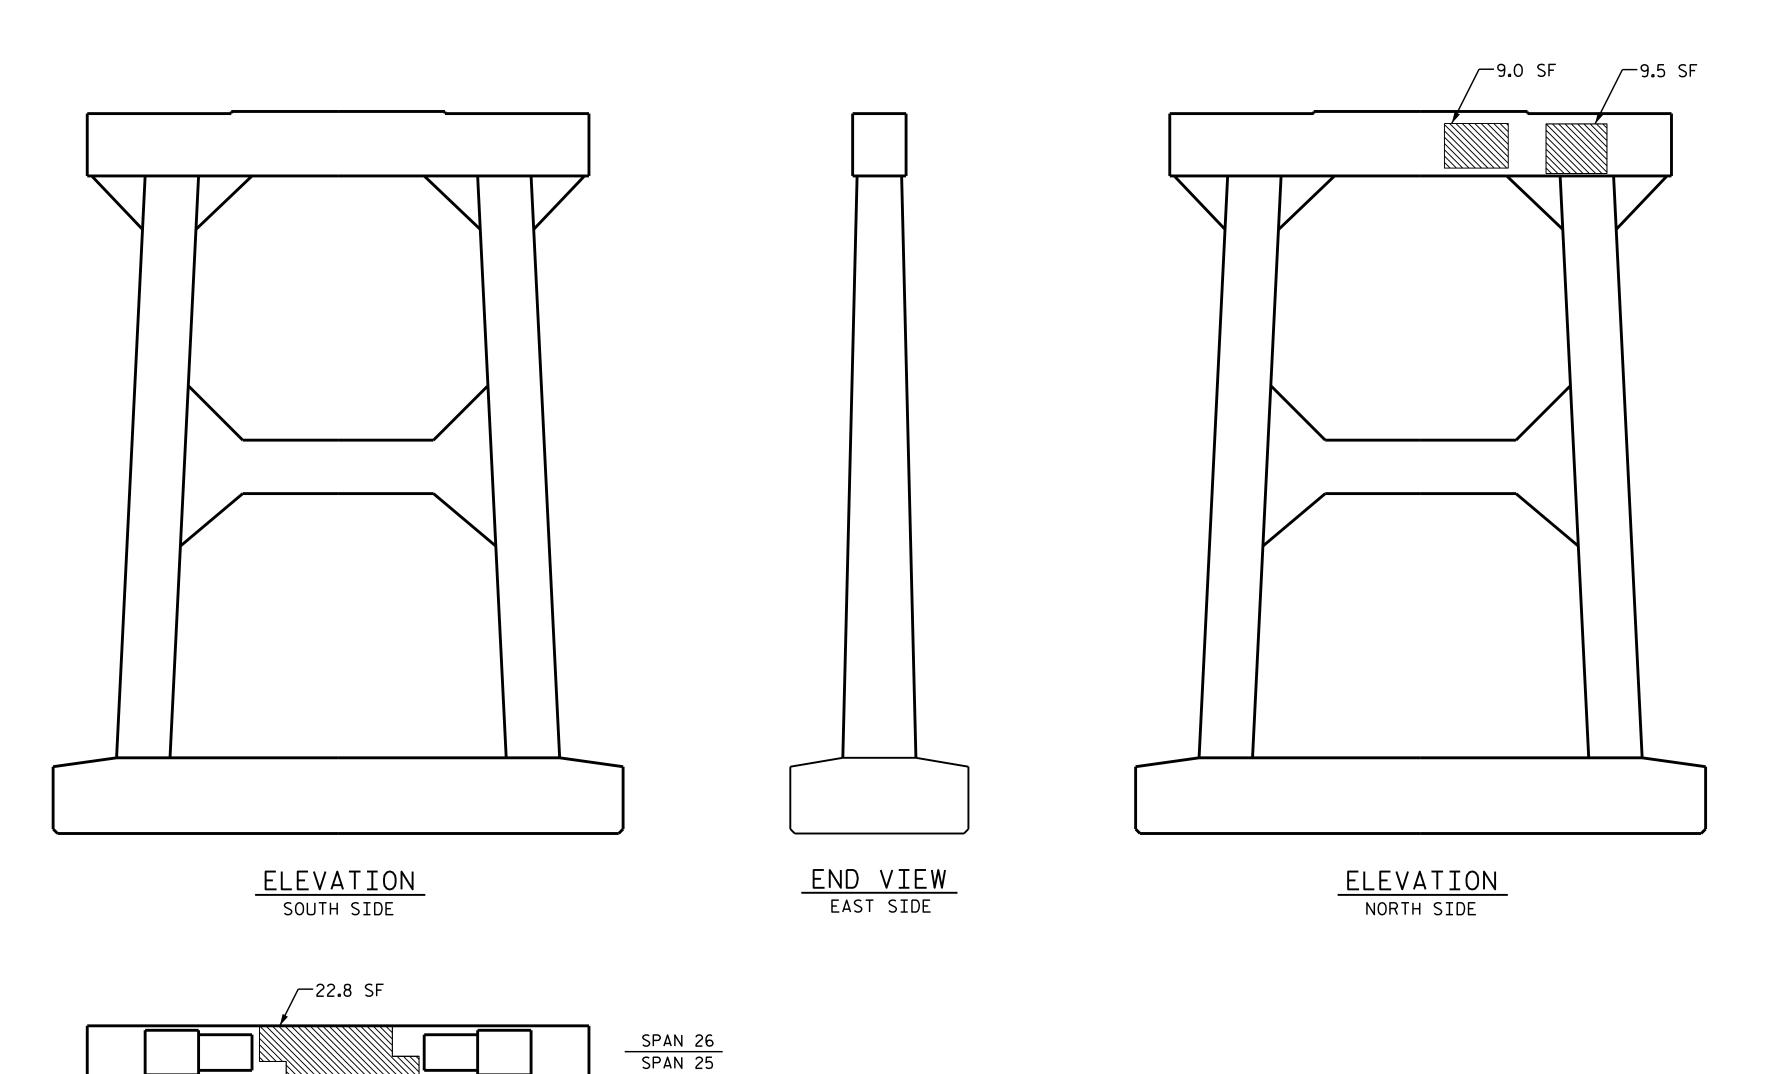
REPAIR QUANTITY TABLE						
REPAIRS BENT 25						
REPAIRS DENT 25	ESTI	MATE	ACT	UAL		
SHOTCRETE REPAIRS	AREA SF	VOLUME CF	AREA SF	VOLUME CF		
CAP	41.3	20.7				
COLUMN	0.0	0.0				
STRUT	0.0	0.0				
FOOTER	0.0	0.0

VALUES IN CHART REPRESENT ESTIMATED REPAIR TOTALS AFTER REMOVAL OF UNSOUND CONCRETE, MIN. OF 1"BEHIND REBAR AND MIN. 2"CL TO SAWCUT. SEE REPAIR DETAILS.

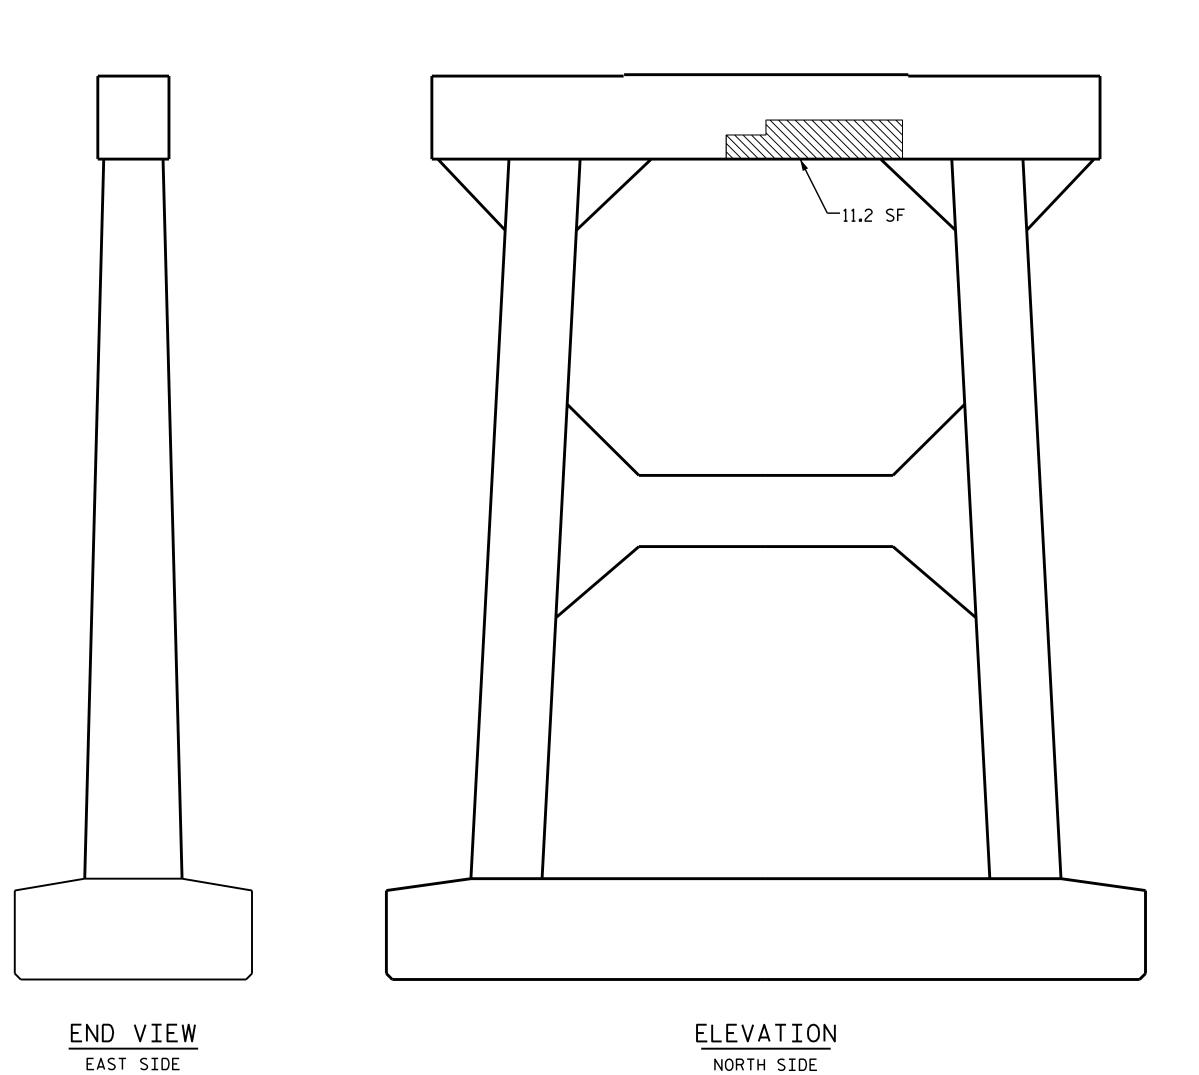
REPAIR QUANTITY TABLE							
REPAIRS BENT 27	QUANTITIES						
REPAIRS DENI ZI	ESTIMATE		ACTUAL				
SHOTCRETE REPAIRS	AREA SF	VOLUME CF	AREA SF	VOLUME CF			
CAP	30.4	15.2					
COLUMN	0.0	0.0					
STRUT	0.0	0.0					
FOOTER	0.0	0.0

VALUES IN CHART REPRESENT ESTIMATED REPAIR TOTALS AFTER REMOVAL OF UNSOUND CONCRETE, MIN. OF 1"BEHIND REBAR AND MIN. 2"CL TO SAWCUT. SEE REPAIR DETAILS.

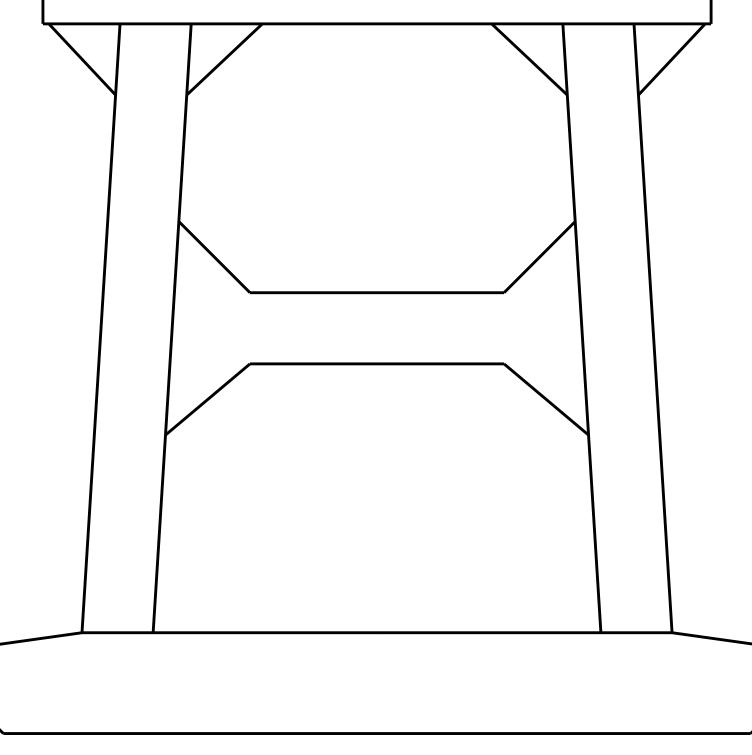
ELEVATION NORTH SIDE

REPAIR QUANTITY TABLE QUANTITIES REPAIRS BENT 28 ESTIMATE ACTUAL AREA VOLUME AREA VOLUME SHOTCRETE REPAIRS SF CF CF 53.0 26.5 COLUMN 0.0 0.0 0.0 STRUT 0.0 FOOTER 0.0

VALUES IN CHART REPRESENT ESTIMATED REPAIR TOTALS AFTER REMOVAL OF UNSOUND CONCRETE, MIN. OF 1"BEHIND REBAR AND MIN. 2"CL TO SAWCUT. SEE REPAIR DETAILS.

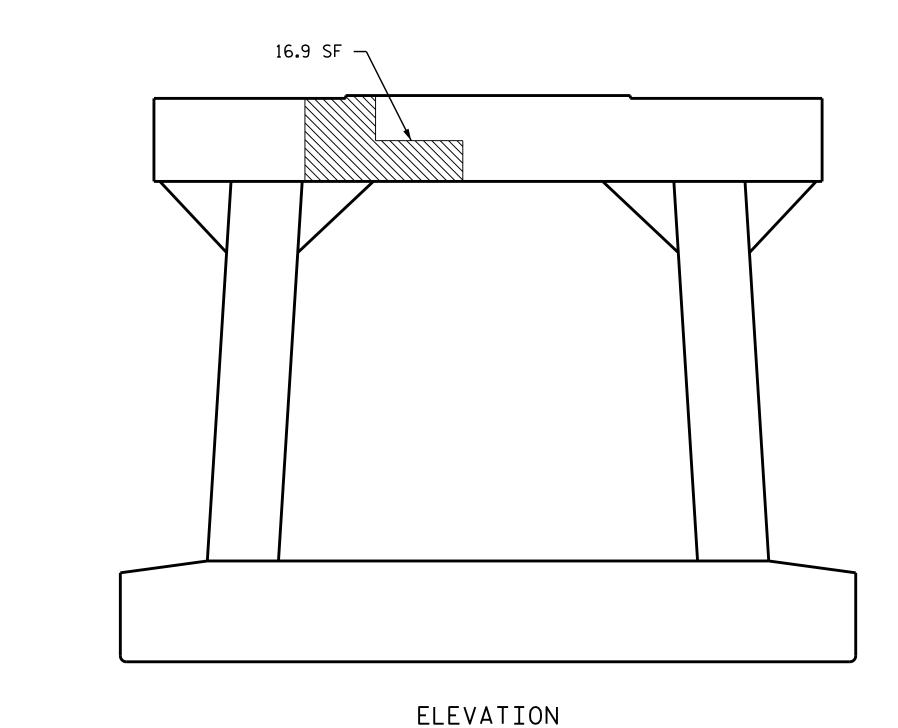
NORTH SIDE B-5941 PROJECT NO.____ BERTIE _ COUNTY

REPAIR QUANTITY TABLE							
REPAIRS BENT 32	QUANTITIES						
REPAIRS DENI 32	ESTIMATE		ACTUAL				
SHOTCRETE REPAIRS	AREA SF	VOLUME CF	AREA SF	VOLUME CF			
CAP	25.4	12.7					
COLUMN	0.0	0.0					
STRUT	0.0	0.0					
FOOTER	0.0	0.0

VALUES IN CHART REPRESENT ESTIMATED REPAIR TOTALS AFTER REMOVAL OF UNSOUND CONCRETE, MIN. OF 1"BEHIND REBAR AND MIN. 2"CL TO SAWCUT. SEE REPAIR DETAILS.

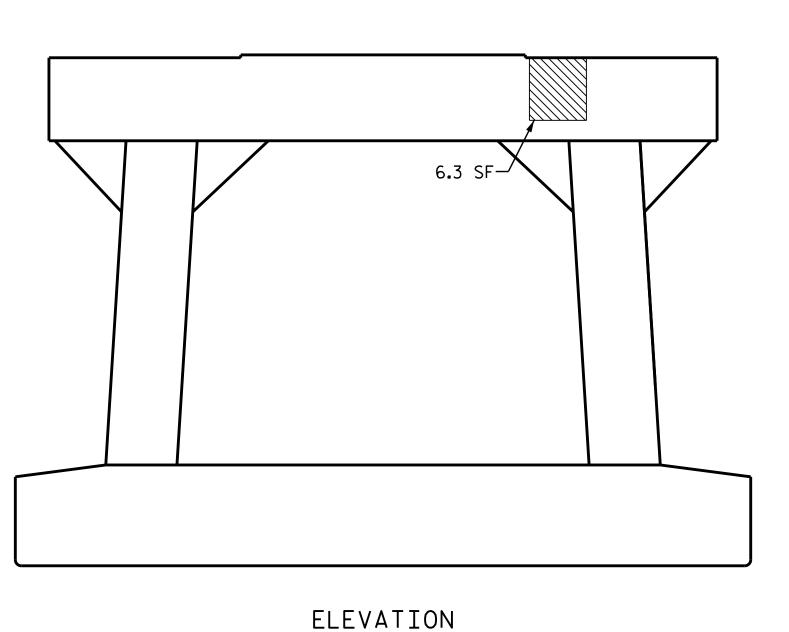
NORTH SIDE B-5941 PROJECT NO.____

REPAIR QUANTITY TABLE					
	REPAIRS BENT 33	QUANTITIES				
		ESTIMATE		ACTUAL		
	SHOTCRETE REPAIRS	AREA SF	VOLUME CF	AREA SF	VOLUME CF	
	CAP	36.2	18.1			
	COLUMN	0.0	0.0			
	STRUT	0.0	0.0			
	FOOTER	0.0	0.0	_

VALUES IN CHART REPRESENT ESTIMATED REPAIR TOTALS AFTER REMOVAL OF UNSOUND CONCRETE, MIN. OF 1"BEHIND REBAR AND MIN. 2"CL TO SAWCUT. SEE REPAIR DETAILS.
