BRIDGE #7 ON NC 45 ACROSS ROANOKE, MIDDLE AND CASHIE RIVERS

TYPE OF WORK: BRIDGE PRESERVATION WITH CONCRETE SUPERSTRUCTURE & SUBSTRUCTURE REPAIR,

PILE ENCAPSULATION AND FENDER REPLACEMENT.

PROJECT NO. B-5941
BERTIE COUNTY
BRIDGE NO. 7

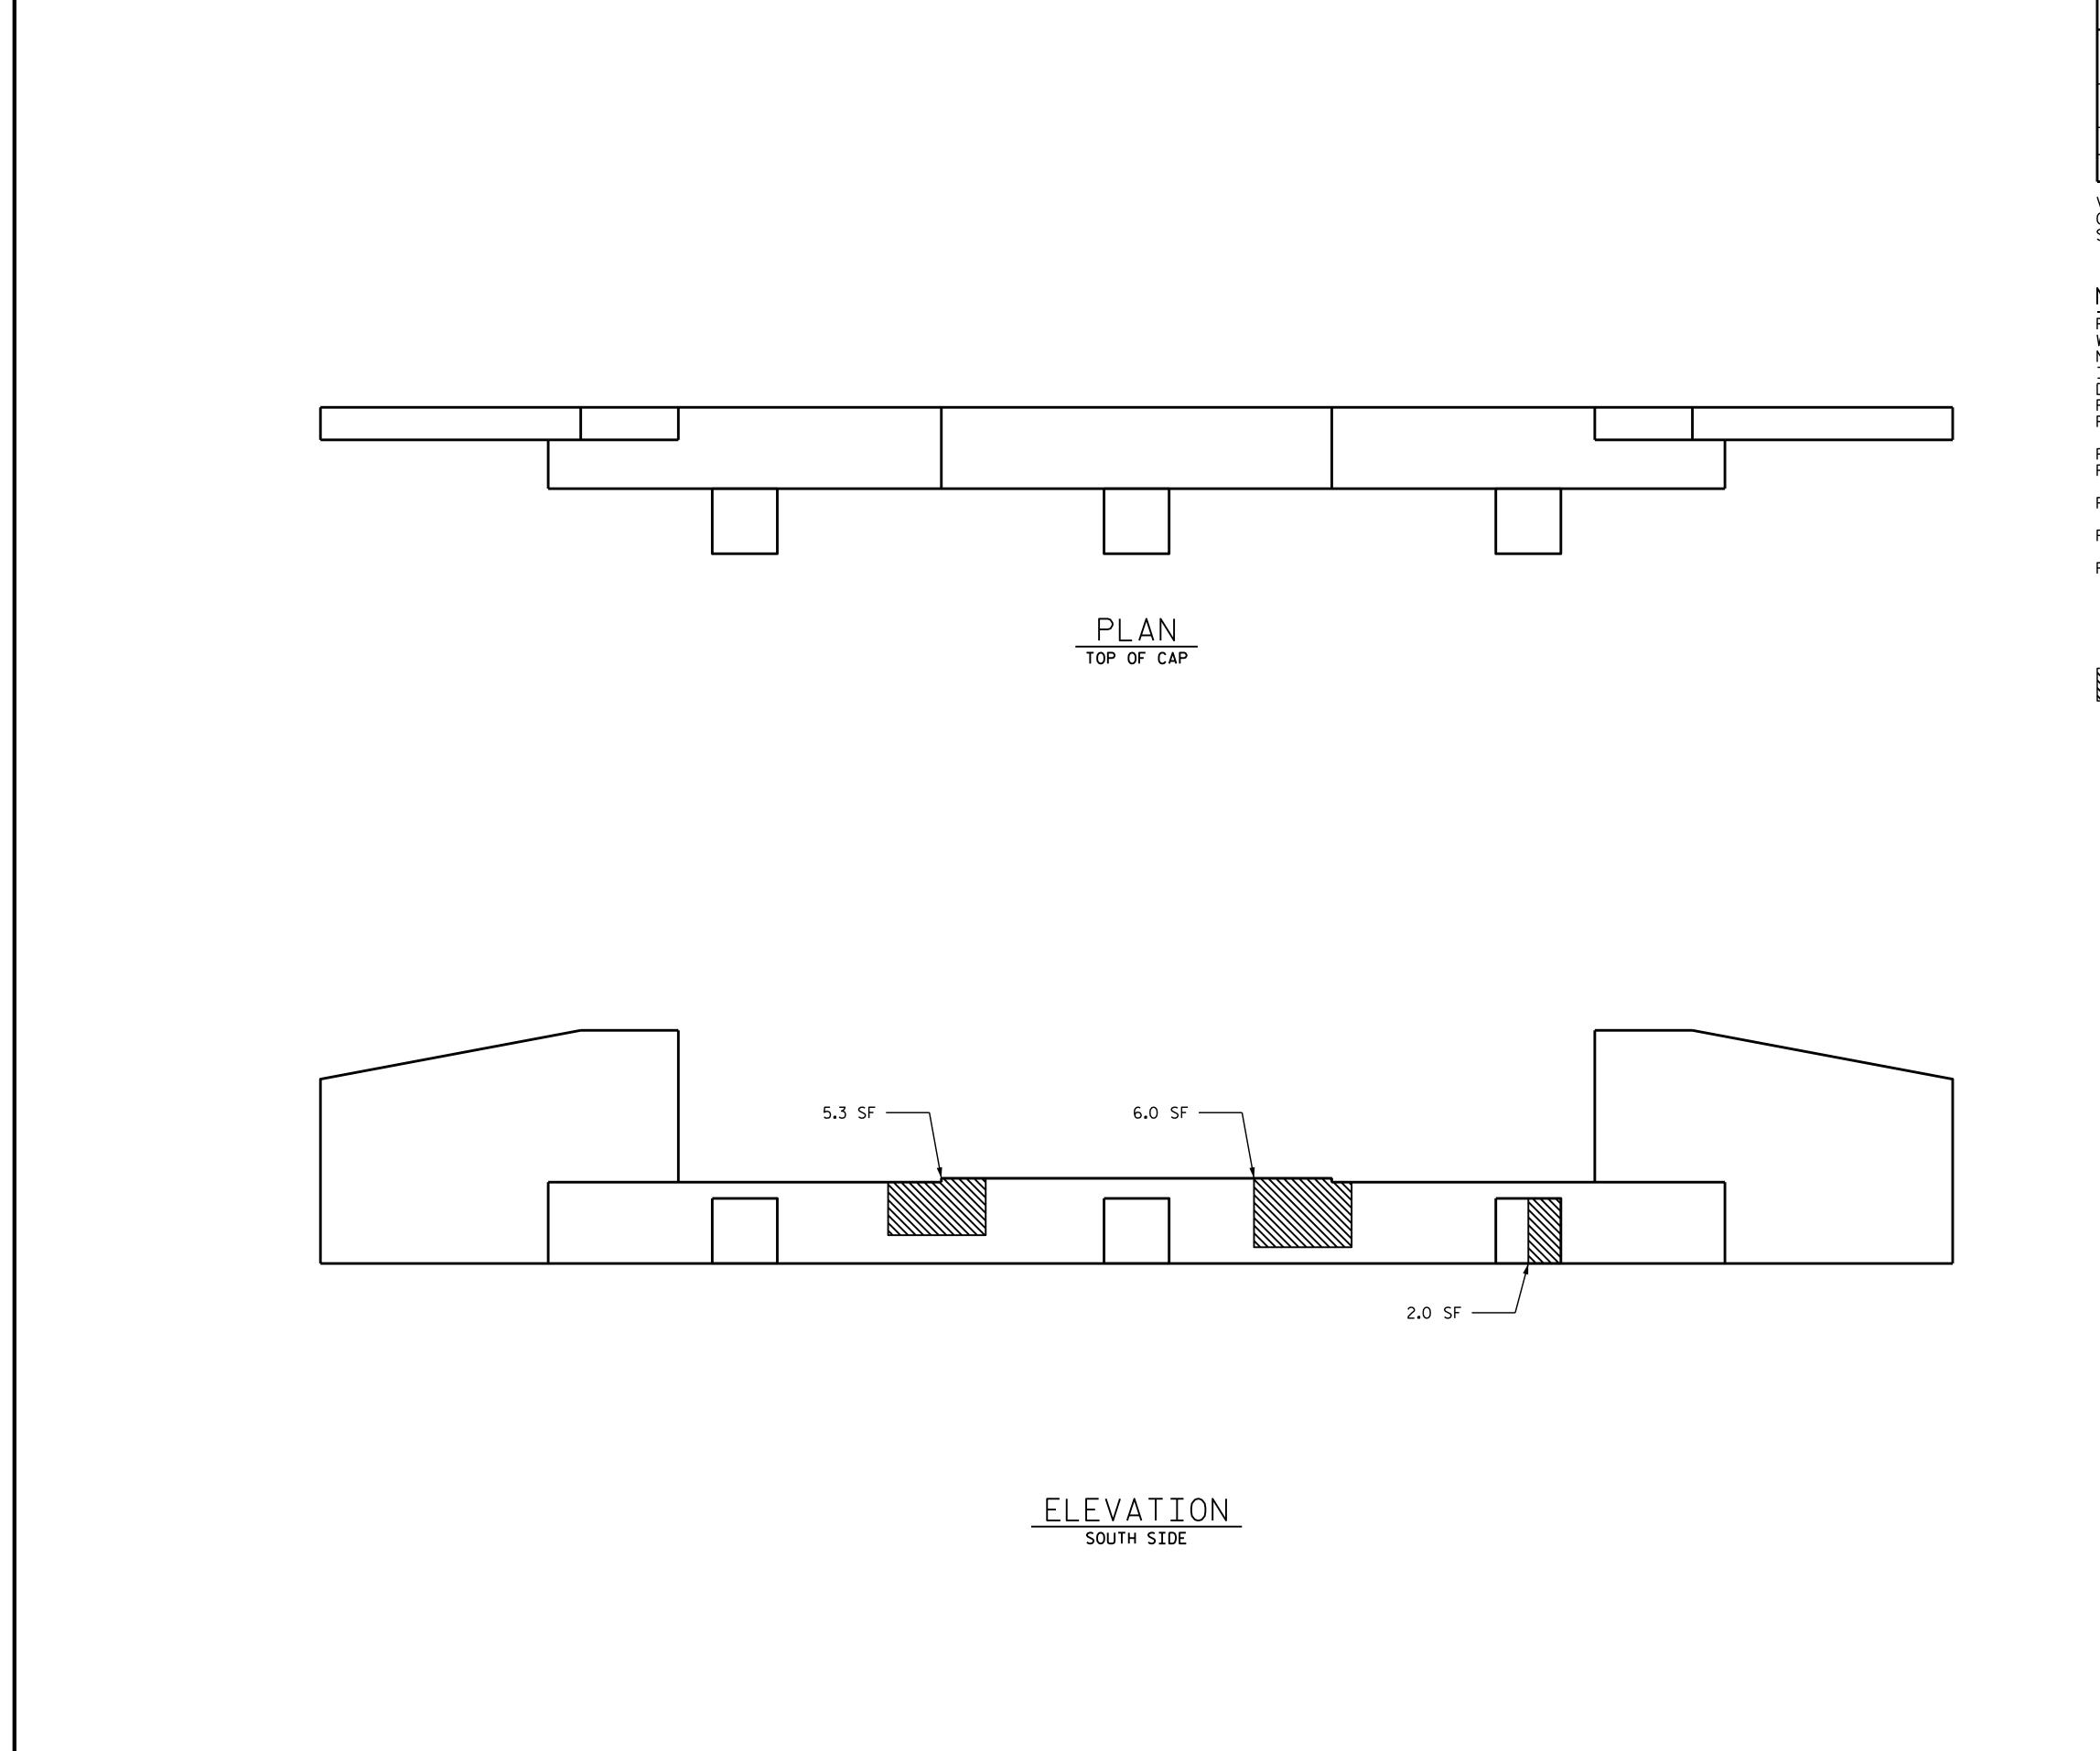
REPAIR QUANTITY TABLE QUANTITIES REPAIRS END BENT 2 ESTIMATE ACTUAL AREA VOLUME AREA VOLUME SHOTCRETE REPAIRS SF CAP (VERTICAL FACE) 13.3 CAP (HORIZONTAL, CORNER) 0.0 0.0

VALUES IN CHART REPRESENT ESTIMATED REPAIR TOTALS AFTER REMOVAL OF UNSOUND CONCRETE, MIN. OF 1"BEHIND REBAR AND MIN. 2"CL TO SAWCUT. SEE REPAIR DETAILS.

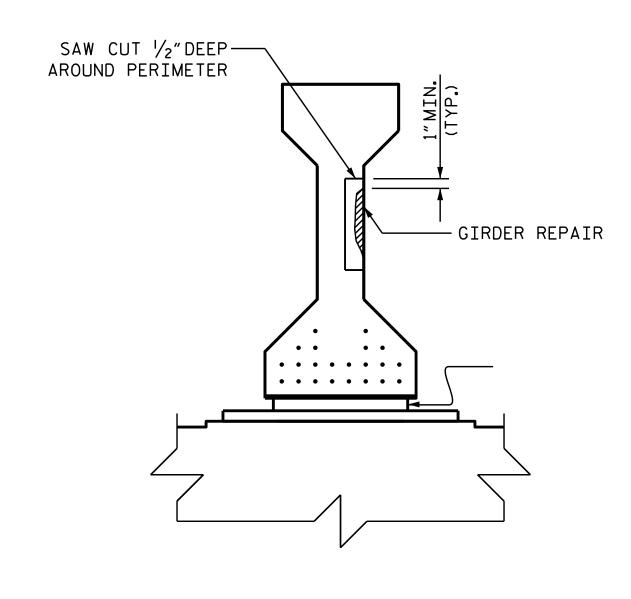
SECTION B-B (IF MORE THAN HALF THE CIRCUMFERENCE OF REINFORCING BAR IS EXPOSED DURING THIS PROCESS, REMOVE ADDITIONAL CONCRETE BEHIND THE BAR. THIS DOES NOT APPLY TO PRESTRESSED STRANDS.)

SAW CUT 1/2" DEEP -AROUND PERIMETER GIRDER REPAIR (TYP.)

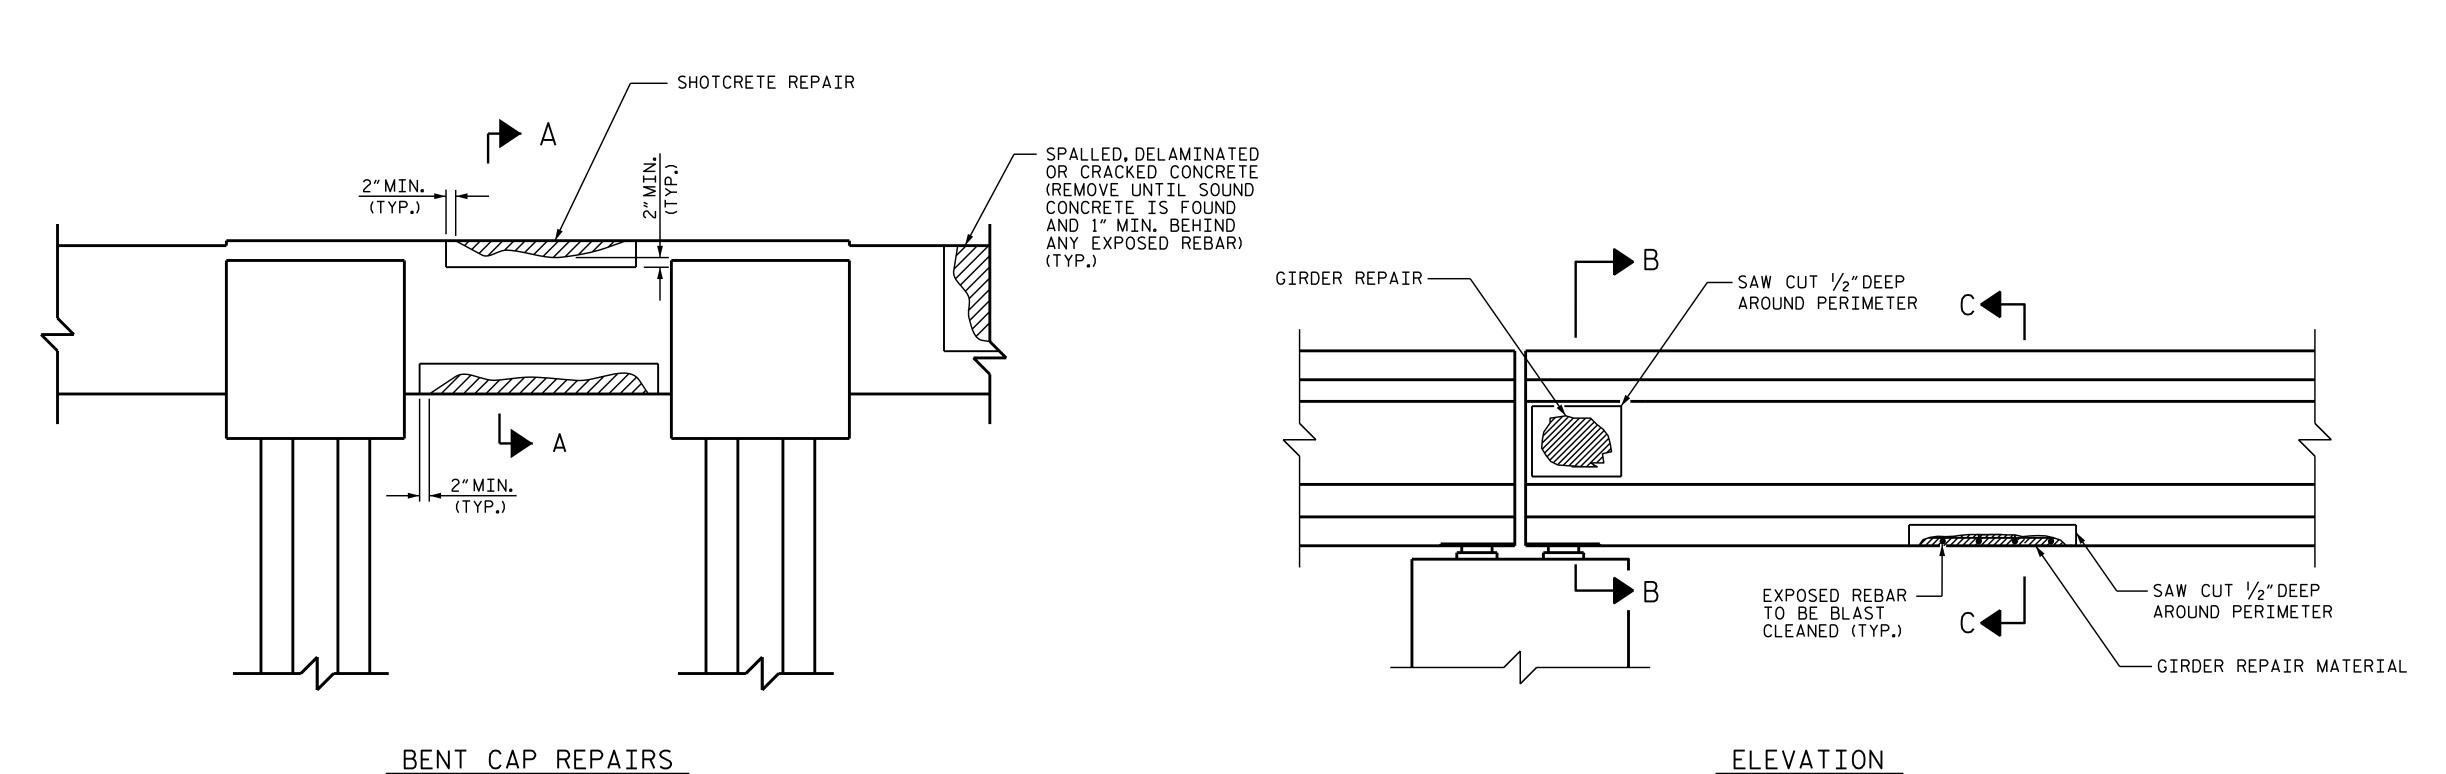
BENT CAP REPAIRS

SECTION C-C

(ALL UNSOUND CONCRETE MUST BE REMOVED. HOWEVER, PRESTRESSED STRANDS SHOULD NOT BE DISTURBED UNLESS ABSOLUTELY NECESSARY. USE EXTREME CARE TO NOT DAMAGE STRANDS. PRESTRESSED STRANDS NOT SHOWN FOR CLARITY.)

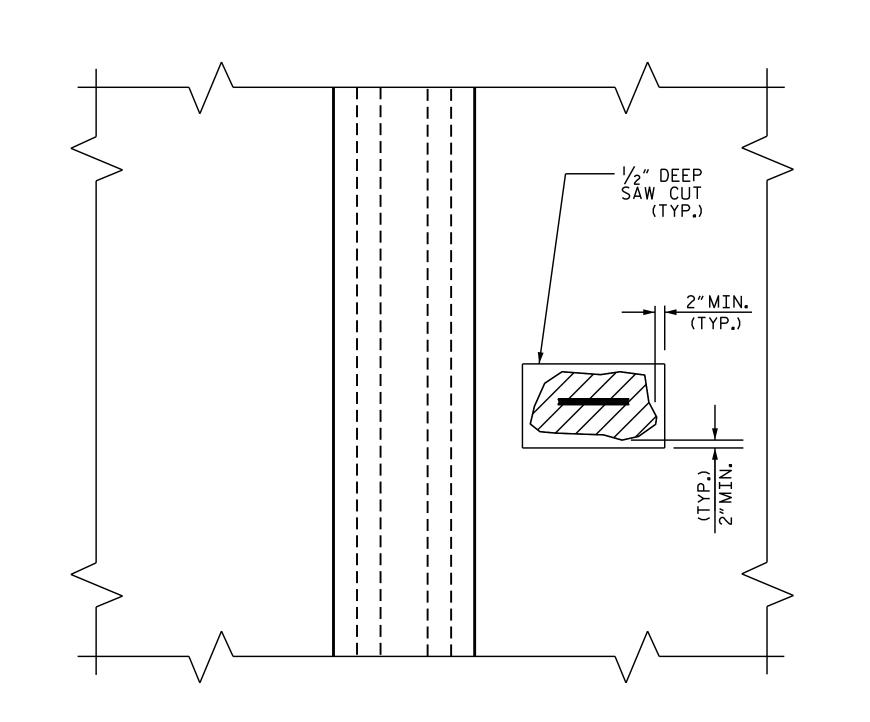
SECTION D-D

— REMOVE 1"(MIN.) BEHIND ANY EXPOSED REBAR SHOTCRETE REPAIR — (TYP.)

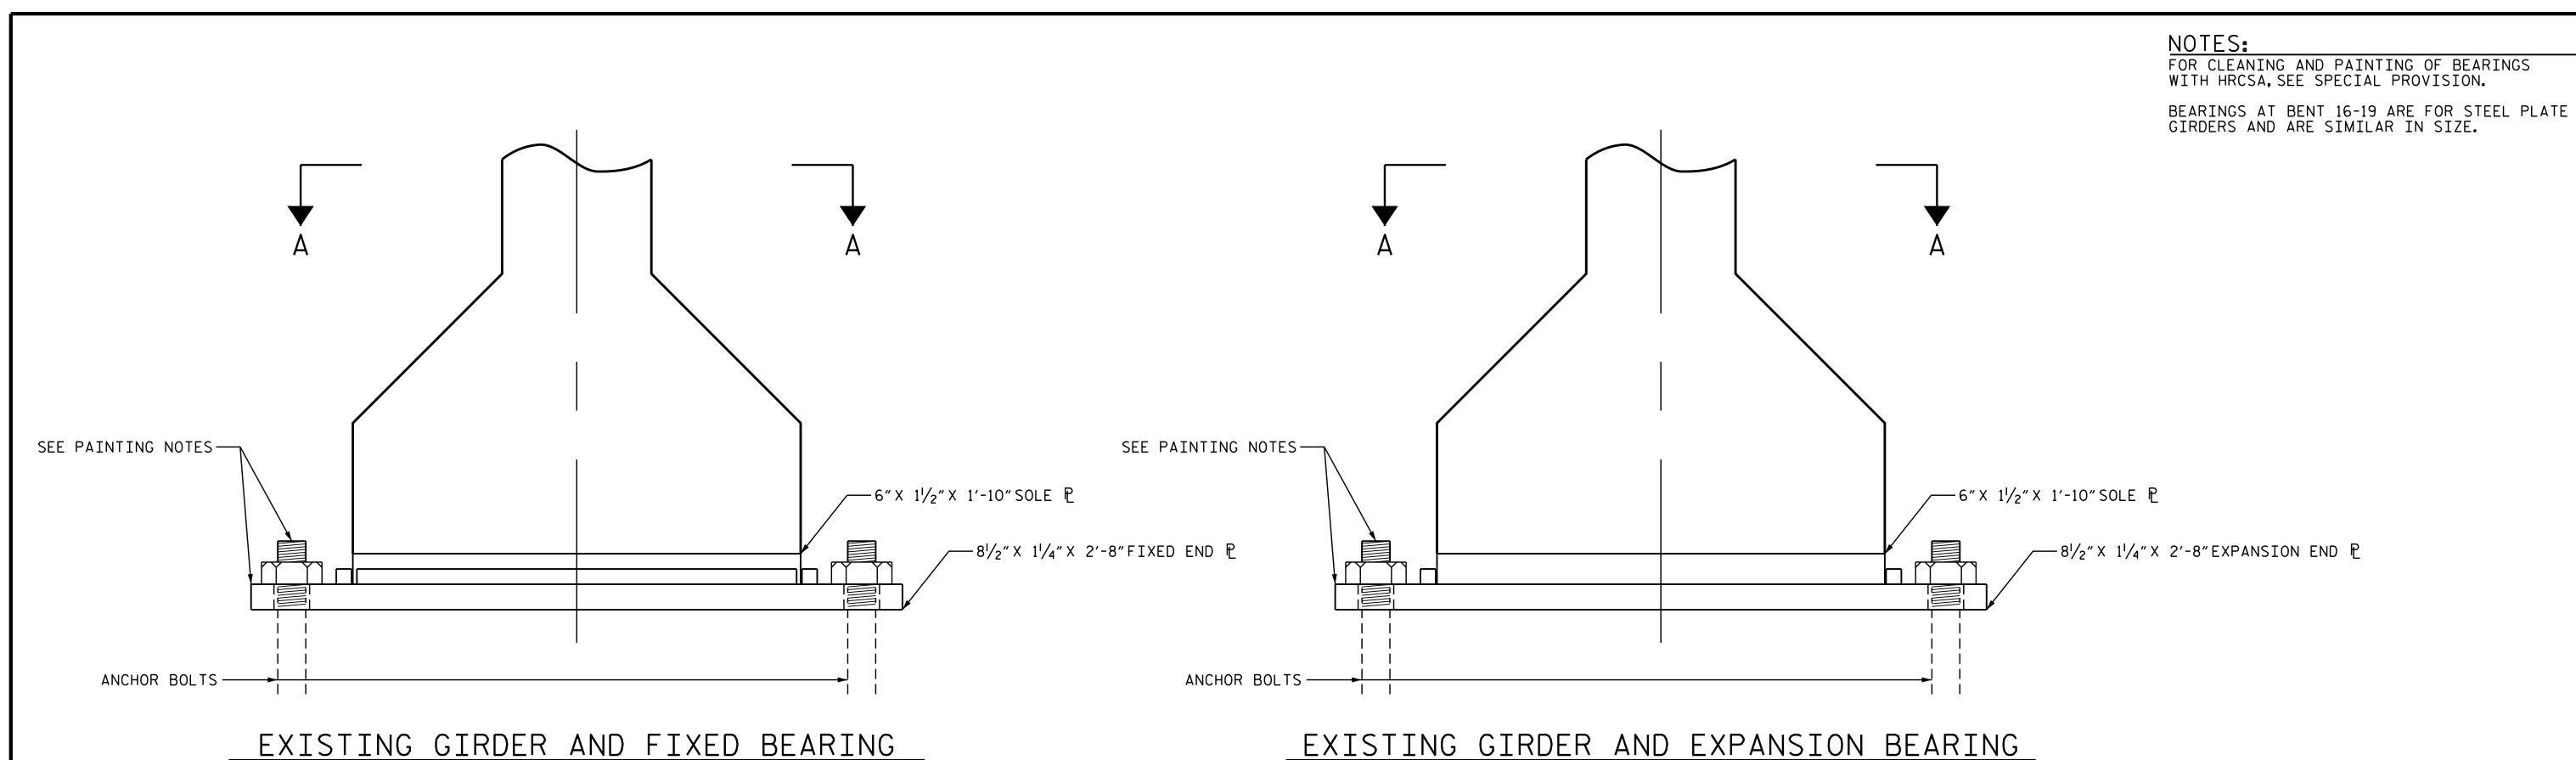
EXISTING GIRDER AND EXPANSION BEARING

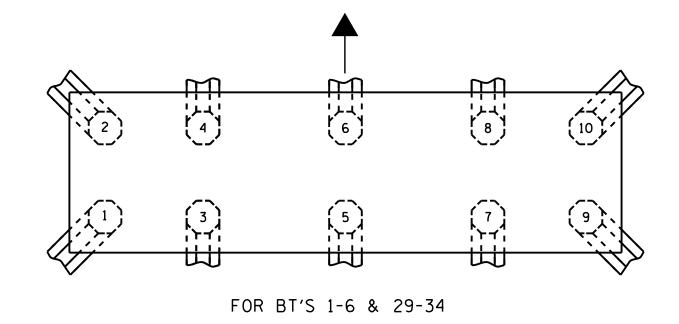
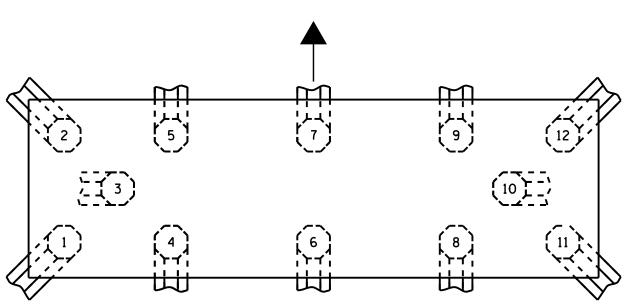
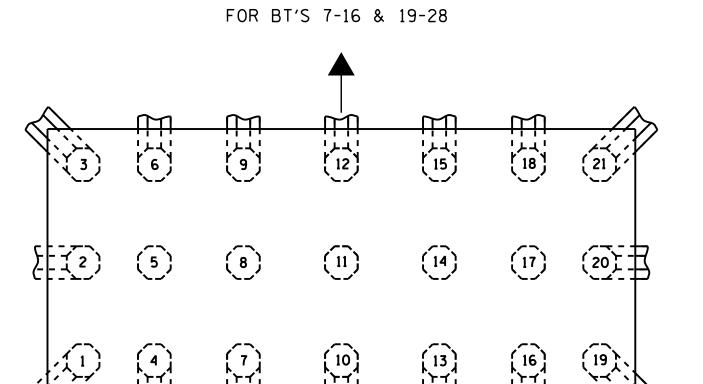
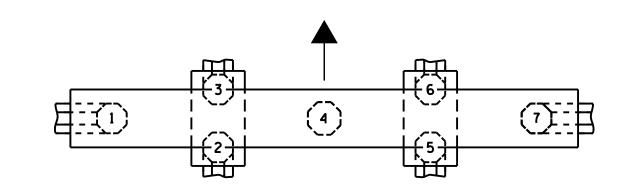
TYPICAL PILE LAYOUT

FOR BT'S 17&18

FOR BT'S 35-37,39-41,43-45, 47-49,51-53,55-57,59-61,63-65, 67-69,71-73,75-77,79-81, 83-85,87-89,91-92,94

FOR BT'S 38,42,46,50,54,58,62,66,70,74,78,82,86,90,93

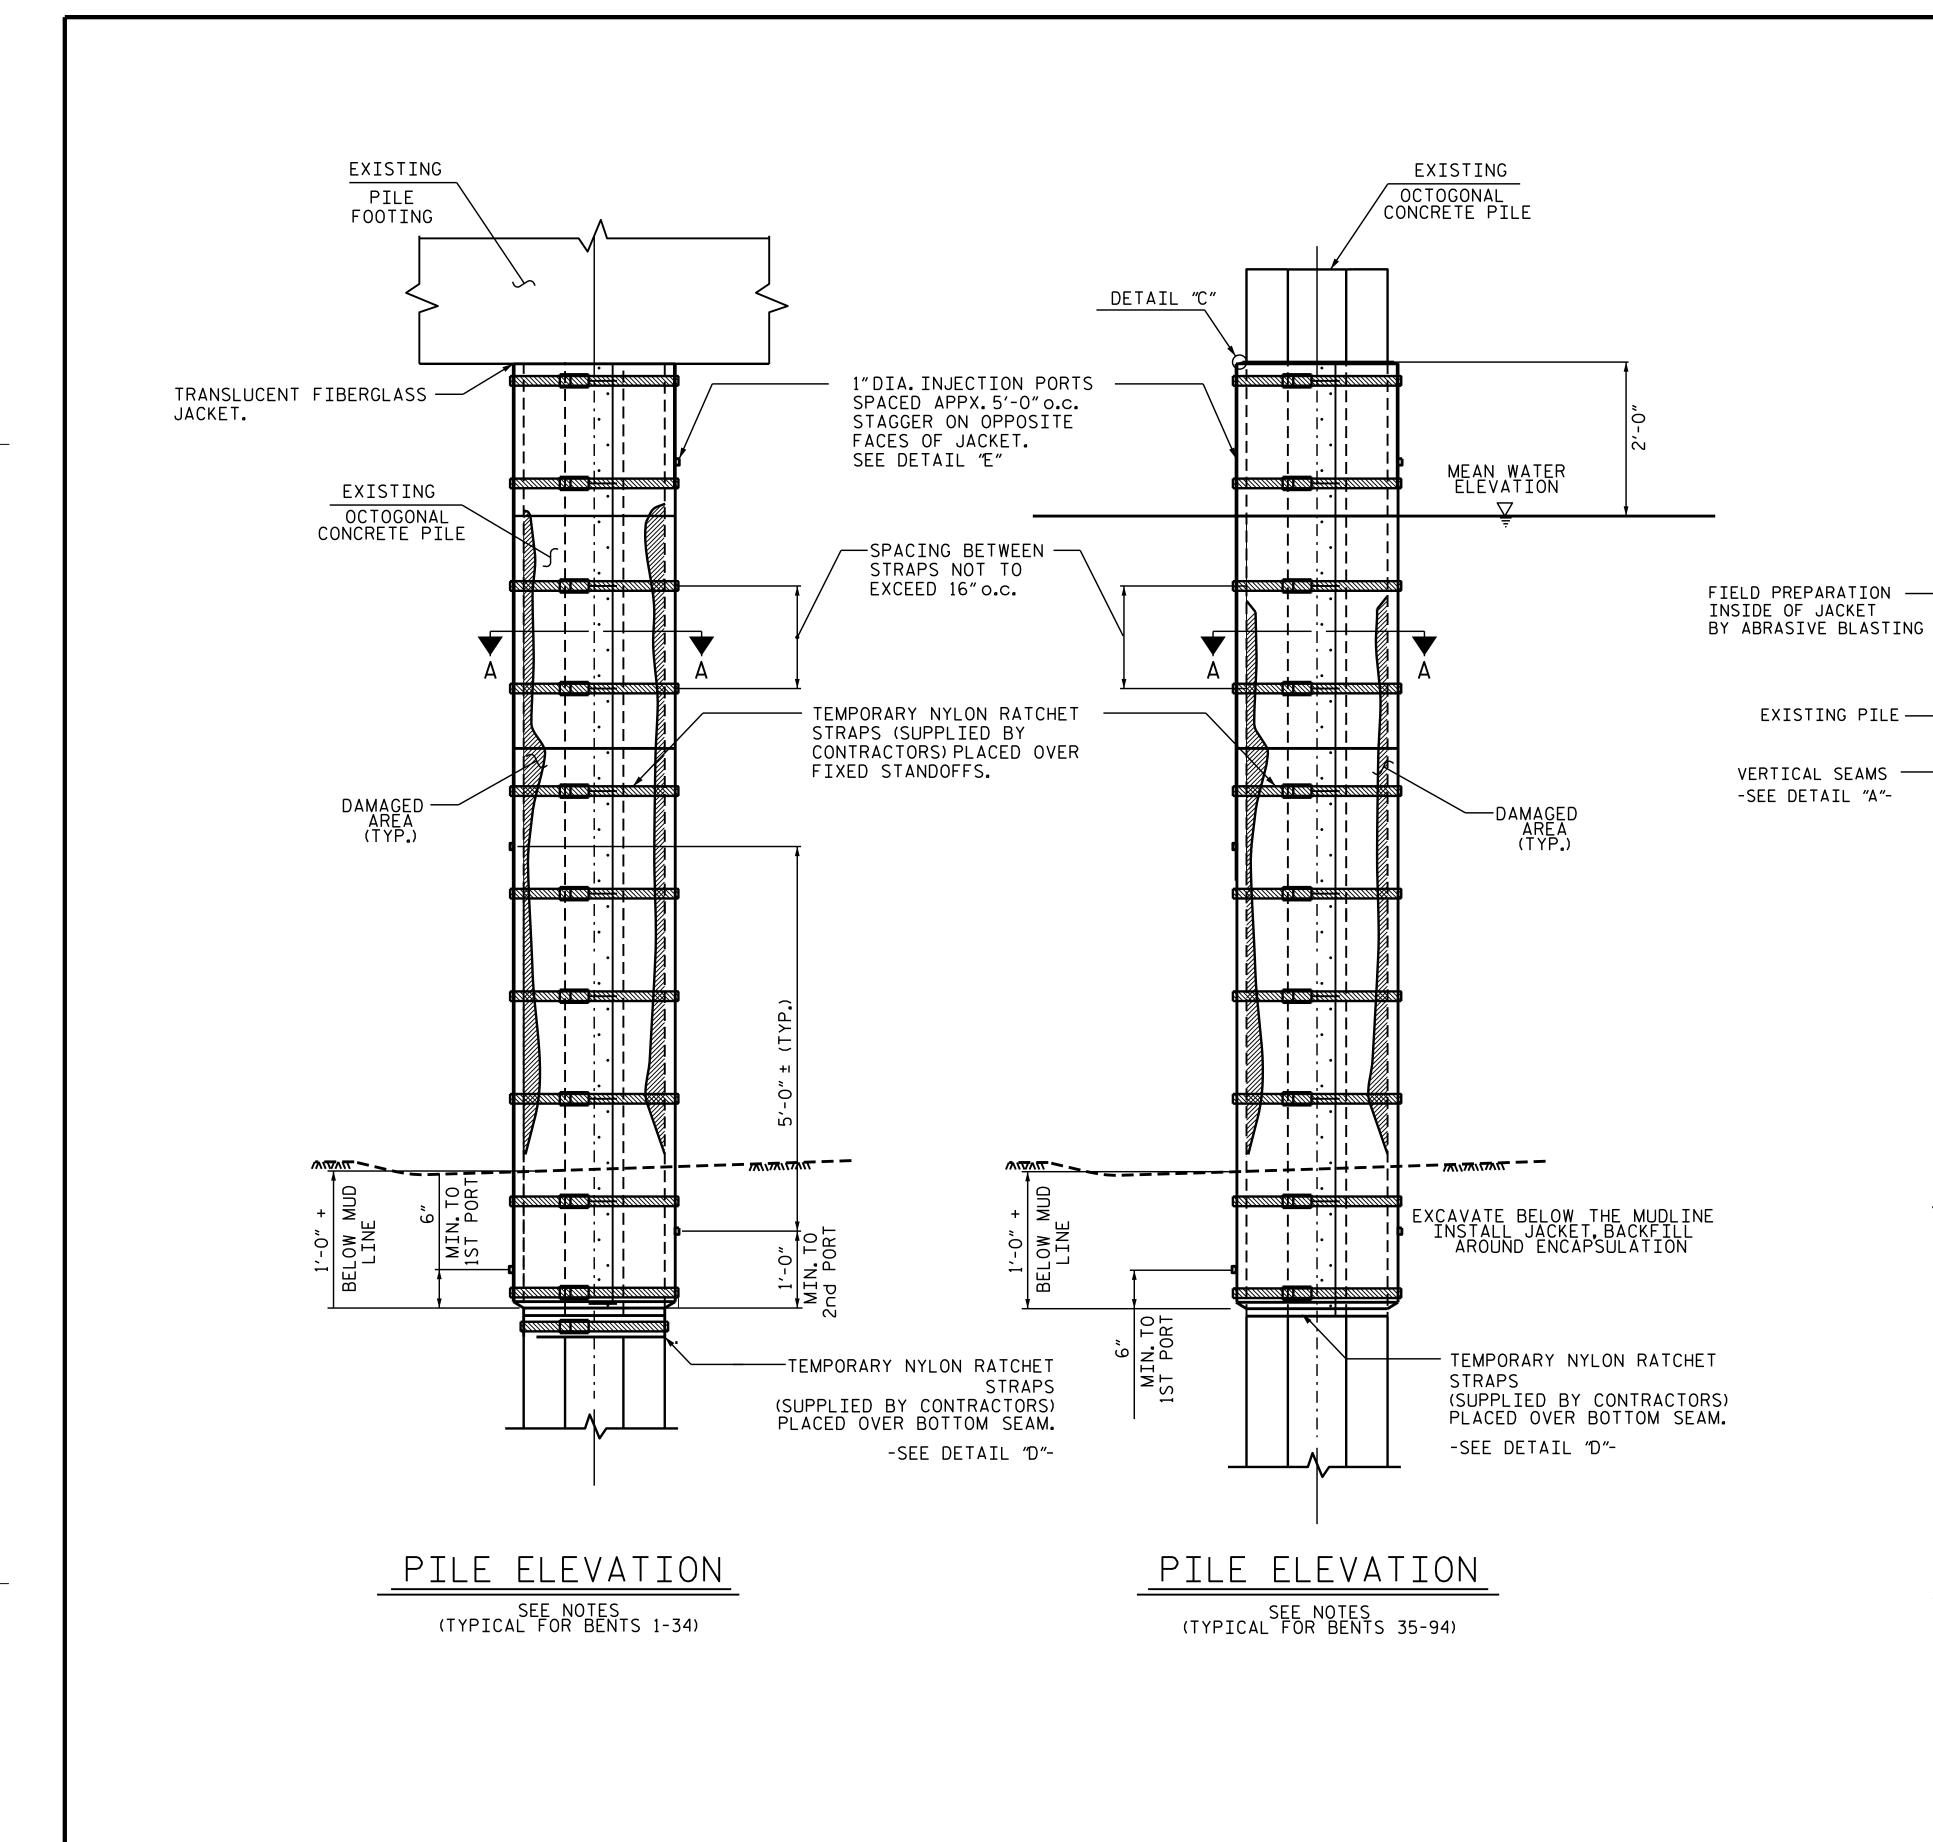
ALL EXISTING PILES ARE 22"OCTOGONAL PRESTRESSED CONCRETE PILES.

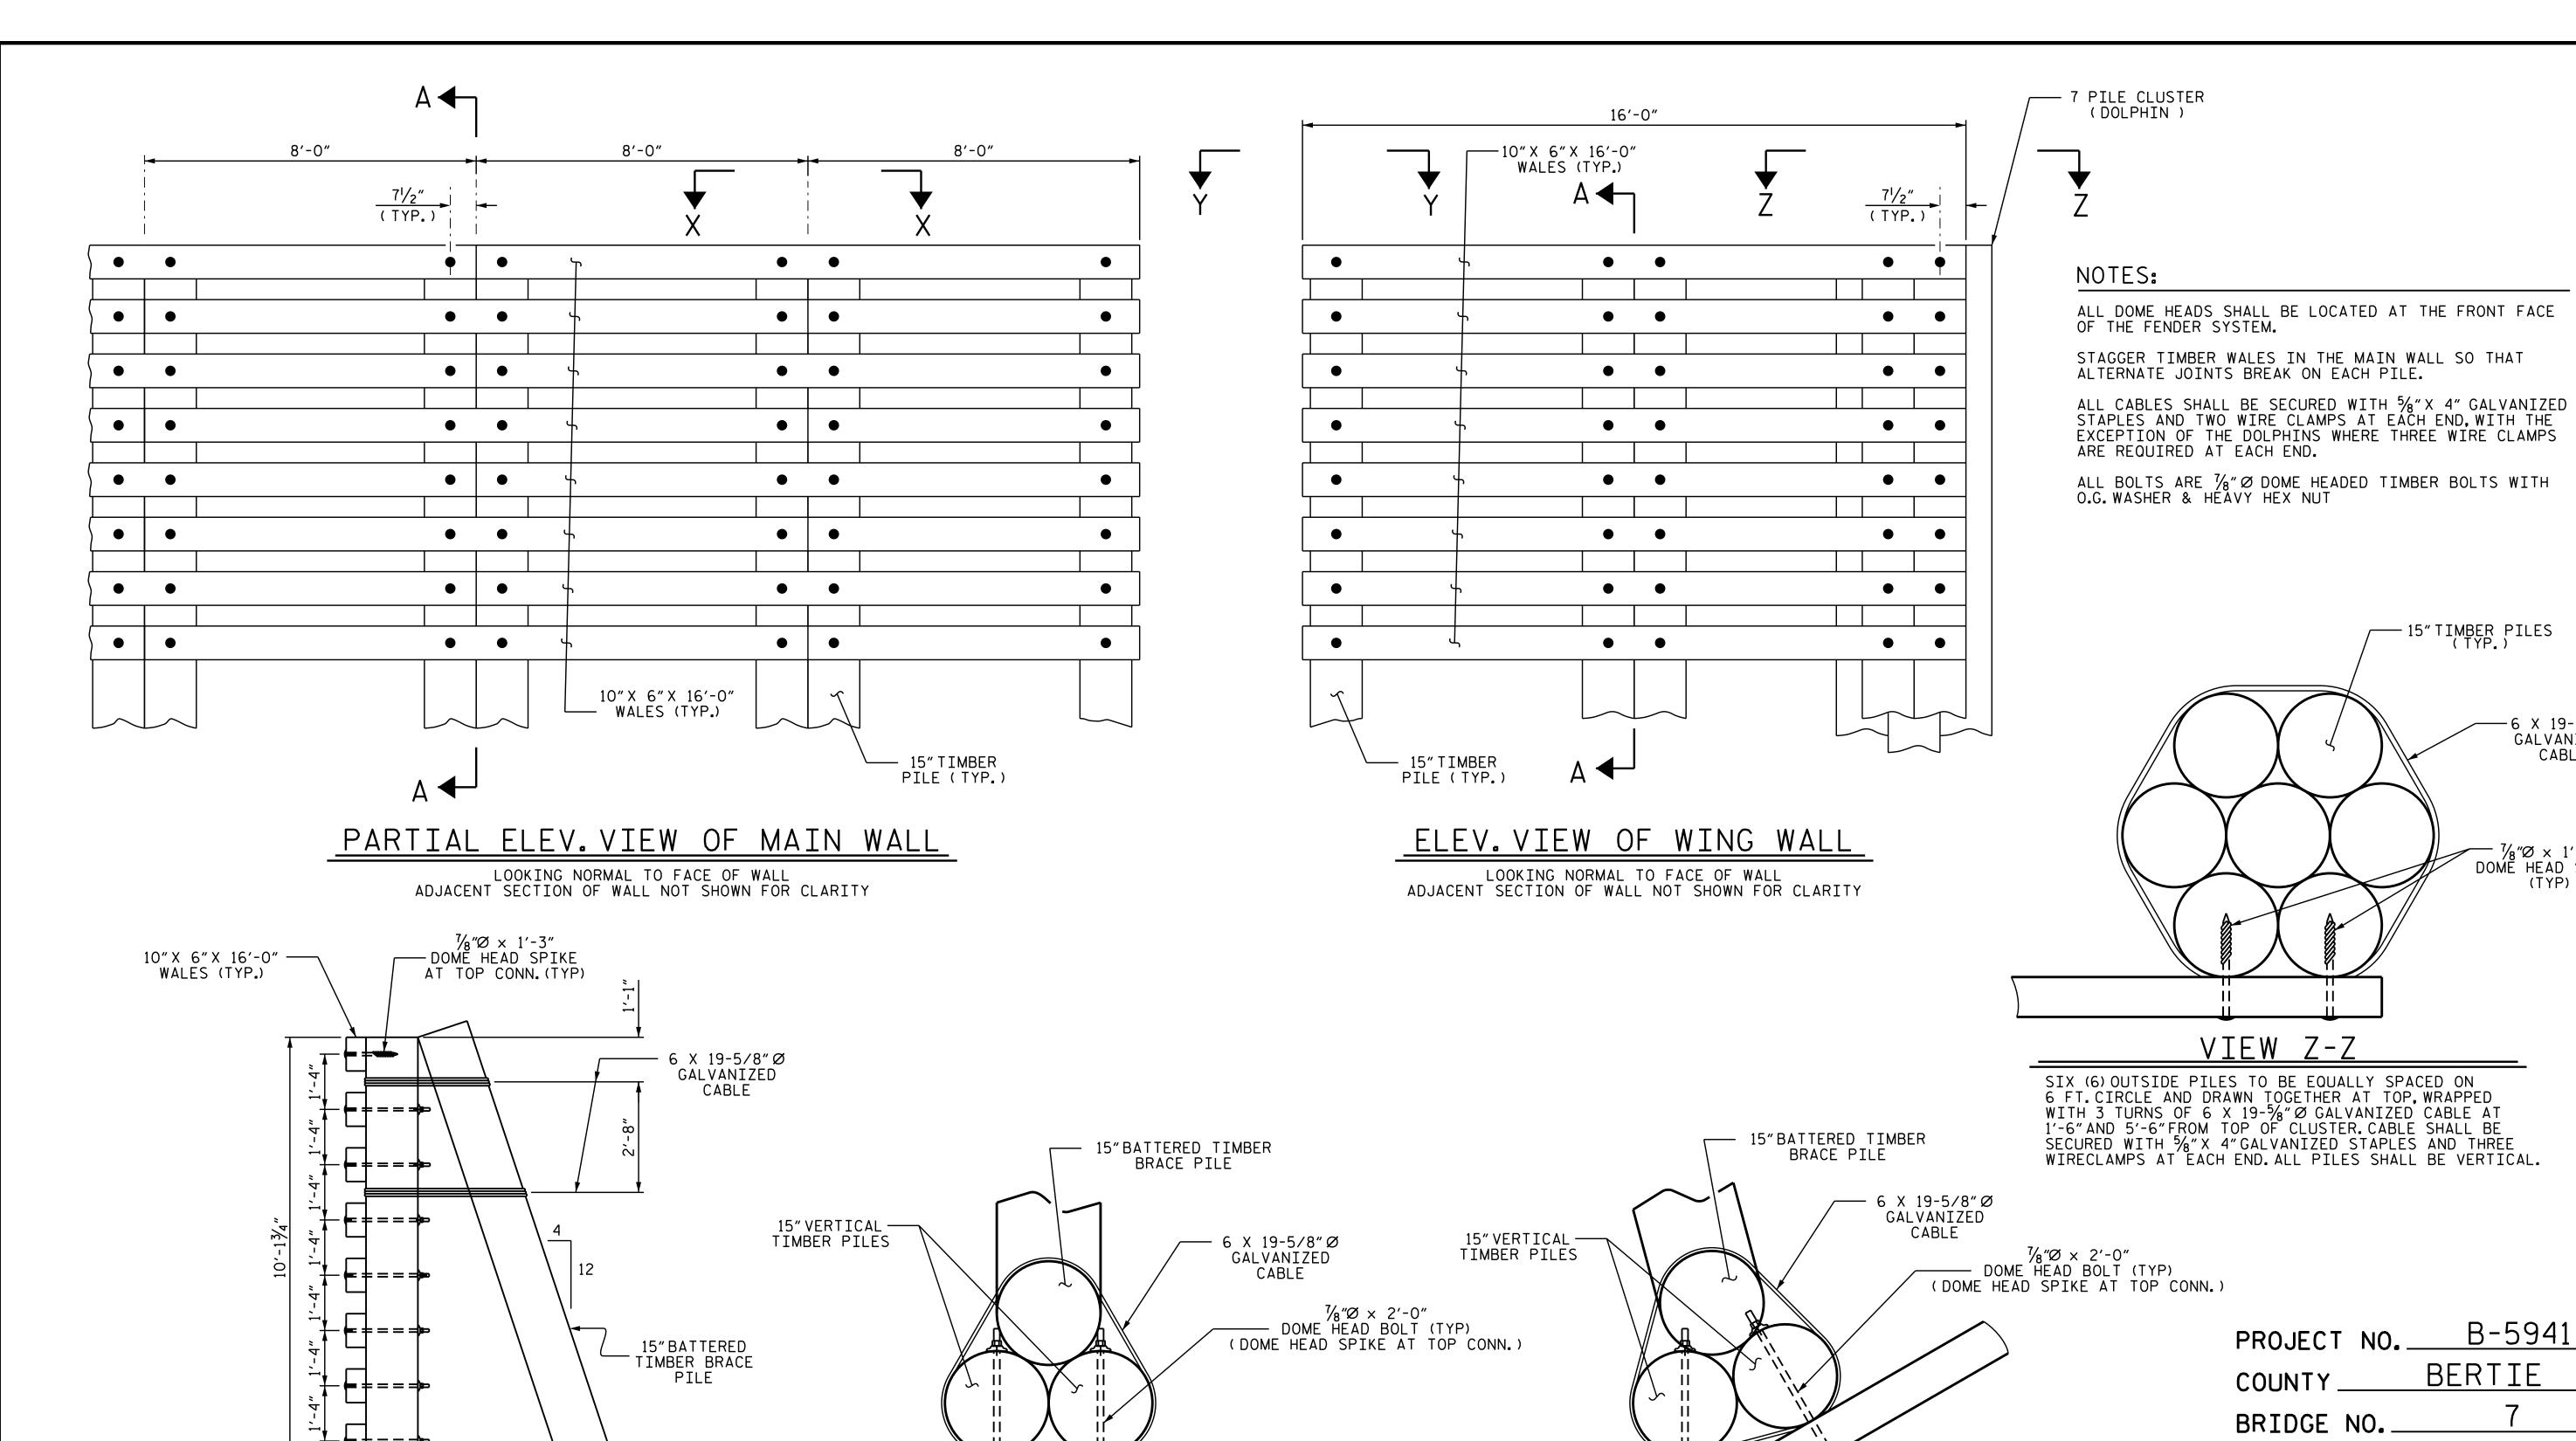
- 15"TIMBER PILES (TYP.)

SECTION A-A

$\frac{7}{8}$ "Ø × 2'-0" DOME HEAD BOLT (TYP.)

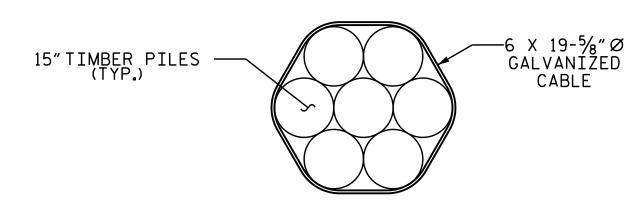
DETAIL OF 7-PILE CLUSTER (DOLPHINS)

PILES 15' FROM ENDS OF FENDER SYSTEM

SIX (6) OUTSIDE PILES TO BE EQUALLY SPACED ON A 6 FT. CIRCLE AT TOP AND BATTERED AT 11/2:12.

DRAW THE PILES TOGETHER AT THE TOP AND WRAP WITH 3 TURNS OF 6 X 19-5/8" Ø GALVANIZED CABLE AT 1'-6" AND 5'-6" FROM THE TOP OF THE CLUSTER. CABLE SHALL BE SECURED WITH 5/8" X 4" GALVANIZED STAPLES AND THREE WIRE ROPE CLAMPS AT EACH END.
