# STATE OF NORTH CAROLINA DIVISION OF HIGHWAYS

LOCATION: BRIDGE # 139 CRAVEN CO., ON SR1470 ACROSS NEUSE RIVER OVER FLOW

TYPE OF WORK: BRIDGE PRESERVATION: JACKETING OF STEEL PILES

STATE OF NORTH CAROLINA DEPARTMENT OF TRANSPORTATION
RALEIGH SUBSTRUCTURE PILE JACKET REPAIR

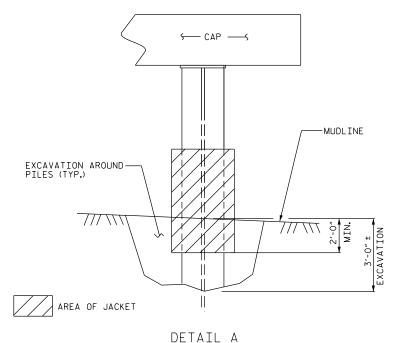
EXCAVATE 3'-0"(±) DEEP AROUND EXISTING PILES. CLEAN EXPOSED PILE BELOW EXISTING MUDLINE. AFTER CLEANING AND TREATING THE HP PILES, BACKFILL EXCAVATED AREA AROUND EACH PILE. SEE DETAIL A.

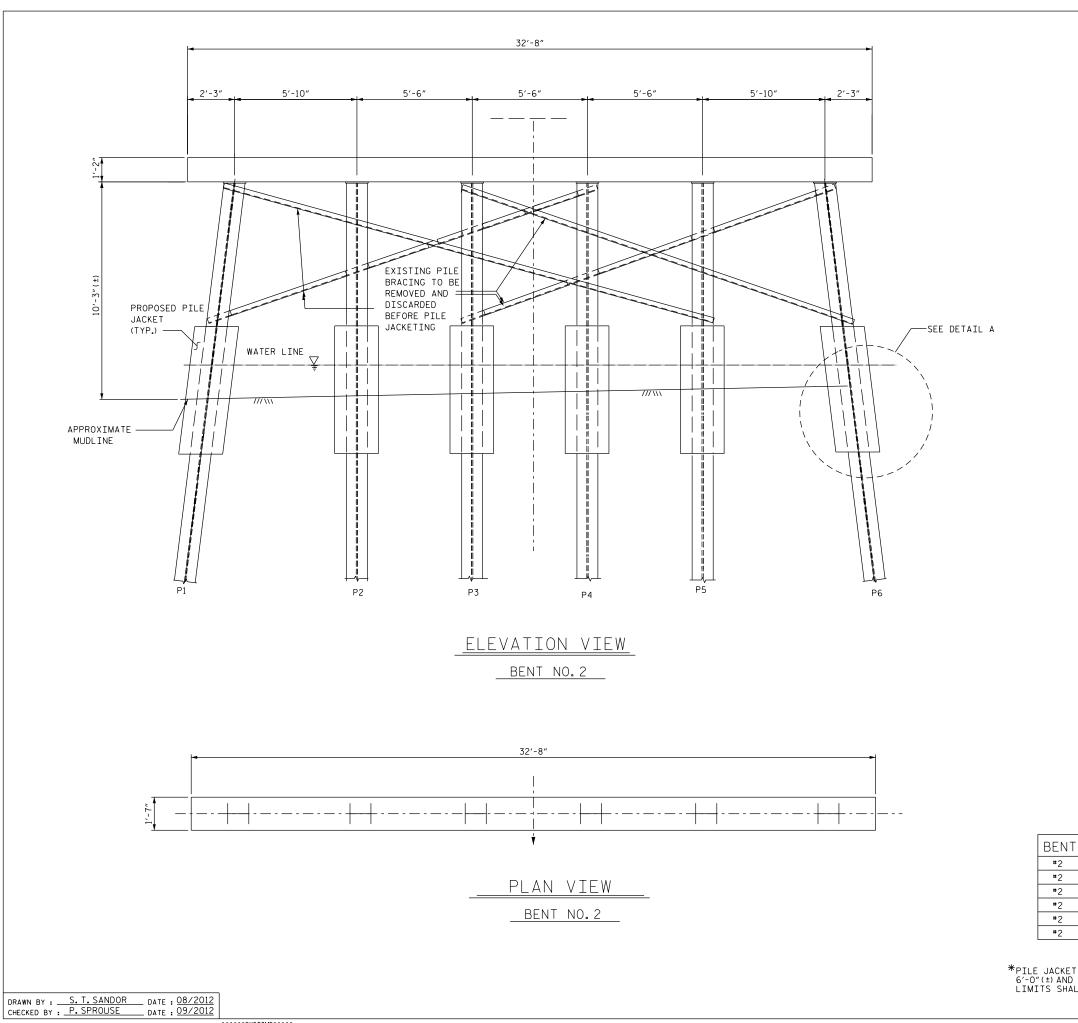
(BENT 2)

EXISTING PILES ARE HP 12 X 53 STEEL PILES.

JACKET PILES TO A MINIMUM OF 2'-0" BELOW THE MUD LINE.

JACKET PILES TO A MINIMUM OF 1'-O" ABOVE THE DAMAGED AREA.

PILE JACKET LENGTHS ARE MINIMUM 4'-0".LIMITS SHALL BE FIELD VERIFIED.

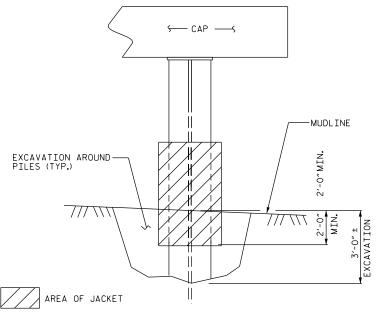
<u>DETAIL A</u>

EXCAVATE 3'-0"(±) DEEP AROUND EXISTING PILES.CLEAN EXPOSED PILE BELOW EXISTING MUDLINE.AFTER CLEANING AND TREATING THE HP PILES, BACKFILL EXCAVATED AREA AROUND EACH PILE.SEE DETAIL A.

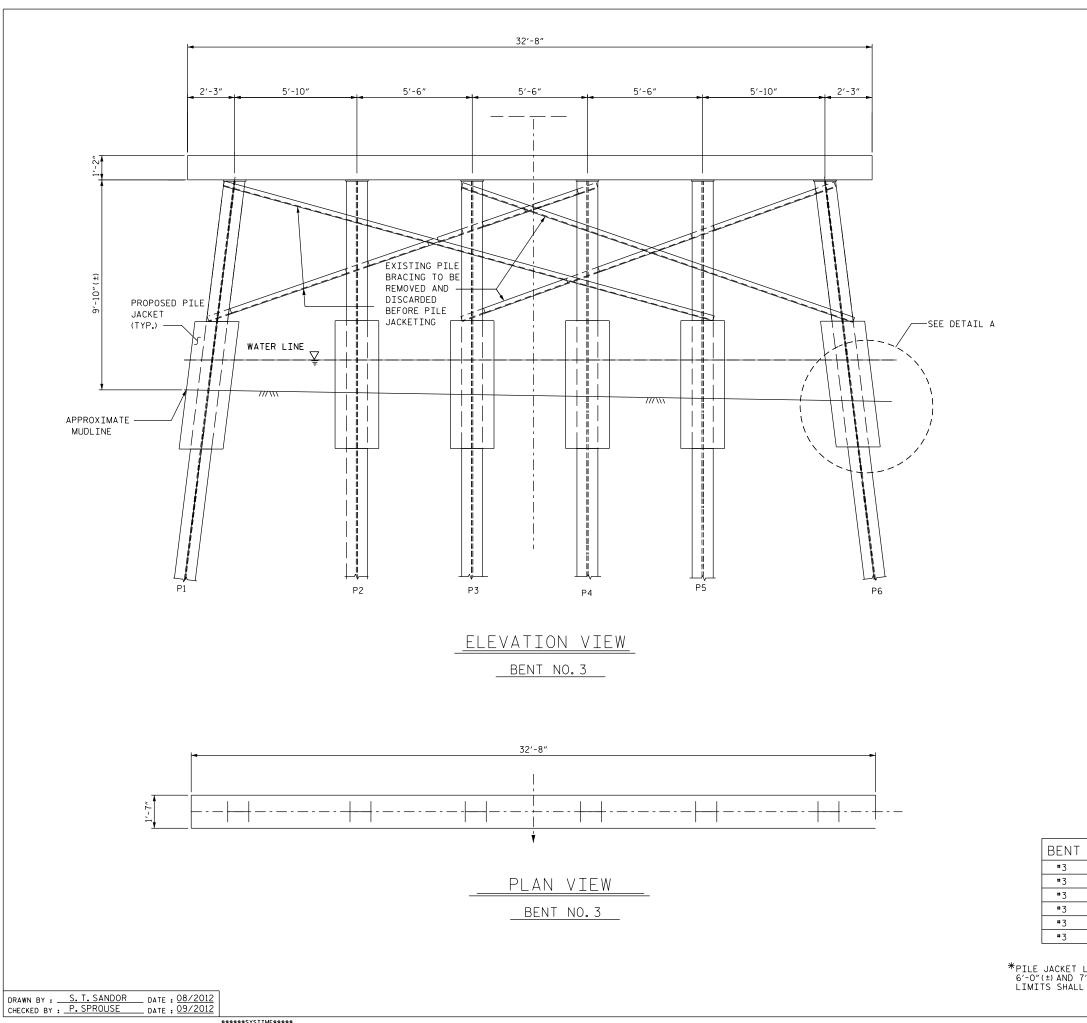
(BENT 3)

EXISTING PILES ARE HP 12 X 53 STEEL PILES.

JACKET PILES TO A MINIMUM OF 2'-0" BELOW THE MUD LINE.

JACKET PILES TO A MINIMUM OF 1'-0" ABOVE THE DAMAGED AREA.

PILE JACKET LENGTHS ARE MINIMUM 4'-0".LIMITS SHALL BE FIELD VERIFIED.

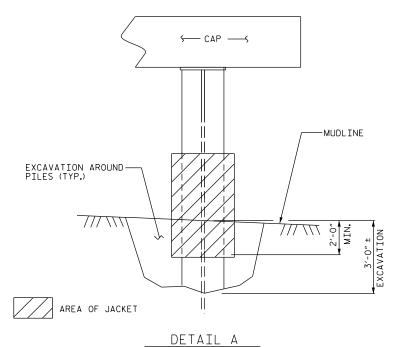
EXCAVATE 3'-0"(±) DEEP AROUND EXISTING PILES. CLEAN EXPOSED PILE BELOW EXISTING MUDLINE. AFTER CLEANING AND TREATING THE HP PILES, BACKFILL EXCAVATED AREA AROUND EACH PILE. SEE DETAIL A.

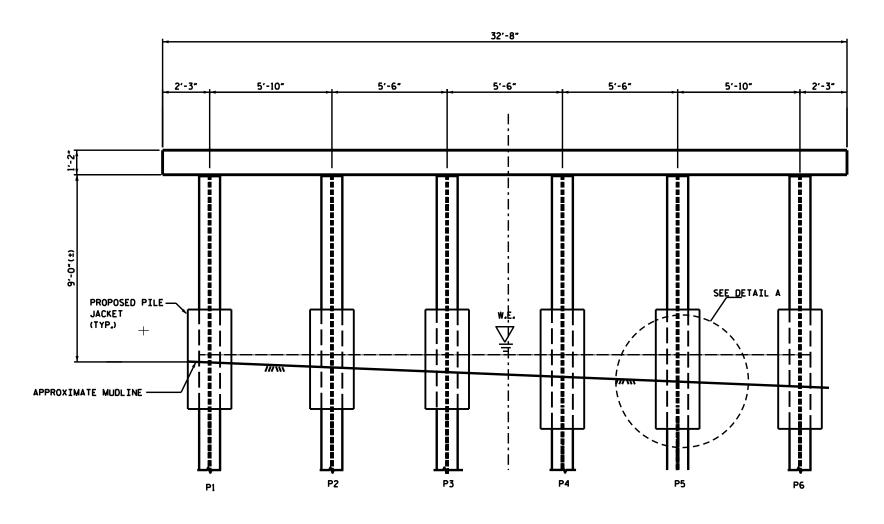
### **ELEVATION VIEW**

END BENT #2

PLAN VIEW END BENT #2

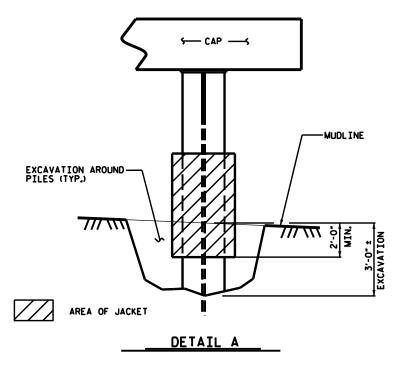
EXCAVATE 3'-0"(2) DEEP AROUND EXISTING PILES. CLEAN EXPOSED PILE BELOW EXISTING MUDLINE. AFTER CLEANING AND TREATING THE HP PILES. BACKFILL EXCAVATED AREA AROUND EACH PILE. SEE DETAIL A.
