STRUCTURE BULLETIN

NCDOT Construction Unit

Current Issues: Stay-In-Place Form Grades

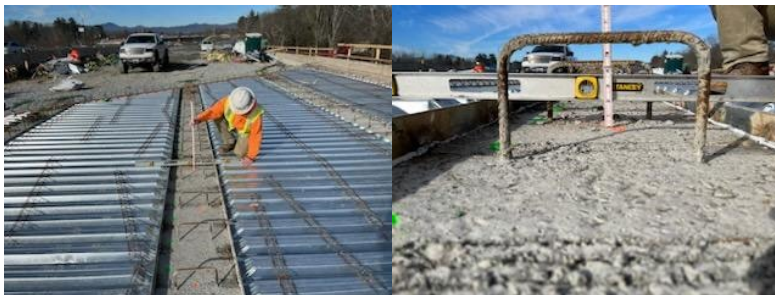
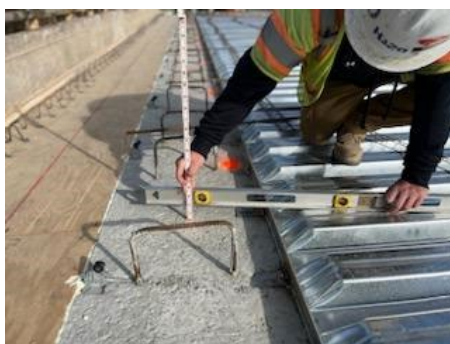
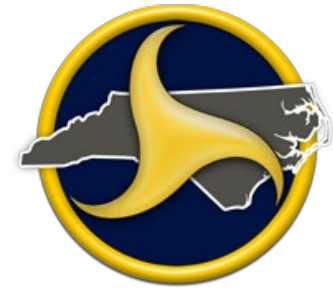
When stay-in-place (SIP) forms are ready to be installed for a bridge, attention needs to be taken to ensure that they are set to proper grade according to the calculated buildups. The buildup grades for each girder should be calculated and verified before installation of the SIP forms begins (see link to video to the right). When the stay-in-place form installers arrive on site, the buildups and shop drawings should be reviewed prior to installation beginning to make sure that everyone is familiar with the plans and installation instructions. If there are any special circumstances for SIP installation for that structure, these should be discussed then also. The SIP installers will often mark the grade for each form on the girder next to the bracket. The inspector should check these as the contractor begins the initial installation to make sure that the installer's process is correct, and that the form is installed at the correct elevation. Thereafter, check the forms periodically to make sure they continue to be installed correctly.

Checks are made by setting the level on the SIP forms as shown by either spanning the girder over the buildup point between the SIP forms or holding the level on the SIP and cantilevering over the buildup point for the outside girders. The measured distance between the girder and the bottom of the level on each buildup point should match the calculated buildup for that buildup point. On several projects within the last year, errors to the SIP forms have been found during the dry run for a deck pour. When the error to the SIP form grade is discovered this late in the deck construction process, corrective action is difficult to make because often all of the reinforcing steel has to be removed in order for grade corrections to be made to the SIP forms. Occasionally, there may be errors encountered with the deflections in the plans or with the shop drawings for the SIP forms. If these are discovered at any point as the buildups are being computed or when the SIP forms are being installed, please contact your Area Construction Engineer to help resolve. Most importantly, checking the forms as they are installed and making any corrections at that time can help to avoid much larger scale corrections later that can result if the SIP forms are installed at an incorrect grade.
