Minimizing Water Quality Impacts of Road Construction Projects

North Carolina Department of Transportation
PROJECT AUTHORIZATION NO. HWY- 2003-04

1. Report No. FHWA/NC/2006-21	2. Government Accession No.	3. Recipient's Catalog No.	
4. Title and Subtitle Minimizing Water Quality Impacts of Road Construction Projects		5. Report Date 1/25/2007

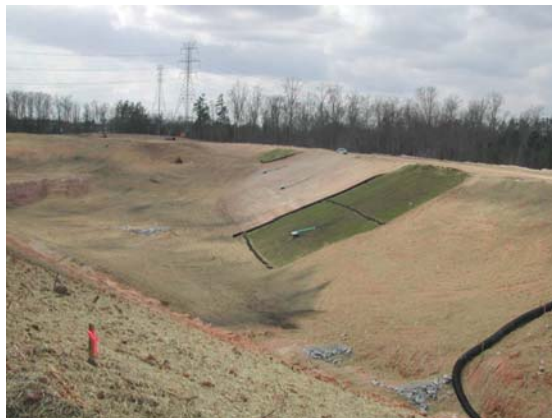
Figure 1.1. Plot overview, including the compost-treated plot (green).

Excelsior and standard straw, both with and without PAM were tested at this site (Figures 1.1 and 1.2). The plots were not replicated and so these results should be considered a demonstration only. Results have shown including PAM into standard erosion control applications aids in preventing rills/erosion from occurring (Figures 1.3 and 1.4). Excelsior with PAM showed a volume decrease (60% and 53%) in both storms (Figure 1.5 a and b). However, straw and PAM only showed a volume decrease (85%) in the first storm (Figure 1.5 a and b). In absolute volume, the effect of the PAM was much greater during the first storm event. Both straw and excelsior with PAM showed a significant turbidity reduction greater than 50% for both storms (Figure 1.5 a and b). Although conditions were favorable, very little grass emerged during this test, either due to poor seed quality or low seeding rates. An adjacent area was treated with municipal compost and seeded separately, but we did not collect data from this area.

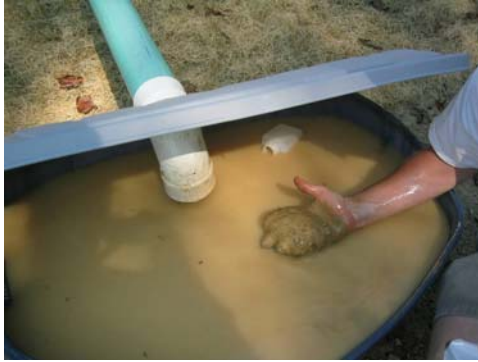
Figure 1.2. Runoff from PAM-treated plot showing flocculated sediment.

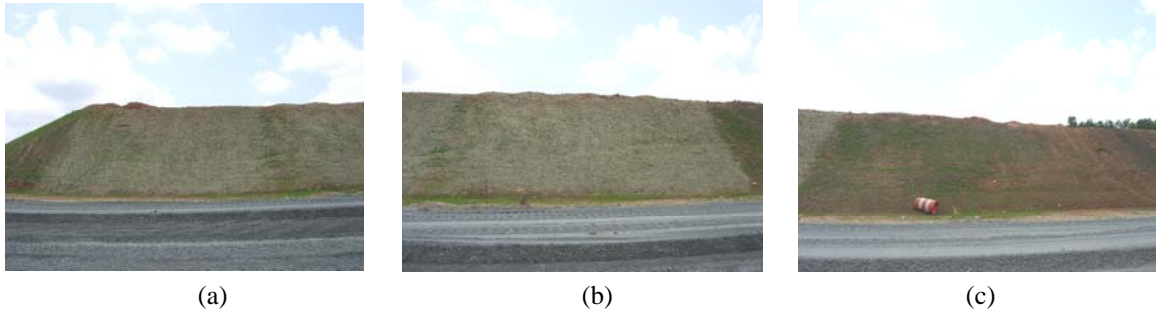
Figure 1.6. Oakdale Rd I hydroseeding plots June 2005. a. Wood hydromulch. b. Wood hydromulch + 20 lb/ac PAM. c. Straw + tackifier + 20 lb/ac PAM.

A second demonstration area was established at the Oakdale Road overpass. A standard mixture of wood fiber mulch and seed with and without PAM was applied to two sections (Figure 1.6 a and b). A seed mixture and PAM was applied to a third section already stabilized with straw and asphalt tackifier (Figure 1.6 c). All plots were fifty feet in length. No water sampling was attempted as we were interested in grass growth primarily. Grass growth between treatments was not noticeably different, but inclusion of PAM seemed to help slope stability (Figure 1.7). The study was cut short due to new grading activities in preparation for bridge installation (Figure 1.8).

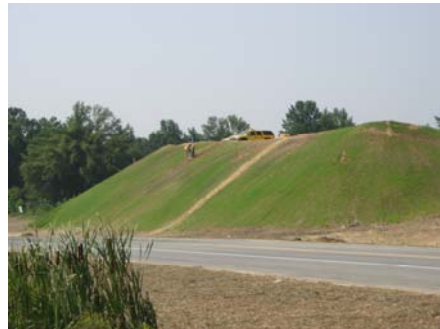
Figure 1.8. Newly established grade and cover at the Oakdale Road overpass site.

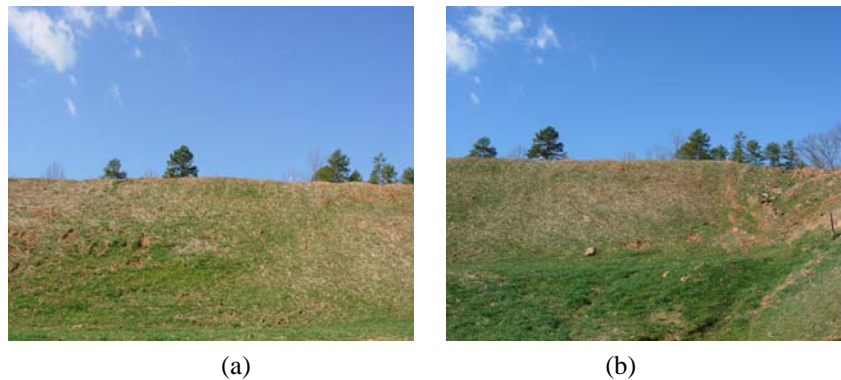
Figure 1.10. Oakdale PAM plot in January 2006. a. right side of plot. b. left side of plot.

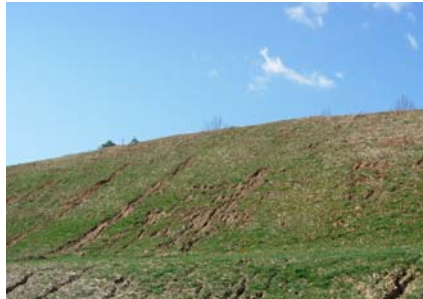
Figure 1.11. Oakdale plot with only standard straw mulch in January 2006.

A third demonstration area was established just east of Oakdale Road. The site was a 2:1 fill slope recently stabilized by the seeding contractor. We applied PAM (23 lbs/ac) on a section of slope that previously had seed, straw and fertilizer applied. We also applied the same amount of water without PAM on a second section. Each section was approximately 38 feet in length and 100 feet wide. Figure 1.9 shows the PAM plot at establishment (November) and Figure 1.10 shows them two months later (January). Figure 1.11 shows the slope without any PAM treatment. There were no obvious differences in grass growth, but the PAM appeared to have less rilling after two months (Figure 1.11).

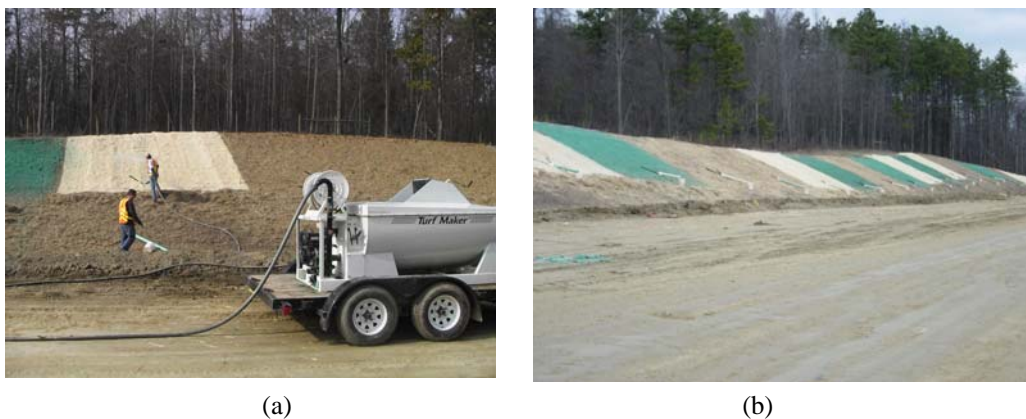
Figure 1.14. Brookshire Boulevard area test plots a. application of PAM to excelsior plot. b. overview of all plots.

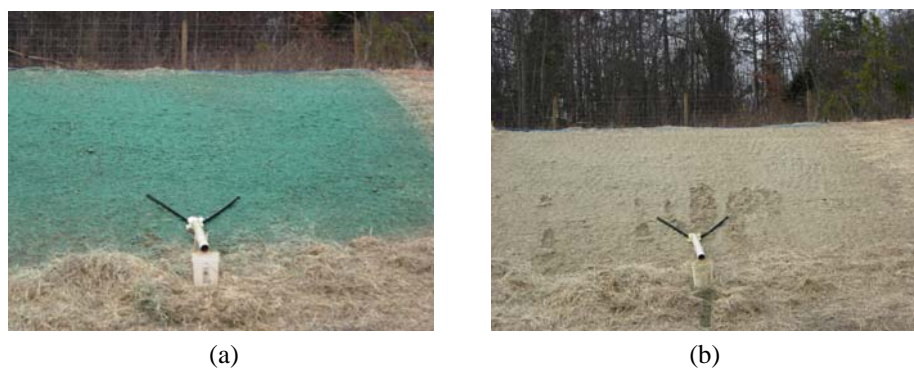
Figure 1.15. Wood hydromulch without PAM a. February 2, 2006 b. February 10, 2006, showing some failure starting at mid-slope.

When totaled over all storm events, there was no clear evidence of a PAM effect among the ground cover treatments (Table 1.1). However, both average turbidity and total sediment were reduced substantially for all three treatments. Most of this occurred during the first event. This is expected as the PAM effect is often reduced with each rain event. Straw alone was not substantially less effective than the other ground covers in total sediment loss, and was significantly better when PAM was added (Table 1.2). The exceptionally large difference with the wood fiber hydromulch is largely the result of the plot shown in Figure 1.15b, as previously noted.

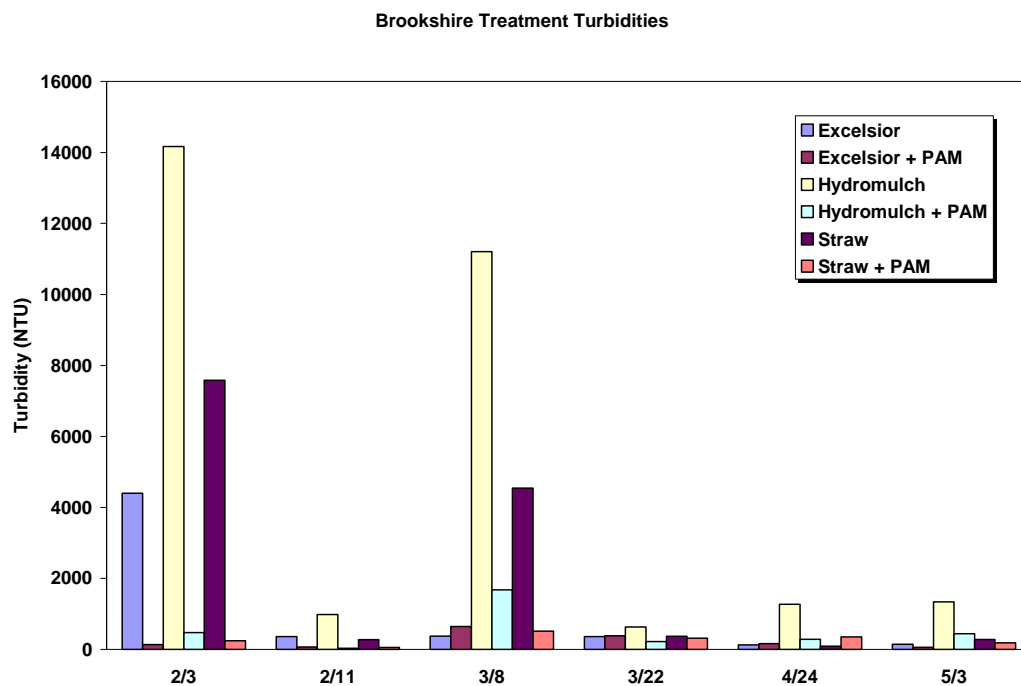
Figure 1.16. Turbidity for runoff from each storm event at the Brookshire Boulevard plots. Shown are averages of three plots per treatment.

Turbidity was very high in the non-PAM treated plots after the first event, but declined sharply afterward (Figure 1.16). In all cases, the PAM treatment reduced turbidity significantly during that event. The PAM effect declined in the straw and excelsior plots, but continued to reduce turbidity in the wood fiber hydromulch plots. The straw and excelsior treatments tended to have similar turbidities while the wood fiber hydromulch tended to have higher turbidity, most likely due to areas of failure in the plots (Figure 1.15b). The total sediment followed the turbidity trends, with wood fiber hydromulch > straw > excelsior, and the PAM treatment reducing sediment losses at least initially (Figure 1.17). The hydromulch failure shown in Figure 1.15b resulted in very high sediment loads during the first several events, which partly explains the subsequent poor performance evaluation of this ground cover.

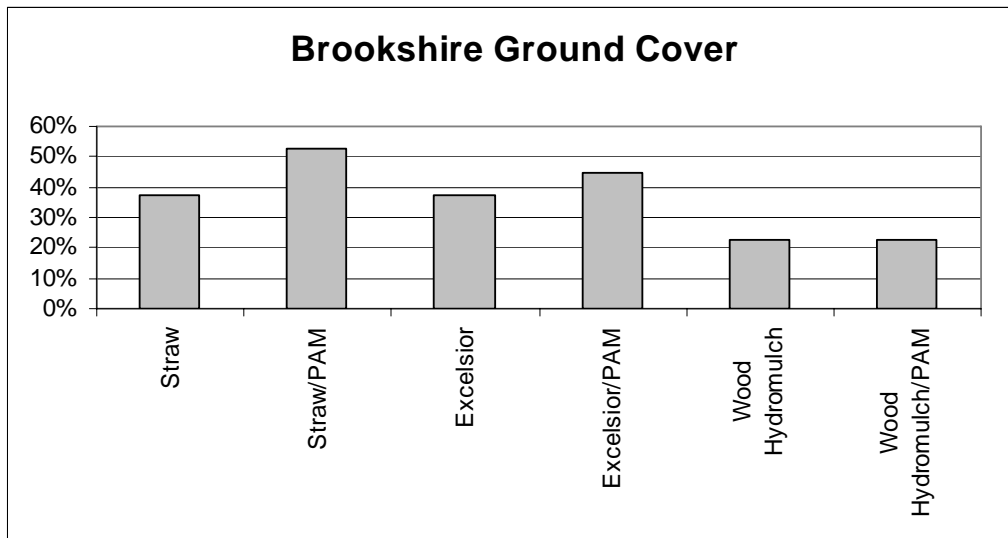
Figure 1.18. Vegetation cover for each treatment at the Brookshire Boulevard area site.

Vegetative cover, as estimated by 4 different evaluators, was somewhat higher in the PAM treatments and lowest on the wood fiber hydromulch treatment (Figure 1.18), although the differences were not as dramatic as for the runoff samples. Biomass followed the same trend (Figure 1.19). Overall, grass growth

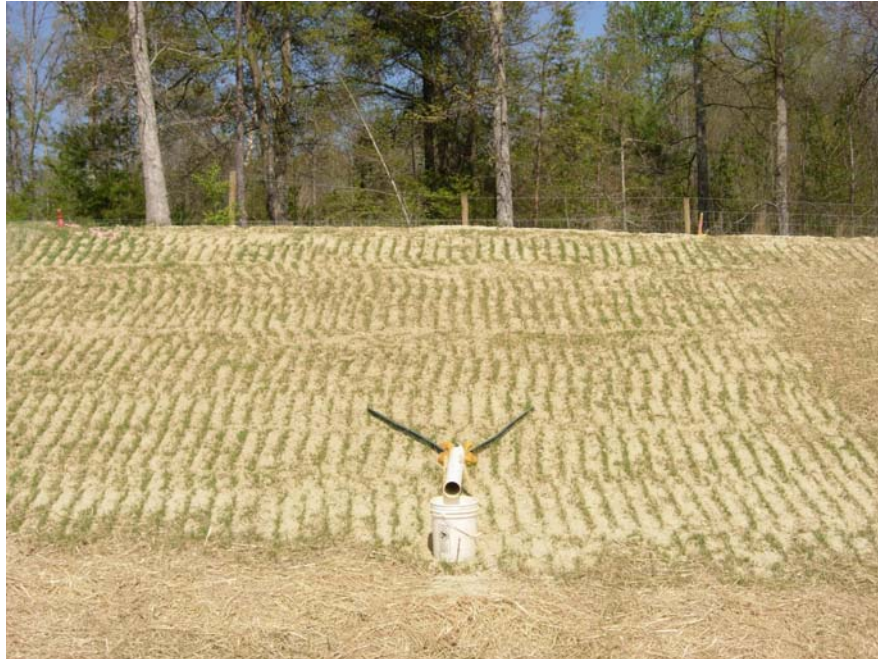
Figure 1.20. Grass growth on a wood fiber hydromulch plot three months after planting.

was relatively uniform at this site, even though the tracking was apparently done across the slope instead of up and down the slope (Figure 1.20).

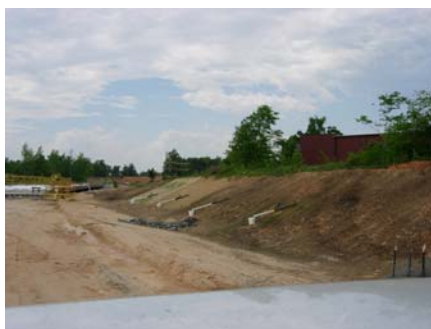
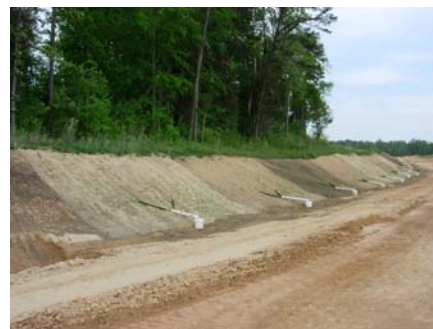
Figure 1.21. Old Statesville plots. a. Plots 1-5, and b. plots 6-18.

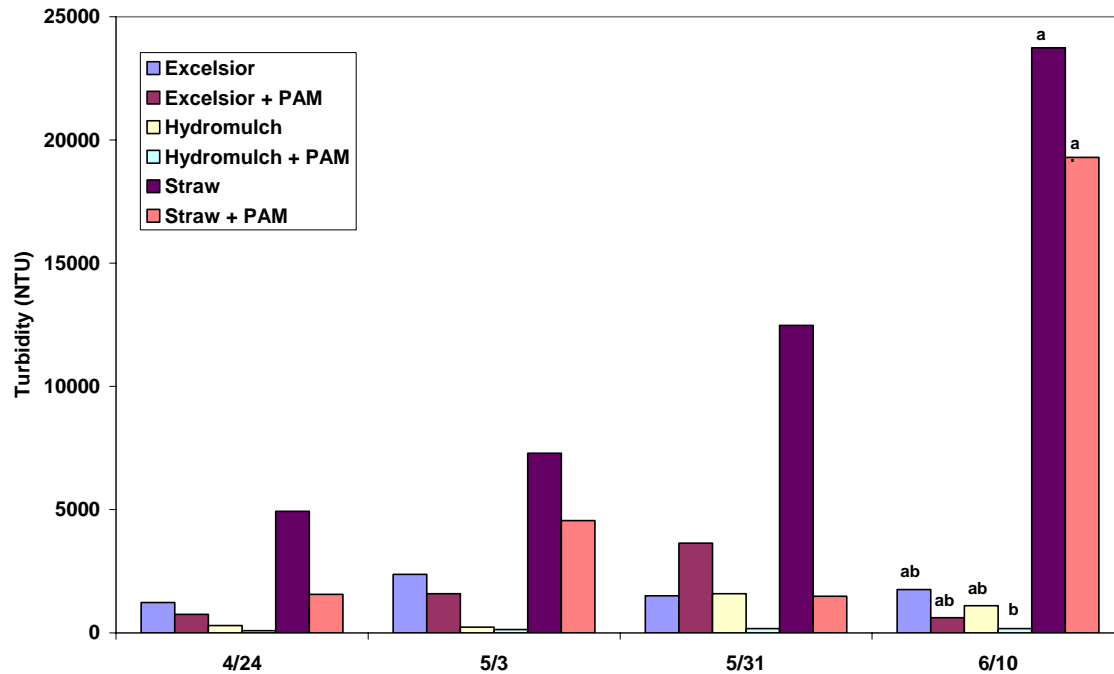
Old Statesville Treatment Turbidities

Figure 1.22. Turbidity in runoff from the plots at the Old Statesville Road site. Shown are averages of three plots per treatment. Bars with different letters are significantly different at $P < 0.10$.

The straw plots again had the highest turbidity, but at this site PAM did not appear to be as useful in reducing it (Figure 1.22). The Flexterra ground cover had lower turbidities than the excelsior matting. A significant runoff event at the end of the evaluation (June) produced very high turbidity, relative to earlier events, in the straw plots but not in the excelsior or Flexterra plots. Overall, the greatest effect of PAM was in the Flexterra ground cover (Table 1.3), but the turbidity was quite low even without PAM in this treatment.

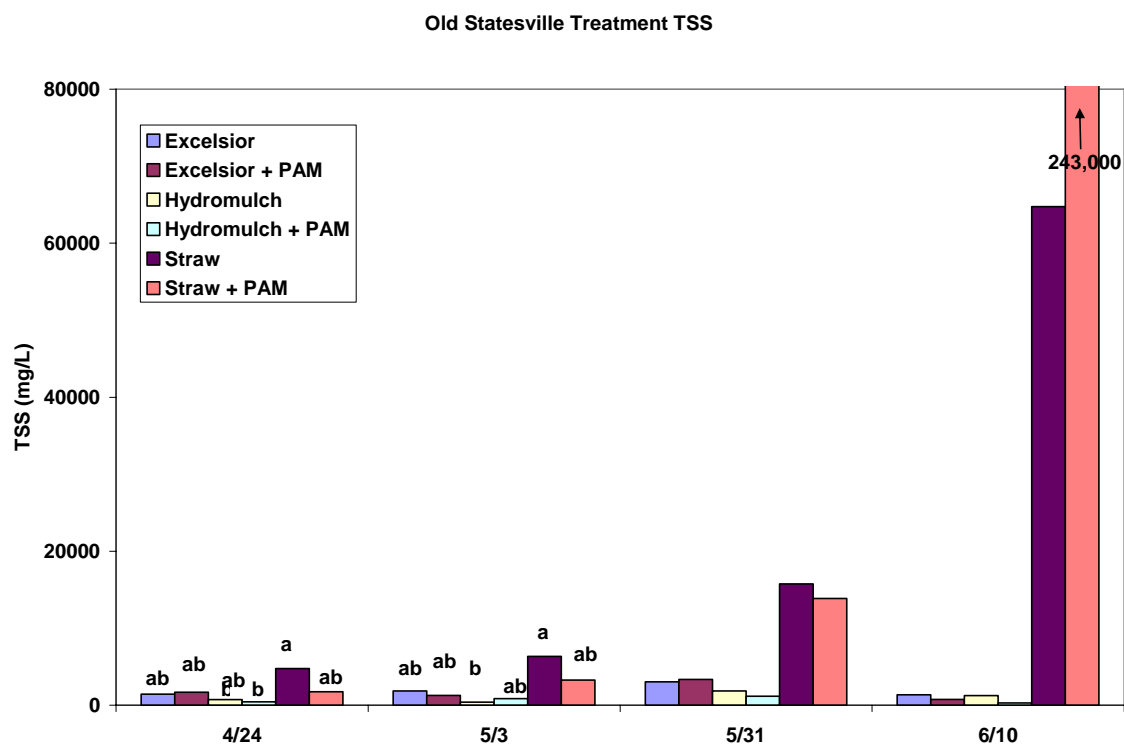
Figure 1.23. Total suspended from treatments from the Old Statesville Road plots. Bars with different letters are significantly different at $P < 0.10$. *Straw/PAM results include one plot for the June 10 event with abnormally high sediment compared to all other data.

Sediment losses followed the turbidity results closely, but the straw and excelsior covers benefited more from PAM than Flexterra (Figure 1.23, Table 1.3). Both alternatives reduced sediment losses compared to

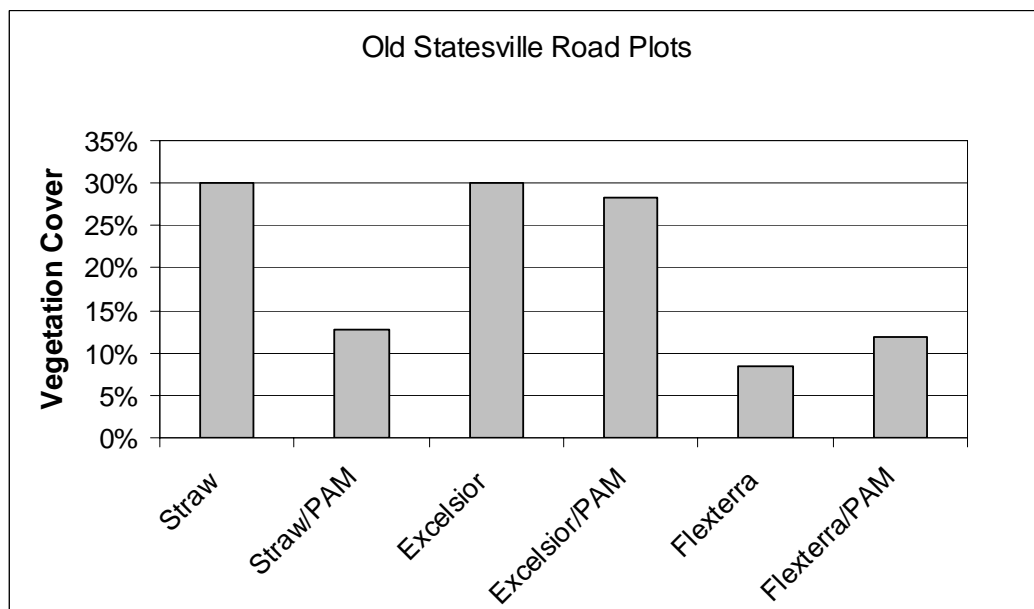
Figure 1.24. Vegetation cover on plots at the Old Statesville Road site, measured in June, approximately two months after establishment.

The coverage after two months of grass growth was better on the straw alone and both excelsior treatments compared to the straw + PAM and both Flexterra treatments (Figure 1.24). Biomass production was very similar in ranking, and the benefits of PAM were not evident in any cover treatment (Figure 1.25). For this location, the Flexterra had a clear advantage in reducing erosion but the grass did not grow as well as in the excelsior treatment. Visual assessments indicated that the excelsior matting had more evenly distributed grass growth compared to other treatments, which had most of the growth in the lower 1/3 of the slope.

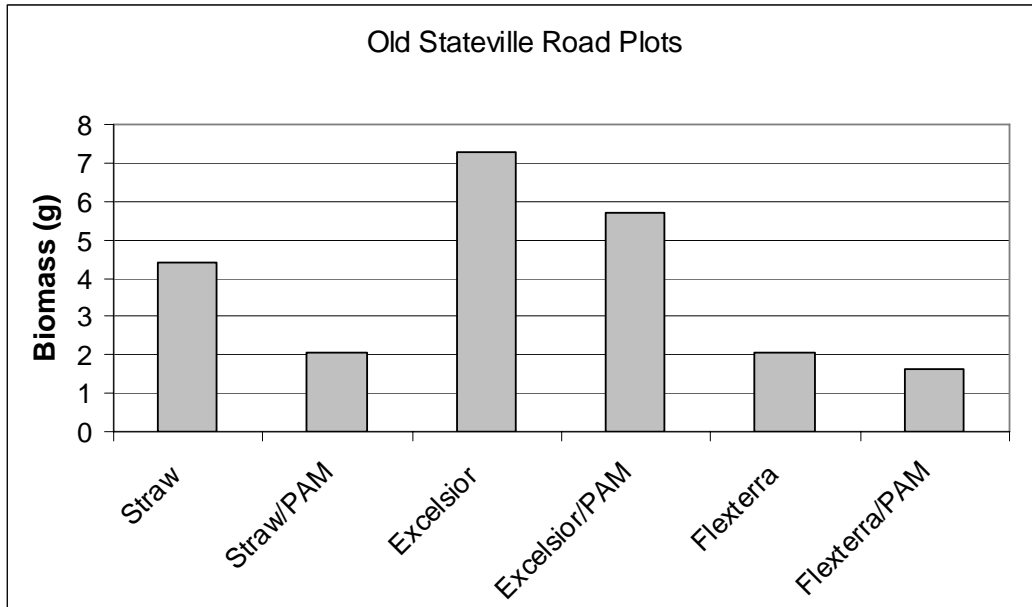
Figure 1.25. Total biomass measured in June, approximately two months after establishment.

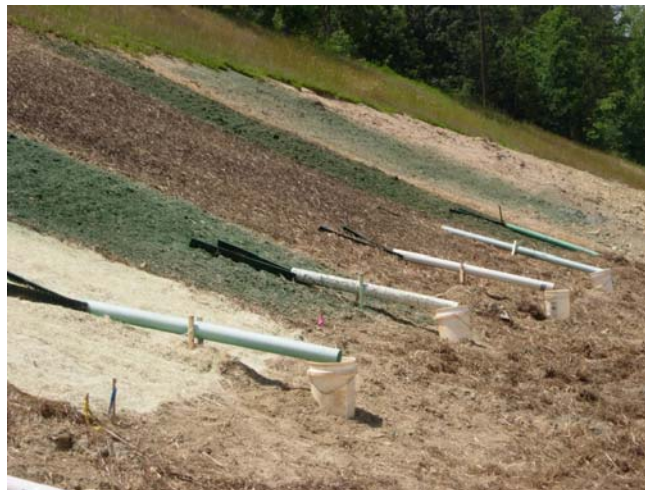
Figure 1.26. Forest Drive plots at establishment.

This site included standard straw with and without PAM, Flexterra mulch, excelsior, cotton hydromulch with and without PAM. The plots were on a 270 ft area of slope, using 15' x 30' plots (Figure 1.26). PAM was applied at a rate of 33 lbs/acre. Soil material at this site was very loose saprolite. Because the seeding was done in the summer, lespedeza was used as a temporary cover.

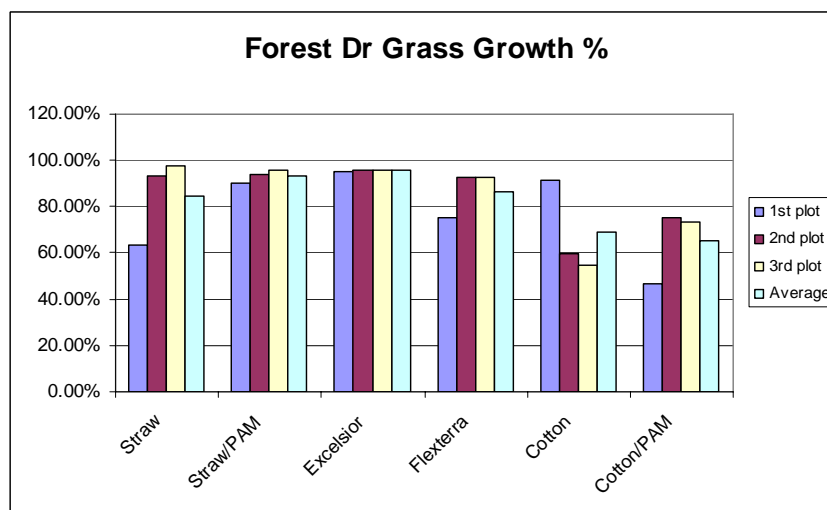
Figure 1.30. Ground cover by plot and average per treatment.

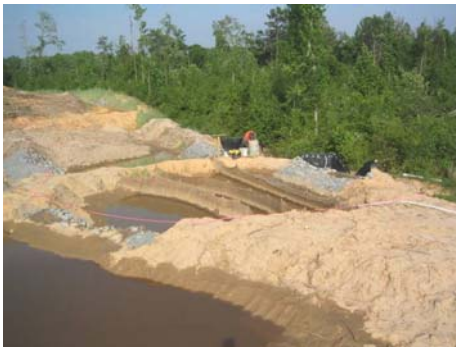
Figure 2.3. Basin 1 and 2.

Our first study area was installed as a paired trap study to evaluate the effects of porous baffles (Figures 2.2 and 2.3). Initially, the drainage areas had moderate slopes and were about two acres in size. In both cases, the flow was diverted into a forebay with a rock/stone outlet into the main pond. The standard traps have the perimeter ditch emptying into the side of the basin. Three baffles were installed using a combination of erosion control blanket (North American Green C-125) plus jute matting. We also experimented with jute matting, manufactured check dams, and PAM logs (Figure 2.4).

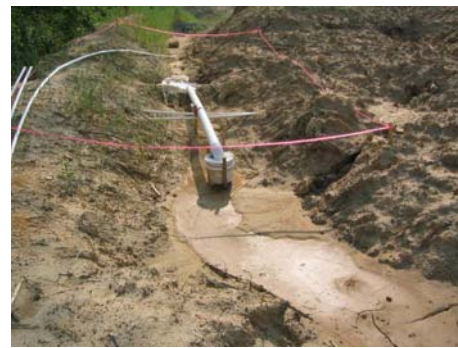
Figure 2.4. Floc log in bucket.

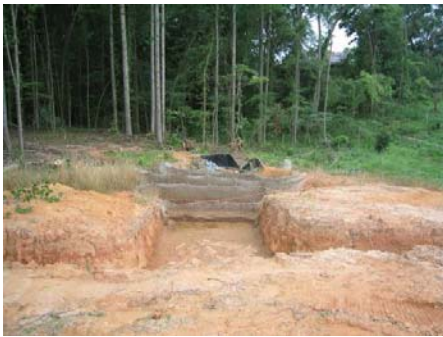
Figure 2.6. Trap 3.

This sediment trap was located on the perimeter of the highway project behind the DOT construction trailer on Oakdale Rd (Figures 2.1, 2.5, 2.6, and 2.7). The drainage area was relatively flat and about one acre in size. The original basin was modified by creating diversions from the two perimeter ditches to force the runoff away from the outlet dam. Porous baffles were also installed. A PAM log was placed in each ditch below the last check dam (Figures 2.7 and 2.8) and the ditch was lined with jute below that and PAM powder was periodically sprinkled on the matting.

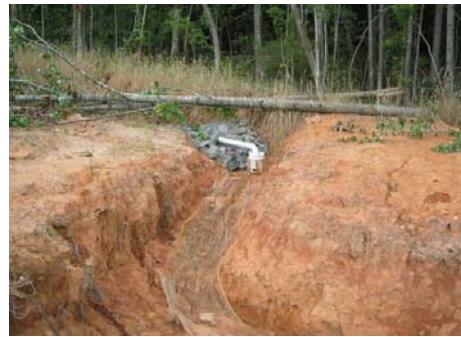
Figure 2.7. Trap 3 ditch with PAM log and jute lining.

PAM logs were placed below a pipe outlet in a bucket (Figure 2.7) and in the open (Figure 2.8). The concept was to settle the heavy sediment behind the check dams and for the turbid water to fall onto the logs, dissolving the PAM. In the bucket, however, we had an accumulation of sediment on the logs which greatly reduced PAM release. The log left in the open also did not appear to be releasing much PAM due to hardening. While some turbidity reduction may have occurred as a result of the PAM treatments, we did not achieve results similar to our findings in controlled testing.

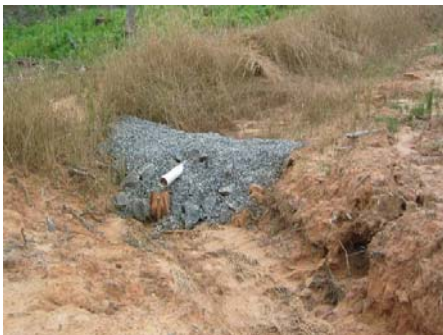
Figure 2.8. PAM log placement below check dam.

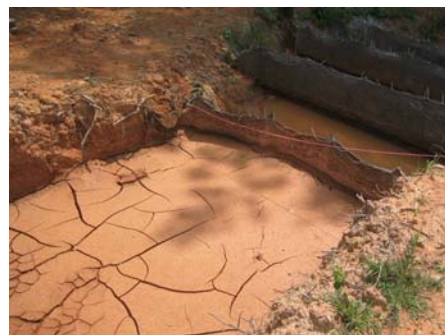
Figure 2.9. Sediment captured above baffle.

The relatively flat terrain and small area resulted in very little runoff into this trap. However, the baffles appeared to work well in settling much of the sediment which did come to the trap (Figure 2.9). Overall, the turbidity leaving this trap was somewhat less than in trap 2, but with different soil, slope, and other factors there is no direct comparison possible. Compared to turbidity measured later in this project as well as at other locations, these turbidities were relatively low.

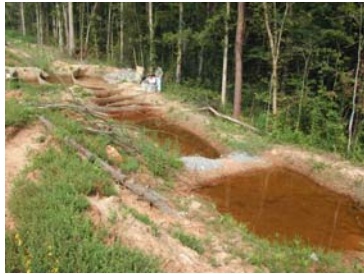
Figure 2.11. Trap 4 with forebay after a storm event.

We observed that the combination of ditch checks, lining with jute, and PAM treatment in the steep ditch appeared to be effective during low-flow events, or toward the end of larger events. This is visually apparent in Figure 2.11, showing very clear water in the forebay. The sampler on the forebay often only obtained one sample in each event, so we were not able to fully confirm our observations. The trap outlet integrated the runoff from both ditches, and the low-slope ditch had little evidence of PAM being effective. However, the turbidity measured leaving trap 4 was often lower than we typically observed (Table 2.6).

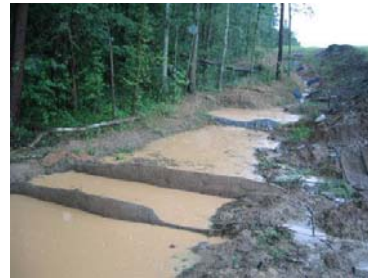
Figure 2.12. Trap 4 during storm event.

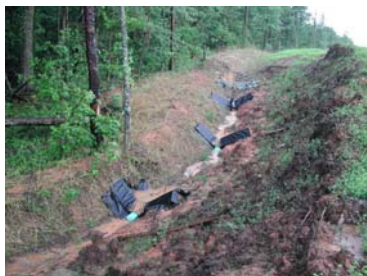
Figure 2.13. Perimeter ditch with check dams and PAM logs.

Sediment trap 4 was located at the bottom of a slope where two perimeter ditches collected runoff (Figure 2.10). One perimeter ditch had a relatively steep slope and this is where we installed multiple check dams (Triangular Silt Dikes) as well as PAM logs placed below the check dams and in corrugated pipe (Figure 2.13). Also on this side, we installed a forebay and porous baffles (Figures 2.11 and 2.12). On the other perimeter ditch, which had very little slope, we installed two check dams (Triangular Silt Dikes) with PAM logs (Figure 2.14).

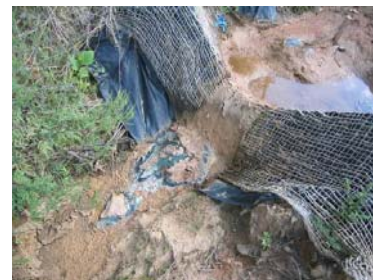
Figure 2.14. PAM log after check dam in low-slope ditch.

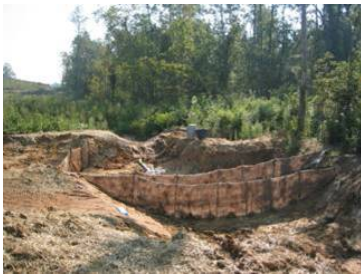
Figures 2.16. Basin 5.

Basin 5 was very similar in physical layout to trap 4 except that it had a skimmer outlet (Figures 2.15-2.18). A forebay was constructed on the side where the steeper ditch was located. Multiple check dams (TSD) were installed in the ditches and they were lined with jute netting. PAM logs were placed below the check dams and powder was periodically applied to the ditch liners.

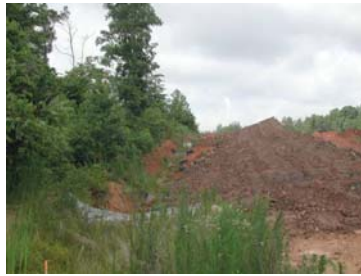
Figure 2.17. Ditch into forebay.

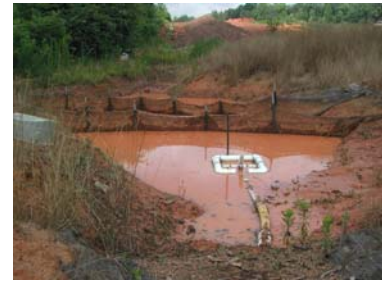
Figure 2.18. Skimmer outlet.

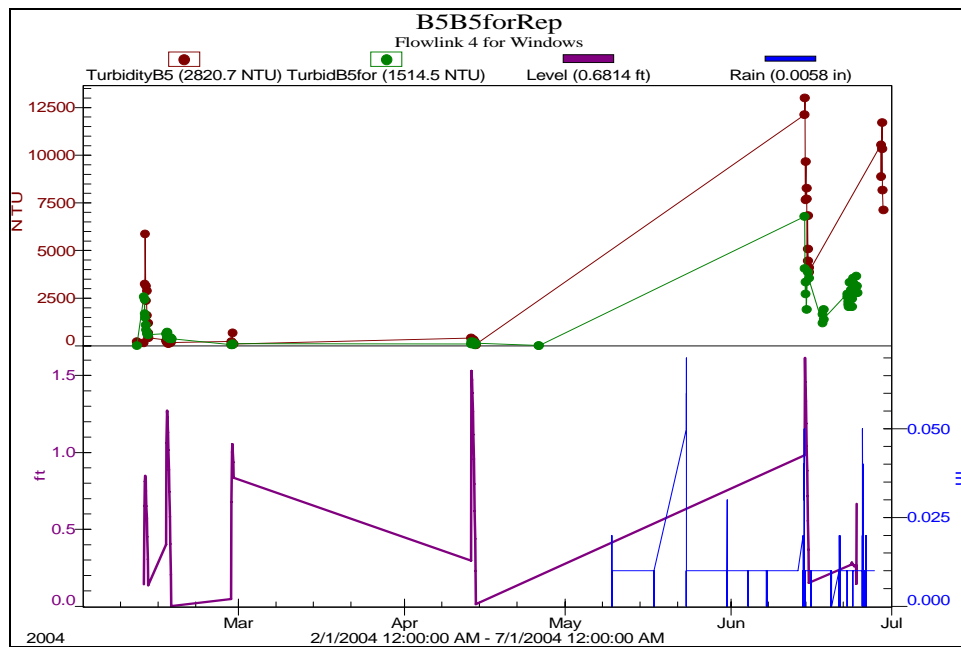
Figure 2.19. Basin 5 turbidity, rainfall and water levels from February 1, 2004 through July 1, 2004. The brown dots represent the basin outlet and the green dots represent the forebay outlet.

The initial results indicated much lower turbidity levels in both the outlet and the forebay compared to typical traps (Figure 2.19, Tables 2.7a and 2.7b). This was likely a result of the PAM treatment to some extent, but sediment loads were relatively low during that period because the site was not being actively disturbed. By June, however, the area above the basin was receiving large amounts of fill material and the turbidity levels increased more than an order of magnitude. We observed that the PAM logs became coated with sediment during this period and probably released very little PAM. Sediment in the ditches also covered up the PAM powder which was applied to the lining material.

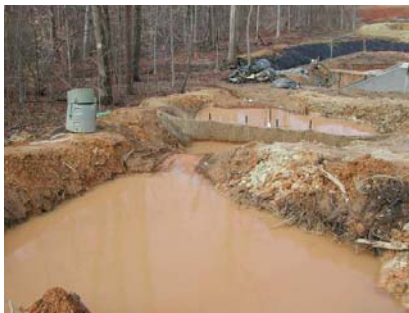
Figure 2.21. Basin 6.

The basin 6 study consisted of a forebay, main basin with baffles and a skimmer outlet (Figure 2.1, 2.20 and 2.21). In this basin set up, two check dams (triangular silt dike and straw wattle) were installed in close succession with PAM logs placed between them to hold them in place and to keep them protected from drying (Figure 2.22). PAM logs were also placed in the spillway from forebay to basin.

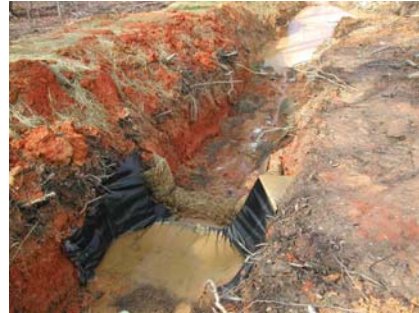
Figure 2.22. Check dam.

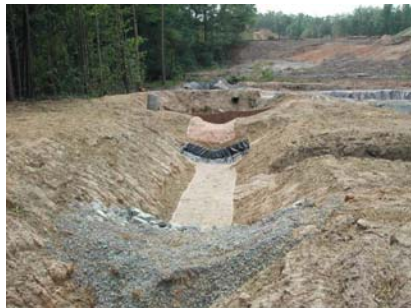
Figure 2.24. Channel into forebay.

The basin was modified to have a baffle in forebay and main basin with a skimmer outlet (Figure 2.1, 2.23 2.24, and 2.25). An intermediate drainage ditch was also added, diverting flow into forebay. PAM logs were placed in the ditches after check dams, inside corrugated pipes to prevent drying out (Figures 2.26 and 2.27). The inlets were all protected with coir blankets.

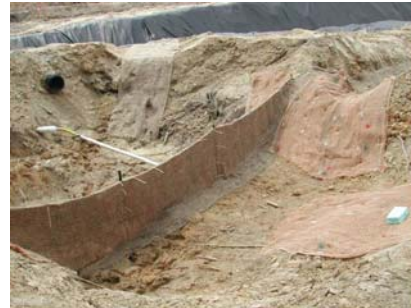
Figure 2.25. Main basin with baffle/skimmer.

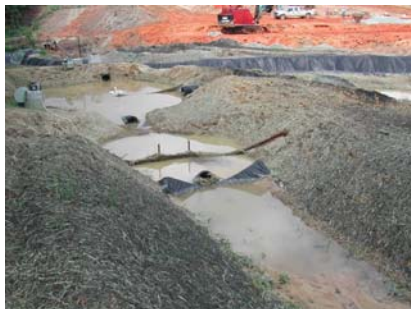
Figure 2.26. Basin 7 during storm event.

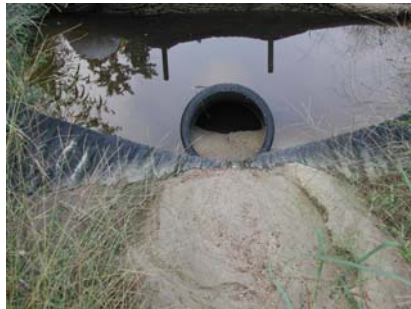
Figure 2.27. Sediment load in pipe.

Turbidity levels were similar in the forebay and the basin outlet, only showing a small decrease with treatment train (Figure 2.28 and Table 2.9 a and b). The high sediment loads coming into the system tended to bury the PAM logs in corrugated pipe, preventing the release of PAM in the runoff (Figure 2.27). In addition, the second ditch entering the basin below the forebay probably reduced the effectiveness of the system. Often the turbidity in the forebay was lower than at the basin outlet.

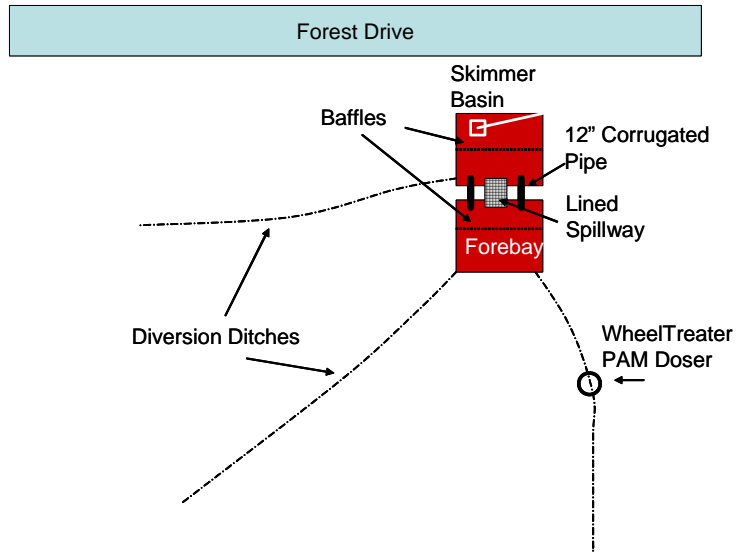
Figure 2.29. Basin 8 design.

Our most significant modification to a basin, up to this point, was at Basin 8. This location had a steep slope which provided an opportunity to establish a more aggressive treatment design. The area draining to the sediment basin was approximately three acres. A forebay was constructed to intercept one perimeter ditch and a new diversion ditch was installed to capture most of the flow on the other side and direct it into the forebay (Figures 2.30 and 2.31). Two 12" pipes were installed in the dam between the forebay and basin along with a lined emergency spillway. The basin had a skimmer outlet and a lined emergency spillway. A single porous baffle was installed in both the forebay and the basin (Figure 2.32). PAM logs were placed in the pipes between the forebay and basin. In addition, the ditches were lined with jute and PAM powder was applied periodically. Additional check dams (TSDs) and PAM logs in pipes were placed in the ditches as well (Figure 2.30). We also experimented with a liquid PAM dosing system (Figure 2.34) in the perimeter ditch.

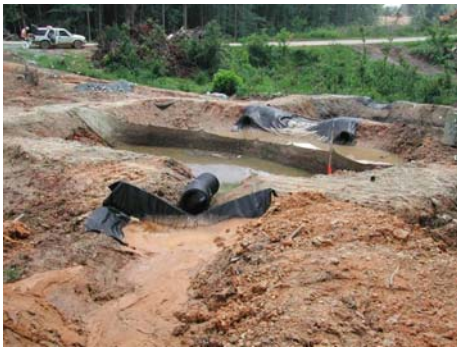
Figure 2.30. Basin 8 forebay with PAM log in pipe.

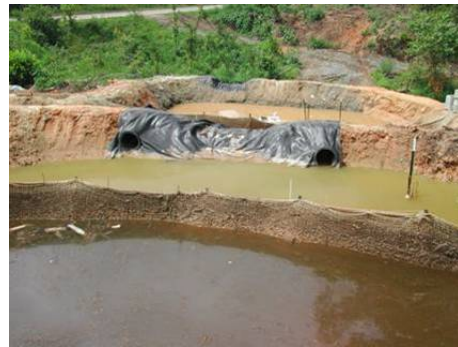
Figure 2.31. Basin 8 after a storm.

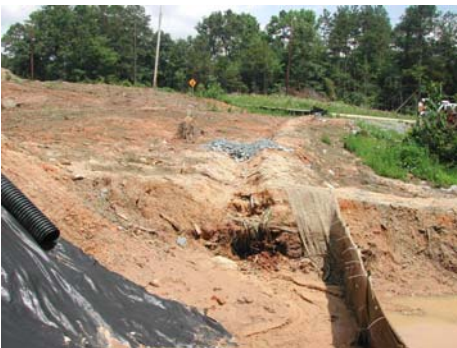
Figure 2.32. Lower perimeter ditch.

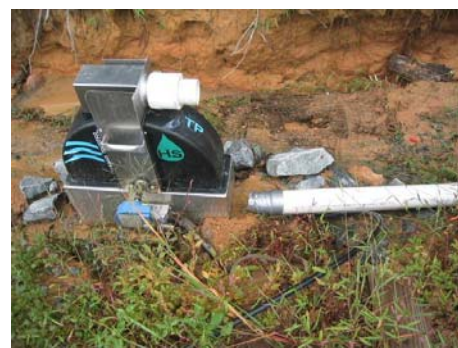
Figure 2.33. Liquid PAM dosing system.

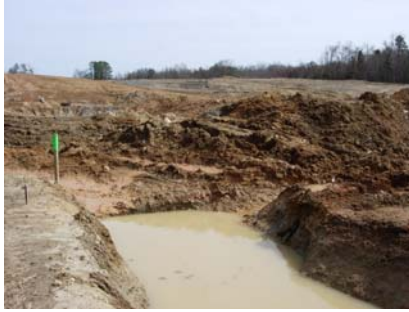
Figure 2.35. March 2005 Basin 10 before modification.

Basin 10 was a sediment trap which we modified largely based on our apparent success in Basin 8. The location of the basin was relatively flat but there were about 4 acres of sloping land draining to it (Figure 2.35). Both it and its watershed underwent many transformations during our 9 months of monitoring. Essentially all the elements from Basin 8 were installed initially, including a skimmer outlet on the basin (Figure 2.36) and large forebay with three baffles (Figure 2.37). Liquid PAM was dispersed using the wheel treater in the side ditch to forebay, but only for a few storms (Figure 2.38). The ditches were lined with jute and additional check dams (Triangular Silt Dikes and GeoRidges, Figure 2.39). PAM powder was applied to the ditches and check dams periodically, and PAM logs were placed below several check dams in the ditches.

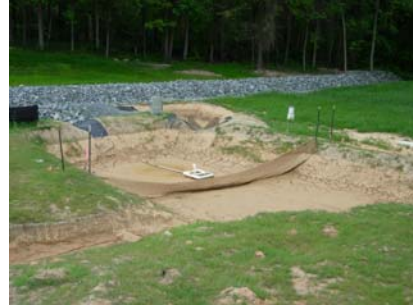
Figure 2.36. Main basin w/baffle and skimmer.

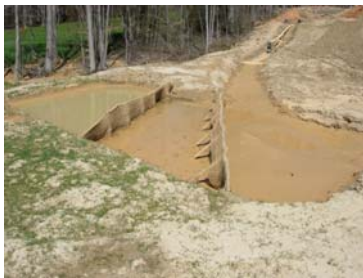
Figure 2.37. Forebay with baffle.

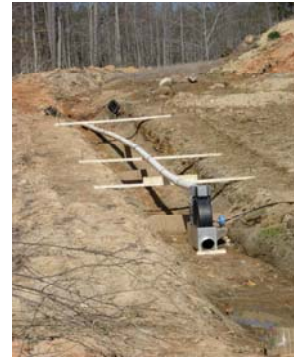
Figure 2.38. Wheel treater in ditch.

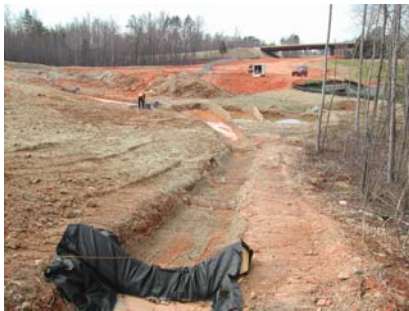
Figure 2.39. Lined perimeter ditch with check dams.

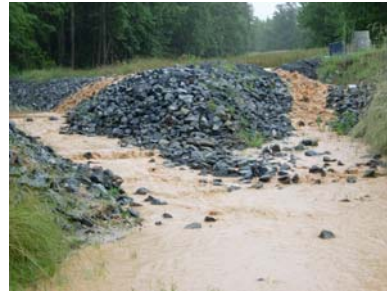
Figure 2.40. June 2005 Overflow into stream.

In late June the forebay was removed by the contractor as well as the skimmer, although it was not clear why. The next three storm events produced the highest turbidities at the basin outlet that we had seen at this site (Figure 2.40 and Table 2.10c). The monitoring results are shown for the whole time period (Figure 41) and for two example storms (Figures 42-43), and indicate a trend toward higher turbidities in the summer as a result of significant disturbances in the watershed. There may also have been a change in sediment type because considerable fill was being added to the roadbed. Because the basin was modified to a smaller, standard trap in July, we considered it a new site and named it “New Basin 10”, which will be discussed in the next section.

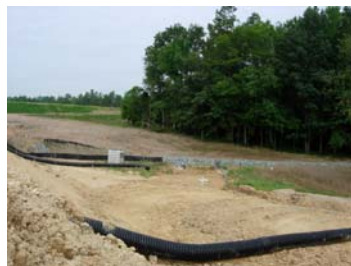
Figure 2.44. New basin 10.

New Basin 10 was a modification from Basin 10, and was actually a sediment trap since the outlet was changed to a rock dam. A single baffle was installed using 700 g/m² coir matting and installed using fence posts and wire. All ditches and channels were lined with jute matting. Two slope drains were installed, draining into main basin and ditch (Figure 2.1, 2.44 and 2.45). PAM logs were installed in each slope drain (1 log 706d/ 2 logs 703d3; each log cut in half). Two check dams (TSDs) were installed in ditch (Figure 2.46).

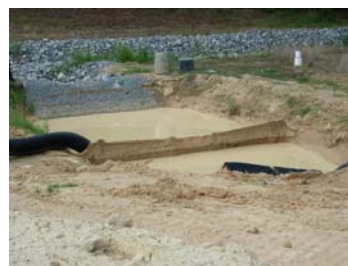
Figure 2.45. New Basin 10 with baffle.

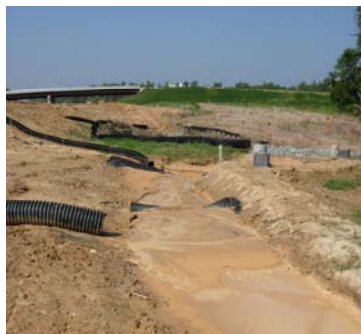
Figure 2.46. New Basin 10 with silt dikes.

The sediment loading to the ditch was very high and clogged the sampler intake so frequently that we discontinued sampling there (Figure 2.46). The slope drains were initially too short and caused significant erosion at their exit, but these were later extended to the ditch or trap (Figure 2.46). Overall, turbidity was quite high exiting new basin 10 throughout the remainder of our monitoring at that site (Table 2.13 and Figures 2.47, 2.48, and 2.49).

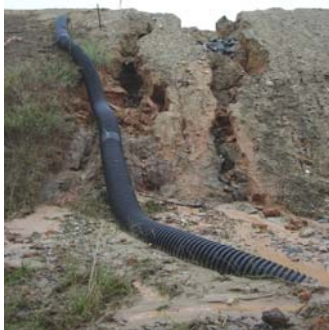
Figure 2.50. Gully from slope drain failure.

During the period we were monitoring Basin 10, a slope drain failure occurred (Figures 2.50 and 2.51). We surveyed the resulting gully to estimate the amount of material eroded as a result of this event. We determined that approximately 1430 cubic feet of soil was lost from the slope, although we did not determine how much of this made it into the basin.

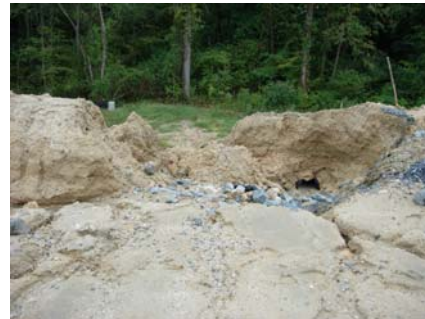
Figure 2.51. Failed Type A inlet protection.

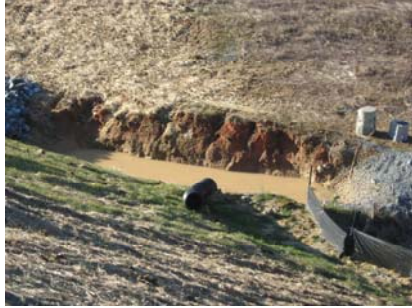
Figure 2.52. Basin 10 opposite.

Trap 10 opposite was a standard basin with a rock outlet located directly across the creek from Basin 10. No modifications were made to this trap or any part of the area draining to it – our interest was in monitoring a typical sediment trap in a relatively similar watershed to Basin 10. This basin was used as a control site to compare our modifications to (Figure 2.1, 2.52 and 2.53).

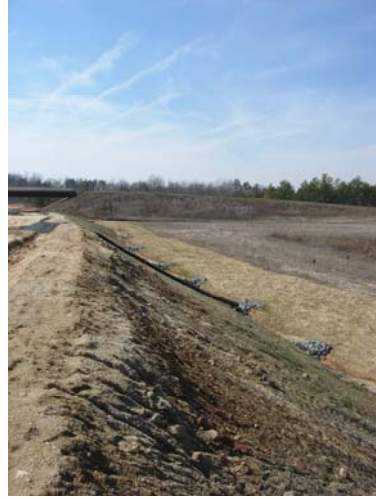
Figure 2.53. Ditch into basin 10 opposite.

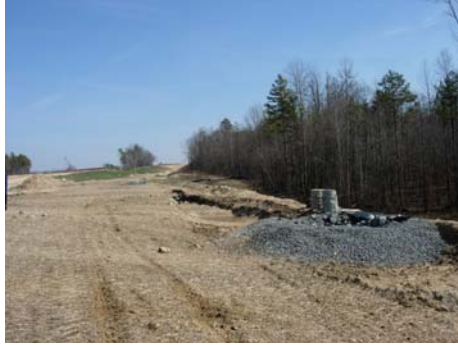
Figure 2.59. Site 11 set up.

Our interest at Site 11 was to evaluate the efficiency of a typical inlet protection device (Figures 2.59 and 2.60). We installed samplers in the ditch and inside the rock dam for this purpose. However, problems with the ditch sampler, including sediment clogging, sampler errors, and removal of the intake by unknown persons, resulted in no data from that sampler. The results we did obtain are shown in Table 2.15 and Figure 2.61.

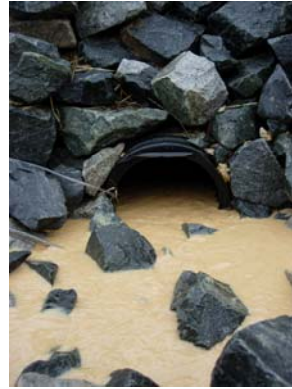
Figure 2.60. Storm flow outlet into slope drain.

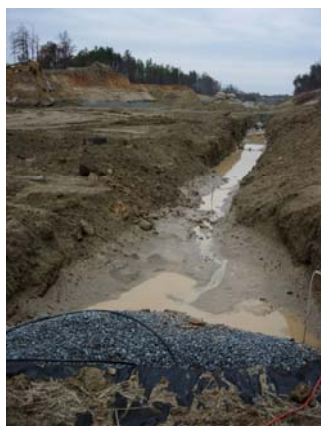
Figure 2.62. Basin 12 inlet.

Trap 12 consisted of a culvert draining a fill area of several acres and a slope drain from a small section of road both draining into a standard trap with a rock outlet (Figures 2.62 and 2.63). No modifications were made physically to this location, but we attempted to introduce PAM in several ways. PAM logs (703d3) were installed in both the culvert and the slope drain inlets (Figure 2.64). In addition, we attempted to dose with PAM solution through the use of a 300 gallon tank with approximately 1 ½ lbs of PAM and water mixed with a sump pump. This later system, which we assembled from spare sampler parts, never functioned properly during the period of testing at this site.

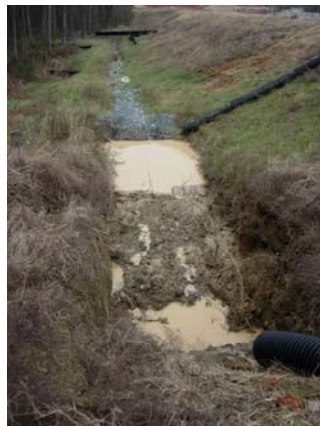
Figure 2.63. Basin 12 outlet.

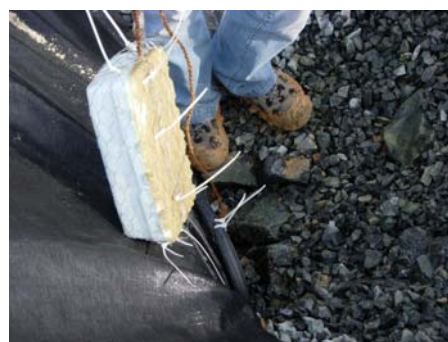
Figure 2.64. Basin 12 PAM Log.

The PAM logs did not appear to have much effect reduction on turbidity, most likely because they did not have sufficient flow to dissolve (Figure 2.64). Before further tests could be run, this site was modified for pipe installation. Table 2.16 a and b illustrate the turbidity levels at this location.

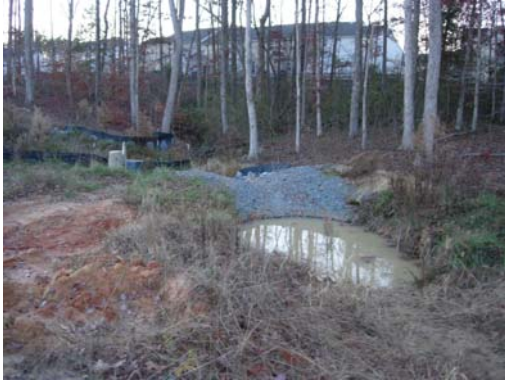
Figure 2.65. Basin 13.

This was a standard sediment trap with a weir installed below the rock dam (Figures 2.1, 2.65 and 2.66). The flow of water at this site was very small as a result of diversions in the ditch and general topography. The data, due to lack of runoff to this basin (Table 2.17 a and b, Table 2.18 and Figures 2.67, 2.68, 2.69 and 2.70).

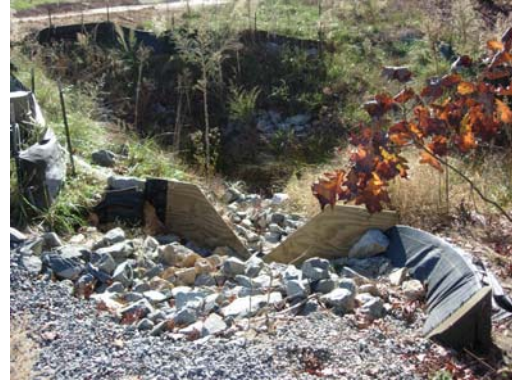
Figure 2.66. Weir at basin 13 exit.

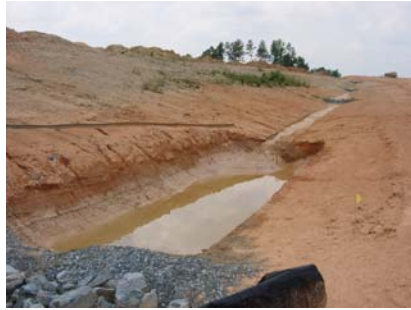
Figure 2.71. Basin 14.

Sediment Trap 14 was a typical Type B trap in an area near final grade (Figure 2.1, 2.71 and 2.72). We installed a sampler in the trap near the inlet to obtain “in” samples. We also installed a weir below the rock dam and a sampler to measure flow and obtain samples at the outlet. Table 2.19 a, b and c illustrate the very high turbidity levels which occurred in this basin. On average, the inlet and outlet turbidity levels were similar, although the inlet water was sometimes less turbid (Figures 2.73, 2.74 and 2.75). Surveys were completed after storm events to determine the capture rates for this basin.

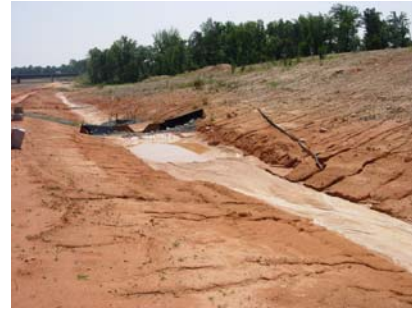
Figure 2.72. Basin 14 sediment accumulated.

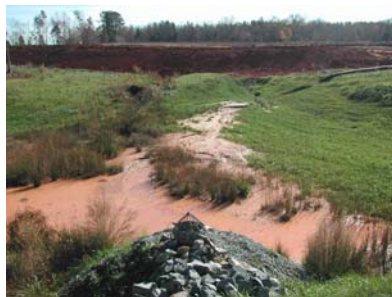
Figure 2.76. Riser basin from dam.

A standard riser basin was installed in 2004 just west of Puckett Road. A small sediment trap remained at the pipe outlet, so we installed a sampler there to obtain water samples. We also installed two PAM logs inside the riser barrel, since this was an ideal location for them. The watershed was relatively small for this structure during the period of monitoring, with much of the water diverted elsewhere. As a result, the basin filled in with vegetation and it essentially became a constructed wetland with a standing pool (Figures 2.76 and 2.77). The combined effects of a large, shallow basin and the PAM treatment resulted in relatively low turbidity and sediment concentrations for most storms, at least compared to the other sediment control structures we were monitoring (Tables 2.20-2.21).

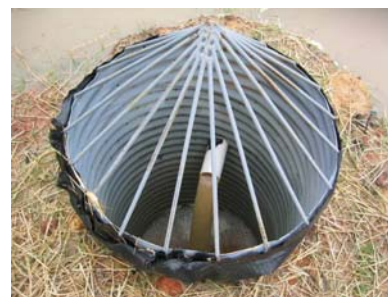
Figure 2.77. Riser basin outlet.

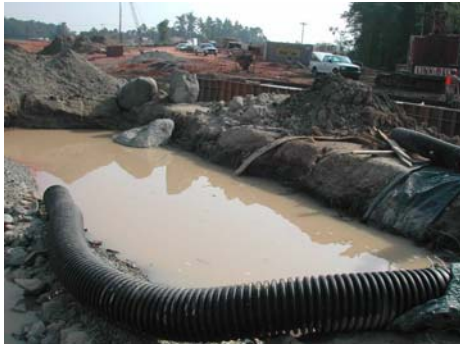
Figure 2.80. Stilling basin initially.

This stilling basin was located off Statesville Rd (Figure 2.79). PAM was incorporated into pumped water prior to entrance into stilling basin by passing the water over two PAM logs and powder spread inside the 60 feet of pipe (Figures 2.80 and 2.81). Only limited testing was done with grab samples at this site, but generally the suspended material was flocculated successfully. Because of the sporadic nature of the pumping there, we did not install samplers.

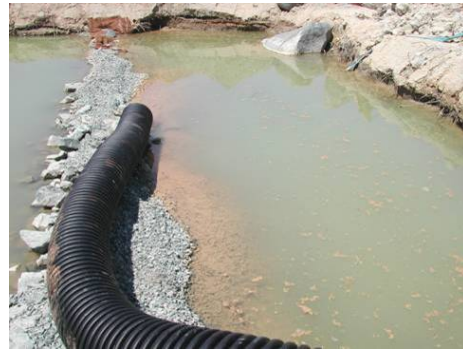
Figure 2.81. Flocs formed on right after pumping.
