Minimizing Water Quality Impacts of Road Construction Projects

North Carolina Department of Transportation
PROJECT AUTHORIZATION NO. HWY- 2003-04

1. Report No. FHWA/NC/2006-21	2. Government Accession No.	3. Recipient's Catalog No.	
4. Title and Subtitle Minimizing Water Quality Impacts of Road Construction Projects		5. Report Date 1/25/2007

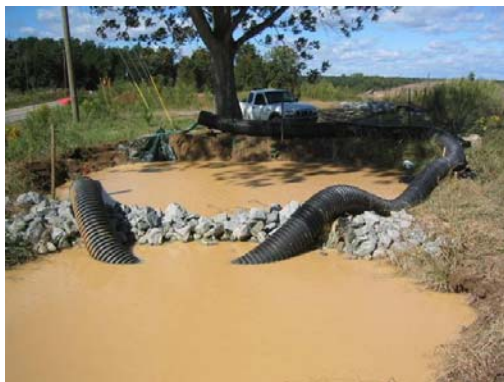
Figure 2.82. Stilling basin setup

This site had two phases for testing. Initially, we attempted to try the passive dosing system in the existing stilling basin (Figures 2.82 and 2.83). This basin was very small and we had great difficulty in keeping our system functioning. Eventually, a second, much larger stilling basin was installed at a considerable distance and drop in elevation from the first basin (Figure 2.84). Two modifications were made. First, we covered the rock baffle in the basin center with coir erosion control matting and sprinkled PAM on it. Second, we stabilized the inlet with coir matting and sprinkled PAM on it as well. A sampler was placed at the outlet of that stilling basin and the results are shown in Figure 2.85. The pumping often occurred as a result of rainfall but not always, since there was a groundwater source where the pumping was being done. The peak of turbidity reflects the pumping activity. This indicates that the PAM dosing was working at low flow, but at peak flow the flocculation was not as complete.

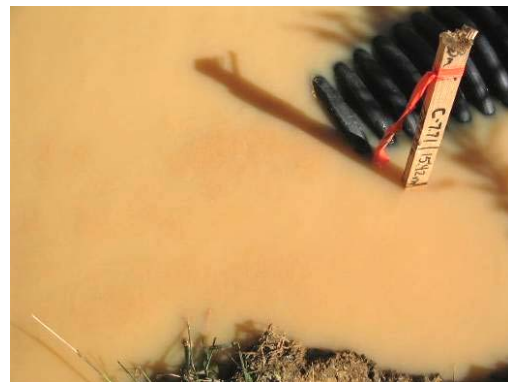
Figure 2.83. Flocs forming in basin

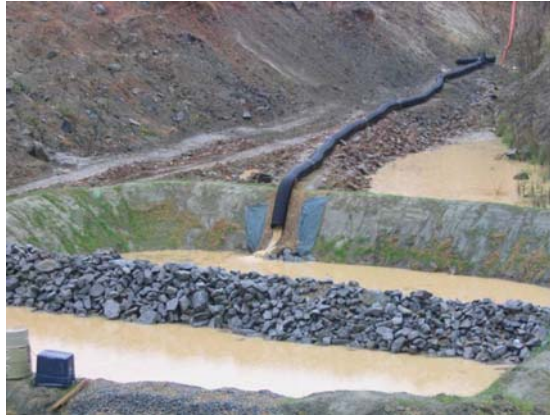
Figure 2.84. Stilling basin setup.

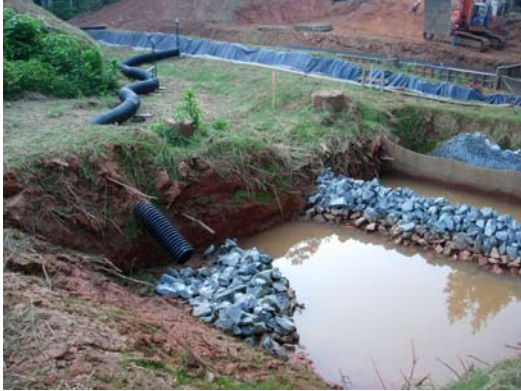
Figure 2.86. Pumping set up.

A small stilling basin was located on Old Statesville Rd at stream crossing (Figure 2.79). Figure 2.86 illustrates the treatment system. We placed 40' of 12" pipe adjacent to the basin and added 2 ½ lbs of PAM throughout the pipe length in four different spots. Collection started after 1 minute, 2 minutes, 3 minutes (stopped pump at this time) and at 4-5 minute when water velocity significantly decreased. Figures 2.87 and 2.88 illustrate the clear water and floc formation that was visually assessed following PAM treatment. This site had very little pumping occur and the basin was removed before we could do further testing.

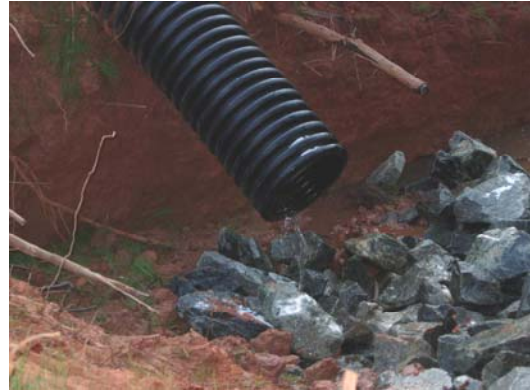
Figure 2.87. Clear water treated with PAM.

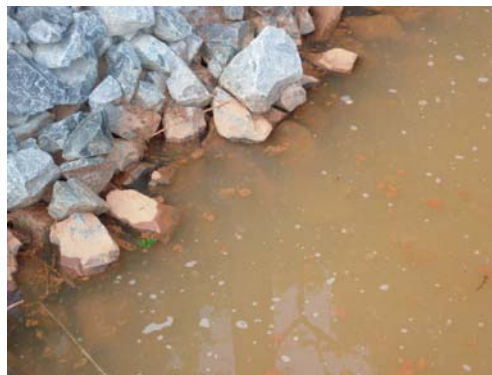
Figure 2.88. Flocs formed in the stilling basin.

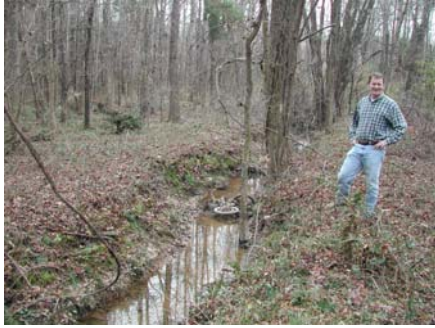
Figure 3.2. Typical cross section in stream 1.

The Stream 1 site was located above any road construction work and downstream of a housing development being constructed (Figure 3.2). Stream 2 had very similar characteristics (Figure 3.3), but it was affected by a culvert below it which was damaged and as a result backed water into the weir. As a result, the Stream 2 data are not as complete as Stream 1. The large area of disturbance associated with the housing development resulted in considerable sediment and turbidity in the stream (Table 3.1). Overall, it did not appear that the stream had significant additions of sediment from the 485 project above what was coming from the upstream construction site.

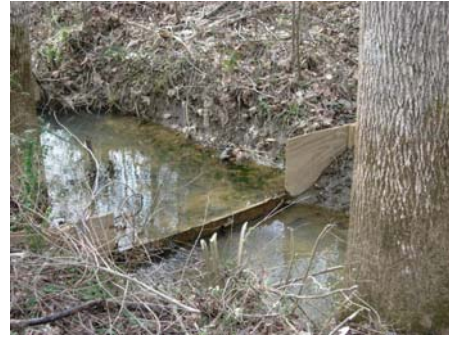
Figure 3.3. Stream 2 monitored cross section with rectangular weir.

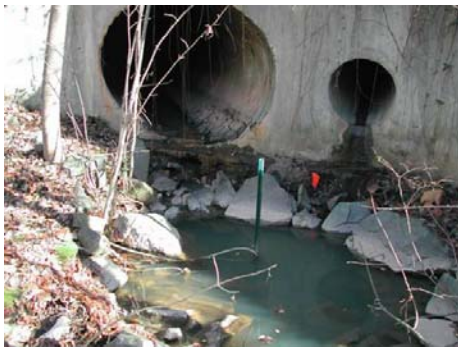
Figure 3.4. Stream 3.

The Stream 3 and 4 paired site was the opposite of the Stream 1 and 2 site. The Stream 3 site had two culverts draining an office park area with no evidence of surface disturbances (Figures 3.4-3.5). As a result, the turbidity levels were relatively low at this site (Table 3.4). Because of the nature of the site, having two culverts, we did not measure flow but only samples the water during storm events.

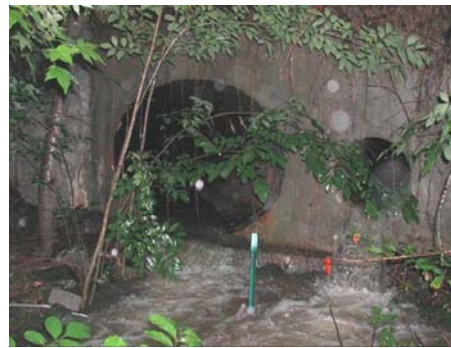
Figure 3.5. Stream 3 during storm.

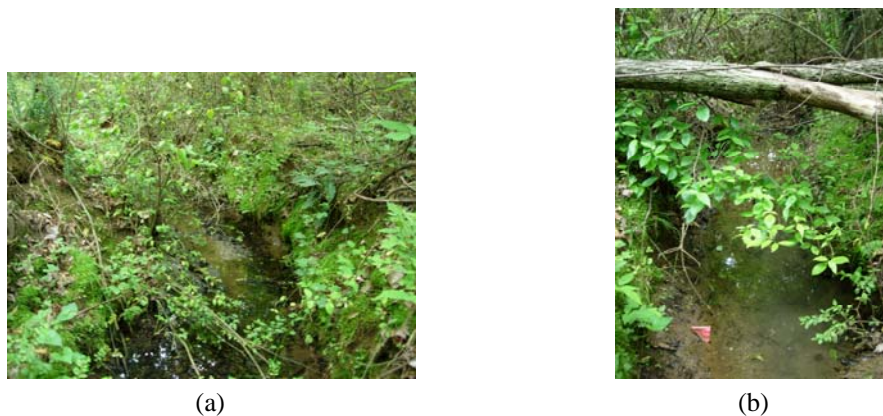
Figure 3.11. Cross-section 100 morphological survey from 2003, 2005 and 2006.

This cross-section is located on a small tributary to Long Creek off Mt. Holly Rd downstream from I-485 construction (Figures 3.9 and 3.10). This site was selected as a reference area, undisturbed by recent construction activities. The survey location for 2003 was relocated in 2005 due to construction impacts at the 2003 location. The cross-section dimensions and substrate measurements from 2005 to 2006 showed no significant changes (Figure 3.11 and Tables 3.5 and 3.6).

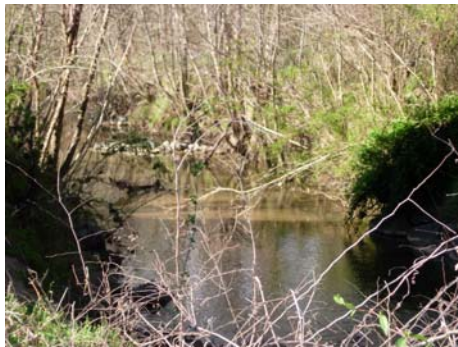
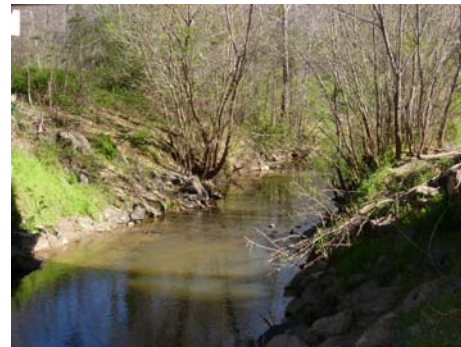
Figure 3.12. a. Typical cross-section looking upstream. b. Typical cross-section looking downstream.

This cross-section is located the furthest downstream on the main stem of Long Creek. The site is directly upstream of highway 16 (Figures 3.12 and 3.13). No significant changes were noted during the study period (Figure 3.14 and Tables 3.5 and 3.6).

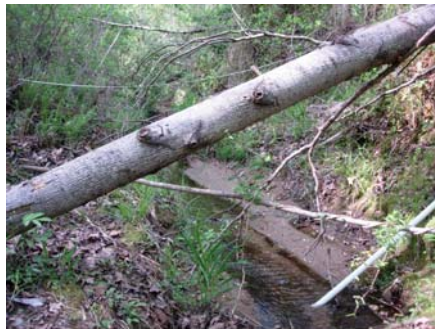
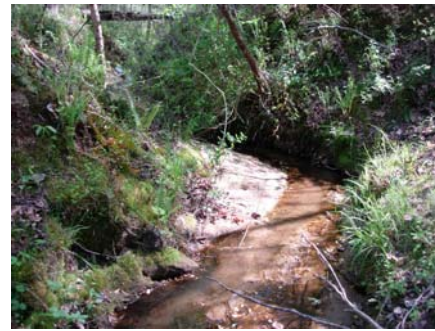
Figure 3.14. a. Typical cross-section looking upstream, b. Typical cross-section looking downstream.

This cross-section is upstream portion of the upstream/downstream study along with station 108. Station 107 is located on a tributary to Long Creek, near Chastain Park, upstream of the I-485 construction project (Figures 3.9 and 3.14). The cross section remained uniform over the monitoring period with a slight increase in area from 76 to 88 square feet. The channel remained a sand dominated channel with what

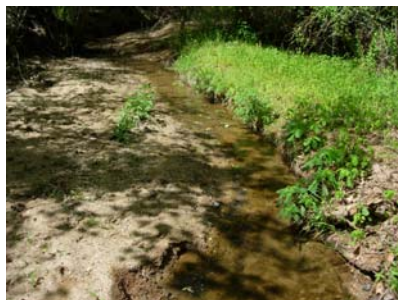
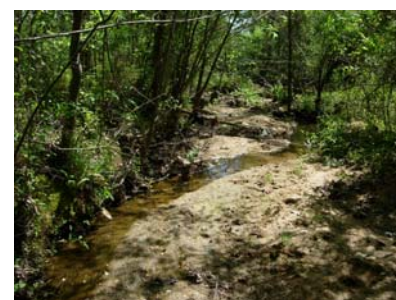
Figure 3.16. a. Typical cross-section looking upstream, b. Typical cross-section looking downstream.

This cross-section is located on a tributary to Long Creek, near Chastain Park, downstream of the I-485 construction project (Figure 3.9 and 3.16). This cross-section is the downstream portion of the upstream/downstream study along with station 107. The channel showed a decrease in cross sectional area over the monitoring period from 30 to 26 square feet. Aggradation is evident in the area of this cross section but there was no change in mean particle size along the bed. Due to the significant amount of bank erosion, the sediment source can not be determined. (Figure 3.17 and Tables 3.5 and 3.6)

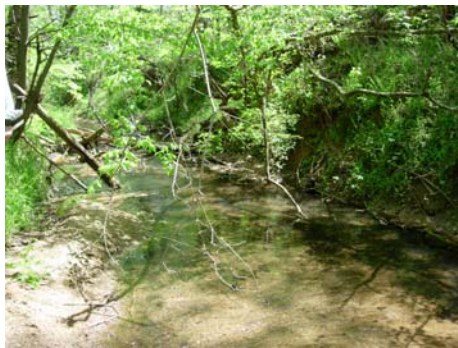
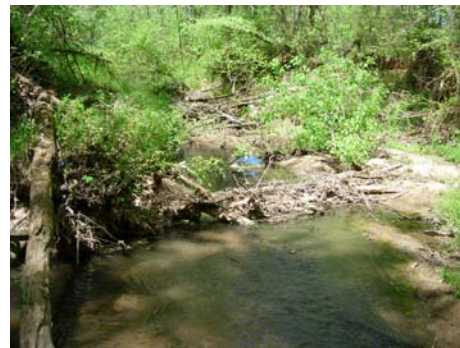
Figure 3.17 a. Typical cross-section looking upstream, b. Typical cross-section looking downstream.

This cross-section was located on a tributary to Long Creek, near Simpson Dr This section is contained within a watershed un-impacted from highway construction and is used as a reference (Figures 3.9 and 3.18). Some erosion was observed on the left bank. The channel in this area is severely incised and some erosion is expected. There was no change in mean particle size during the study. (Figure 3.19 and Tables 3.5 and 3.6)

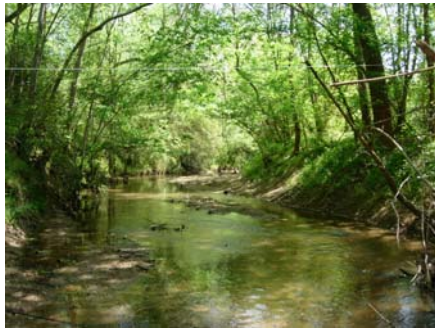
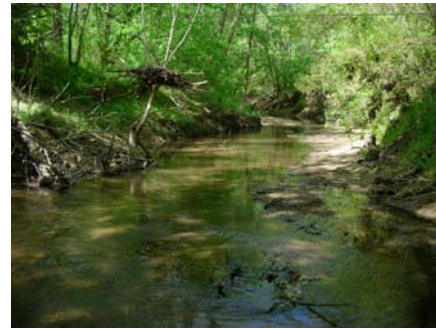
Figure 3.19 a. Typical cross-section looking upstream, b. Typical cross-section looking downstream.

This cross-section was located on the main stem of Long Creek, upstream from USGS gaging station and downstream from I-485 construction site (Figures 3.9 and 3.19). A small increase in channel cross sectional area occurred but overall the channel remained stable with only a small decrease in mean channel particle from 0.5 to .25mm. A sand dominated system is an indication of channel bank instability upstream but this cannot be directly linked to the highway construction. (Figure 3.20 and Tables 3.5 and 3.6)

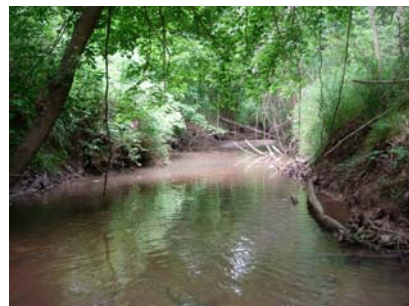
Figure 3.21. a. Typical cross-section looking upstream, b. Typical cross-section looking downstream.

This cross-section was located on the main stem of Long Creek, near Beatties Ford Rd downstream from I-485 construction (Figure 3.9 and 3.21). The channel cross sections remained similar throughout the study period with minor fluctuations in area. The bed scoured 0.5 feet over the study period but well within expected limits for a sand dominated system of this size. No channel aggradation was evident. (Figure 3.22 and Tables 3.6 and 3.6)

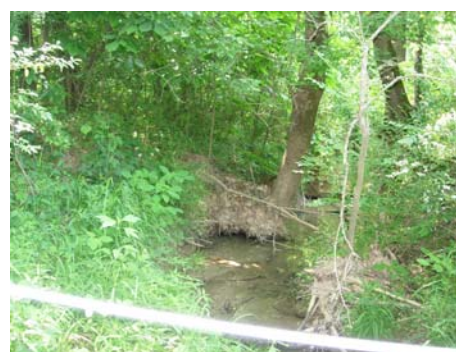
Figure 3.23 a. Typical cross-section looking upstream, b. Typical cross-section looking downstream.

This cross-section was located on a tributary to Long Creek, near Beatties Ford Rd, downstream from I-485 construction site (Figures 3.9 and 3.23). This section is the upstream portion of the upstream/downstream pair (121/122). This site was chosen due to its proximity to a housing development that was under development during the study. Aggradation is evident from the cross section as the area went from 43.9 to 40.4 square feet. Upstream sediment source is likely at this section since it follows a similar pattern as the upstream cross section (station 122). Mean bed material remained silt/clay for duration of the study. (Figure 3.24 and Tables 3.5 and 3.6) The 2005 cross section survey was skipped due to site access limitations.

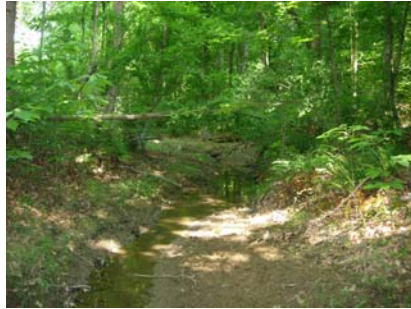
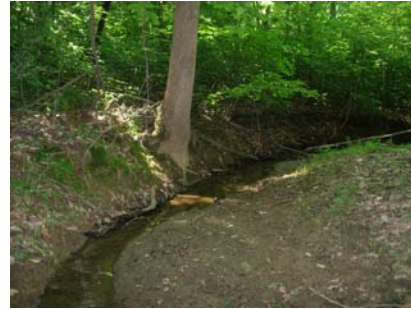
Figure 3.25. a. Typical cross-section looking upstream, b. Typical cross-section looking downstream.

This cross-section was located on a tributary to Long Creek, upstream from the I-485 construction site (Figures 3.9 and 3.25). This section is the upstream portion of the upstream/downstream pair (121/122). This site was chosen due to its proximity to a housing development that was under development during the study. Some aggradation occurred between 2003 and 2005. Sediment source is likely the development upstream of the section. Aggradation in the channel and along the floodplain was evident in this area. (Figure 3.26 and Tables 3.5 and 3.6)

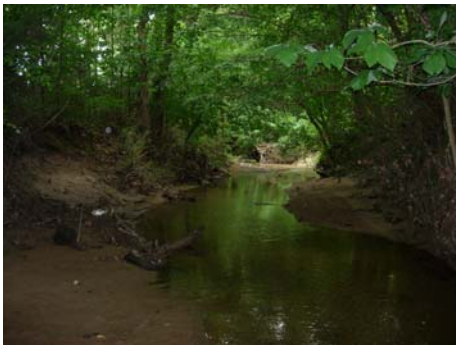
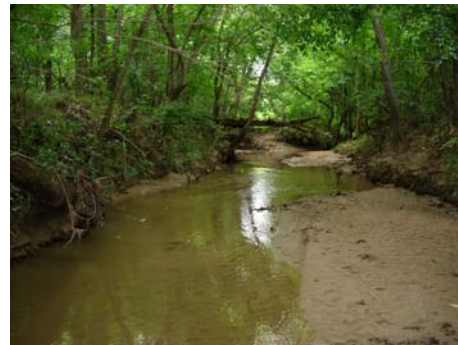
Figure 3.27. a. Typical cross-section looking upstream, b. Typical cross-section looking downstream.

This cross-section was located on the main stem of Long Creek, below WT Harris Blvd and downstream from I-485 construction (Figure 3.9 and 3.27). An overall increase in channel cross sectional area can be seen in the cross section and no aggradation. Mean bed particle size decreased from 0.5 to 0.2mm. (Figure 3.28 and Tables 3.5 and 3.6)

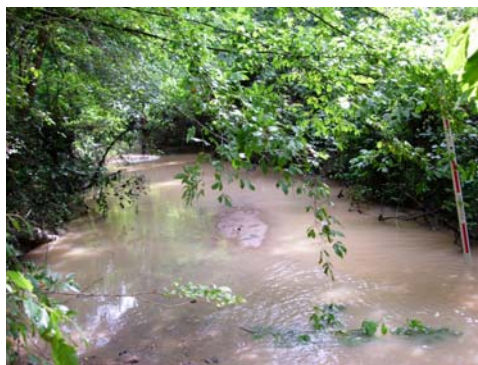
Figure 3.29. Typical cross-section looking upstream.

This cross-section was located on the main stem of Long Creek by Forest Drive downstream from I-485 construction (Figures 3.9 and 3.29). The channel remained similar between years 2005 and 2006. The 2003 section was taken at different location. That section was unable to be field located in subsequent years. No bed aggradation or degradation was evident in the cross sections. (Figure 3.30 and Tables 3.5 and 3.6)

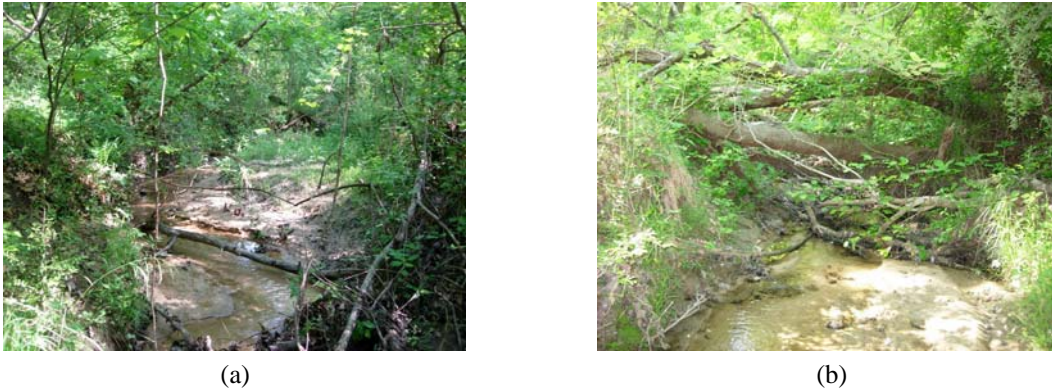
Figure 3.31 a. Typical cross-section looking upstream, b. Typical cross-section looking downstream.

This cross-section was located on a tributary to Long Creek where Alexanderana Rd crosses, upstream from I-485 construction site (Figures 3.9 and 3.31). This section is the upstream portion of the upstream/downstream pair (131/132). This site was previously impaired with a large amount of sediment likely from upstream farming practices. The left channel bank eroded during the study, which increased the

cross sectional area from 42.5 to 51.4 square feet between 2005 and 2006. The channel bed remained relatively consistent and the substrate decreased from 1.0 to 0.4mm. Aggradation within the channel is evident at this cross section which is upstream of the highway project. (Figure 3.31 and Tables 3.5 and 3.6)

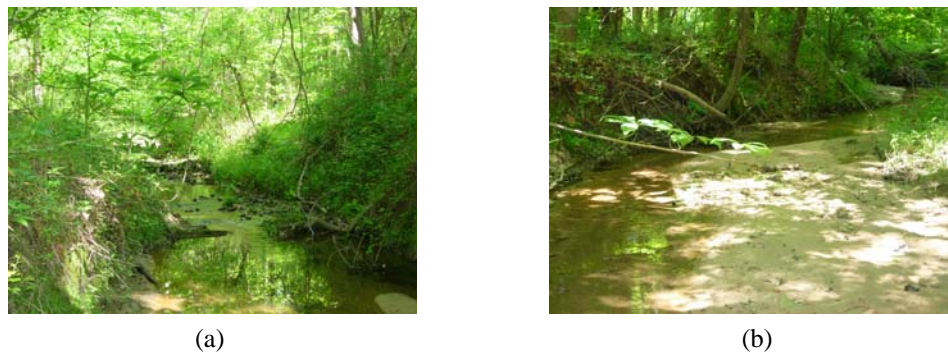
Figure 3.33. a. Typical cross-section looking upstream, b. Typical cross-section looking downstream.

This cross-section was located on a tributary to Long Creek where Alexanderana Rd crosses, downstream from I-485 construction site (Figures 3.9 and 3.33). This section is the downstream portion of the upstream/downstream pair (131/132). This site was previously impaired with a large amount of sediment likely from upstream farming practices. The channel remained consistent during the study period with some aggradation within the channel. Cross sectional area decreased slightly but the sediment source could not be singled out. The channel substrate decreased from 6.9 to 0.4mm. (Figure 3.34 and Tables 3.5 and 3.6)

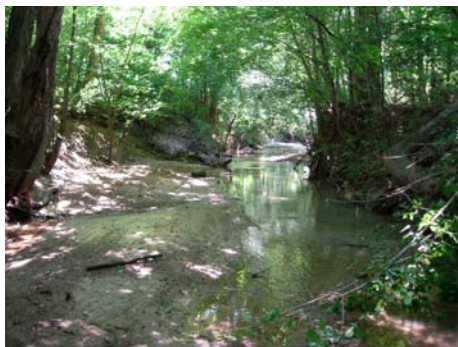
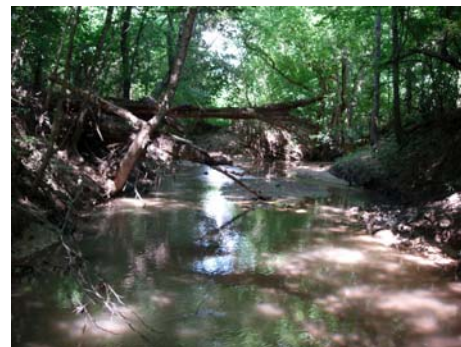
Figure 3.35. a. Typical cross-section looking upstream, b. Typical cross-section looking downstream.

This cross-section was located at the most upstream sample site on the main stem of Long Creek, near Hwy 21 and downstream from I-485 construction (Figures 3.9 and 3.35). The channel cross section increased during the study period from 112 to 125 square feet due mostly to bed degradation. Channel banks remained stable. Channel substrate decreased from 0.35 to 0.2mm. (Figure 3.36 and Tables 3.5 and 3.6)

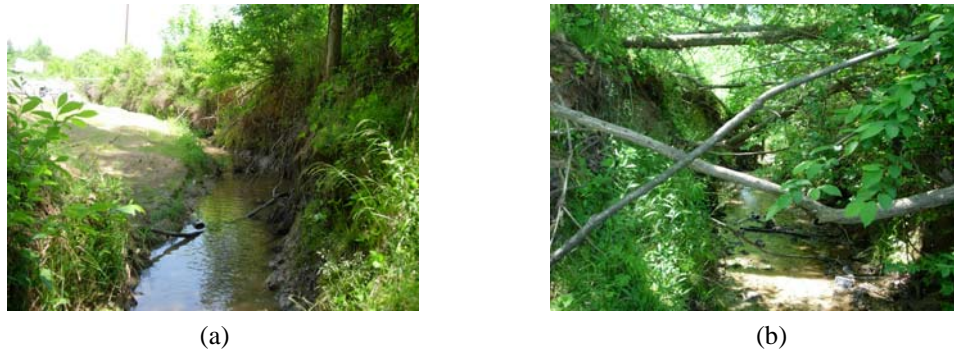
Figure 3.37 a. Typical cross-section looking upstream, b. Typical cross-section looking downstream.

This cross-section was located on a tributary to Long Creek, off Hwy 21 downstream from I-485 construction at the Statesville road intersection. (Figures 3.9 and 3.37). The channel in this area had the most potential to be directly impacted by construction activities since a large percentage of its watershed was being disturbed by highway construction activities. The 2003 section was relocated because it was originally established within the footprint of the highway project. 2005 and 2006 sections showed a little widening and deepening but no significant aggradation. Mean channel particle decreased from 5.7mm in 2005 to 0.25mm in 2006. Highway construction directly upstream of the cross section is the likely source of the decrease in particle size. (Figure 3.38 and Tables 3.5 and 3.6)
