# **VALUE ENGINEERING AND COST EFFECTIVENESS OF VARIOUS FIBER REINFORCED POLYMER (FRP) REPAIR SYSTEMS**

Research Project 2006-10

Final Report

In cooperation with the  
North Carolina Department of Transportation

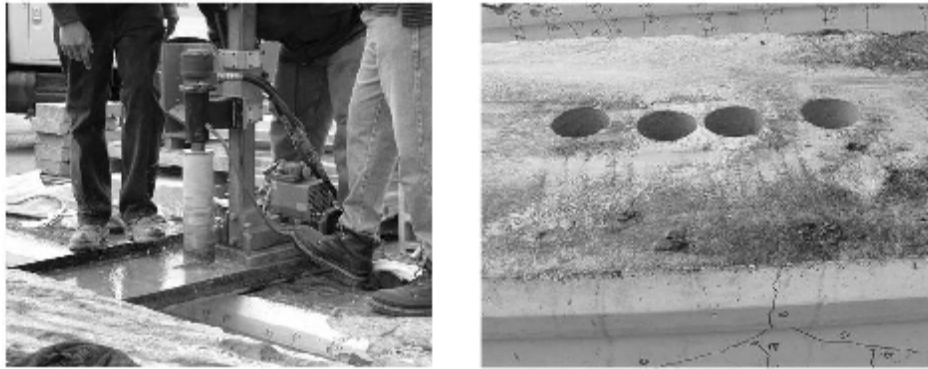
compression testing machine. By inspection, it was observed that the concrete had river rock type aggregate varying in diameter from approximately 0.5 in to 1.0 in. Due to the difficulty in obtaining a typical sized sample of 8 in long, the cores were drilled in the deck where a core of 5 inches in length was obtained, as shown in Figure 3.3. The appropriate correction factor from ASTM C42 was then applied to obtain the compressive strength of each core sample. Results of the compression tests are given in

Figure 3.3 Concrete core drilling operation for C-Channel girders

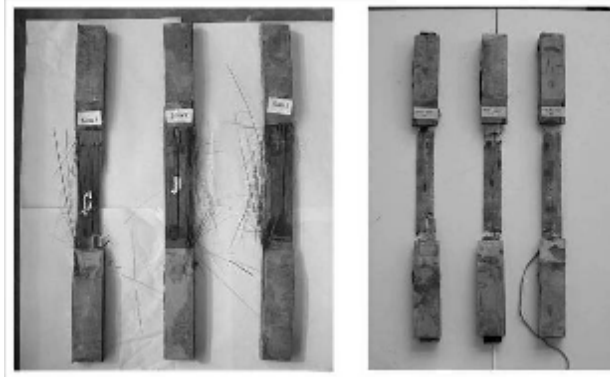
second possible mode of failure was less violent and rupture occurred through the cross section as shown in Figure 3.5. In general, failure of the pre-cured laminate strips was according to the first mode, while the wet lay-up laminates failed according to the second mode. This behavior is due to the fiber volume fraction in the pre-cured laminates which is significantly greater than the wet lay-up sheets. The only exception was the high modulus pre-cured laminates, which failed due to a smooth rupture through the cross section. If the rupture of the CFRP occurred in the vicinity of the aluminum grips the test was not included. Test results for all the CFRP tension tests are given in Table 3.3.

*Figure 3.5 Typical pre-cured (left) and wet lay-up (right) specimens after tension testing*

The prepared specimens were tested using a MTS machine. The strain of the CFRP was measured using a 0.24 in TML FLA-6-11 120  $\Omega$  electric resistance strain gauge placed at the center of the width and gauge length of the specimen. Two distinct modes of failure were observed during the tension testing. The first behavior was characterized by sudden and brittle rupture of the fibers through the CFRP matrix as shown in Figure 3.4. The

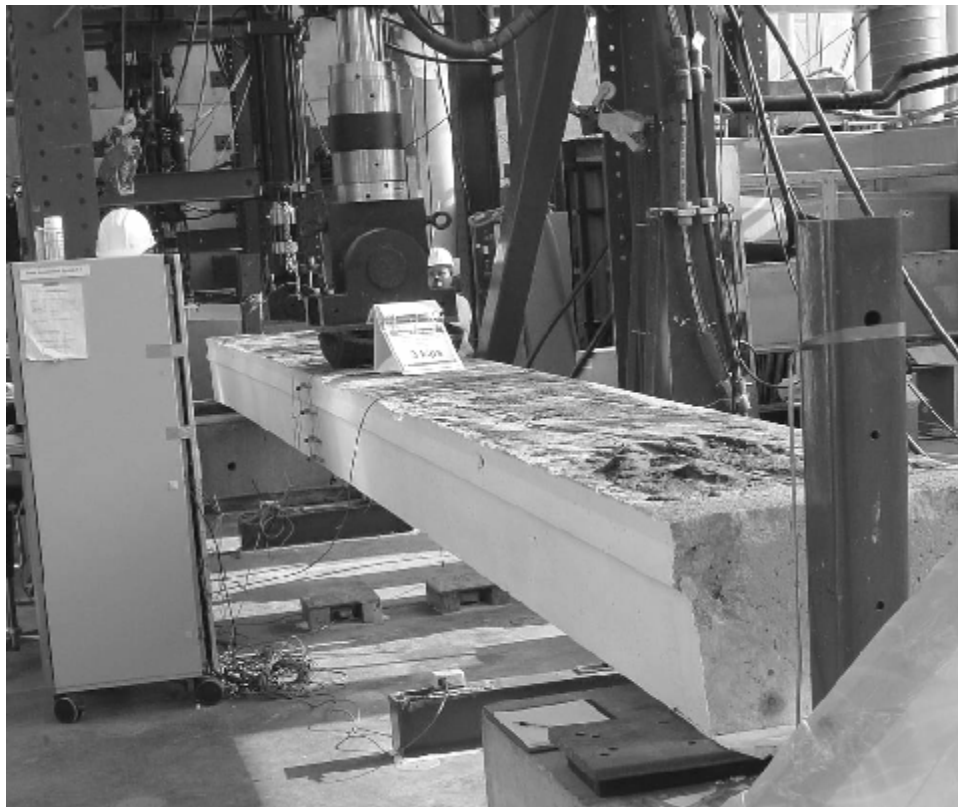
The displacement behavior of the girders during testing was monitored using three sets of string potentiometers, placed at quarter spans, and two linear potentiometers to measure vertical displacement over the supports. The compressive strain in the concrete was measured using a combination of PI gauges (a strain gauge mounted to a spring plate) and two 2.4 in TML FLA-60-11 120  $\Omega$  electric resistance strain gauges located at midspan. PI gauges were also placed at various locations at the level of the lowest prestressing strand to measure the crack width and to determine the strain profile along the depth of the girder. The tensile strain in the CFRP reinforcement was measured using six 0.24 in TML FLA-6-11 120  $\Omega$  electric resistance strain gauges: two at midspan, two at 6 in from midspan and two at 12 in from midspan. Additional tensile strain gauges were provided for the girders tested as part of the bond study, and these are discussed in the next part of this dissertation. Figure 3.6 shows a typical test setup for the C-Channel girders under static loading conditions.

*Figure 3.6 Typical test setup for C-Channel girders tested under static loading conditions*

bridges constructed in the early 1960s usually have a substructure of wooden piles that is difficult to mimic in the laboratory. However, in order to simulate small displacements at the supports, the girder was supported at both ends on a 2.5 in thick neoprene pad which in turn rested on a 1.0 in steel plate. Hydrostone was used at the supports for leveling purposes. The width of the neoprene pad was 8.5 in which provided a clear span of 342 in for each tested girder.

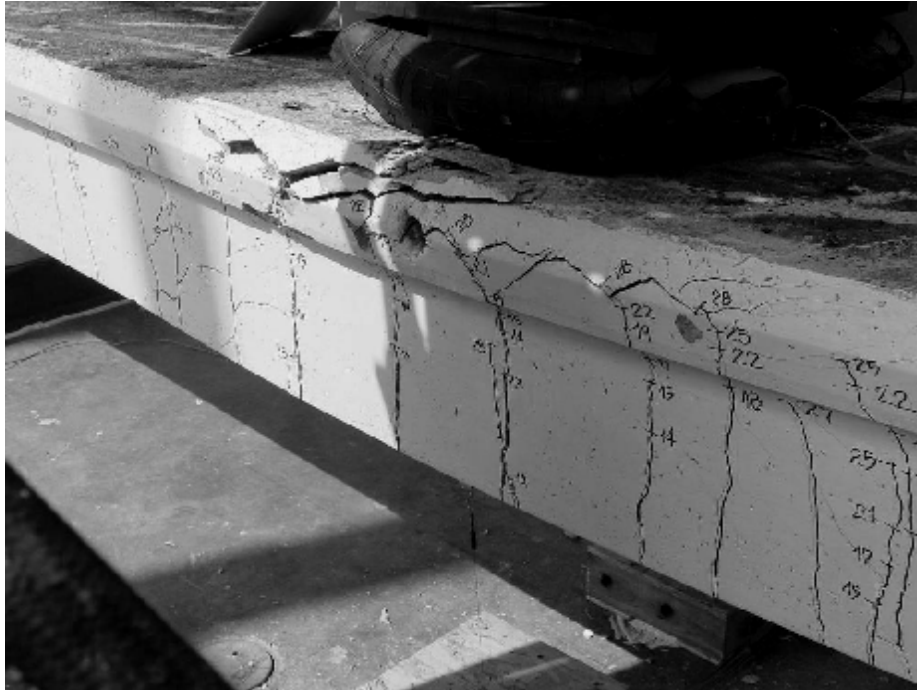
*Figure 3.7 Failure due to concrete crushing of girder CS*

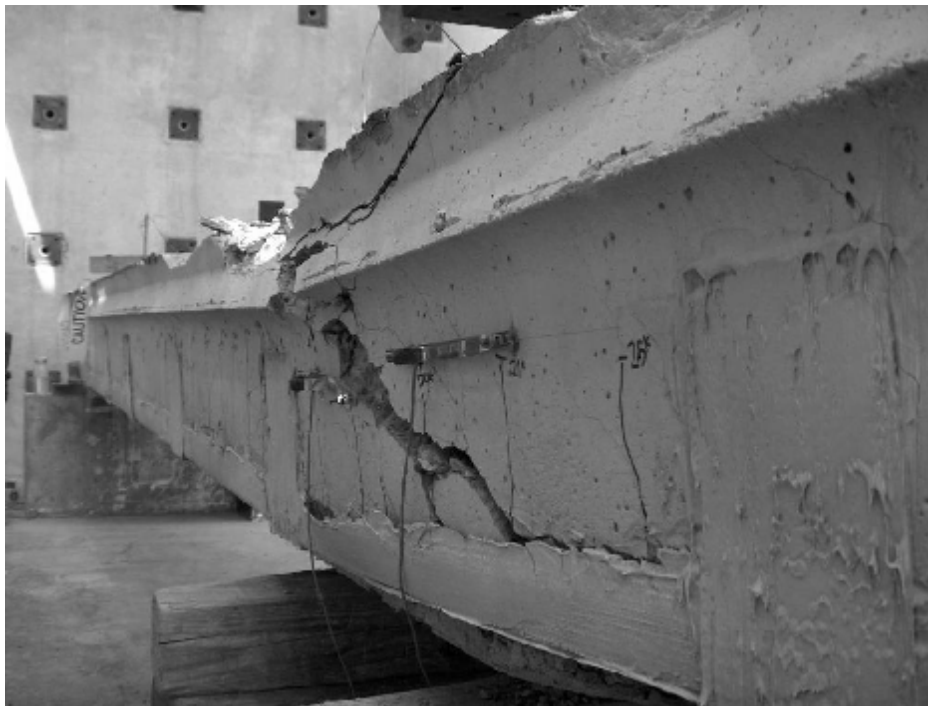
During the initial loading cycle, the observed cracking load was 13.2 k and the observed crack re-opening load was 8.5 k, which corresponds to an effective prestress force of 15.6 k per strand. Failure was due to crushing of the concrete followed by debonding of SRP material at midspan at a load of 48.8 k as shown in Figure 3.8, an increase of 46.5 percent compared to girder CS. Immediately after concrete crushing, a large shear crack propagated at a 45 degree angle from a flexural crack near midspan to the compression zone causing catastrophic failure.

*Figure 3.8 Concrete crushing failure of girder SRPS*

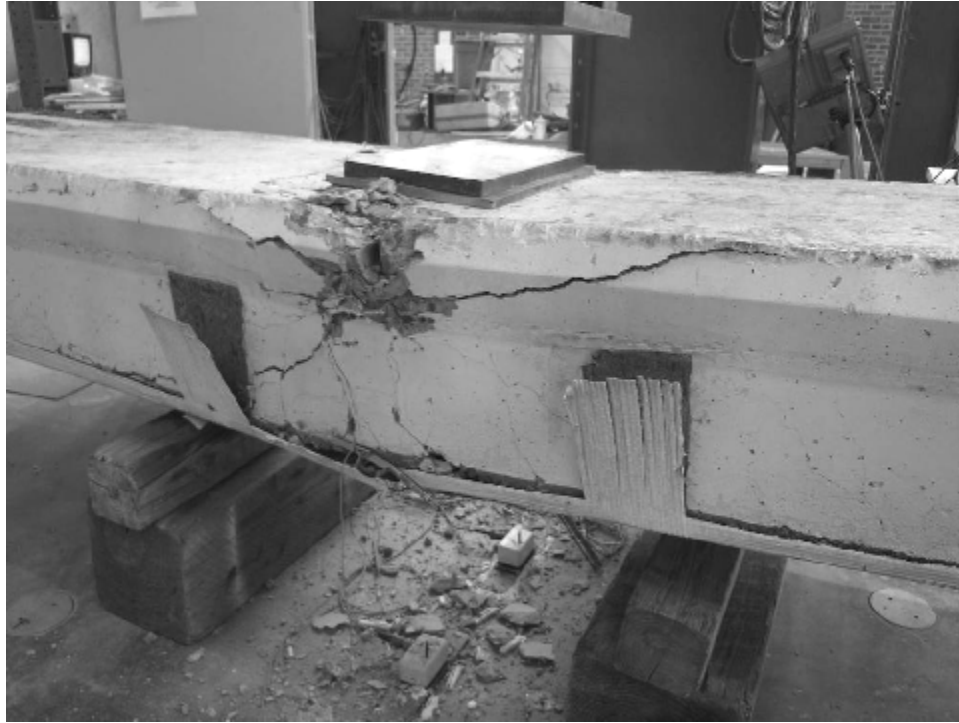
A C-Channel girder designed to achieve a 30 percent increase in capacity using CFRP wet lay-up sheets (EB7F) was tested under fatigue loading conditions. From the initial loading sequence, the cracking load was measured at 12.9 k, and the effective prestress force calculated as 15.7 k. The fatigue load applied varied from 2 k to 12.1 k, which represents a 30 percent increase in live load based on HS-13 type loading. After 1.25 million cycles an accidental overload condition of 30 k was applied to the girder, which caused a residual displacement of 1.77 in. The fatigue test was then resumed and the girder completed 2 million cycles of fatigue loading with little additional degradation. A final static test was performed on the girder to assess the damage due to fatigue loading. The ultimate load achieved during the final static test was 44.2 k, which is a 2.2 percent increase in ultimate load compared to girder EB7S. Failure was due to rupture of the externally bonded CFRP sheets as shown in Figure 3.11. After the ultimate load was achieved, the girder continued to resist load, behaving similarly to the control specimen. Catastrophic failure occurred due to concrete crushing at a load of 37.6 k.

*Figure 3.11 Concrete crushing after FRP rupture of girder EB7F*

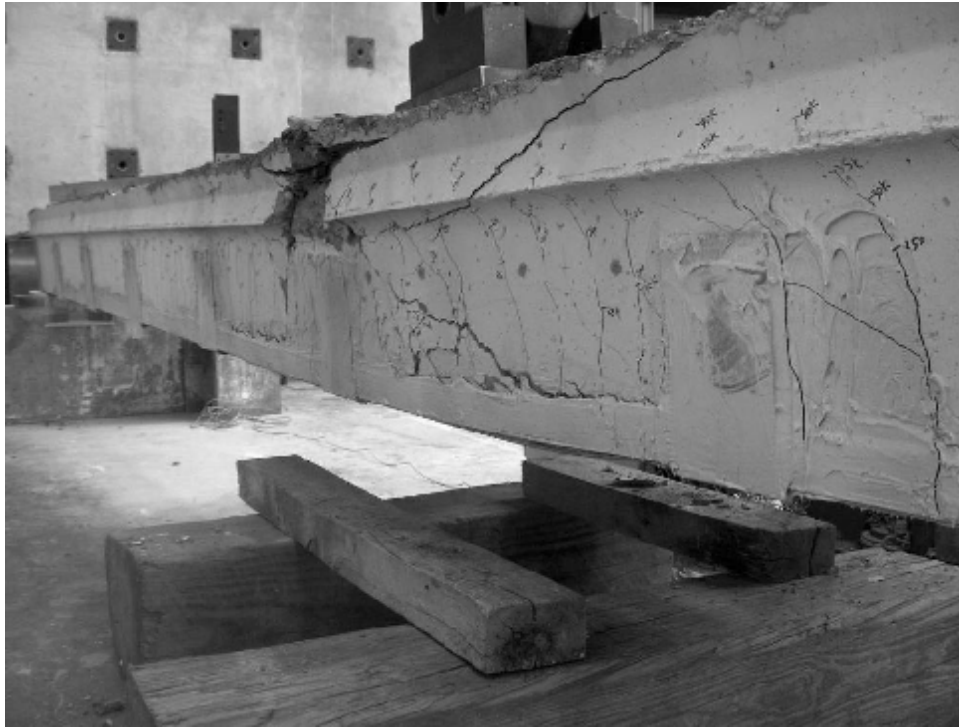
Girder SRPF was strengthened to achieve a 30 percent increase in ultimate capacity, and was tested under cyclic loading between the load levels of 2 k and 12 k, which corresponds to a 30 percent increase in HS12 live load. During the initial loading cycle, the observed cracking load was 14 k and the observed crack re-opening load was 9.4 k, which corresponds to an effective prestress force of 16.7 k per strand. The girder achieved over 2 million cycles of loading with very little degradation. During the final static test, failure was due to crushing of the concrete at midspan at a load of 50.9 k, an increase of 52.8 percent compared to girder CS. Underneath the loading area at

midspan the SRP material was partially debonded between the flexural cracks, but this did not lead to failure due to the wrapping and the U-wrap debonding mitigation. Immediately after concrete crushing, a large shear crack propagated at a 45 degree angle from a flexural crack near midspan to the compression zone causing catastrophic failure. Compared to a similar girder tested under static loading conditions (SRPS), SRPF failed at a load 4.28 percent higher, mainly due to a higher effective prestress force. The failure of girder SRPS is shown in Figure 3.12.

*Figure 3.12 Concrete crushing failure of girder SRPF*

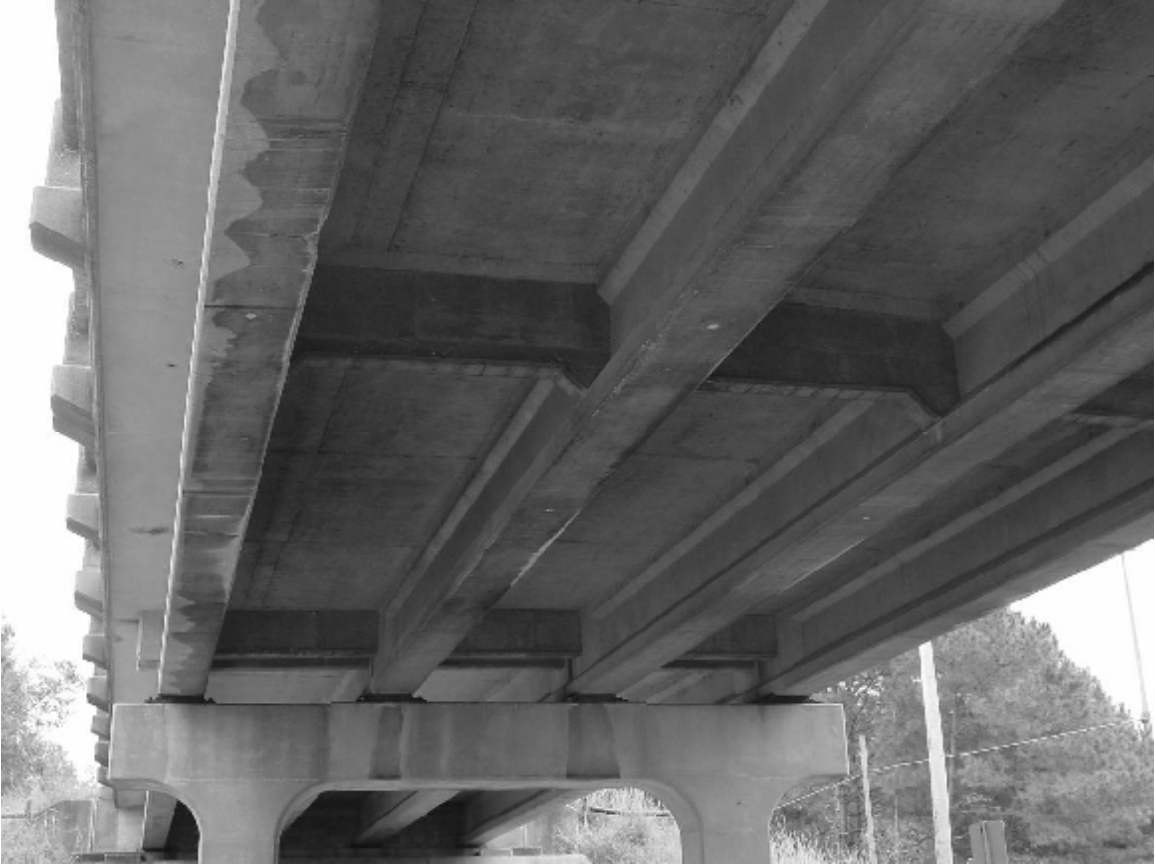
*Figure 4.1 Undamaged eastern span of NC Bridge 169*

In October 2003, a tractor trailer carrying improperly secured excavating equipment impacted the prestressed concrete superstructure of NC Bridge 169 shown in Figure 4.1, in Robeson County, North Carolina. The impacted bridge was located on Green Springs Road (SR 1718) over Interstate 95. Originally built in 1959, the bridge consisted of four 55 ft long spans. Each span was made up of four AASHTO Type II prestressed concrete girders spaced at 7 ft intervals. The impact of the excavating equipment heavily damaged the first exterior girder by nearly severing it in half. The second and third girders were missed, and the last girder was then struck, causing a large loss of the concrete section and rupturing one prestressing strand.

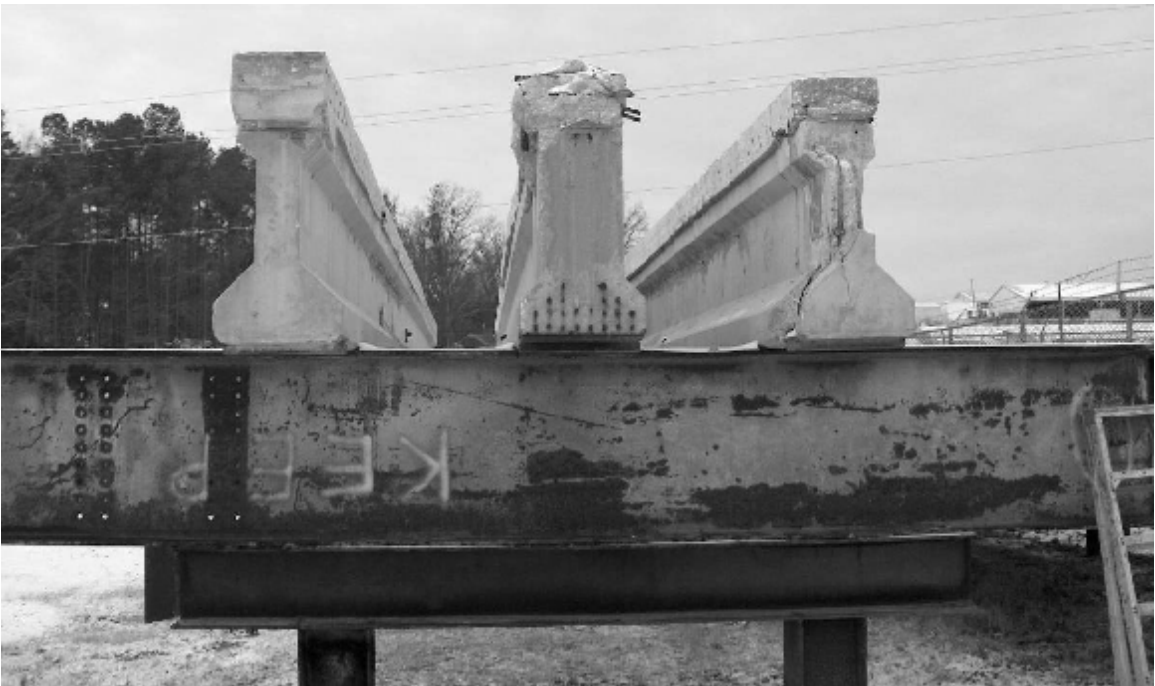
*Figure 4.2 AASHTO Type II girders at the NCDOT maintenance facility*

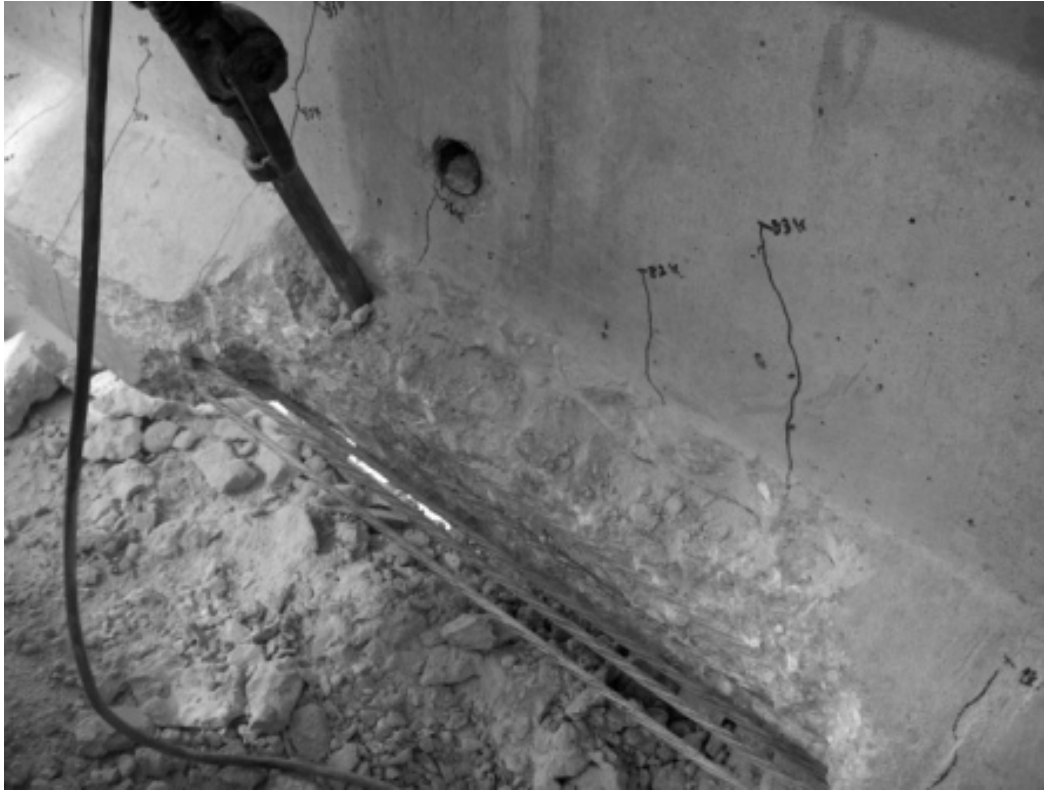
*Figure 4.4 AASHTO2 during removal of concrete*

As previously mentioned in Section 4.1, AASHTO2 was received by the researchers undamaged, except for several transverse cuts approximately 0.4 in wide in the composite deck after the removal of the diaphragms. In order to simulate impact damage, a large portion of the tension flange of the girder was removed (Figure 4.4), and four prestressing strands were ruptured (Figure 4.5), corresponding to a reduction in prestressing force of 14.3 percent. The length of the damage was extended to a total of 2.0 ft on either side of midspan on the front side of the girder only. Approximately 2.2 ft<sup>3</sup> of concrete was removed, as shown in Figure 4.5.

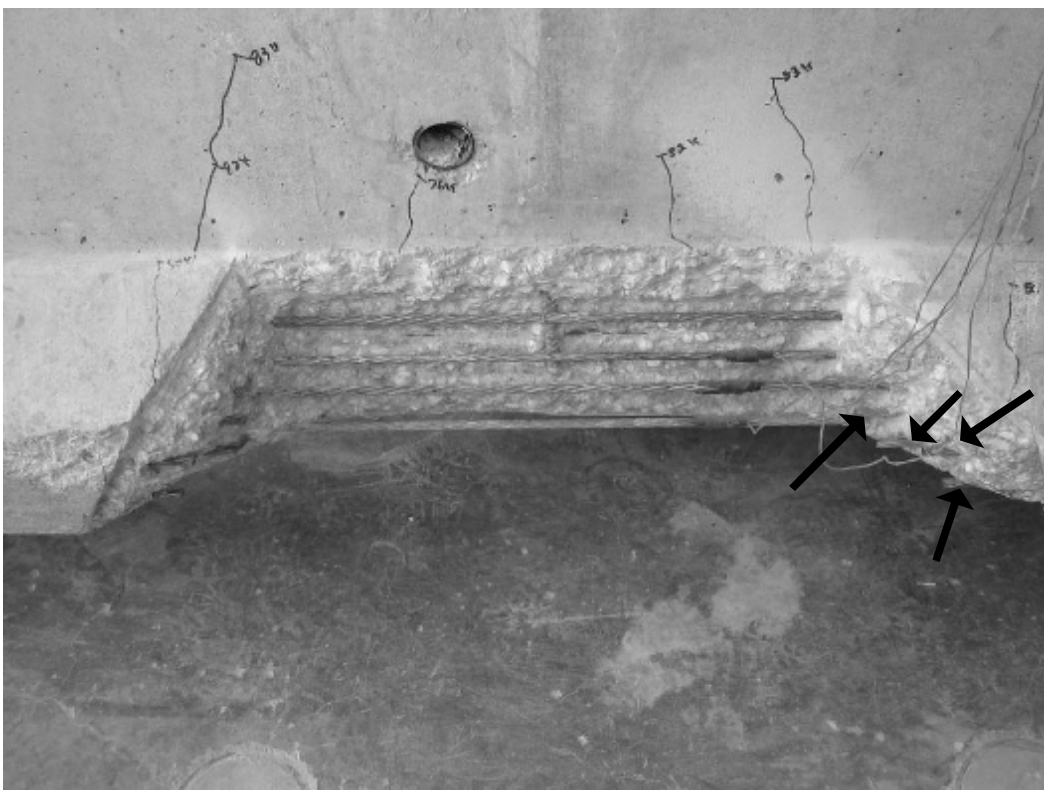
*Figure 4.5 Simulated damage of AASHTO2 girder*

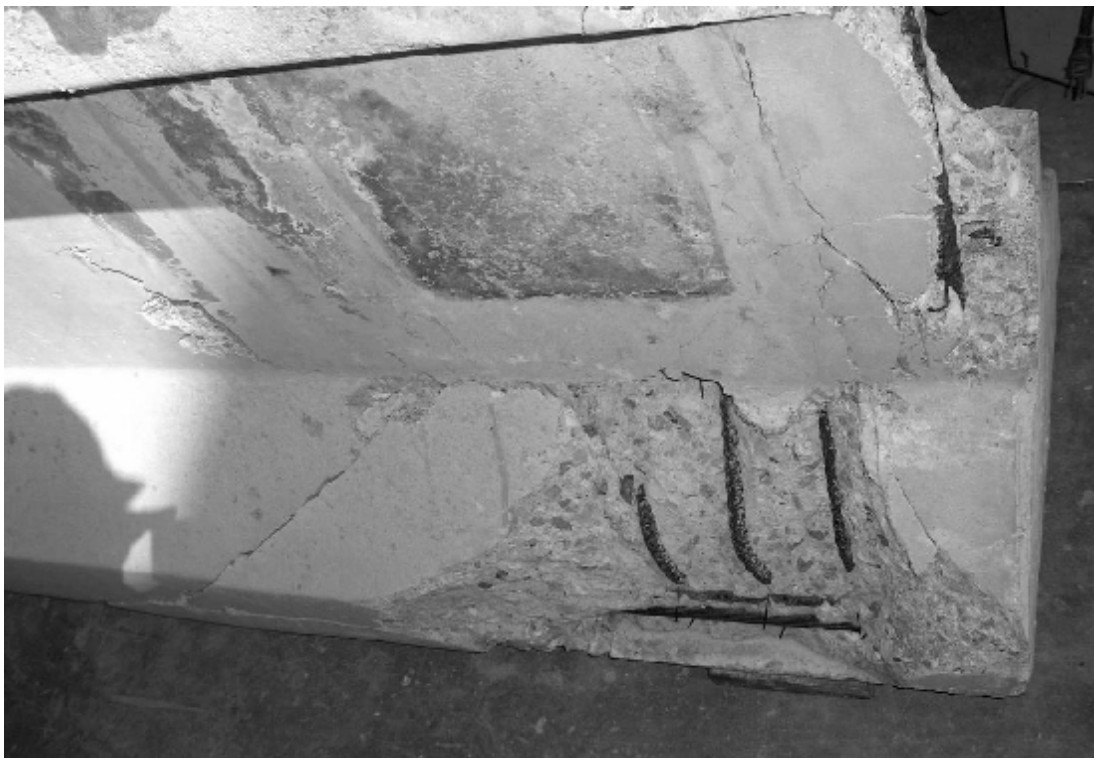
*Figure 4.6 Damage to right support of AASHTO3 caused during transportation of girder*

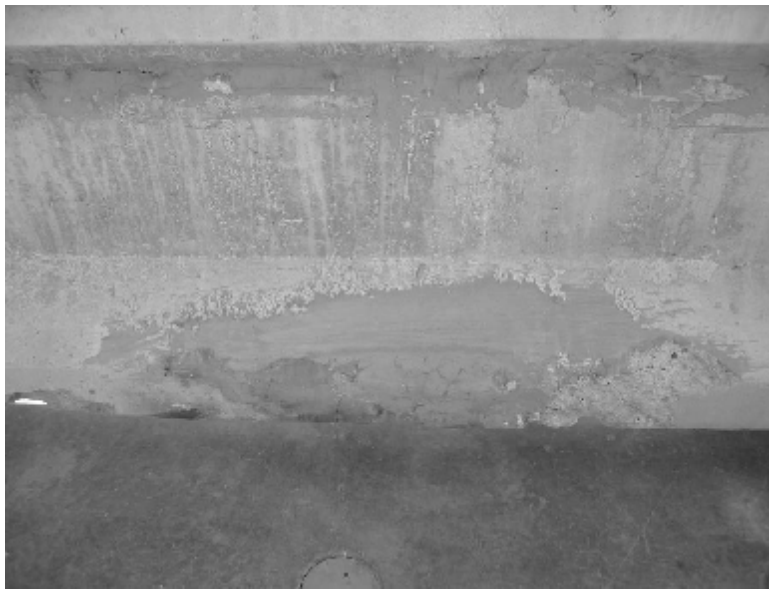
*Figure 4.8 AASHTO3 defects after arriving at the testing facility*

AASHTO3 had been impacted several times prior to being removed from the bridge. Figure 4.8 shows one section where an earlier concrete repair had been performed along with epoxy injection of the cracks caused by vehicular impacts. In order to simulate impact damage to this girder, a large portion of the tension flange was removed, similar to girder AASHTO2, and three prestressing strands were ruptured (Figure 4.9), corresponding to a reduction in prestressing force of 18.8 percent. The length of the damage was 2.0 ft to the left of midspan and approximately 5.0 ft to the right on the front side only. It was intended for the damage to be symmetrical about midspan, but the presence of earlier repairs made it difficult to cut as planned. A total of approximately 2.4 ft<sup>3</sup> of concrete was removed, as shown in Figure 4.9.

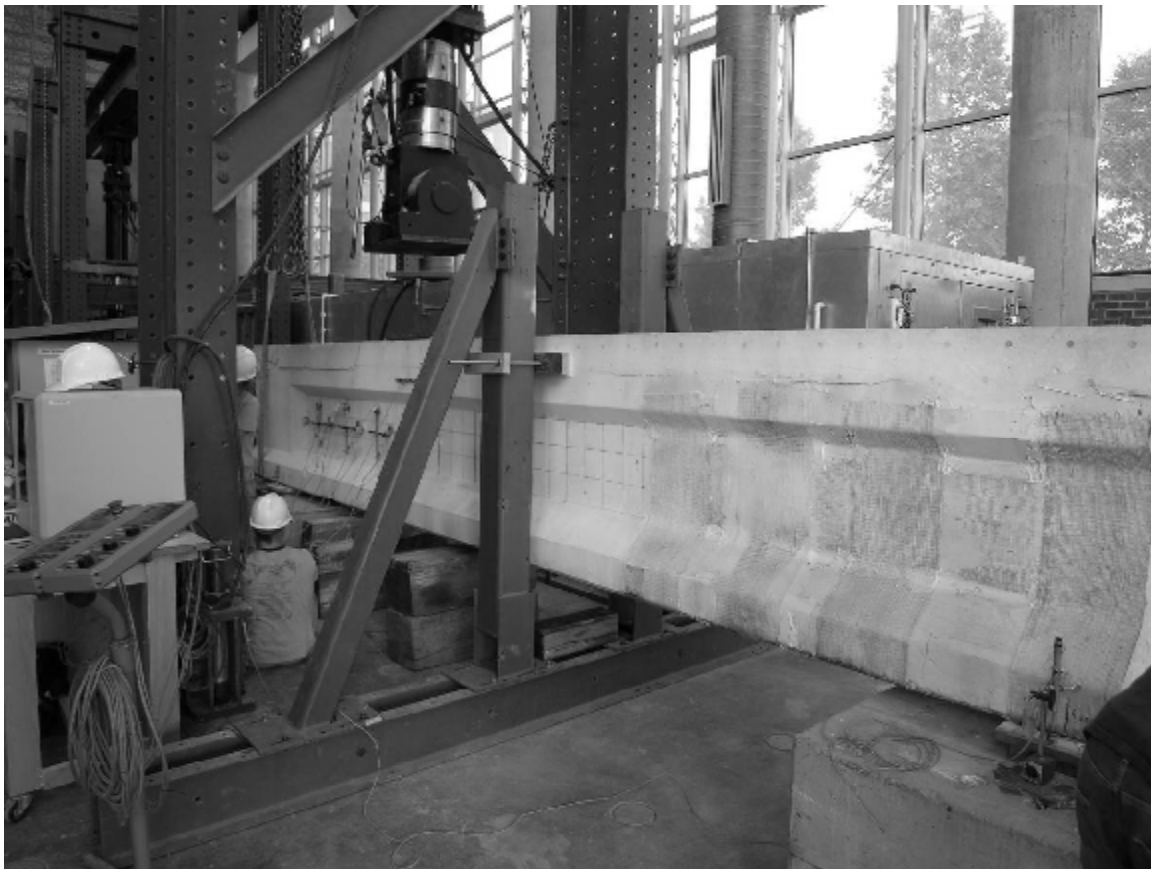
*Figure 4.10 AASHTO2C test specimen*

The first girder tested during the shear study, AASHTO2C, was tested monotonically to failure as a control specimen. The girder, shown in Figure 4.10 was prestressed with 28-7/16 in diameter 250 ksi strands. The total length of the girder was 20.67 ft, with a span of 17.83 ft from center-to-center of the supports. Based on measurements taken at two foot intervals, the average width of the composite deck was determined to be 16.5 in. Cross section and elevation drawings of AASHTO2C are shown in Figure 4.11.

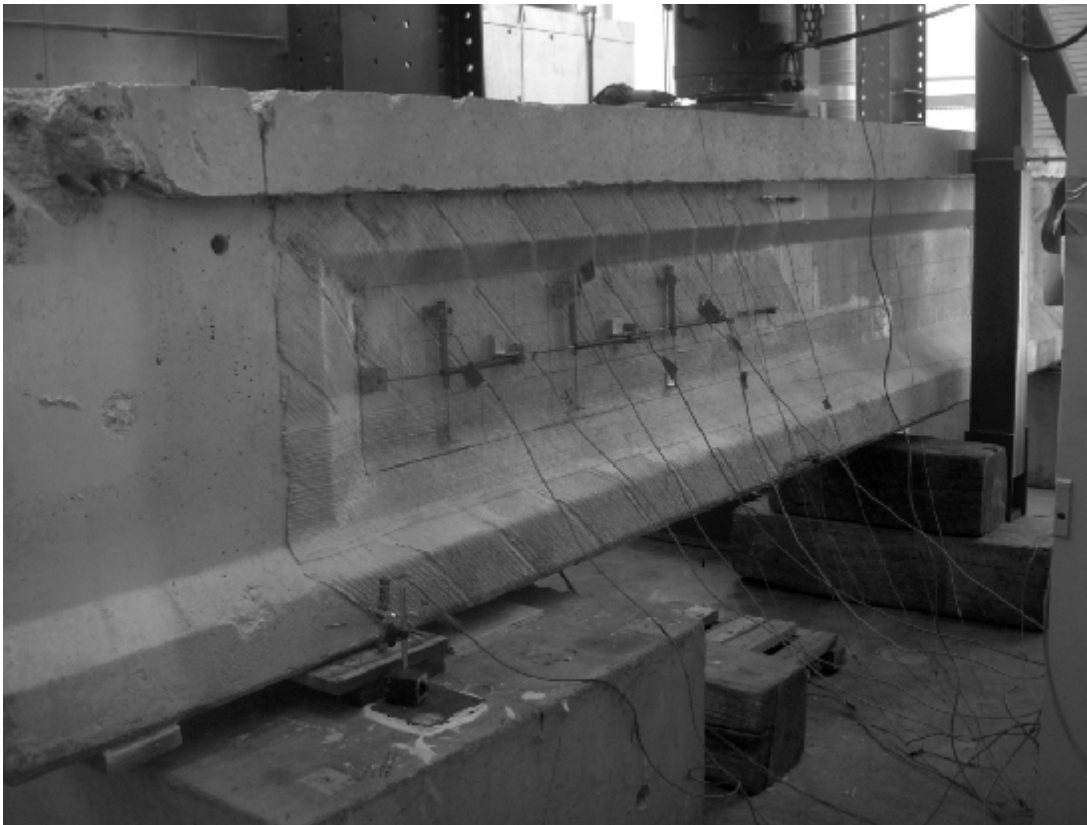
*Figure 4.12 AASHTO2R test specimen*

AASHTO2R was tested monotonically to failure as a shear critical member with simulated damage repaired with CFRP sheets as shown in Figure 4.12. The girder was prestressed with 28-7/16 in diameter 250 ksi strands. The total length of the girder was 20.67 ft, with a span of 17.83 ft from center-to-center of the supports. Based on measurements taken at two foot intervals, the average width of the composite deck was determined to be 16.5 in. Cross section and elevation drawings of AASHTO2R, including CFRP repair details, are shown in Figure 4.13. It should be noted that the section properties for AASHTO2R are the same as AASHTO2C but were not included for clarity.

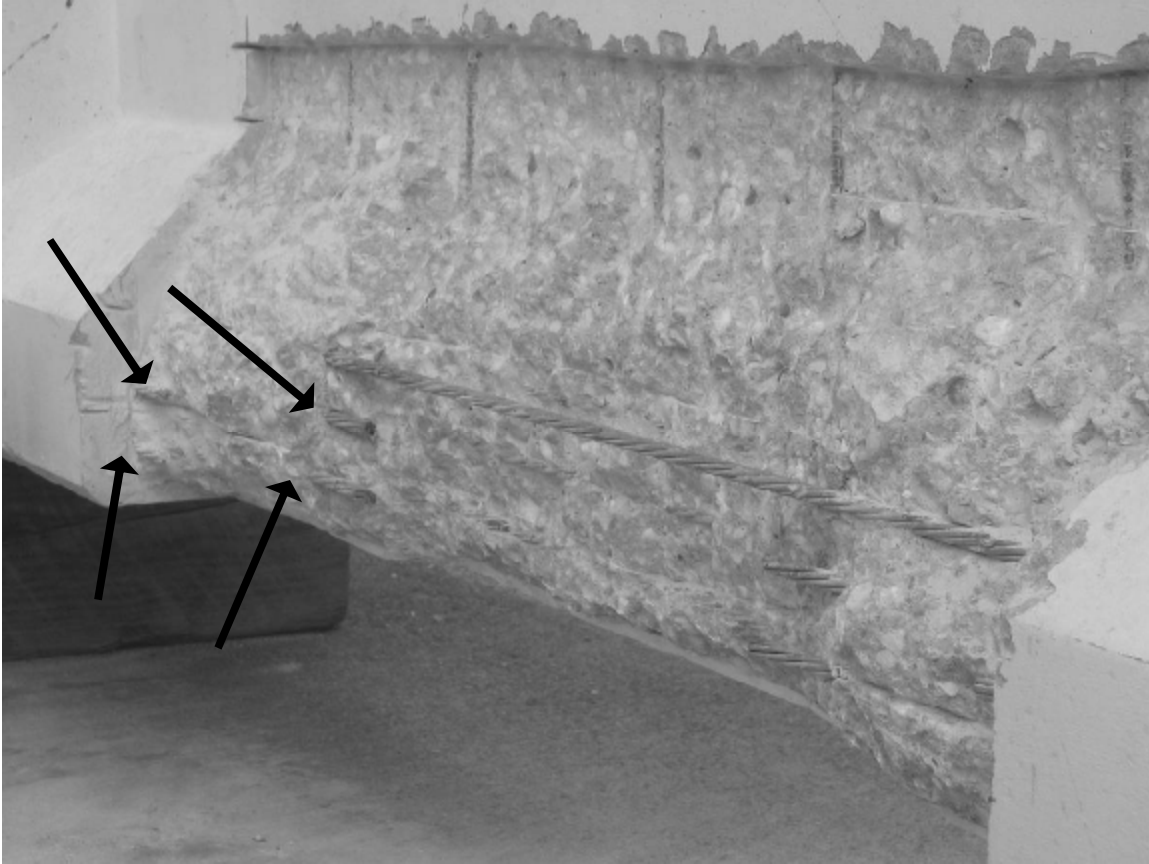
*Figure 4.14 AASHTO2R after completion of simulated damage*

In order to simulate impact damage, a large portion of the tension flange of the girder was removed, and four prestressing strands were ruptured (Figure 4.14), corresponding to a reduction in prestressing force of 14.3 percent. The length of the damaged began 1 ft past the face of the left support and extended 4 ft to the right. A total of approximately 1.5 ft<sup>3</sup> of concrete was removed, as shown in Figure 4.14.

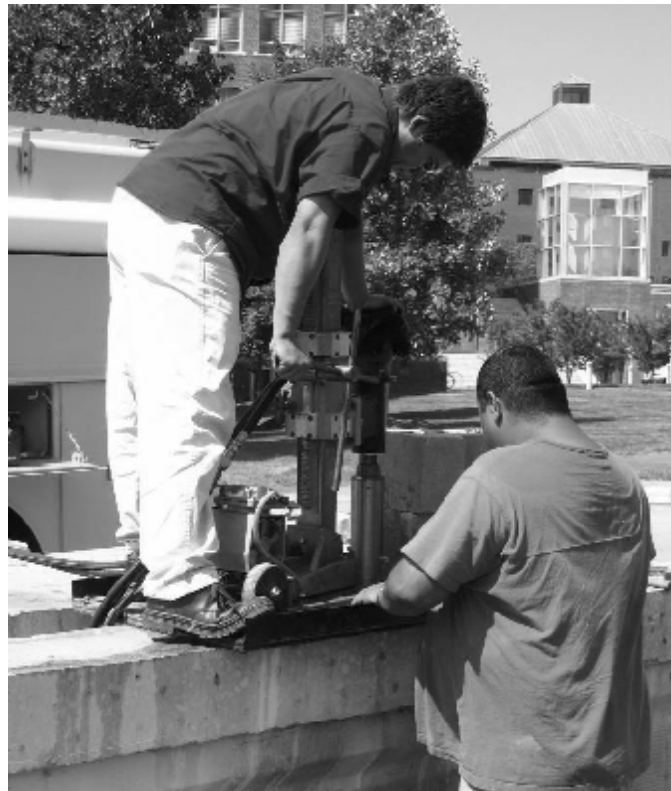
*Figure 4.18 NCDOT personnel removing core samples*

Several core samples were taken from both the girders and deck slab by qualified NCDOT personnel (Figure 4.18). The cores were then tested in accordance with ASTM C42 in an MTS closed-loop universal testing machine used to apply a constant rate of displacement. Concrete strains were measure using the stroke of the MTS machine. Eight inch long core samples were not able to be obtained due to the configuration of the AASHTO girders. The cores taken from the deck slab were approximately 5 inches in length. Likewise, the only feasible place to take cores from the girder itself was from the web, which was 6 inches in width. 4 in by 8 in cylinders were also cast of the various concrete repair materials used during the research. Table 4.2 lists the average results of all concrete testing for each AASHTO girder.

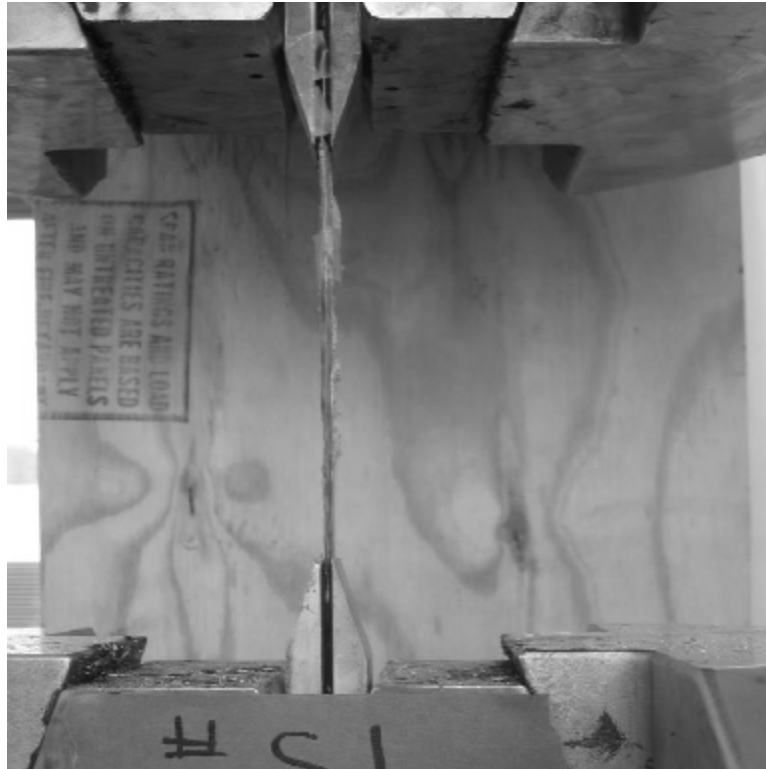
Figure 4.19 Typical CFRP tension test setup

All CFRP samples were cut out of witness panels to a width of 1 in and a length of 17.5 in. The samples were then bonded to aluminum tabs using Wabo MBrace© Saturant (Wabo 2002) to produce a gauge length of 6 in. Figure 4.19 shows a typical CFRP tension test setup. The strain of the CFRP was measured using a 0.236 in TML FLA-6-11 120  $\Omega$  electric resistance strain gauge placed at the center of the width and gauge length of the specimen. The primary mode of failure was the sudden and brittle rupture of the fibers in the CFRP, as shown in Figure 4.20 (left). The second, and less frequent mode of failure, was rupturing of the CFRP matrix through the cross section, as shown in Figure 4.20 (right).

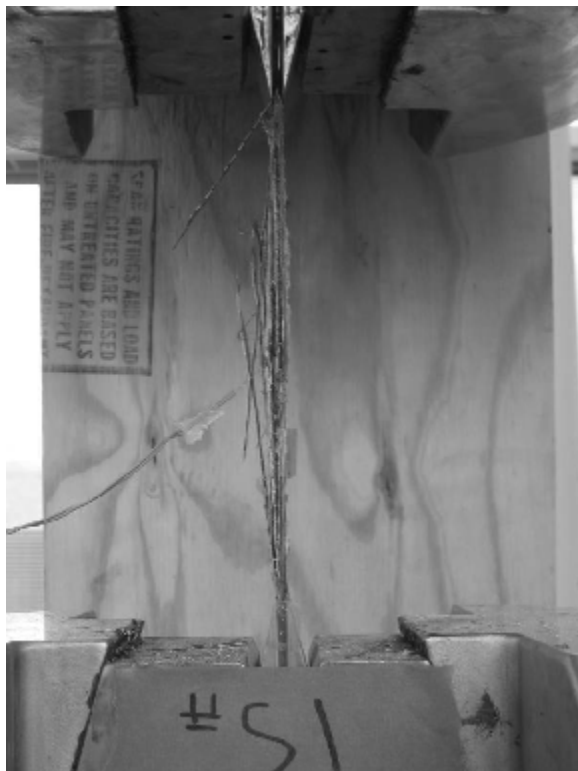
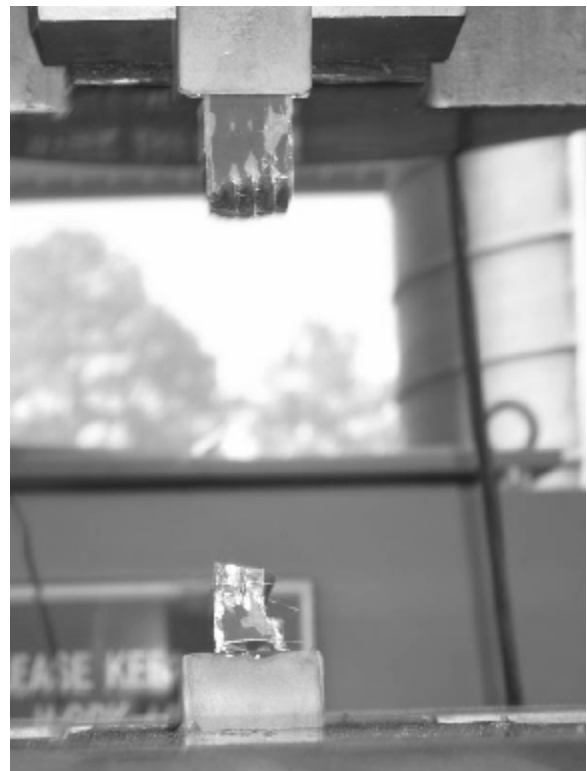
Figure 4.20 Failure through the fibers (left) and failure through cross section (right)

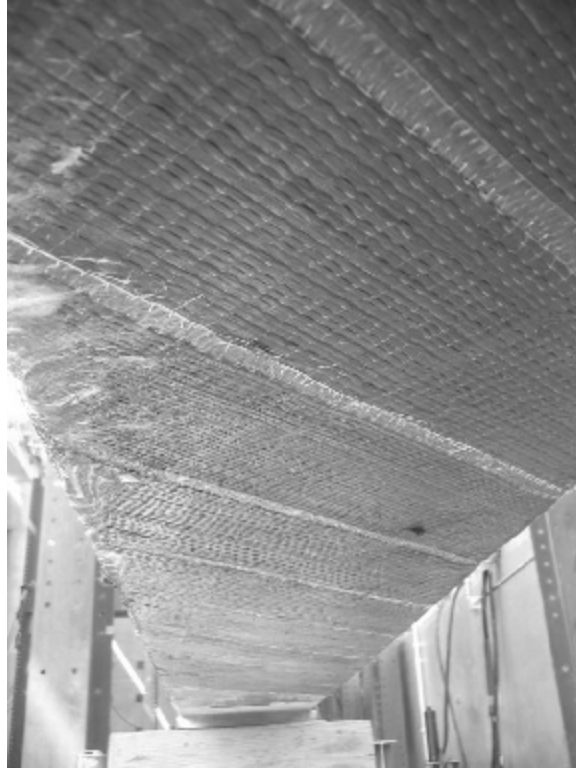
*Figure 4.22 CFRP crossing pattern on bottom of AASHTO2R girder*

2. The termination points of the longitudinal CFRP were staggered at a distance of 2 in to minimize plate-end debonding effects.
3. Two layers of 6 in wide transverse CFRP sheets were oriented perpendicular to the anticipated shear cracks to fully utilize their unidirectional strength. A 0.5 in space was left between each sheet to allow for moisture evaporation and allow for possible inspection. The transverse sheets started at the top flange of the girder, and made a 45 degree angle to the bottom of the girder. Once it reached the bottom, the sheet was smoothly transitioned and extended to the opposite side of the bottom flange before being terminated. This configuration created a crossing pattern on the bottom of the girder, as shown in Figure 4.22. This pattern of diagonal sheets began at the left support and ended below the loading point.

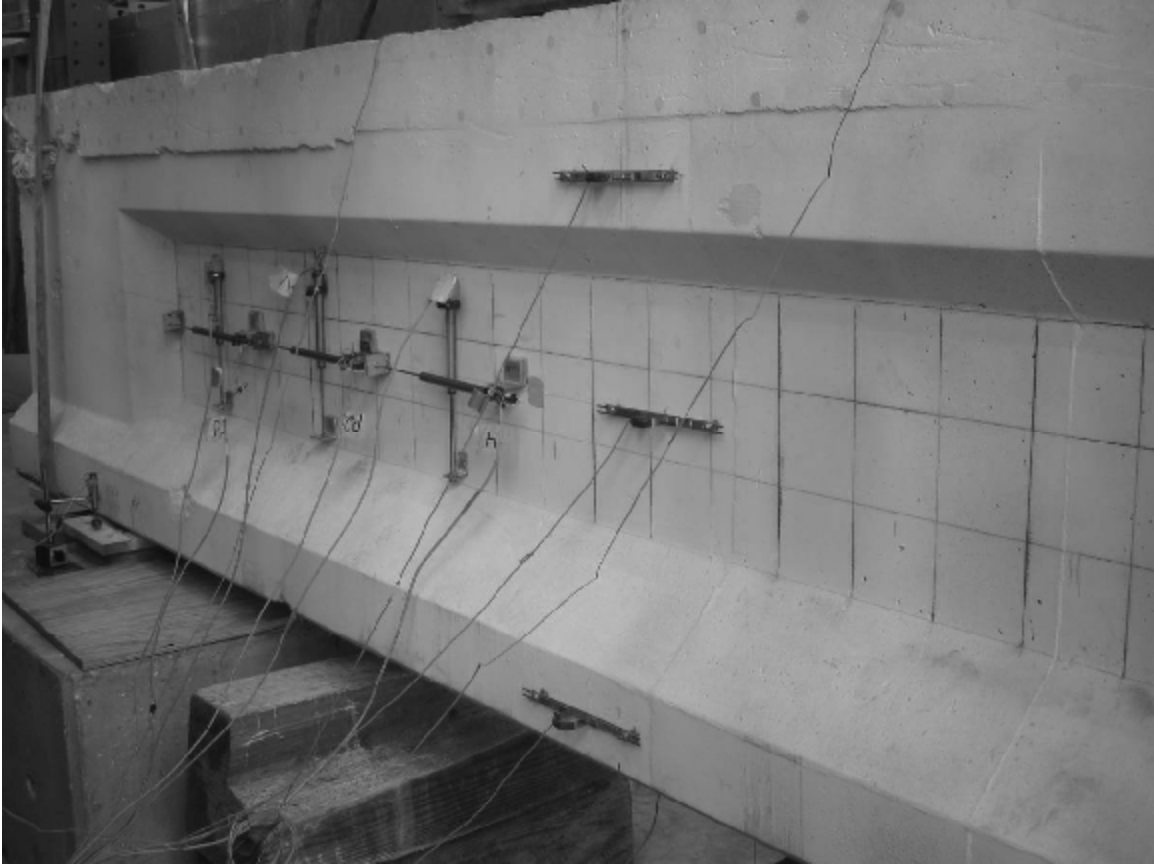
*Figure 4.33 Typical layout of linear potentiometers for AASHTO2C and AASHTO2R*

The displacement beneath the load point of each girder was measured using two string potentiometers. The compressive strain in the deck and girder were measured at midspan using both PI gauges (a strain gauge mounted to a spring plate) and 2.36 in TML FLA-60-11 120  $\Omega$  electrical resistance strain gauges. The shear crack widths were measured using three sets of two linear potentiometers oriented perpendicular to each other as shown in Figure 4.33. The location of the instrumentation for both girders was selected to determine: 1) the strain profile below the load point, and 2) to compare the crack widths of the control specimen with those of the repaired specimen. AAHTO2R was instrumented with 0.236 in TML FLA-6-11 120  $\Omega$  electrical resistance strain gauges along the CFRP diagonal struts to determine the strain distribution along the length of the girder.

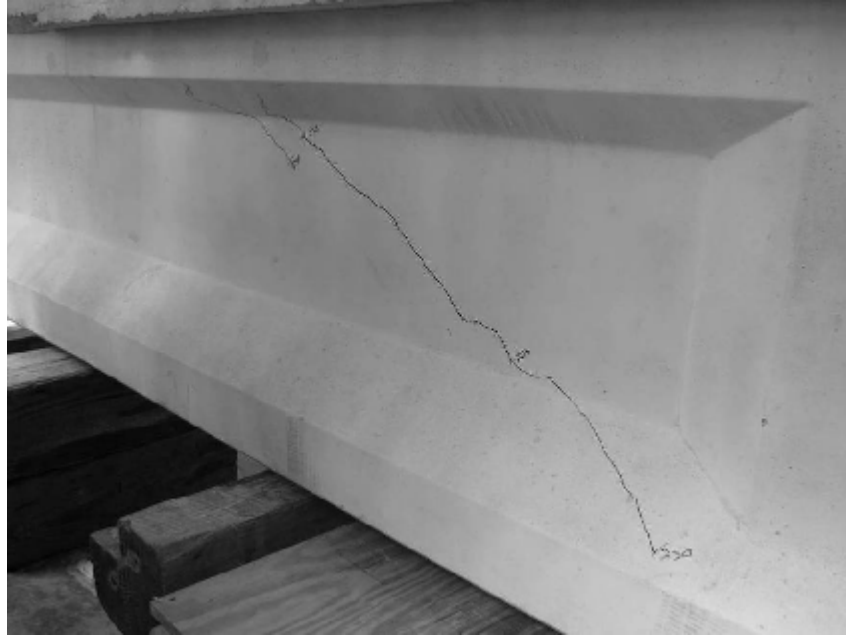
*Figure 4.38 Initial shear cracks in AASHTO2C girder (back side)*

AASHTO2C was loaded at a constant rate of 0.05 in/min up to a load of 275 k, then loaded at a rate of 0.02 in/min up to failure. The first visual crack formed in the web at 45 degrees from the left support on the back side of the girder at a load of 225 k. Additional shear cracks formed in the web as the girder continued to be loaded up to its ultimate capacity of 413.7 k before failing in web shear. At ultimate, a shear crack on the shear critical span, left side, of the girder in the web propagated toward both the left support and left edge of the loading plate, causing the section to split along this line. The initial web shear cracks on the back side of the girder are shown in Figure 4.38, while the catastrophic web shear failure is shown in Figure 4.39. Complete test results are presented in Chapter 5.

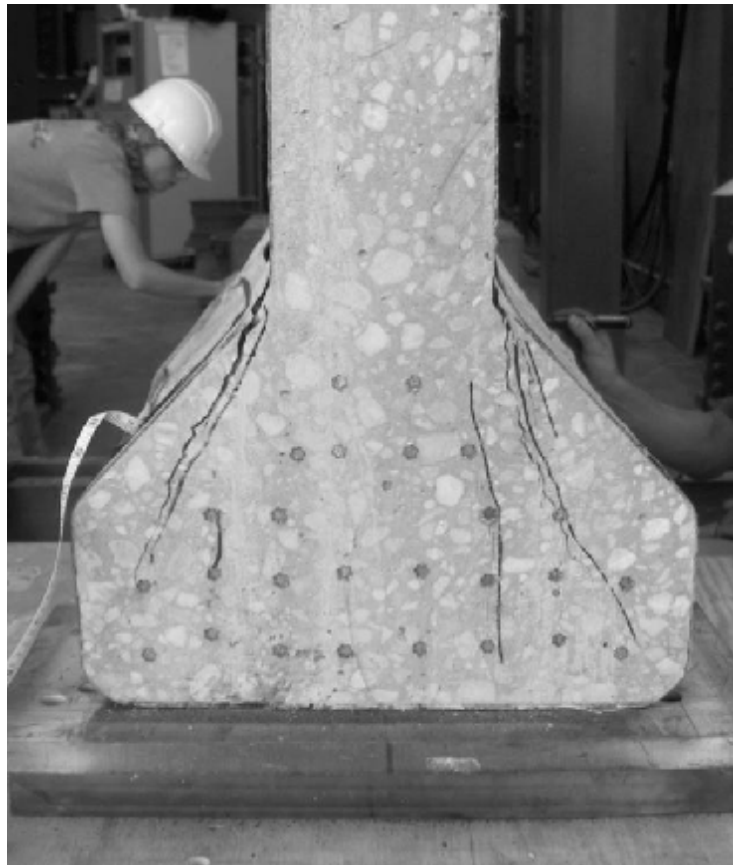
*Figure 4.40 Failure in transfer zone of girder AASHTO2R*

AASHTO2R was loaded using a 600 k hand-controlled jack. The girder was loaded as evenly as was possible with the hand-controlled hydraulic unit. The first visible crack formed on the test specimen at a load of 344 k just beyond the right termination point of the CFRP on the front side of the girder. The crack that formed was a flexural crack, however other cracks were heard prior to this, but they were located beneath the diagonal CFRP struts and thus not visible. The girder was then loaded to an ultimate load of 446.3 k before shear forces in the right transfer region began debonding the prestressing strands, as shown in Figure 4.40. This debonding led to decreased flexural capacity on the right side of the girder, which ultimately resulted in a flexural-shear crack propagating through the right, undamaged, side of the specimen from the load point to the support. Plate end debonding at the right termination point of the bottom longitudinal CFRP also occurred in this same region. The flexural-shear failure is shown in Figure 4.41. It should be noted that the transverse CFRP sheets that are visibly debonded were not part of the shear study, but were left over from the flexural repair of the specimen. Complete test results are presented in Chapter 5.

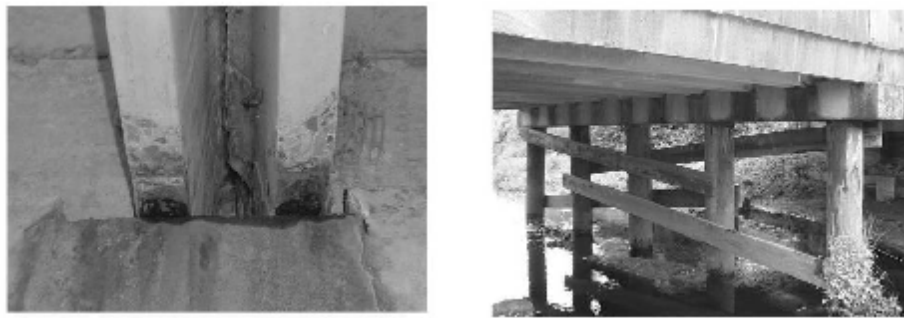
*Figure 7.1 Corrosion of bearing plate (left) and typical timber substructure (right)<sup>1</sup>*

<sup>1</sup> Corrosion of bearing plate is from Bridge 70 in Catawba County, NC. Timber substructure shown is from Bridge 43 in Carteret County, NC

From limited observations and from information given in the literature it can be concluded that some common problems encountered at C-Channel bridge sites are: 1) corrosion of lower prestressing strands near midspan resulting in longitudinal cracking and spalling (shown in Figure 7.1), 2) corrosion of the bearing plate at the support, resulting in spalling of concrete around bearing region (shown in Figure 7.1a), 3) shear cracks extending from area near support into the deck and 4) cracking of deck near midspan as a result of incorrect lifting maneuvers during original girder installation. In addition to these items observed with the superstructure elements, various other poor conditions can be found in the timber substructure (Figure 7.1b). Since strengthening may increase the posted capacity of the bridge, the timber substructure must be carefully evaluated to ensure that these increased loads do not lead to poor performance or deterioration. Therefore it is highly recommended to monitor the structural performance of any bridge strengthened using CFRP systems, especially the timber substructure. It is also essential to evaluate the efficiency of the timber substructure prior to installation of any strengthening technique.

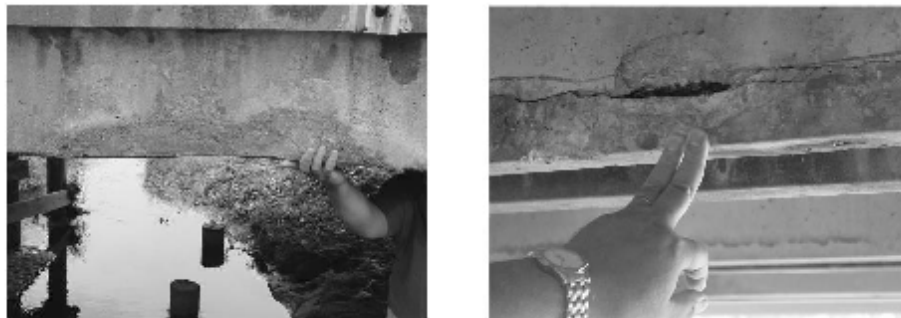
*Figure 7.2 Concrete spalling repair (left) and corrosion of lower prestressing strand (right)<sup>2</sup>*

<sup>2</sup>Concrete spalling repair is from Bridge 43 in Carteret County, NC. Corrosion of prestressing strand is from Bridge 14 in Pamlico County,
