# **VALUE ENGINEERING AND COST EFFECTIVENESS OF VARIOUS FIBER REINFORCED POLYMER (FRP) REPAIR SYSTEMS**

Research Project 2006-10

Final Report

In cooperation with the  
North Carolina Department of Transportation

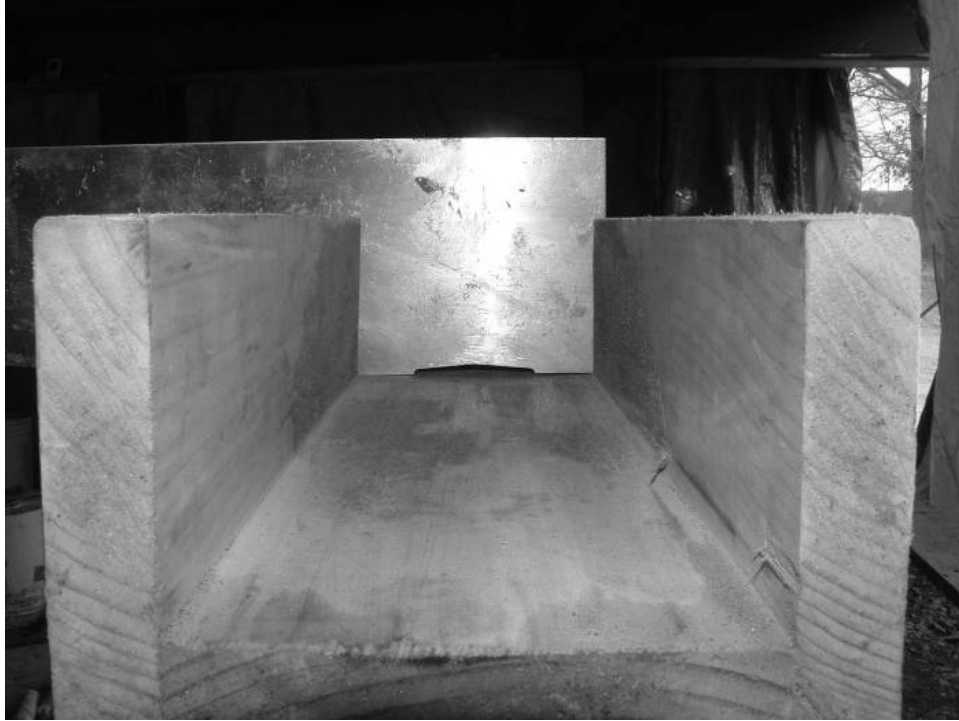
The installation of an externally bonded CFRP pre-cured laminate should begin by cutting the laminate to the specified dimensions and cleaning the CFRP surface. The adhesive should then be mixed in the appropriate ratio using a suitable electric mixer for the specified duration at ambient temperatures specified by the manufacturer. Using an adhesive bed, or guide is the best way to apply the adhesive to the CFRP laminate surface. The strip is placed longitudinally in the bed and the adhesive placed on one side of the metal plate. When the strip is pulled through the bed, a thin layer of adhesive is deposited on the CFRP strip in a triangular cross-section.

*Figure 8.1 Adhesive bed for externally bonded CFRP laminate installation*

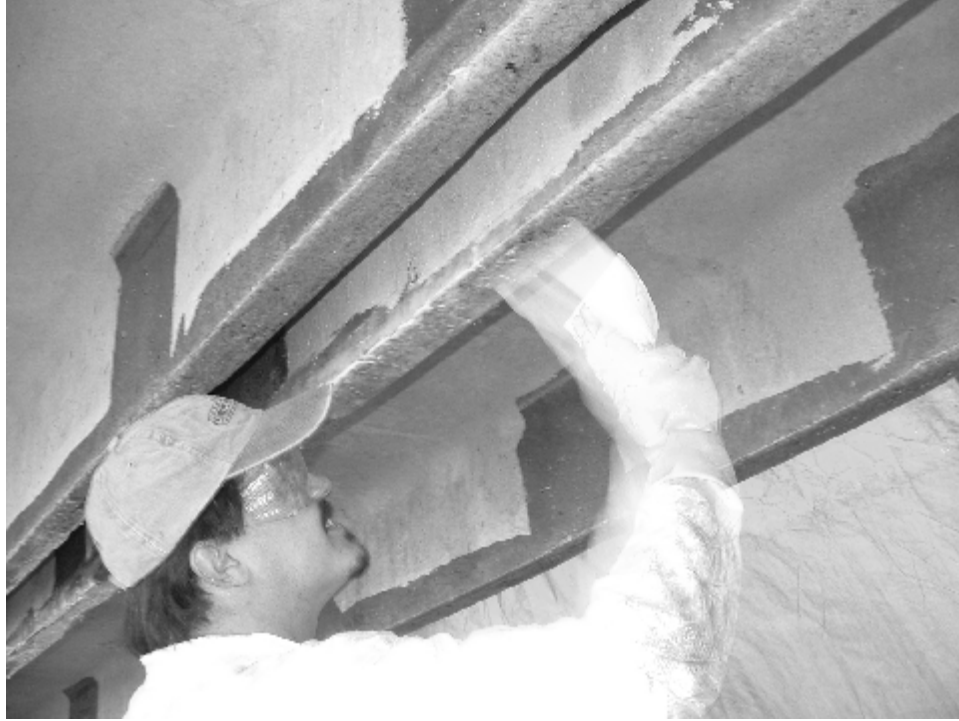
All primers, putties and saturants should be mixed in the appropriate ratios with an electric mixer for the correct duration in ambient temperatures specified by the manufacturer. A primer coat is usually applied first to the concrete surface to penetrate open pores. Next, a bonding agent or putty is applied using a trowel to smooth the concrete surface and fill in small voids or gaps not adequately filled in during concrete repair and surface preparation. The putty is commonly made by mixing the primer/saturant with a thixotropic agent like untreated fumed silicon dioxide (Cabosil®). An approximate mixing ratio to the primer/saturant is 1:1 by volume.

*Figure 8.2 Application of putty for wet lay-up*

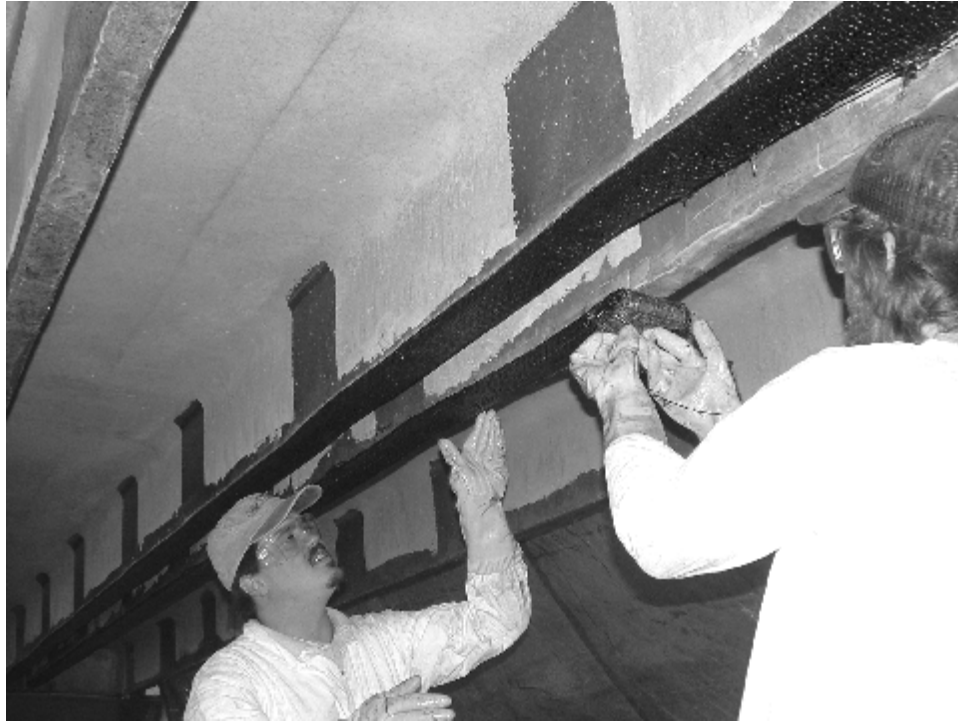
Once the primer and putty applied to the concrete surface have become tack-free (depends on ambient temperatures) the saturated CFRP sheet may be installed as shown in Figure 8.3. The sheet is put in place by hand and rolled in the direction of the fibers using a plastic serrated roller.

*Figure 8.3 Installation of CFRP sheets*

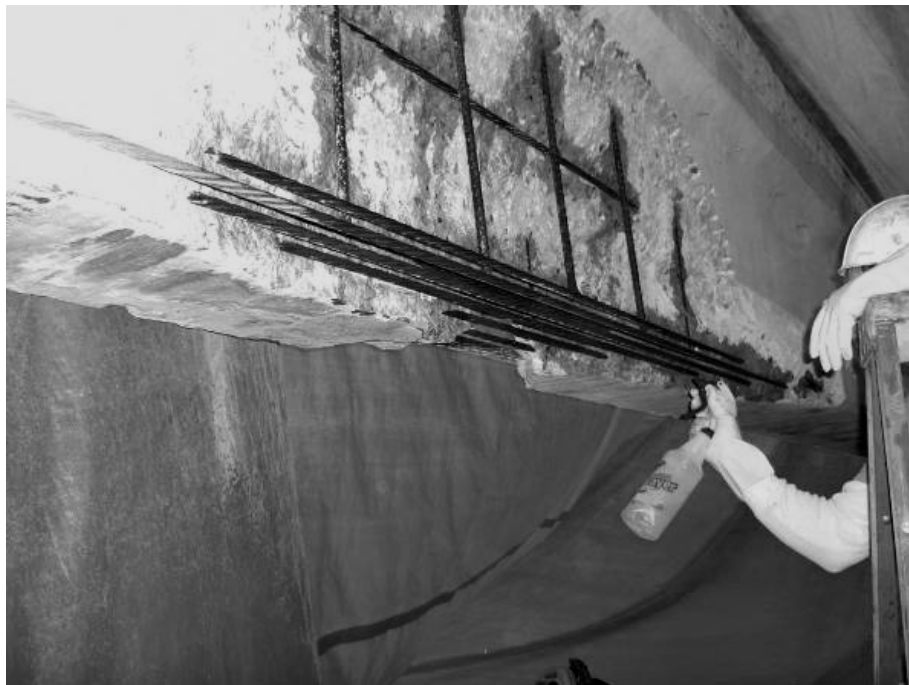
The restoration of a damaged prestressed concrete section can be a large task involving formwork and shoring or simply routine patching of lost cover concrete in the region below the lower prestressing strand. Before beginning restoration, all defective concrete should be removed in accordance with ACI Committee 546 (1996) using an appropriate jack-hammer or electric saw, to a depth of 0.5 in beyond the repair area in order to expose sound aggregates. Prior to application of the concrete repair material, the condition of the regular reinforcement and prestressing needs to be carefully evaluated. Discovery of corroded prestressing strands was found in some of the C-Channel bridges. In the flexural design of a CFRP strengthening system, it might be required to reduce the area of the prestressing strands in response to corrosion damage. To prevent further corrosion, application of a corrosion inhibitor is highly recommended. Cementitious, epoxy-modified products such as Sika Armatec® 110 EpoCem acts as an anti-corrosion coating in addition to a bonding agent for repairs to concrete and steel. An alternative, the two layer spray-on corrosion inhibitor Tyfo® CIS, can be used for restoration of the strands.

*Figure 8.4 Application of corrosion inhibitor*

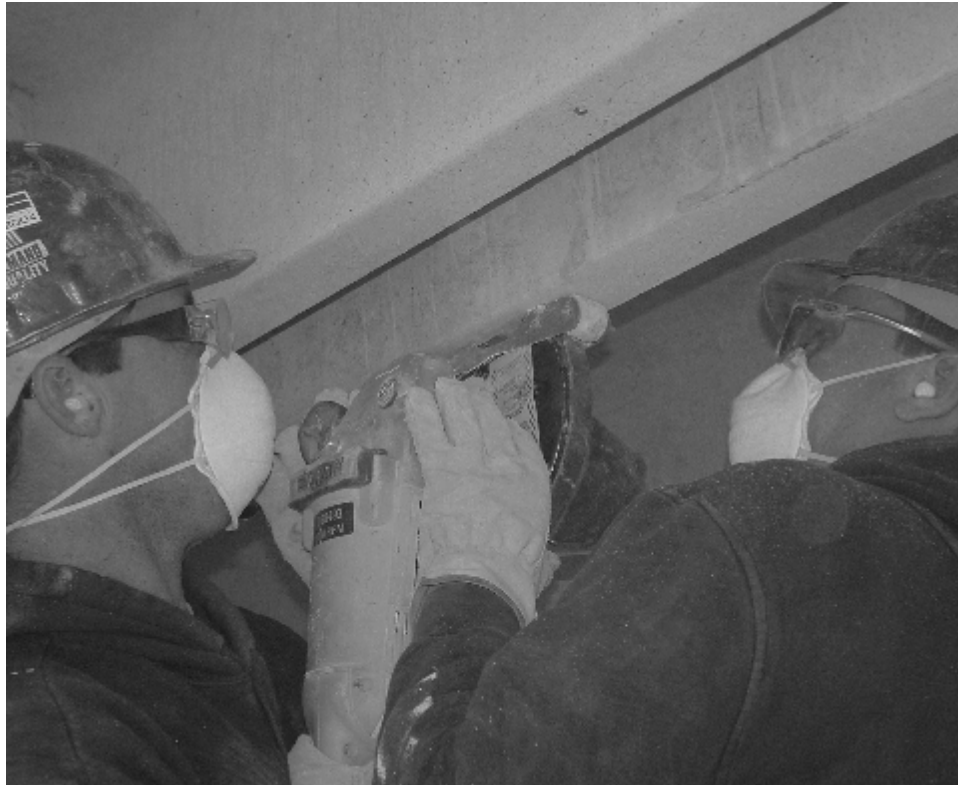
*Figure 8.6 Cutting of NSM groove*

An electric saw with two diamond bit blades aligned to the correct width and depth should be used for cutting of NSM groove, as shown in Figure 8.6. After the two saw cuts are made, the concrete within the cuts can be removed using an electric chipper. Groove cutting for NSM systems should take care not to fracture any of the surrounding concrete. If concrete becomes damaged it may be repaired with structural two-part epoxy mixed with sand or an appropriate material.

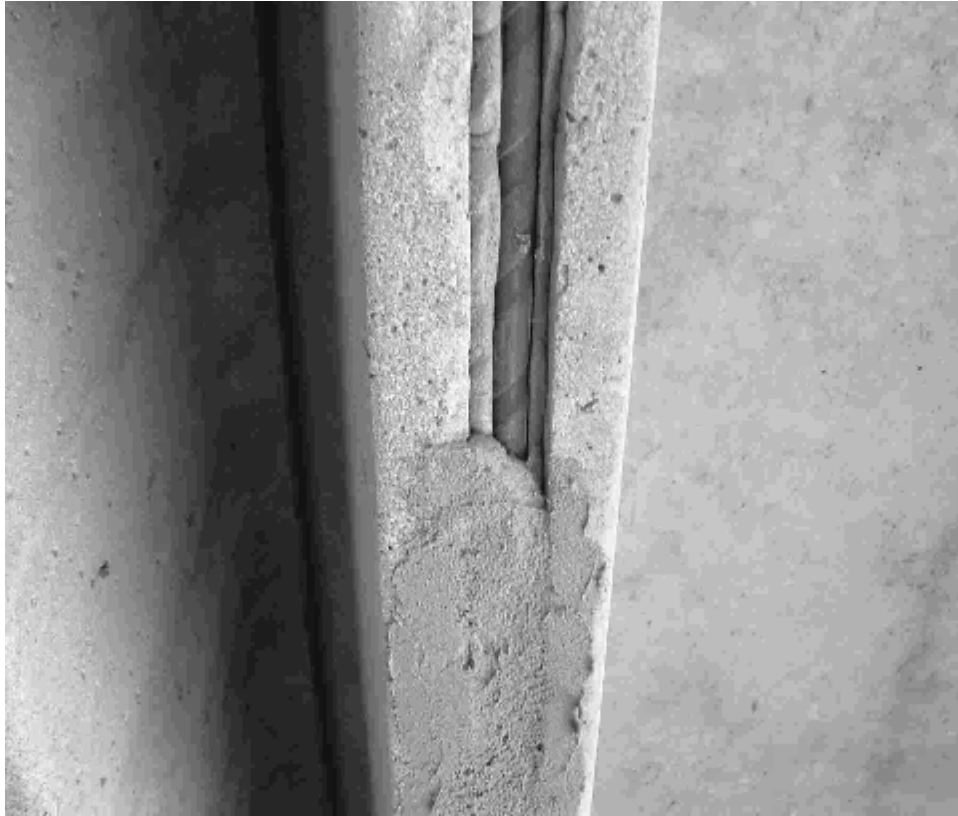
*Figure 8.7 NSM bar in groove*

The installation of a NSM system is straightforward. The adhesive should first be mixed in the appropriate ratios using an electric mixer for the specified duration in ambient temperatures specified by the manufacturer. The CFRP bar or strip should be cut to the specified length, cleaned and placed at mid-depth of the NSM groove.

The bar should then be lightly pressed to allow the adhesive to flow around the bar/strip cross section. The groove shall then be completely filled with additional adhesive and the surface leveled.
