# Response Planning, Assessment, and Rapid Restoration of Service of Bridges in Extreme Events: Background and Summary (2024)

Web-Only Document 390

## Response Planning, Assessment, and Rapid Restoration of Service of Bridges in Extreme Events BACKGROUND AND SUMMARY

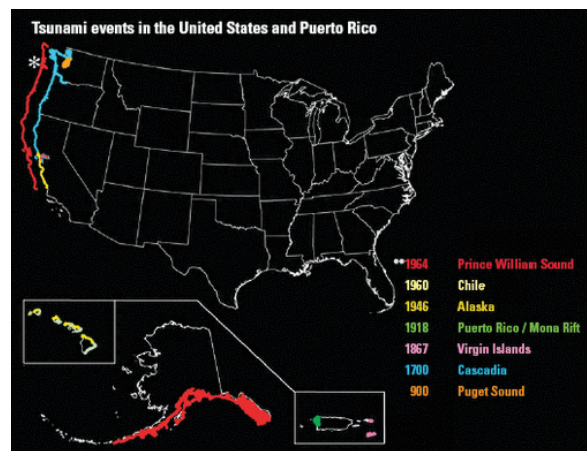
Figure 2-1. Threats of Emergency Events Across the USA

Geography and climate are major factors when it comes to anticipated extreme events for state DOTs. Some events, like collisions, fires, and floods can occur in every state. However, other events like earthquakes, tsunamis, and hurricanes tend to occur in specific regions of the United States.

(A) Hurricanes (Taylor 2017)

(B) Earthquake (USGS 2018)

(C) Historic Tsunamis (USGS 2020)

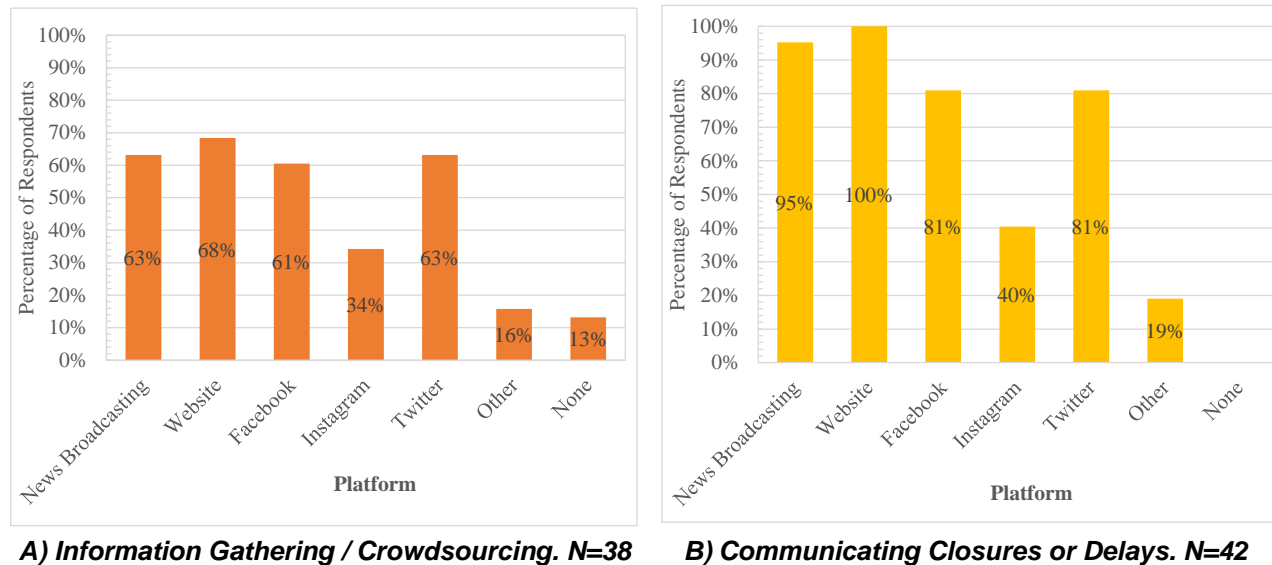
**Figure 2-2. Technology Used by State DOTs**

To gather information, state DOTs harness the power of crowdsourcing and social media. State DOTs tap into this wealth of knowledge to identify areas damaged after an extreme event, to verify damage, and to share information with the public (Department of Homeland Security and Technology 2014). If combined with a Geographic Information System (GIS) or other geospatial database, social media can be a powerful tool at identifying areas of concern and help with relief efforts. It can also be used to warn the public about evacuation routes, closures, and staging areas. Questionnaire respondents indicated that social media platforms (such as Twitter, Instagram, and Facebook) were some of the main methods to gather information from the public, but also to share information with the public (Figure 2-2).

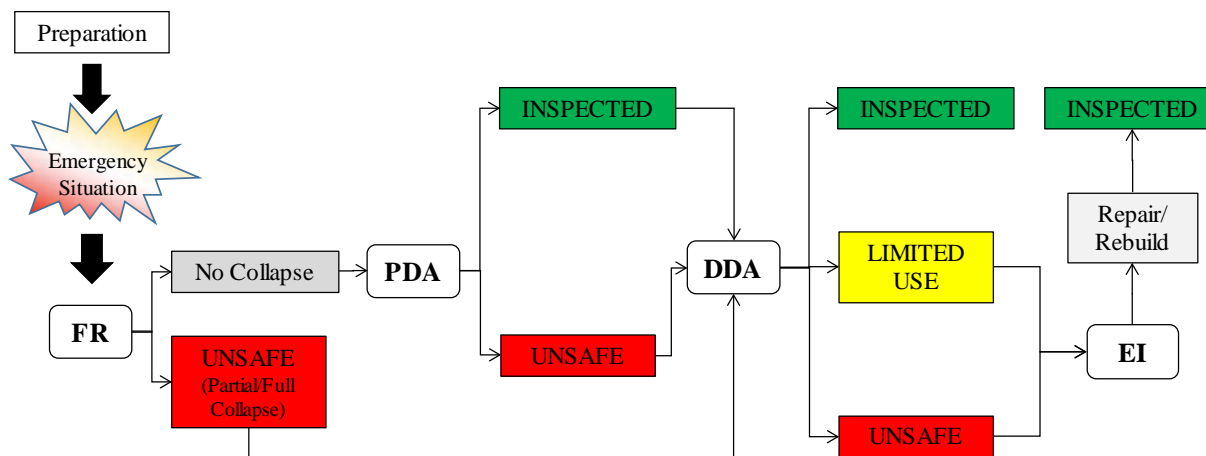
**Figure 2-5. Assessment Stages and Subsequent Primary Level of Coding (Olsen et al. 2016)**

*NCHRP Research Report 833* presents a four stage assessment process for emergency events (Figure 2-5). The four stages are: Fast Reconnaissance (FR), Preliminary Damage Assessment (PDA), Detailed Damage Assessment (DDA), and Extended Investigation (EI). Each level of assessment builds on

information collected in the previous assessment. If a structure is deemed as “unsafe”, then further investigation is required.

UNSAFE = The structure requires further evaluation in the next assessment stage prior to being open to traffic.

LIMITED USE = Potentially dangerous conditions are believed to be present and usage is restricted to ensure public safety.

A hierarchy of assessment levels can ensure an efficient response and improve situational awareness to assist with event response and recovery planning to a broad range of events. The project team recommends using the assessment framework described in *NCHRP Research Report 833* (Figure 2-5).

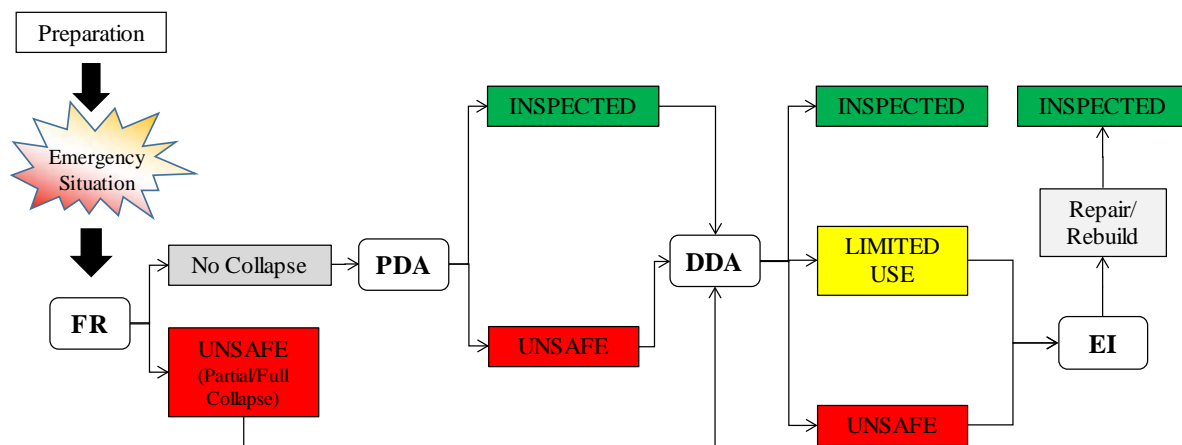
UNSAFE = The structure requires further evaluation in the next assessment stage prior to being open to traffic.

LIMITED USE = Potentially dangerous conditions are believed to be present and usage is restricted to ensure public safety.

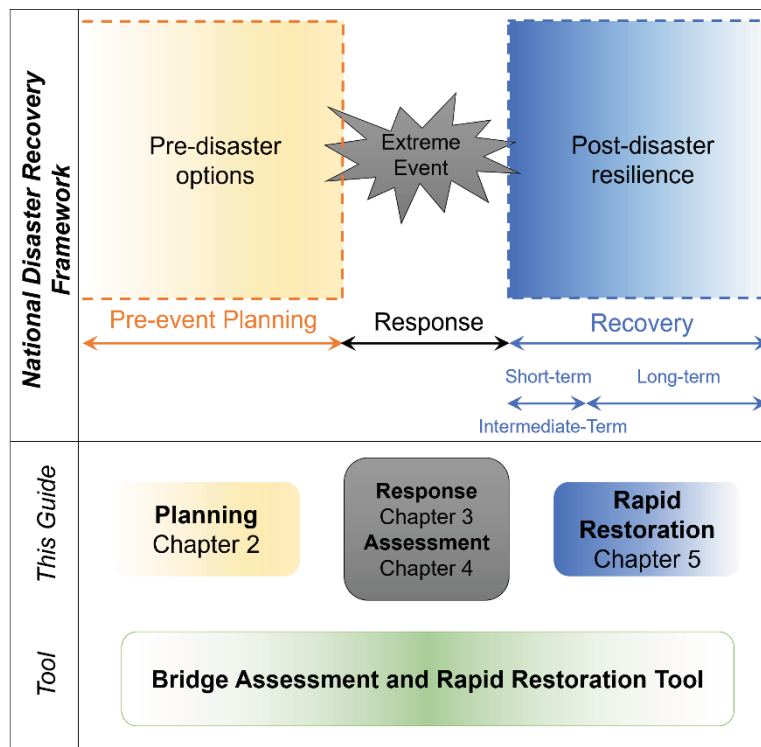
**Figure 4-1.** NCHRP Research Report 1098: Guide for Response Planning, Assessment, and Rapid Restoration of Service of Bridges in Extreme Events *Components and Alignment with the National Disaster Recovery Framework (Homeland Security 2016).*

The guide focuses on a typical extreme event cycle with three main phases: planning, response/assessment, and rapid restoration. Figure 4-1 shows how the NCHRP 14-45 Guide sections (See *NCHRP Research Report 1098*) aligns with the National Disaster Recovery Framework (Homeland Security 2016), which divides an event into Pre-event Planning, Response and Recovery. The guide is applicable to a variety of extreme events including earthquakes, tsunamis, hurricanes/storm surge, flooding/scour, fires, collisions, and man-made events.

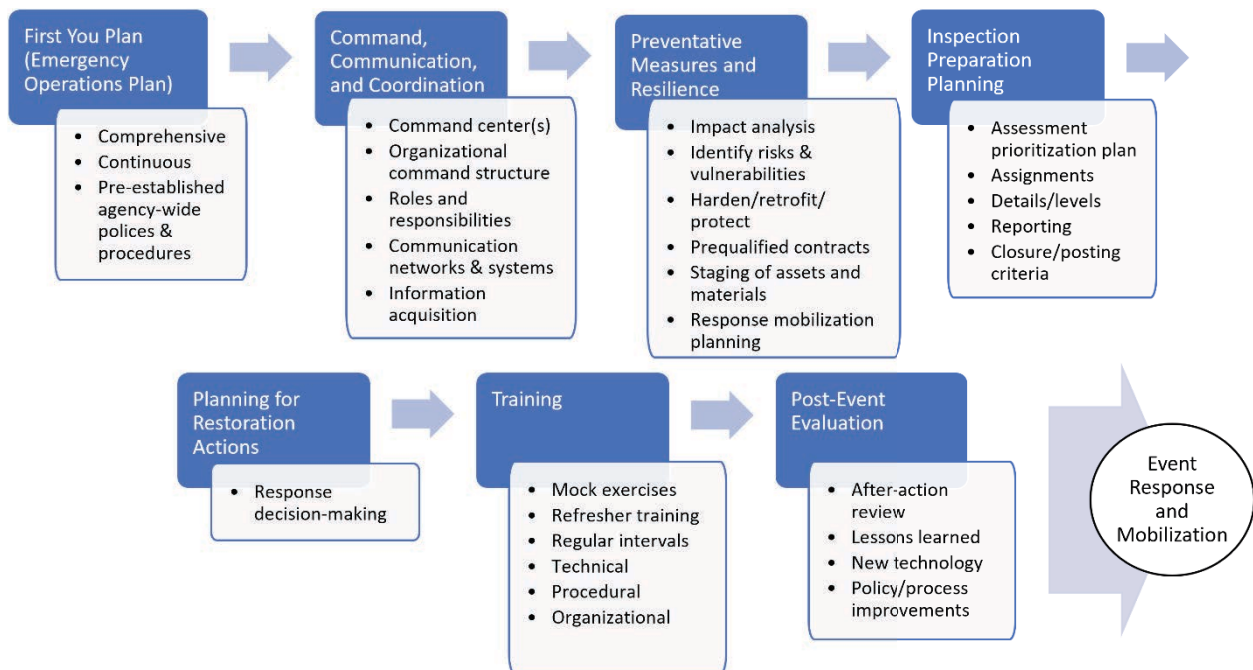
**Figure 4-2. Elements of Pre-Event Planning and Preparation**

Chapter 2 of the guide presents procedures to be implemented well in advance of an extreme event to facilitate rapid restoration of service of bridges and thus improve the long-term resiliency of the network. State DOTs are guided to revise or develop an Emergency Operations Plan (EOP) to define the operations at all phases of an event. Elements to be included in the EOP are command, communication, and coordination plans; resilient and preventative measures; inspection and assessment preparation; planning for restoration actions; training; and defining a post-event evaluation process. Additional details of these elements are shown in Figure 4-2.

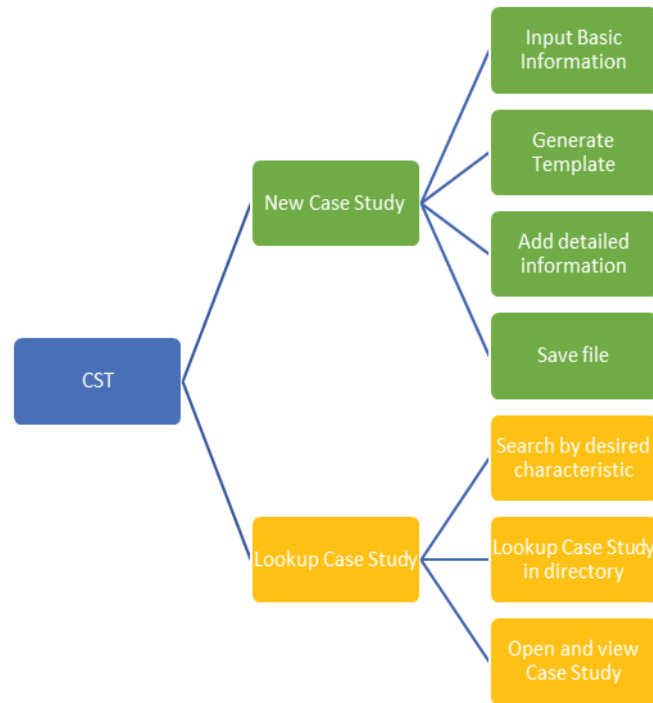
**Figure 5-10. CST User Workflow**

The Case Study tool (CST) provides a sample of recent events that can serve as examples for State DOT-specific knowledge transfers and to share lessons learned with other state DOTs. The CST has two features: (1) to generate new case studies from an Excel and Word-based template, and (2) to review existing case studies (Figure 5-10). The CST is preloaded with 27 case studies and include a form to quickly generate additional case studies in the same format. The existing case studies are PDFs of Word documents, and the template case studies are Word documents that contains a brief overview of the emergency event, cost, assessment techniques, type of repairs, and key lessons learned with each project. The included case studies are based on the NCHRP 14-45 literature review and were collected from several state transportation agencies from across the United States. They represent a wide range of emergency event types, assessment techniques, and repair solutions adopted during extreme events from the recent past. Sample case studies are shown in Appendix C.

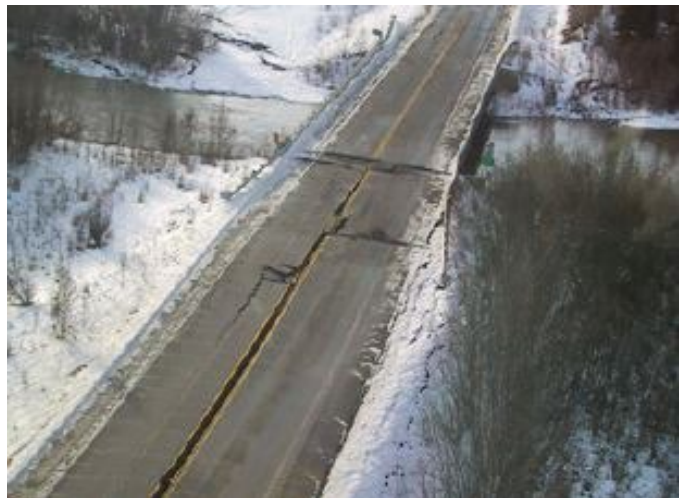
One truss bridge experienced a shifted rocker bearing. Luckily, the shifted pin and bearing did not separate, so maintenance crews were able to jack the bridge up and push the pins back into their original slots. Old railroad rails were welded together and used as piles in the original construction. However, these failed a few years later due to the brittle material and had to be replaced during the repair.

**Figure C-1. Shifting of the Tok Cutoff Bridge (McCarthy 2003)**

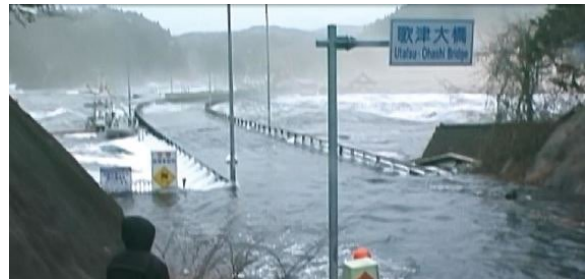
**Figure C-2. Utatsu Bridge Flooded (Kawashima & Matsuzaki, 2012)**

On March 11, 2011, the 9.0 magnitude Great East Japan Earthquake struck much of the nation. The earthquake subsequently caused a tsunami, destroying entire communities, as shown in Figure C-2. Imposing enormous damage and casualties, the earthquake and tsunami left with an opportunity for researchers and practitioners to verify the resilience of structures and infrastructure. Amid many other factors, researchers were able to investigate the effectiveness of the seismic design features added to many structures after the 1978 Miyagi-ken-oki and 1995 Kobe earthquakes and how to implement tsunami-resilient structures in the future. One piece of evidence for ‘good practice’ is that many of the bridges that did not sustain severe damage in the 2011 earthquake had been repaired or retrofitted after the 1978 and 1995 earthquakes, showing the benefits of lifecycle intervention measures (Kawashima & Matsuzaki 2012).

A video captured the Utatsu bridge being inundated by the tsunami. Eventually, the entire bridge was engulfed in the waves (Figure C-2). From the video, the flow velocity was calculated to be about 6m/s (Kawashima and Matsuzaki 2012).

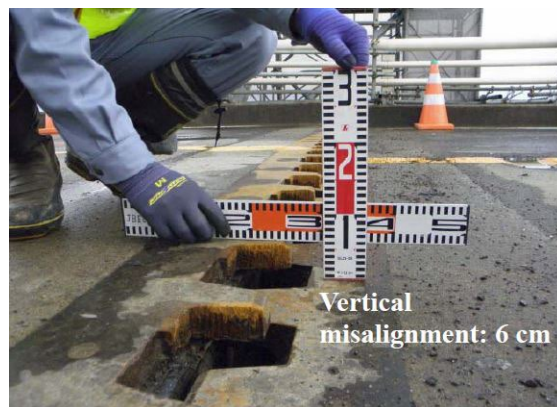
**Figure C-3. Earthquake Damage Observed Yuriage Bridge Damage (Japan Bridge Engineering Center 2011)**

At the Yuriage Bridge, tsunami waves passed under the structure, but were not intense enough to generate any significant damage, and the observed damage was attributed to seismic motions (EERI 2011). This damage was concentrated at the steel roller bearings. Seismic motions built up stresses at the bearings, where failure was observed. The bridge also experienced damage at the ends of its prestressed girders, which was attributed to radial stresses originating at the bearing (Kawashima 2012). The bearing damage was also thought to be caused by pier movement, which was caused partially by liquefaction. This caused a vertical shift on the deck of 6 cm, and a horizontal shift of 5cm. These measurements were performed during field visits as shown in Figure C-3A (Japan Bridge Engineering Center 2011).

This steel bridge suffered rupture and local buckling to its braces. One of the gusset plates also disconnected due to corrosion and torsion, as shown in Figure C-3B (Kawashima 2012). Bearing bolts also fractured, and their chunks were laying near the connections. The expansion joint protector was dislodged due to these fractured bolts. On the bridge deck, the teeth-like expansion joint suffered extreme separation from longitudinal motion (Japan Bridge Engineering Center 2011).

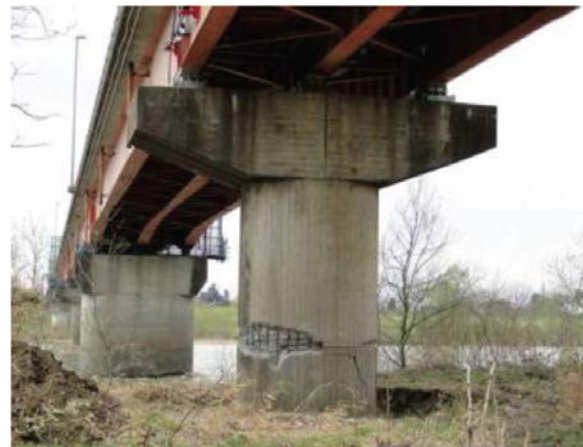
**Figure C-4. Fuji Bridge Damage (Kawashima & Matsuzaki, 2012)**

The Utatsu Bridge suffered a flexural failure at one of the columns as shown in Figure C-4, even though it was seismically retrofitted prior to the tsunami and earthquake. This failure was assumed to be caused by the seismic motions, which weakened the structure. The following tsunami then damaged the adjacent span 3 and washed away 8 spans in total (Japan Bridge Engineering Center 2011). Most of the span damage and uplift was caused by the deformation of lateral seismic restraints which freed up the spans to be pushed off their bearing. This unseating was caused by either the tsunami lateral forces or just buoyant forces (Kawashima 2012 and Japan Bridge Engineering Center 2011). The bridge was retrofitted a few years before the tsunami, and cable restraints were added between the spans that eventually washed away. Some of the restrainers ruptured, but others stayed intact, and the washed away spans were found still connected downstream of the flow (Kawashima and Matsuzaki 2012).

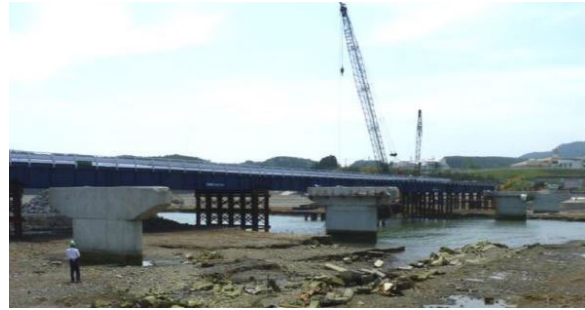
The Koizumi Bridge had been seismically retrofitted with hydraulic dampers at the abutments before the event. However, these enhancements could not withstand the inundation by the tsunami, which washed away all six spans of the bridge. A site investigation conducted revealed that most of the spans were lifted off their piers from the upward forces produced by the tsunami. The lateral restrainers from shear keys and dampers could not compete with the lateral tsunami forces; once freed from lateral restraint, the spans were floated away from the vertical forces (EERI 2011). One of the main channel piers was washed away after deep scour was formed (Japan Bridge Engineering Center 2011).

**Figure C-5. Koizumi Bridge Damage (Istrati et al. 2017, photo by E.V. Monzon)**

To restore traffic and post-disaster recovery, a temporary structure was built to move people and goods after the tsunami (Figure C-5) (EERI 2011).

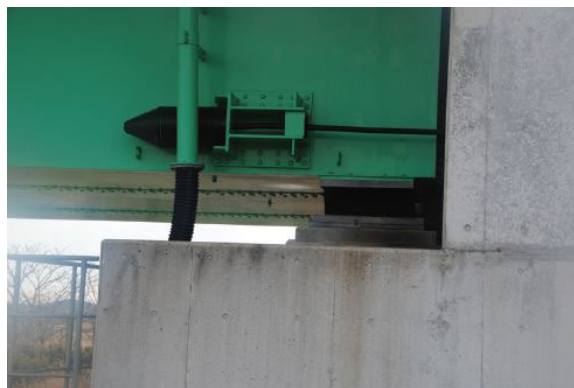
**Figure C-6. Elastomeric Bridge No Damage (Kawashima & Matsuzaki 2012)**

Bridges that used elastomeric bearings were found to be less likely to suffer earthquake motion damage, as shown in Figure C-6. Bridges that included dampers or other seismic force reducing devices also tended to perform better (Kawashima 2012). The use of elastomeric bearings was implemented extensively after the 1995 Kobe earthquake, as they also tended to perform better in that earthquake (Kawashima 2011).

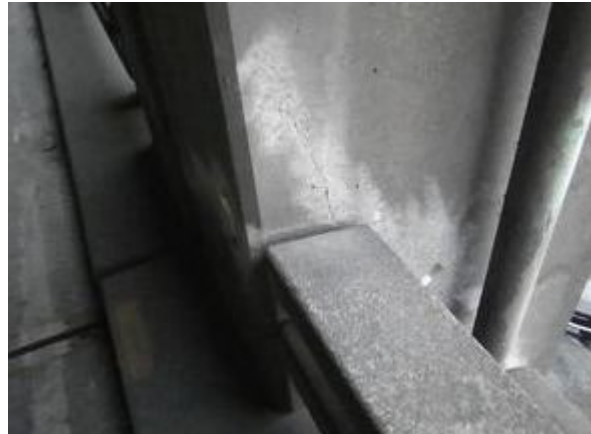
**Figure C-9. Cracks from Continued Column Settling (Lindblom 2014)**

The Alaskan Way Viaduct was initially inspected immediately following the Earthquake in February of 2001. During this inspection, there were no concerns about the bridge's structural integrity. However, in April of that same year, cracks were found near the structure's joints at the connections between the decks and columns, as shown in Figure C-9. These cracks were attributed to liquefaction of the surrounding soil. The inadequate soil below the bridge was estimated to be 30 feet deep in some regions, and consisted of loose soil, sawdust, and rubble. More alarming, the soil was held up by an aging wooden seawall. This discovery accelerated the need for a structure replacement, as the threat of the Cascadia Subduction Zone earthquake worried engineers (Farley 2018). An additional structural assessment was later conducted and found that the Nisqually Earthquake had weakened the connections between the columns and decks. Furthermore, it identified foundation problems due to shifting of the structure, which was compounded with cracks. The structure continued to shift even years after the earthquake. By 2009, the columns had settled an estimated 1.5 to 5.5 inches, depending on the location (Ott 2011).

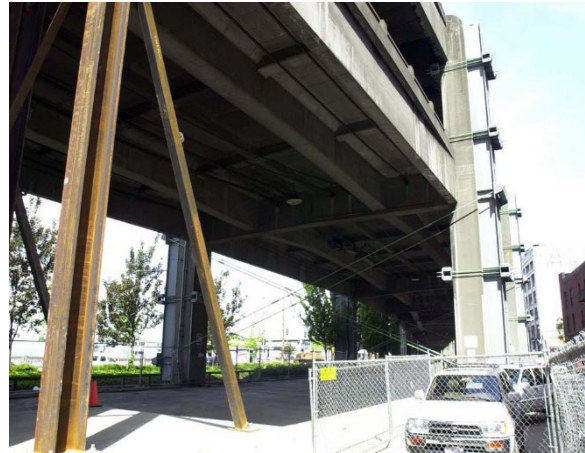
**Figure C-11. Temporary Supports After Nisqually Earthquake (Photo by Erik Stuhaug, Courtesy Seattle Municipal Archives (113883))**

The Alaskan Way Viaduct was intermittently closed after the April 2001 discovery of cracks to install shoring and other temporary supports. As the structure continued to shift years after, WSDOT installed additional reinforcements in the columns and imposed weight limits on the bridge (Ott 2011). Examples of the temporary support deployed are shown in Figure C-11. These supports remained in place until the bridge was removed.

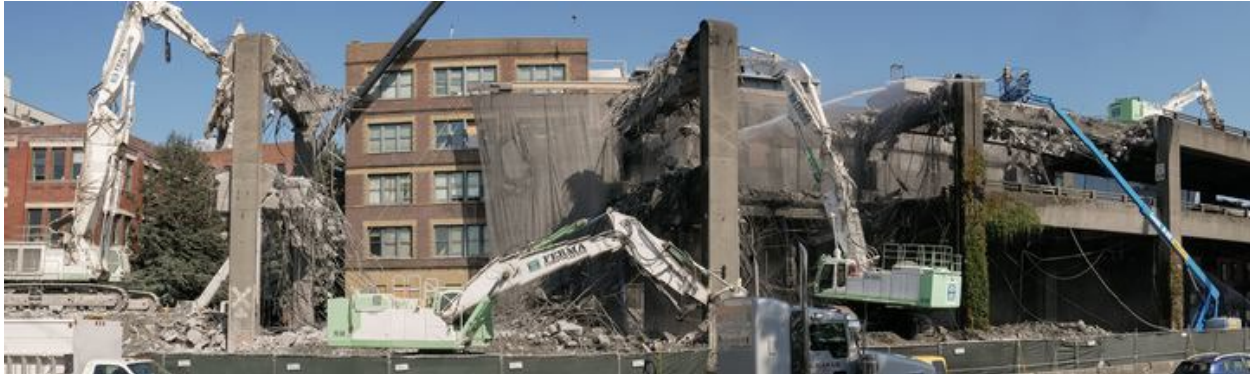
**Figure C-12. Removal of Alaskan Way Viaduct (Washington State Department of Transportation 2018)**

Demolition of the Viaduct began in 2011 (Figure C-12) and was completed in 2019. The new double-deck tunnel totaled over 9200 feet in length. Tunnel boring operations began at the end of 2015 and continued until early 2017 (Ott 2011).

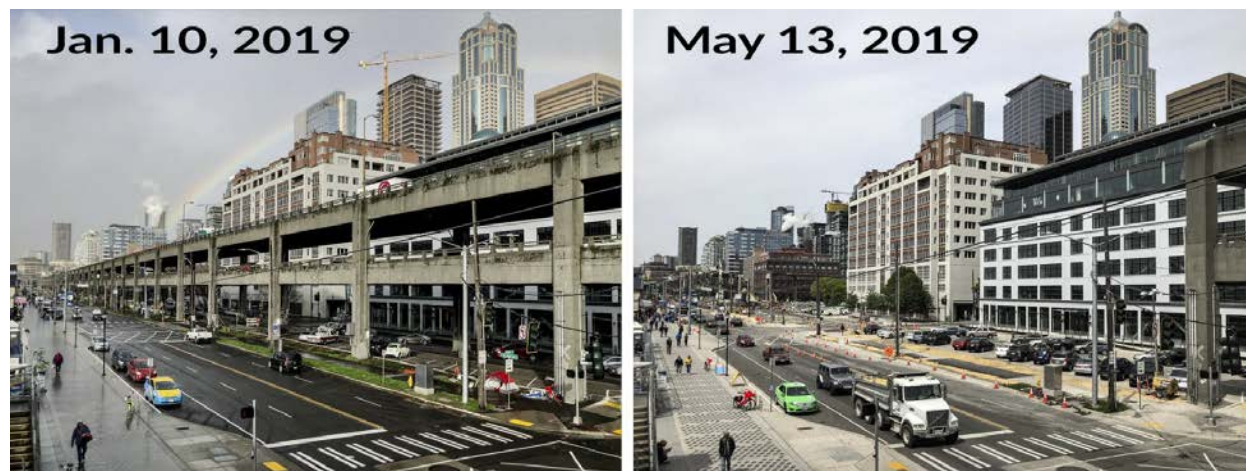
**Figure C-13. Before and After of Alaskan Way Viaduct Removal (Washington State Department of Transportation 2019)**

Additionally, the decision to replace the structure with a tunnel was not easy. There were mixed opinions on what to do with the structure. Some environmental groups argued for the demolition without any replacement. A study was conducted with that scenario, and found that Seattle would be in gridlock, causing a full city shutdown. This idea was quickly vetoed despite pushes from the groups (Ott 2011). Despite these challenges, the removal of the iconic structure paved the way to a new Waterfront, as shown in Figure C-13.

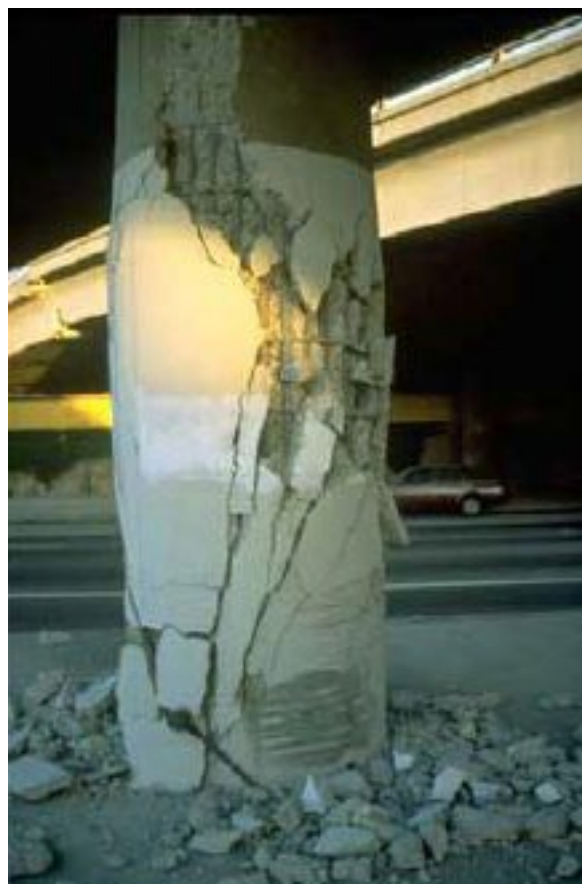
**Figure C-16. Typical Column Spalling Damage**  
(Marsh & Stringer 2013)

Typical damage from the Northridge earthquake included spalling and cracking of concrete abutments, settlement of approach slabs, tipping, or displacement of bearings, and spalling of column concrete cover,

as shown in Figure C-16. Most of the bridges impacted were built before 1971 when more stringent bridge seismic standards were introduced, but some bridges built after 1971 also experienced minor damage. Bridge structures in Northridge built after 1971 with more stringent seismic standards experienced minor damage that was easily repaired (Cooper 1994). Assessment of bridge damage determined that the level of damage was found to correlate with bridge skew, abutment and pier type, and span continuity. Moreover, reinforced concrete bridges saw the most damage overall, many of which had short columns with limited amounts of transverse steel leading to shear failures (Marsh et al. 2013).

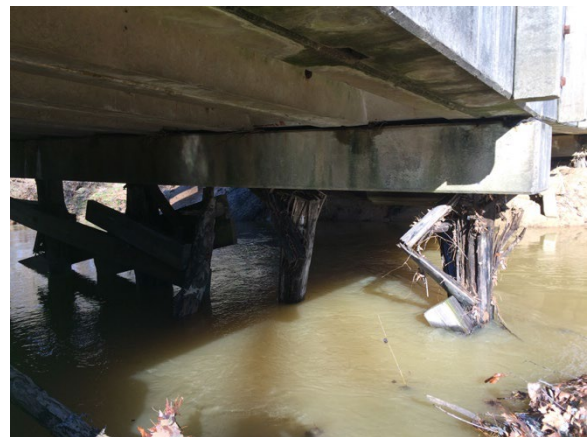
**Figure C-18. Debris Damaged Columns (Courtesy of Heavy Bridge Maintenance, ARDOT)**

2018 Flooding in Arkansas led to the Highway 54 over Sanders Creek Bridge to be impacted by a large chunk of floating debris. A combination of debris impact and pile deterioration crushed the wooden intermediate bent, causing the bridge to sink (Figure C-18). Fortunately, the highway travel volumes were low, and the detour was short. Because of this, ARDOT was able to cultivate a newer method of repair with a Bailey Bridge system to jack up the bridge, allowing for the rapid replacement of the bent.

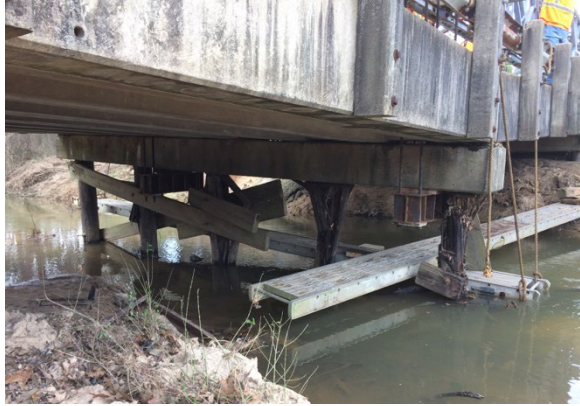
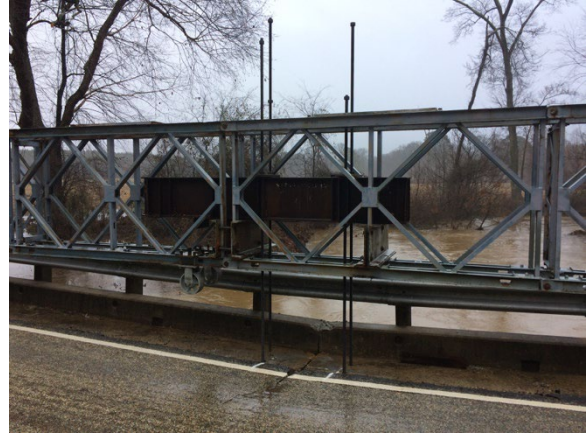
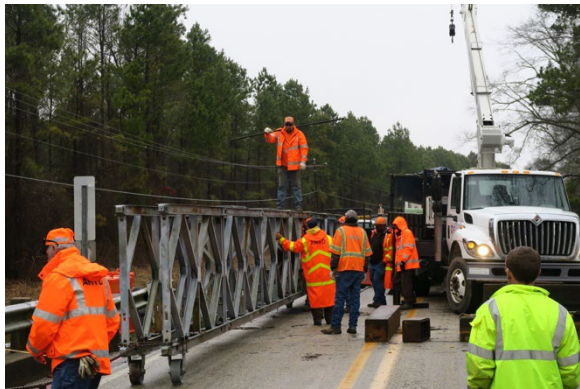
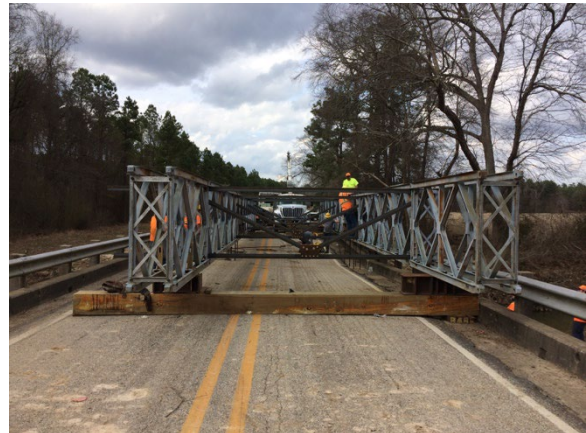
**Figure C-19. Permanent Restoration (Courtesy of Heavy Bridge Maintenance, ARDOT) (A) Preparation for Jacking (B) Jacking System in Place (C) Launching of Bailey Bridge (D) Bailey Bridge Installed Across the Structure**

To repair the bridge, the sinking superstructure had to be lifted. This was accomplished by creating saddles to lift the bent cap with Bailey trusses equipped with jacks. From here, the crushed timber piles were able to be removed, and new piles could be installed. To place the Bailey Bridge truss, heavy-duty casters were bought, and brackets were built to connect the Bailey Bridge to the casters. Then the crew pushed the trusses into position and boom trucks on each side of the bridge approach were used to lift the Bailey Bridge into place (Figure C-19).

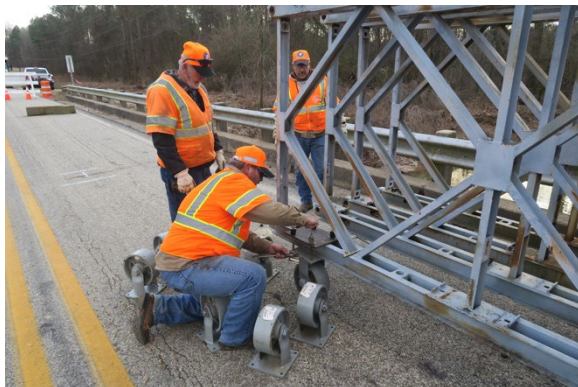
**Figure C-20. Innovations (Courtesy of Heavy Bridge Maintenance, ARDOT) (A) Installation of Casters (B) Replacing the Bent**

The casters and other supplies used for this project were purchased at the Federal Surplus (Figure C-20A). The Arkansas DOT found this was a great resource to take advantage of. The DOT highly recommends it to other transportation agencies for quality materials and equipment for a low price.

Typically, Bailey Bridges are used as temporary structures to reopen a structure. However, for this project, the system was used to lift the cap along with the superstructure off its crushed piles to replace the bent (Figure C-20B). This creative solution solved the problem of lifting the structure off the crushed piles without requiring heavy equipment on the structure. The Arkansas DOT had previously used a Bailey Bridge truss to pick up a damaged superstructure beam, but this was the first application of lifting a cap beam.

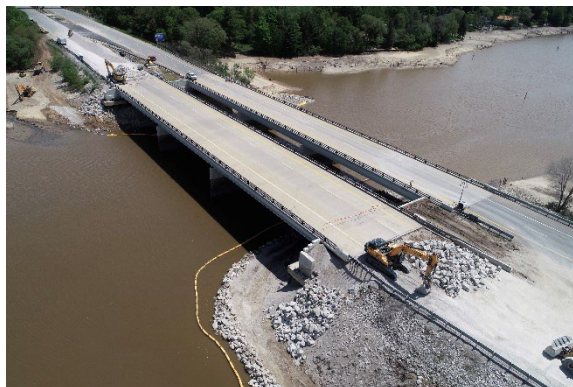
**Figure C-21. Repairs to US-10 Bridge Approaches (Michigan Department of Transportation 2020)**

A combination of visual inspections, drone footage, and underwater inspections were conducted to assess the situation. The underwater inspections (Browne et al. 2010) were heavily focused on the intermediate piers, as these did not have as much noticeable damage from the surface, and engineers wanted to be sure there was not extensive damage below the surface (Murdock 2020). The extent of the damage is shown in Figure C-21.

The eastbound bridge suffered less damage than the westbound, so repairs were started on this structure first. Construction on the eastbound bridge was completed by June 4<sup>th</sup>, which opened the bridge to one lane of traffic in each direction (Lamb 2020). To make this possible, a crossover system was first constructed to provide westbound traffic access to the eastbound bridge (Heideman 2020). On June 14<sup>th</sup>, the westbound bridge opened, restoring normal traffic patterns (Lamb 2020). The total cost of repairs totaled \$1.78 million (Heideman 2020).

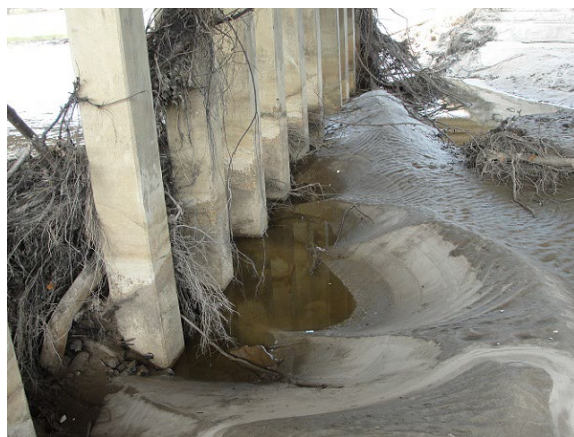
**Figure C-23. Scour Damage at Bent (Images courtesy of Padgett et al. 2018)**

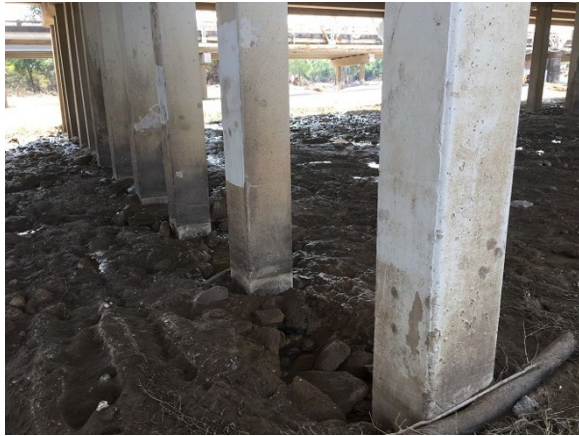
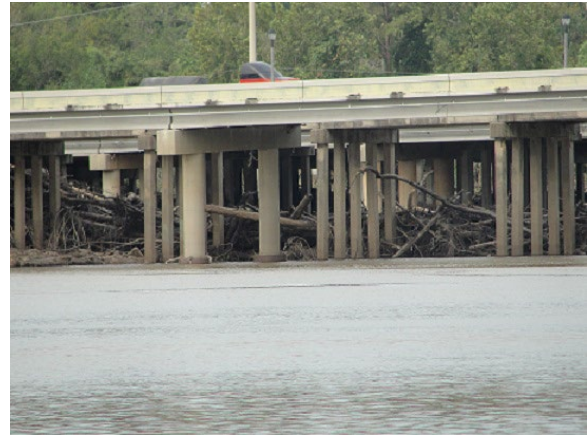
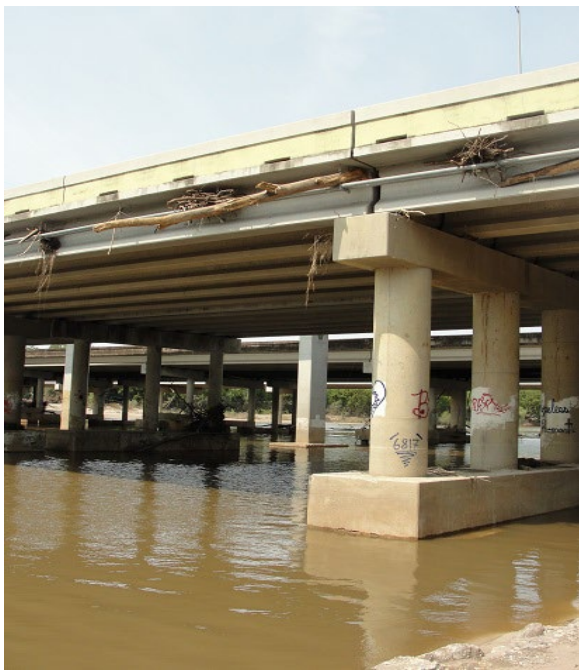
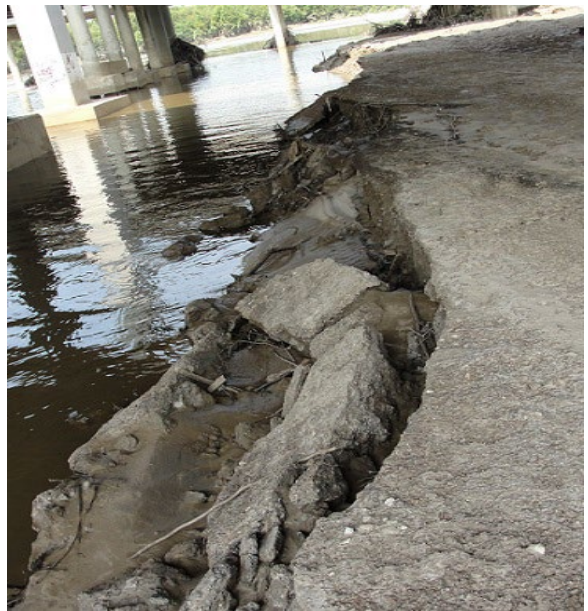
**Figure C-24. Damage Observed (Images courtesy of Padgett et al. (2018)) (A) Scour Along Column Bents (B) Debris Build-Up (C) Debris Trapped at Deck Level (D) Erosion Along Bank**

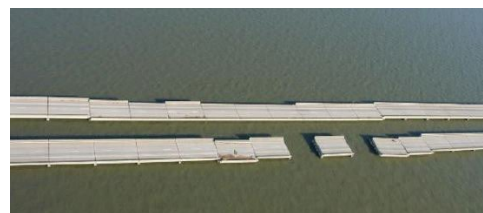
**Figure C-28. Aerial View of Damaged and Missing Spans (Alipour 2016)**

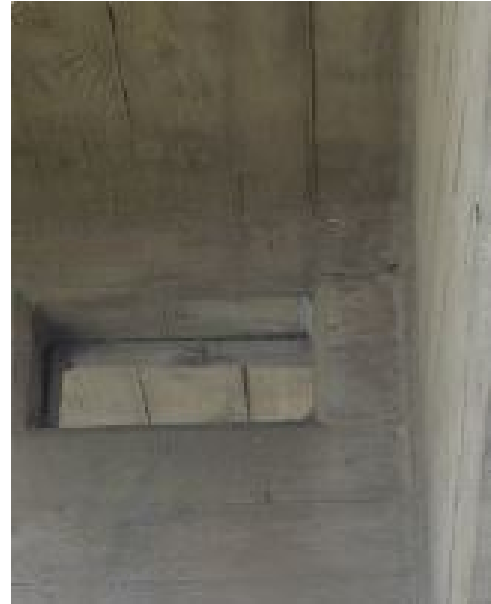
**Figure C-30. Highway 11 Bridge Girder Opening (Chen et al. 2007 with funding from USGS)**

It was noted that the higher spans toward the center of the lake’s navigation channel did not suffer the same levels of damage as the lower approach spans. This finding suggests that the cause for the bridge collapse was built-up hydrostatic pressure, which made it easier for the spans to float away. Lab tests were conducted with replica girders and found that if only 55% of the volume was filled with trapped air, the spans were able to float away. Using surge data, it is estimated the bridges experienced up to 70% of filled voids, significantly higher than the 55% threshold that would initiate floating spans. With this buoyancy, it would only take the slightest horizontal disturbance to shift the spans off the bents and cause the 50+ missing spans and hundreds of shifted spans. Furthermore, the adjacent Highway 11 bridge span did not experience the same damage as the I-10 Bridges. The design of the girders in the I-10 Bridges included holes through them to relieve the hydrostatic pressure build-up, as shown in Figure C-30. Further inland on the lake, a railroad bridge also did not experience the same damage, and that bridge’s design included solid deck slabs, which did not allow for any built-up hydrostatic pressure. These empirical findings imply that appropriate surge-resistent bridge-span design is essential to water-crossing bridges in hurricane prone coastal regions.

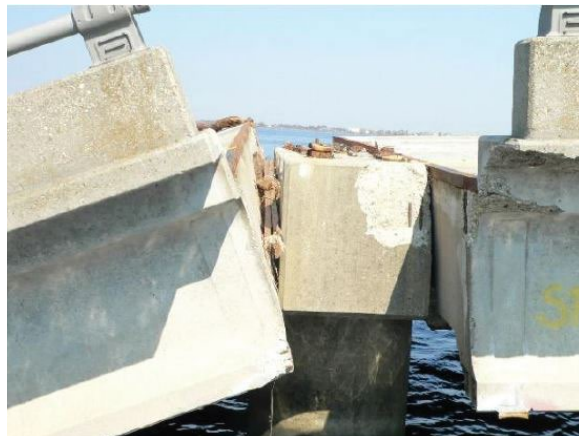
**Figure C-31. Girders Fallen off Bent (Alipour 2016)**

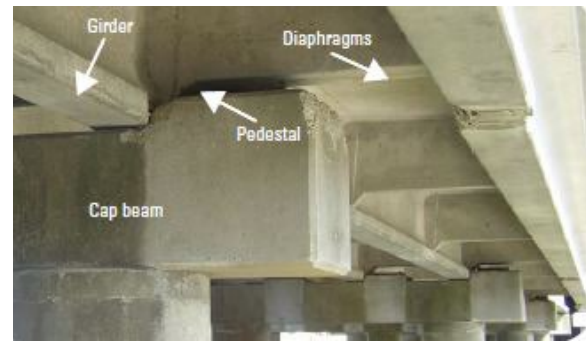
**Figure C-32. Girder Design Creating Trapped Air (Chen et al. 2007 with funding from USGS)**

During a hurricane or major flooding event, damage might not be from the common causes such as debris impact or scour, but from the buoyant forces on the bridges. Bridges are not always designed for uplift, and they should be designed to not trap air under the deck or in the superstructure to provide some relief to these forces. Figure C-32 highlights this flawed design. Additionally, bridges seismicity-inactive regions are not always designed to dynamic forces in mind, and this can cause issues during dynamic moving of water. Static designs should still be used, but dynamic forces should also be considered for water-crossing bridges subject to extreme flood or surge events. To consider dynamic lateral loadings from water, the shear keys should be installed to hold girders in place (Robertson et al. 2007).

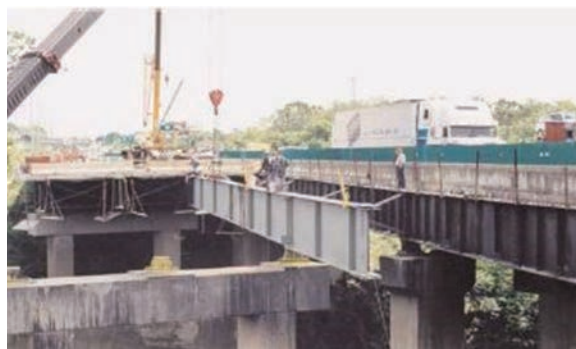
**Figure C-33. Placement of New Girders (Bai and Kim 2007)**

The Chester Creek Bridge was built in 1965, with a three-span continuous steel girder design and a concrete deck. The substructure was composed of concrete bents. On May 23rd, 1998, a gasoline tanker truck collided with the I-95 Chester Creek Bridge center median, flipping over the barrier, and crossing traffic on the southbound lanes. The truck impacted another vehicle and spilled 8700 gallons of fuel, which burst into flames. The southbound lanes of the bridge experienced severe damage from the fire (The Washington Post 1998). Engineers decided to replace the damaged portions with an identical structure, for a total cost of \$4 million, as shown in Figure C-33 (Bai and Burkett 2006).

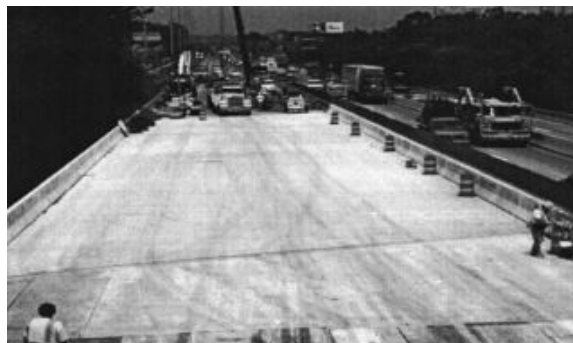
**Figure C-34. Curing of New Deck (Bai, Burkett and Nash 2006)**

After setting the girders in place, steel deck pans were set between them. Then, reinforcing bars were installed, and the 10in thick deck was poured, as shown in Figure C-34. Once the deck was cured, two lanes were moved back to the southbound side for a partial reopening on June 25th. From this point, new concrete barriers were added to replace the old median and the rest of the lanes were open to traffic. Repair work on the minor-damaged bent continued until July 3rd, which was 12 days ahead of schedule. The total cost of the project was \$4 million, and the contractor received \$500,000 in overtime pay (Bai, Burkett, and Nash 2006).

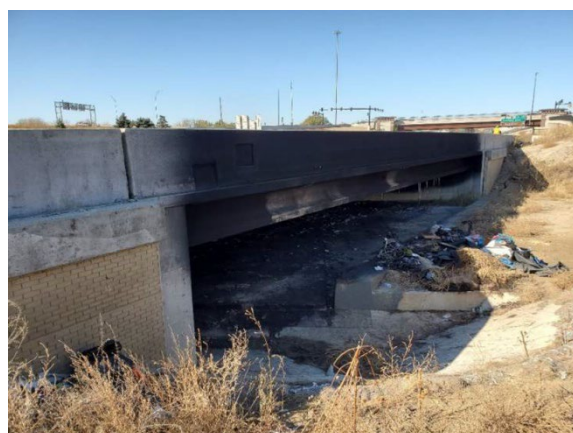
**Figure C-36. Fire Damage to I-29NB Perry Creek Conduit Bridge (Used with permission © Iowa Department of Transportation, HDR 2019)**

IDOT was almost finished with the 12-year long I-29 improvement project when a fire, caused by a homeless campfire, which ignited a nearby propane tank, causing an explosion, broke out under the I-29NB Perry Creek Conduit Bridge on October 30<sup>th</sup>, 2019 (Figure C-36). The single span bridge carried 3 northbound lanes of traffic and had been completed only a year before (Deckert 2019). 8 concrete beams made up the superstructure, and three interior girders suffered severe damage, and two with some damage because of the fire (HDR 2019). IDOT hoped the repair would take under a month, but a consultant investigation revealed the extensive damage to the interior girders – causing the structure to be ultimately replaced. Its completion marked the end of the I-29 improvement project (Deckert 2019 and Rennie 2020).

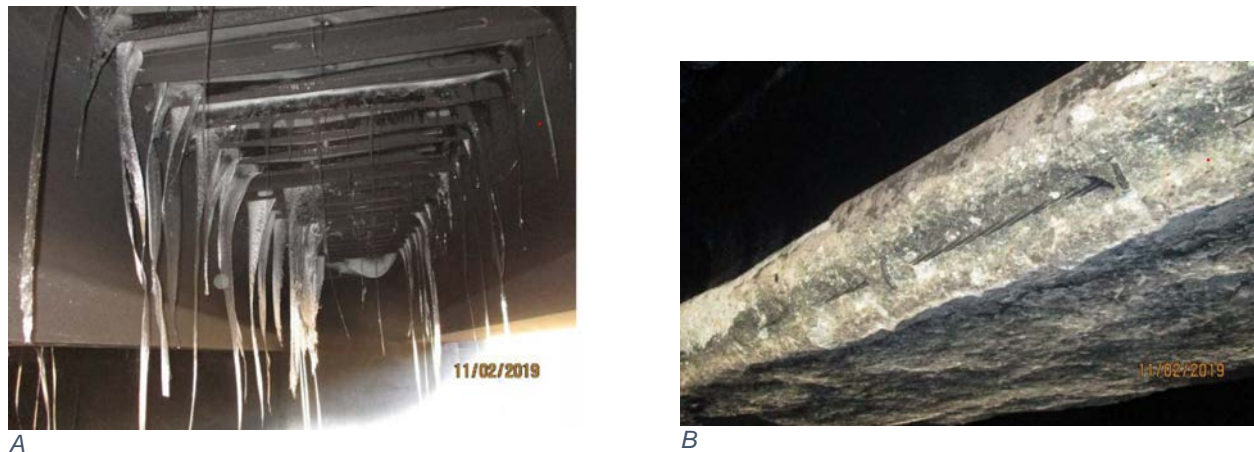
**Figure C-38. Fire Damage (Used with permission © Iowa Department of Transportation, HDR 2019) (A) Stay-in-Place Construction Forms and Cross Bracing (B) Spalled Concrete**

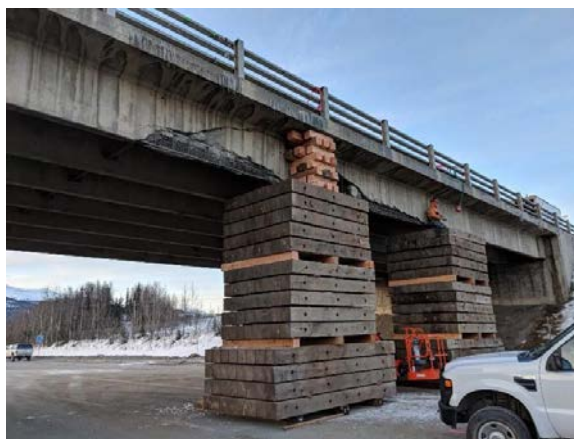
**Figure C-43. Temporary Shoring Required for Girder Removal (Levings & Murray 2018)**

On day 3, the bridge was shored using wooded-like pallets called cribbing (Figure C-43). Because the girder was so heavily damaged, a multi-step process was undertaken to safely remove the girder to avoid buckling. With the cribbing in place on each side of the damaged area, holes were cored through the deck and girder top flange to crack a lifting location for the cranes (Figure C-42). The cranes then lifted the girder up just enough to carry the dead load. Then, the girder was cut longitudinally

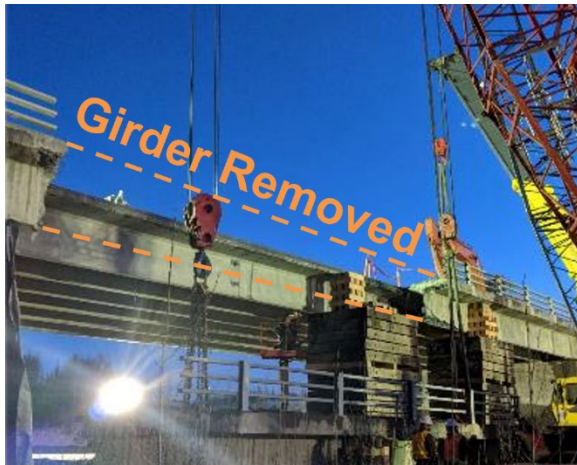
**Figure C-45. Girder Removal 71104 (Levings & Murray 2019)**

to disconnect it from the adjacent girder. To completely sever the girder into two halves, the damaged area was picked at with an excavator, and then the two halves of the girder were lifted away separately (Figure C-45). This process took place over a few days, and by day 5, the girder removal was complete, and the region was cleaned up (Figure C-44). By 10pm on day 5, the bridge was able to be reopened to traffic until permanent repairs were built in 2020 (Levings and Murray 2019).

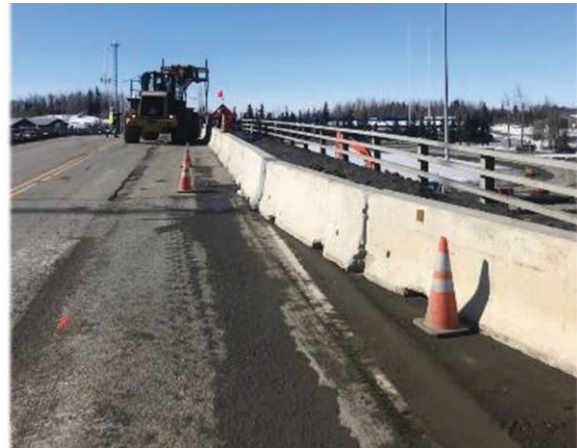
**Figure C-44. Temporary Repair Clean Up 71106 (Levings & Murray 2019)**

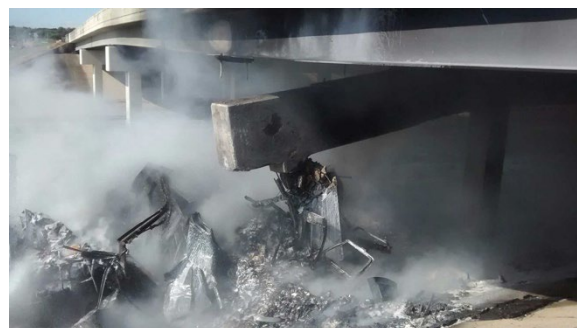
**Figure C-48. Damage to Bent (Courtesy of Heavy Bridge Maintenance, ARDOT)**

On June 27<sup>th</sup>, 2017, a commercial vehicle collided with the Highway 1B overpass over Interstate 555 in Jonesboro, Arkansas, leaving extensive damage to the structure (Figure C-47, Figure C-48, and Figure C-49). Both the interstate and highway were closed because of the collision. Damage included heavily damaged bridge columns, bent cap, and cracking of the deck. A temporary bent was installed to reopen the interstate, and permanent repairs were completed two weeks after the collision, reopening Highway 1B. The entire repair portion of the project along with traffic control cost approximately \$247,000. The bridge painting was let to contract for \$237,704. All repair work was completed by the Arkansas Department of Transportation (ARDOT).

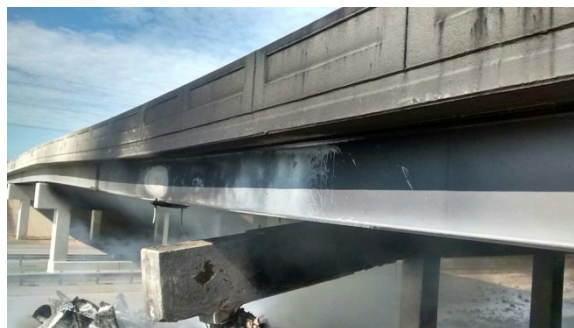
**Figure C-49. Damage to Bent (Courtesy of Heavy Bridge Maintenance, ARDOT)**

A visual assessment of the structure revealed the heavily damaged bent that took the brunt of the impact. The four columns that made up the bent sustained significant damage, and one was extensively damaged. The damaged bent caused a few of the girders to have no intermediate support, causing the structure to sag. Immediately following the collision, it was unclear if the structure was in jeopardy of collapsing; however, further investigation indicated the overpass was not in danger of collapse (Arkansas Online 2017).

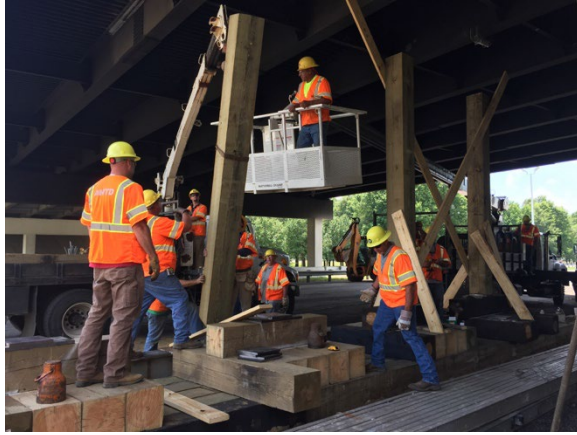
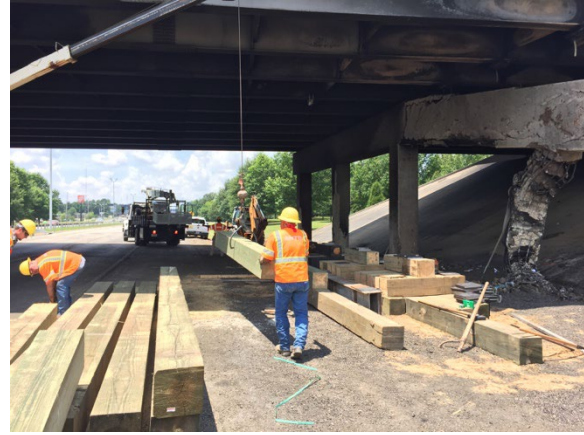
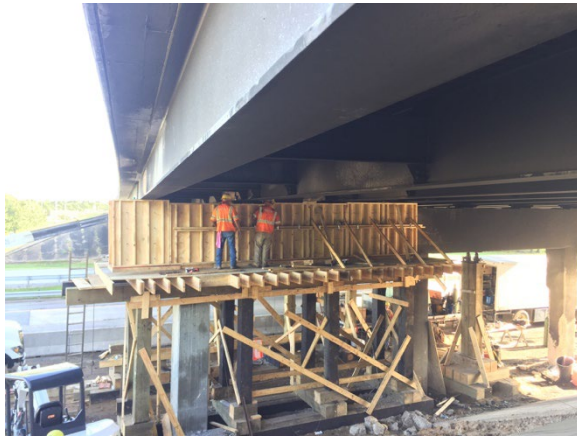
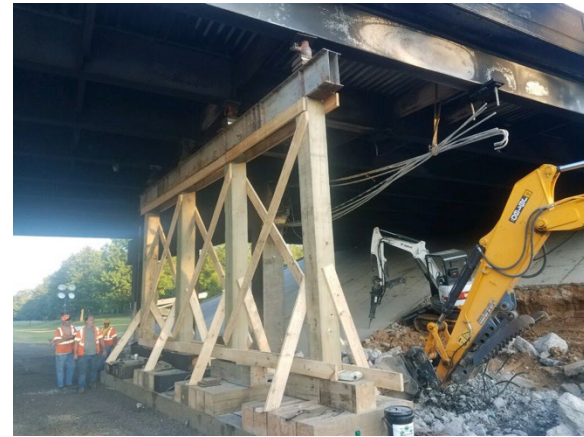
**Figure C-50. Temporary Structure (Courtesy of Heavy Bridge Maintenance, ARDOT) (A) Assembly of Temporary Bent (B) Beginning Construction Stages of Temporary Bent (C) New Bent Forms (D) Temporary Bent**

The permanent repairs required crews to work mostly around the clock. Highway 1B was fully opened on July 10<sup>th</sup>, two weeks after the collision. The permanent structure consists of a new intermediate bent (Figure C-50C). The four steel main girders were found to not require replacement or splicing (KARK 2017).

The closure caused a significant traffic backlog, as upwards of 43,000 vehicles use this stretch of highway/interstate daily. To reduce the impact on commuters, the temporary structure was installed (Figure C-50D).
