# Response Planning, Assessment, and Rapid Restoration of Service of Bridges in Extreme Events: Background and Summary (2024)

Web-Only Document 390

## Response Planning, Assessment, and Rapid Restoration of Service of Bridges in Extreme Events BACKGROUND AND SUMMARY

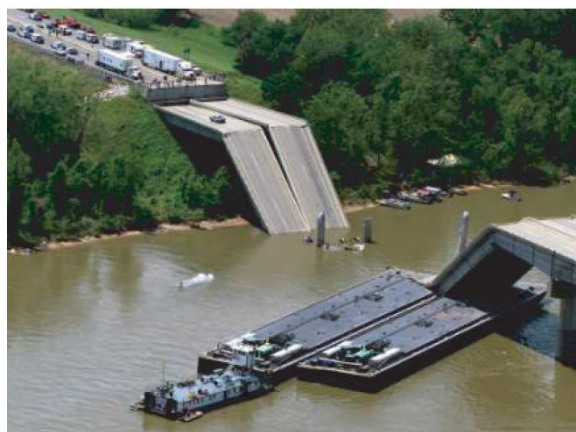
**Figure C-51. Collapse of I-40 Webbers Bridge (Georgia Tech Research Corporation et al. 2012)**

On May 26th, 2002, a towboat pulling two empty barges collided into the I-40 Webbers Fall Bridge on the Arkansas River after the boat operator suffered a medical episode, which caused him to blackout (Georgia Tech Research Corporation et al. 2012). The collision resulted in the collapse of four bridge spans and the adjacent piers into the Arkansas River depicted in Figure C-51. Rescue diver response teams were deployed following the collapse and the event resulted in a total of fourteen deaths (FHWA 2002). To expedite the reopening of the bridge, bridge engineers chose to replace the spans with prestressed, precast concrete girders and a single steel span to tie into the existing steel structure. The I-40 Webbers Falls Bridge was reopened to traffic just sixty-four days after the collision (Bai and Kim 2007).

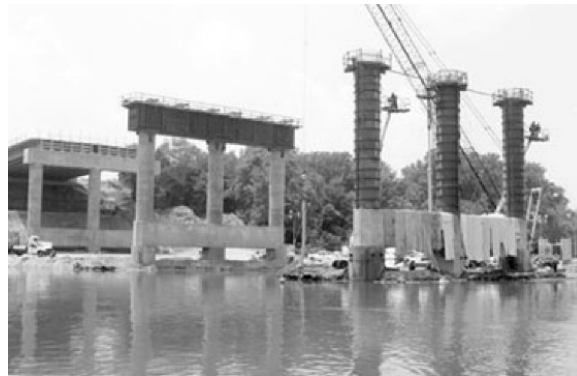
**Figure C-52. Reconstruction of Piers (FHWA 2002)**

Instead of sticking to the original steel design of the bridge, the Oklahoma DOT decided to replace the damaged spans with three prestressed, precast concrete girders. The Oklahoma DOT chose this technique to reduce the time needed for bridge repairs (Bai and Kim 2007). Bridge engineers chose to design one steel bridge span to tie the prestressed, precast concrete spans into the existing steel structure. They also reconstructed the damaged piers, as shown in Figure C-52. To monitor the curing of the concrete sections, the contractor used computer chips to measure the temperature of the setting concrete (FHWA 2002).

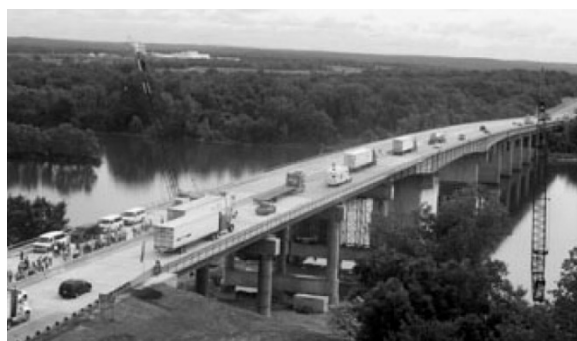
**Figure C-53. Completed Repairs (FHWA 2012)**

Scheduling and cost estimating are difficult tasks in emergency situations such as the I-40 Webbers Falls Bridge collapse and reconstruction process. At project completion, the final costs associated with bridge reconstruction were double the original cost estimate, but the project was finished ten months sooner than originally predicted. The use of technology such as iPads and laptops can better monitor construction efficiency and progress. Cameras were used to capture, document, inspect, and monitor the restoration process of the I-40 Webbers Bridge following the collapse. Access to current information on bridge restoration can be used to keep cost estimates and scheduling current throughout the bridge restoration process (Bai and Kim 2007). Figure C-53 shows the completed bridge structure.

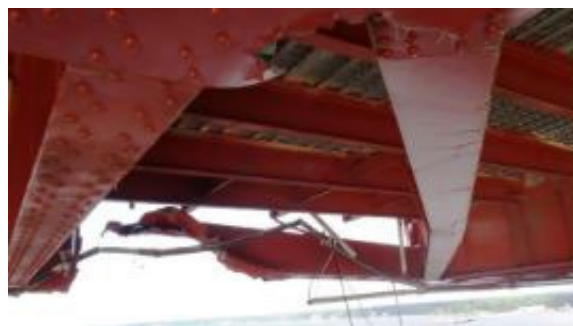
**Figure C-54. Severed Tension Chord (Courtesy of Sanya Watts, Watts 2013)**

On September 26<sup>th</sup>, 2013, a US Naval Ship collided with the Mathews Bridge, striking the north bottom truss chord about halfway along the middle span. The stern of the ship was already underneath the superstructure, but the stern ramp was not lowered, and it struck the bridge. The ship's momentum was too great to stop before the damage could ensue. Subsequent inspections found the impact left the tension chord (the bottom member of the truss) cut, which forced a load redistribution, and the floor system took on the "extra" load, as shown in Figure C-54. This put extra stress on members that were not originally designed to resist. Any additional loads from traffic would have put the bridge at risk for collapse. The severed truss element was fracture critical due to its classification as a tensile carrying, nonredundant member. The bridge reopened to traffic thirty-three days after the impact, saving road users an estimated \$7 million due to its rapid completion (Watts 2013).

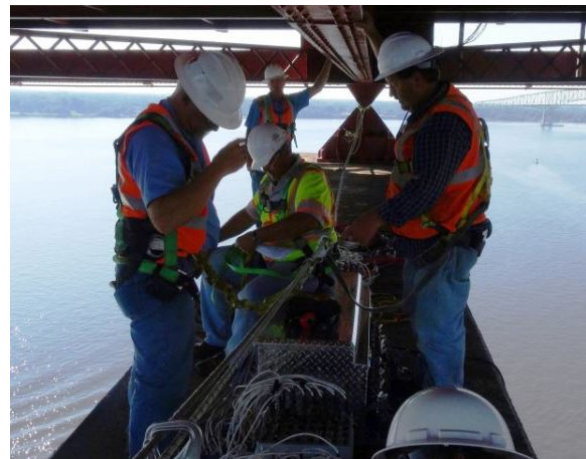
**Figure C-55. Strain Gauge Installation and Wire Management (Courtesy of Sanya Watts, Watts 2013)**

To monitor the effects of load redistribution during the repair, bondable foil strain gauges were installed on the damaged north truss to monitor the initial and redistribution loads on the bridge once construction

began, as shown in Figure C-55 (Alipour 2016 and Watts 2013). This was especially important during the jacking and de-tensioning processes of the chord. The gauges were also used to monitor for buckling in the upper chord during repair, and on the south truss to have a preliminary basis to compare the data from the north truss (Alipour 2016).

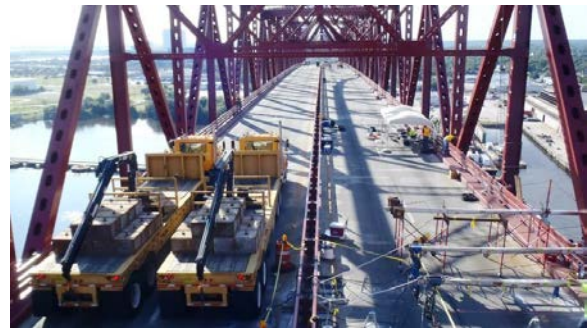
**Figure C-56. Load Testing (Courtesy of Sanya Watts, Watts 2013)**

A temporary repair was put in place to permit construction of the damaged cross members, then a final chord replacement was designed, and traffic was returned (Alipour 2016). Surveying was completed each day to monitor the deck and floor beams for any signs of creep (Alipour 2016). At each completion of the repair work (temporary and final), load tests were conducted using Florida DOT flatbed trucks driven across the deck. The trucks stopped at three locations and the bridge was monitored for performance, as shown in Figure C-56 (Alipour 2016).

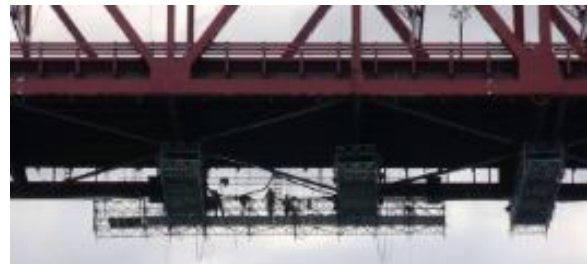
**Figure C-57. Scaffolding on Mathews Bridge (Courtesy of Sanya Watts, Watts 2013)**

The first step in the repair process was to install the scaffolding that would be used by workers, as shown in Figure C-57. This was challenging due to load constraints on the bridge, so the entire bridge repair was completed in stages. Once the scaffolding was in place, a pair of beams were positioned so they could be anchored to the eastern span to provide some geometric restoration to the north truss, acting like a strong back and saddle system. A plant in Tampa, FL manufactured seventy-foot long beams and then trucked the beams to the bridge site. Because of the length of the beams in transportation, special permits had to be attained, and a cable pully system was used to set them into place.

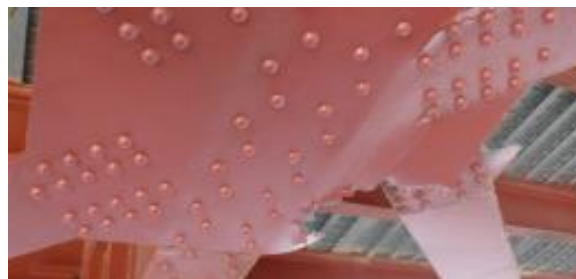
**Figure C-59. Damaged Gusset Plate (Courtesy of Sanya Watts, Watts 2013)**

With the temporary chord in place, other repairs could then take place on the damaged components, as shown in Figure C-59. The north bracing failed due to block shear at a gusset plate and buckling occurred in many members. The floor beams that were misaligned did straighten back out with the realigned geometry of the temporary chord, but the damaged gusset plates were not realigned and stiffened with angles (Watts 2013).

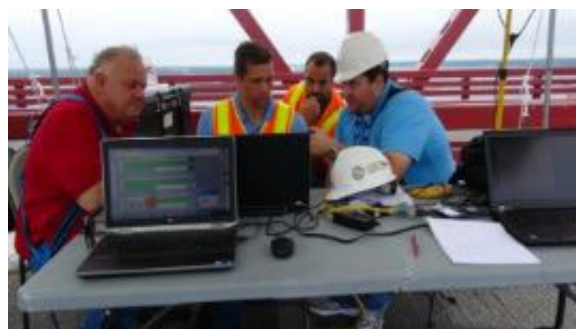
Monitoring the force paths and redistribution is instrumental during the repair and evaluating the integrity/safety of the repaired bridge. To streamline the strain gauge installation process, the locations were pre-mapped out. These regions were then cleaned and prepped for placement, including surface finishing and waterproofing. The gauges themselves were delicate and welded in-place. Over thirteen miles of wire was run across the bridge, linking all the gauges to a central data acquisition system (DAQ). Information in the DAQ could be accessed from anywhere, allowing for real-time monitoring from any location, as shown in Figure C-60. Delicate coordination had to take place not to damage the gauges or their wires throughout the repairs.

**Figure C-60. Data Monitoring (Courtesy of Sanya Watts, Watts 2013)**

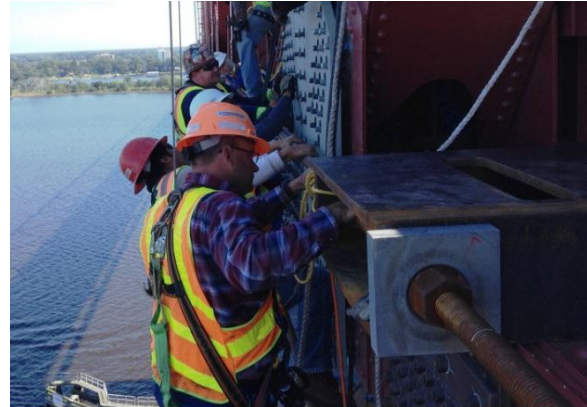
**Figure C-61. Repairs made next to Temporary Chord (Courtesy of Sanya Watts, Watts 2013)**

A major challenge for the project was the weight restriction on the bridge due to the redistribution of the load from the severed chord member. Cranes and other heavy equipment could not be brought on the bridge, so crews had to assemble some items in place (like the permanent chord) or use a pulley system, as shown in Figure C-61.

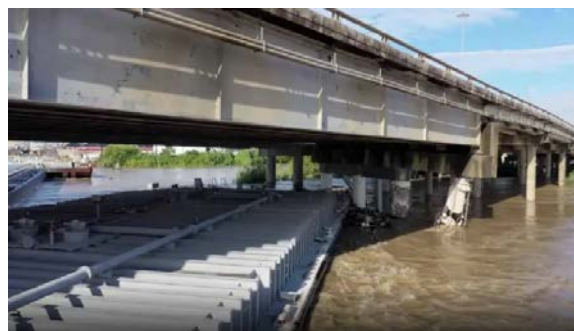
Due to the remnants of Tropical Storm Imelda, which cause the strong current in San Jacinto River, nine barges had broken away from their moorings at the San Jacinto River Fleet on September 20<sup>th</sup>, 2019. Two of them hit the I-10 Bridge, causing extensive damage to the bridge's concrete columns, as shown in Figure C-62. The I-10 Bridge was immediately closed, and crews implemented a lengthy detour route. After the barges were removed, TxDOT reconfigured eastbound and westbound traffic, with two lanes in each direction, on the eastbound side of the bridge until permanent repairs could be made (Begley 2019; The Maritime Executive 2019).

**Figure C-62. Severe Column Damage from Barge Impact (Clement 2019)**

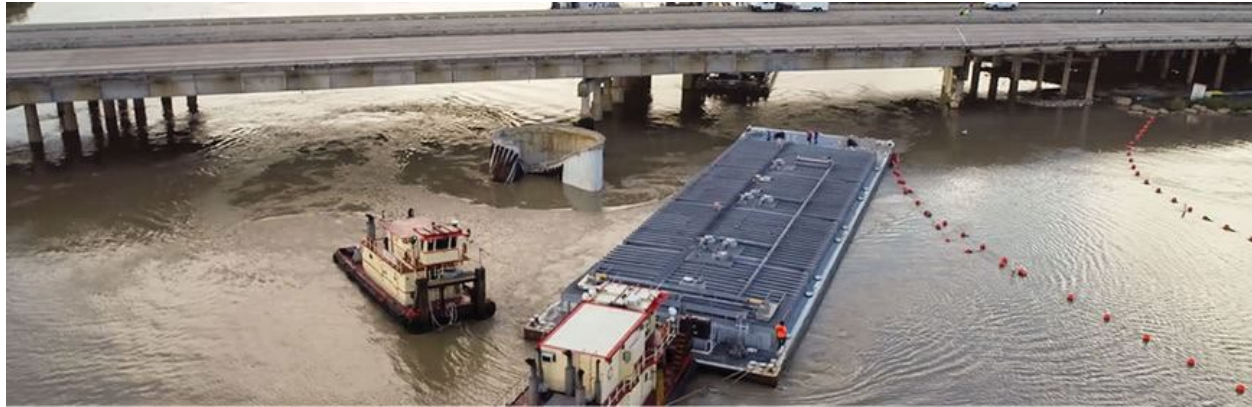
**Figure C-64. Barge Removal (McCormack 2019)**

Furthermore, there were many concerns centering around the removal of the barges (Figure C-64). The two barges were carrying toxic substances, and there was worry they had already, or could cause, contamination into the San Jacinto River. Moreover, during repairs, barge traffic was limited to prevent further damage. The I-10 bridge had been struck multiple times before by barges, so it was not an uncommon event (McCormack 2019). Additionally, the San Jacinto Waste Pits Superfund Site is located adjacent to the bridge, so there was concern removing the barges might impact the site. Fortunately, the US Coast Guard confirmed there was no adverse impact to the river, or the Superfund Site caused by the barge collision (Begley 2019).

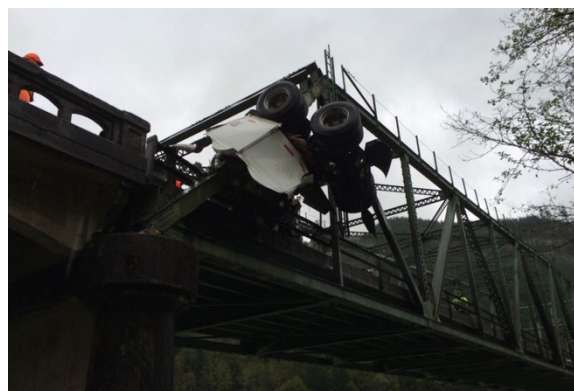
On Wednesday, April 12<sup>th</sup>, 2017, a semi-truck crashed into one of the compression members on the historic Scottsburg Bridge along Highway 38 near Scottsburg, Oregon, as shown in Figure C-65. The through-truss was originally constructed in 1929 and had been a repeat victim of collisions. The narrow, windy road leading up to the bridge caused it to be frequently hit. This time, however, the damage was significant, and the bridge was fully closed for 4 days, forcing drivers to use a 100+ mile detour. Local school districts also were forced to use the detour, adding 1.5+ hours to student's bus rides to and from school (KPIC 2017b). The Oregon DOT hired a contractor to perform heat straightening on the damaged member and called in its geometronics group to take laser scans of the bridge to identify any other areas of hidden damage (Kinney 2017).

**Figure C-65. Truck on Truss Member (Oregon DOT 2017)**

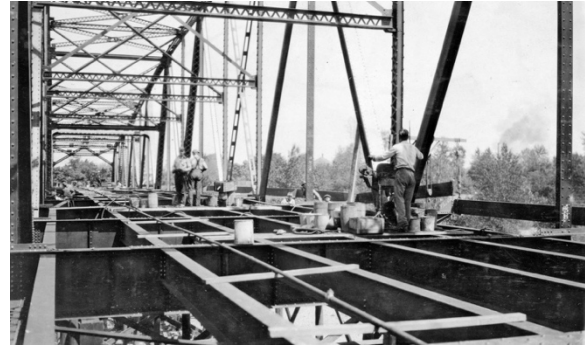
The Scottsburg Bridge had been hit multiple times since its original construction in 1929, as shown in Figure C-66. The combination of the approach roadway and narrow structure routinely left a pile of side mirrors, awnings, and other car parts in the Umpqua river below. ODOT has placed several “narrow bridge” signs before each final approach to the bridge to warn drivers. On the opposite side of the main collision, they even wrapped a timber beam to the compression member to protect it from future crashes. Unfortunately, during this collision, that was not the crash location.

**Figure C-66. Original Construction (Oregon DOT 1929)**

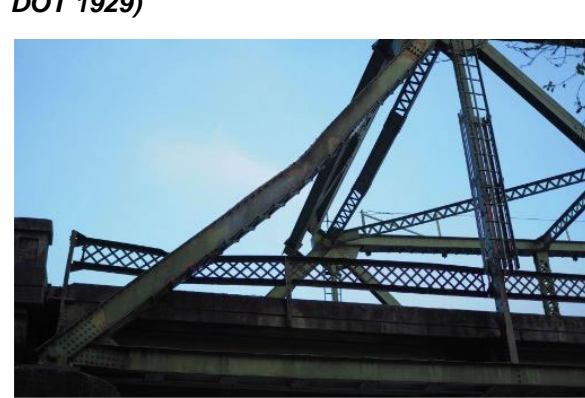
The Oregon DOT uses a Flash Alert system that automatically notifies the DOT when there is a collision, or a 911 call related to a bridge. This was how they were notified in the case of this collision. The district maintenance staff receive the alert from the system and are the first on scene from the DOT to investigate. Then, if their initial assessments warrant further exploration, they can call in for engineers to come out and perform their assessment. This is the process that occurred for the Scottsburg bridge. Figure C-67 shows some of the damage after the truck was removed from the truss.

**Figure C-67. Side View of Member Distortion (Dobson 2017)**

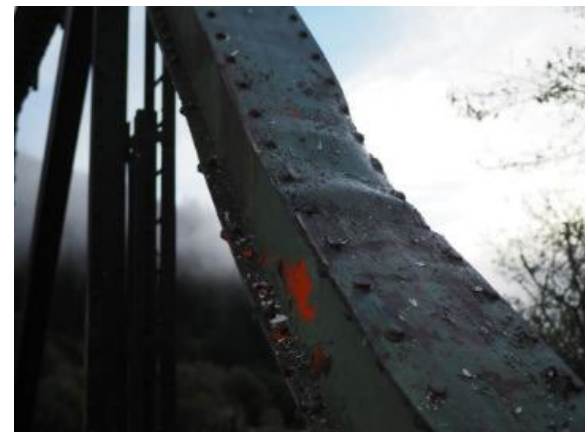
After the wreck was removed from the bridge, the focus of the inspection was the damaged compression member. A visual inspection indicated this steel truss element was severely deformed, including a change in section thickness, deflection, paint delamination, local flange buckling, and high stress points, as shown in Figure C-68. Measurements were taken of the deformed section, and paint was removed to better view the metal. MT testing was performed on several areas to show crack propagation, which was near the web and flange interface. Cracks near some of the member's rivets and in an angle piece of the nearby floor beam were also noted (Dobson 2017).

**Figure C-68. Compression Member Buckling (Dobson 2017)**

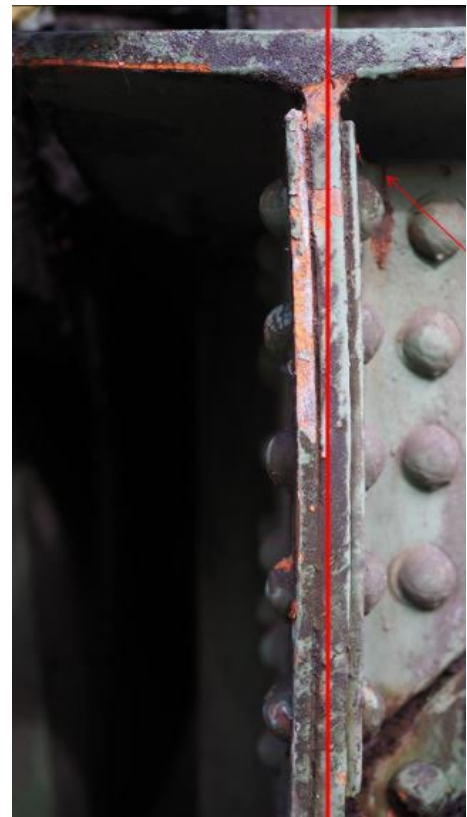
Even after the visual assessment was complete, the engineers and inspectors on site were puzzled, as water was pooling on the deck near where the damaged member was located, even after the heat straightening. This indicated there were additional deflections caused by the accident, but crews could not determine where. At this point, the geometronics group was called on scene to perform the scans and help identify the areas of further damage (Figure C-69) (Kinney 2017).

**Figure C-69. Floorbeam Buckling (Dobson 2017)**

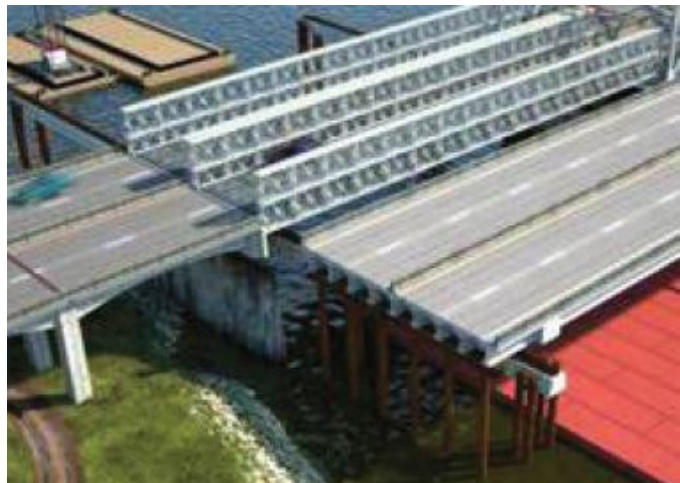
**Figure C-71. Temporary modular bridge (Washington State DOT 2014)**

The temporary structure used was a side-by-side dual lane modular truss ACROW bridge. This structure had to maintain the same river height clearance as before (or could be higher) and ensure the installation

was quick to reduce traffic disruption, and not increase seismic loads on the structure in case of an earthquake (Washington State DOT 2014). This system is shown in Figure C-71. The temporary structure was assembled and installed by the emergency contractor already established by WSDOT prior to the collision.

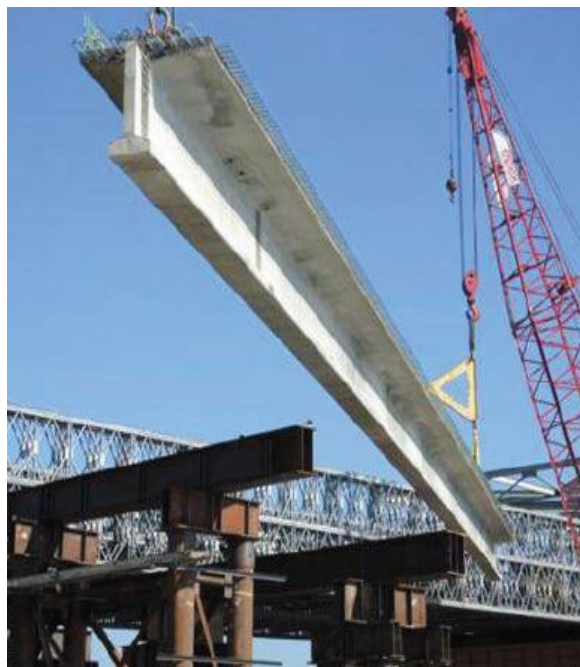
**Figure C-72. Prestressed Girders Lifting into Place (Washington State DOT 2014)**

The replacement span was constructed out of prestressed girders with extra wide flanges and high-strength concrete closure pours, as shown in Figure C-72. This design was chosen to minimize the amount of curing time for the deck once all the girders were set into place. The girders used light-weight concrete to match the weight of the old truss – this allowed the original bents to be used, saving time and money (Washington State DOT 2016). Other designs considered for the replacement included a steel through-truss (to match the remaining spans), which was deemed too time-intensive, or steel plate girders with a concrete deck. Ultimately, the winning firm chose the prestressed concrete design.

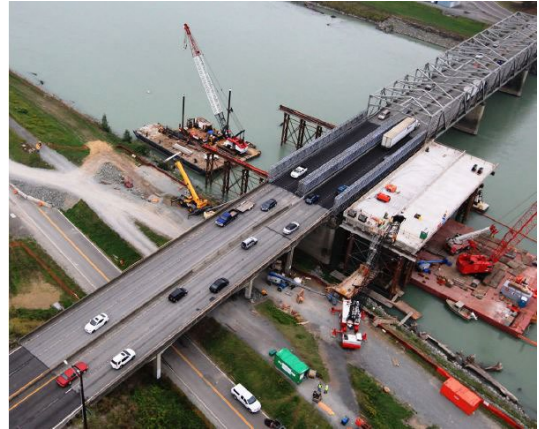
Erecting a temporary modular bridge, as shown in Figure C-74, reduced the need for traffic detours around the collapsed structure. The nearby bridges in the towns of Burlington and Mt. Vernon did not have adequate capacities to carry interstate traffic levels, so the temporary structure also reduced the impact on these communities and ensured commerce could proceed as normal.

**Figure C-74. Traffic Flow with Temporary Structures (Washington State DOT 2016)**

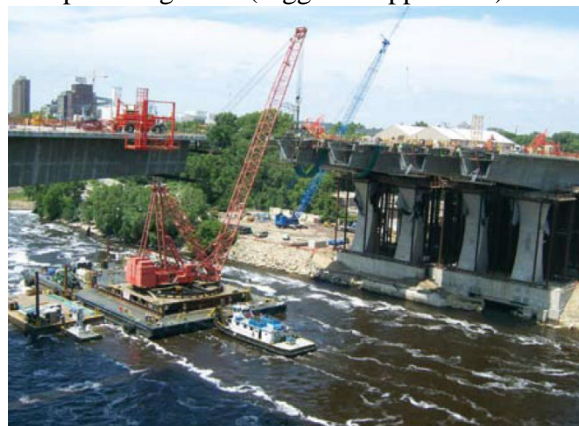
The box girder superstructure included cast-in-place side spans and a precast segmental main span that crossed the river. Construction operations of the side spans and precast main span segments occurred simultaneously to reduce the overall construction time. In addition, the eight long-line casting beds were operated simultaneously. Once the precast segments were constructed, they were transported and stored adjacent to the river until it was time to install them. Segments were then delivered to the site by barge and lifted with a barge-mounted crane as shown in Figure C-82. The 120 precast segments were erected in forty-seven days. Midspan closure pours connect the cantilever spans from opposite sides of the river. Each pair of adjacent precast segments were connected with a longitudinal closure pour. The entire bridge deck was transversely post-tensioned to add durability to the riding surface (Figg & Phipps 2008).

**Figure C-82. Placement of Main Span Precast Segments (Figg & Phipps 2008)**

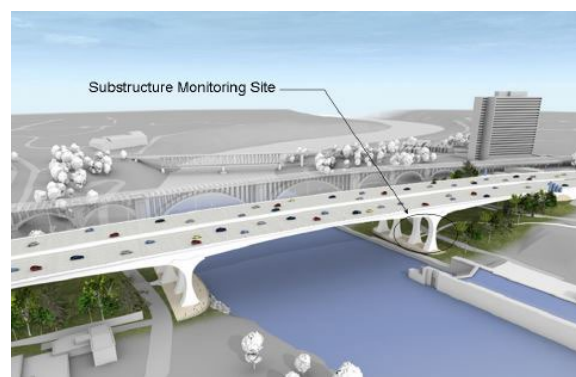
**Figure C-83. Computer Rendering of Replacement Bridge (Collins et al. 2014)**

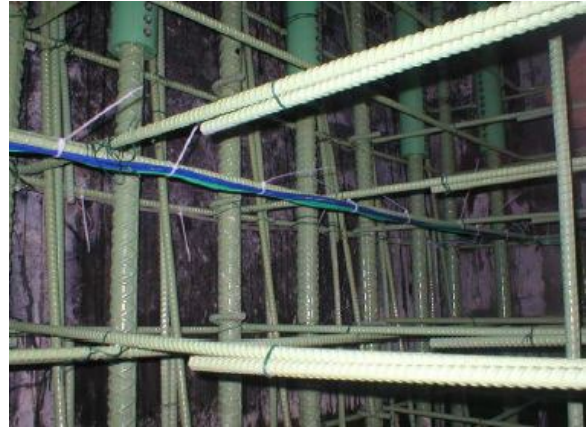
During construction thermal monitoring was used to monitor the curing of the mass concrete elements (i.e., drilled shafts and pier footings). These devices were placed on the reinforcement prior to pouring concrete, as shown in Figure C-83 and Figure C-84. Construction load monitoring was also used in the bridge during erection, which included strain gauges attached to the reinforcements. Lastly, long-term monitoring after the structure completion was implemented, including live load truck tests, deck corrosion, box girder vibration and strain monitoring. The results from the sensors have shown the ability to detect minute changes within the structure, which can be used to prevent a major emergency event such as another collapse (Collins et al. 2014).

**Figure C-84. in Gauges on the Reinforcement of Replacement Bridge (Collins et al. 2014)**

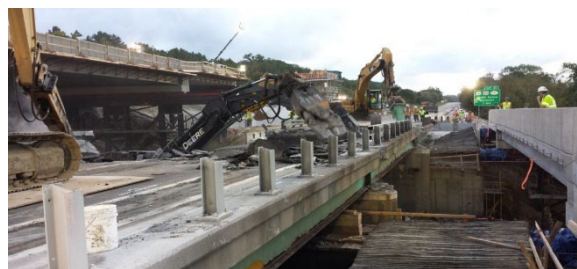
**Figure C-89. Bridge Demolition (Bhajandas et al. 2014)**

The original twin bridges were built in 1967 and were 140 feet long length and 33.3 feet wide. The eastbound bridge had a sufficiency rating of 62.0; the westbound bridge had a rating of 60.2. In addition, the bridges had other structural deficiencies that needed to be addressed, as revealed by inspection reports. Temporary steel supports were put in place on both bridges to prevent web crippling. Leaking joints severely damaged the bridge, and the deck wearing surface had worn asphalt. Lastly, approximately 25% of the steel girders were significantly rusted, as noted by a visual inspection (Bhajandas et al. 2014). An image from demolition is shown in Figure C-89.

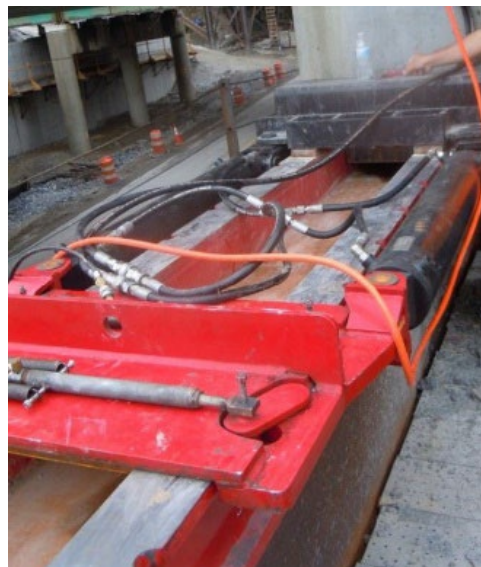
**Figure C-94. Push Gripper Installation (Bhajandas et al. 2014)**

For the ABC stage of the project, a prequalified contractor managed the operations. The contractors used their expertise to select the best method for moving the structure, whether it is with Self Propelled Modular Transporters (SPMTs), rollers, or jacks. In this instance, the Push Gripper was selected. One was placed at each diaphragm to push the bridge into place using hydraulics. The bridge slid across PTFE bonded to elastomeric pads, which had a friction coefficient of only approximately 8% (Bhajandas et al. 2014).

During the westbound (first) slide, one of the Push Grippers advanced quicker than the other, causing the bridge to fishtail and bind. This was attributed to heavy rains at the time and poor communication between workers. This error was later corrected for the eastbound slide, which was accomplished without incident (Bhajandas et al. 2014). See Figure C-94 for a view of the Push Gripper and Figure C-95 for an image of the slide from the ground.

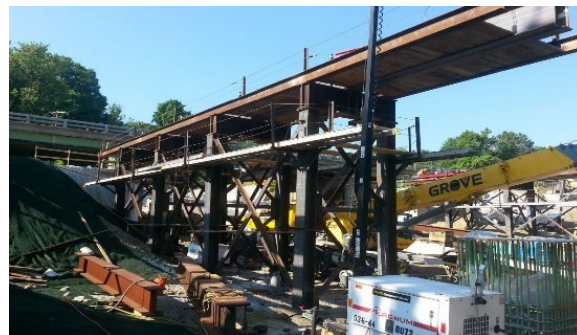
**Figure C-95. Slide in of Bridge (Bhajandas et al. 2014)**

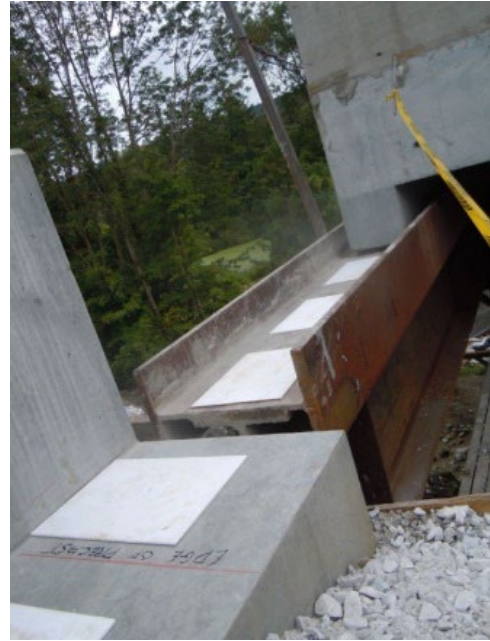
**Figure C-97. Sliding of Approach into Place (Bhajandas et al. 2014)**

When it came to sliding the bridges into place, a conservative value for the coefficient of friction should be used to account for unforeseeable events, like poor weather conditions, that will impact the coefficient (Bhajandas et al. 2014). See Figure C-97 for an image of the slide.

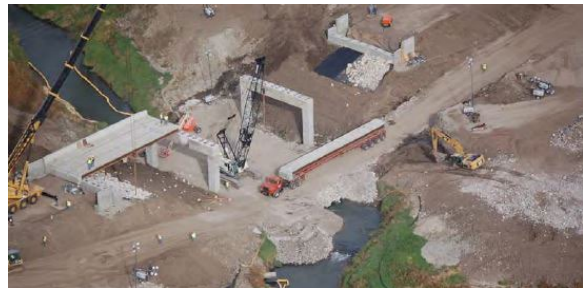
**Figure C-99. Aerial View of Construction Site with Culverts (Used with permission © Iowa Department of Transportation, Evans 2017)**

Before the existing bridge was demolished, drilled shafts for the new bridge were bored and filled with concrete and reinforcement (Iowa Department of Transportation n.d.). Concurrently, the necessary culvert implementation for the stream diversion was built to create a dry workspace for cranes and other equipment, as shown in Figure C-99 (Evans 2017).

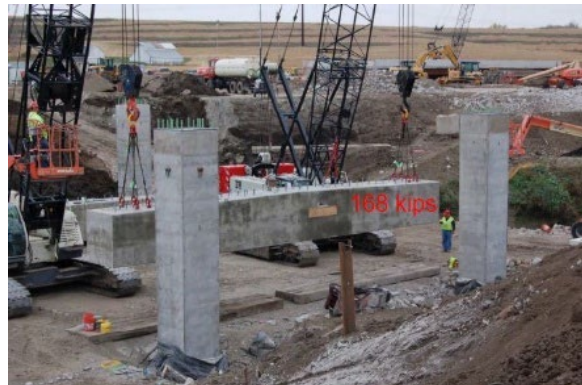
**Figure C-101. Pier Cap Placement (Used with permission © Iowa Department of Transportation, Evans 2017)**

techniques (Iowa Department of Transportation and Sivakumar 2017). Self-consolidating concrete was used in the abutment assembly to finish off the pile caps. Anchors and bearings were installed on both the abutments and the bent caps. From here, the precast wingwalls were installed (Evans 2017).

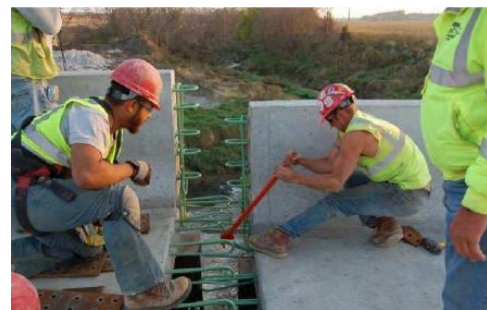
**Figure C-102. Hairpin Fitting Challenge (Used with permission © Iowa Department of Transportation, Evans 2017)**

The use of hairpin joint bars made it difficult to assemble the precast pieces, as the curved bars were hard to align, as shown in Figure C-102. The contractor recommended future use of straight bar ends for UHPC bonding to avoid fit problems and misalignments. Furthermore, the joints were often congested, and any adjustment to the hairpins to allow for a proper fit ran the risk of damaging the epoxy on the bars. The UHPC joints are critical, as they are what hold the bridge together. Any cracks can lead to freeze-and-thaw damage, so it is imperative there is clear communication between the manufacturer and workers. The UHPC joint at the abutment was difficult to form, so the UHPC leaked under the backwall, which created a mess. Figure C-103 shows the pouring of a UHPC joint.

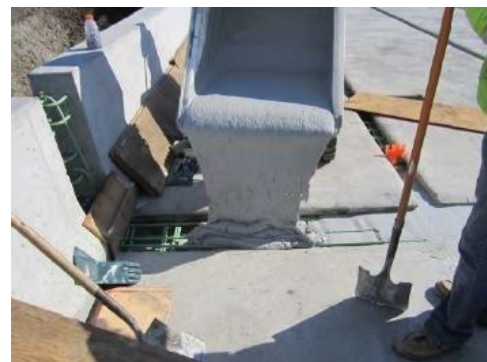
**Figure C-103. UHPC Poured into Place (Used with permission © Iowa Department of Transportation, Evans 2017)**

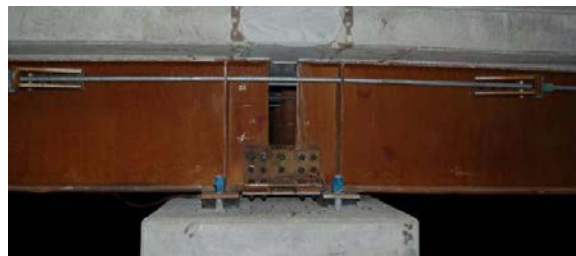
The use of UHPC over a pier cap had not yet been investigated before this project. The high loads could create cracks and debonding from the steel, which could later turn into leaking joints. Tests were conducted to determine if UHPC could be used in this capacity. The results found that adding post-tensioning rods would limit the likelihood of the joint from debonding and cracking, so this was added to the design, as shown in Figure C-104. During installation, all the rods were stressed simultaneously for an even load distribution (Evans 2017).

**Figure C-104. Post-Tensioning over Pier Cap (Used with permission © Iowa Department of Transportation, Evans 2017)**

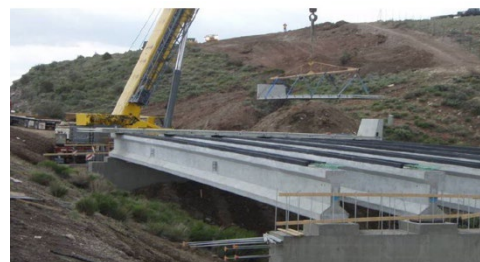
**Figure C-105. Installation of Precast Element (Culmo 2011)**

To prepare for the 2002 Olympics, Utah DOT (UDOT) used Accelerated Bridge Construction (ABC) to prepare its infrastructure for the influx of visitors as well as to showcase the state-of-the-art technology at that time. This push for ABC was a success and by 2010, ABC became standard practice for all cases where it was deemed practical and cost effective. Examples of ABC projects are shown in Figure C-105 and Figure C-106.

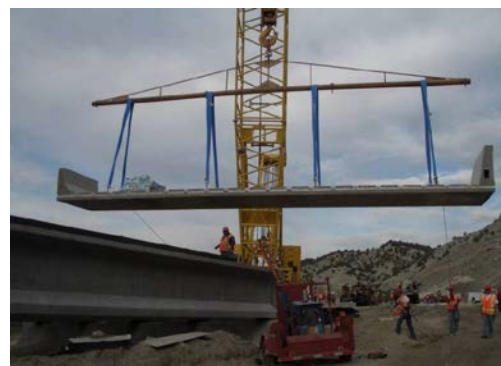
**Figure C-106. Precast Slab Placement (Culmo 2011)**

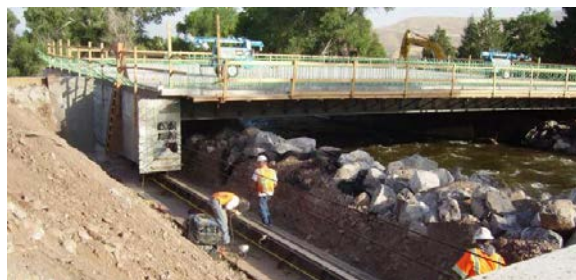
**Figure C-107. Bridge Slide-In Installation (Culmo 2011)**

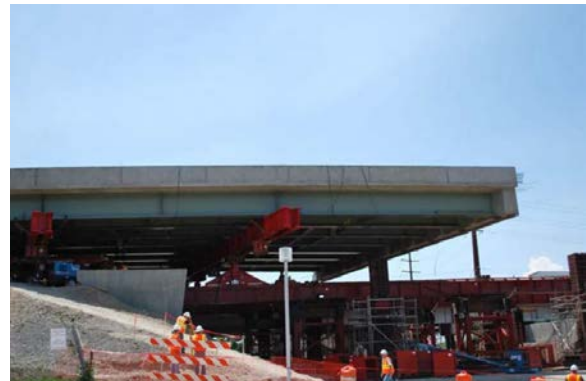
**Figure C-110. SPMT on I-80 Bridge Replacement (Culmo 2011)**

When using SPMTs to move superstructure components into place (Figure C-110), internal stresses (often unaccounted for) induced by the dynamic motion may adversely impact the structure. To test the impact of this movement, Utah State University attached strain gauges to different superstructures during the SPMT process at the beginning of the 2002 ABC push. They concluded that an additional dynamic load allowance of approximately 15% of the dead load should be included during design to prevent any major issues. They also found that torsional effects during transport were negligible, but only if the bridge was wrapped properly and movements were maintained within specified tolerances. Furthermore, the use of SMPTs often equates to large overhangs of spans during the move. Utah found that its original rule of support at third points led to damaged parapets and cracks in the deck. To reduce cracking, overhangs were limited to only 20% of the overall length.

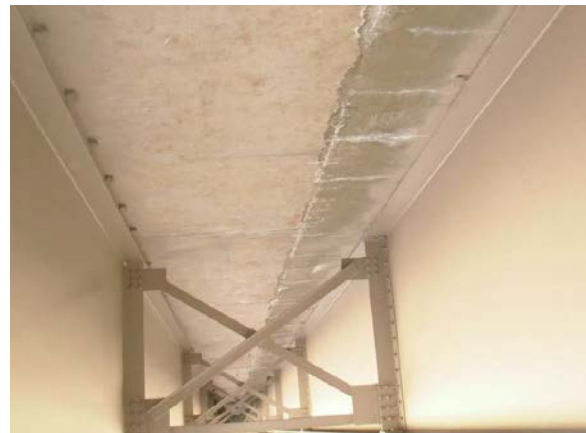
**Figure C-111. Closure Pour Crack (Culmo 2011)**

Often, high strength closure pours are specified for ABC. This is required to meet the early-strength requirements for a speedy construction, but these mixes often lead to cracking due to drying shrinkage (Figure C-111). Specifying lower strength concrete can help solve this problem and reduce cracking potential. However, DOTs must be sure to check their requirements for closures because, for traditional cast-in-place projects, the concrete strength may be significantly higher and often specifications do not change between cast-in-place and precast.

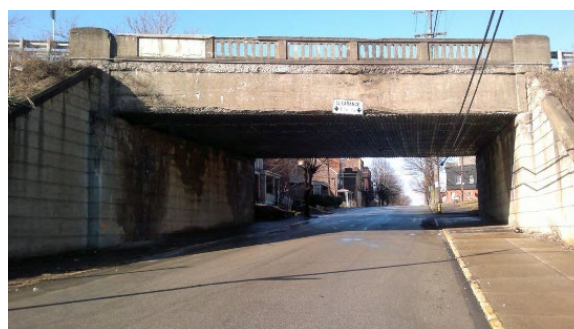
**Figure C-112. Original Bridge (Ruzzi et al. n.d.)**

The original bridge was built in 1930 and used a T-Beam Superstructure design. The bridge had a low clearance of 13'-9" which was deemed too low for larger vehicles, as shown in Figure C-112. Moreover, the superstructure was actively crumbling, and debris was falling through a hole in the deck, making a speedy repair imperative (Ruzzi et al. n.d.).

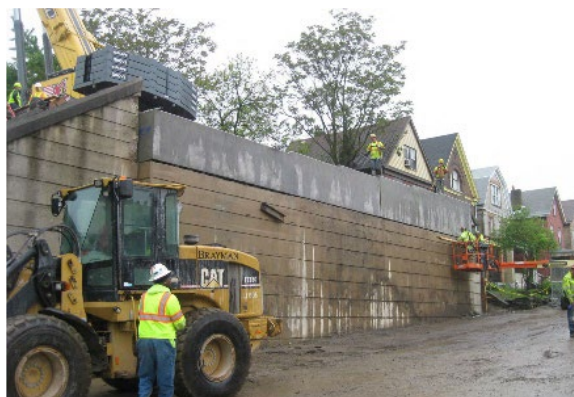
**Figure C-114. Abutment Cap (Ruzzi et al. n.d.)**

The construction was set to take place over a weekend to minimize traffic disruption. As soon as the bridge closed at 9pm on Friday, demolition began. The abutment was saw-cut along the backside to remove the deteriorated portions, and then the superstructure was demolished, including the approaches. With the debris cleared, the new (and taller) abutment caps were lifted into place. The abutment caps were secured with dowels, and shims were placed to reach the correct seat elevations, as shown in Figure C-114. The gaps created by the shims were filled with rapid set grout via

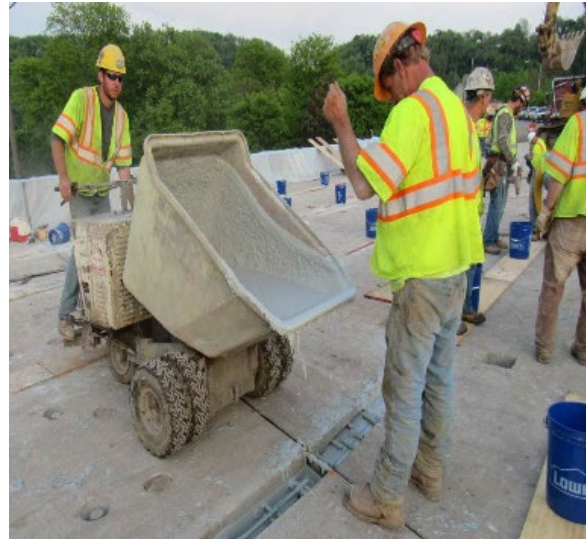
**Figure C-116. LMC Placement (Ruzzi et al. n.d.)**

Then, cranes were used to lift the precast modular slabs into place, as shown in Figure C-115. These slabs were made up of steel girders with a composite lightweight precast concrete deck slab. At the same time, the precast approach slabs were also installed. These slabs had a steeper angle than in the original bridge to accommodate the higher bridge span. Lightweight concrete was used for the new bridge to reduce weights required by the cranes. Ultra high-performance concrete (UHPC) was used for the closure pours as shown in Figure C-116. Once cured, the bridge was opened to traffic (Ruzzi et al. n.d.).

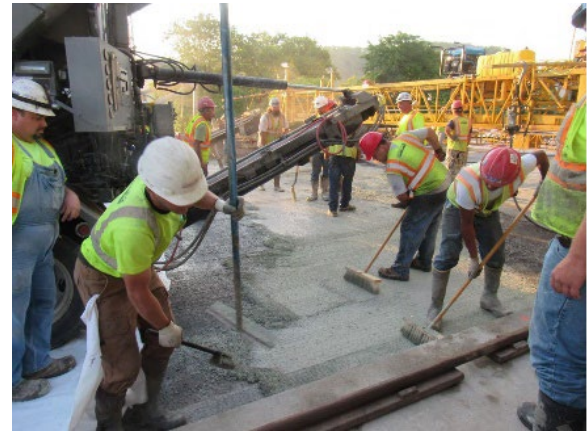
**Figure C-117. UHPC Pouring of Joint (Ruzzi et al. n.d.)**

In the days that followed the reopening, the abutments were backfilled to better support the bridge loads. Rapid set Latex Modified Concrete (LMC) was placed over the sawcut groves, and epoxy resin was added to the abutment surfaces as a protective coating, as shown in Figure C-117 (Ruzzi et al. n.d.).

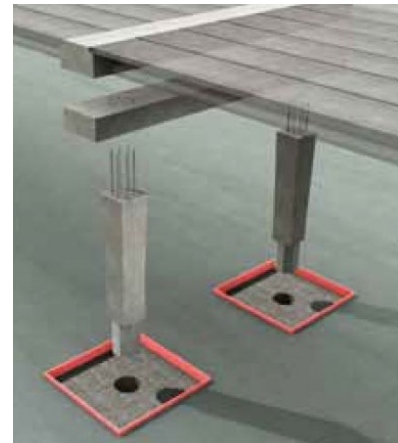
**Figure C-120. Integrated Footings and Bent Cap with Columns (Courtesy of PCI Journal, Khaleghi et al. 2012)**

The precast components were manufactured off site and trucked to the project. As a test, WSDOT wanted the columns to be cast in segments to see how easily they could be linked together. The columns were short enough to be transported in complete sections, but this may not be the case for larger structures. The bridge components would then be assembled in a socket-style connection highlighted in Figure C-120 (Khaleghi et al. 2012).

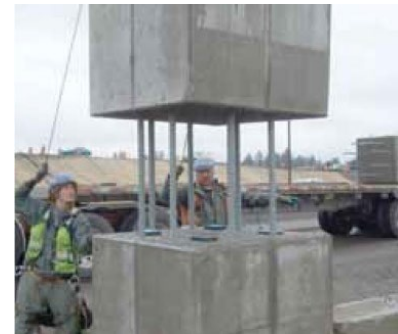
**Figure C-121. Setting of a Column Segment (Courtesy of PCI Journal, Khaleghi et al. 2012)**

Before setting the columns, the region around the bents were excavated, the footing forms were set in place, and the concrete poured. Then, the column segments, which were manufactured off site, were lifted into place and reinforcement bars were added and grouted to create one cohesive unit. The remaining segment of the columns were strung onto the exposed reinforcement bars, in the same fashion as stringing beads on a necklace, as shown in Figure C-121.

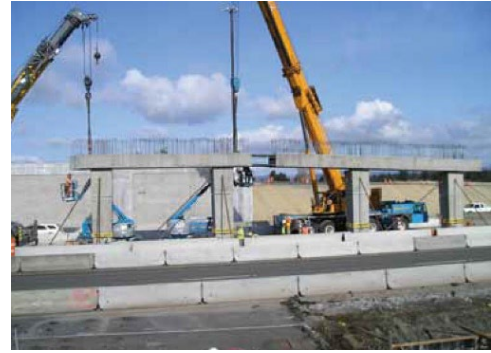
**Figure C-122. Setting of a Pier Cap Segment (Courtesy of PCI Journal, Khaleghi et al. 2012)**

For setting the pier cap beam, shims and bracing were set, as shown in Figure C-122. Then the precast beam segments were lifted into place and grout was used to bond the cap beams, column, and reinforcement together. The challenge was to ensure a proper moment transfer from the cap beam to the columns, as further discussed in the following sections. Once the cap beam was lowered, then girders were set, and finally the 5" thick topping was poured. The diaphragms were added after the top slab was cast. Lastly, the sidewalk and traffic medians were cast-in-place, and the bridge was completed (Khaleghi et al. 2012).

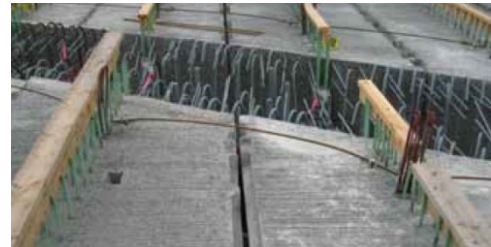
**Figure C-124. Narrow Joints (Courtesy of PCI Journal, Khaleghi et al. 2012)**

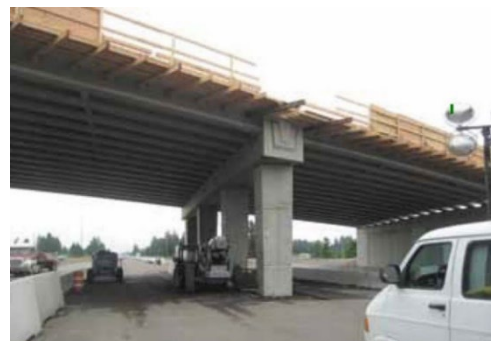
**Figure C-123. Architectural Column and Pier Cap Detailing (Courtesy of PCI Journal, Khaleghi et al. 2012)**

A benefit to using precast over cast-in-place and other traditional methods is the convenience of adding architectural features to the bridges, as shown in Figure C-123 This can be done by the manufacturer at the plant, reducing the field time necessary for such details while still making the structure aesthetically pleasing (WSDOT 2016).
