# Using Three-Dimensional GPR Data to Map Remnant Infrastructure and Interpret the Past

Keith C. Seramur  
Seramur & Associates, PC

## Reconstructing the Facility Infrastructure Using GPR

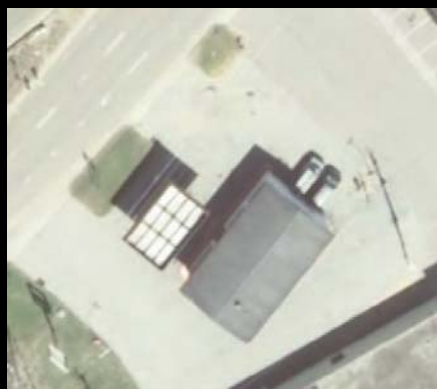
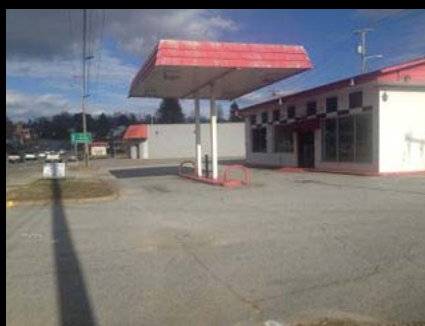
### Former Gas Station in Franklin NC

#### Unknown

- Number of Tanks
- Number of Tank Pits
- Number of Dispenser Islands

- Re-paved after UST closures
- No surface evidence of tank pits or additional pump islands
- Facility name and Property ownership changed
  - Street numbers changed

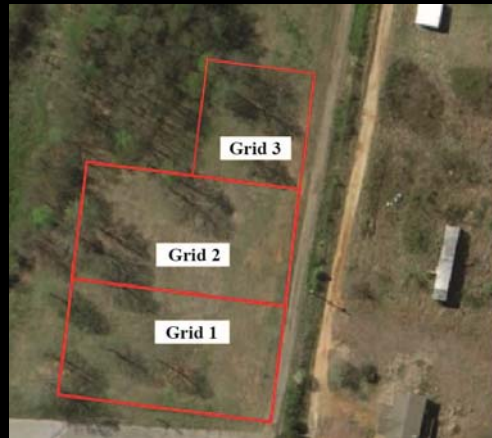
### Piedmont Industrial Facility

- Filled Ravine adjacent to the Facility
- Consultant Detected buried Metal
