## Conclusions

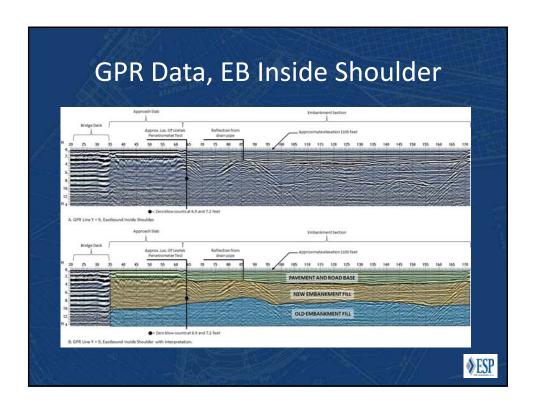
- Voids behind retaining wall formed by water flow into and around areas of slumping/flowable fill during construction before closure pour made.
- Vertical settlement of approach slab caused by loose material left in place during construction.
