**Speed Study Evaluation of  
Crosswalk Relocation & Dual Speed Table Installation**

**Order # 4100000250  
SR 1730 (Turkey Farm Road)  
Stoneridge/Sedgefield Swim & Racquet Club  
Orange County**

Safety Evaluation Group  
Traffic Safety Systems Management Section  
Traffic Engineering and Safety Systems Branch  
North Carolina Department of Transportation

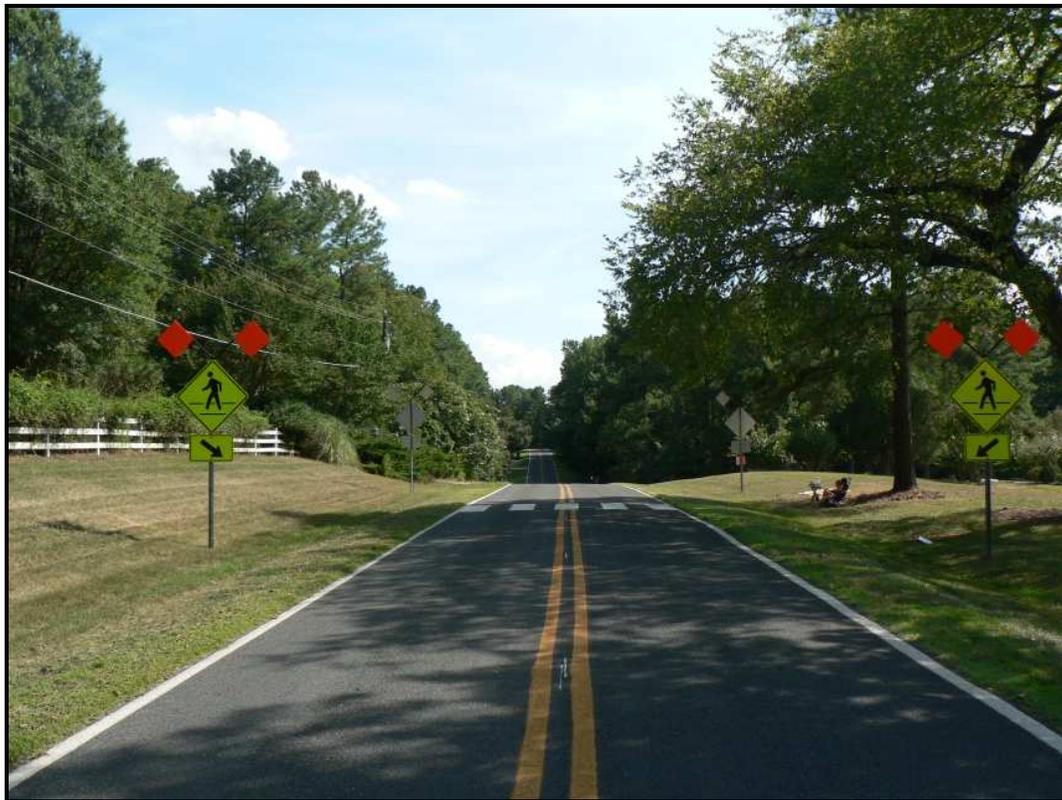
**Before Period Crosswalk Location**

For this reason, a crosswalk had previously been installed at the crest of the vertical curve located directly in front of the community center (see aerial map). However, this facility was rarely used due to the fact that it crossed into a resident's private property and did not have sidewalks connecting it to other major facilities. Most pedestrians would rather cut across the grass and cross SR 1730 at the intersection of Forest Ridge Drive. Citizens have been concerned about the speed of vehicles along this roadway and the safety of pedestrians (especially children) crossing the roadway to access the swim and racquet club.

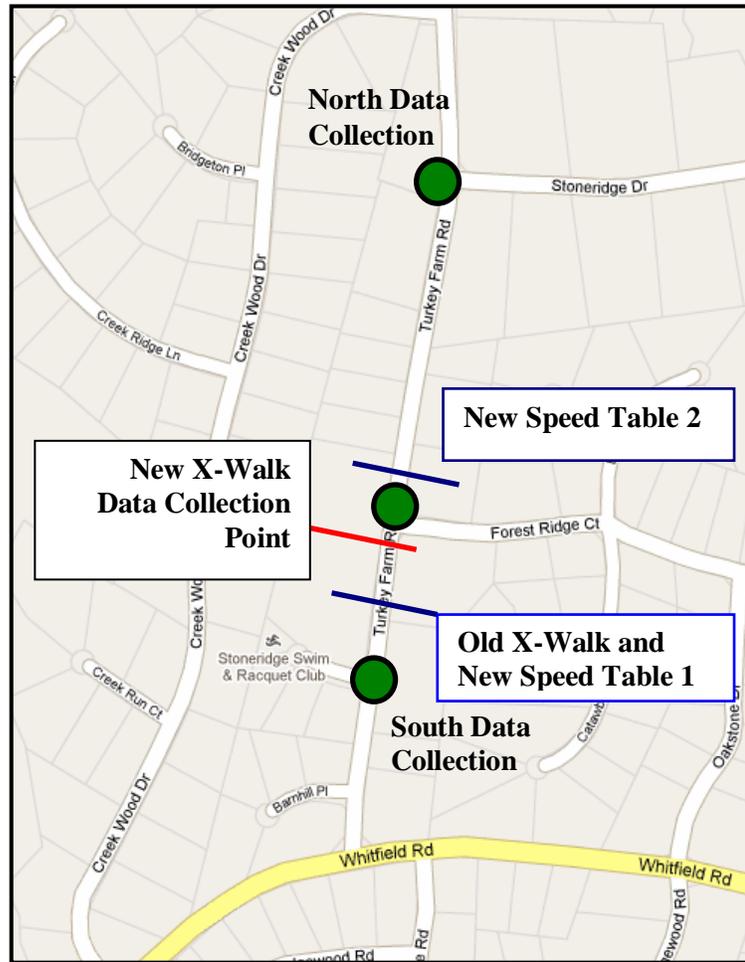
From the diagram above, the countermeasure installed a speed table over top the previous crosswalk at the crest of the vertical curve, relocated the crosswalk north to the Forest Ridge intersection, and installed a second speed table north approximately 200 feet of the Forest Ridge intersection. The diagram also indicates the three locations of our data collection: at the crosswalk, north, and south of the countermeasure.

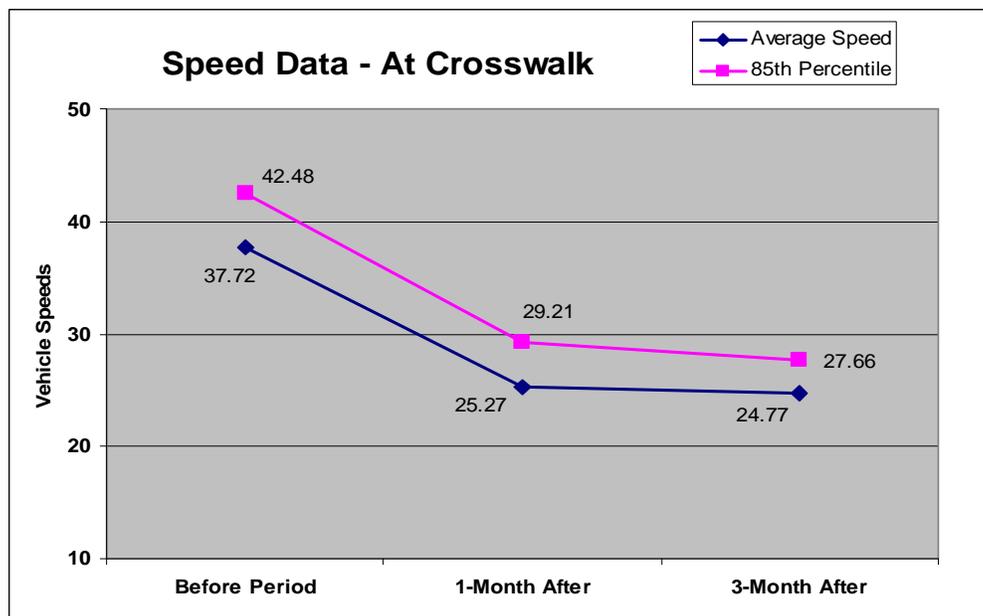
**Figure 1: Crosswalk Data**

<b>At Crosswalk – Forest Ridge Court</b>			
	Before Period	1 Month After	<b>3 Month After</b>
Total Observations	235	171	<b>109</b>
Average Speed	37.72	25.27	<b>24.77</b>
85 <sup>th</sup> Percentile	42.48	29.21	<b>27.66</b>
% Exceeding Speed Limit	66.8 %	1.2 %	<b>0.92 %</b>

The previous chart and graph (Figure 1) represent the speed data for the crosswalk located on SR 1730 (Turkey Farm Road). This data was collected at the crosswalk atop the vertical curve during the before period and was moved approximately 200 feet north during the after period which it was then positioned between the two (2) speed tables. The data shows a sharp decline in all categories with reduction in vehicles speeding from 67 percent to 1 percent through the analysis. The speed tables are posted with a 20-mph advisory speed limit; however the study was based on the 35-mph posted roadway speed limit since the 20-mph speed limit can not be legally enforced.

Figures 1 through 3 below show the results of the speed data collected for our analysis at the three different data collection sites. The data in figure 1 is shown with combined northbound and southbound data because the difference between directions was determined to be small and insignificant.

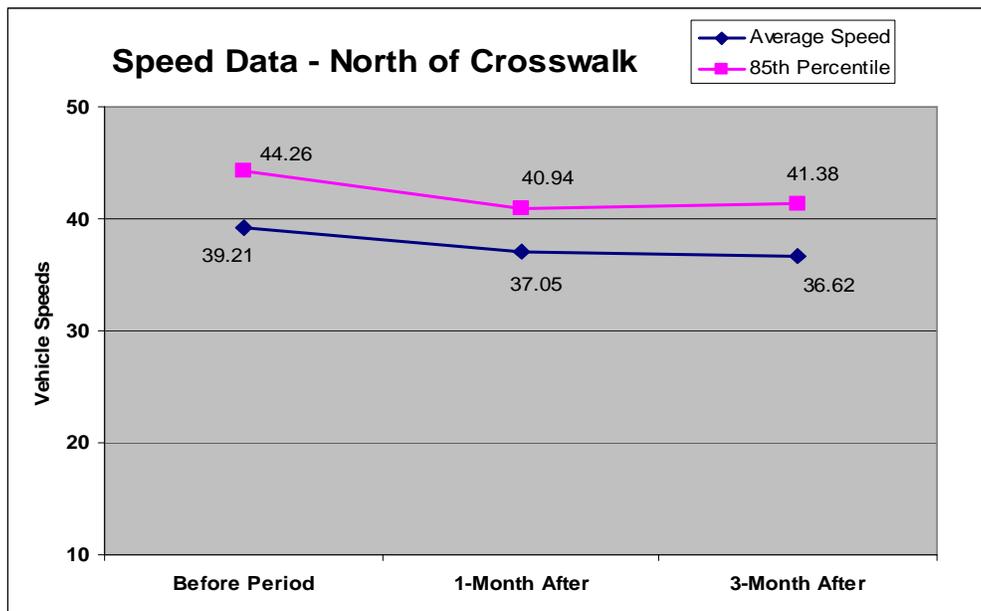
**Figure 2: North of Crosswalk Data**

<b>North of Crosswalk – Stoneridge Drive</b>			
	Before Period	1 Month After	3 Month After
Northbound Observations	58	62	<b>74</b>
NB Average Speed	39.21	37.05	<b>36.62</b>
NB 85 <sup>th</sup> Percentile	44.26	40.94	<b>41.38</b>
% Exceeding Speed Limit	75.9 %	61.3 %	<b>58.1 %</b>

The previous chart and graph (Figure 2) represent the speed data for SR 1730 (Turkey Farm Road) located north of the crosswalk. This data was collected at the intersection of Turkey Farm Road and Stoneridge Drive in free-flow traffic conditions for northbound vehicles only. The Safety Evaluation Group wanted to verify that installation of the speed tables had not caused motorists to change their upstream driving behaviors. We anticipated that vehicles would accelerate and speed following the speed table installation in order to compensate for time lost.

However, the data above shows that the vehicle speeds north of the crosswalk actually reduced slightly (by 2.5 miles per hour) and have been maintained through the 3-month period. The percentage of vehicles exceeding the posted 35 mph speed limit also decreased by more than 15 percent through our evaluation.

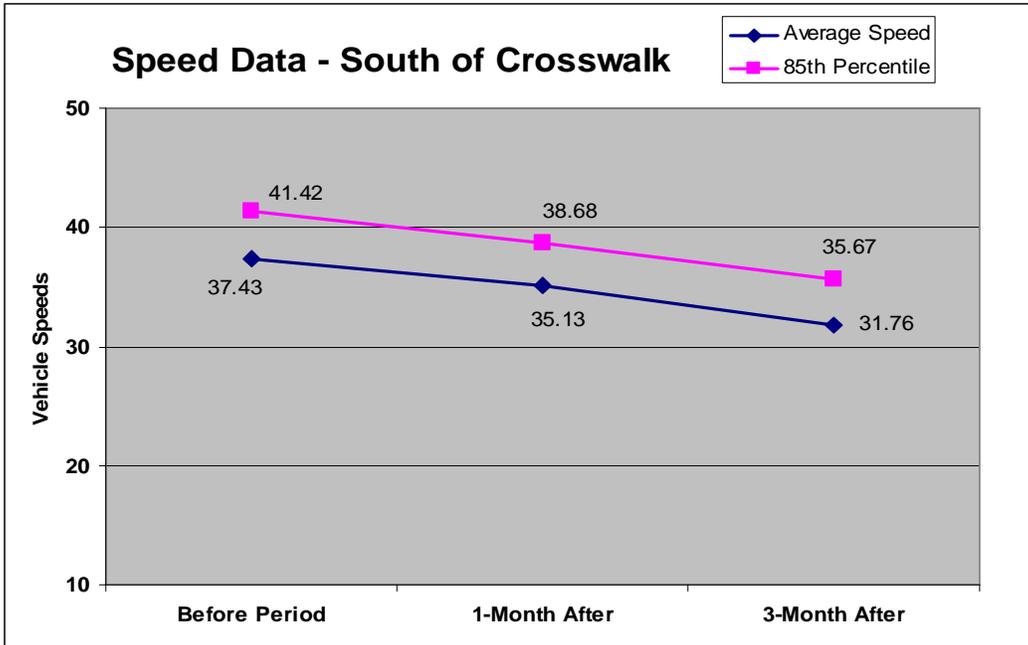
**Figure 3: South of Crosswalk Data**

<b>South of Crosswalk – Hollowood Court</b>			
	Before Period	1 Month After	<b>3 Month After</b>
SB Total Observations	65	64	<b>71</b>
SB Average Speed	37.43	35.13	<b>31.76</b>
SB 85 <sup>th</sup> Percentile	41.42	38.68	<b>35.67</b>
% Exceeding Speed Limit	63.1 %	51.6 %	<b>19.7 %</b>

The previous chart and graph (Figure 3) represent the speed data for SR 1730 (Turkey Farm Road) located south of the crosswalk. This data was collected at the intersection of Turkey Farm Road and Hollowood Court in free-flow traffic conditions for southbound vehicles only. The Safety Evaluation Group wanted to verify that installation of the speed tables had not caused motorists to change their downstream driving behaviors. We anticipated that vehicles would accelerate and speed following the speed table installation in order to compensate for time lost.

However, the data above shows that the vehicle speeds south of the crosswalk actually reduced slightly (by 4 miles per hour of the 85<sup>th</sup> percentile speeds at the 1-month mark) and have been maintained and reduced further through the 3-month period. The percentage of vehicles exceeding the posted 35 mph speed limit at this location also decreased by more than 40 percent through our evaluation. Since the distance between the speed tables and the stop sign at Whitfield Road was minimal, we discovered that motorists drove conservatively through this segment from the necessity for speed reduction due to crossing speed tables as well as slowing to stop at the stop sign.

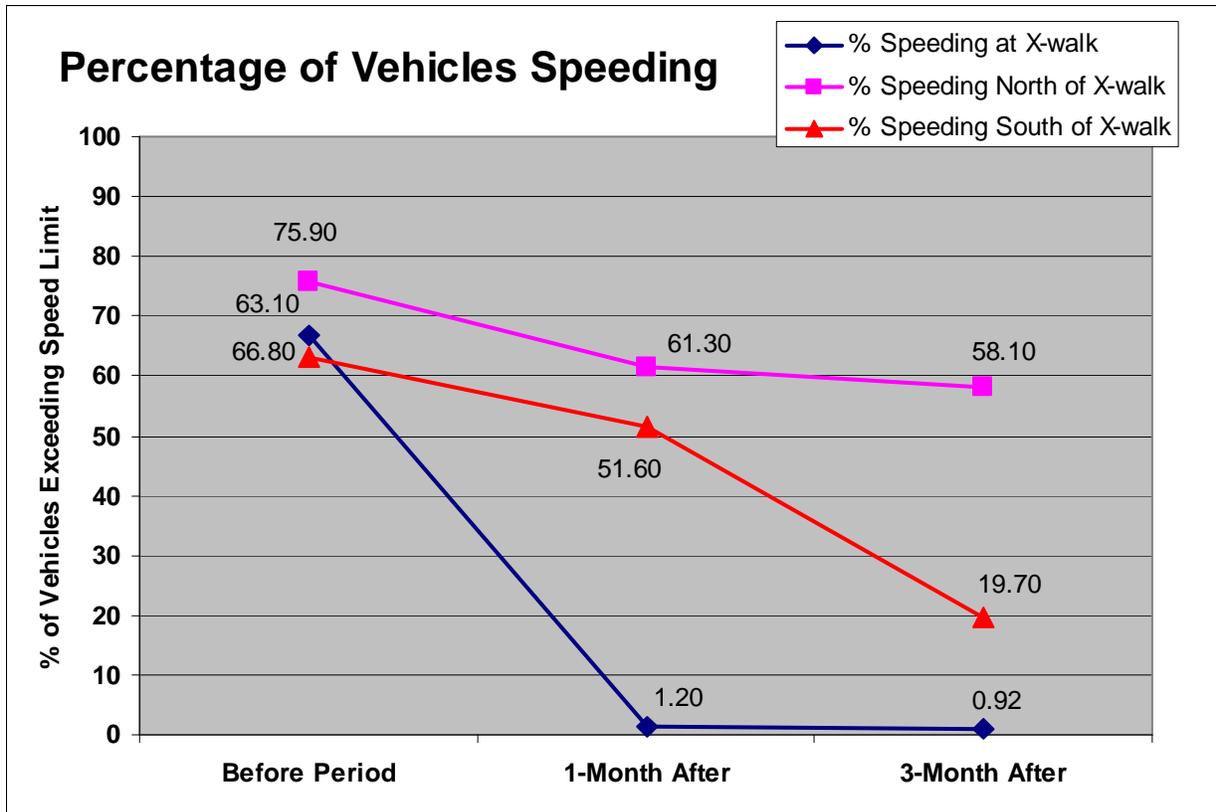
Figure 4: Graph of Percentage Exceeding Speed Limit

The previous graph (Figure 4) compares the reduction in the percentage of vehicles exceeding the speed limit of the three different data locations. We would anticipate much higher speed compliance at the crosswalk location since the roadway is forcing motorists to reduce below the 35 mph posted speed limit to safely traverse the speed tables. However, the data indicates that higher compliance is still yet achieved at the 3-month mark at all three locations.
