Spot Safety Project # 01-03-209

**Spot Safety Project Evaluation of the Signal Addition
(Installation of Traffic Signal with Metal Poles and Mast Arms)
US-158 at Bonnett St
Dare County**

Documents Prepared By:
Stantec Consulting Ltd.
for
Safety Evaluation Group
Traffic Safety Systems Management Section
Transportation Mobility and Safety Division
North Carolina Department of Transportation

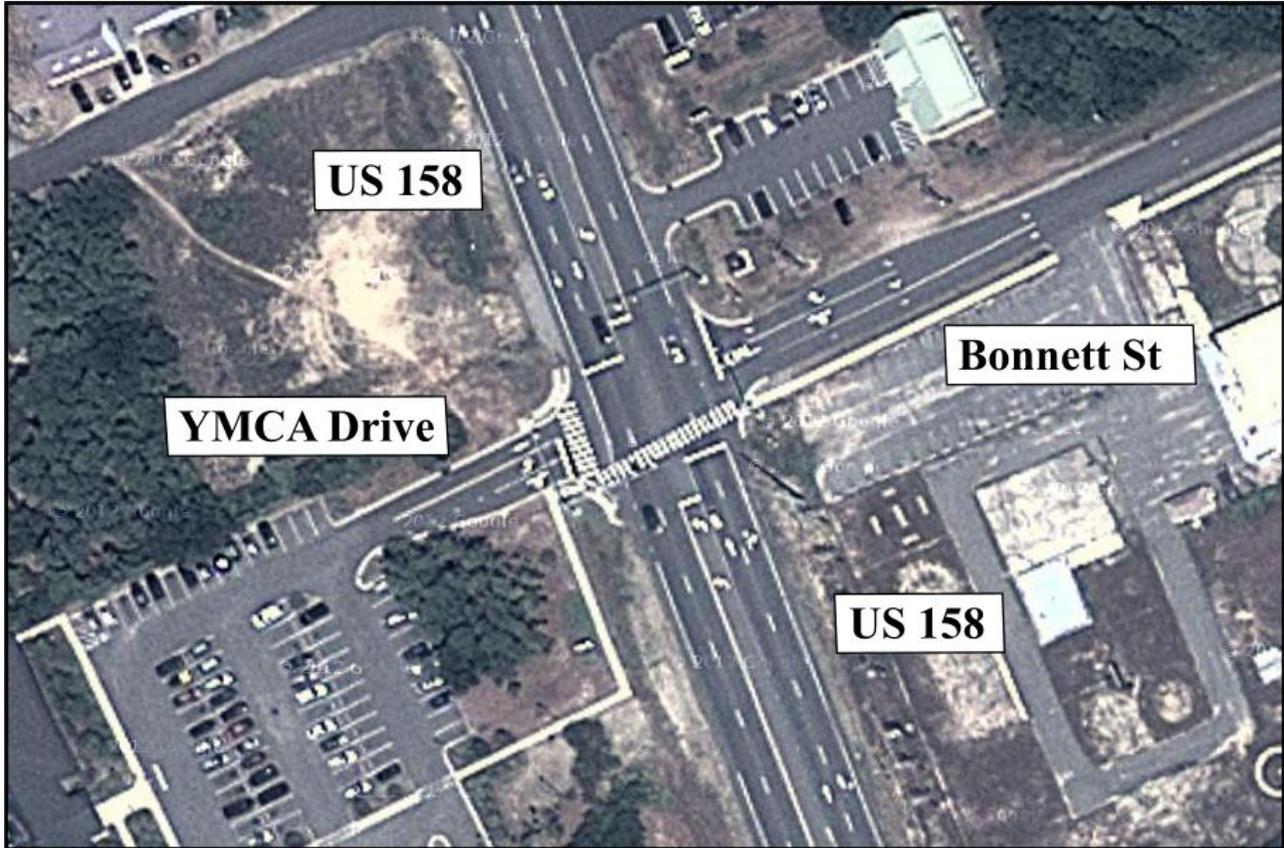
Aerial Provided from Google Maps

The Before treatment data consisted of all crashes within 150 feet north and 300 feet south of the subject intersection at US 158 and Bonnett Street. The After treatment data consisted of all crashes within 150 feet north and 150 feet south of the subject intersection at US 158 and Bonnett Street. *Please see attached location map and aerial map for further details.*
