Evaluating Options to Increase Specific Service (Logo) Signs From Six Businesses to Nine Businesses per Service

FINAL REPORT UNC Highway Safety Research Center

March 2007

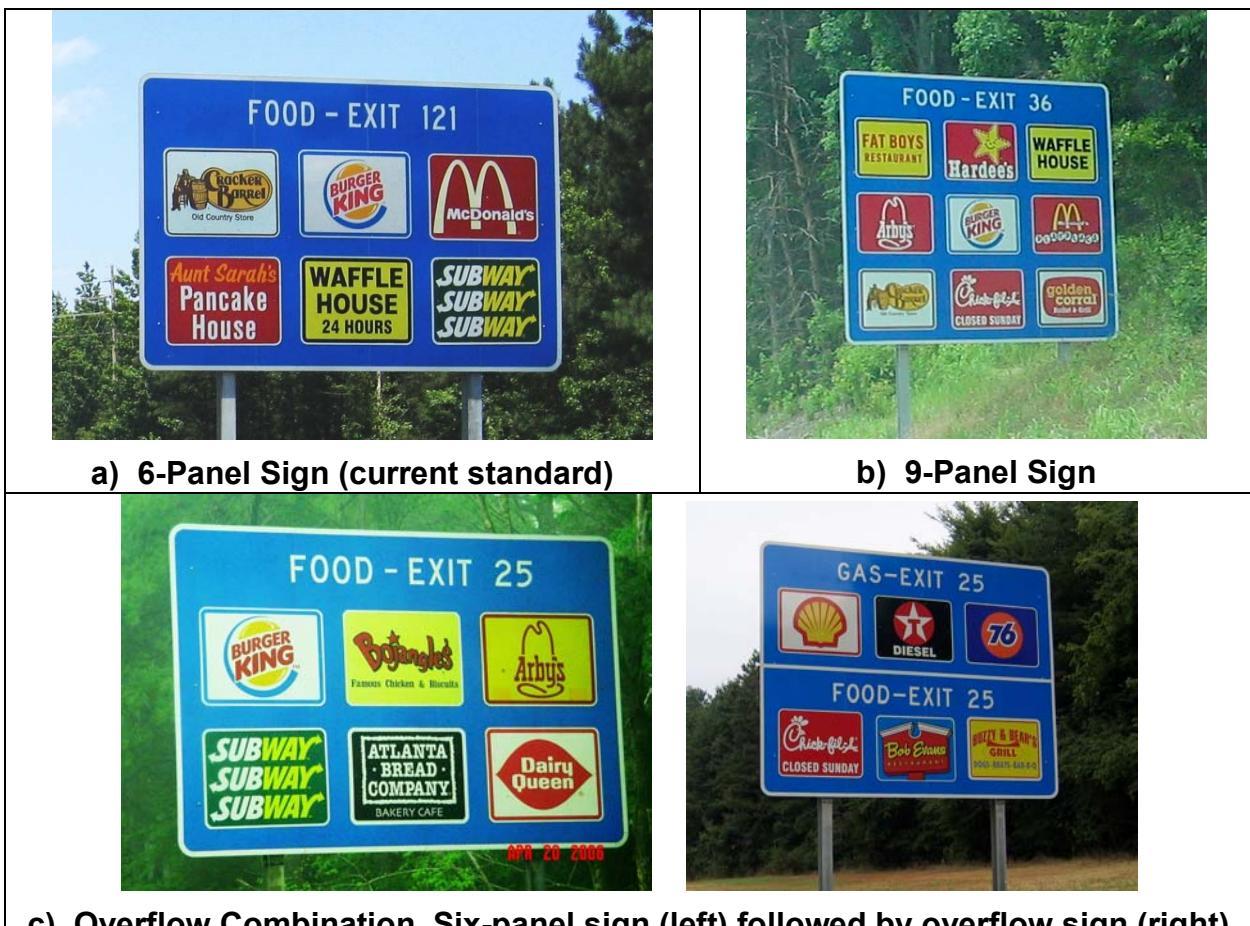
- 9-Panel Sign a single board displays 9 logo business panels (see Figure 1b)
- Overflow Combination a single service type has panels on more than one logo sign at a given interchange, thus the overflow sign has two services (e.g., food and gas) shown on the same sign in addition to a full 6-panel sign for that service (see Figure 1c)

c) Overflow Combination. Six-panel sign (left) followed by overflow sign (right)

These new design strategies (Figures 1b and 1c) are intended to provide traveling motorists with more information on specific services available at upcoming interchanges. However, before implementing (or recommending to implement) on a large scale, NCDOT desires to ensure there is not a negative effect on safety. If it were determined that more logos add to driver distraction, motorists may pay less attention to the road. In order to test the effects on the motorists' driving behaviors and determine if these strategies have a negative effect on safety, NCDOT sponsored the UNC Highway Safety Research Center to conduct a research study on selected sites throughout North Carolina where the experimental 9-panel and overflow signs had been installed or were soon to be installed.

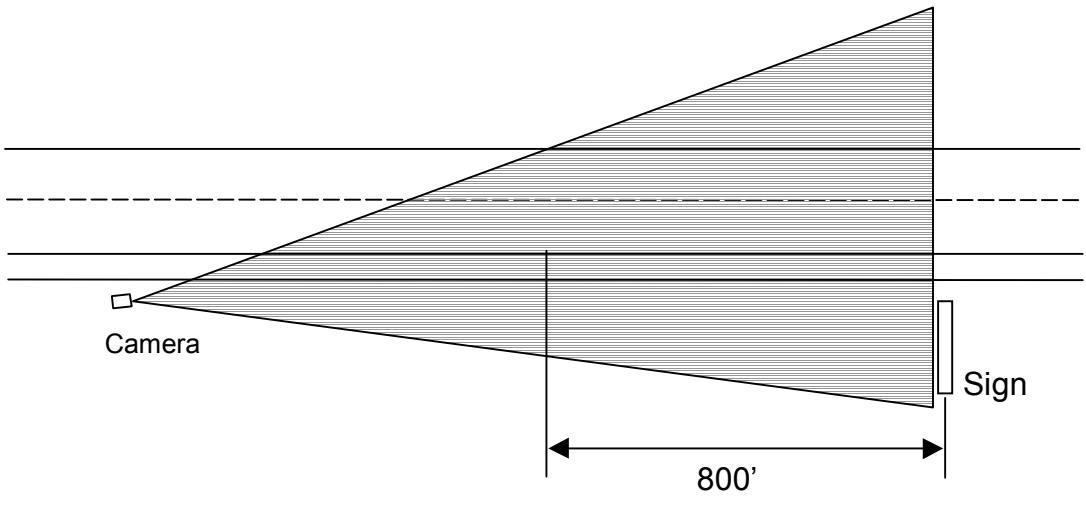
Figure 2. Illustration of Target Viewing Area

One important parameter to define was the target viewing area in the video. The target area needed to encompass enough roadway length to capture useful data on driver behaviors but not so much that it would be difficult to see the behaviors as they occurred. It was decided that 800 feet was the amount of roadway length that could feasibly be viewed in the video frame. Thus, the data collection was situated to capture a viewing area from the sign of interest to approximately 800 feet upstream of the sign.

The video camera needed to be placed in such a way that it would not be conspicuous and affect behaviors of the drivers as they passed through the target area. It was determined that the best placement of the camera would be upstream of the target area, zoomed in to the appropriate viewing of the target area (Figure 2). The possibility of placing the camera at the sign and viewing the vehicles as they approached the sign was considered but was discarded since the brake lights of the vehicles would not be visible from that position. Overhead positions (e.g., nearby overpasses) within 800 feet of the logo sign were not available at the study sites.

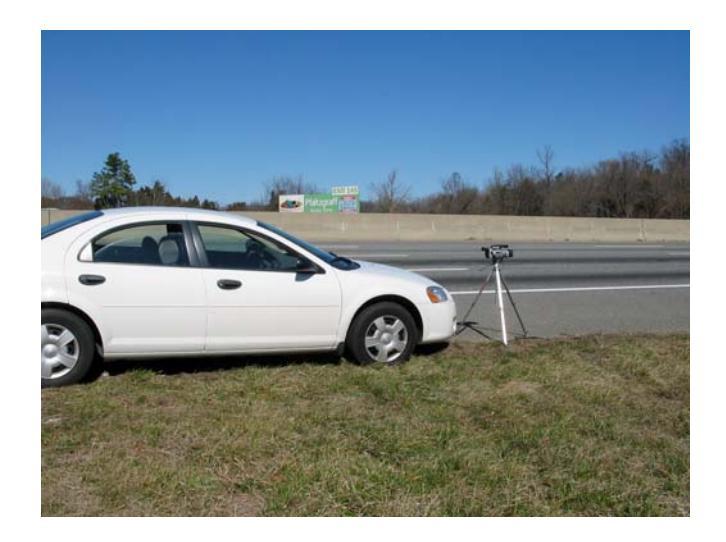
Figure 3. Video Camera Placed in Front of Parked Vehicle

The camera was situated on a tripod placed on the ground in front of the data collector's car (Figure 3). The height of the tripod did not significantly affect the quality of viewing and could be adjusted for the best view at each site. For example, the camera in Figure 3 was lowered to be able to include the sign of interest in the shot (needed to see under another sign that was closer). Additionally, placing the camera in front of the car allowed it to be hidden from motorists, so as to minimize bias from motorists who felt they were being watched.

A Sony Digital Handycam DCR-VX2000 camcorder using 60-minute MiniDV tapes was used to record driver behaviors. One hour of video was recorded for each site. Traffic volume was counted by individual lanes during this hour. For sites with more than two lanes in the direction of interest, only the two rightmost lanes were included in volume counts and subsequent data reduction. Drivers who were concerned with exiting for food would presumably be in one of these two lanes.
