Asphalt Pavement Repair Typical Section

Asphalt Repair Detail I-77 Iredell County

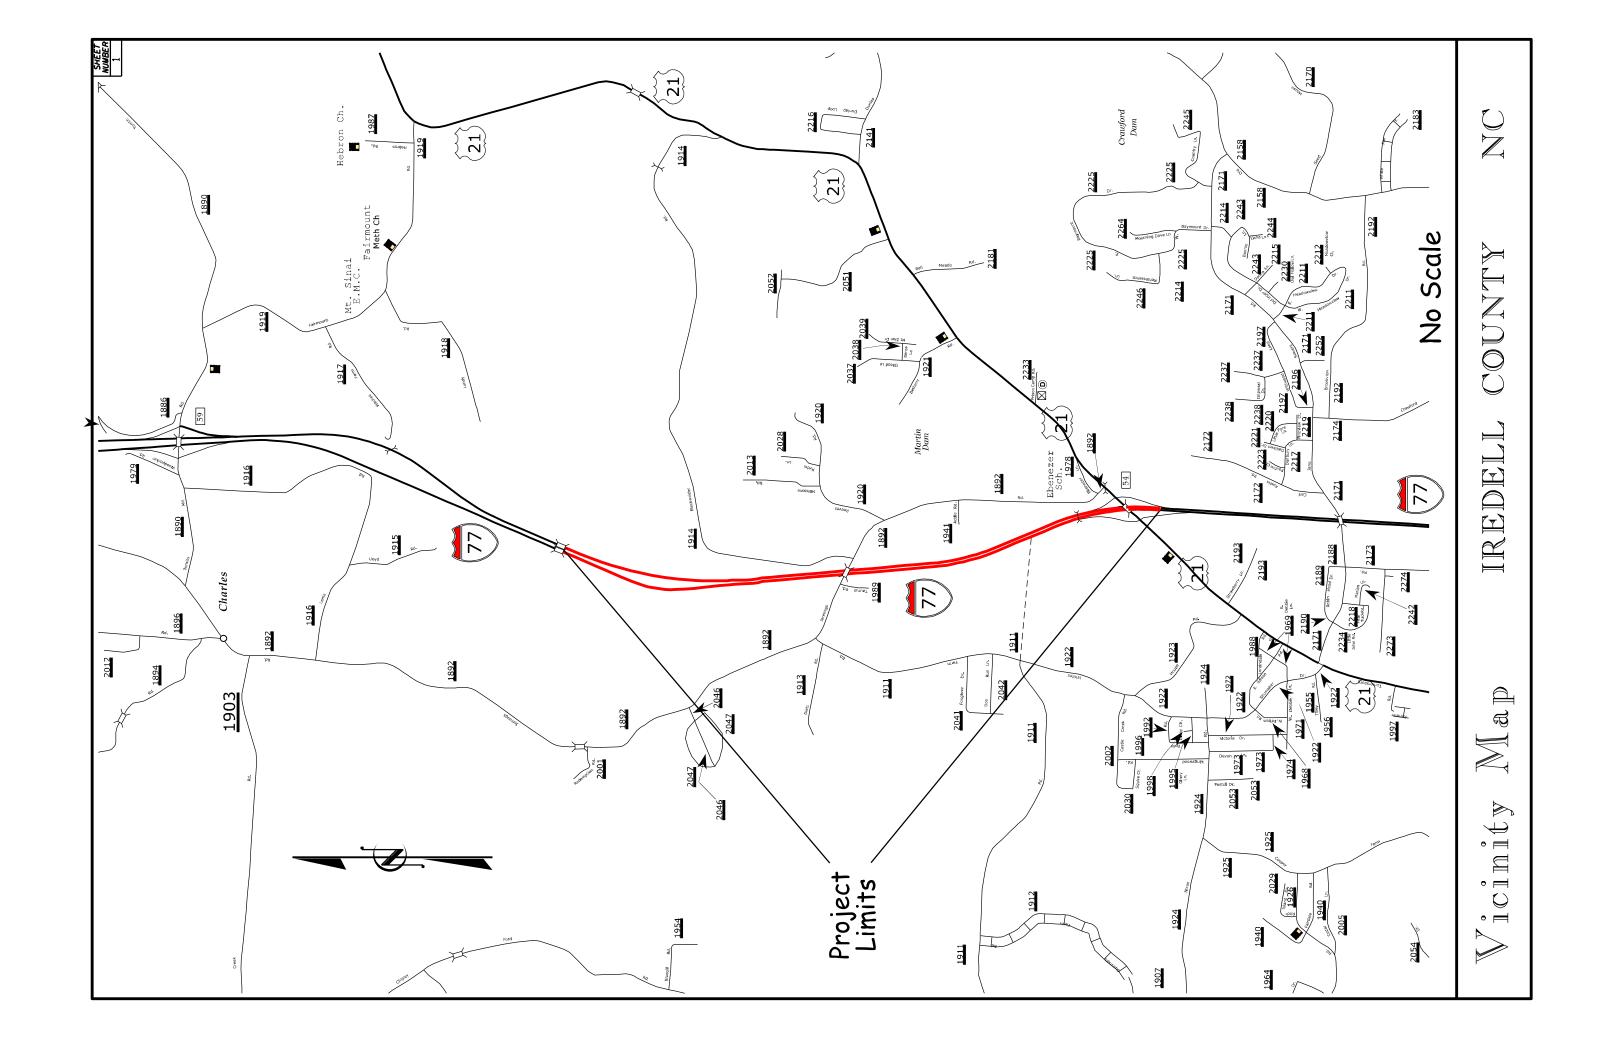
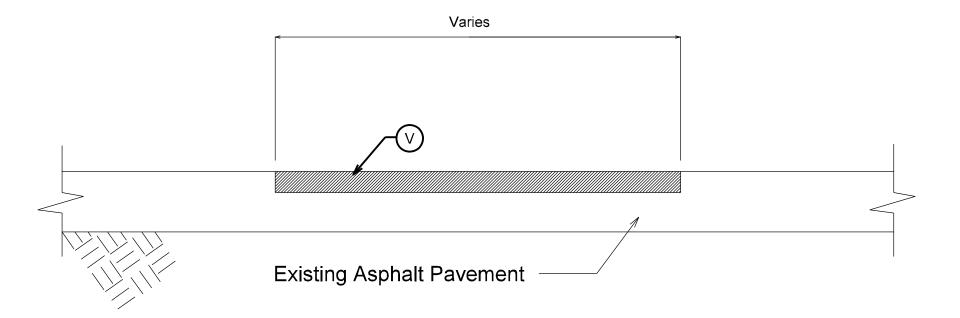
MIII approximately 3" in depth and replace with asphalt surface course, type S 9.5D
