# STRUCTURE BULLETIN

## NCDOT Construction Unit

### Current Issues: Pile Sleeves in MSE Walls

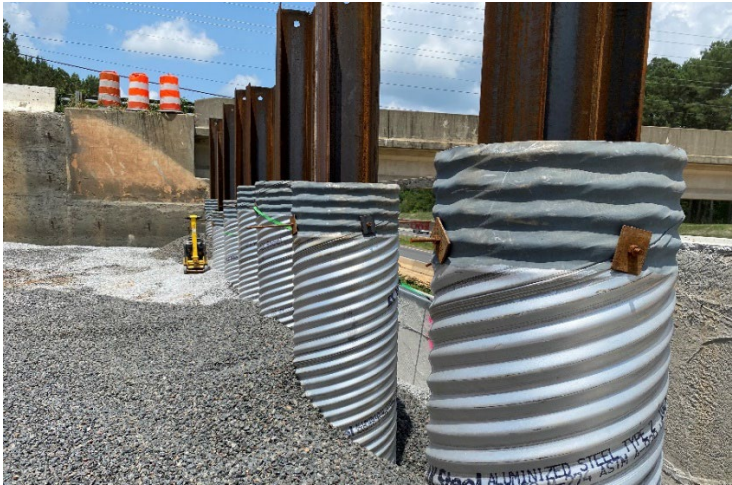
If you have built an MSE wall, then you have probably seen pile sleeves as shown in the picture above; but have you ever wondered what they were for? The sleeves are typically a corrugated metal pipe and are filled with loose sand around the piles. There are two primary reasons for the pile sleeves, downdrag and/or lateral forces due to integral end bents. Downdrag is pile settlement in response to settlement of the surrounding soil. When an MSE wall is built, the weight of the MSE backfill places a surcharge on the ground below the wall which can cause this material to consolidate and settle over a period of time, depending on the type of material. If this happens, the settlement can pull the pile downward with it through friction. This can affect the geotechnical design of the pile if either not accounted for in the design, or if mitigation techniques such as pile sleeves are not taken to limit the downdrag effect on the pile. One important factor is the order of installation. This critical information can be found in the MSE wall plan notes. If the pile sleeves are being used to offset downdrag, the plan notes will typically require that the sleeves be placed, the MSE wall constructed, and then the piles driven (after a specified waiting period, if required). This allows settlement to occur prior to driving the pile. If the plan notes specify a certain order, this should not be changed without approval from the Geotechnical Operations Engineer. Because this note is located on the MSE wall (cont.)

If pile sleeves are required only due to movement associated with integral end bents on MSE walls, the plan notes may not require a specified order of installation of the pile and sleeve. The inspector should always check the MSE wall notes as well as the structure plan notes for any specific requirements.

Regardless of which gets installed first, the pile or the sleeve, the Contractor should take care to ensure that the layout is correct and that the MSE wall construction does not move the piles or sleeves out of alignment.

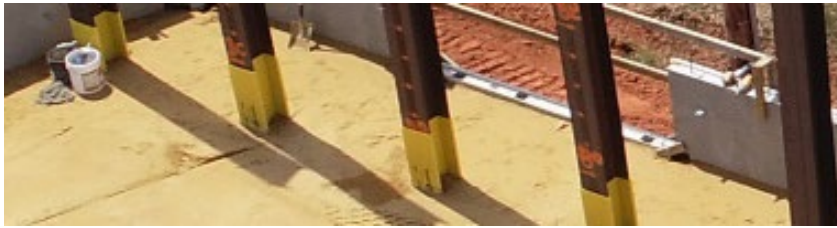
Occasionally, a Contractor will propose using a “Yellow Jacket” as shown above instead of a pile sleeve. This reduces, rather than eliminates the friction on the pile and therefore reduces the downdrag on the pile. Because this only partially reduces downdrag, they should not be used unless Geotech has approved them.
