**Final Report**

**North Carolina Department of Transportation  
Research Project No. 2006-16 (IBRC 2004)**

***Evaluation of Design and Construction of HPC Deck Girder Bridge in  
Stanly County, North Carolina***

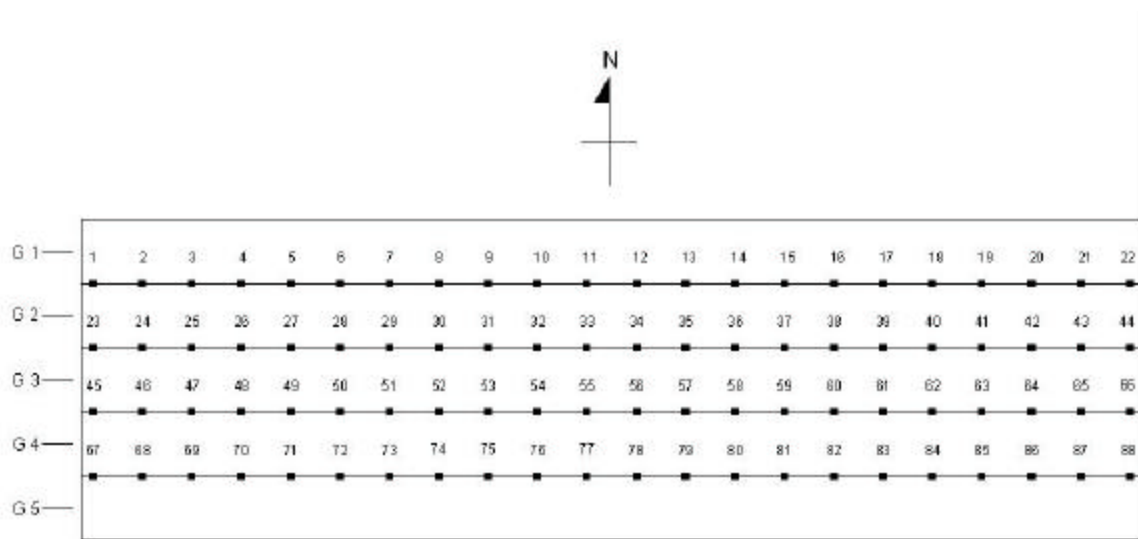
**Figure 2-12. Plate Numbering in Plan View**

Based on the plate stresses obtained from the Larsa™ model, a connection fatigue analysis was performed. The welded connector plate experiences the highest fatigue stress based on Truck 1 loading condition, and caused a maximum stress in the first plate between girder lines 2 and 3 (see Figure 2-12 for plate numbering). The axis and plane geometry of the plate is shown in Figure 2-13, “X” being the longitudinal axis of the bridge.

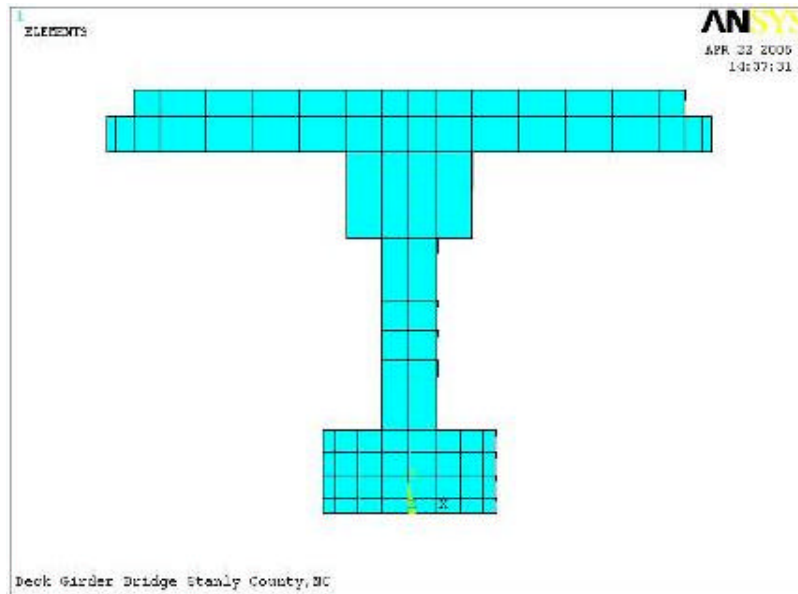
**Figure 3-1. Equivalent Deck Girder Cross Section**

the plates and diaphragms due to the prestress and dead load were recorded in ANSYS™ so that post-construction live load effects could be analyzed separately. The equivalent girder cross section is shown in Figure 3-1.

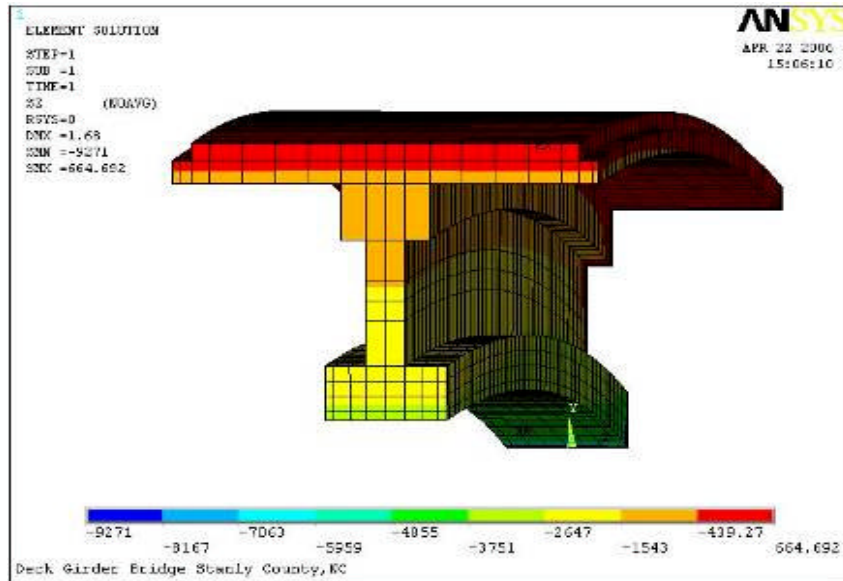
**Figure 3-2. Prestress + Self-Weight Normal Stress**

The simply supported girder was created using SOLID65 elements, which are 3-D reinforced concrete elements with cracking and crushing capabilities. The prestress force was induced by using axial LINK8 elements with an initial strain. The steel plates and diaphragms were modeled using the two-node BEAM4 line elements. The deck girder cross section was modified from the one described in Interim Report III, to allow the plates and diaphragms to be placed between adjacent girders. The steel members were modeled using 36 ksi steel with an elastic – perfectly plastic stress/strain relationship. The deformed girder under the prestress and self-weight conditions is shown in Figure 3-2.

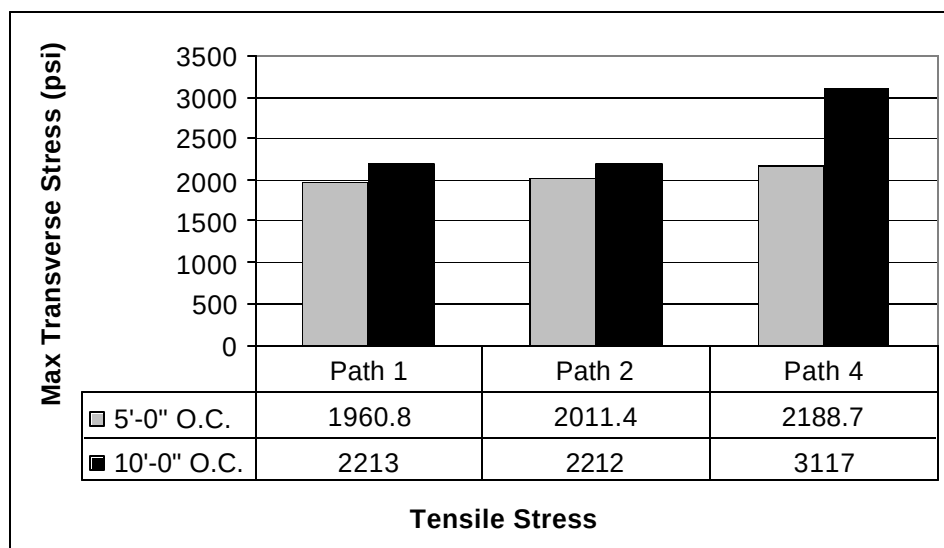
**Figure 3-10. ANSYS™ Maximum Tensile Transverse Plate Stress**

The plate spacing was increased to 10'-0" on center and the maximum tensile and compressive transverse stress values (peak values from ANSYS not necessarily corresponding to an actual strain gage location on the bridge) in the plates were compared (see Figures 3-10 through 3-11). This was completed to evaluate the effect of connection spacing on the stress in the plates and the diaphragms. The larger spacing increased the plate stresses, and thus reduced the safety factor of these connections significantly – therefore, this modification is not recommended without redesigning the connection detail. The influence of the spacing on the plate principal stress (highest stress at a given location, acting on the principal plane) is shown in Figures 3-12 through 3-13.

The maximum tensile transverse plate stresses with the plates at 10'-0" on center were found to be 200-1000psi higher than the 5'-0" on center plate spacing. The maximum transverse compressive stress was found to be approximately twice as high with the increased plate spacing. The maximum tensile principal stress difference was found to be 700psi. The compressive principal stress comparison resulted in a larger difference ranging from 120-2300psi. The largest stress induced in the plates when spaced at 10'-0" on center was 11,115psi in compression.

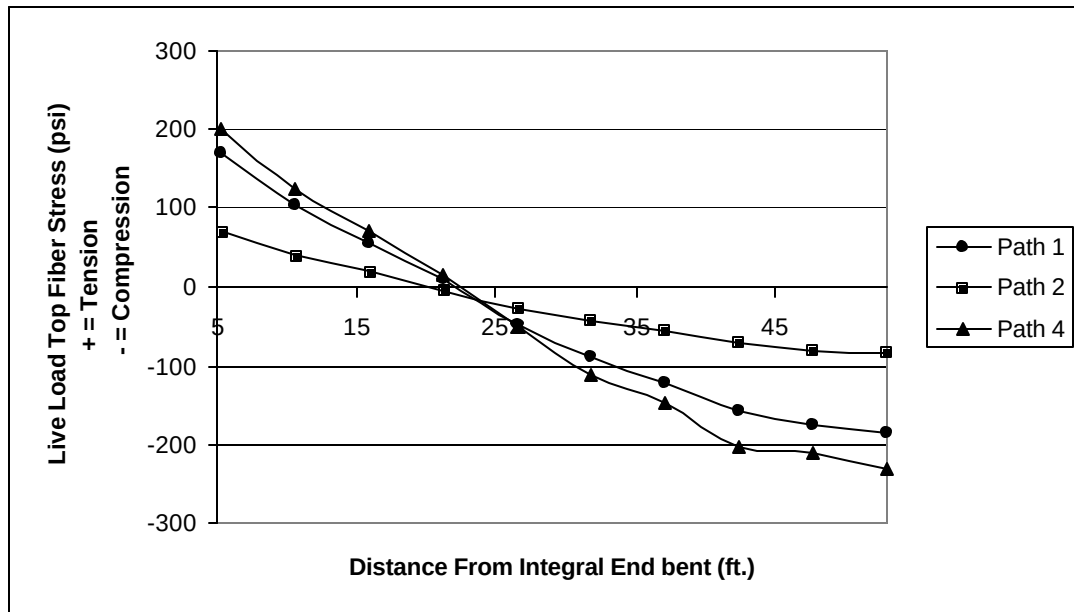
**Figure 3-23. Top Fiber Live Load Normal Stress - Deck Girder 1**

the end bent, the compressive stress at mid-span, and the live load inflection point at about 25'-0" from the support.

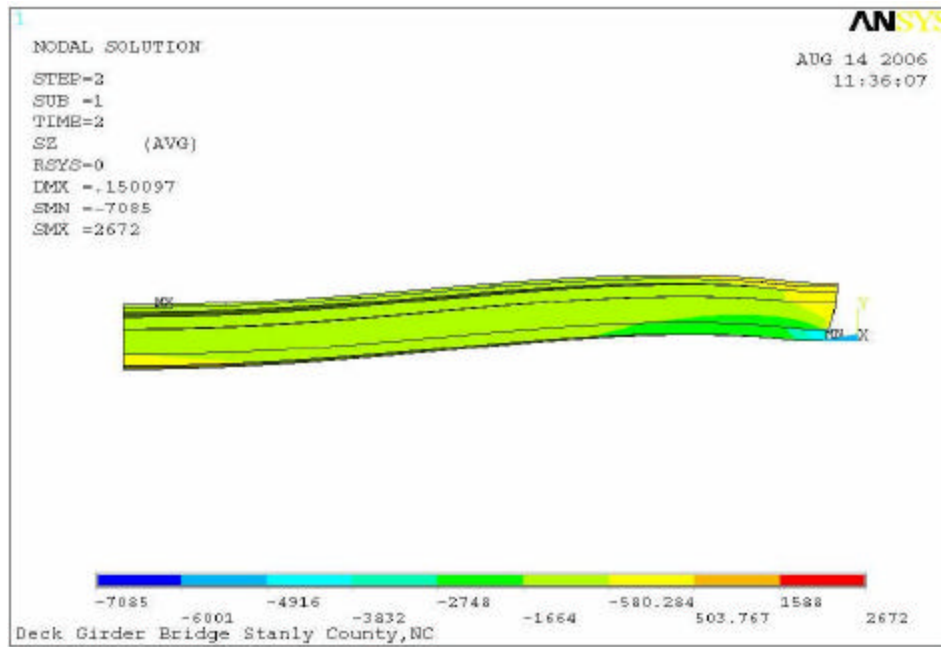
**Figure 3-24. Deformed Shape and Un-adjusted Normal Stress- Deck Girder 1**

The maximum tensile stress that occurs due to the live load was found to be 200psi at approximately 5.3 ft. from the integral end bent wall. The deformed shape of deck girder one is shown in Figure 3-24. In this figure, the associated stress values are not adjusted to exclude prestress and self-weight.

The stress in the top of the deck girder, resulting from prestress and self-weight, is shown at the deck girder end and mid-span (see Table 3-1). The total tensile stress at 5'-4" from the end bent wall was found to be 902psi. This value is higher than the 563psi design concrete tensile stress limitation (or 862psi, using actual  $f'_c=13,202$ psi measured on the bridge test day, using cylinders made during deck girder fabrication), which is also proven by hairline cracks present in the flanges of the bridge deck girders. The mid-span normal stress is well within the design specified compressive stress limitations. The large stress observed at the 5'-4" length could be slightly higher than the actual value due to

the debonding of strands in the actual girder fabrication process. However, the ability to de-bond the prestressing strands was not available in the ANSYS™ FE program.

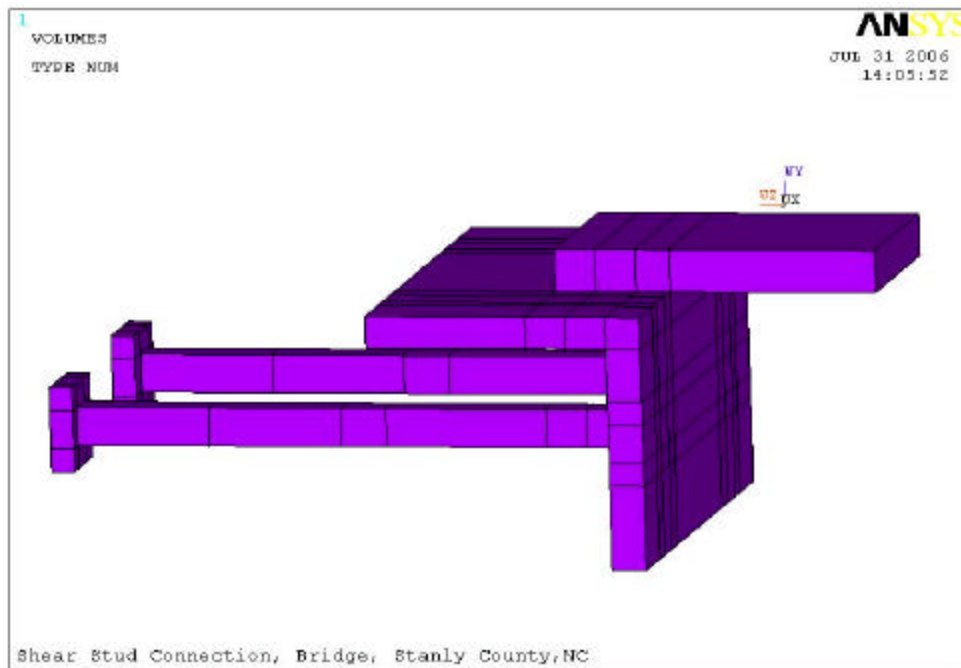
**Figure 4-1. Flange Connection Un-deformed Shape**

As the flange connection analysis began, an FE model was used to help the research team predetermine material and connection behavior. In order to accurately understand the connection's behavior, a basic model of the studded connection with the steel plate was generated using ANSYS™. The model was a six inch piece of angle with two shear studs attached to the back side, and a 3" x 4" x ½" steel plate welded to the top of the angle (see Figure 4-1).

The FE model was created using SOLID45, a 4-node brick element. Simplifications were made when generating the model such as, equating the circular areas to square areas in order to get a simplified mesh within the FE program. The steel properties of the connection were found in the PCI Design Handbook 6<sup>th</sup> Edition (2004), with an ultimate

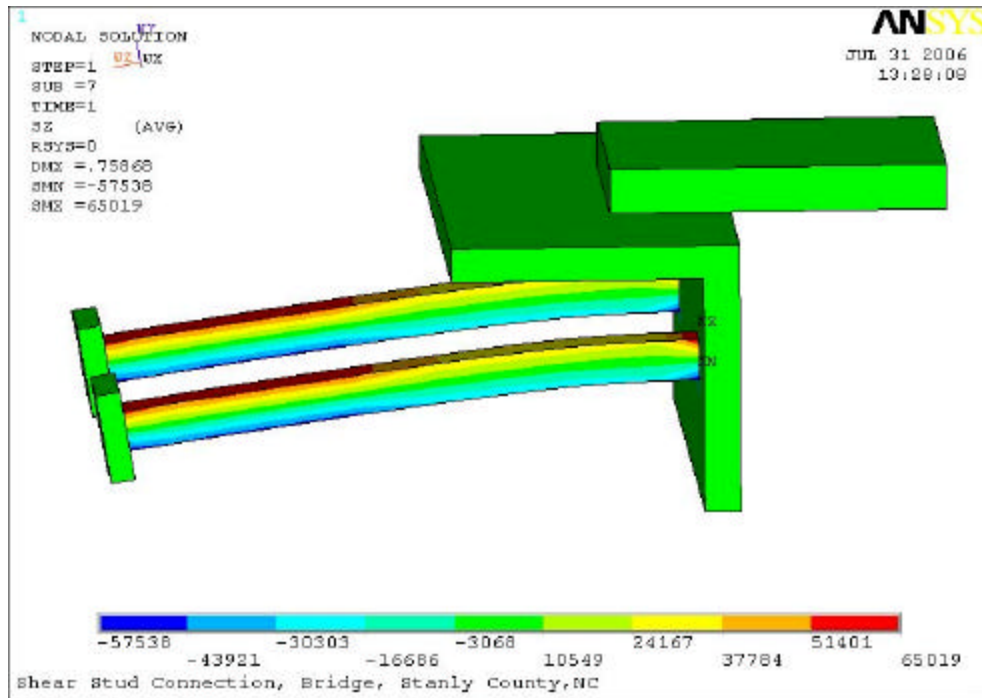
**Figure 4-2. Flange Connection Deformed Shape**

strength of 65 ksi for tensile members. The FE model was then fixed at the base of the stud head. An eccentric tensile load was then placed on the plate. According to the FE program this particular connection was able to withstand approximately a 1,450 lbs eccentric load before yielding was observed at the front of the two studs where the angle and studs were connected. Figure 4-2 shows connection's deformed shape at a load level of 1,450 lbs.

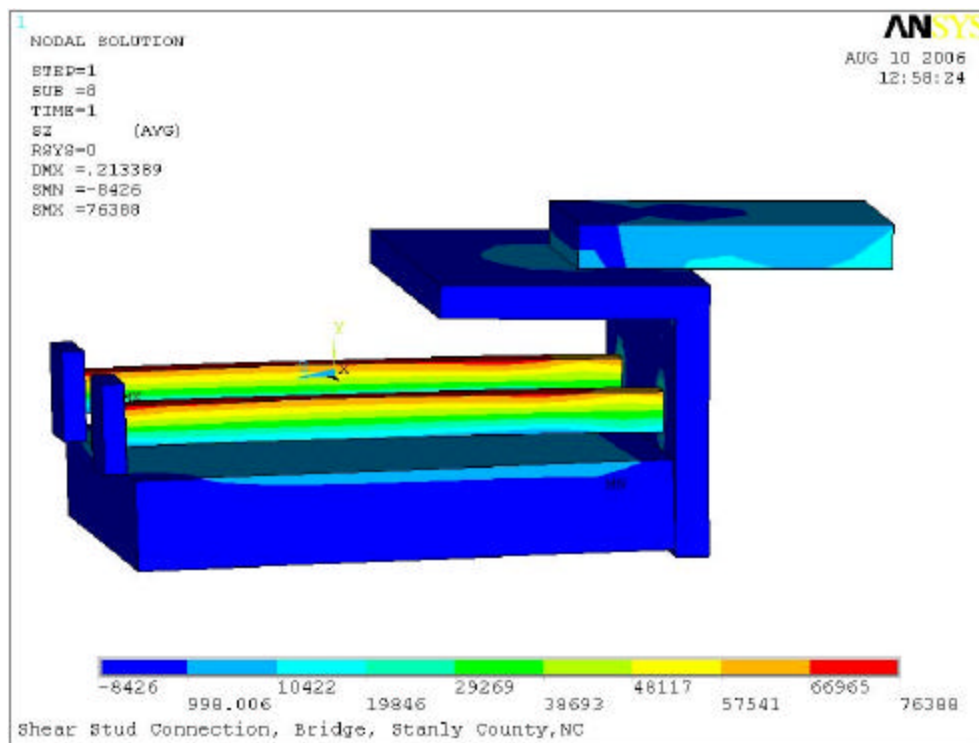
**Figure 4-3. Deformed Flange Connection with Pivot Surface**

After testing the connection specimens, the research team re-visited the FE model in order to re-evaluate the experimental results. The laboratory testing showed that the connection was not simply controlled by yielding at the base of the stud (where it meets the angle). As the connection reached failure (defined as loss of at least 30% of peak load), the deformed connection began to rotate rather than translate. Essentially, the bottom of the angle acted as a fulcrum for the connection to pivot on as the angle and plate rotated outward and the studs elongated. The failure was modeled more accurately in ANSYS™ by placing a block just behind the bottom of the angle.

This more accurate FE model showed that the connection can take a much higher load due to the connection of the angle and shank. The revised FE model shows that flexural yielding occurred in the shanks of the shear studs before the load reached ultimate. The plate never attained stresses with the magnitude of those observed in the studs. However, when the loading conditions were at failure, the angle reached similar stresses as the studs.

The load that the revised FE model reached was approximately four to five times what the connection alone could hold, reaching load levels between 6,000 lbs and 7,000 lbs. During the laboratory testing, according to all of the strain gages attached, that initial yielding occurred in the shanks of the shear studs. Similarly, as load was applied to the FE model the first location that yielding occurred was in the shanks of the connection, thus confirming the FE model analysis. Figure 4-3 shows this interaction and how the fulcrum allows for increased load to be applied to the flange connection.

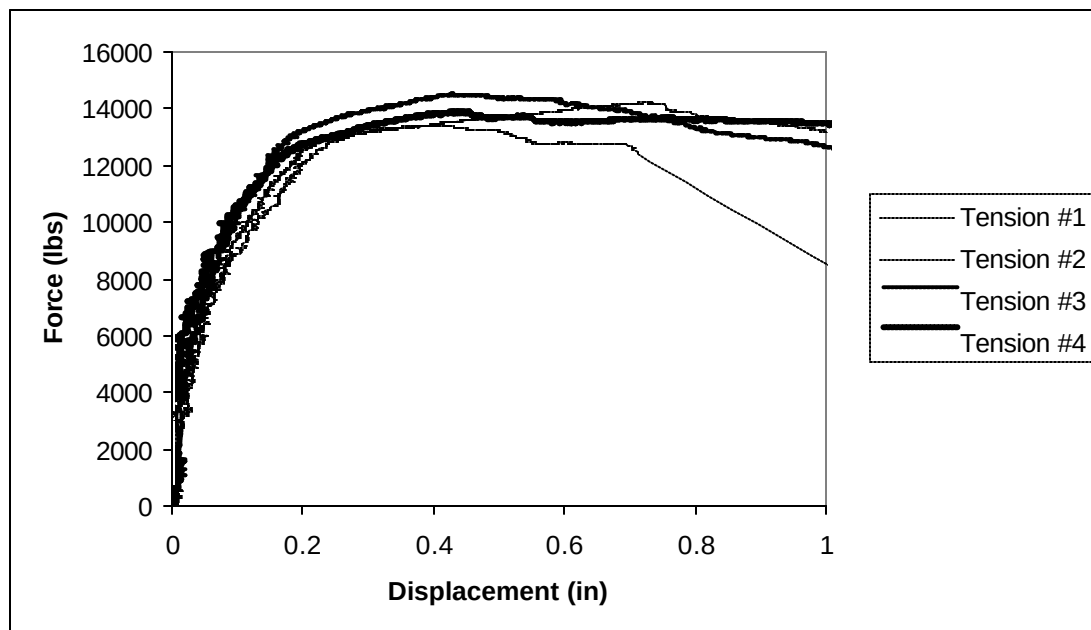
**Figure 4-8. Load vs. Displacement for Tension Tests**

The average load versus displacement graphs for the four tensile test specimens are shown in Figure 4-8. Figure 4-9 is a picture of the connection failure with a tensile load. It is clear from these curves that the angle yielded (adjacent to the welded shear studs – the location of peak bending moment from eccentric loading) and the largest deformation occurred at an approximate load of 5,000 lbs, transferring the force mostly through tension to the embedded studs. An average capacity of 12,778 lbs capacity was reached, followed by large deformations, and finally, a failure due to stud/angle connection fracture.

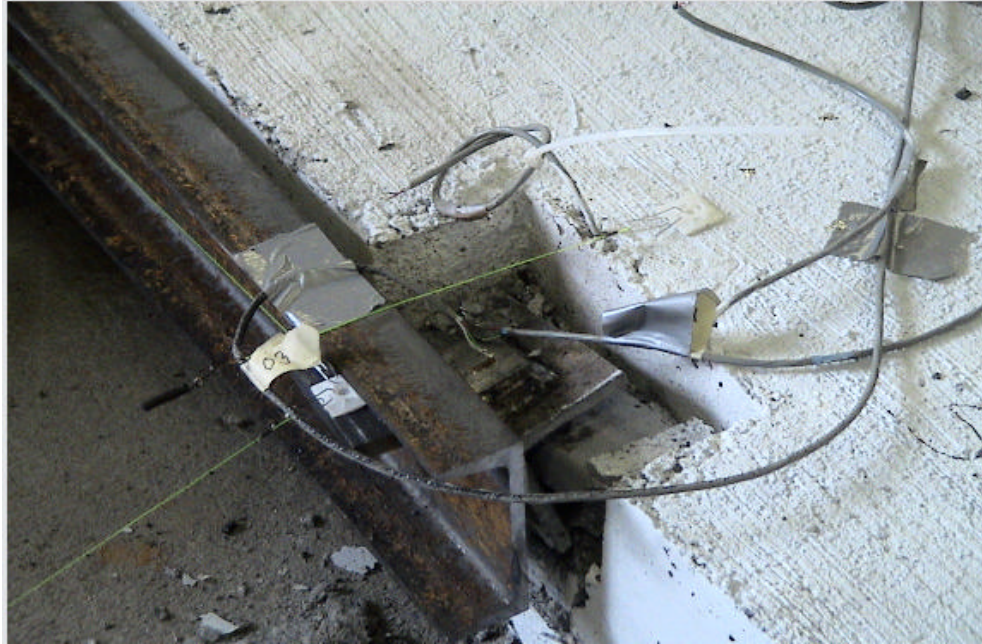
**Figure 4-12. Shear Connection Failure**

Even though four shear tests were performed, the results of only three tests are included in Figure 4-11. Figure 4-12 is the deformed shape of the connection after being subjected to ultimate shear loading. One of the specimens did not produce reliable research data, and was omitted from further common analysis. During the testing of specimen #2, the research team noticed that all initial cracking and yielding took place similarly to the other specimens. In researching why Test #2 had a much higher ultimate capacity than the other specimens, primarily pointed at the construction process (in all probability during the placement of the concrete) the rebar cage slipped under one or both of the

studs. This steel-to-steel connection would appear to cause a higher ultimate load than the concrete to steel interface that the research team usually witnessed throughout testing.

At approximately 5,000 lbs in Figure 4-11, shifts in the graphs indicate that some of the connection steel members yielded. After this initial steel yielding, load redistribution occurred, which was followed by significant rotation of the connection angle, resulting in a failure governed by stud-to-angle connection capacity. The average ultimate value for the shear tests was 24,646 lbs.

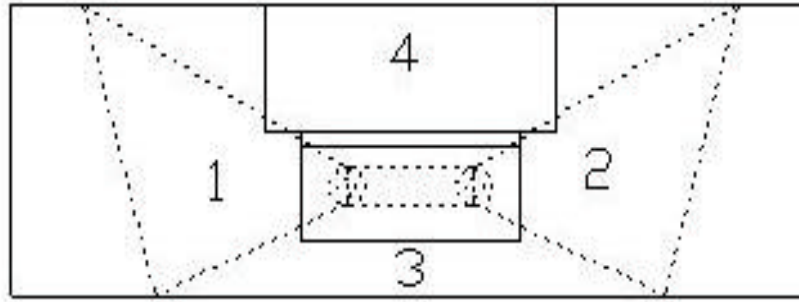
**Figure 4-13. Trapezoidal Areas**

$$A_N = A_{1+2+3+4} = 56.75\text{in.} + 56.75\text{in.} + 58.24\text{in.} + 72.14\text{in.} = 243.88\text{in}^2$$

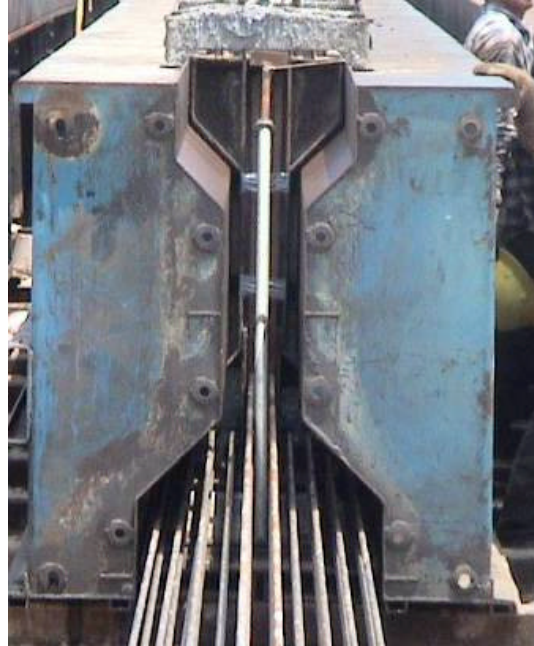
**Figure 5-7. Final Placement of Girder Formwork with Connectors**

The connector ties that would connect the girder with the deck were then brushed clean of concrete to ensure proper bonding. The concrete was left to cure for 17 to 18 hours, so that the girder formwork could be removed. During the curing process, burlap cloth and tarps were used to cover the concrete. A water system, which ran underneath the tarps and burlap cloth, provided a steady mist for the duration of the curing time. The concrete strength when the girder formwork was removed varied between 5,500psi and 8,000 psi.

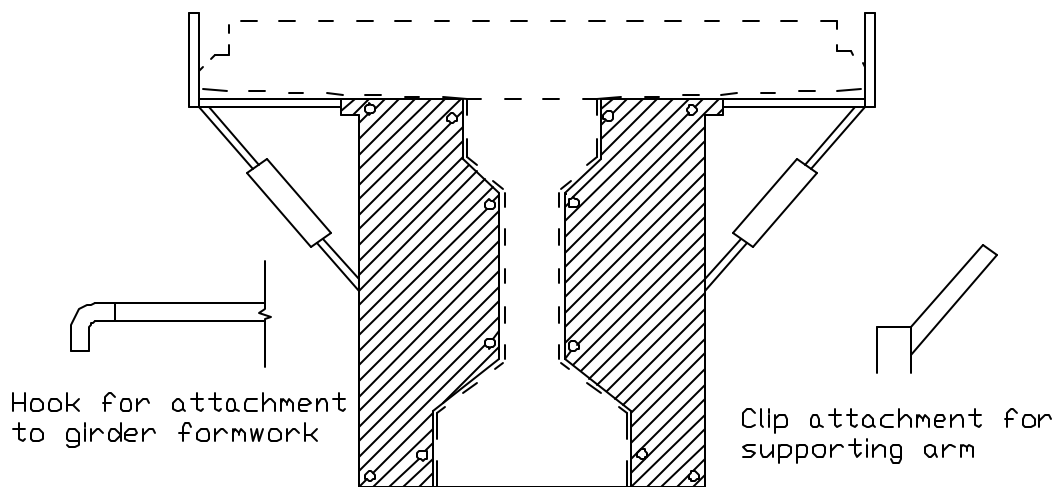
**Figure 5-19. Formwork with Turn Buckles**

The formwork also required the girders to be poured in two separate parts. For future use, it is suggested to allow the deck formwork to attach directly to the existing AASHTO girder formwork. This would allow the deck girders to be poured in one day instead of two. On the other hand, this will only make economic sense when these types of deck girders are fabricated in larger quantities. Several ideas were considered, but only one is presented here at a rough sketch level. No attempt was made to fully design these possible modifications. First, two longitudinal steel plates are fabricated that are fastened together at an angle of 90 degrees on the edge (see Figure 5-19). These two pieces would then hook into the top outside edge of the existing Type III girder formwork. These hooks would slide into slots on the existing formwork and hook into place.

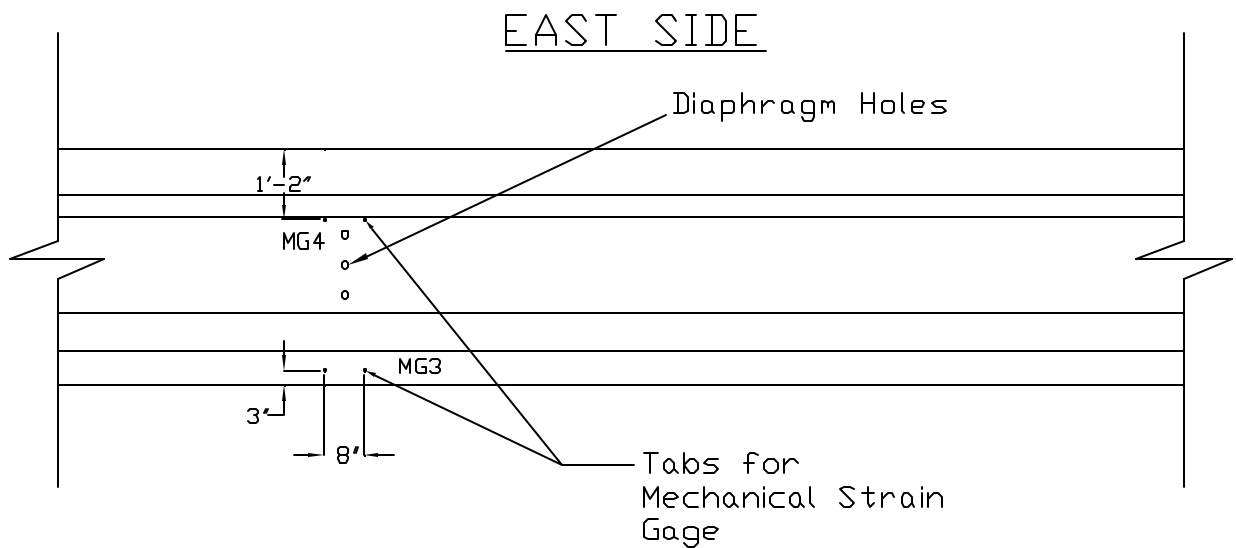
**Figure 5-21. Location of Tab Inserts at Quarter Point on the Girder**

Each set of holes were spaced 8 inches on center. The mechanical strain gage required special brass inserts to be secured into these holes, so that measurements of strain could be made using tabs screwed into these inserts. A template was made for the installation of the inserts, allowing for a better insert positioning while the fast curing epoxy hardened. A two-part epoxy was used to glue the inserts into place. Once the epoxy was set, the template was removed from the tabs.

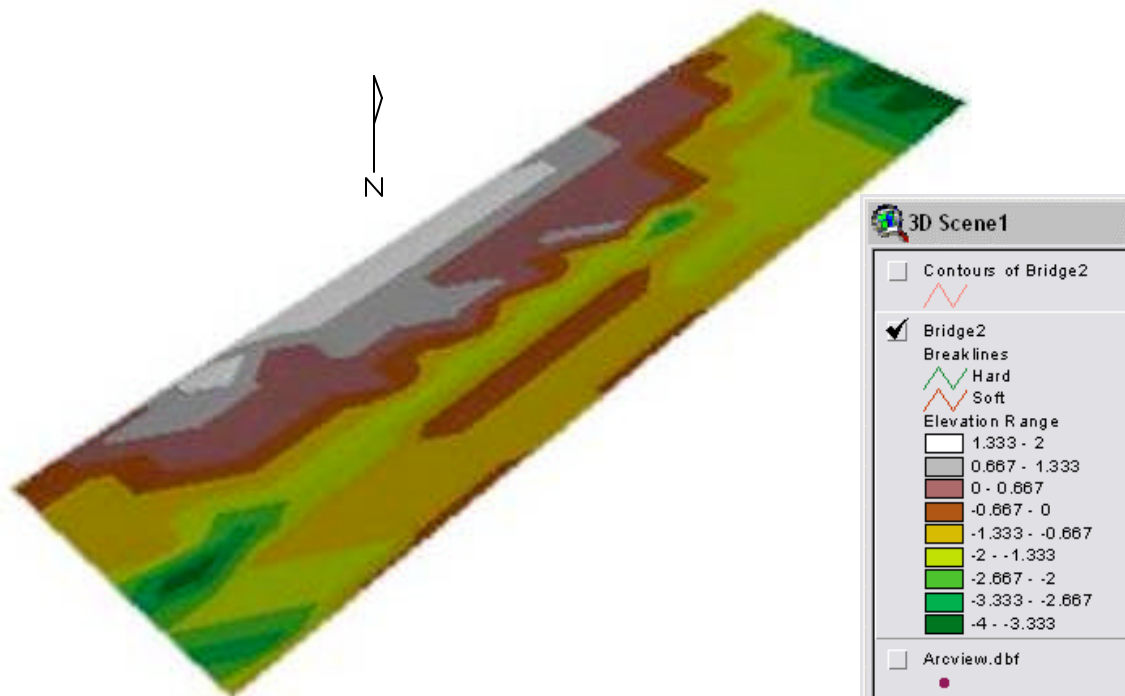
**Figure 5-29. Arcview GIS 3.3® Image of Riding Surface Without Wearing Surface**

Furthermore, when asphalt is not needed, if an extra inch of concrete would be placed on the deck surface during fabrication, this layer can be removed by surface grinding after the members are installed, allowing for a smoother riding surface. Finally, the use of lightweight concrete could reduce the gross weight by 20% (and would present a few design challenges to be considered), which would reduce the demand for both hauling and lifting equipment, as well as the demand on the gravity load supporting system.

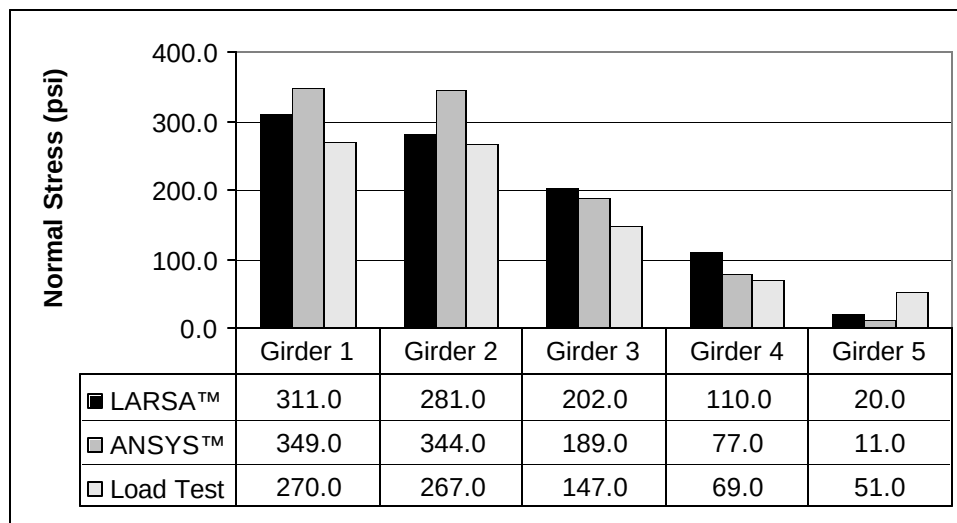
**Figure 7-1. Normal Stress at Mid-Span Path 1**

The deck girder normal stress values that were recorded during the load test were compared to the values obtained from the ANSYS™ and Larsa™ models. The stress values were taken at mid-span on the bottom extreme fiber of each of the five fixed-end deck girders. These values were found to be very similar. The FE and Larsa™ models consistently predicted slightly larger stress values on all three load paths. This difference could be attributed to the parapet wall or imperfections in the path that the truck traveled as the load test was being conducted. The asphalt overlay also provides slightly more distribution of the tire load on the actual bridge surface. The comparisons from all three load paths are shown in Figures 7-1 through 7-3.

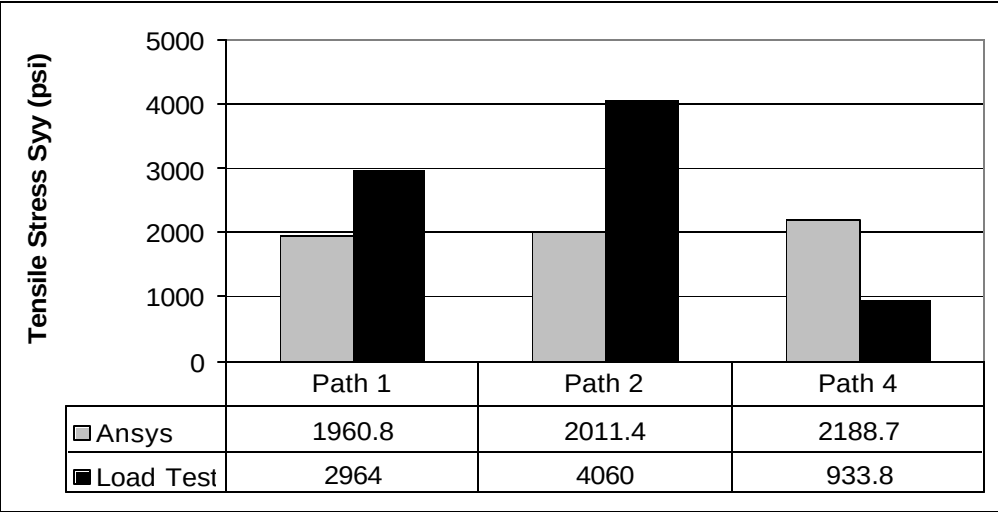
**Figure 7-11. Maximum Transverse Tensile Plate Stress**

The plates that were instrumented during the actual load test were mainly in one quadrant of the bridge. The maximum plate stresses that were obtained were the maximum transverse stress value as the truck crossed the entire bridge. The ANSYS™ model plate stress values were observed when the truck caused near maximum displacement and stress values in the deck girders. The maximum plate stress in the transverse direction (perpendicular to traffic) that was computed by ANSYS™ versus the maximum load test stress value is shown in Figures 7-11 and 7-12.

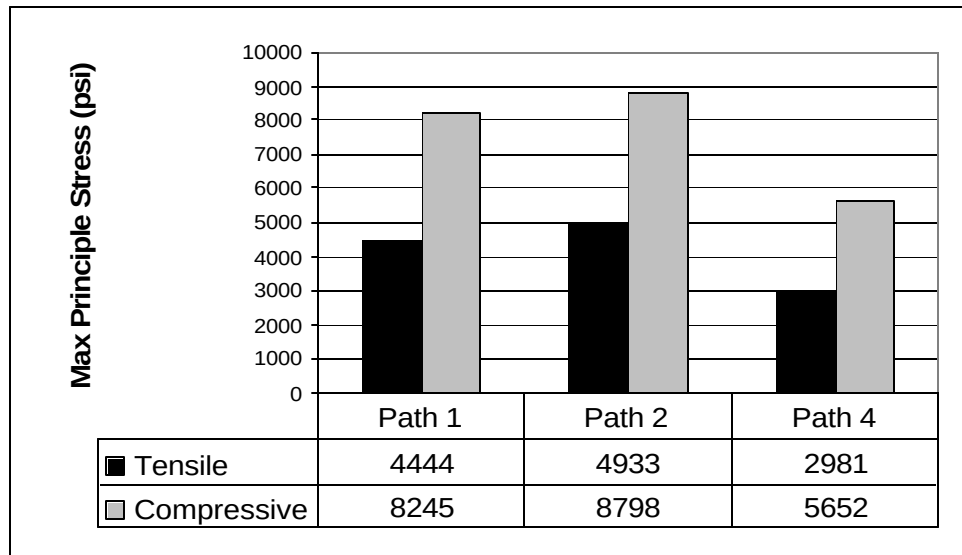
**Figure 7-13. Maximum Principal Plate Stress**

The maximum principal stress that occurred in any plate, when the deck girder stress was largest, is shown in Figure 7-13. The principal stress was not measured in the actual load test but was computed in the ANSYS™ model.

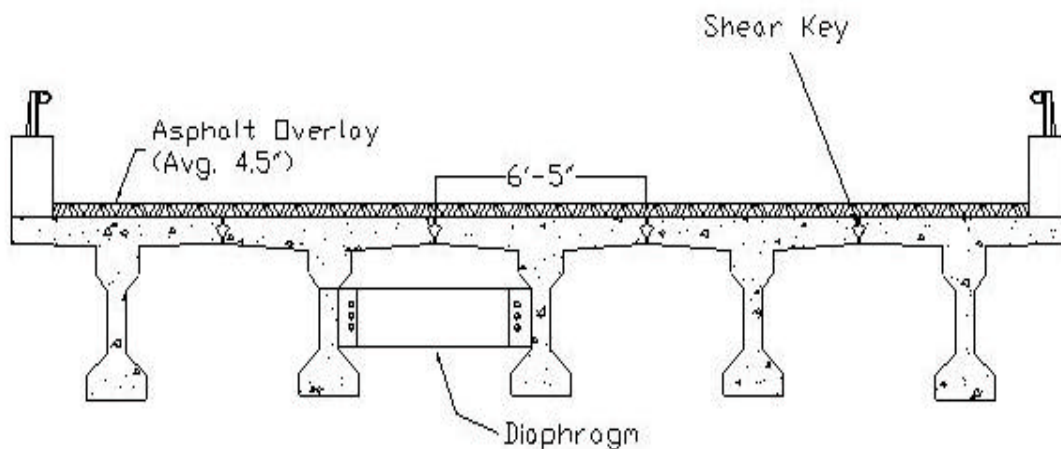
**Figure A-2. Section View of Deck Girder Bridge**

The replacement bridge consisted of five prestressed deck girders made from standard AASHTO Type III girders (see Figure A-2). The deck girders were spaced at 6.5 feet on center, with intermediate diaphragms at mid-span and quarter points along the bridge. The deck also had embedded angle connections along both sides of the interior girders and on the inner flange of the exterior girders, placed every 5 feet. The embedded angles were connected by a 3"x 4"x ½" plate. The deck girders also contained a grouted shear key along the edge of the flanges between girders. Each end of the bridge was embedded into an integral end bent that was poured at a later date. The guard rail that was attached to the parapet wall was a one-bar metal rail also shown in Figure 44. The bridge also required an average of 4½" of asphalt due to the location of the bridge: one of the abutments was located in a sag curve.

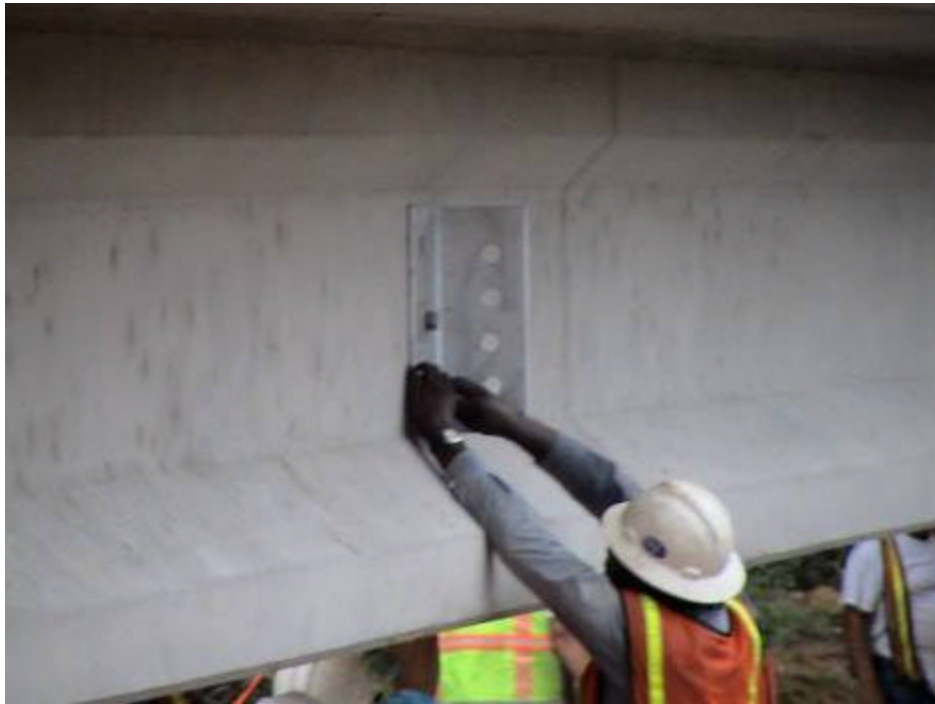
**Figure A-12. Hand Tightening of the Angles Before Deck Girder Placement**

Prior to lifting, the angles for the steel diaphragms were attached at the proper locations on the deck girder. The steel angles were only hand tightened during this initial phase (see Figure A-12). They were tightened in accordance with the plan specifications, once all the deck girders were in final position. Once the two cranes were attached and the steel angles tightened, the deck girder was lifted off of the truck in unison. The cranes then slowly rotated the deck girder above the abutments. Once the deck girder was in the correct location above the abutments, each crane slowly lowered the deck girder down (see Figure A-13). The deck girder was carefully placed onto the bearing pads.

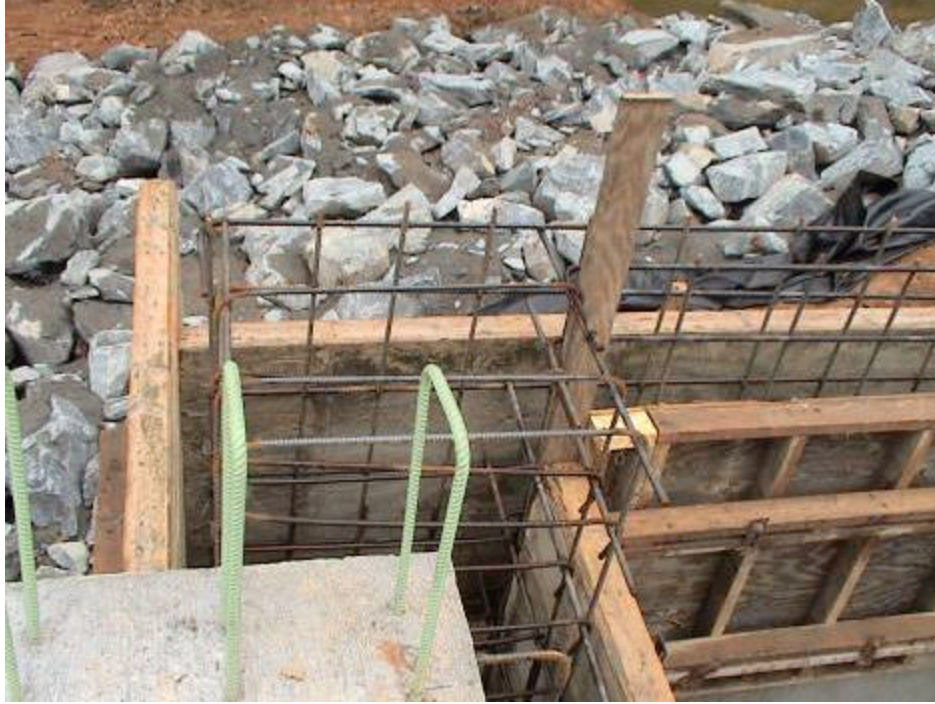
**Figure A-24. Integral End Bent Rebar and Formwork**

During the grouting of the shear key, the integral end bent construction began as well. The East bent was constructed first, and then the West would follow. Rebar was tied according to the plans, and then the formwork was fabricated using plywood (see Figure A-24). The East facing of the formwork was braced using 2x4's stabilized into the fill soil. Then, the concrete was ordered and transported to the site. The concrete was poured directly from the truck into a concrete bucket. The bucket was lifted by a crane on site from the truck to the end bent location. Once the bucket was above the proper location, the release lever was pulled and the concrete was dumped into the formwork (see Figure A-25). A mechanical vibration device was used to remove any voids in the concrete (see Figure A-26). Once the concrete reached the desired elevation a trowel was used to smooth it. The same process was repeated for the West bent.
