## ‘PRIVATEER FARM’ INSPECTION REPORT

MITIGATION SITE NAME Privateer Farm	TIP # X-0002	WBS # N/A	INSPECTION DATE Nov-2015
--	-----------------	--------------	-----------------------------

COUNTY Cumberland	# ACRES 430
----------------------	----------------

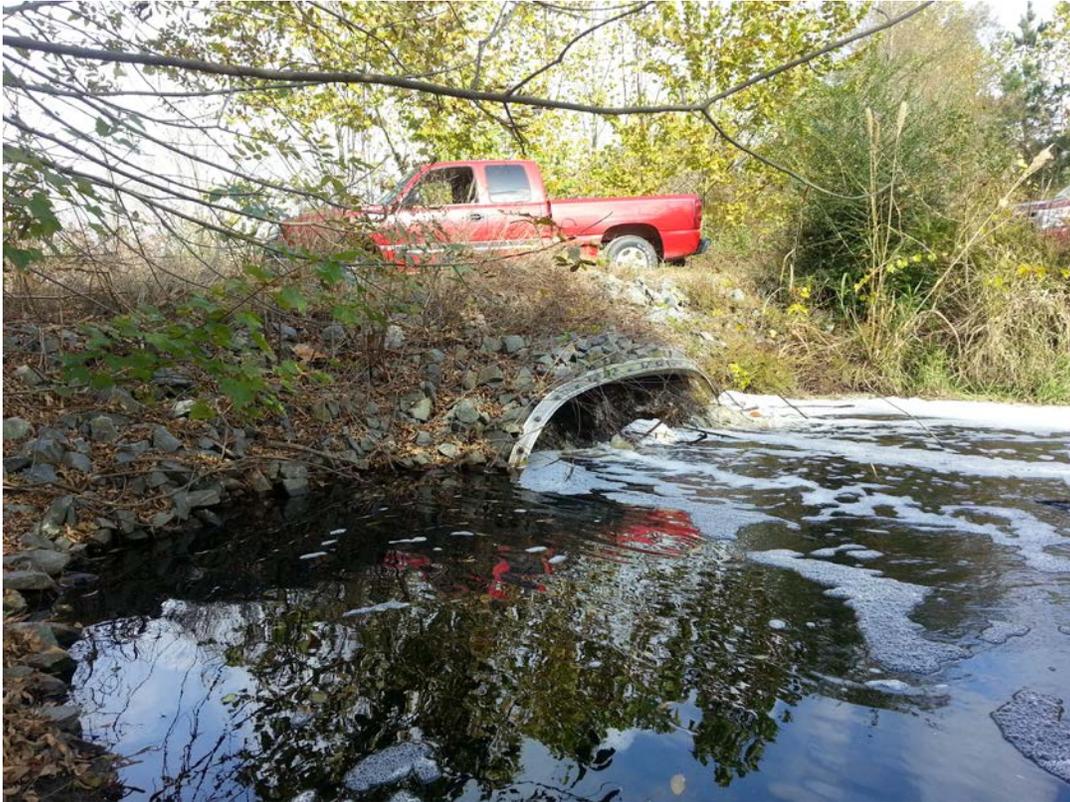
**COMMENTS:** The southern culvert at the access road crossing has a beaver dam inside of it (see photo). This is causing a large portion of the upstream to become flooded and may result in culvert breaching if left alone to spill over the road. We met John Ray (ex-NRCS manager) at the site and he expressed concerns about the flooding. They would like to plant in the spring for wildlife management and are concerned that the flooding with hinder this. The rest of the site appears to be in excellent condition. Main gate at road was locked.

Photo 1 – Southern culvert at access road blocked by beaver dam.

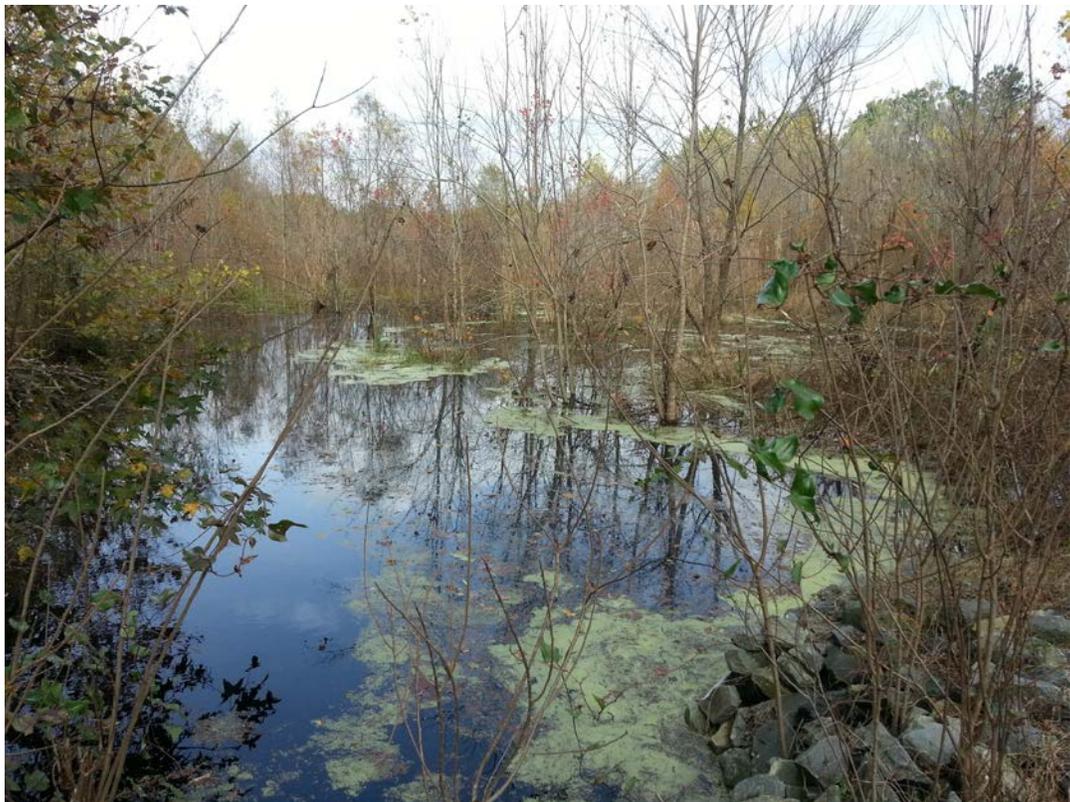
Photo 2 – Flooding looking upstream from blocked culvert.
